21st January, 2020

**RE: Grouse Creek School Building – Seismic Evaluation** for the existing original portion of the school building located in Grouse Creek, UT.

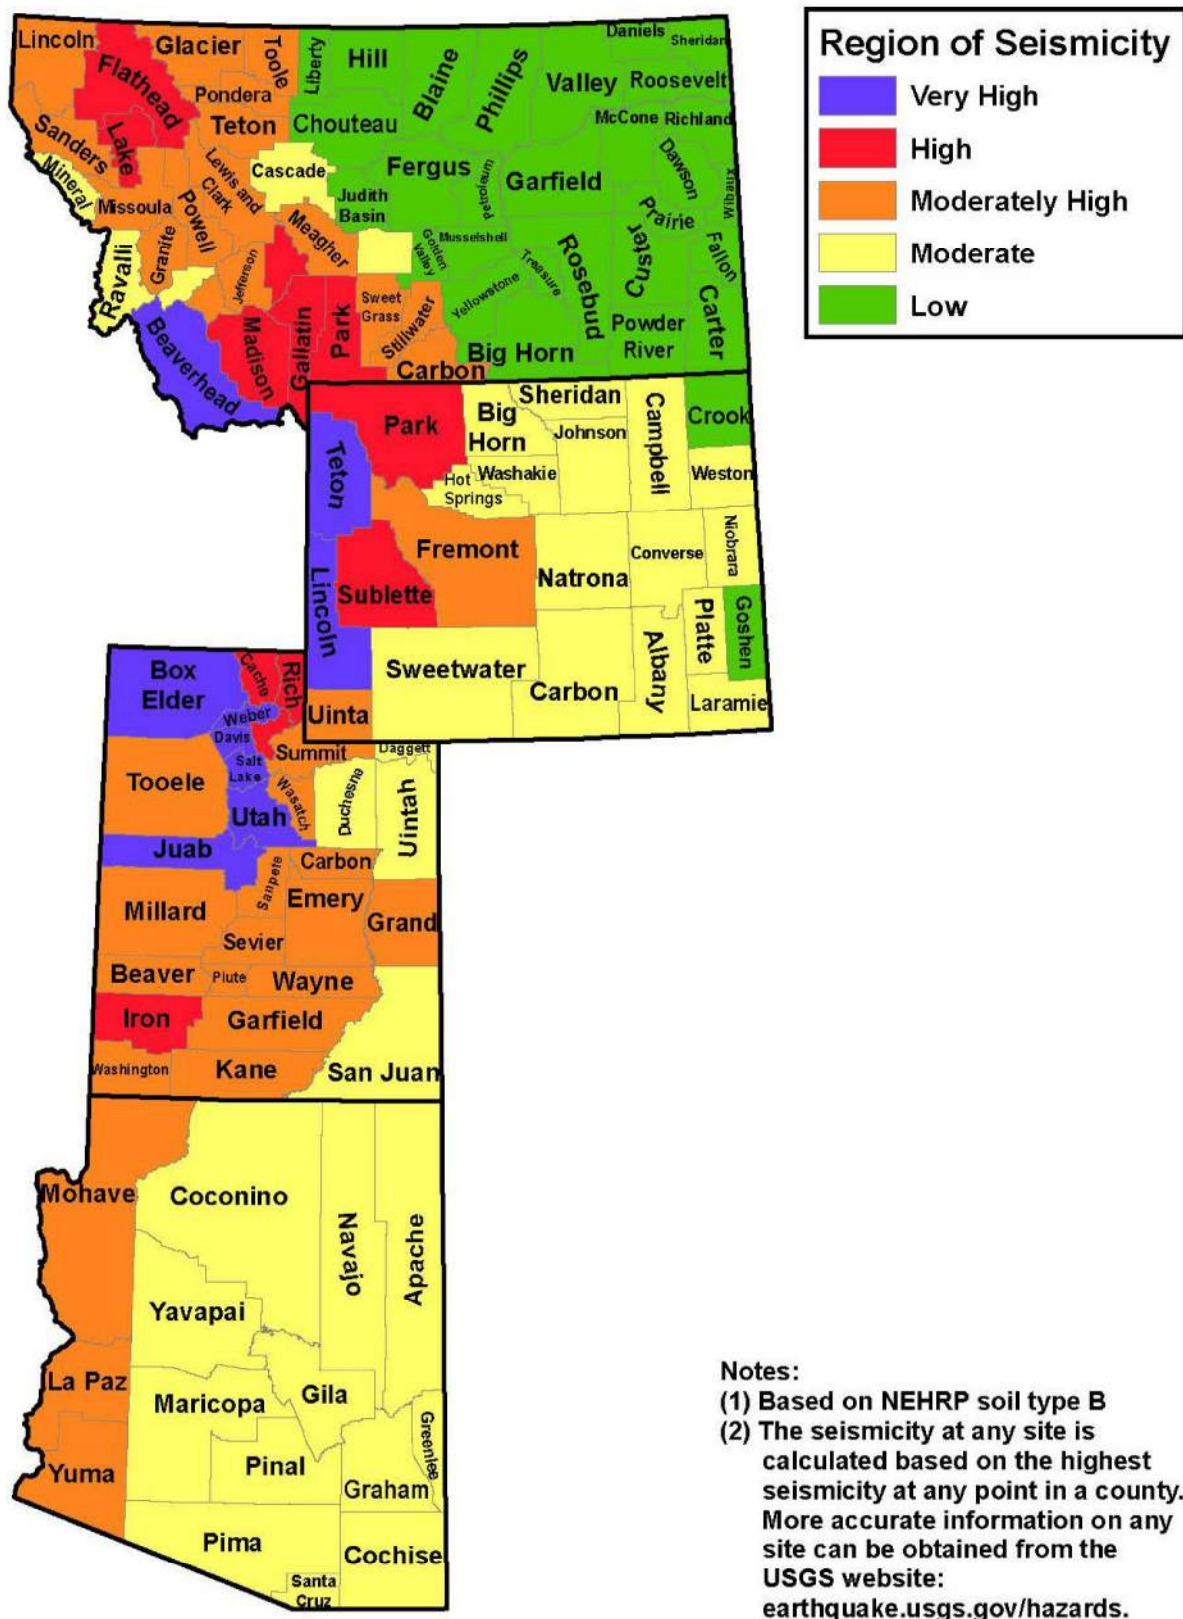
Figure A-3 Seismicity regions in Arizona, Montana, Utah, and Wyoming.

**Figure 1** indicates Box Elder County is considered a “Very High” Region of Seismicity.

However, this appears due to the potential high seismic accelerations in Brigham City, near the mountains. The site-specific accelerations in Grouse Creek are lower, with  $S_s = 0.424g$  and  $S_1 = 0.1395g$  (see attached **Figure 2**). Thus, the Region of Seismicity for Grouse Creek would be considered “Moderate” (see attached **Figure 3**), and not “Very High”.

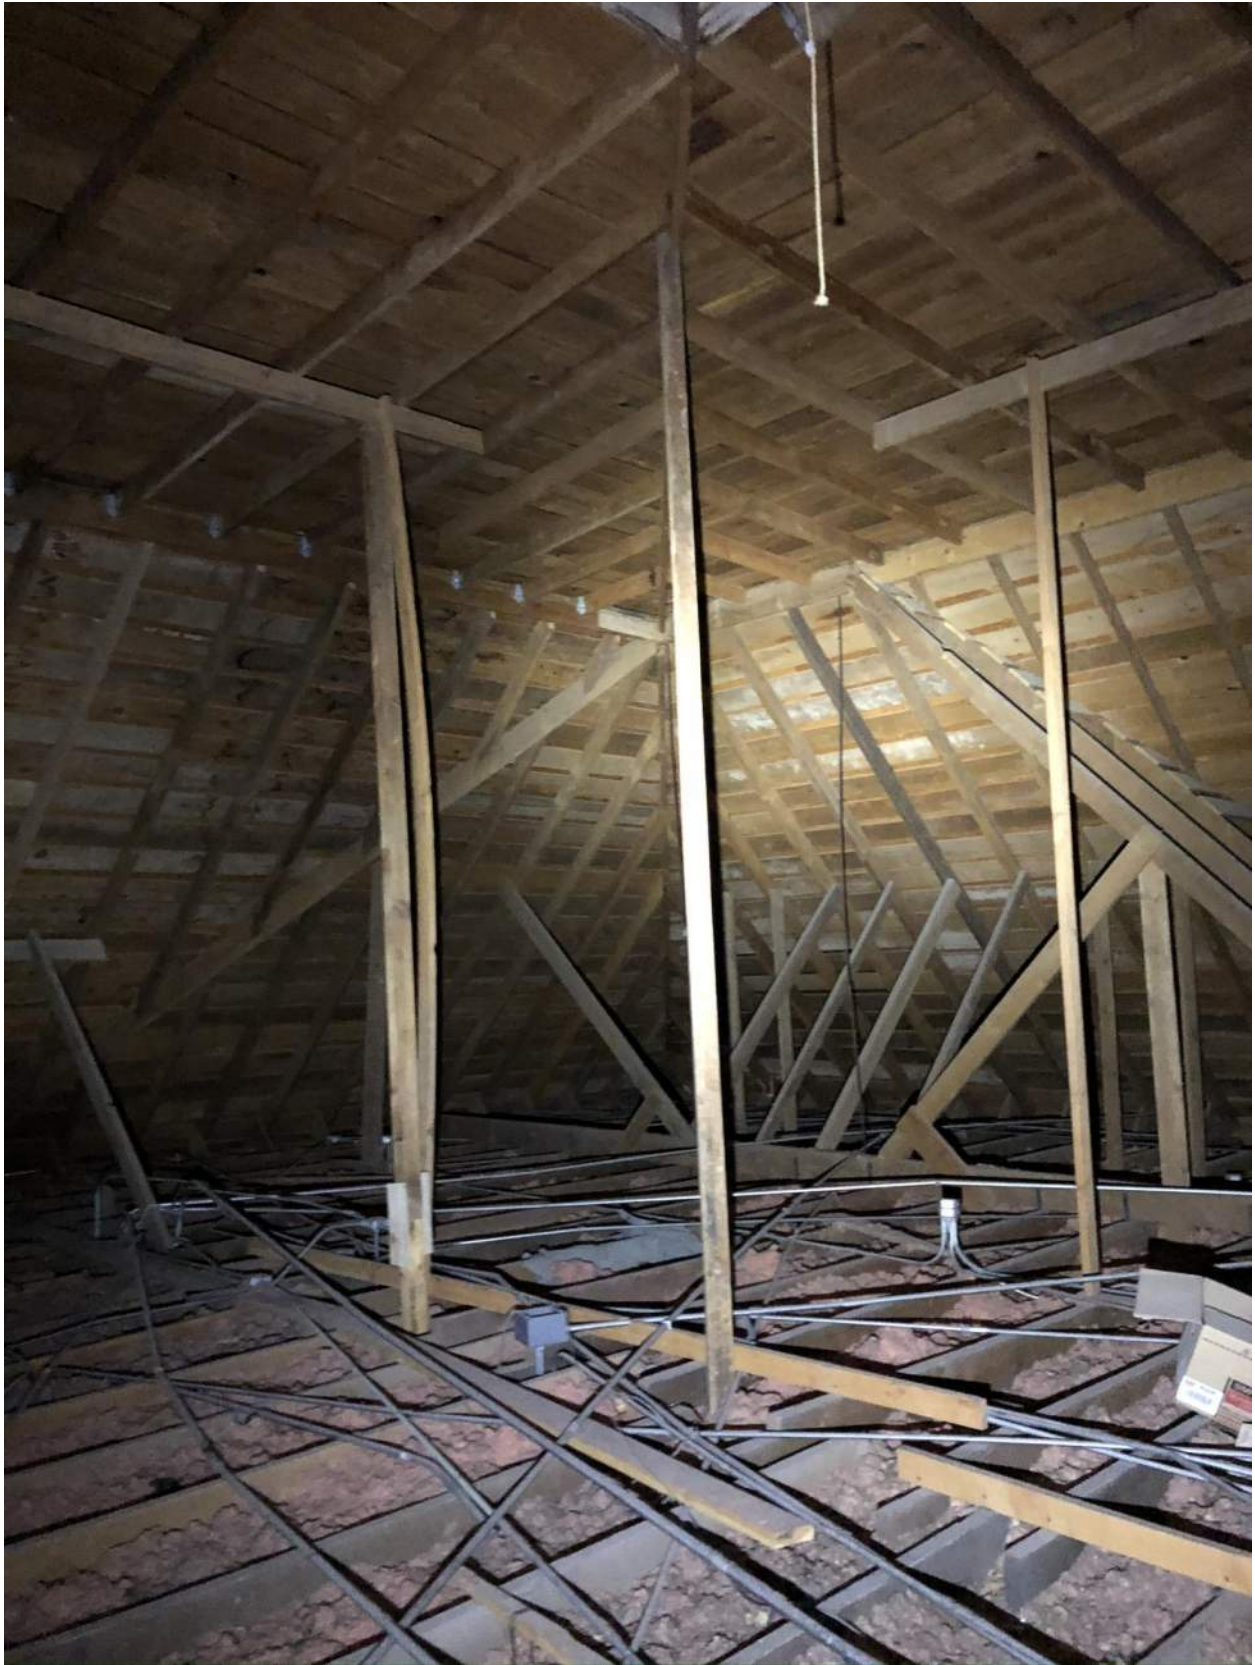
Photo 4 – Existing roof framing over classroom area. Note erratic, inadequate support and bracing.

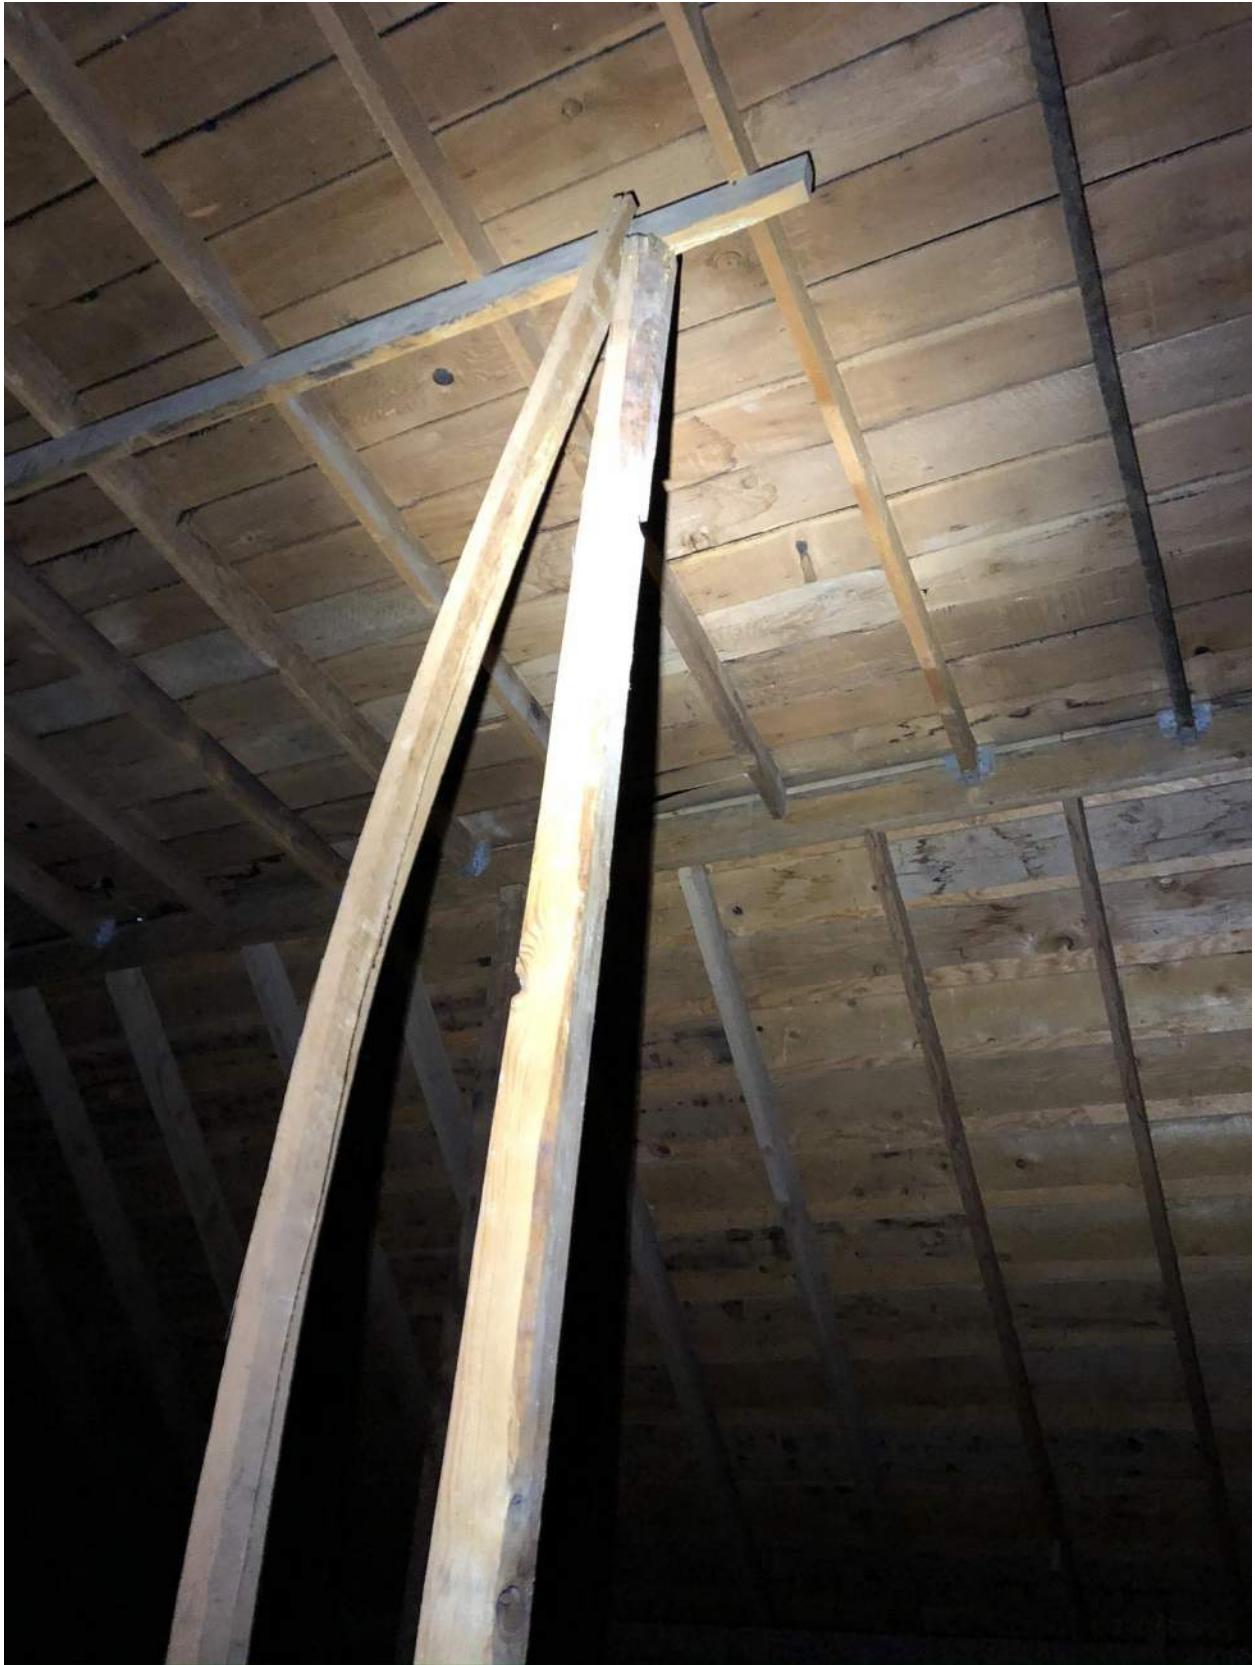
Photo 5 - Existing roof framing over classroom area. Note buckled and bowed bracing member.

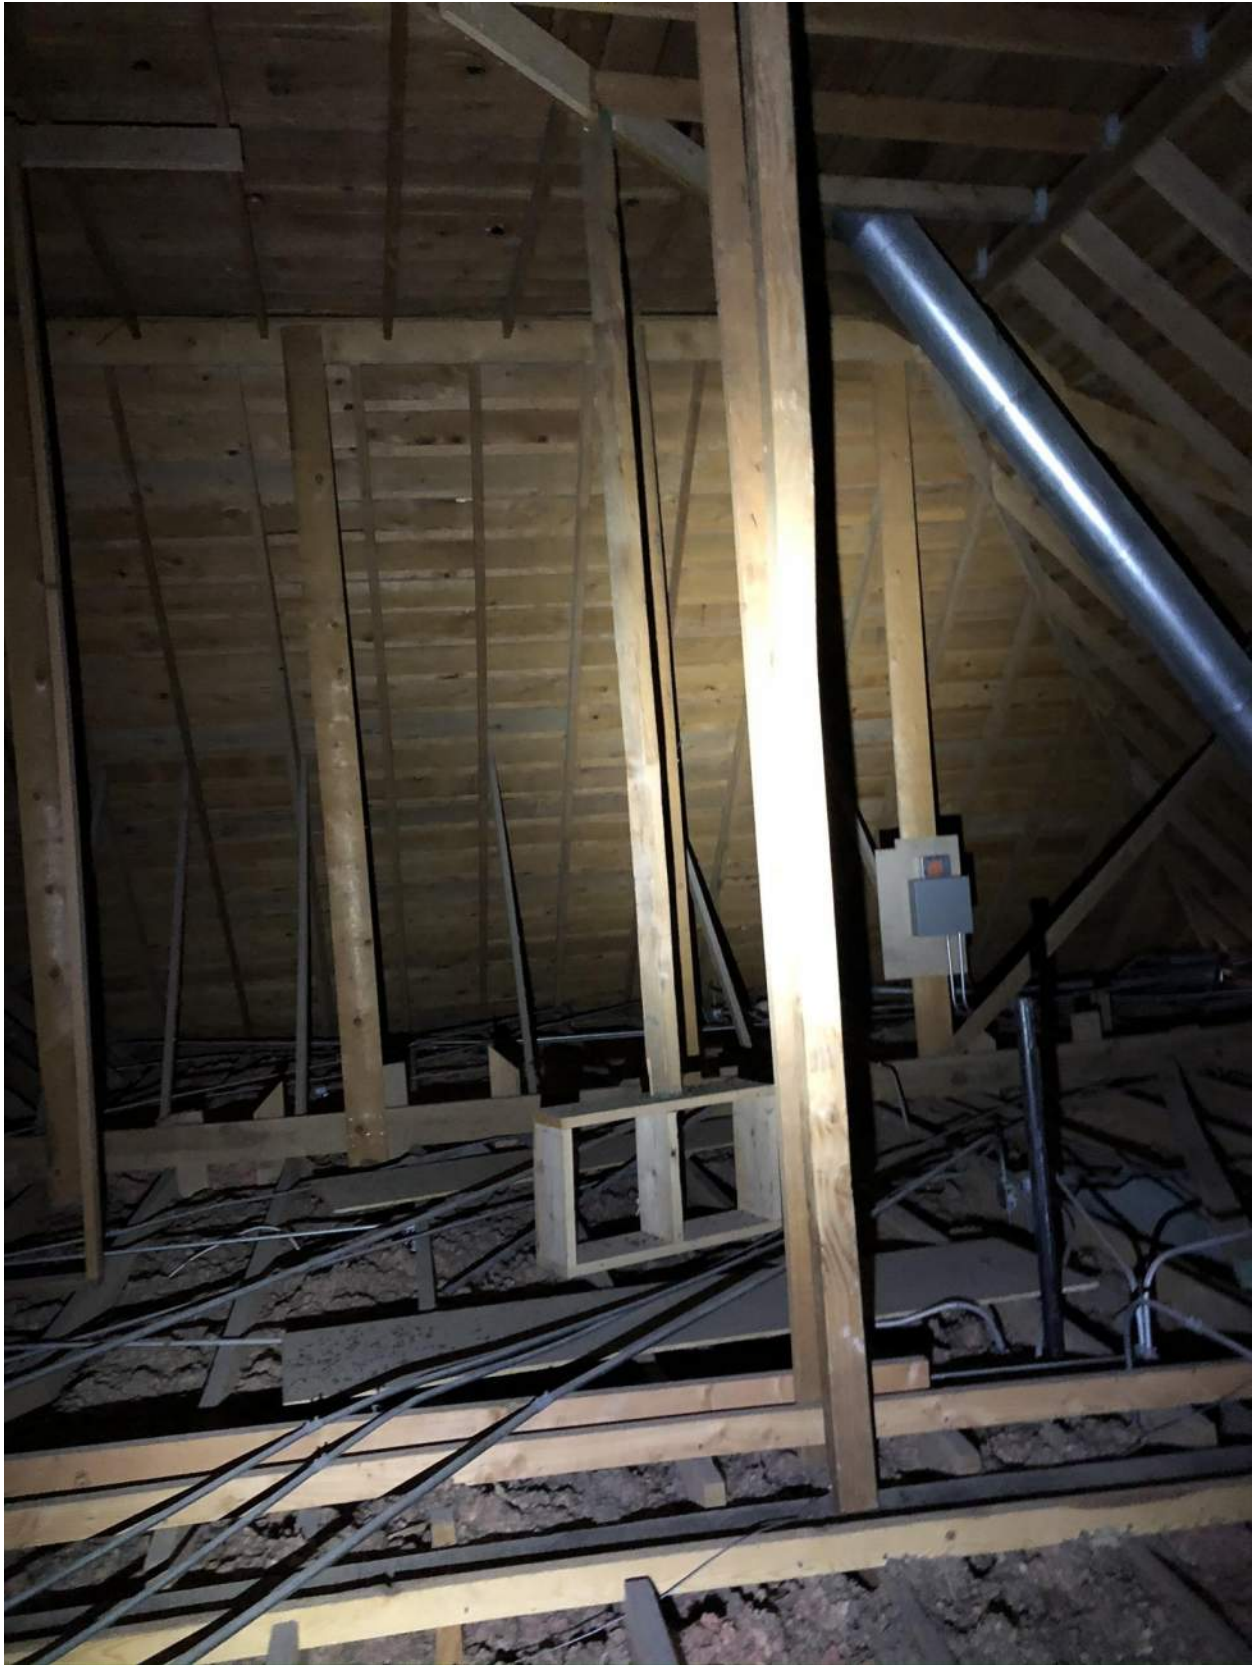
Photo 6 - Existing roof framing over classroom area. Note erratic, inadequate support and bracing.

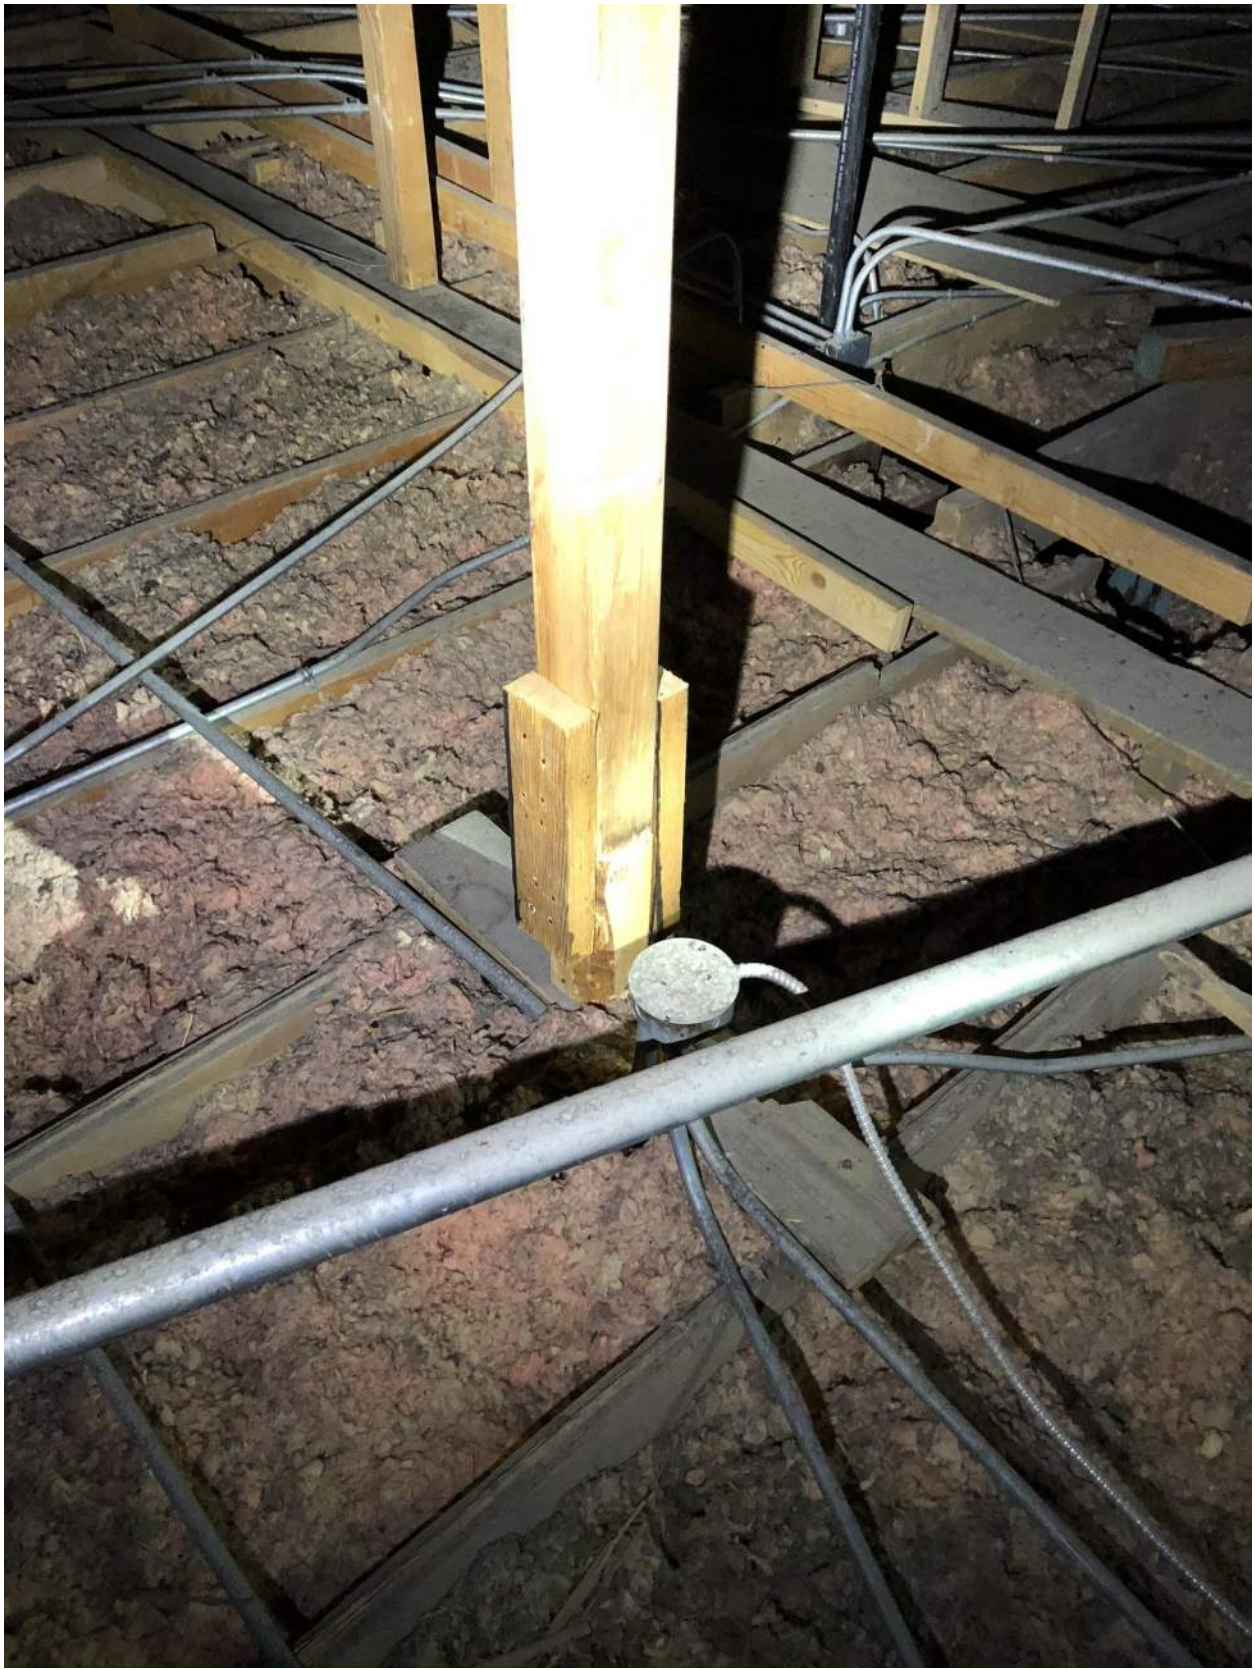
Photo 7 - Existing roof framing over classroom area. Scabbed together, unstable support brace.

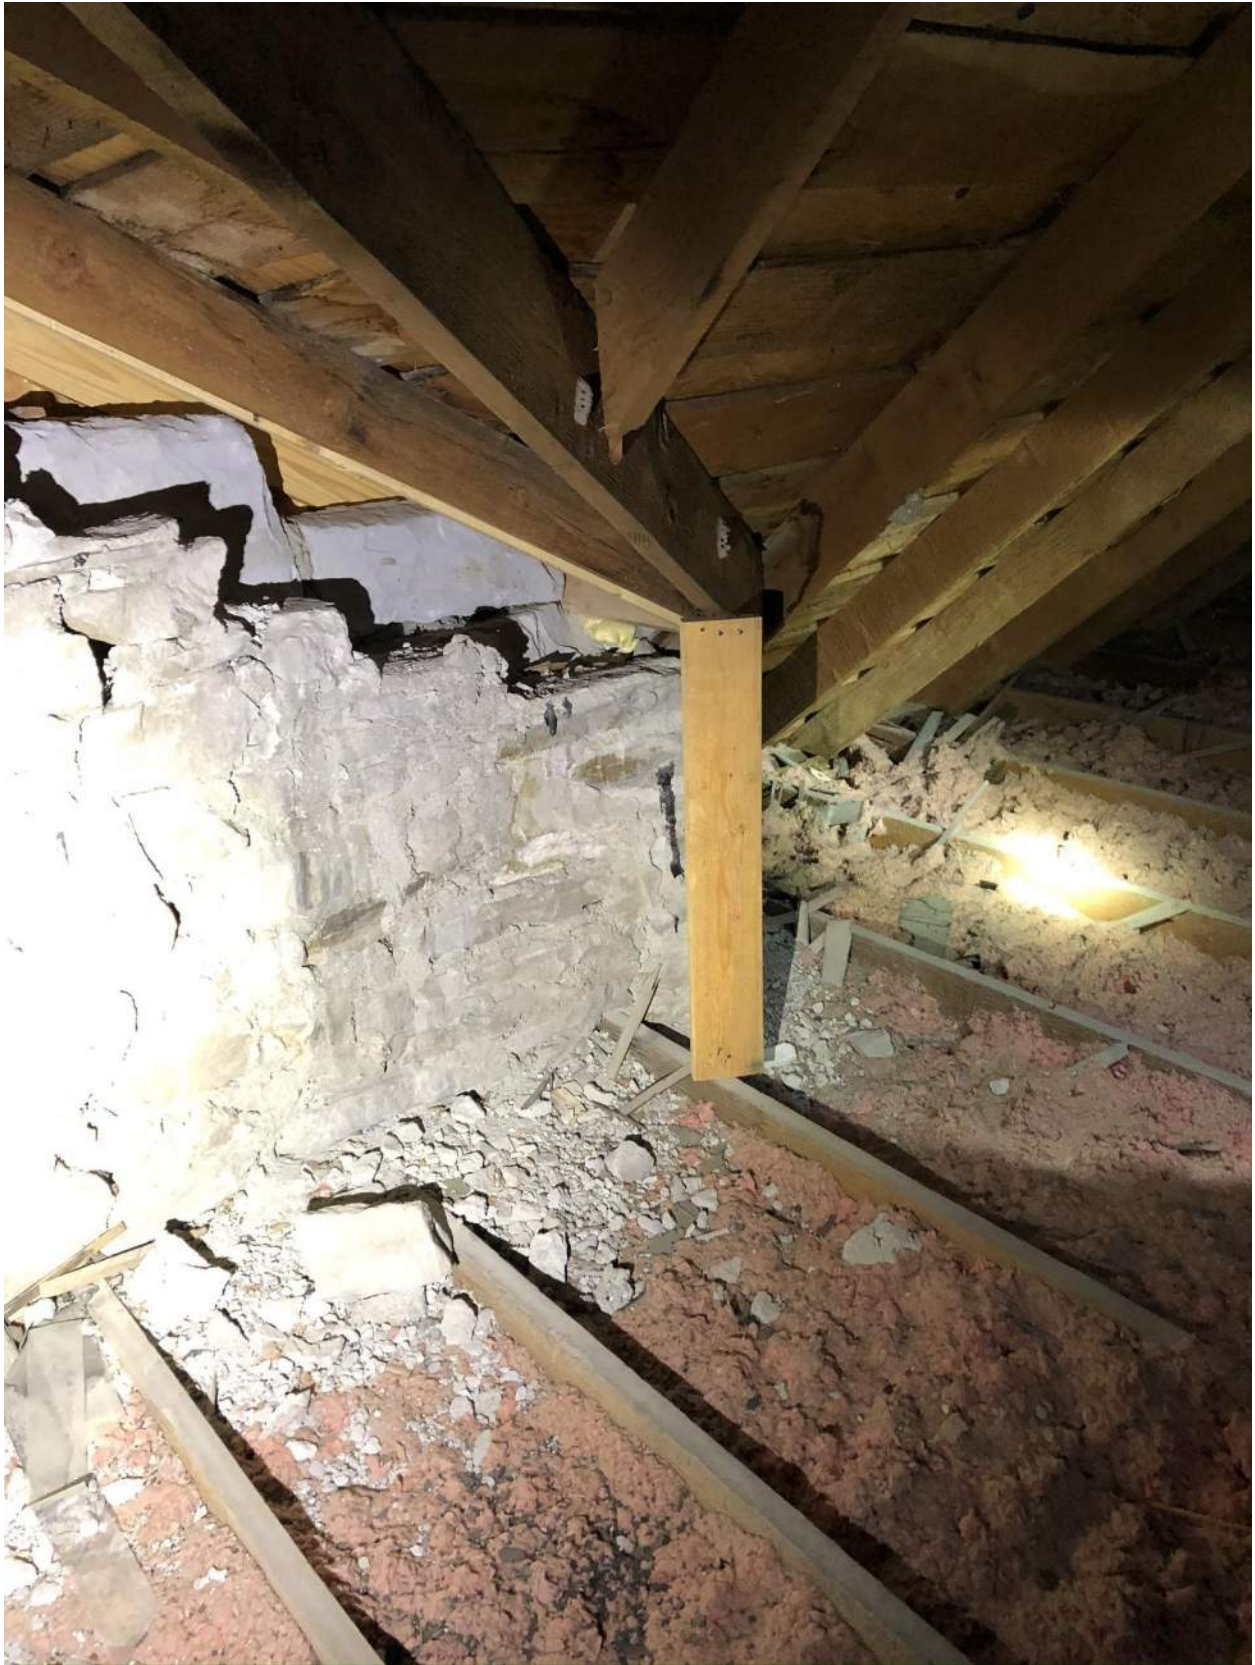
Photo 8 - View of inside face of gabled end wall above east entry. This is the condition at the base of the roof valley. Inadequate brace and support.

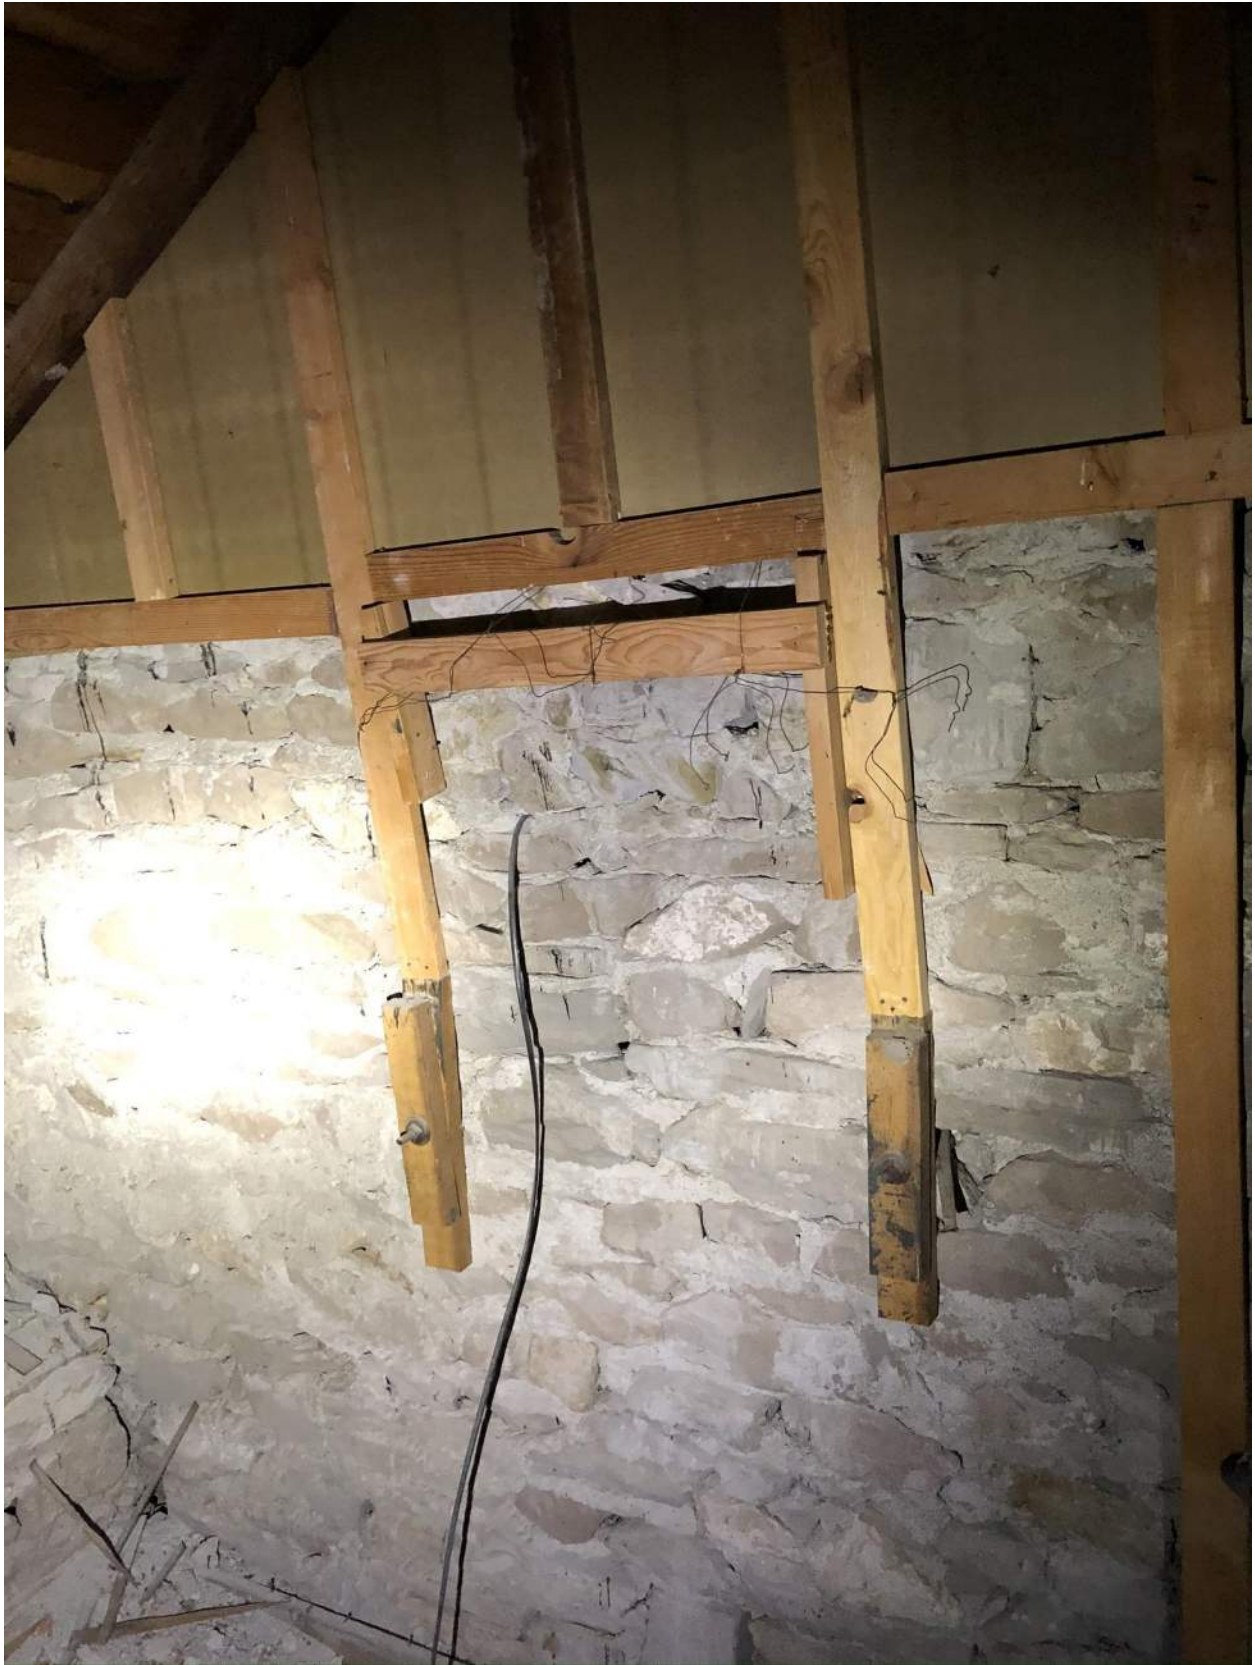
Photo 9 - View of inside face of gabled end wall above east entry. This shows how the wood canopy is anchored.

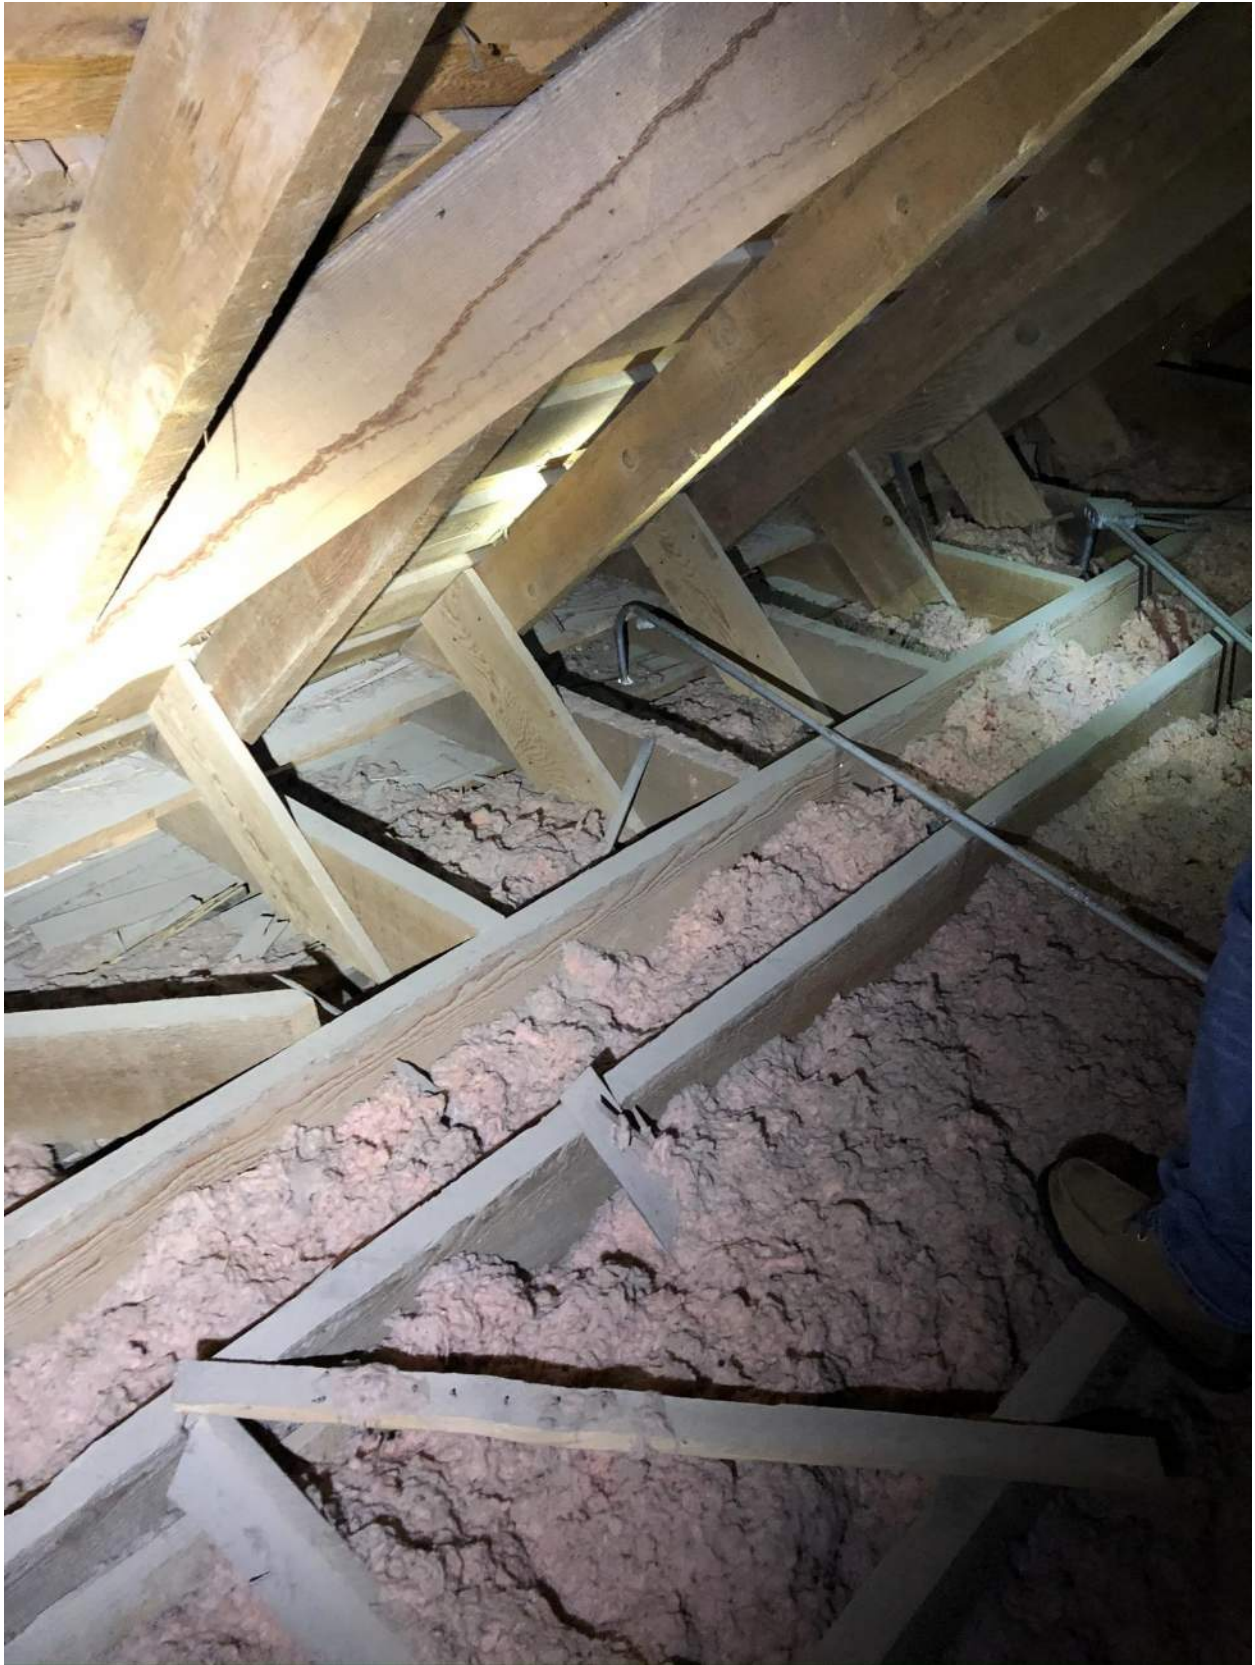
Photo 9 – View of roof to wall connection along north and south exterior walls. No in-plane shear connection or out-of-plane anchorage to the stone wall below.

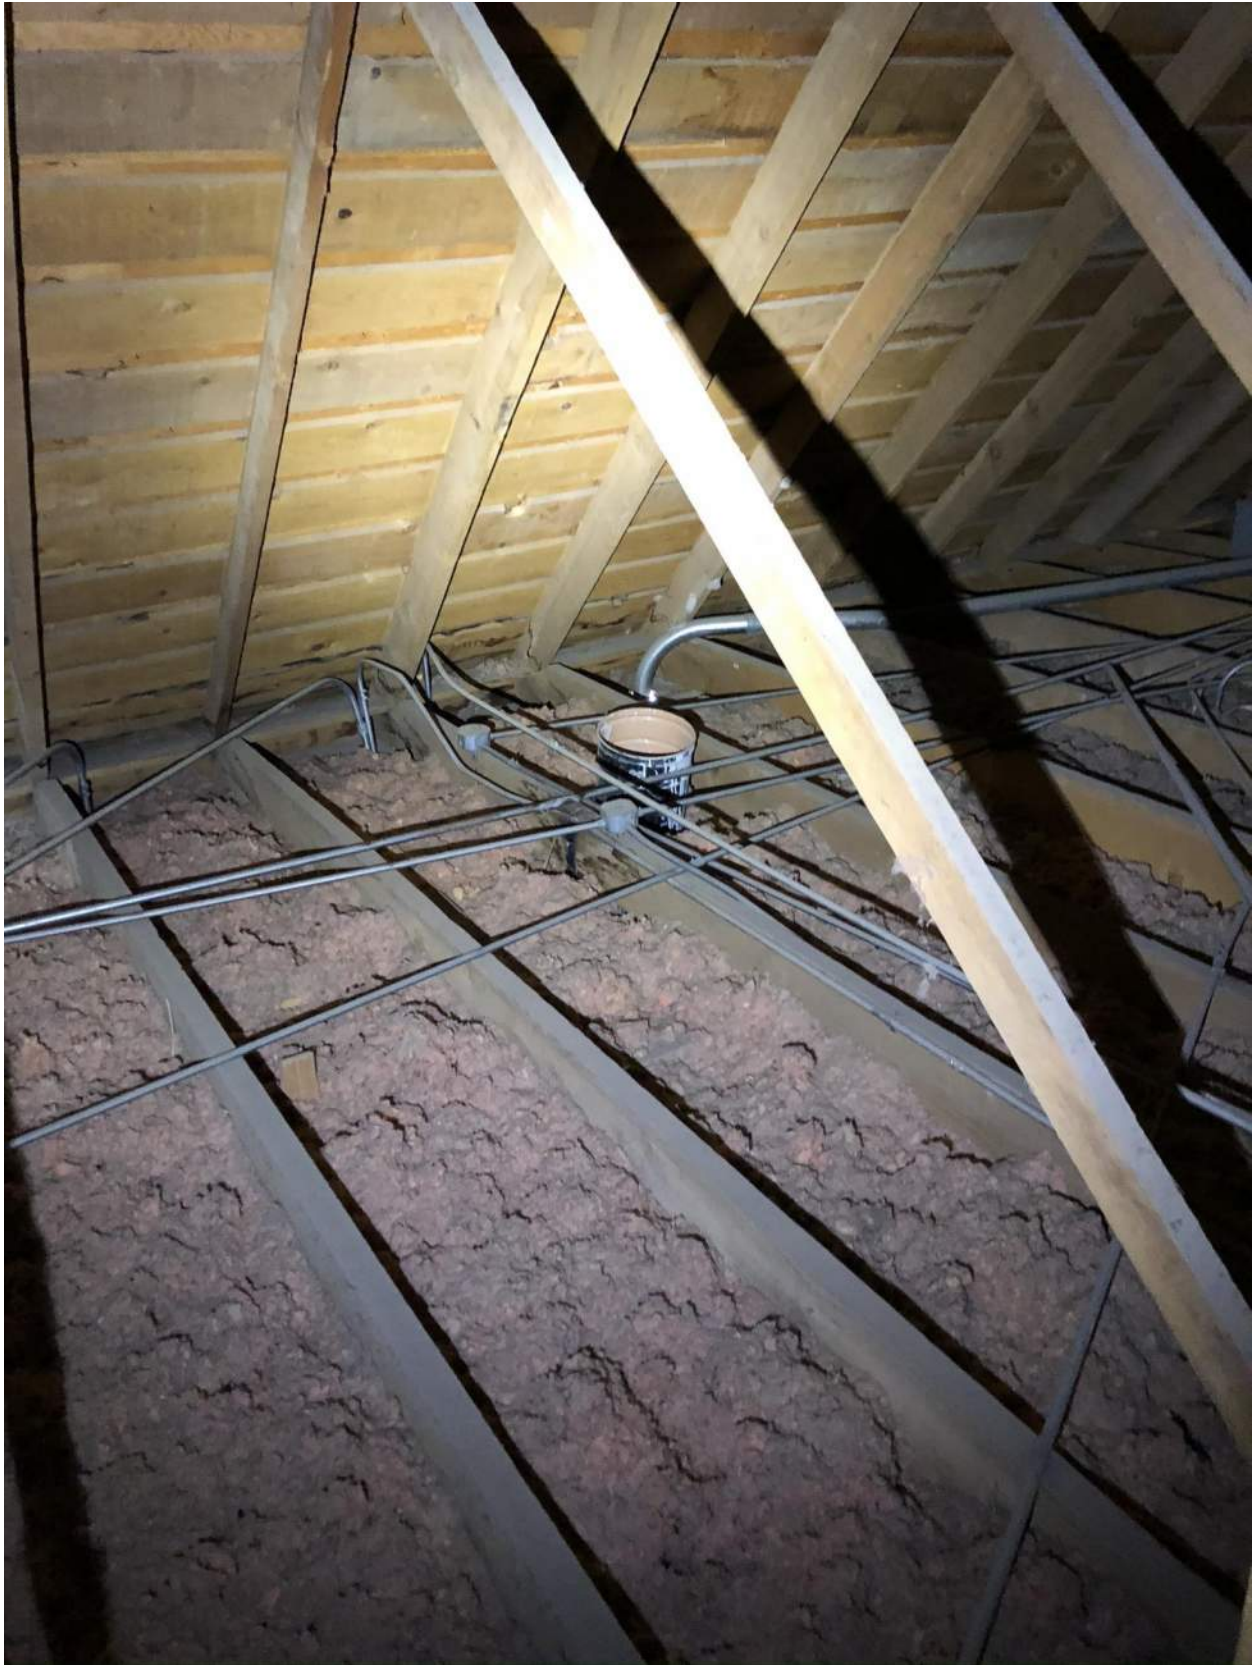
Photo 10 – View of roof to wall connection along east and west exterior walls. No in-plane shear connection or out-of-plane anchorage to the stone wall below.

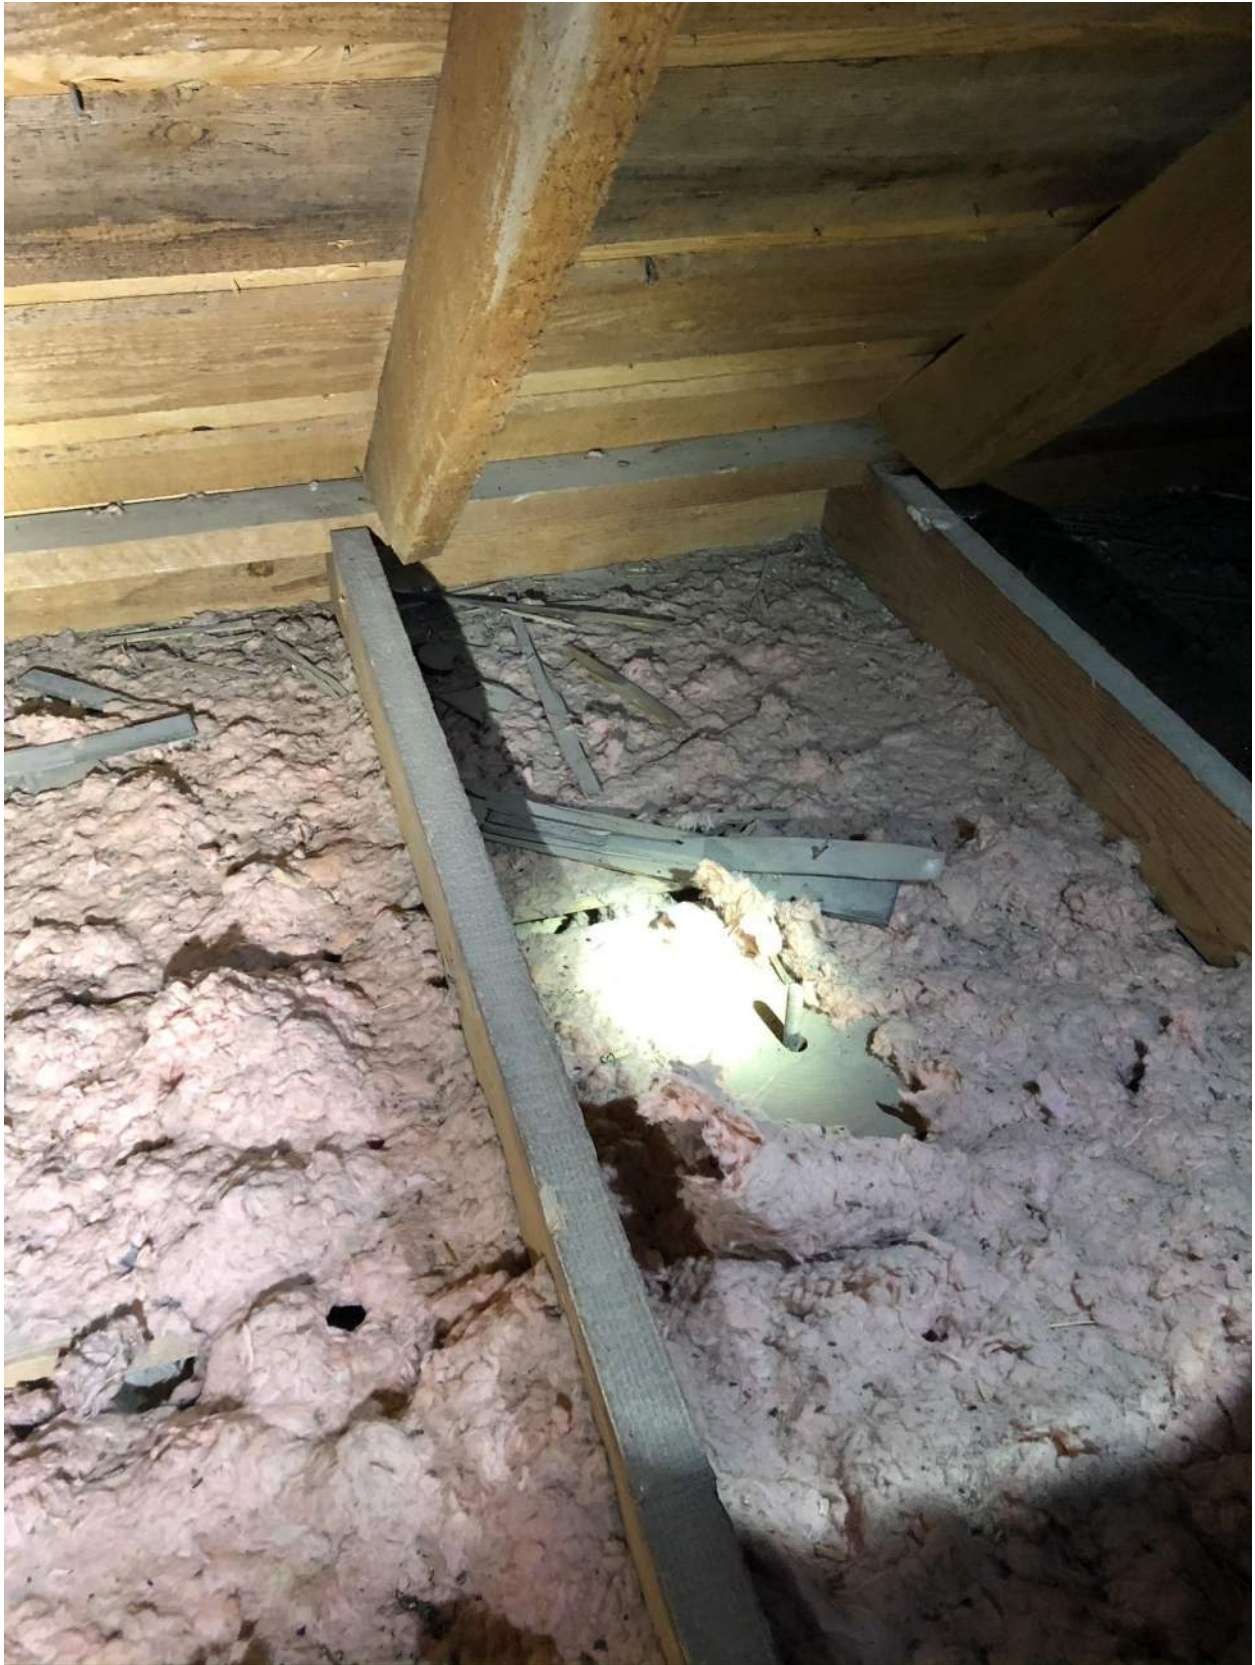
Photo 11 – View of existing anchor bolts along top of stone exterior walls. Bolt locations are erratic. Not nuts or washers are present on the anchor bolts.

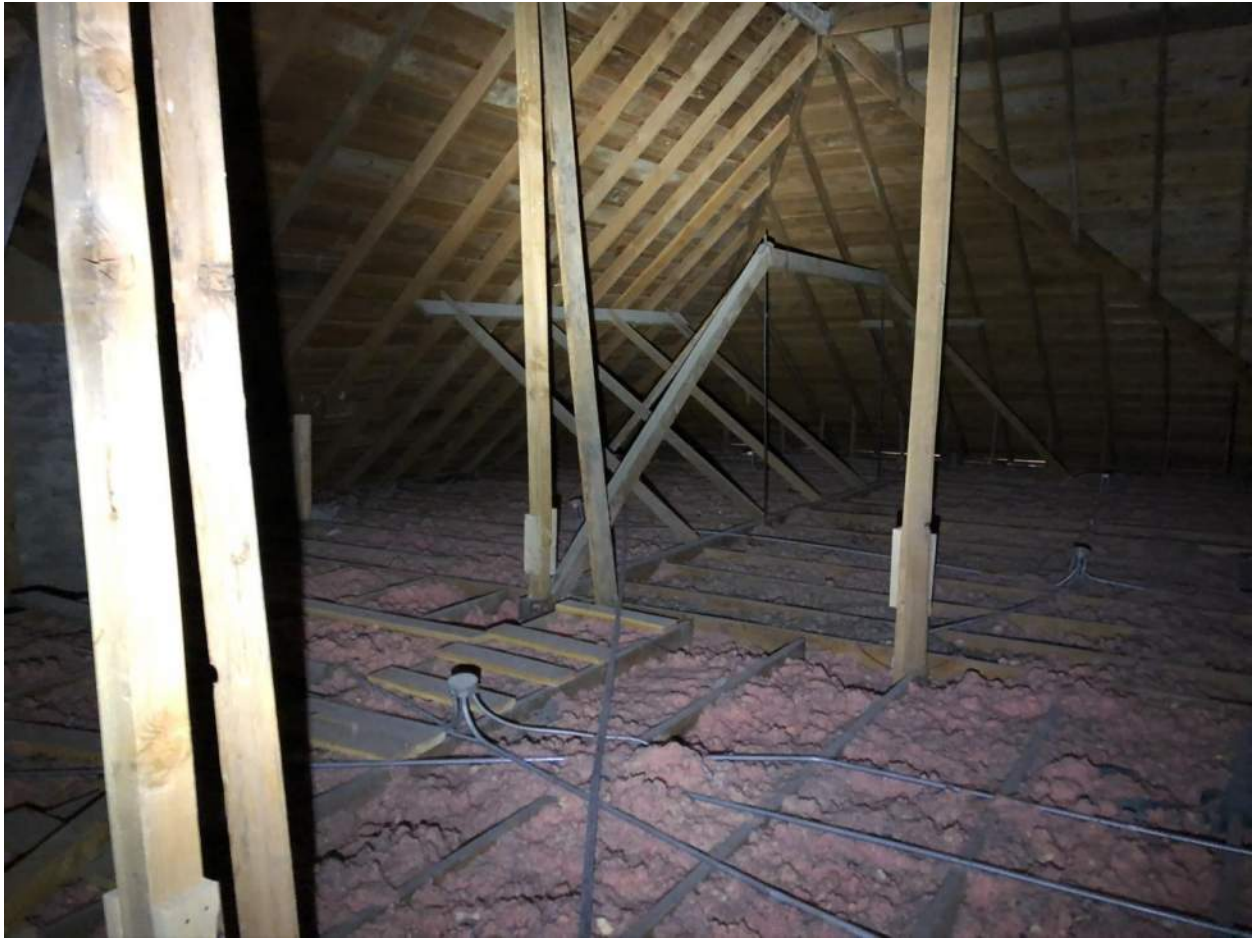
Photo 12 – View of wood and steel rod attic truss for ceiling joist support. This truss is clearly inadequate for its intended use.
