21st January, 2020

**RE: Grouse Creek School Building – Seismic Evaluation** for the existing original portion of the school building located in Grouse Creek, UT.

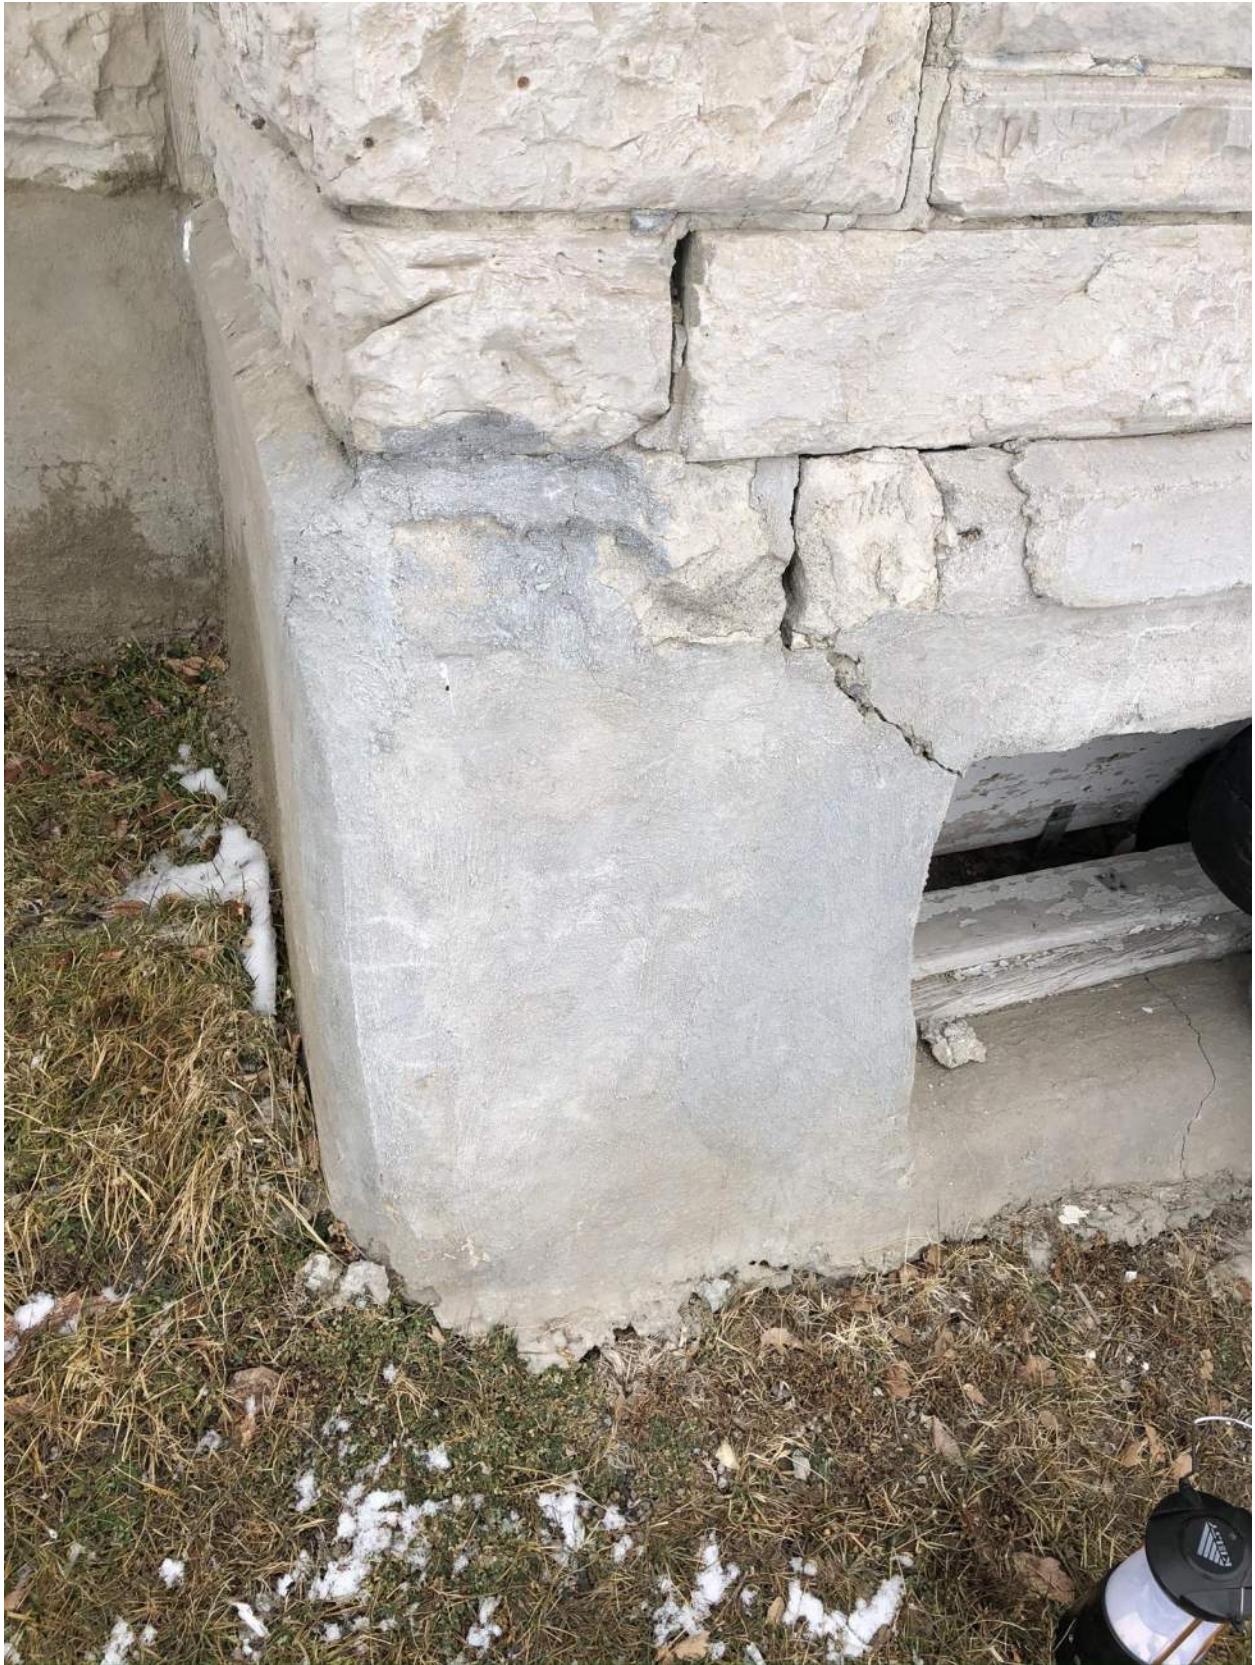
Photo 13 – View of foundation along the south wall. Settlement and cracking are present.

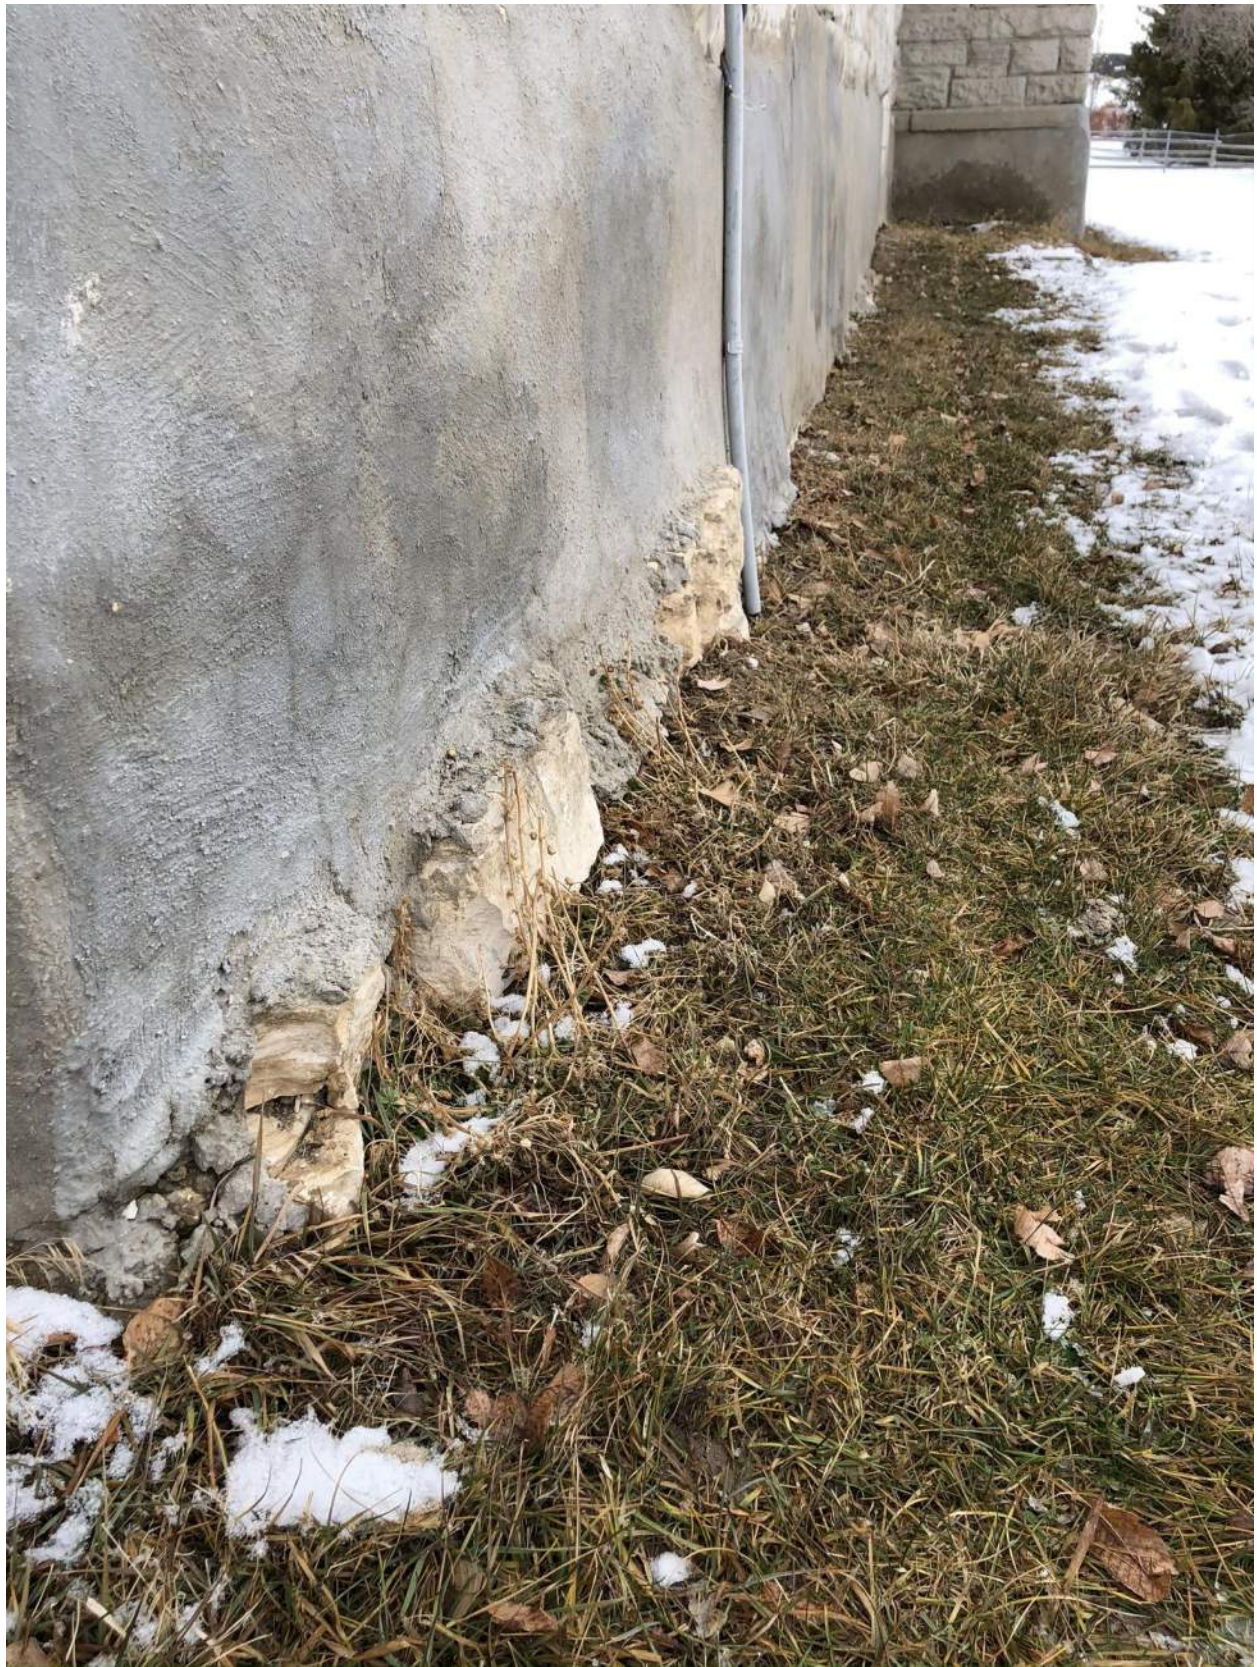
Photo 14 – Another view of the foundation along the south wall. Plastered stone.

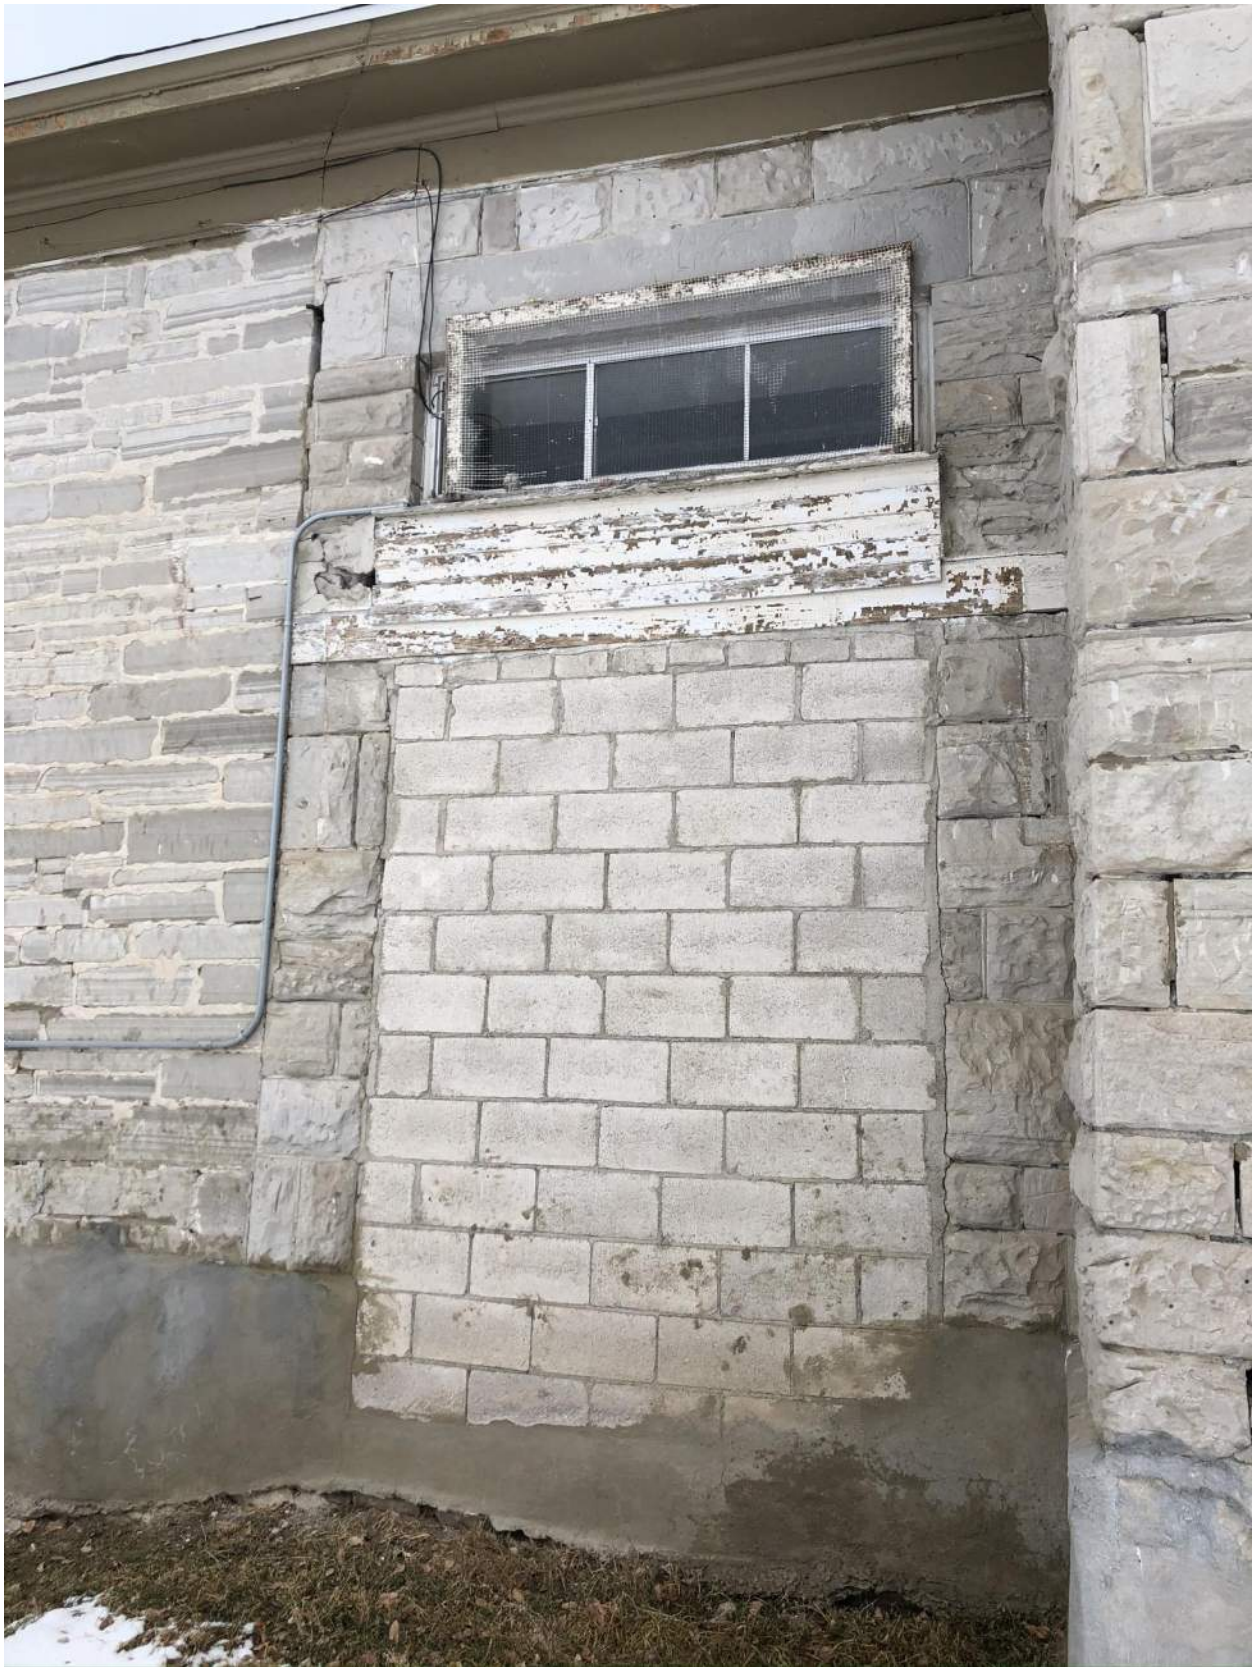
Photo 15 – View of infilled opening in south exterior wall. Note the wood header below the window, which is deteriorating.

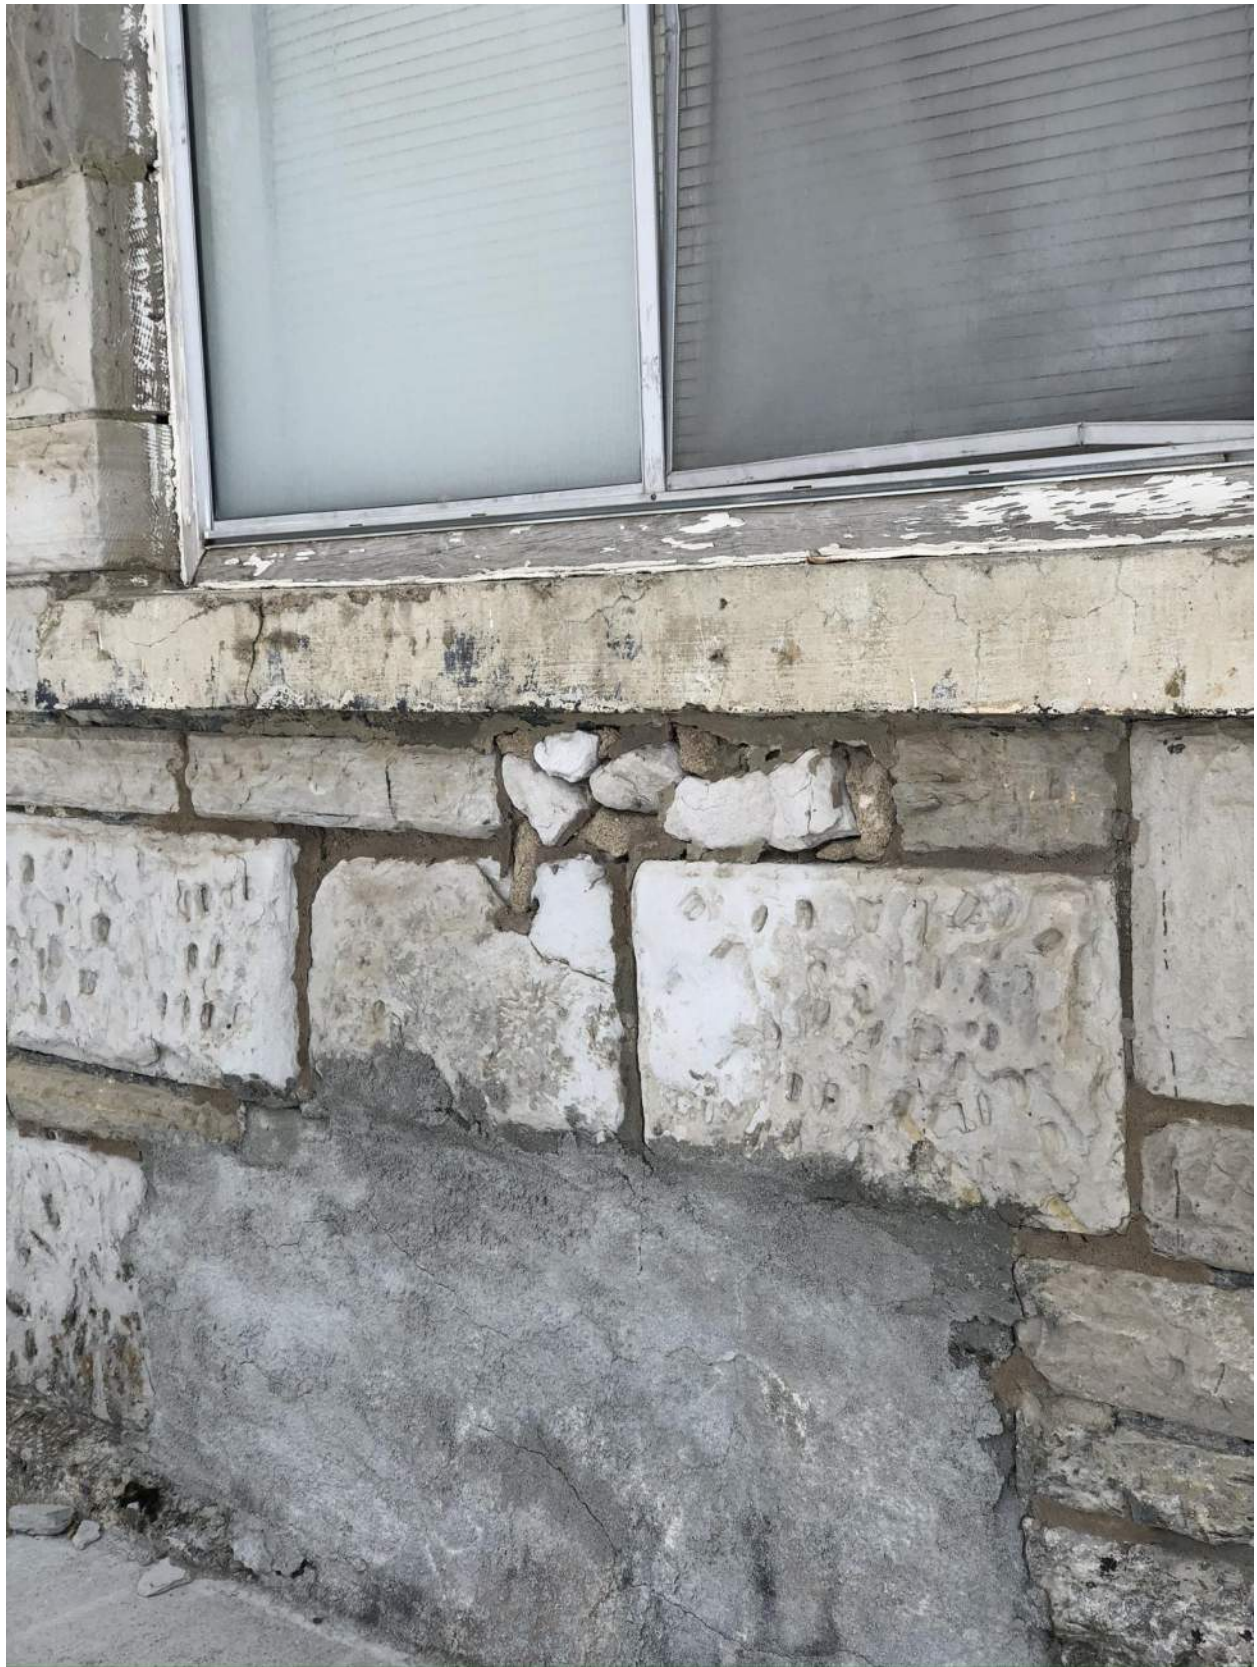
Photo 16 – View of stone and deteriorating mortar along the north exterior wall.

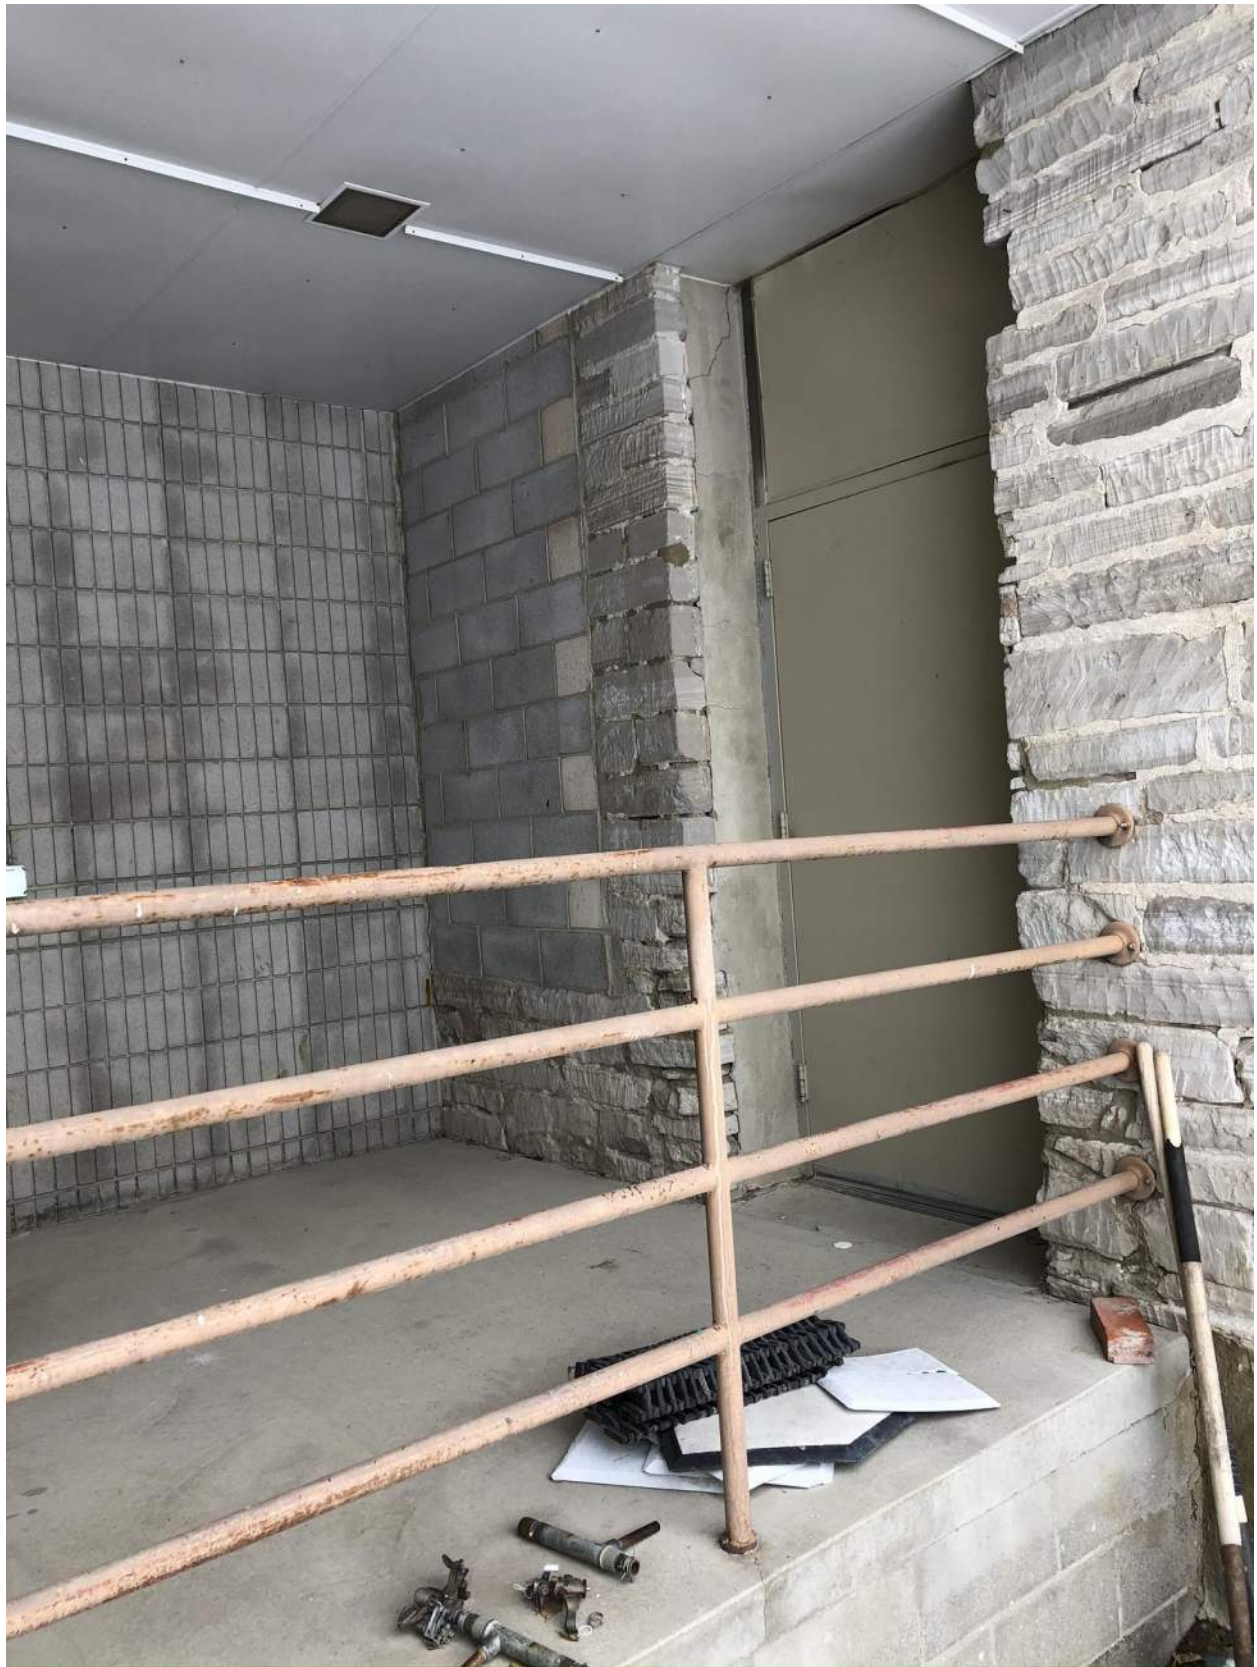
Photo 17 – View of infilled opening in west exterior wall at the Breezeway.

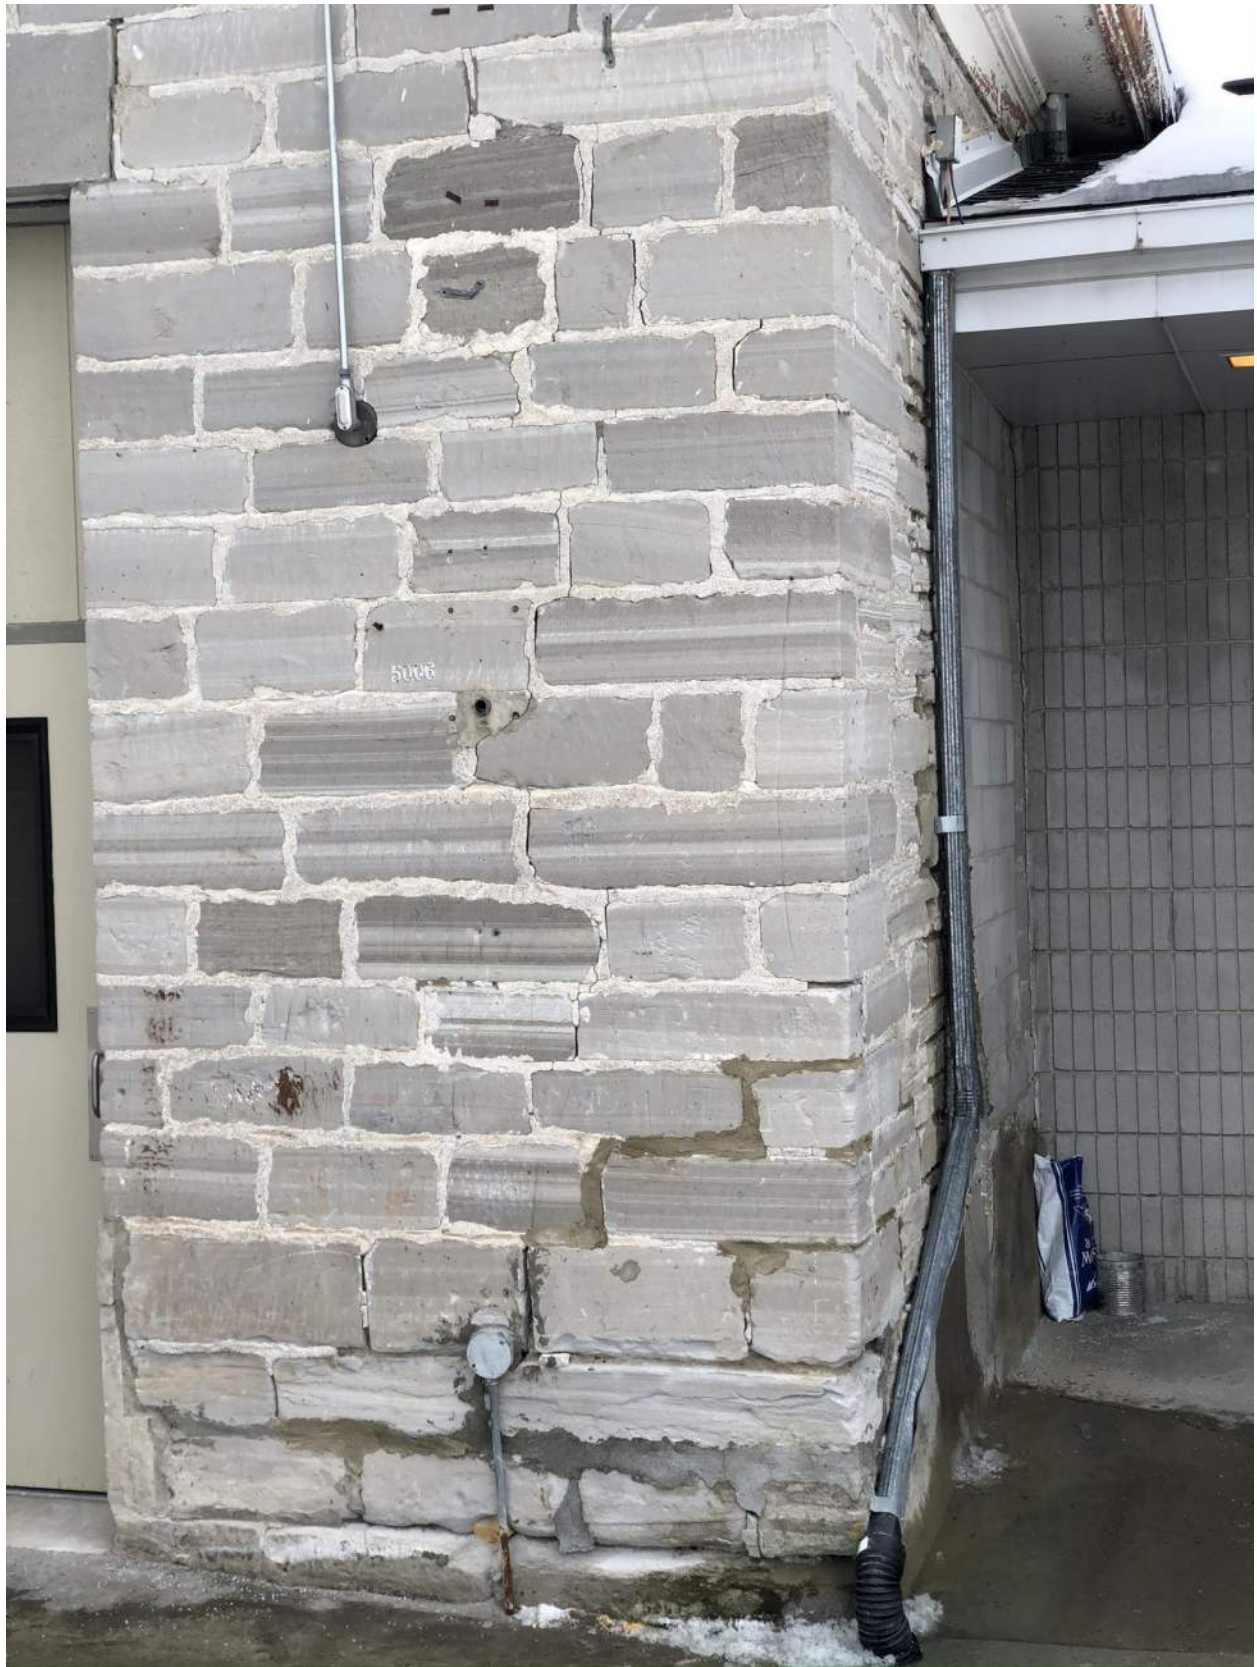
Photo 18 – View of the northwest corner of the kitchen area, near the breezeway. Note mortar deterioration and cracking.
