**TREMCO INCORPORATED
WEATHERPROOFING TECHNOLOGIES, INC.
ROOF ANALYSIS REPORT**

DATE: September 9, 2019

BUILDING: Old Library
609 Labbe,
San Diego, TX 78384

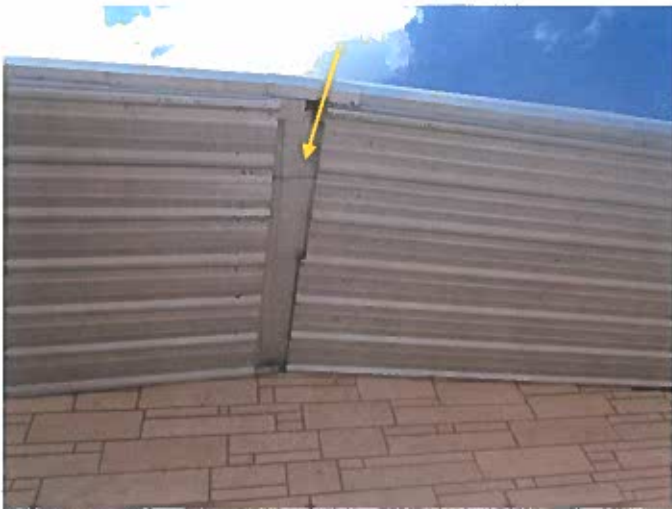
Soffit trim installed without trim closure.

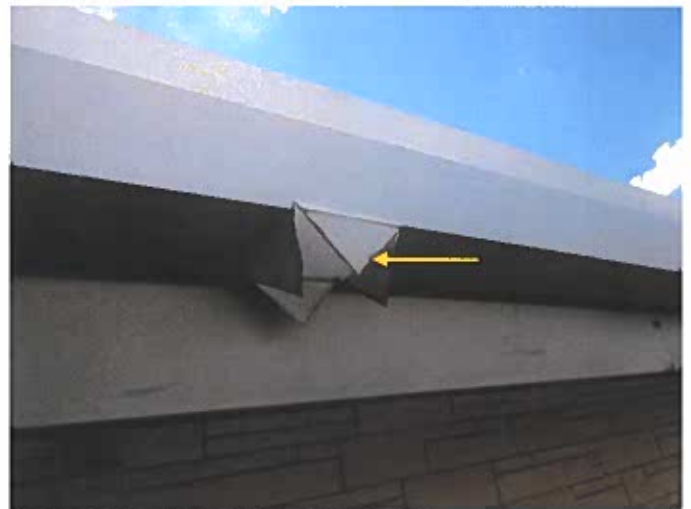
Incomplete and missing downspouts.

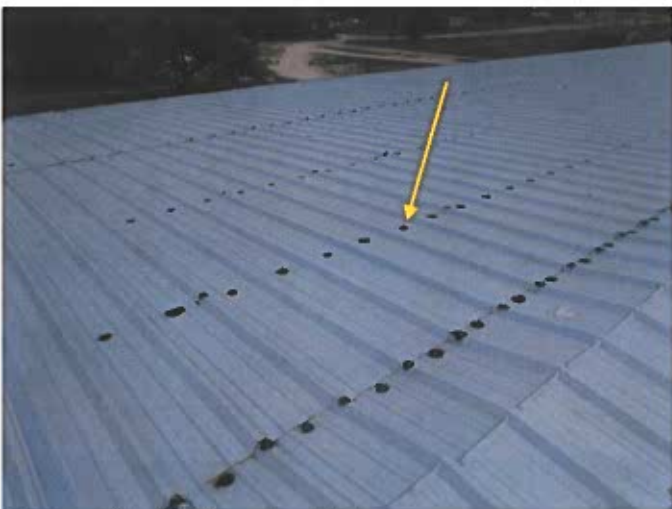
Previous repair attempts at fasteners.

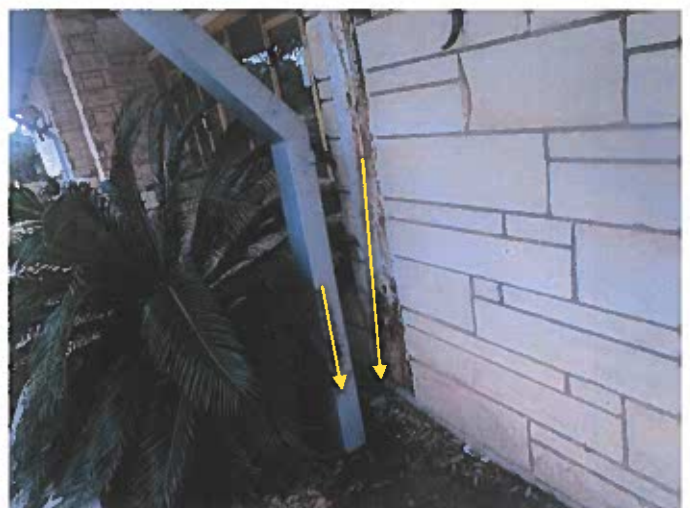
Loose downspout not in drain location.

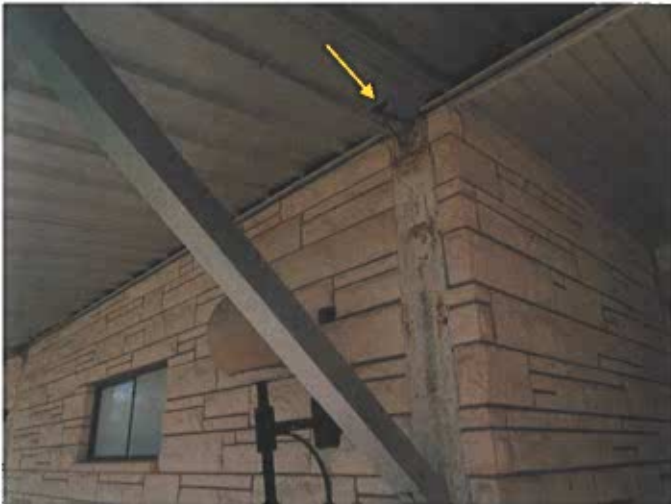
Rust accumulation on structural metal. Trim should be installed over angled protrusions.

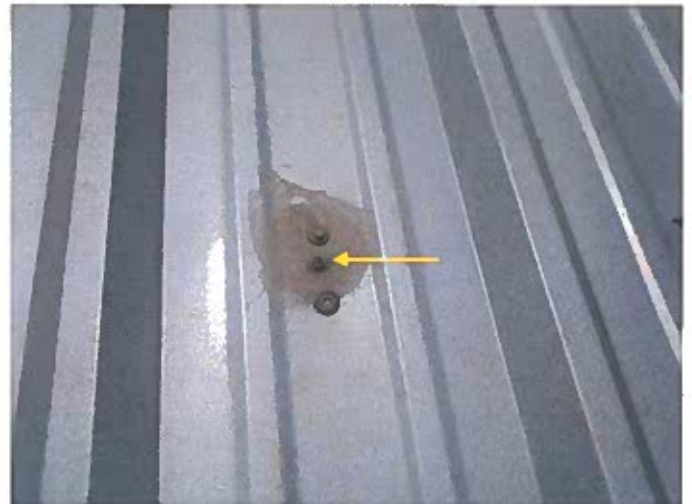
Fastener missing gasket. Multiple screws in proximity indicate missed anchor point to purlin.

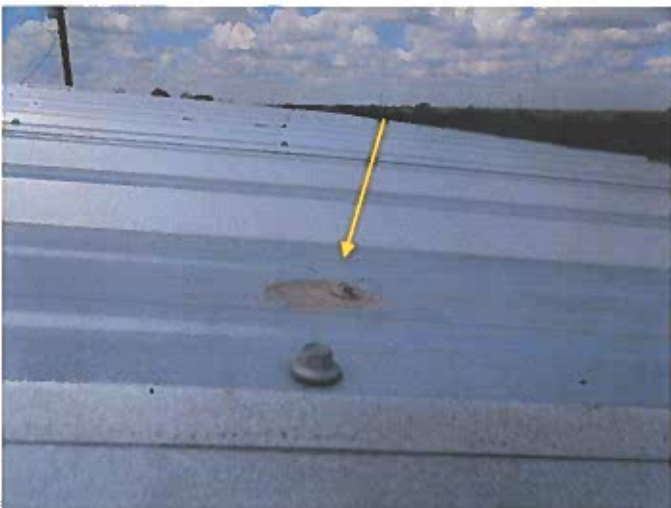
Screw off center.

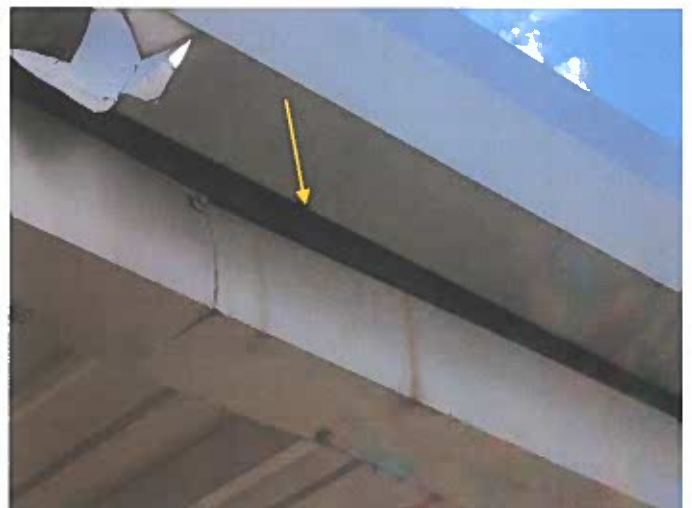
Exposed structural metal.

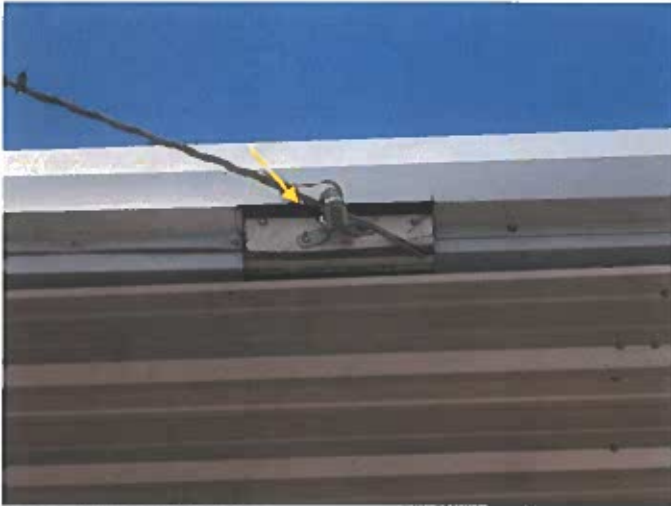
Incorrect eave flashing.

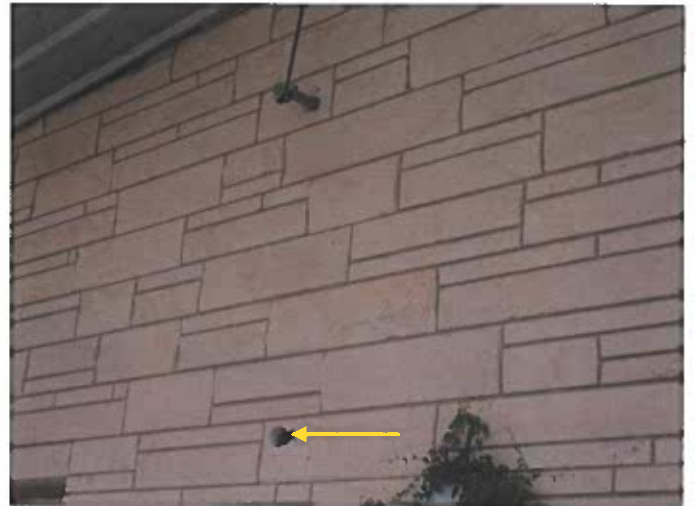
Open wall penetration.

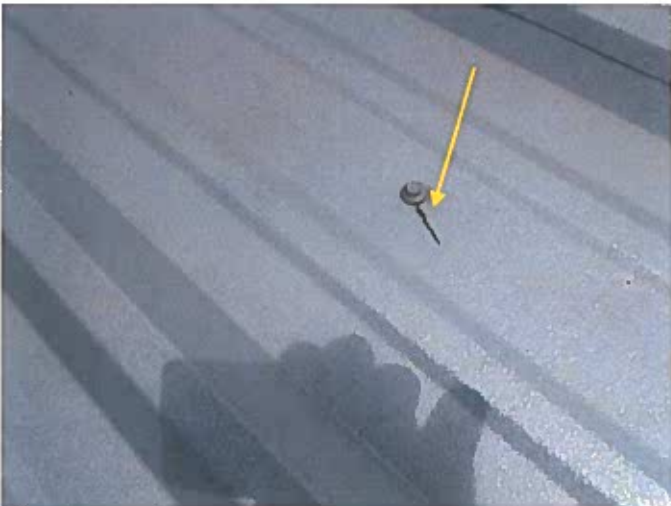
Over torqued screw.

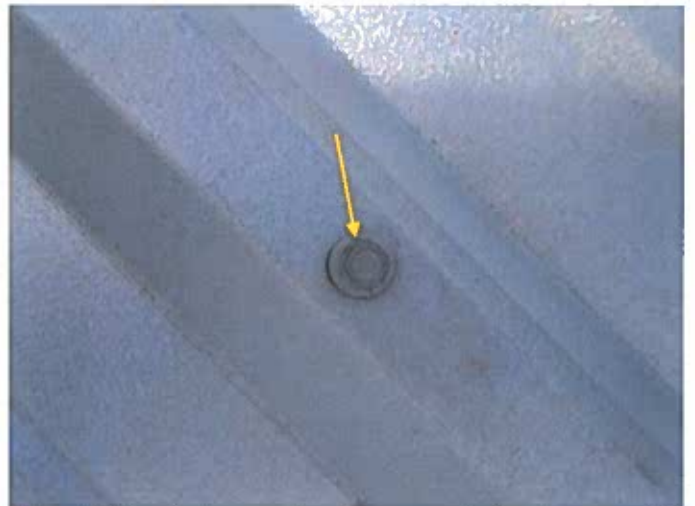
Not a lifetime fastener. Fasteners used of a lower quality than recommended.

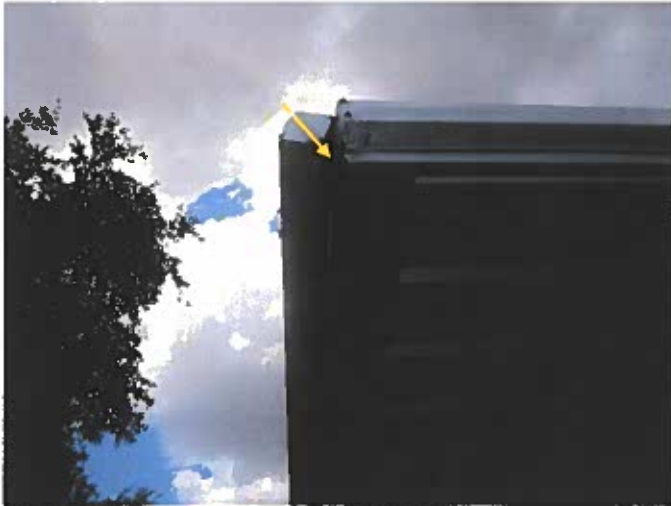
Gutter pulling away from perimeter edge.

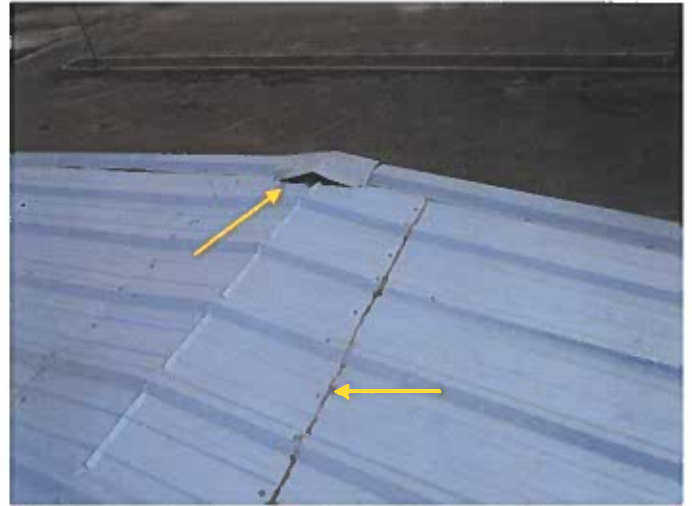
Previous repair attempts. Open gable end ridge cap.

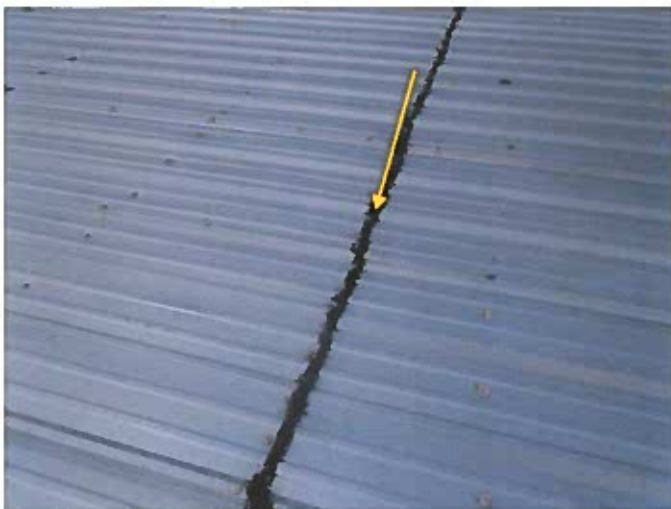
Previous repair attempts.

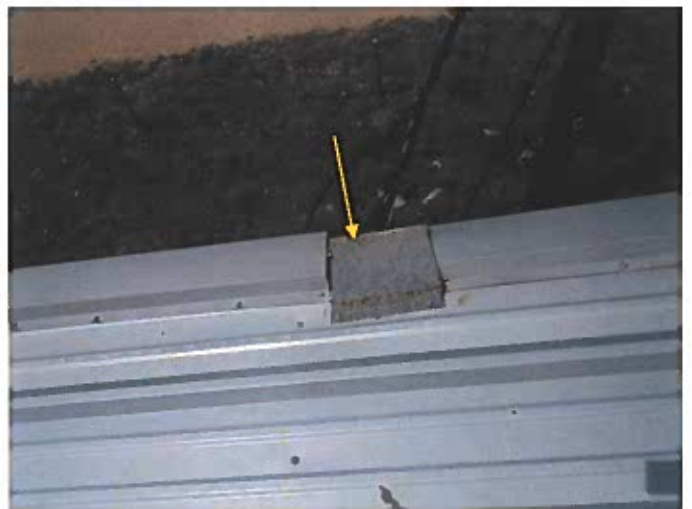
Improper flashing.
