**NORTH SLOPE**

**WAINWRIGHT  
AREAWIDE MECHANICAL AND ELECTRICAL  
BUILDING ASSESSMENT AND INVENTORY SURVEY REPORT**

**August 19, 2024**

### ALAK K-12 SCHOOL

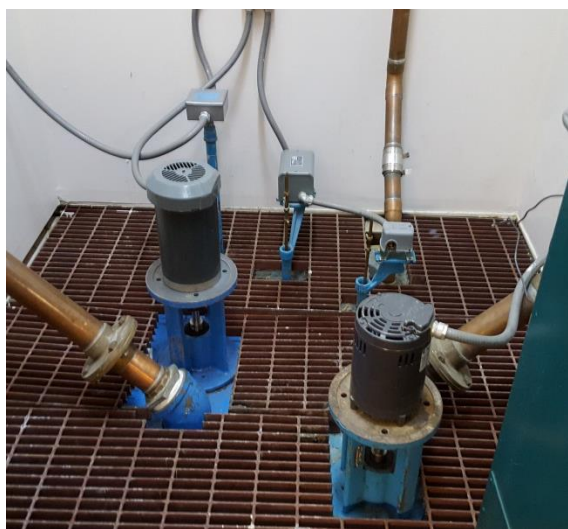
Photo M1 – East Lift Station

As noted in the plumbing description the two lift station rooms in the building are not provided with ventilation, which is required by code.

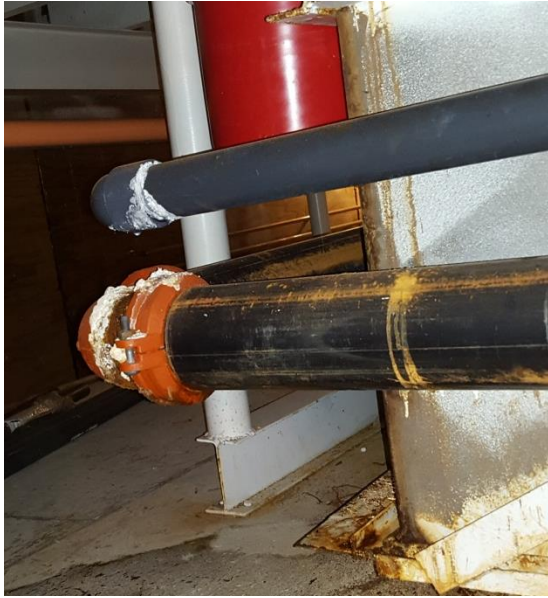
The building has a swimming pool that outwardly appears to be in good shape but has outdated and failing equipment that needs replaced. The underside of the pool enclosure is rusty and has pipes that are leaking. The main circulation pump is also leaking, and the chemical mixing equipment is not functioning properly. The heat exchanger appears to be relatively new but connected piping is corroding and leaking and none of the pipe is insulated. Also, due to lack of dehumidification pipe throughout the pool equipment area is corroding.

*Photo M3 – Leaking and Corrosion Under Pool*

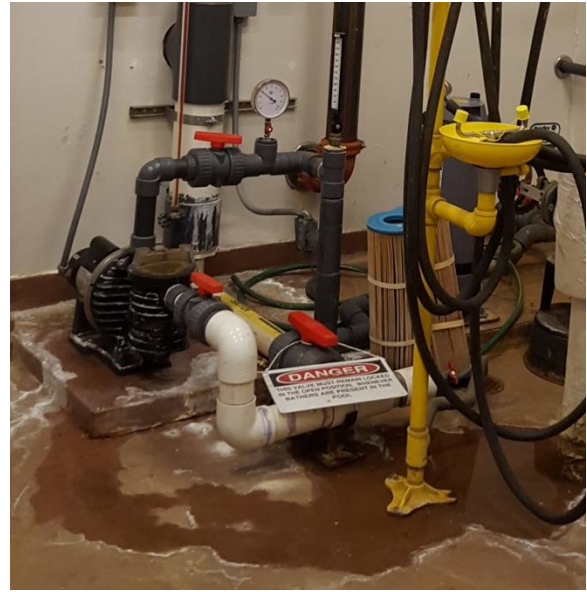
*Photo M4 – Leaking Pool Circulation Pump*

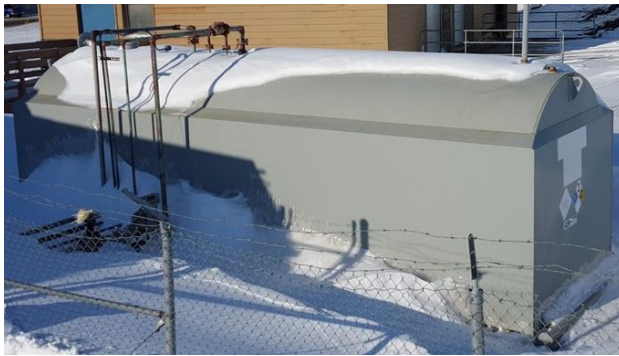
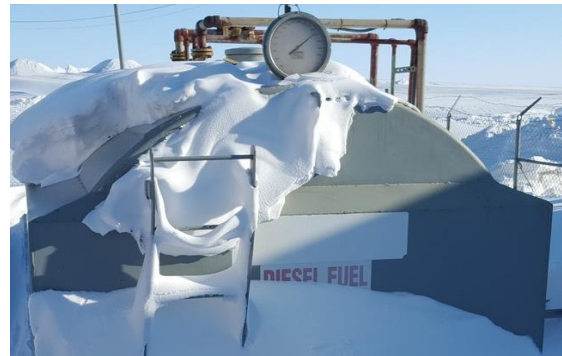
*Photo M5 and Photo M6 – Exterior Fuel Oil Storage Tank*

The condition of the fuel oil system is fair. No leaks were observed but piping is almost 30 years old, if not older, and the outside piping is corroding. The fuel oil storage tank appears to be single wall with an integral containment dike. Tank trim and placards do not meet current code requirements and the access ladder appears to have been hit and deformed. The supply piping from the tank to the school is bent as well. Access to the tank is poor for fueling and maintenance activities. The fuel oil day tank in the boiler room appears to be in fair condition but is at the end of its reasonable service life. The entire fuel oil system warrants replacement with a new UL-142 above ground double wall tank, new distribution piping and new day tank.

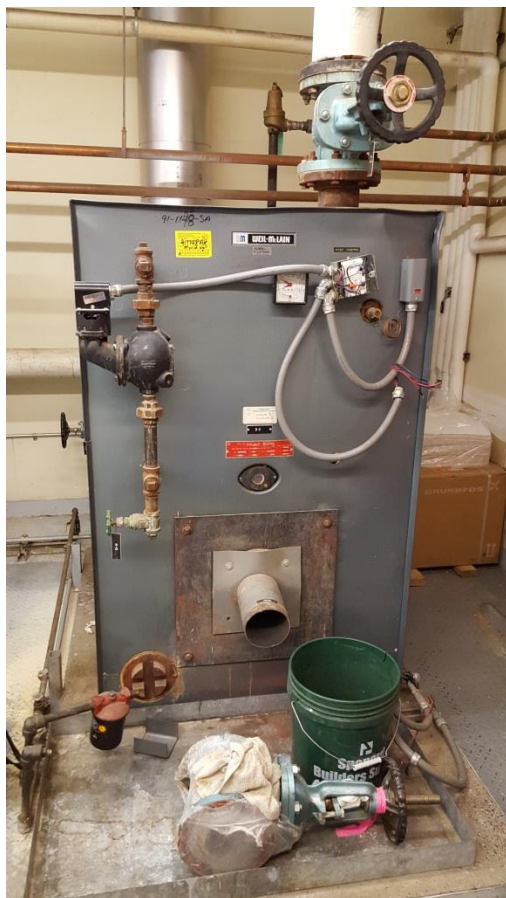
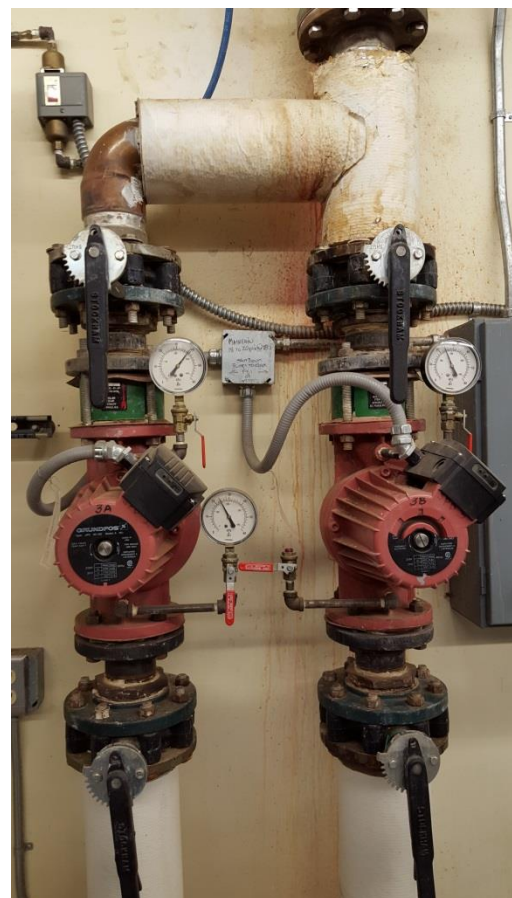
The heating system is located in the high school portion of the building and consists of three fuel oil cast iron boilers, each rated at 1,084,000 BTU/hr gross output each. The boilers were installed in 1990. The boilers are in poor condition. Only one was operating at the time of the site visit and is running rough and corrosion was observed on the flues. The boilers are piped in a primary only system with two sets of system pumps piped in parallel for redundancy. The building heating pumps are constant volume and are leaking at flange seals. There are pumps in the boiler room as well as in the elementary school mechanical room. The piping as configured does not ensure even flow to each boiler and it does not provide minimum return water protection or minimum flow to the boilers. The piping configuration can lead to condensation of flue gases due low temperature, overheating of glycol solution and uneven system

Photo M7 – Failed Boiler

heating as each boiler receives part of the flow regardless of boiler operation. The piping system should be replaced with a primary/secondary pumping system with variable flow secondary pumps. The primary/secondary pumping system would ensure adequate flow to each boiler, allow control system to flow water only through operating boiler and would provide energy savings with the variable speed secondary pumps. The variable speed secondary pumps would operate to match actual system demand, saving energy and improving overall system performance. Supporting equipment such as expansion tanks, air separators, glycol storage/fill tanks, and other similar equipment also be replaced. A boiler emergency shutdown switch needs to be installed per code.

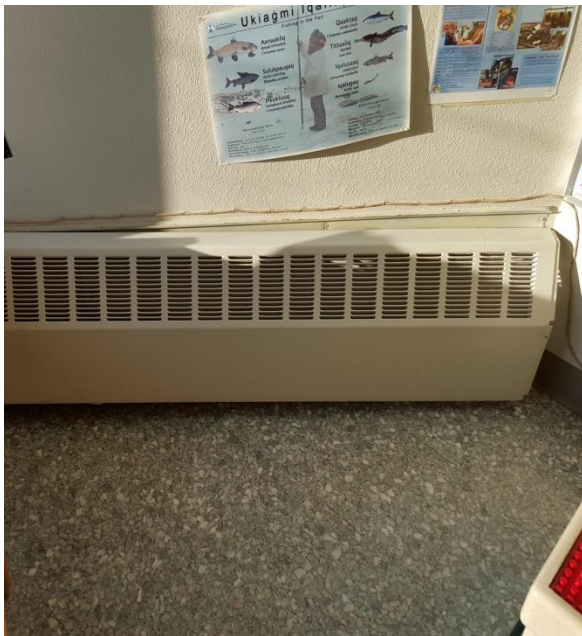
Terminal heating equipment in the building includes fintube baseboard with enclosures, cabinet unit heaters, and unit heaters. The equipment is generally in good condition, but a number of baseboard enclosures are damaged and falling off, cabinet unit heaters have light damage and unit heaters are leaking at pipe connections. Also given that the heating glycol likely has some acidity to it the heating equipment is likely to be corroding. For these reasons in addition to age it is recommended that all of the terminal heating equipment be replaced.

Photo M10 – Fintube Enclosure Falling Off Wall

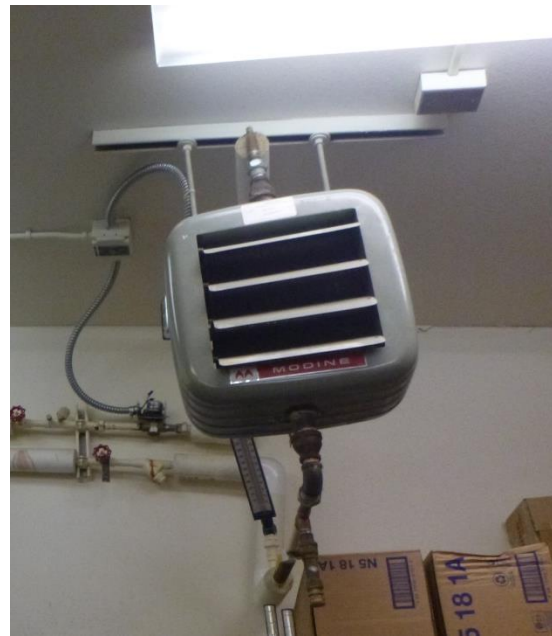
Photo M11 – Old Unit Heater

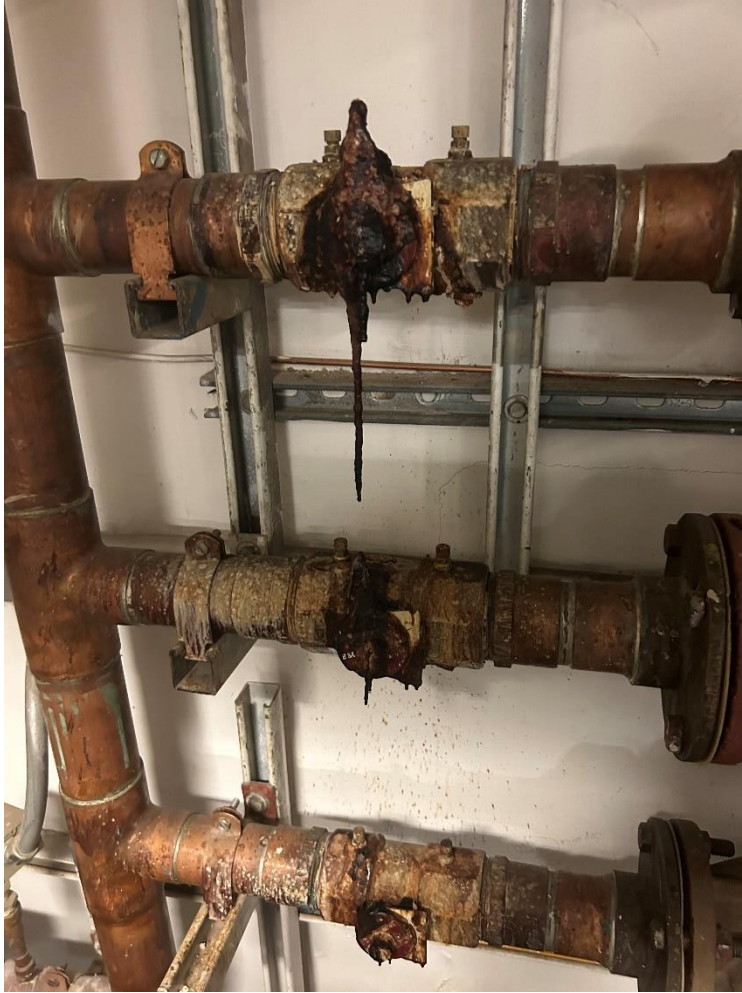
***There are no changes to the heating system report. Glycol has continued to leak at valves of main circulation pumps in the elementary wing causing significant corrosion damage.***

***Photo M12 – Glycol Leak at Elementary school circulation pumps***

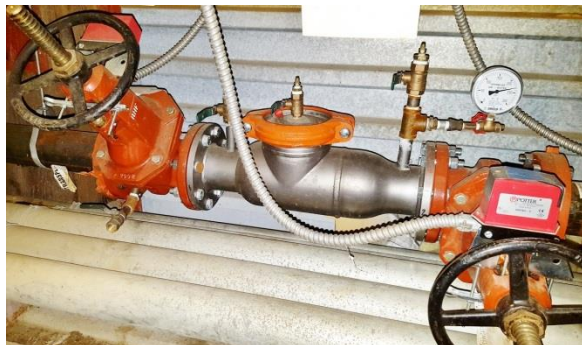
**Photo M16 – Vehicle Maint. Double Check Valve**

The fire protection system is a NFPA 13 wet sprinkler system tied into the village water utility on the northeast end of the school. At one time the high school and elementary school appear to have been served by separate water sources but were combined into one some time ago. The sprinkler system is served by a water service entrance from the vehicle maintenance building on the northeast end of the school, with a double check valve assembly in the crawlspace of that building. However there appears to be a second double check valve assembly in the pool mechanical room. We do not currently have sprinkler plans of the building, so it is unclear exactly how the system is set up. Overall the system appears to be in good condition. No leaks were observed but piping in the pool mechanic. room is lightly corroded due to moisture. It is recommended that the double check valve in the pool room be removed, if possible, to reduce pressure drop in the system, remove a potential point of failure, and reduce maintenance. An abandoned pump controller remains in the pool mechanical room from a long-demolished fire pump and should be removed to provide more space in the room.

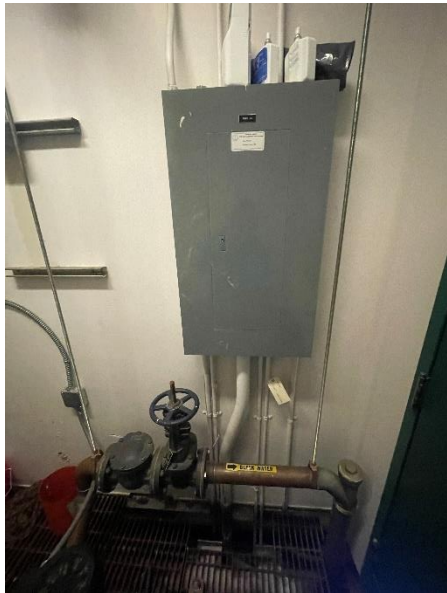
The power system is largely unchanged from the previous inspection. Panels appear to be in good condition throughout with about 70% of them being original panels and 30% being newer panels that were installed around 1997. Panel schedule appeared to be accurate, and all panels have spare parts readily available. Panel EA has a black water line in its NEC working clearance, see photo E3. This is a

code violation and was a code violation when installed. The generator was manufactured in 1984 and is now 40 years old. With the age and of this generator and the criticality of its applications in Wainwright it would be recommended that it is replaced in the near future.

**Photo E3– Panel ‘EA’ Code violation**

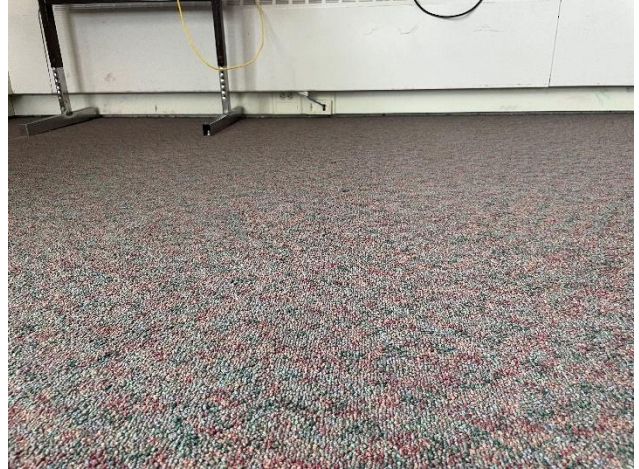
**Photo E5 – Typical Wiremold**

The wiring devices and cabling systems in the building are largely unchanged from the previous inspection. Receptacles appear to still be in fair condition. Wire mold and wiring appeared to still be in OK condition (*Photo E5*)

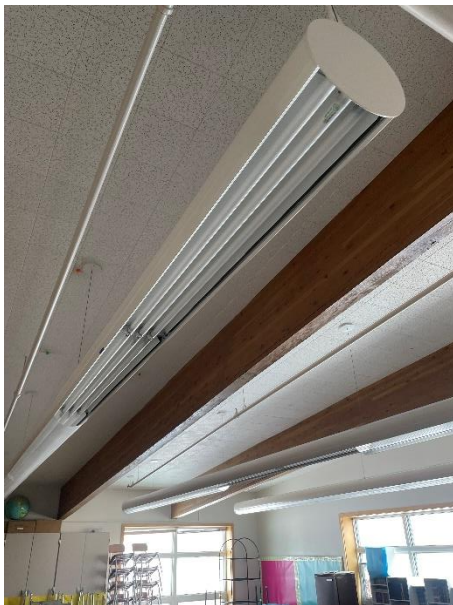
**Photo E6– Typical Classroom lighting**

The existing lighting throughout the building is in poor condition which many broken fixtures or fixtures missing components. See (*Photo E6*) for a typical classroom light with missing lenses. The lighting has continued to deteriorate since the last inspection and is nearing end of useful life. It would be recommended that this school undergoes a lighting upgrade to new, energy efficient LED lighting.

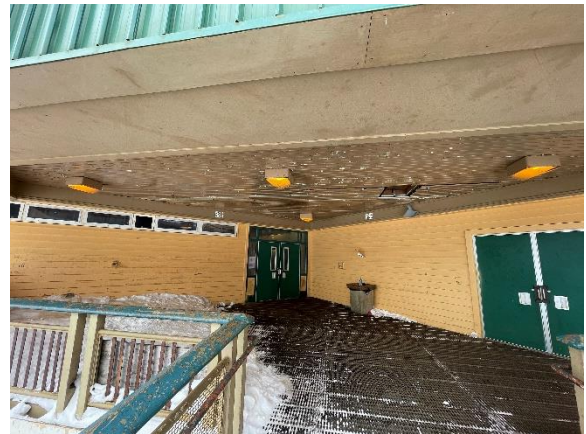
**Photo E7 – Exterior Entry Lighting**

Exterior lighting was utilizing HPS bulbs and appeared to be always on even when it was the middle of the day (*Photo E7*). For energy savings it would be recommended to upgrade the fixtures to LED and provide controls that turn off lighting when illuminate it is not needed.

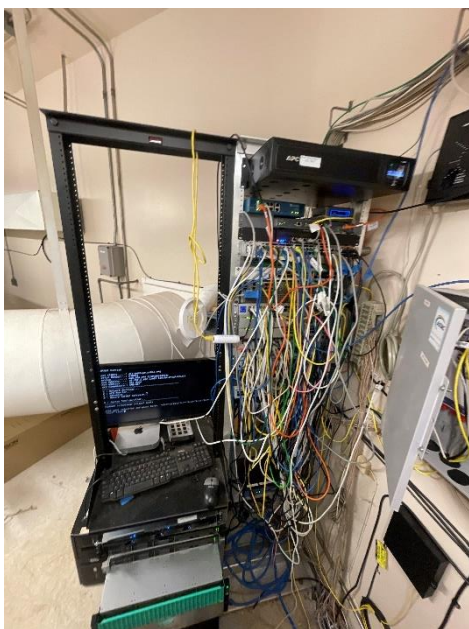
**Photo E8– Telecommunication Equipment**

**The Telecommunication System is largely unchanged from the previous inspection. The organization of the main data rack is poor and could be reconfigured in a more workman-line manner.**

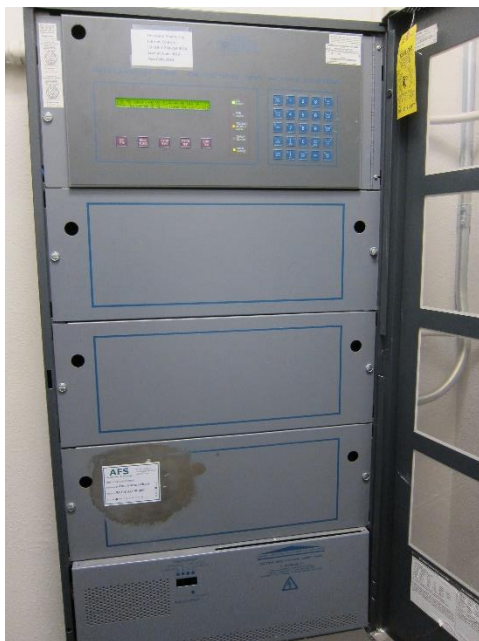
The only problem is that the fire alarm panel is 15+ years old and is approaching the end of its useful life and soon the maintenance staff will have difficulty finding parts. The fire alarm panel always has an error, even after troubleshooting the panel, the problem never goes away.

**Photo E8– Old Fire Alarm Control Panel**

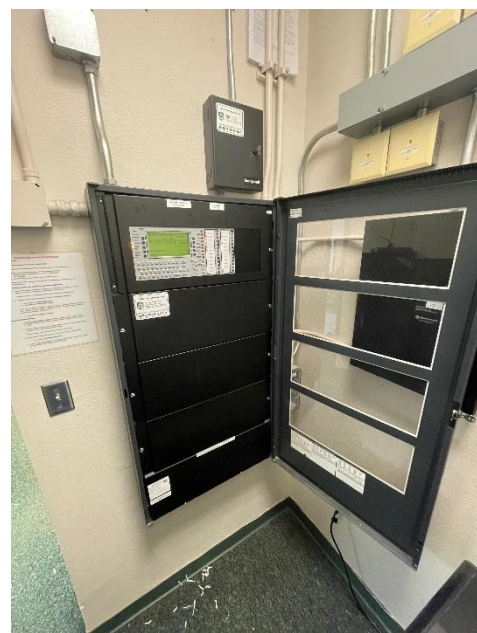
**Photo E9– New Fire Alarm Control Panel**

The fire alarm system has been upgraded since the last inspection. The new system is a Notifier by Honeywell. The new system consists of a new FACP, annunciator panel, booster panels, notification devices and signaling devices in existing locations. It was noticed on site that the FACP was indicating two alarm modes: Supervisory and System Trouble. This indicates an error with a component that is monitored by the FACP and that there could be a power issue within the system. The system is in excellent shape and should last many years. See updated (*Photo E9*) of the fire alarm control panel.

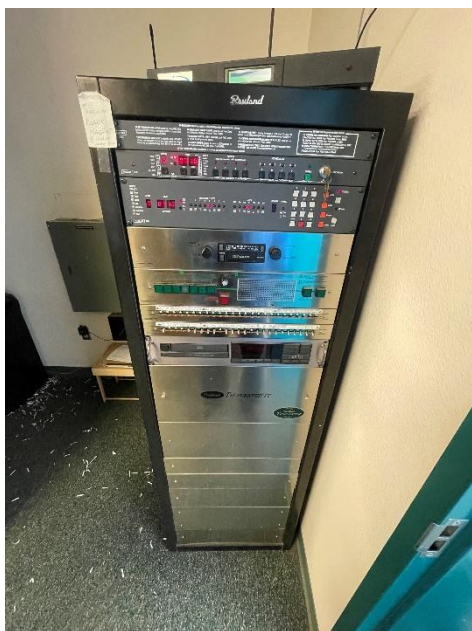
**Photo E10 – Intercom Headend Equipment**

The school has a stand-alone intercom headend equipment located in the admin area (*Photo E10*). The intercom system is in average working condition and is still used, but past its useful life. Parts may become harder to find as the unit starts breaking down.

The intercom system has remained unchanged since the previous inspection. The System is very old and beginning to fail. The power supply for the intercom is failing and buzzes loudly every 15 min. This creates distraction and nuisance noises for personnel working the main office. Many of the speakers in the building have an audible buzz at 60hz. This could be because the wiring for the system is experiencing cross talk from power systems in the building. It would be recommended to upgrade to a newer intercom system in the near future.

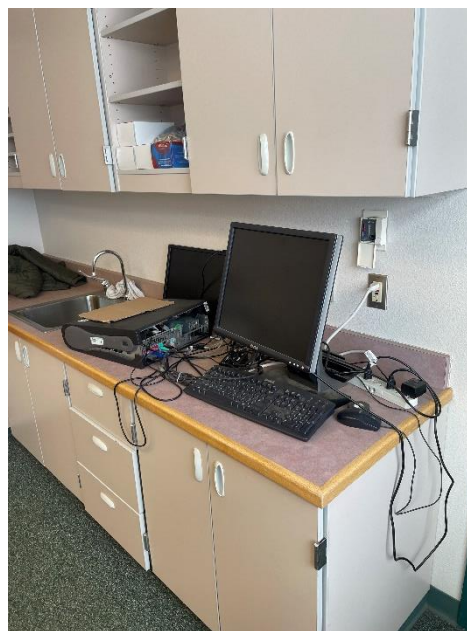
**Photo E11–Bell Systems Headend Equipment**

The bell system no longer works in the building. The head end equipment has been dismantled and it is unknown how to repair. (*Photo E11*) It would be recommended that a new bell system be installed, one that could be integrated with a new intercom system would be recommended.
