**HOPSON MIDDLE SCHOOL**

**MECHANICAL AND ELECTRICAL  
BUILDING ASSESSMENT AND INVENTORY SURVEY REPORT**

**August 19, 2024**

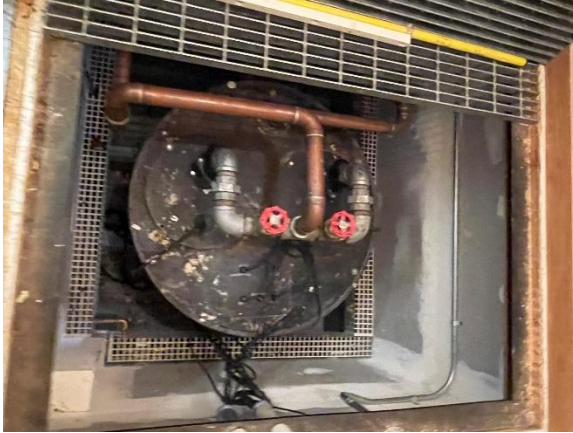
Photo M1 – Lift Station

***There are four lift stations in the school all are in fair to poor condition and need to be re-built; this would include new pumps, controls, and piping to the gravity main.***

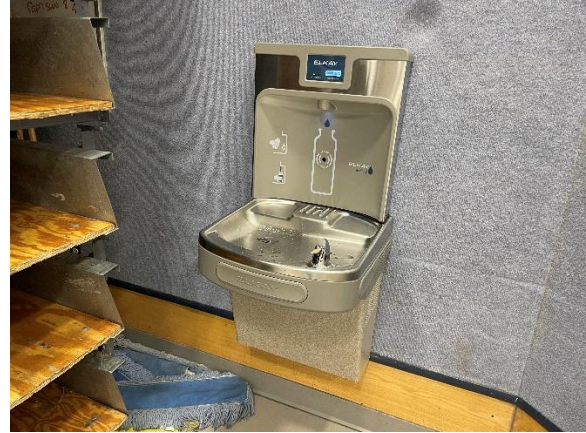
Photo M2 – Bottle Filler / Drinking Fountain

***The drinking fountains were replaced with bottle fillers and are in good condition.***

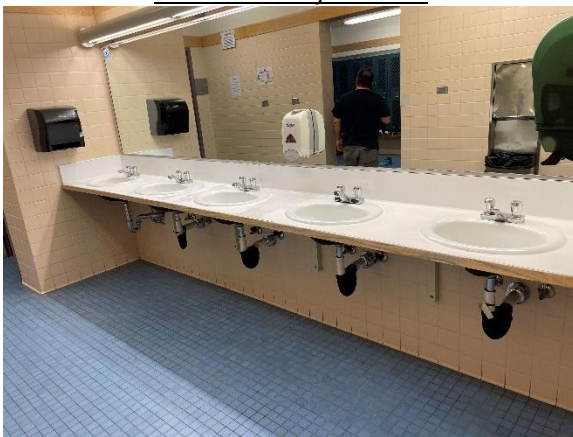
The condition of the plumbing piping is fair. The plumbing fixtures vary in condition from fair to good. The lavatories are not insulated and do not have anti-scald valves. None of the lavatories appeared to be ADA compliant. Some of the toilets and urinals have automatic flush valves and others have manual valves. It is recommended that all the toilets and urinals be converted to automatic flush valves. The lavatories and countertops are in poor condition and should be replaced.

Photo 3 – Lavatories in Boys Restroom

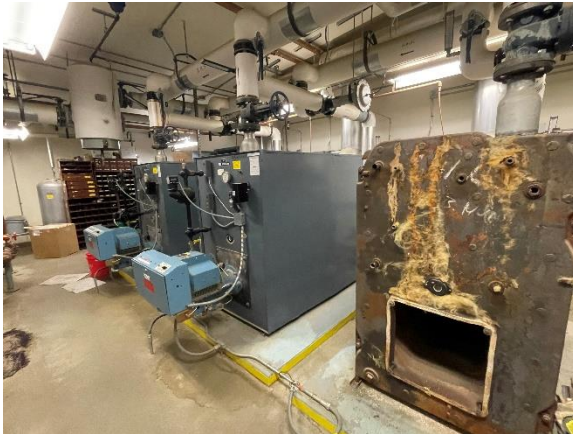
***The boilers have leaking sections and are currently scheduled to be re-built this summer.***

**Photo M4– Boiler mechanical room**

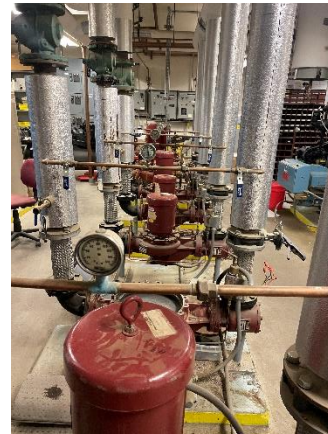
***The heating pumps are at the end of their useful life and parts are hard to find; the heating pumps should be replaced.***

**Photo M5 – Heating Pumps**

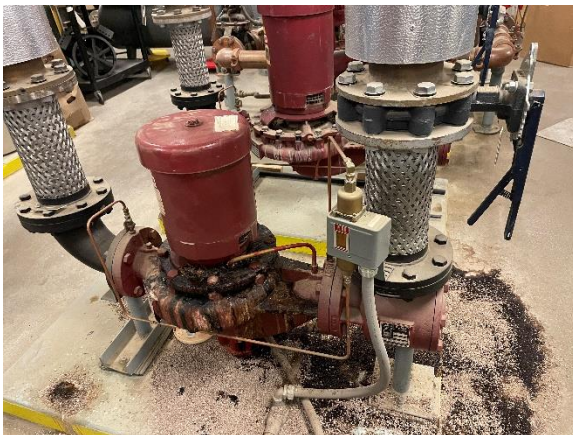
**Photo 6 – Leaking Heating Pump**

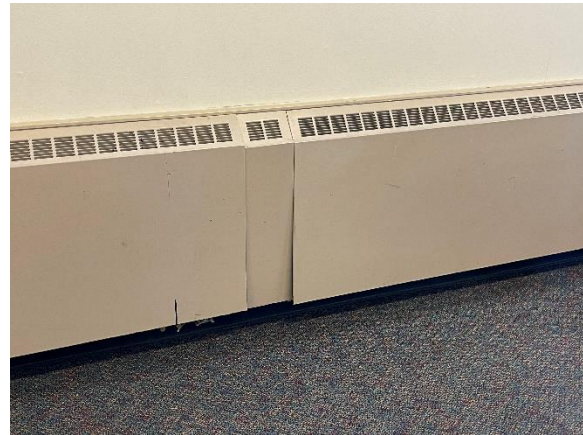
***Many of the fin-tube heating covers are damaged and need to be replaced.***

**Photo 7– Damaged Fin-Tube Heater**

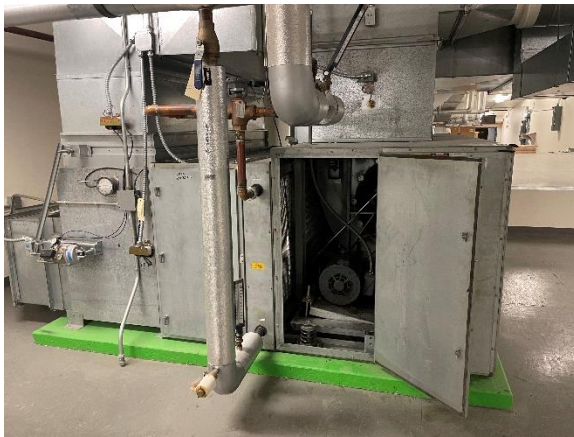
**Photo M8– AHU-5**

***AHU-5 was not operational, the fan motor was tripping the motor electrical overloads. Additionally, AHU-5 is a variable flow unit that uses inlet vanes to control the air flow. The inlet vanes should be locked open and a VFD installed to control the fan motor speed.***

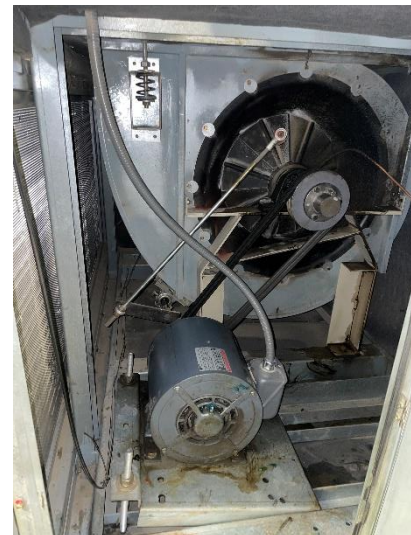
**Photo M9 – AHU-5 Inlet Vanes**

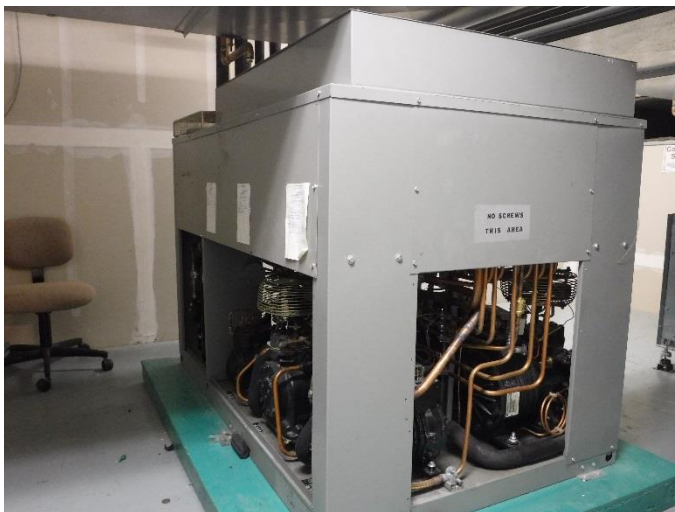
The school has a commercial grade kitchen with associated stove, exhaust hood and fire suppression system. The kitchen stove and hood are not used to prepare meals for the students. The kitchen equipment is in good condition. The condensers for the kitchen freezers are located in the mezzanine return air plenum and have air directed across them to dump their heat into the air stream. The compressors utilize Ozone depleting refrigerants and should be replaced with non –Ozone depleting refrigerant systems and relocated to be out of the return air plenum.

Photo M16- Kitchen condensers located in mezzanine

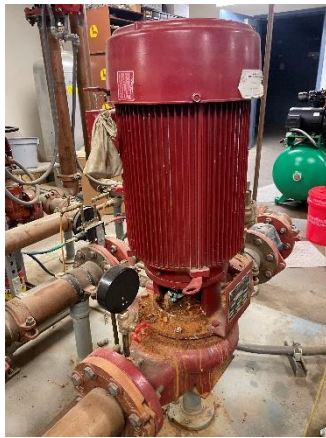
**Photo M16– Fire Protection Pump**

***The fire pump is heavily corroded and needs to be serviced and inspected by a qualified sprinkler technician.***

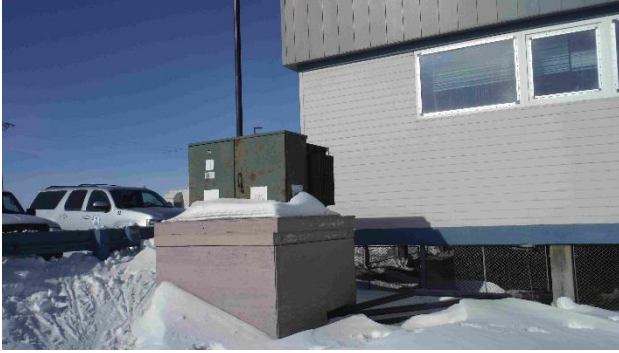
Photo E1–Service Transformer

The existing service is fed from a platform-mounted transformer which has (3) 4" non-metallic conduits exiting the transformer enclosure and then transfers to rigid steel conduit below the building. One of the non-metallic conduits is significantly damaged and needs to be replaced (Photo E1).

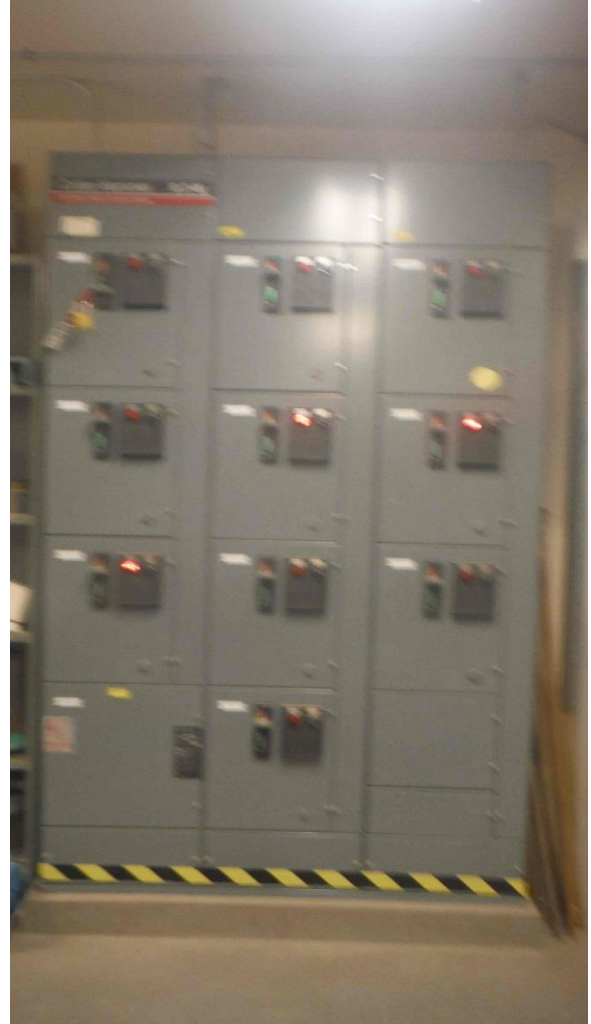
Photo E2– MCC

In the boiler room an MCC is being used to house motor starters and controls for large mechanical equipment in the boiler room (Photo E2). The MCC is no longer manufactured, and replacement parts are difficult to obtain. As the existing equipment appears to be functioning no replacement is required but as mechanical equipment is replaced or upgraded, we recommend providing individual motor starters for each equipment.

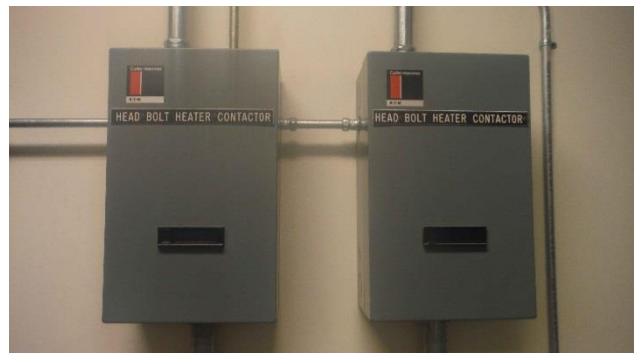
Photo E4– Headbolt Heater Contactors

Existing contactors are beyond their end of life and can be replaced for the approximately the same cost of rebuilding the existing equipment (Photo E4). The contactors are currently working and do not need to be replaced at this time.

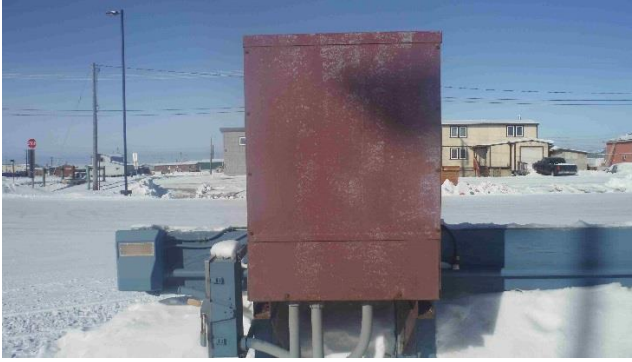
Photo E5– Headbolt Heater and Transformer

Headbolt heaters are fed from an exterior mounted transformer. The secondary feed of the transformer connects to breaker boxes which are wiring to 3' SO cables with plugs on the ends (Photo E5). The breaker box housings are made of a plastic material which becomes brittle and breaks in the cold weather. The existing breaker boxes may be replaced with a new stainless steel box.

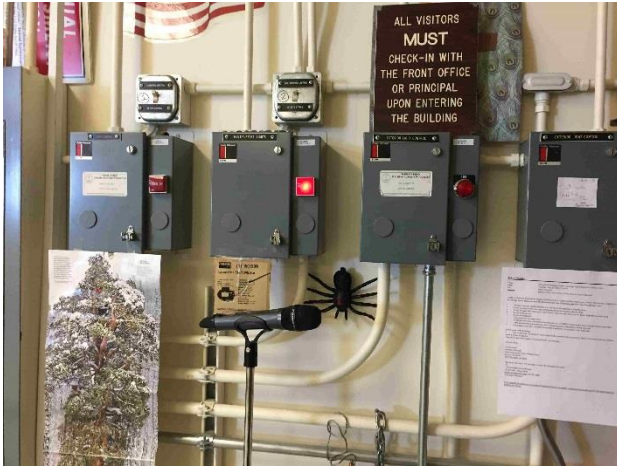
Photo E6– Lighting Contactors

The facility lighting system consists mostly of linear T8 fluorescent fixtures. The gym lighting is high-bay Metal Halide fixtures with LED replacements. The upstairs maintenance access corridors had porcelain base bare lamps where most of the incandescent lamps have been replaced with compact fluorescent. All controls are manual except in common areas and exterior parking lot lighting, where outdated lighting contactors are used with timers or photocells. Controls are mostly manual except in common areas and exterior parking lot lighting, where outdated lighting contactors are used with timers or photocells (Photo E6).

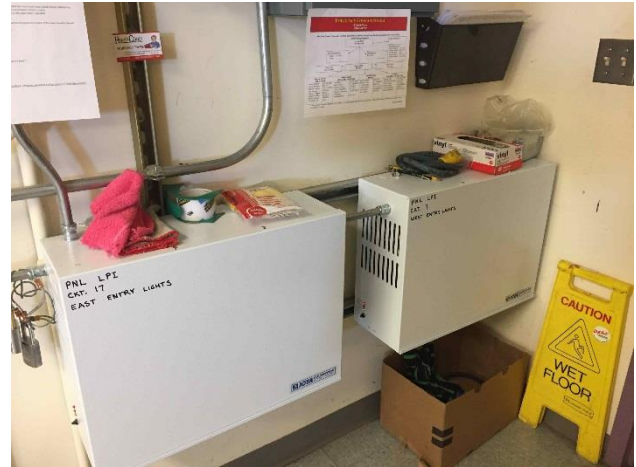
Photo E7– Emergency Lighting Inverters

The existing emergency lighting system uses emergency lighting units and some inverters. The inverters (Photo E7) provide power for emergency egress lighting. The emergency lighting units are adjustable, dual head fixtures with battery back-up, and halogen or LED lamps. When tested the halogen lamps were inoperable while all LED lamps were functioning. We recommend replacing the halogen fixtures with LED so that adequate emergency egress lighting is available in the facility.

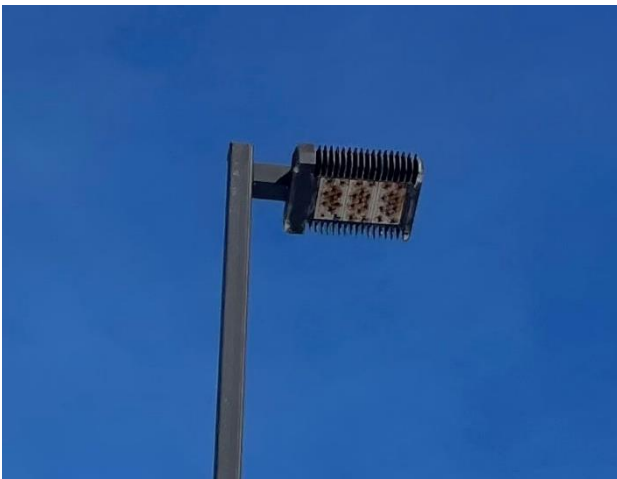
Photo E7a-Area Light

***Area LED lights are rusting out and the underground branch circuits are starting to fail, see photo E7a.***

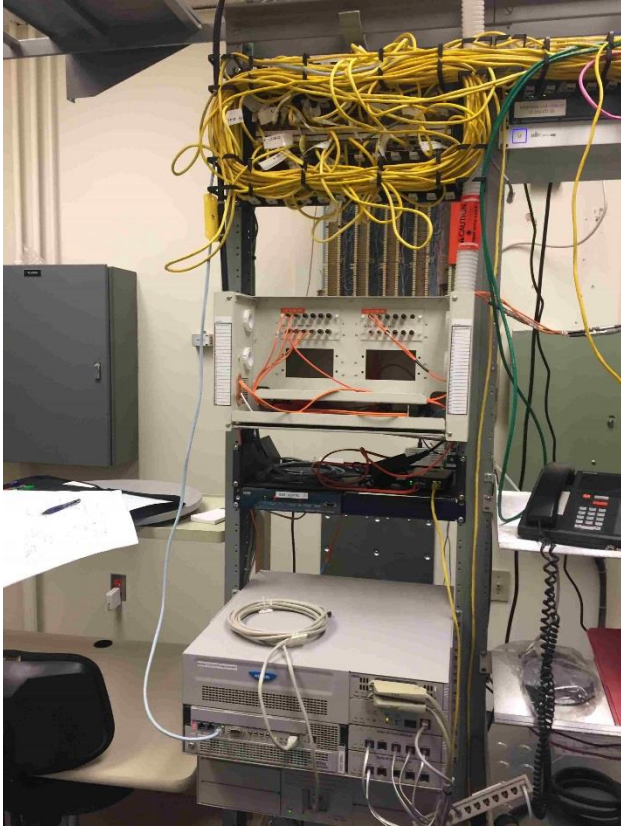
Photo E8– Fiber Optic Rack

The building has a dedicated room for the telecommunication system. The system consists of a fiber optic rack which provides connectivity between racks in the building and other NSB sites in Utqiagvik (Photo E8). The room also has a telecomm rack which is used for Voice Over Internet Protocol (VOIP) phone system and data (Photo E9). This system consists of CAT 5e cabling to data outlets for the Wireless system, administrative offices and classrooms. Based on conversations with IT personnel additional data drops would help in the classrooms considering the data needs of the students. They also explained that the VOIP system in place is not functional at this time. Although the current infrastructure appears to be close to capacity the existing racks have adequate capacity for expansion to allow for additional equipment. Some additional organization and labelling of the existing cabling would help with installation of any new systems.

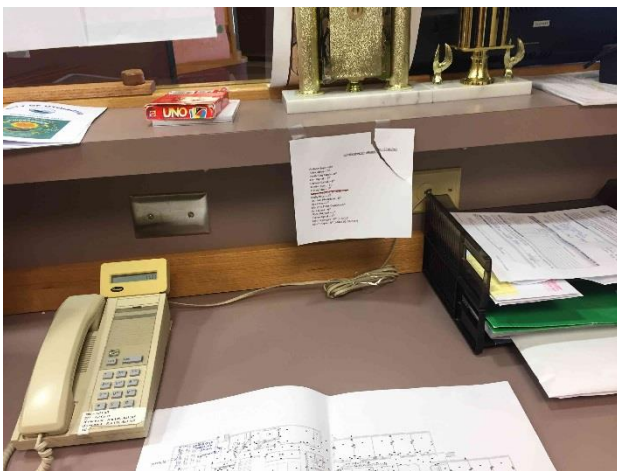
Photo E10– Existing CAT 3 Telephone

The main Telephone Terminal Board is also in this dedicated room for the main telephone in the system. It also has some existing CAT 3 telephone systems which connect into the existing paging systems (Photo E10).

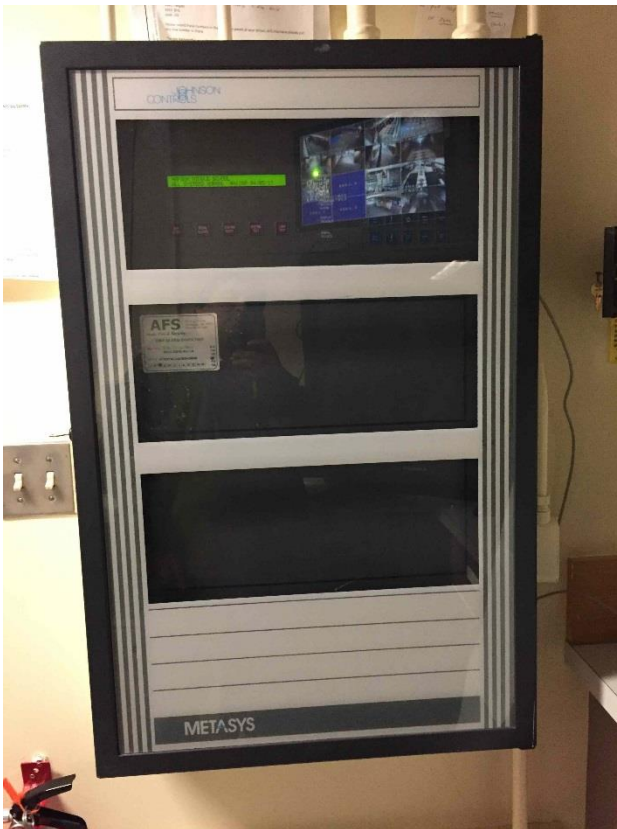
Photo E11– Fire Alarm Control Panel

The existing fire alarm system is a conventional class B system, Johnson Controls Metasys (Photo E11). In admin and support areas there are a few locations which do not have adequate occupant notification per the current code requirements. This system is old but still functioning and new parts are available through Johnson Controls. An upgrade of the system to an addressable system would improve system reliability and reduce maintenance requirements. With the building fully sprinklered, most of the smoke detectors may be removed when the system is upgraded to an addressable system.

***AFS has upgraded the Metasys to a new Notifier control panel which is compatible with the existing smoke detectors while the annunciating system have all been replaced and upgraded. Additional devices and wiring will be required to update to a voice evacuation system, but the new FACP can support this upgrade.***
