Geneva Community Unit School District #304
Operations and Maintenance
7 Year Capital Improvement Plan

January 9, 2017

This report analyzes the existing facilities and their related conditions. It takes a look at the next seven years in which the highest priority needs will be addressed first. These priorities will be based on financial considerations such as cost and efficiencies, condition of existing facilities, code compliance, and the comfort and safety of our buildings. While it is difficult to imagine every possible scenario that our buildings face, I have compiled a comprehensive outlook of the present facilities based on current conditions. This report covers all buildings and grounds the District owns and estimates the funding required to maintain our properties at an optimal teaching and learning environment. Projected costs by building are included in the Appendix. The Seven Year Capital Improvement Plan is intended to provide the information needed to assist the District Board of Education and Administration with the decisions they will face with regard to future financial support of our buildings.

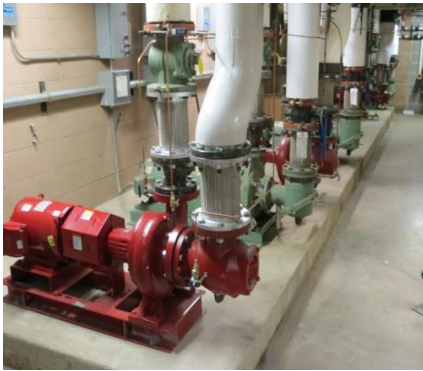
Secondary Pumps (3)

Replace pumps that are nearing the end of their life cycle.

Variable Frequency Drives will greatly increase energy efficiency and lengthen the life of the pumps.

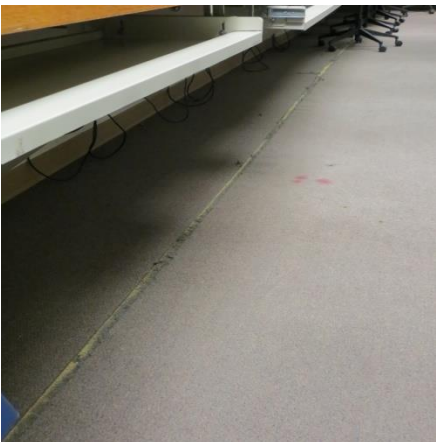
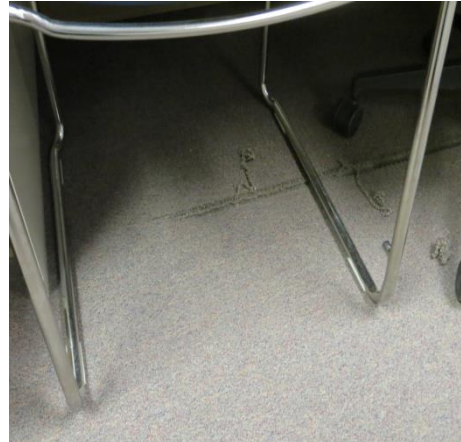
The carpet is starting to fray and cause trip hazards.

Carpet will need to be replaced.

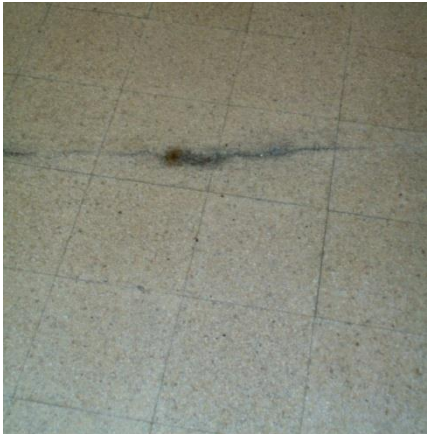
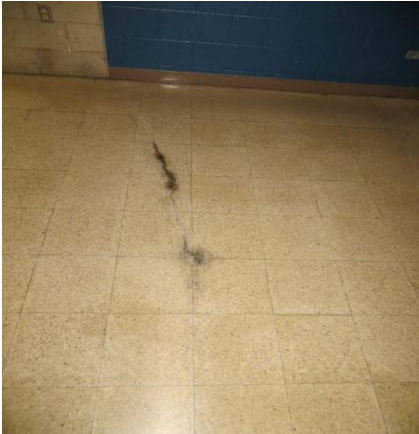
Flooring

Existing quartz tile is cracking and has faded.

Replace tile in phases.

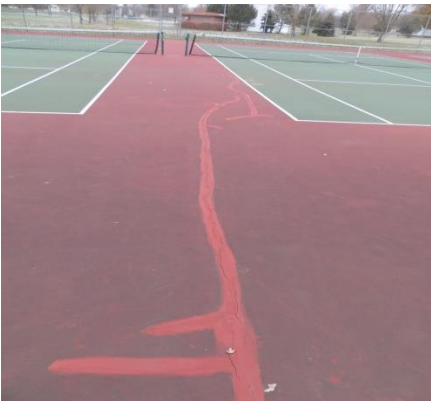
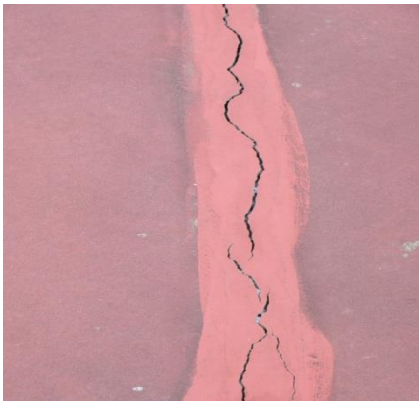
Tennis Court Resurface

Cracks and patches throughout courts.

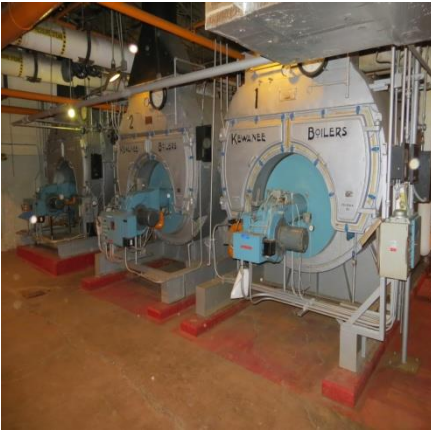
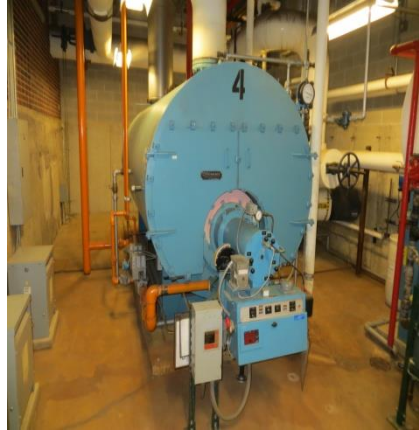
Boiler Replacement

Breakdowns and repairs are becoming more frequent and costly.

Replace steam boilers with hot water boilers for energy efficiency.

Locate new boilers from boiler house to high school.

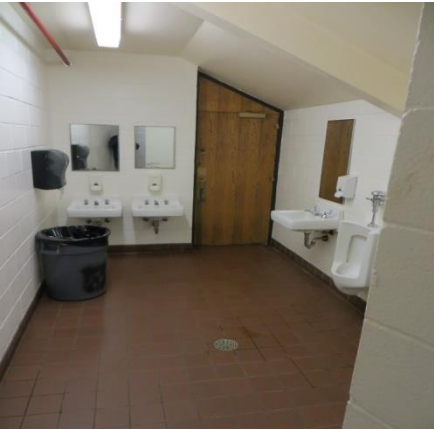
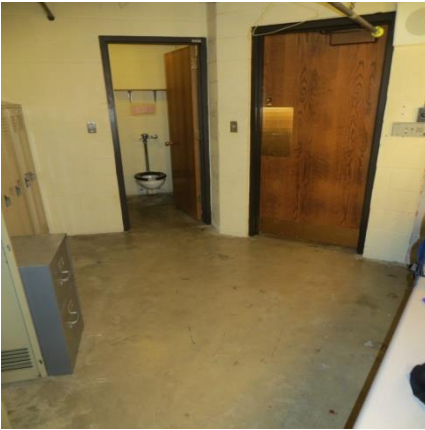
Cafeteria and Stage Craft Bathrooms

Bathrooms are 42 years old.
Showing significant wear.
Need to update.

Renovate Cafeteria bathrooms	Update	\$ 100,000.00	M	2	42 years old and in need of updating		\$ 100,000.00					
Roof - Southwest side	Replace failing section	\$ 450,000.00	M	2	Nearing end of life cycle of 25 years.		\$ 450,000.00					
Domestic Water Piping	Replace old piping with copper piping and provide new ball valves for adequate shut-off	\$ 50,000.00	M	2	Current piping is deteriorating and starting to leak on a consistent basis		\$ 50,000.00					
Auditorium Stage and house lighting	Update the entire lighting system	\$ 200,000.00	M	3	Lighting panel becoming obsolete and parts are no longer available			\$ 200,000.00				
Air Handlers (7)	Need Re-built	\$ 175,000.00	M	4	42 years old				\$ 175,000.00			
Parking Lot	Periodic maintenance; Seal-coating	\$ 75,000.00	M	4	Resurfaced/Seal-coated 2013				\$ 75,000.00			
Renovate Stage craft area including bathrooms	Update	\$ 125,000.00	M	5	42 years old and in need of updating					\$ 125,000.00

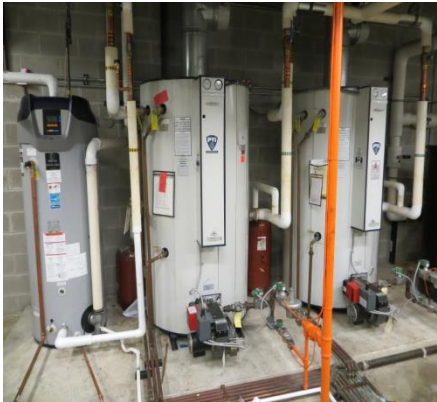
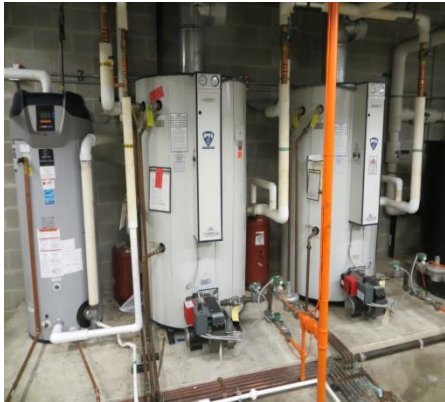
Hot Water Heaters

The two 500 gallon PVI water heaters are nearing the end of their life cycle.
Replacement will be needed within the next seven years.

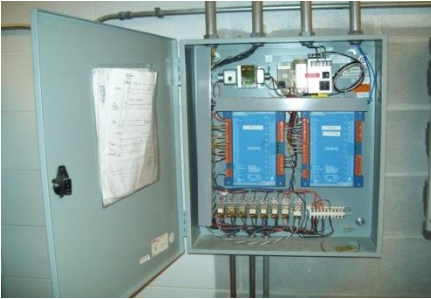
Lon Controller

Lon controls throughout the building.

Outdated and costly to repair.

Replace Lon to BACnet.

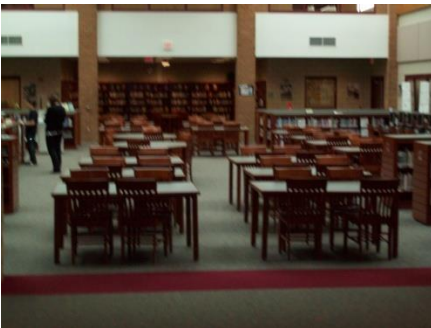
LMC

AHU is undersized for space.

Only two VAV boxes serving the space.

Recommend increasing the capacity of the AHU and adding four to six VAV boxes with controls to increase comfort and control humidity.

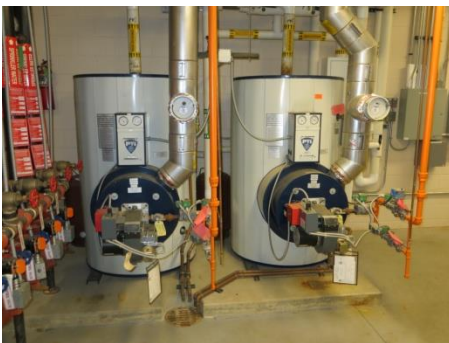
Hot Water Heaters

The two 300 gallon PVI water heaters are nearing the end of their life cycle.

Replacement will be needed within the next seven years.

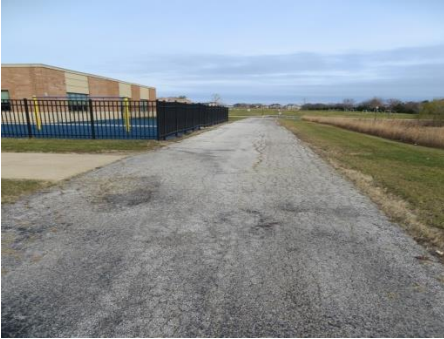
Fire Lane

Pavement starting to show excessive cracking and breakdown.

Will need to be resurfaced.

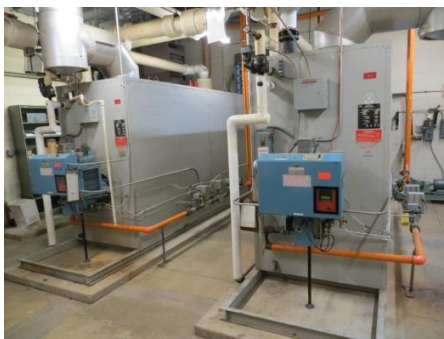
Boiler Replacement

23-year old boilers are inefficient and nearing the end of their estimated service life as per ASHRAE.

Replace with new high efficiency boilers.

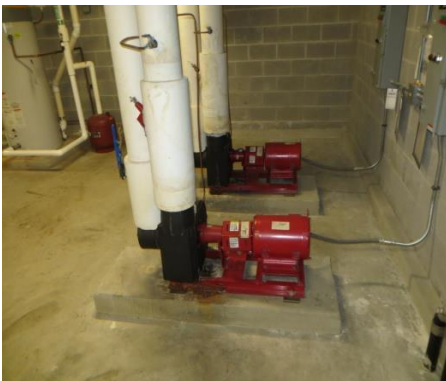
Secondary Pumps

18 years old and nearing end of their estimated service life as per ASHRAE.

Need to be replaced with energy efficient design.

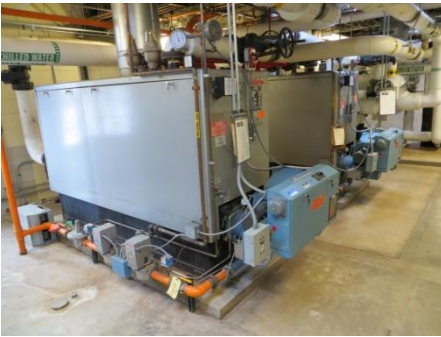
Boiler Replacement

27-year old boilers are inefficient and nearing the end of their estimated service life as per ASHRAE.

Replace with new high efficiency boilers.

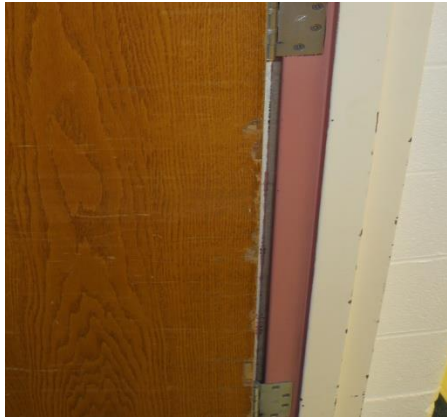
Interior Doors

Several doors in the building are damaged and in need of replacement.

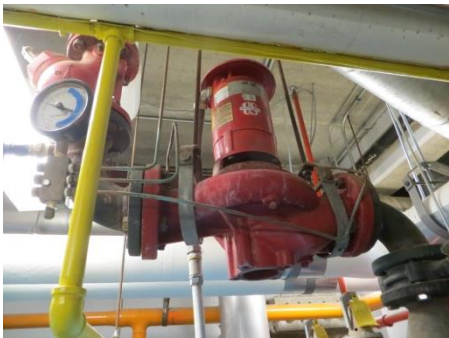
Primary Boiler Pumps

Original to the building.

Need replacing with energy efficient design.

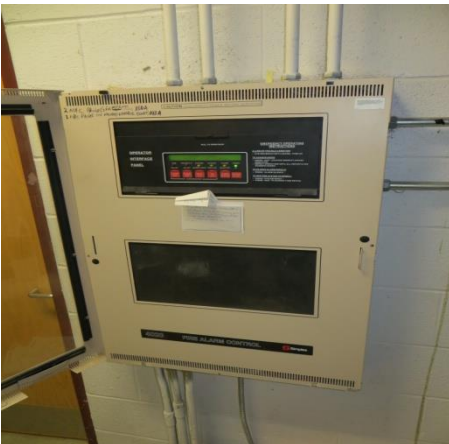
Fire Alarm System

Simplex fire alarm system needs to be updated.

Escalating repair costs and consistent breakdowns.

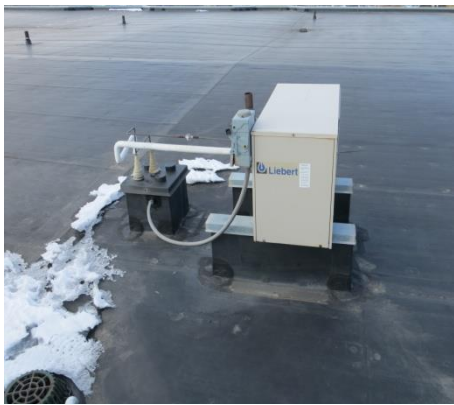
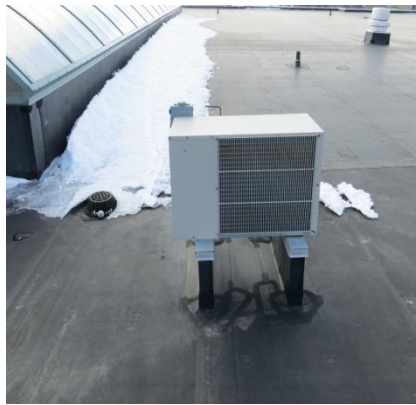
Air Handling Unit

Air handling unit is nearing the end of its life cycle.

Will need to be replaced in the next two to four years.

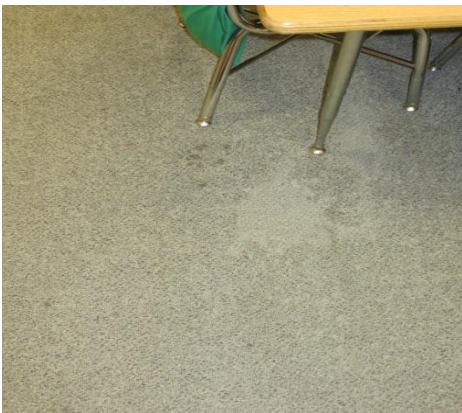
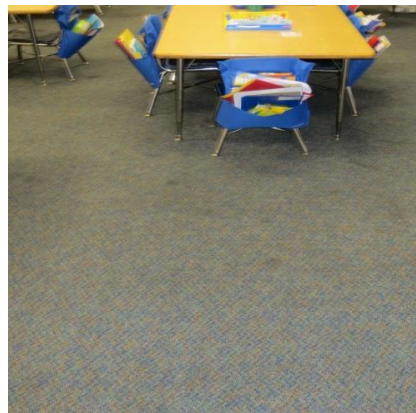
Carpet Replacement

Carpet is starting to show wear and staining that we are unable to remove.

Life cycle of carpet is 12-20 years.

Carpet will need to be replaced.

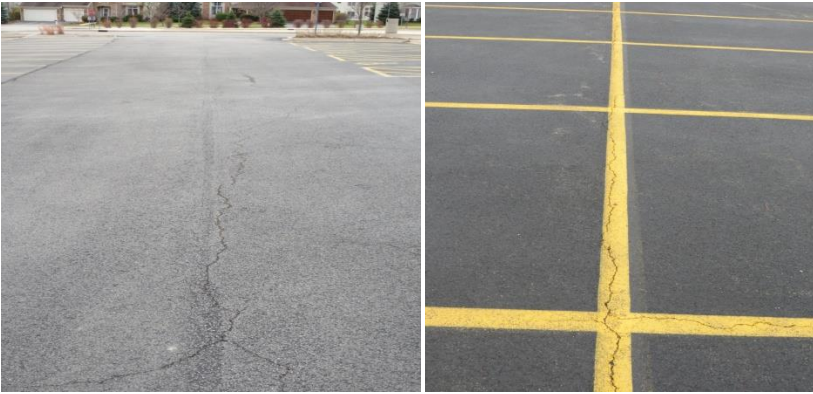
Parking Lot

Several areas are starting to show cracking.

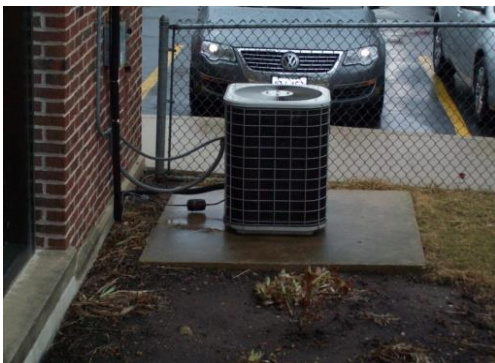
Fan Coil and Condensing Units

The entire building is cooled with fan coil units.

Several are beginning to fail and most will need to be replaced in the next two to seven years.

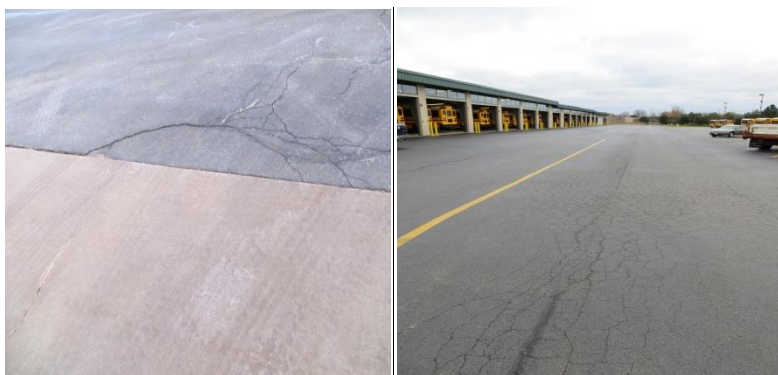
Parking Lot

Pavement starting to crack and breakdown.

Resurfacing will be needed in the next two to three years.

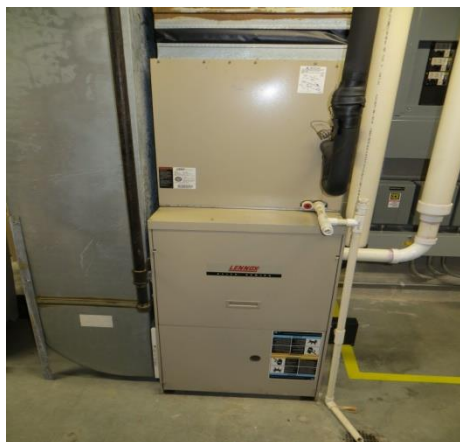
HVAC Split System

The 3 Lennox split systems are nearing their ASHRAE recommended service life.

Replacement will be needed within the next seven years.

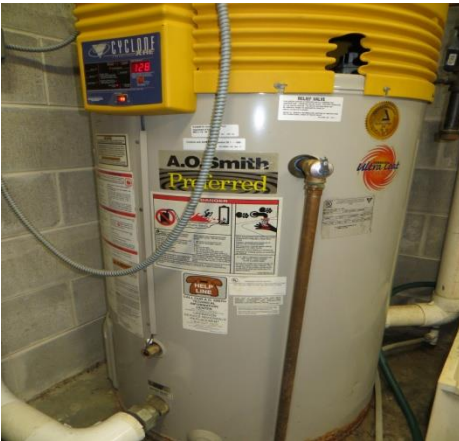
Hot Water Heater

The 60 gallon A.O Smith water heater is nearing the end of its life cycle.

Replacement will be needed within the next two to five years.

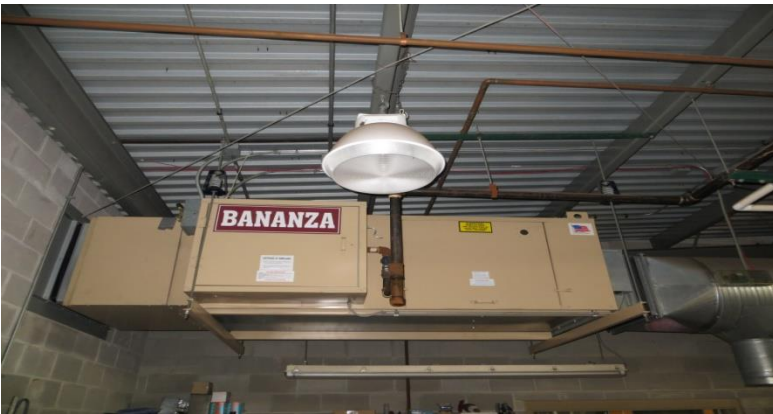
Air Handling Unit

The three Bananza make-up air units are nearing their ASHRAE recommended service life.

Replacement will be needed within the next seven years.
