# HISTORIC OLD CENTRAL HIGH SCHOOL: REHABILITATION

Understanding the Facility Assessment

June 11, 2019

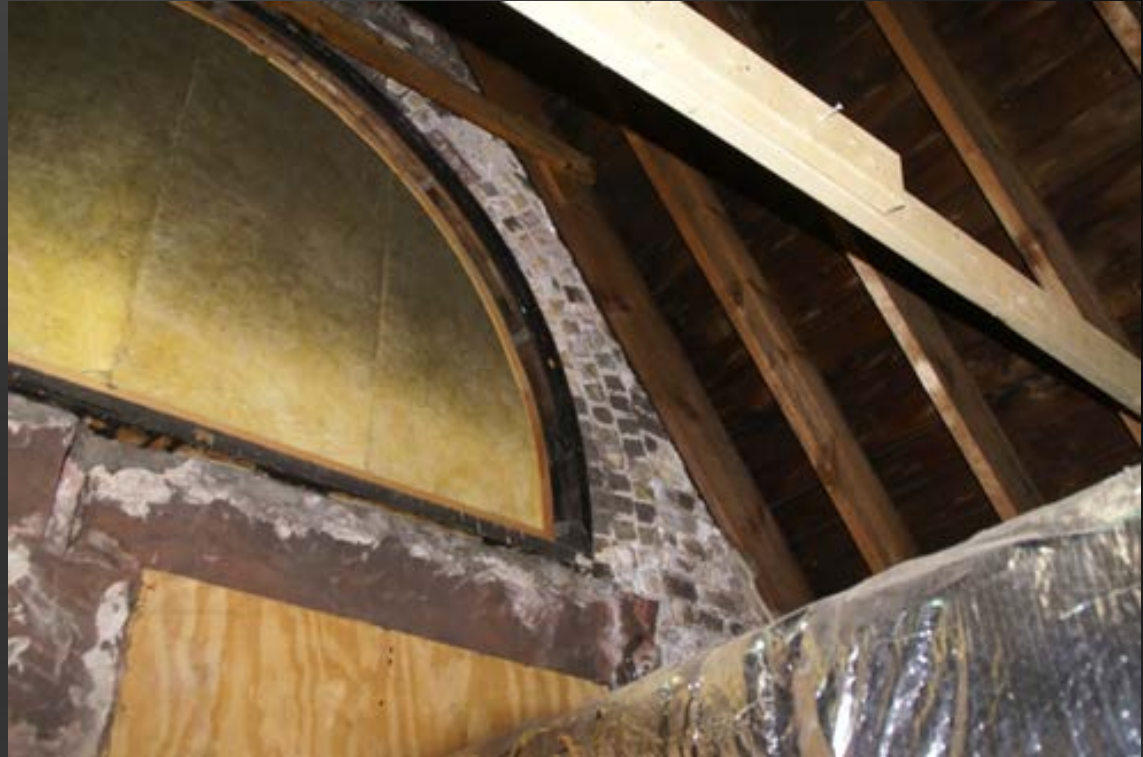
## LEAKAGE CONCERNS

North wing entrance

Girls' locker room

Board room

Dormer attic spaces

Loading dock

Basement

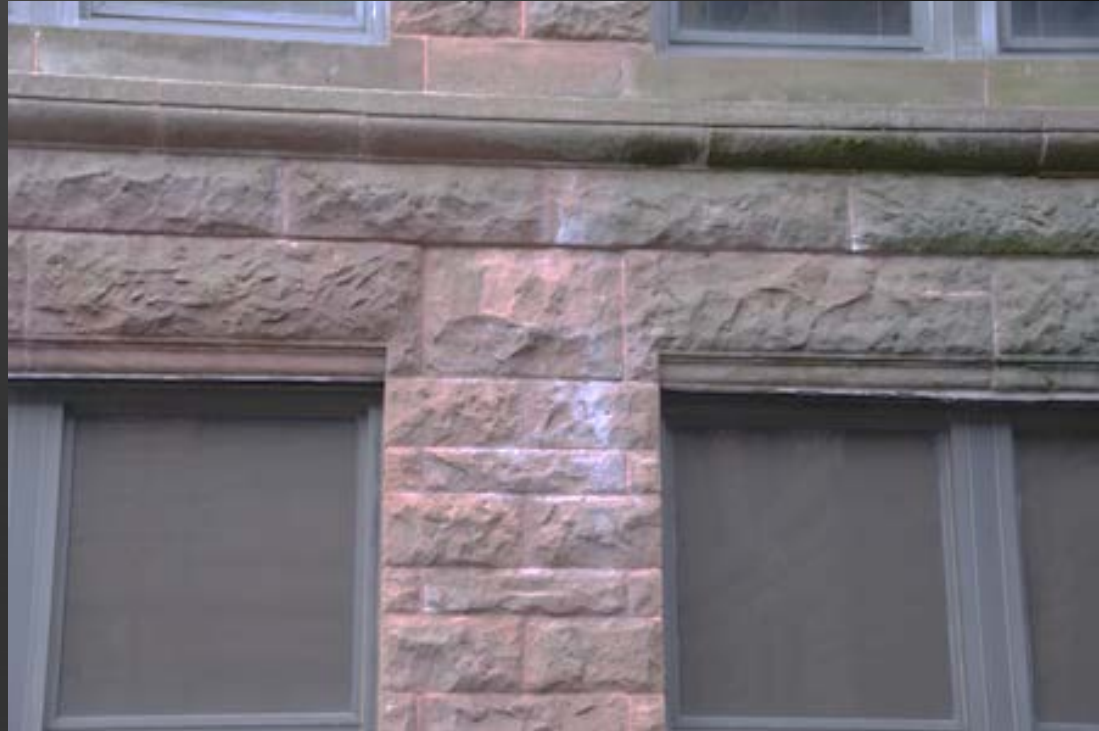
## EXTERIOR WALLS AND CHIMNEY

Deteriorated mortar

Deteriorated and  
cracked stone

Deteriorated chimney

Deflected lintels

Efflorescence

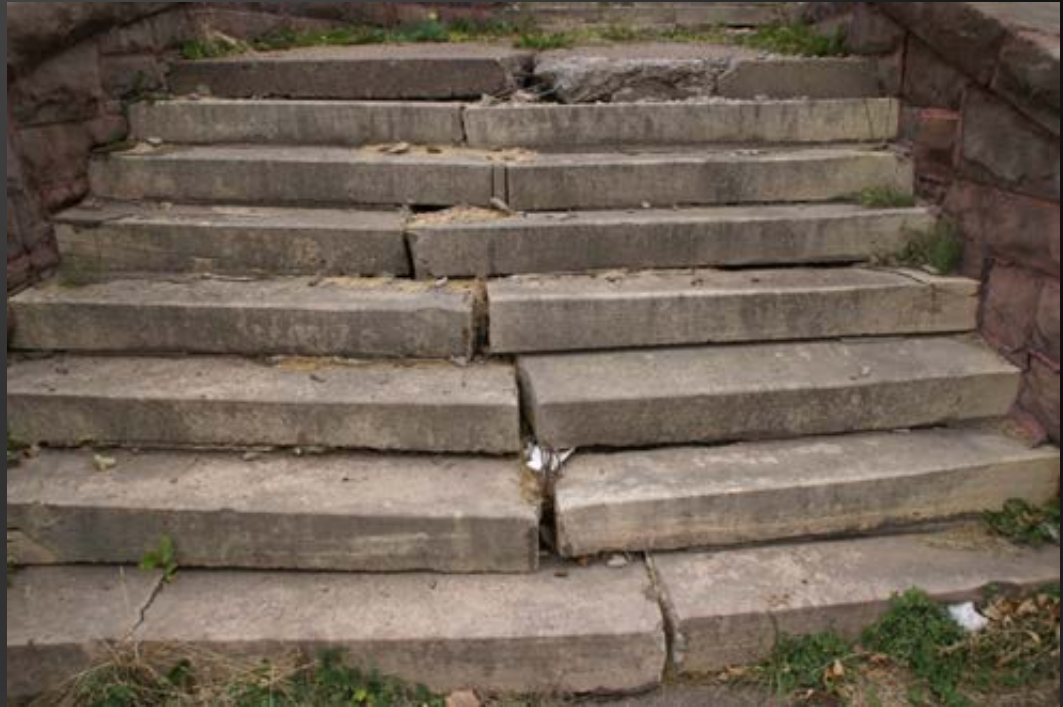
## ENTRANCE STAIRS

Cracked terrazzo tiles

Cracked concrete  
landings

Cracked concrete steps

Deteriorated mortar and  
stone side walls

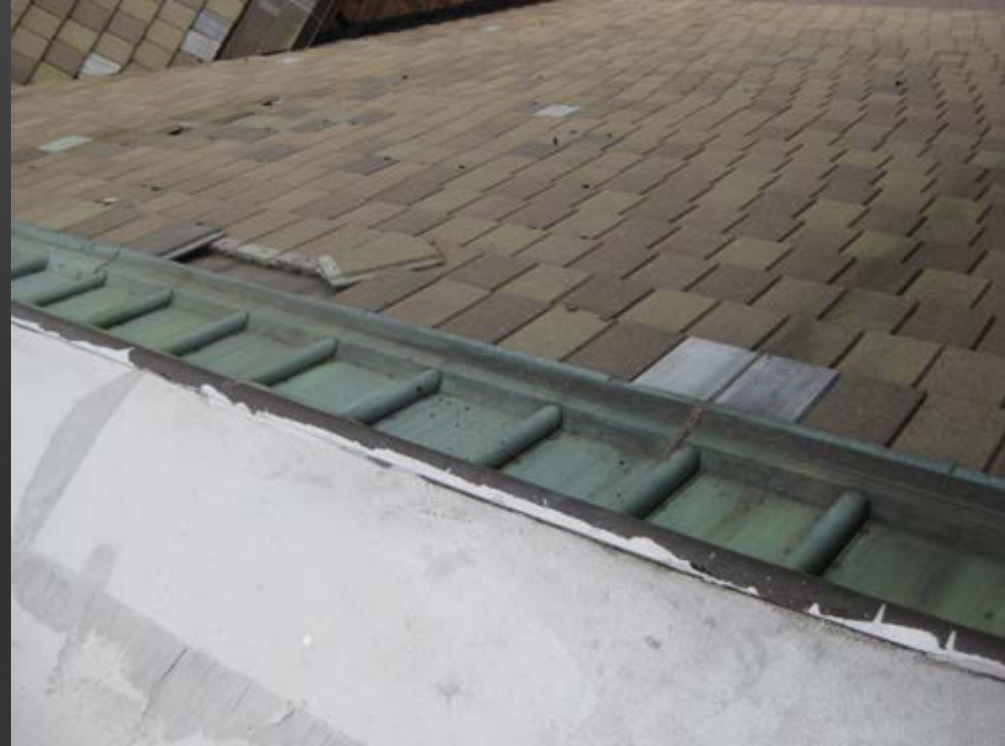
## ROOFS

Missing tile

Damaged snow retention system

Damage from high winds

Falling snow and ice

Need for fall and lightning protection

Reinstall gutters and downspouts

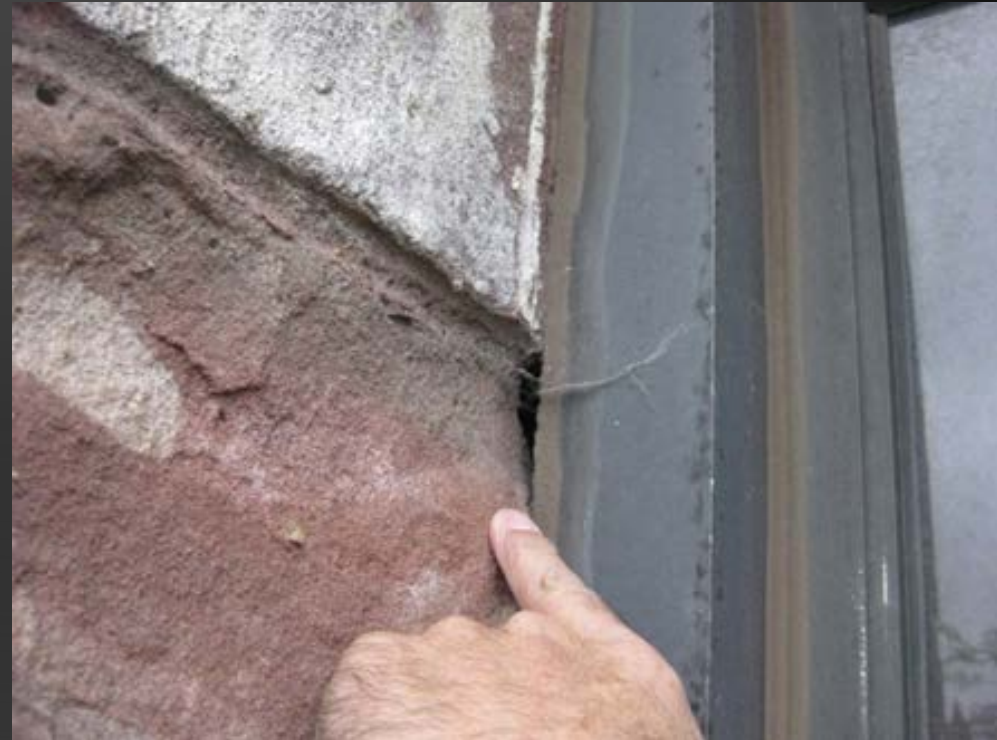
## WINDOWS

Deteriorated perimeter sealant

Failed glazing gaskets

Original single-pane in attic

Deficient operation hardware

Air infiltration

Moisture infiltration

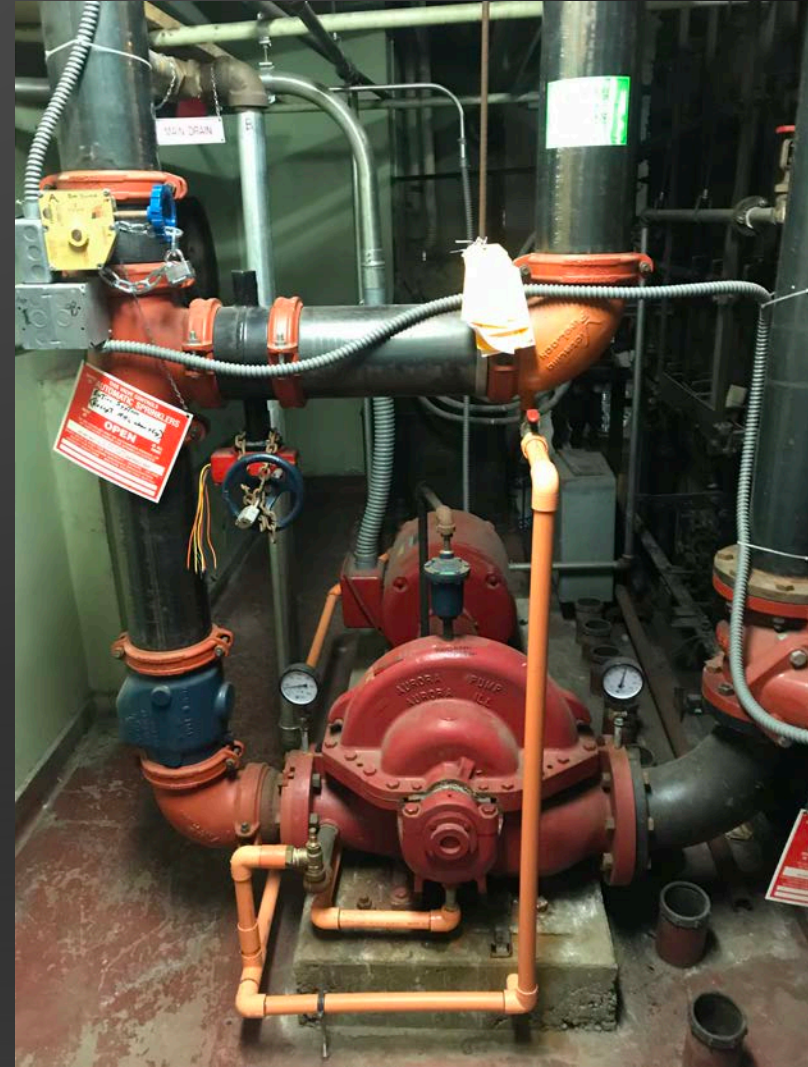
## FIRE PROTECTION

Existing Fire Pump

Fully Sprinkled

Dry Systems

Some Gaps

Functional

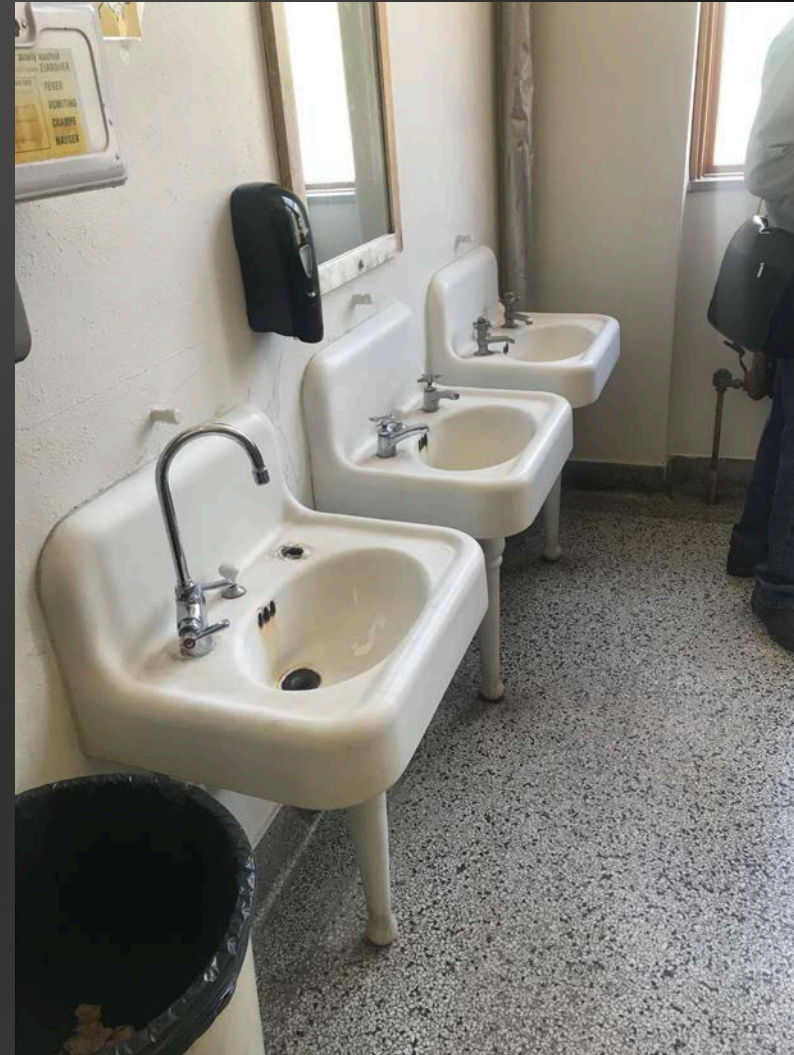
## PLUMBING

Accessibility

Old Piping

Old Fixtures

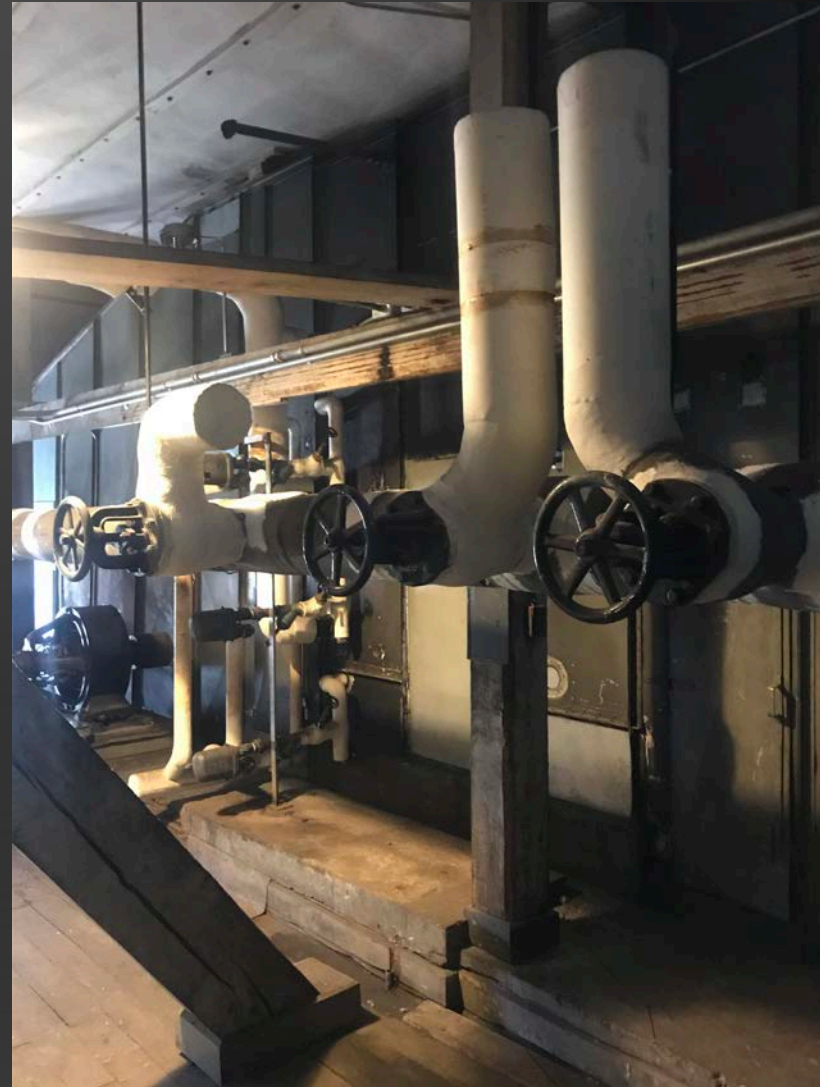
## HVAC

Steam to Hot Water Conversion

45 to 100 years old

Cooling

Control

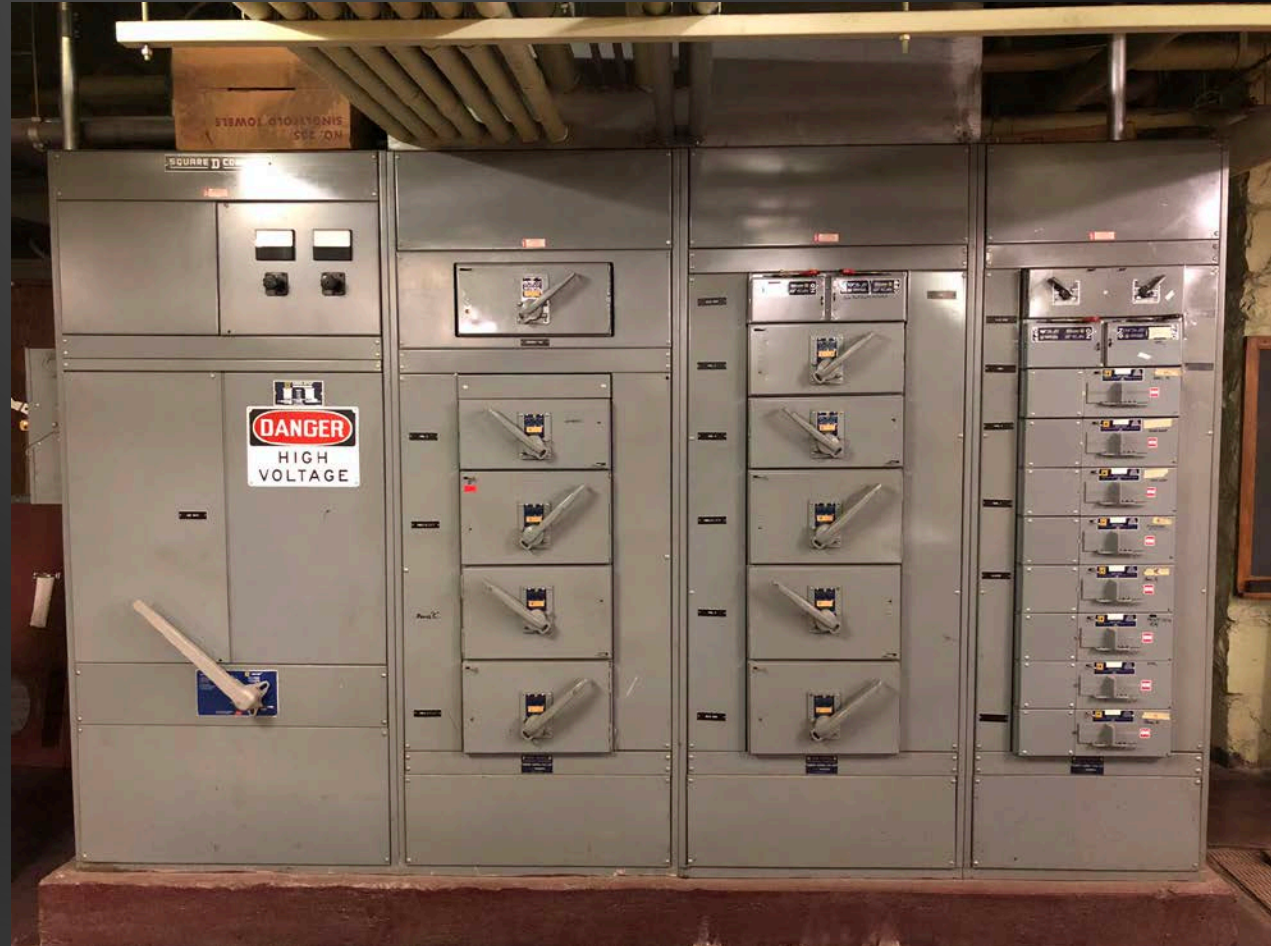
## POWER

Main Switchboard is full

Some panelboards are full

Damaged receptacles

Surface Raceway

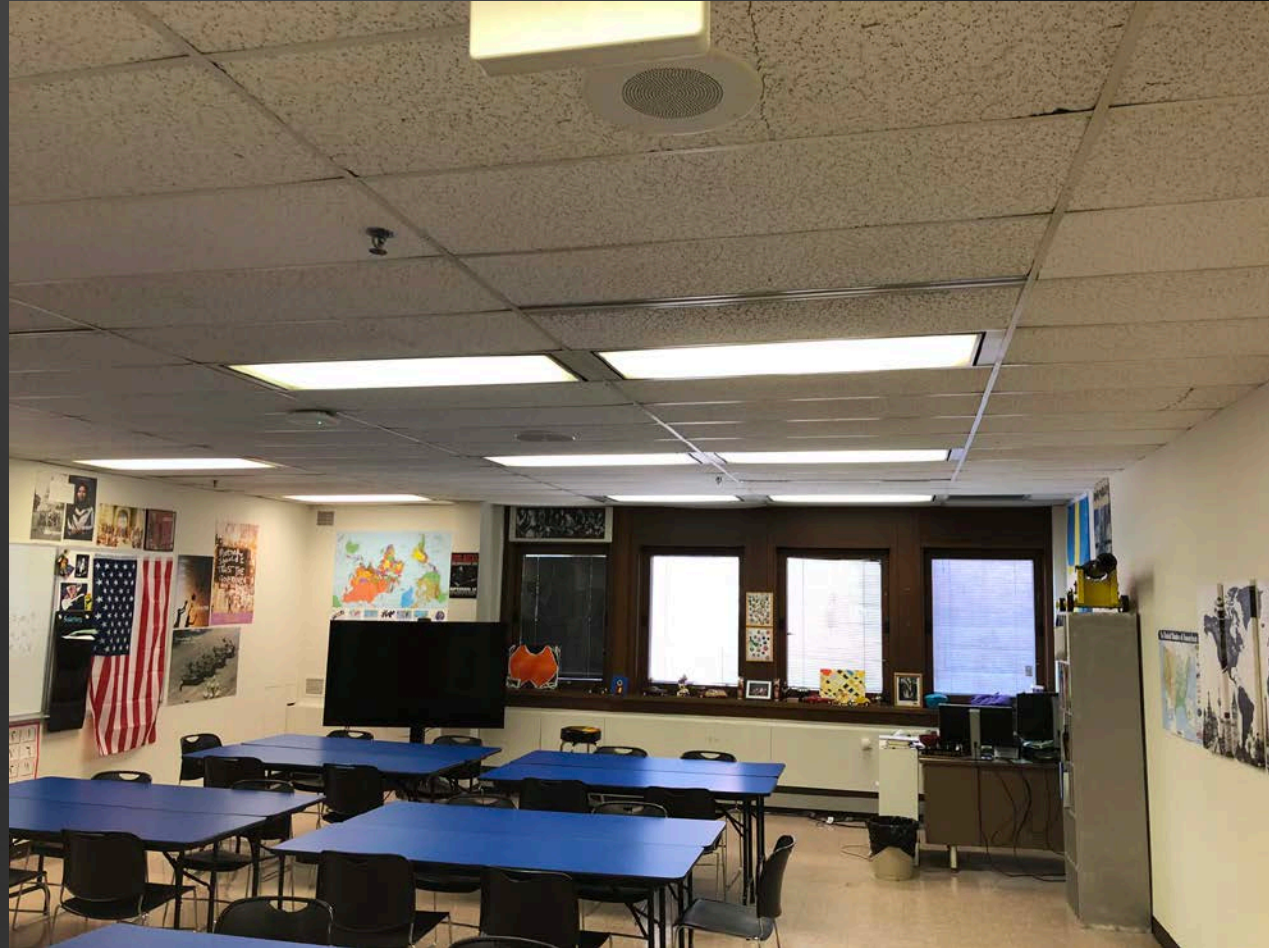
## LIGHTING

Fluorescent lighting

Basic switching for  
lighting controls

Aging Egress and Exit  
lighting, internal  
batteries.

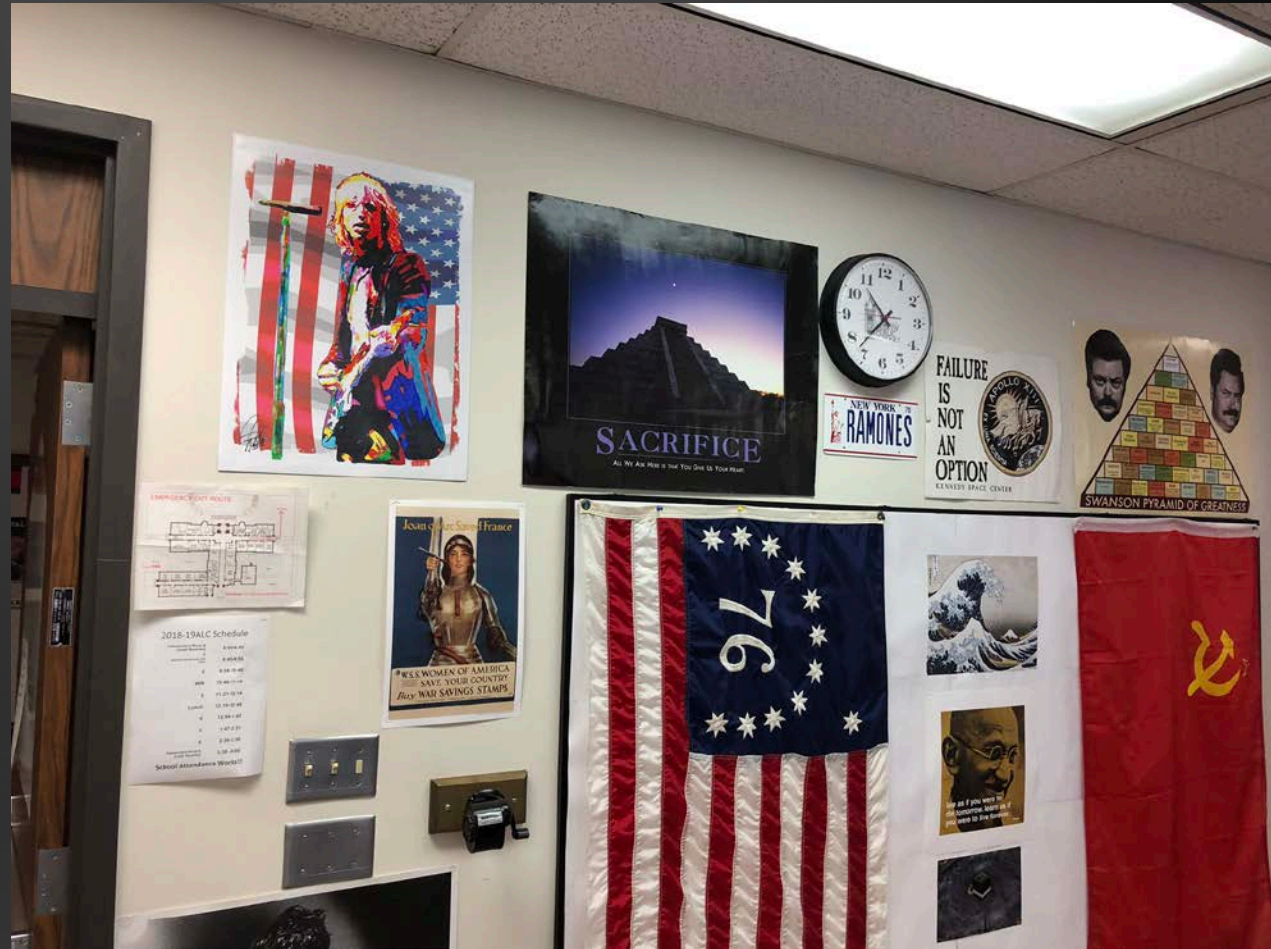
## Clock are not syncing and showing correct time

# Clocks are not standardized

## Replace clock system

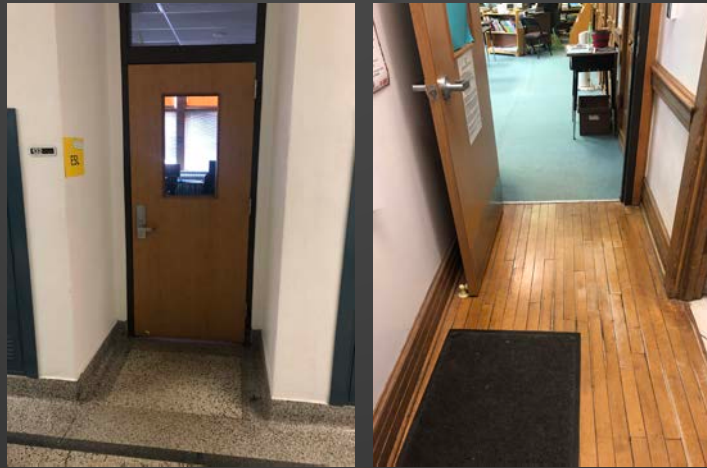
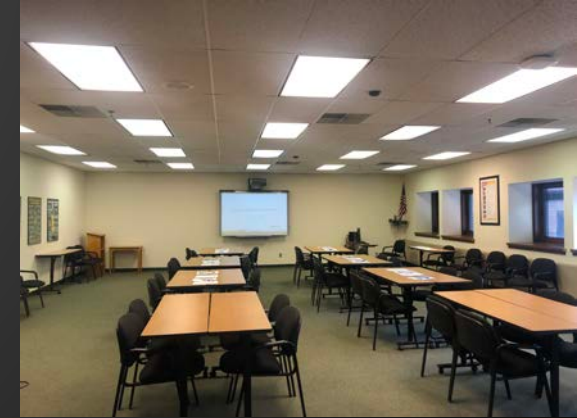
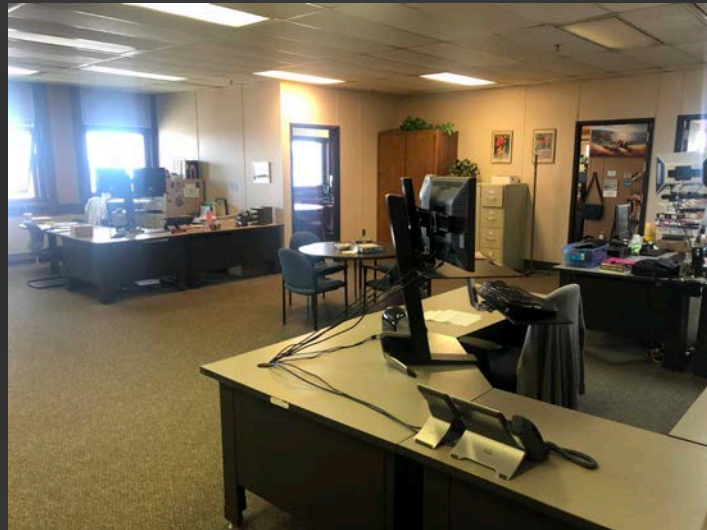
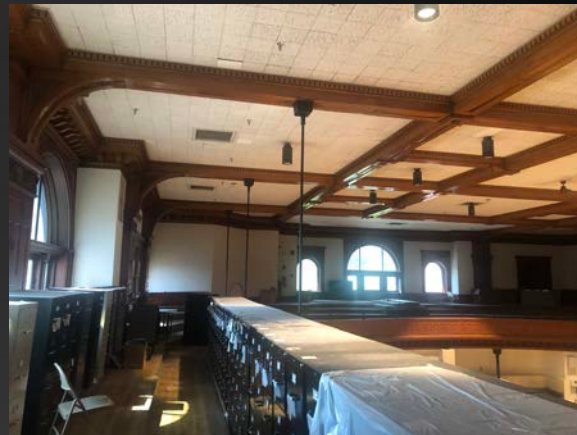
## ARCHITECTURAL FINISHES

Condition- Poor to Good

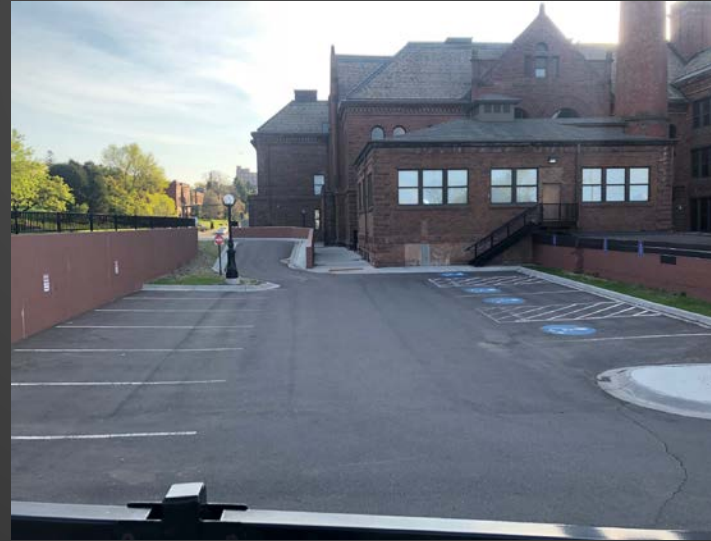
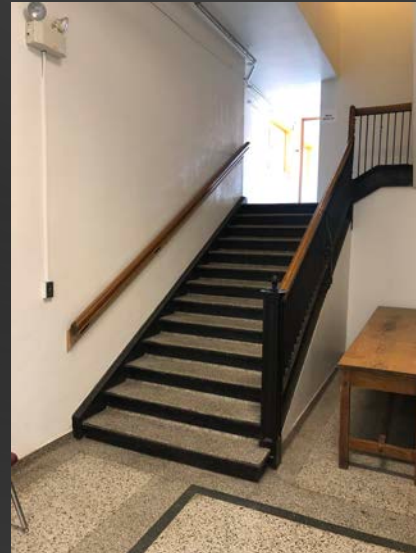
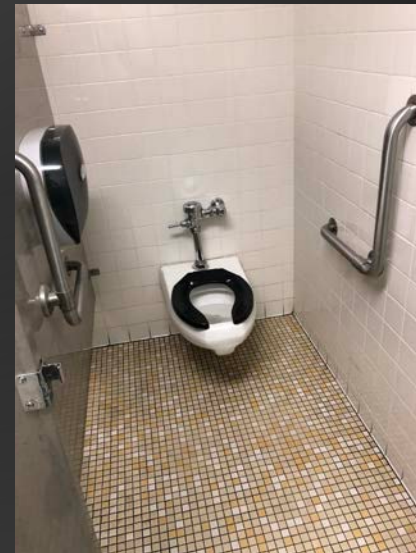
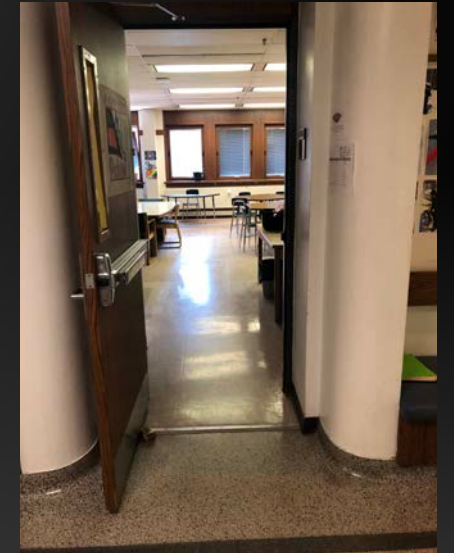
## CONCERNS

Accessible Routes

Building Entrances

Vertical Circulation

Restroom Facilities

Interior doors and signage
