## Certificate of Substantial Completion

**PROJECT:** *(name and address)*  
2022-024.PRE - FRANKLIN CUB  
ACADEMY  
1049 Sloan Drive  
Franklin, IN 46131

# Site Visit Construction

## Interior/Exterior Punch List - 7/2/26

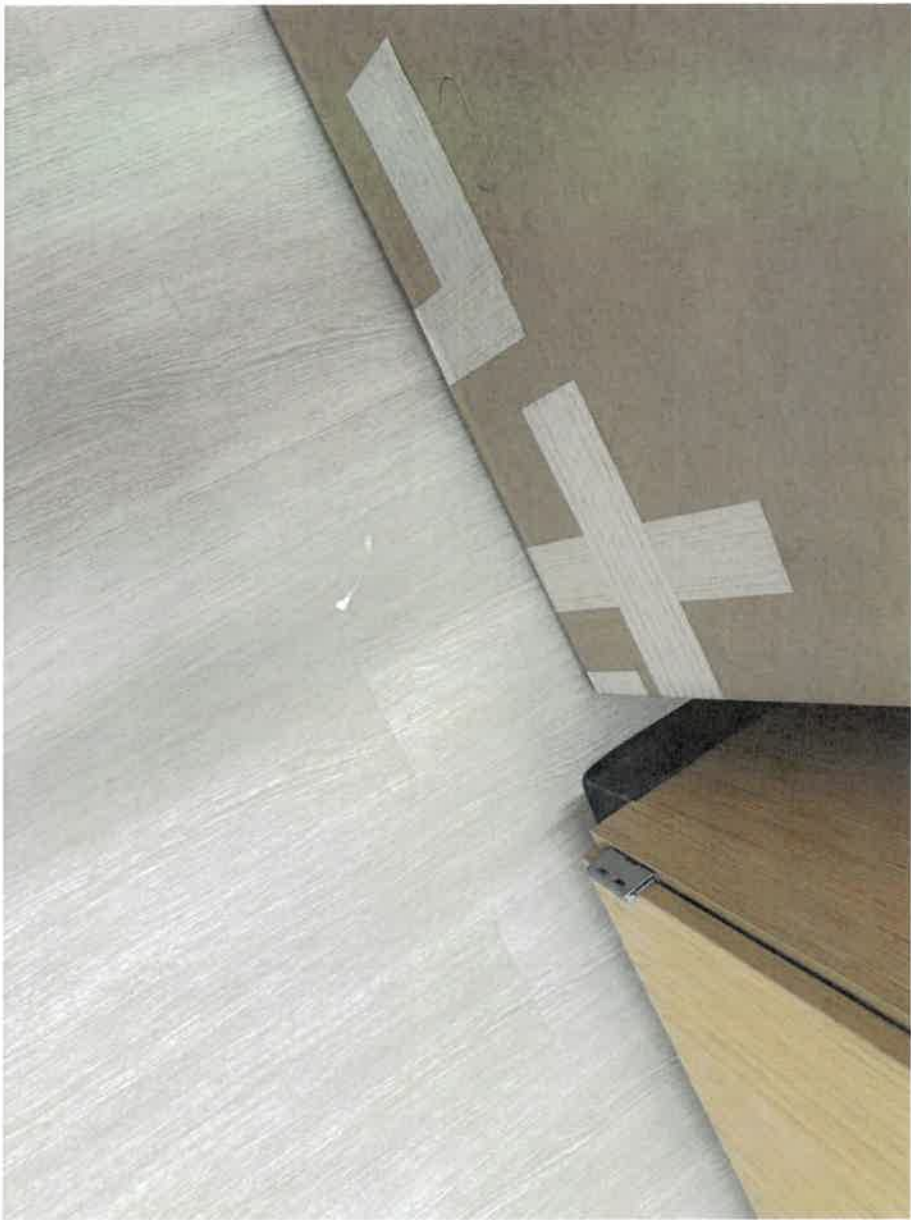
ITEM: 027-001

SUBJECT: A108  
REMARKS: Paint on floor near casework  
CATEGORY: Quality

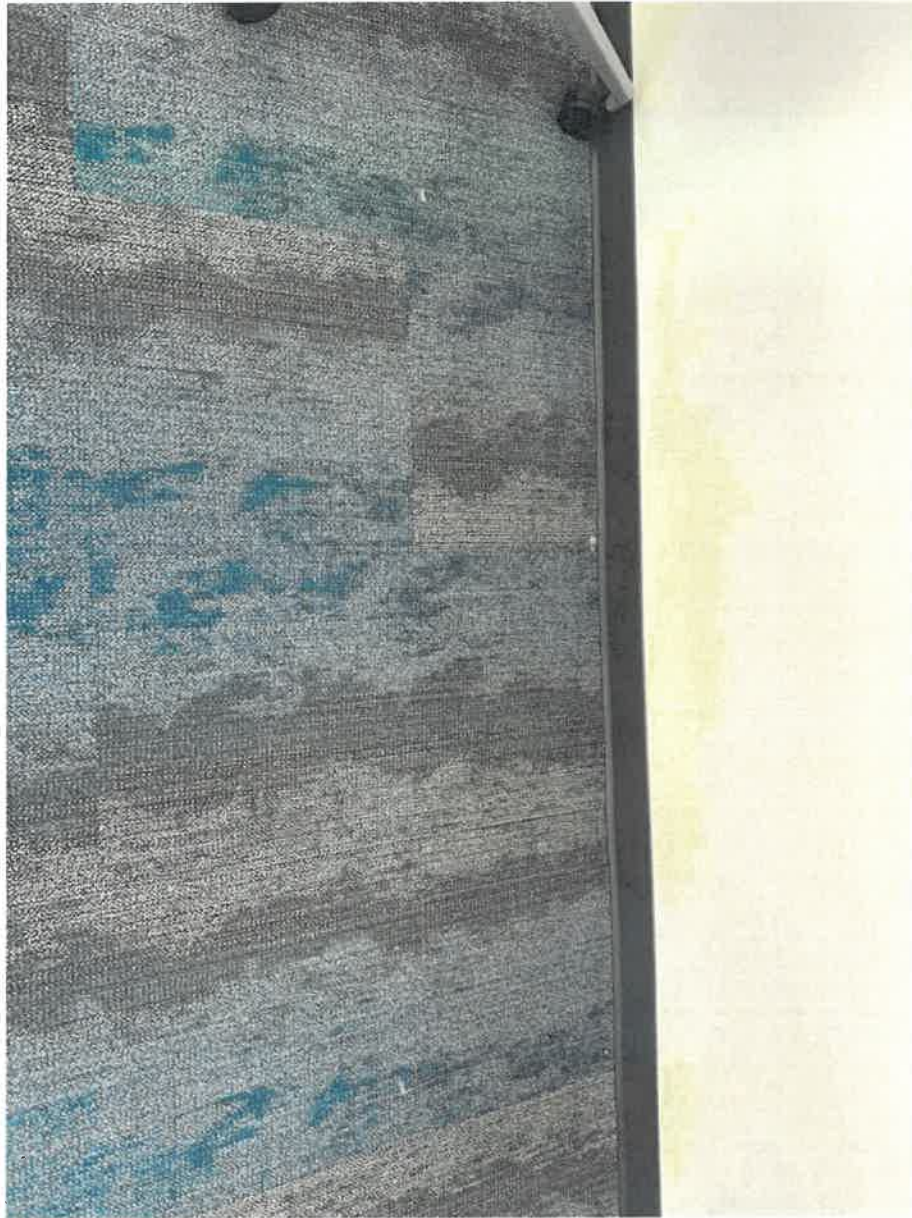
ITEM: 027-002

SUBJECT: A102  
REMARKS: Paint on carpet near window  
CATEGORY: Quality

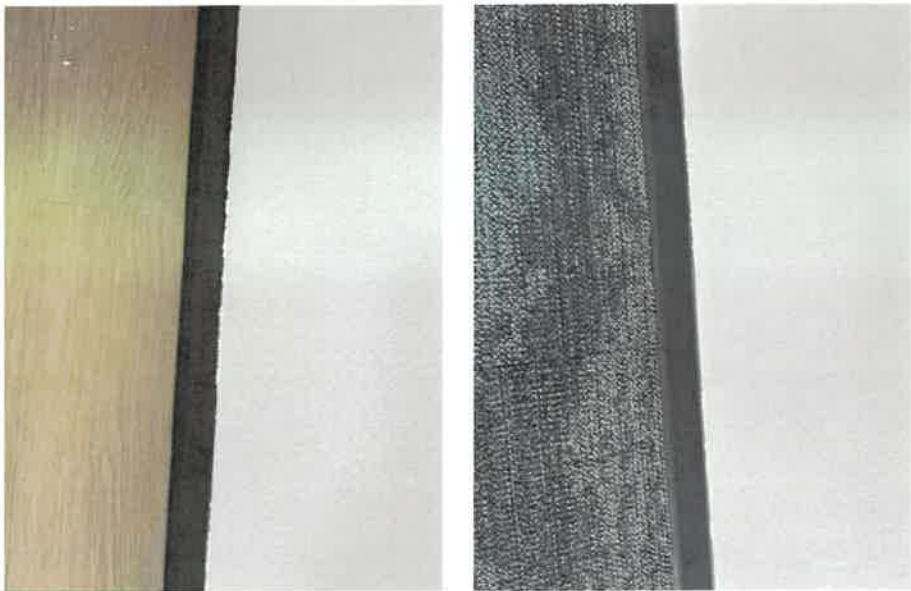
ITEM: 027-003

SUBJECT: General  
REMARKS: Paint on Base  
CATEGORY: Quality

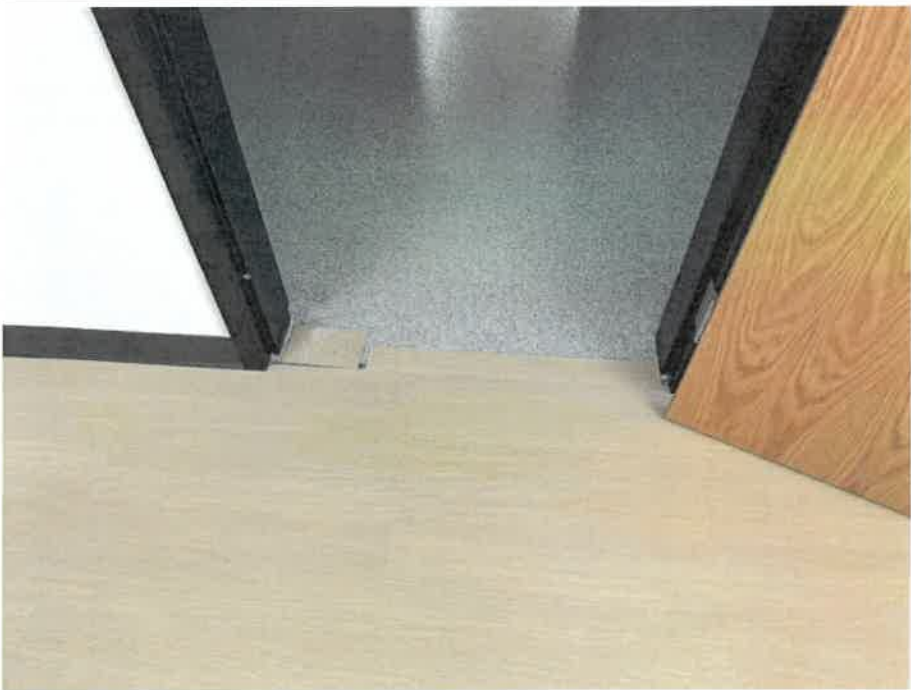
ITEM: 027-004

SUBJECT: B100  
REMARKS: Finish LVT at restoom  
CATEGORY: Quality

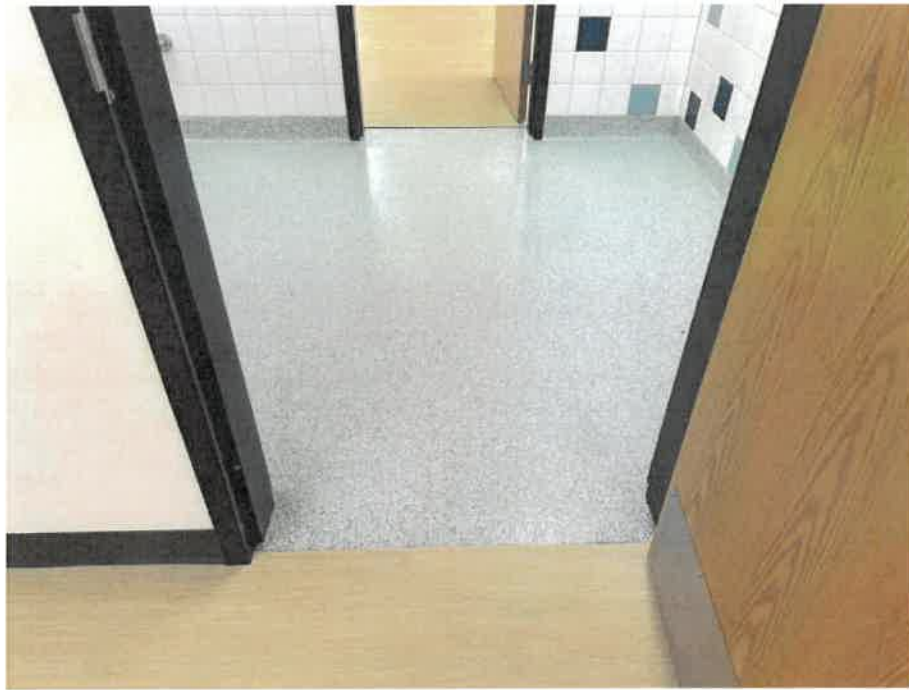
ITEM: 027-005

SUBJECT: General  
REMARKS: Install Flooring transitions  
CATEGORY: Quality

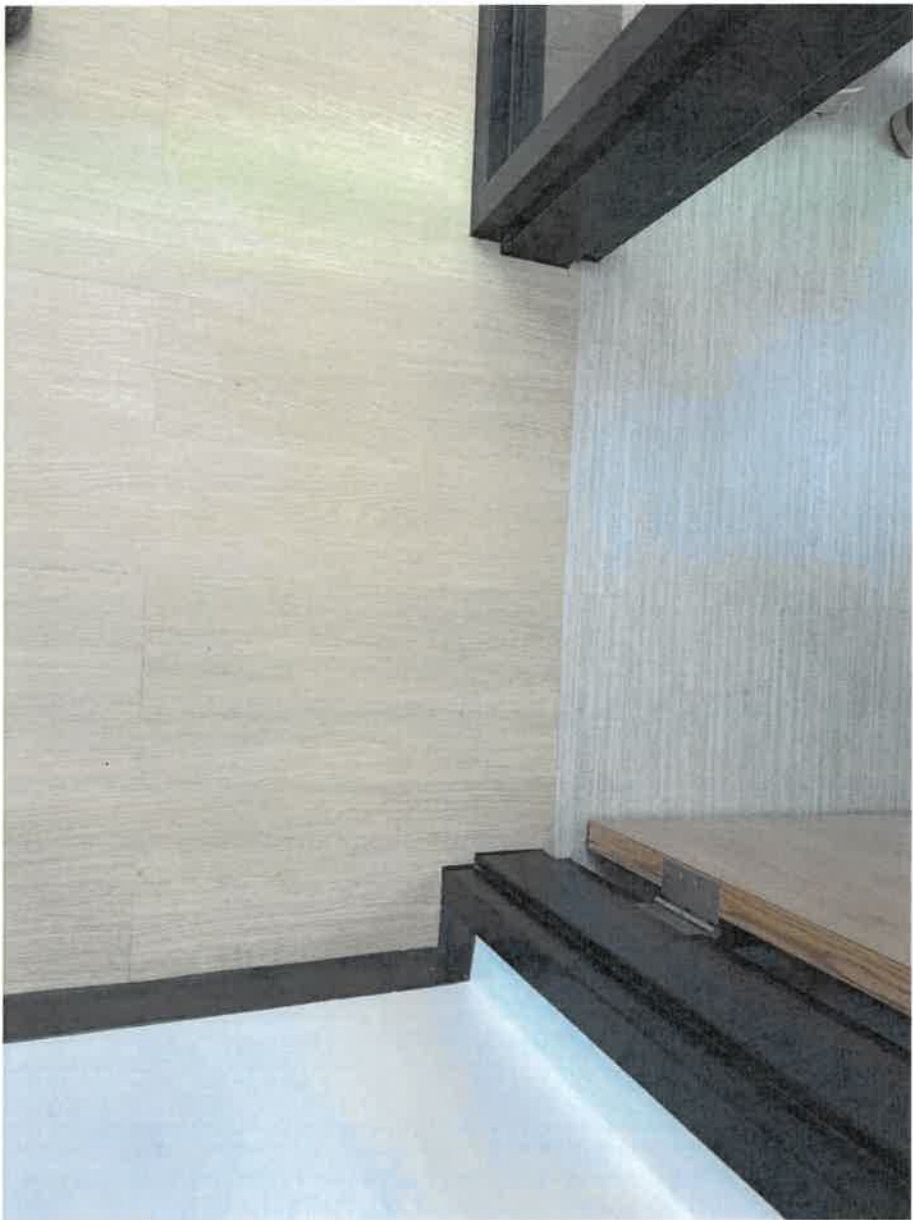
ITEM: 027-006

SUBJECT: General  
REMARKS: Caulk flooring at door frames  
CATEGORY: Quality

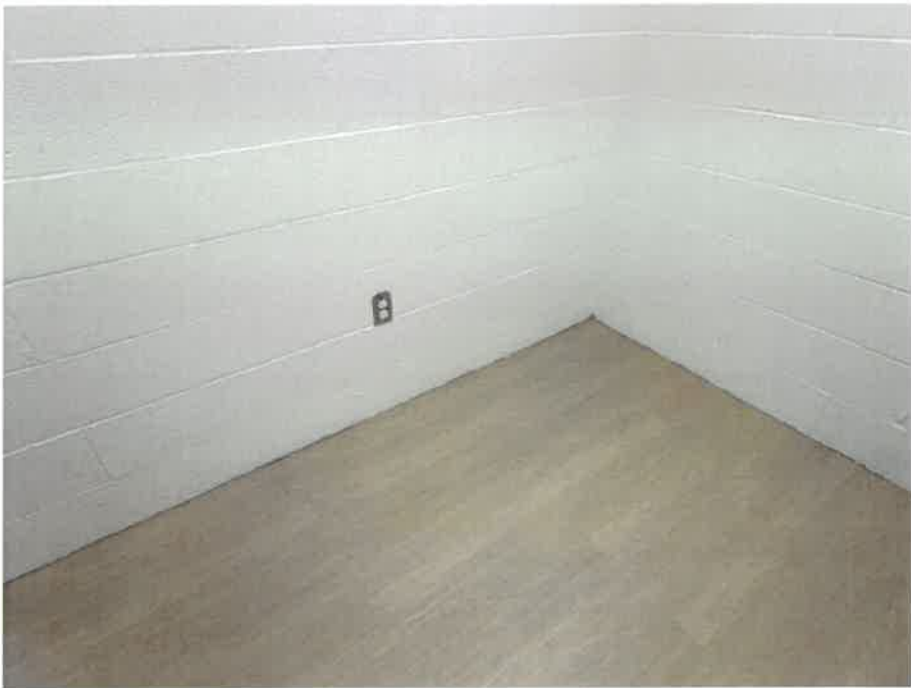
ITEM: 027-007

SUBJECT: General  
REMARKS: Wall base missing in storage rooms  
CATEGORY: Quality

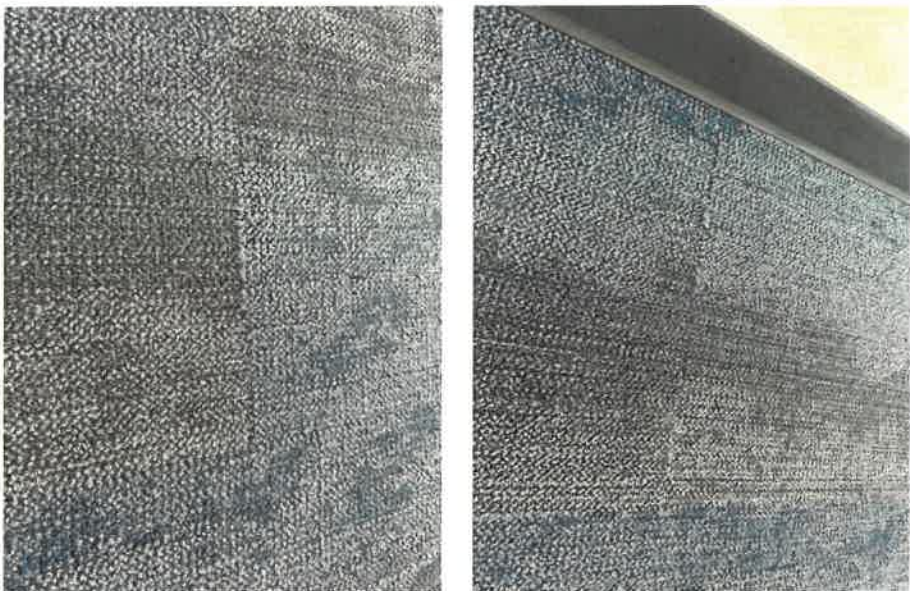
ITEM: 027-009

SUBJECT: General  
REMARKS: Carpet seams are fraying  
CATEGORY: Quality

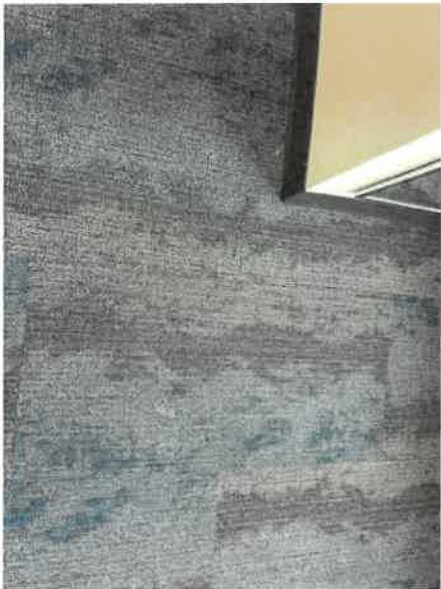
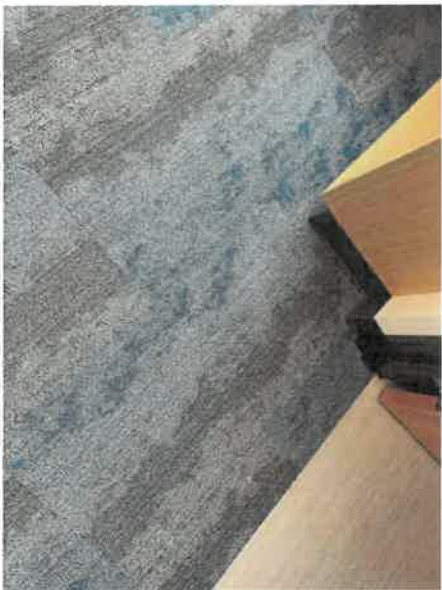
ITEM: 027-010

SUBJECT: B105  
REMARKS: Paint on the floor near window  
CATEGORY: Quality

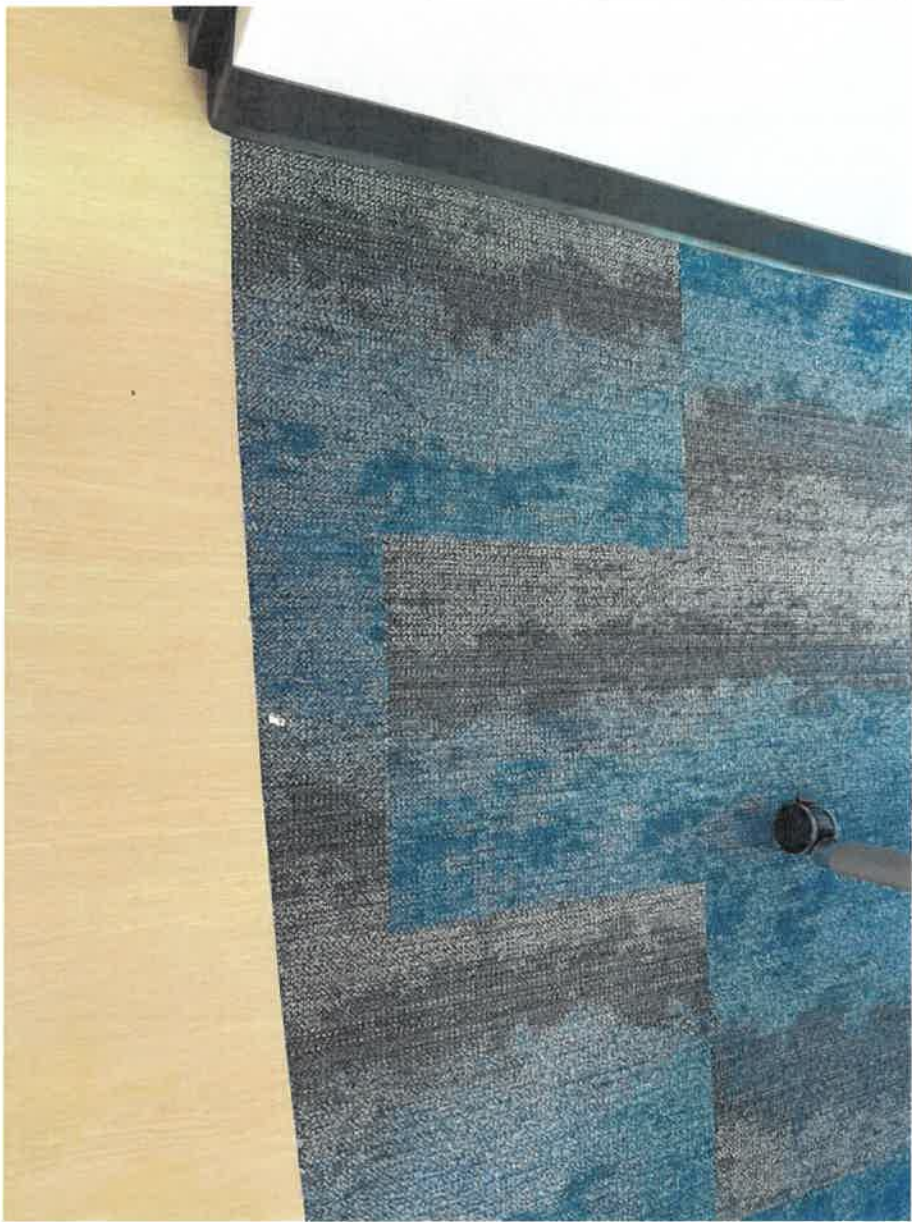
ITEM: 027-011

SUBJECT: B107  
REMARKS: Paint on the floor near window  
CATEGORY: Quality

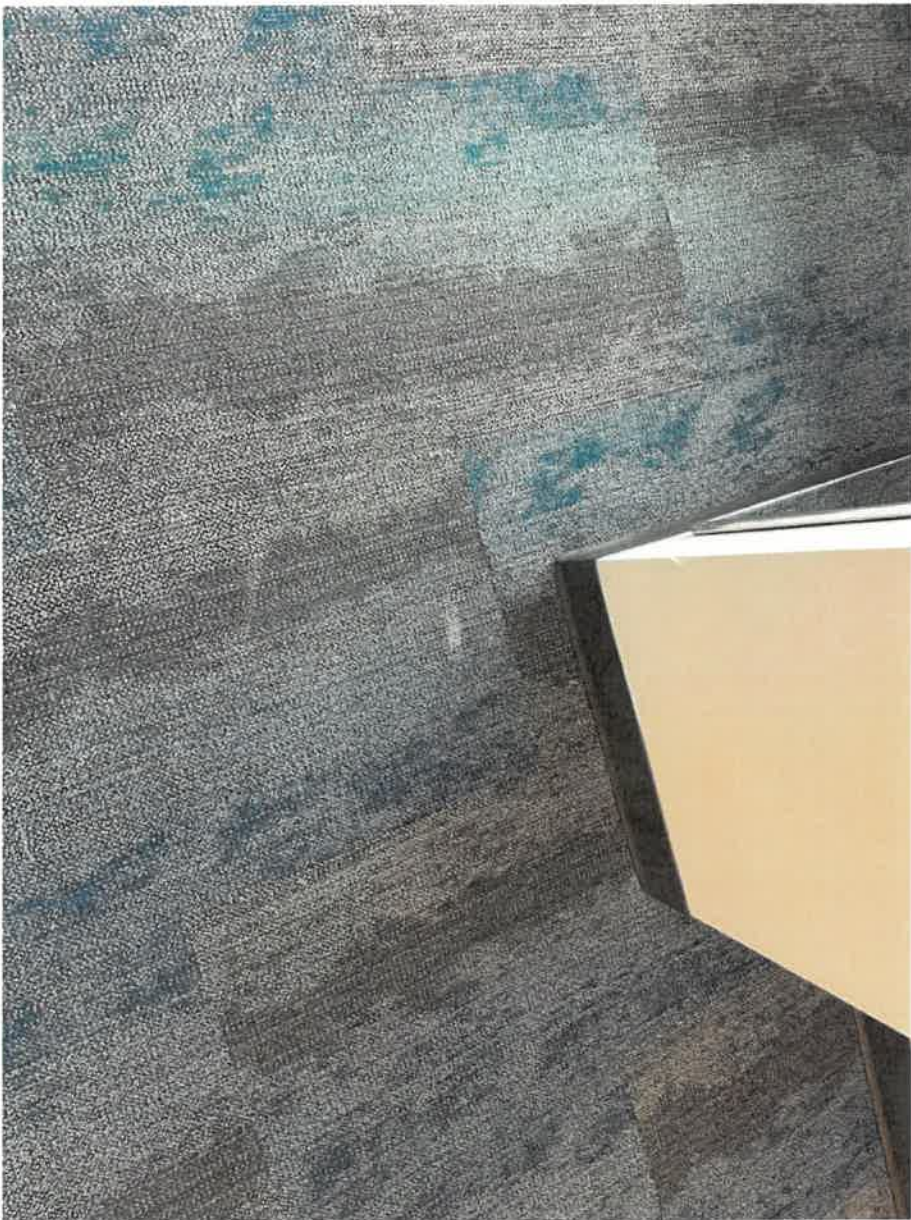
ITEM: 027-012

SUBJECT: B107  
REMARKS: Paint on the floor near window  
CATEGORY: Quality

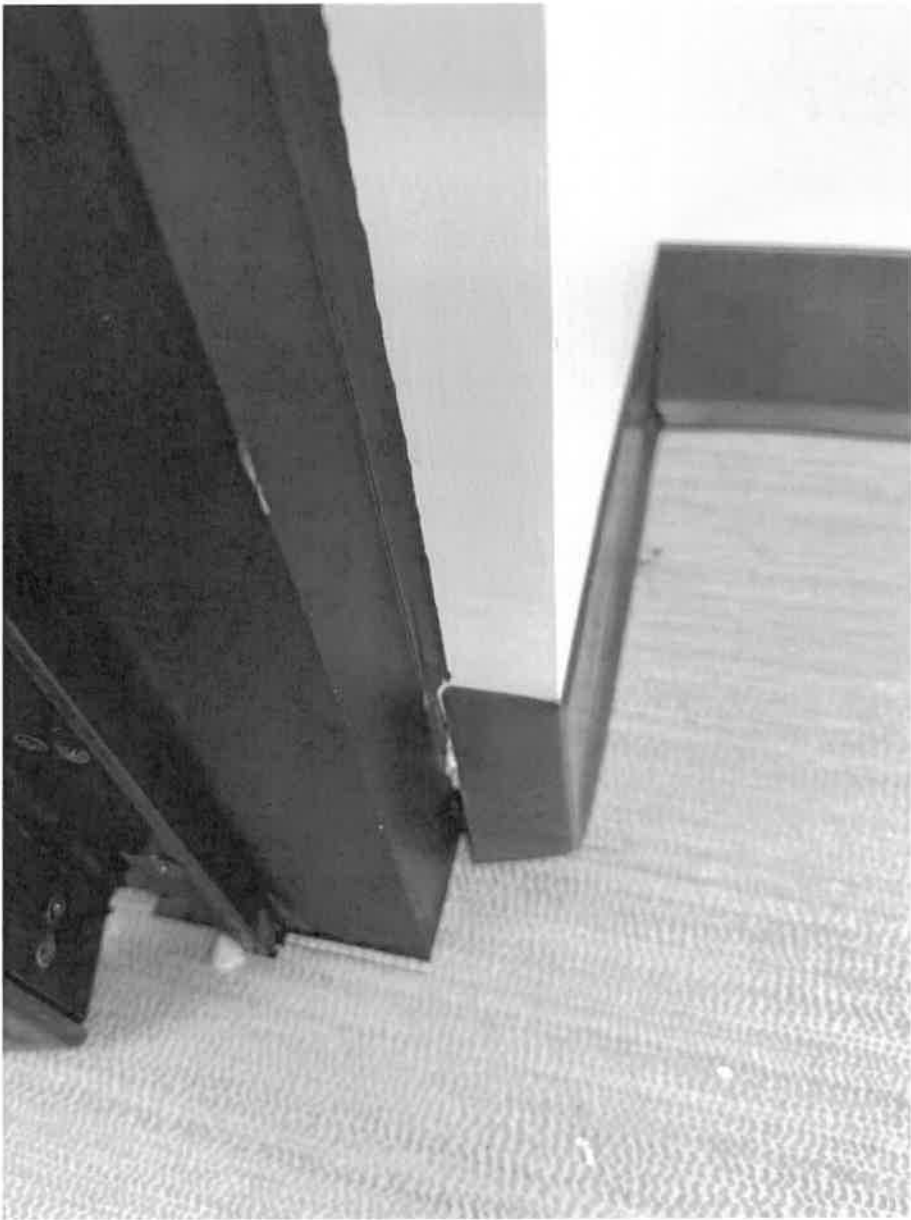
ITEM: 027-013

SUBJECT: Corridor H101  
REMARKS: Caulk base to frame  
CATEGORY: Quality

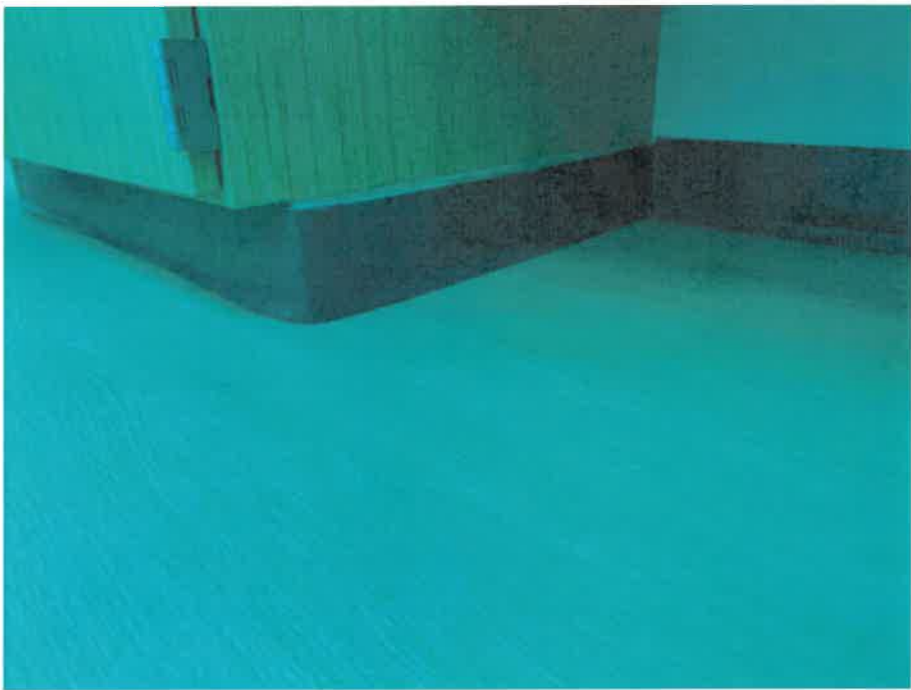
ITEM: 027-014

SUBJECT: C101  
REMARKS: Replace Base at casework  
CATEGORY: Quality

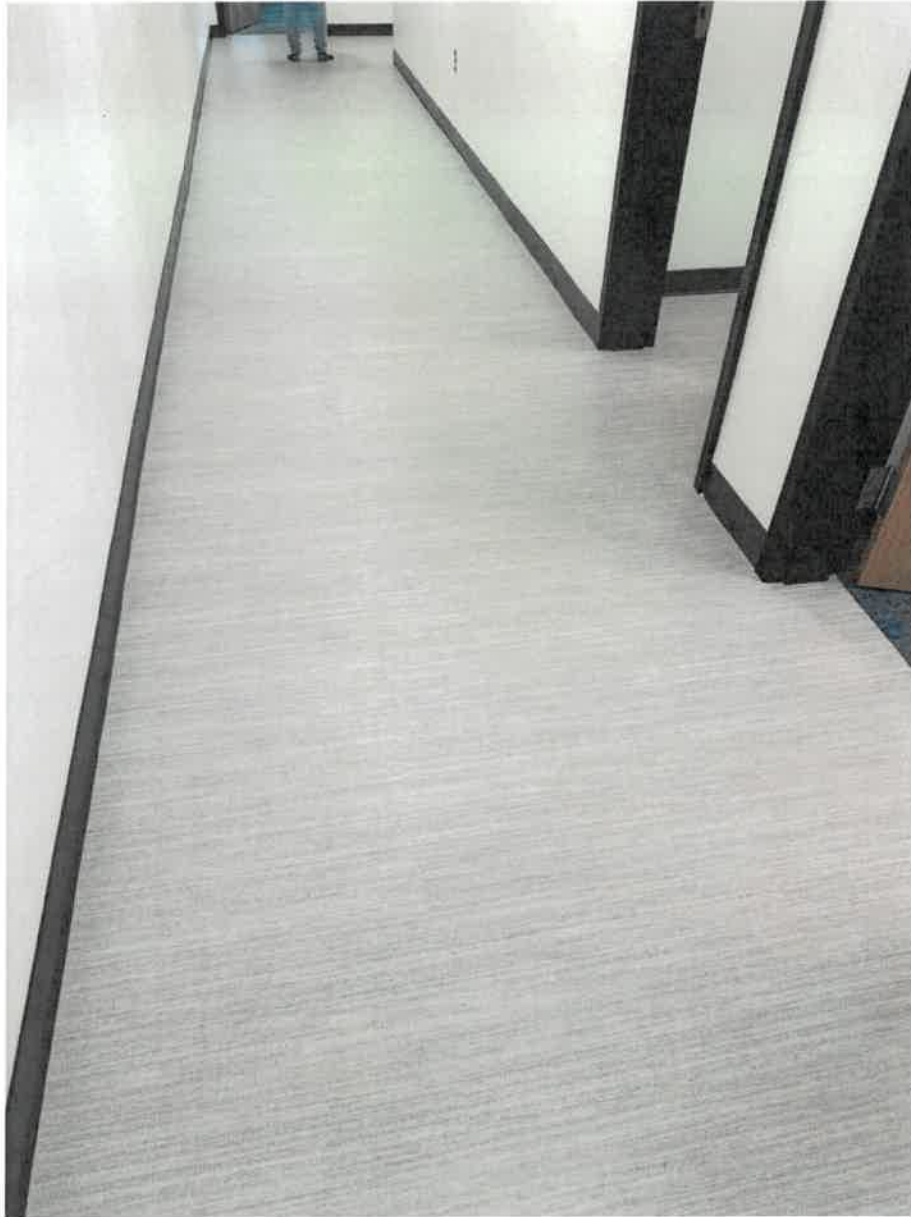
ITEM: 027-015

SUBJECT: Corridor H100  
REMARKS: VWB is wavy  
CATEGORY: Quality

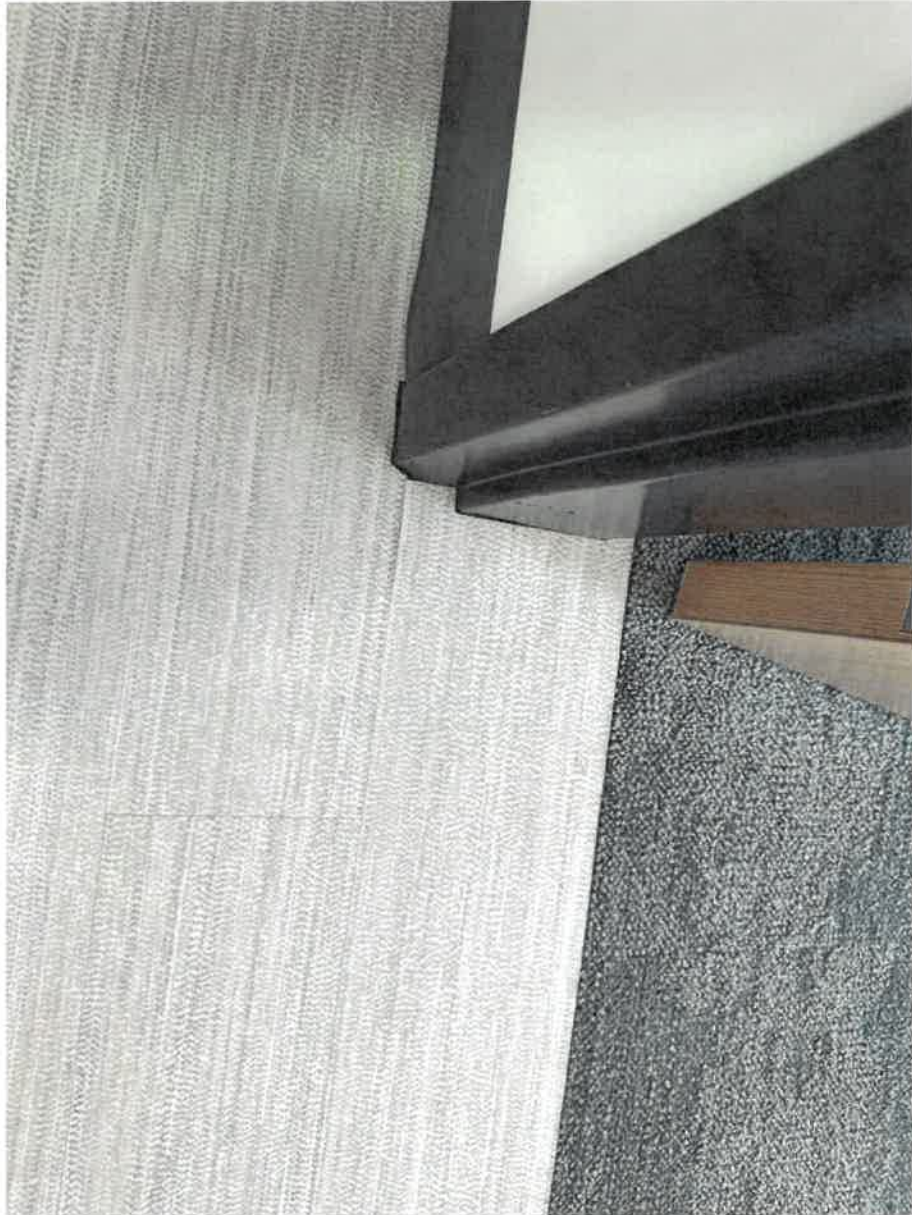
ITEM: 027-016

SUBJECT: Corridor H100  
REMARKS: LVT coming loose outside A104  
CATEGORY: Quality

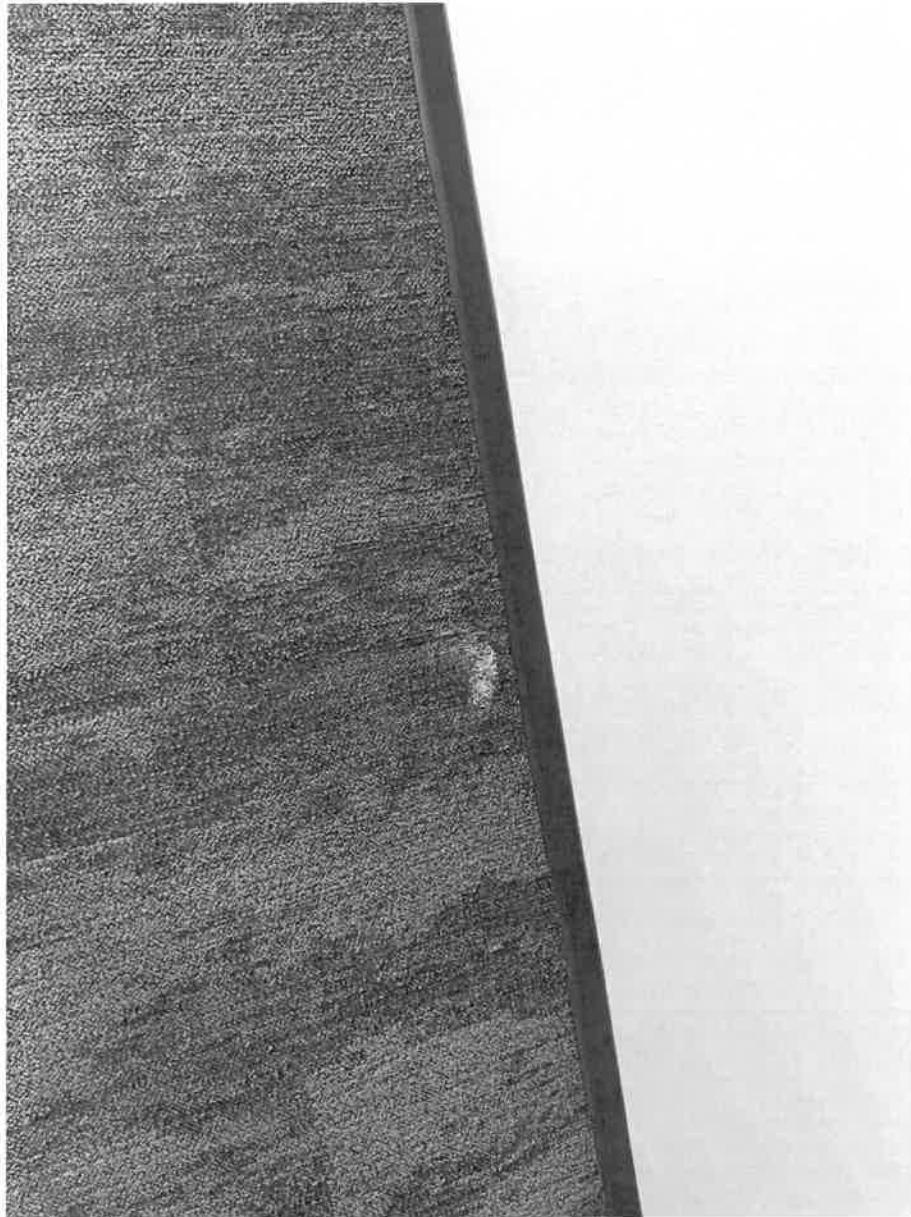
ITEM: 027-017

SUBJECT: A103  
REMARKS: Paint on carpet near window  
CATEGORY: Quality

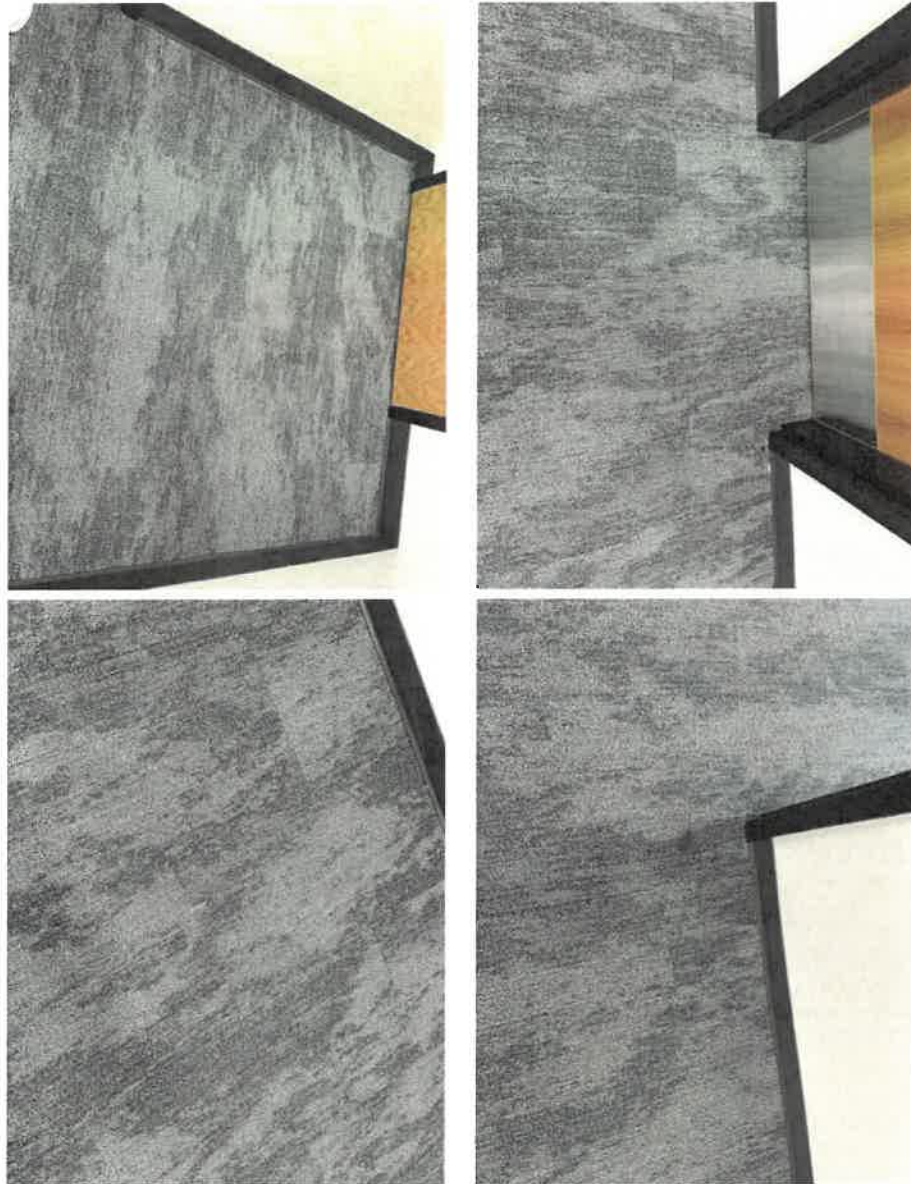
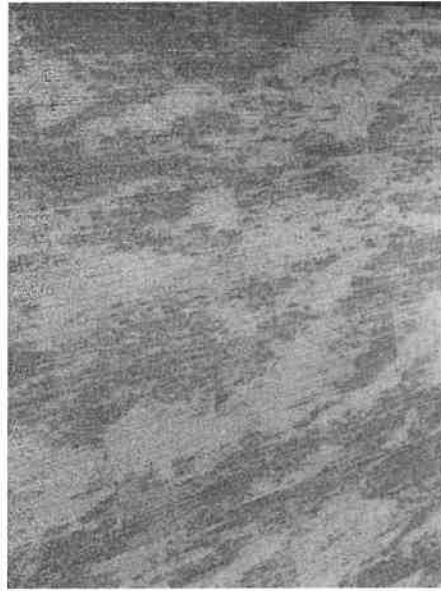
ITEM: 027-018

SUBJECT: A100  
REMARKS: Paint/Mud on carpet  
CATEGORY: Quality

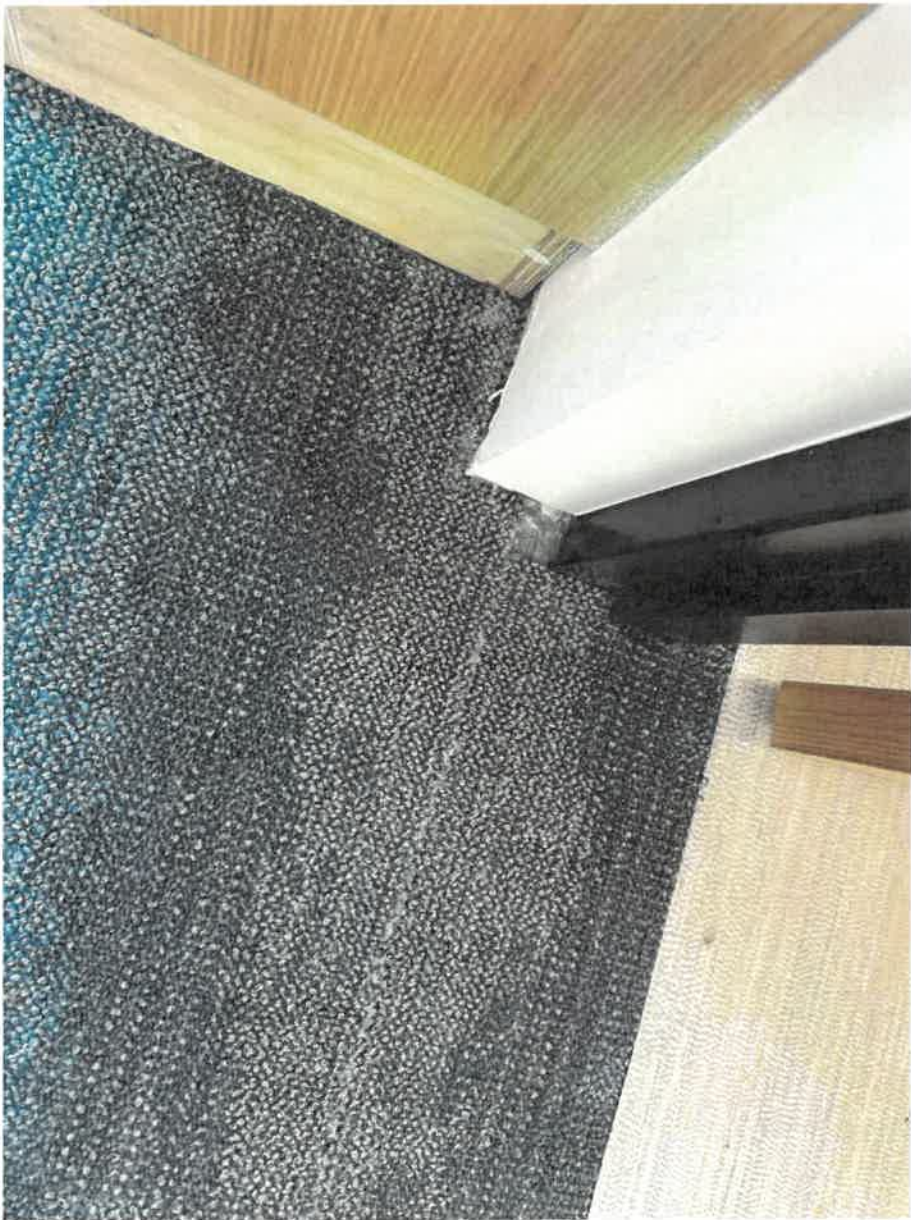
ITEM: 027-019

SUBJECT: D105a  
REMARKS: Missing carpet  
CATEGORY: Quality

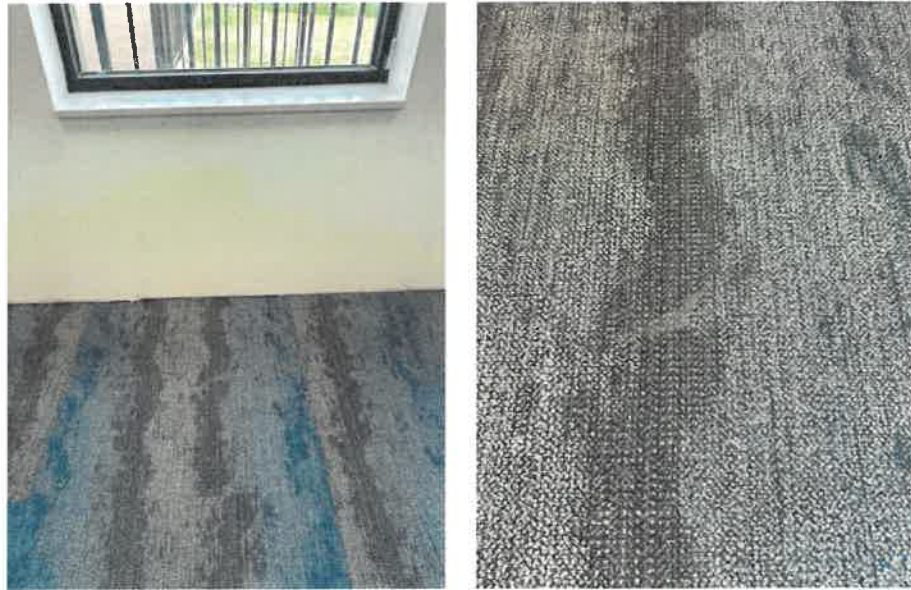
ITEM: 027-020

SUBJECT: D103  
REMARKS: Paint on carpet near window  
CATEGORY: Quality

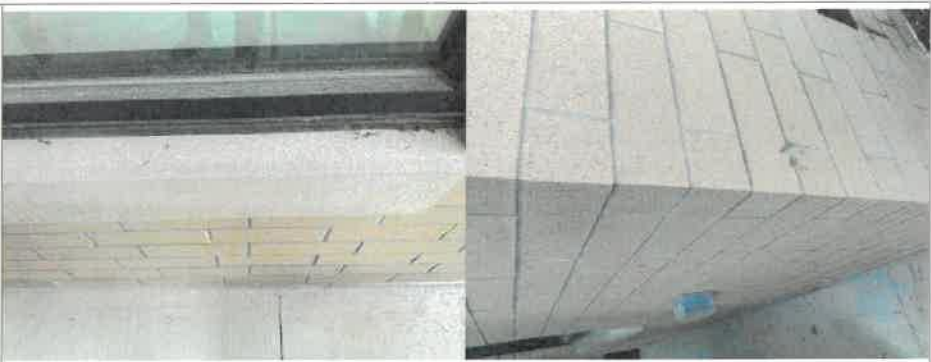
| SPACE NUMBER | SPACE NAME | ELEMENT | LOCATION | DESCRIPTION | STATUS LABEL | ID | SUPPORTING DOCS |
|---|---|---|---|---|---|---|---|
| | N/A | Exterior | | Remove liquid armor from brick at main entrance | Open | 0000<br>6 | |

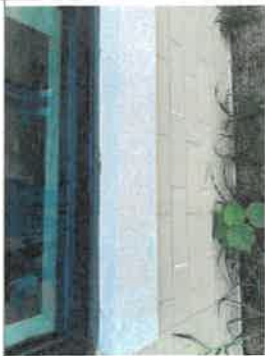
| SPACE NUMBER | SPACE NAME | ELEMENT | LOCATION | DESCRIPTION | STATUS LABEL | ID | SUPPORTING DOCS |
|---|---|---|---|---|---|---|---|
| | N/A | Exterior | | Remove Joint sealant on sills | Open | 0000<br>7 | |

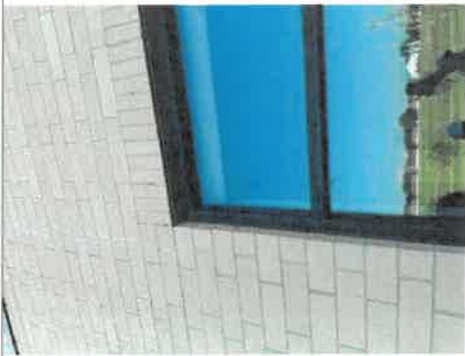
| SPACE NUMBER | SPACE NAME | ELEMENT | LOCATION | DESCRIPTION | STATUS LABEL | ID | SUPPORTING DOCS |
|---|---|---|---|---|---|---|---|
| | N/A | Exterior | | Mortar missing on west side of building | Open | 0000<br>8 | |

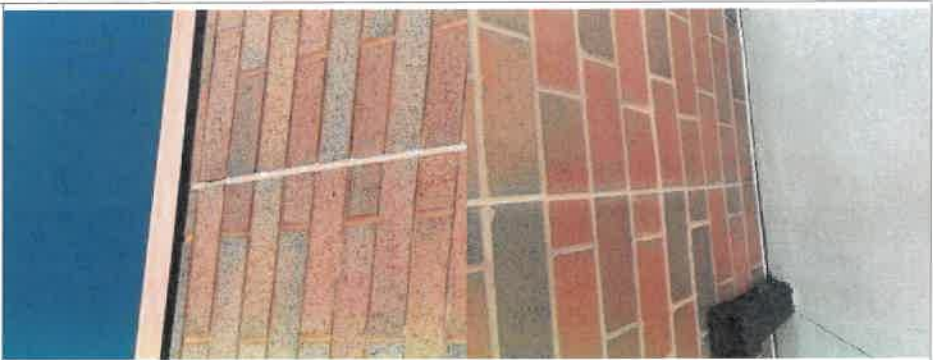
| SPACE NUMBER | SPACE NAME | ELEMENT | LOCATION | DESCRIPTION | STATUS LABEL | ID | SUPPORTING DOCS |
|---|---|---|---|---|---|---|---|
| | N/A | Exterior | | Remove weeps from masonry control, joints, multiple locations | Open | 00017 | |

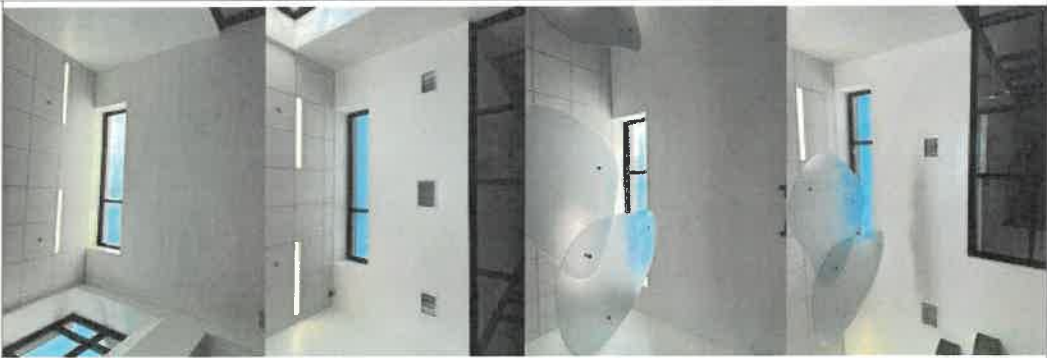
| SPACE NUMBER | SPACE NAME | ELEMENT | LOCATION | DESCRIPTION | STATUS LABEL | ID | SUPPORTING DOCS |
|---|---|---|---|---|---|---|---|
| | N/A | Vestibule V100 | | Window millions are not symmetrical | Open | 00020 | |

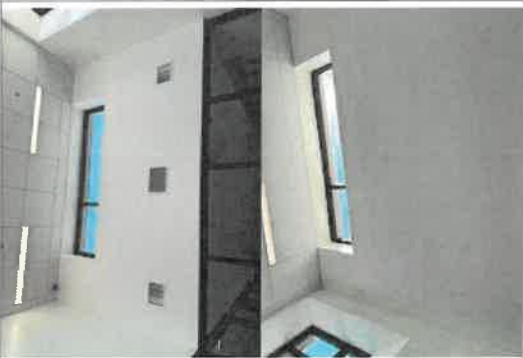
| SPACE NUMBER | SPACE NAME | ELEMENT | LOCATION | DESCRIPTION | STATUS LABEL | ID | SUPPORTING DOCS |
|---|---|---|---|---|---|---|---|
| | N/A | Vestibule V100 | | Sills are not sloped | Open | 0002<br>2 | |

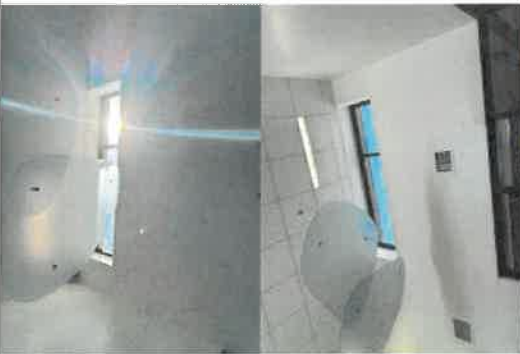
| SPACE NUMBER | SPACE NAME | ELEMENT | LOCATION | DESCRIPTION | STATUS LABEL | ID | SUPPORTING DOCS |
|---|---|---|---|---|---|---|---|
| | N/A | Vestibule V100 | | Door should not have notch at bottom | Open | 0002<br>3 | |

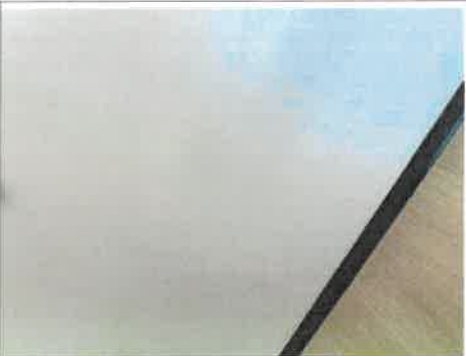
| SPACE NUMBER | SPACE NAME | ELEMENT | LOCATION | DESCRIPTION | STATUS LABEL | ID | SUPPORTING DOCS |
|---|---|---|---|---|---|---|---|
| | N/A | Workroom C112 | | Fix drywall | Open | 0003<br>0 | |

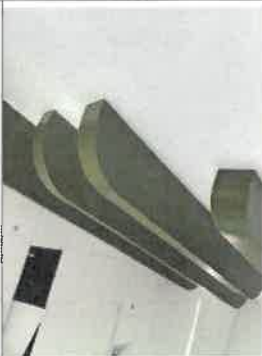
| SPACE NUMBER | SPACE NAME | ELEMENT | LOCATION | DESCRIPTION | STATUS LABEL | ID | SUPPORTING DOCS |
|---|---|---|---|---|---|---|---|
| | N/A | Great Room C108 | | Touch up bulkheads | Open | 0003<br>1 | |

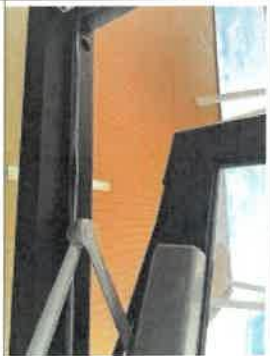
| SPACE NUMBER | SPACE NAME | ELEMENT | LOCATION | DESCRIPTION | STATUS LABEL | ID | SUPPORTING DOCS |
|---|---|---|---|---|---|---|---|
| | N/A | Opening C108.2 | | Seal needs replaced | Open | 0003<br>2 | |

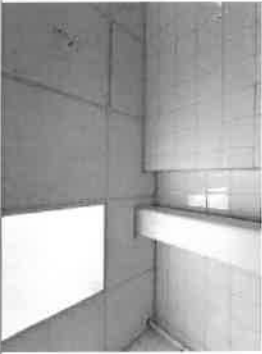
| SPACE NUMBER | SPACE NAME | ELEMENT | LOCATION | DESCRIPTION | STATUS LABEL | ID | SUPPORTING DOCS |
|---|---|---|---|---|---|---|---|
| | N/A | Laundry/Jan C103B | | Replace short tile and install escutcheon at condensate line | Open | 0003 6 | |

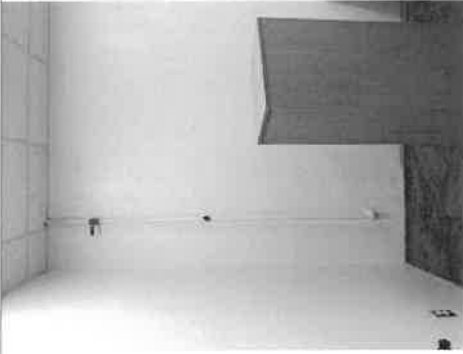
| SPACE NUMBER | SPACE NAME | ELEMENT | LOCATION | DESCRIPTION | STATUS LABEL | ID | SUPPORTING DOCS |
|---|---|---|---|---|---|---|---|
| | N/A | Office C103A | | Fire protection drain pipe not shown to be exposed | Open | 0003 7 | |

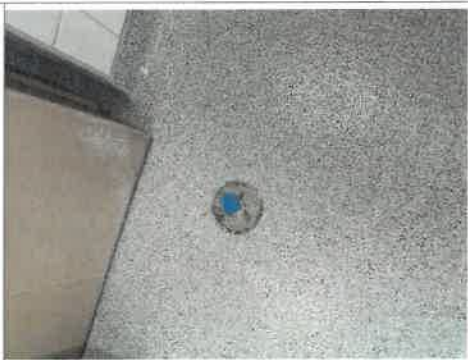
| SPACE NUMBER | SPACE NAME | ELEMENT | LOCATION | DESCRIPTION | STATUS LABEL | ID | SUPPORTING DOCS |
|---|---|---|---|---|---|---|---|
| | N/A | Handwashing C150 | | Replace clean out cover | Open | 0004<br>1 | |

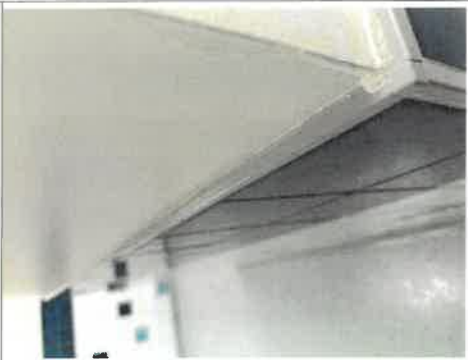
| SPACE NUMBER | SPACE NAME | ELEMENT | LOCATION | DESCRIPTION | STATUS LABEL | ID | SUPPORTING DOCS |
|---|---|---|---|---|---|---|---|
| | N/A | Girls C151 | | Caulk between wall and schluter strip | Open | 0004<br>2 | |

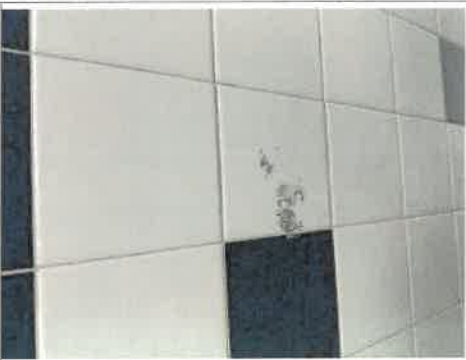
| SPACE NUMBER | SPACE NAME | ELEMENT | LOCATION | DESCRIPTION | STATUS LABEL | ID | SUPPORTING DOCS |
|---|---|---|---|---|---|---|---|
| | N/A | Girls C151 | | Clean tile | Open | 0004<br>3 | |

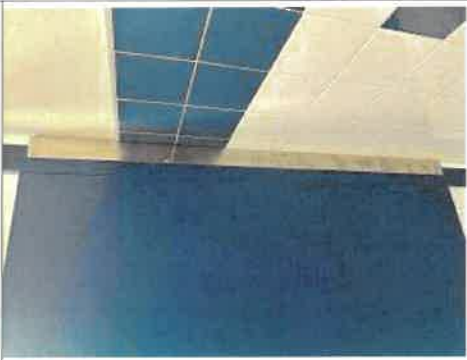
| SPACE NUMBER | SPACE NAME | ELEMENT | LOCATION | DESCRIPTION | STATUS LABEL | ID | SUPPORTING DOCS |
|---|---|---|---|---|---|---|---|
| | N/A | Girls C151 | | Clean residue on partition stainless steel | Open | 0004<br>4 | |

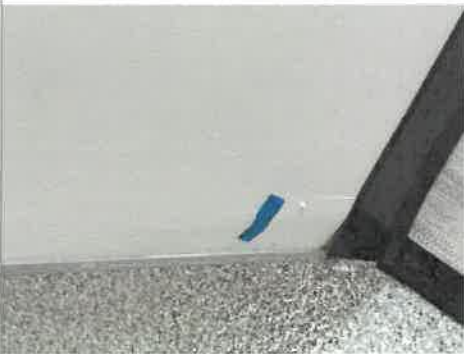
| SPACE NUMBER | SPACE NAME | ELEMENT | LOCATION | DESCRIPTION | STATUS LABEL | ID | SUPPORTING DOCS |
|---|---|---|---|---|---|---|---|
| | N/A | Handwashing C150 | | Repair damaged corner | Open | 0004 5 | |

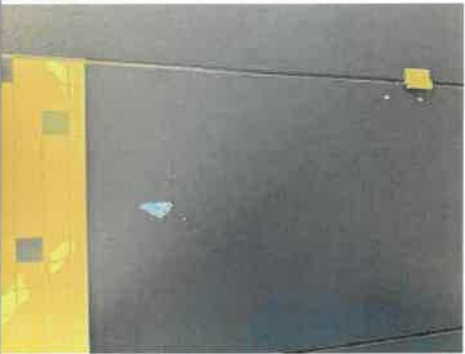
| SPACE NUMBER | SPACE NAME | ELEMENT | LOCATION | DESCRIPTION | STATUS LABEL | ID | SUPPORTING DOCS |
|---|---|---|---|---|---|---|---|
| | N/A | Boys C152 | | Repair scratches on partition | Open | 0004 6 | |

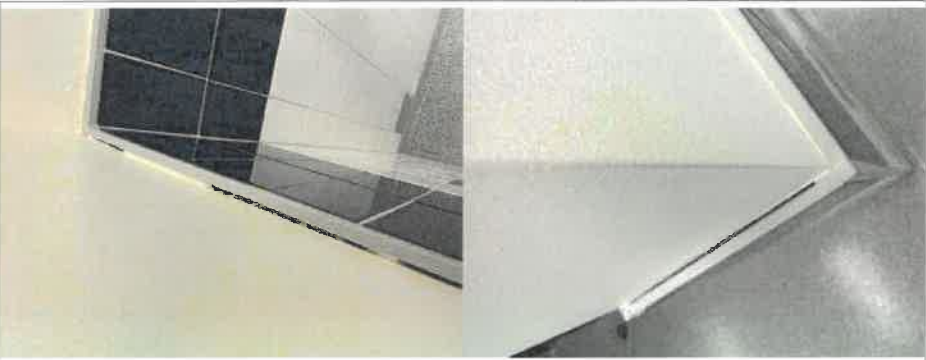
| SPACE NUMBER | SPACE NAME | ELEMENT | LOCATION | DESCRIPTION | STATUS LABEL | ID | SUPPORTING DOCS |
|---|---|---|---|---|---|---|---|
| | N/A | Boys C152 | | Caulk wall to schluter | Open | 00047 | |

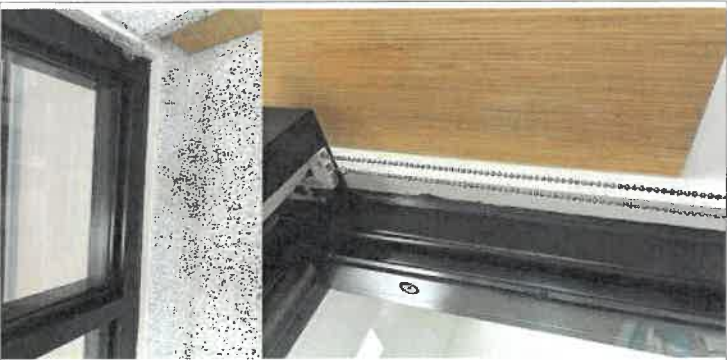
| SPACE NUMBER | SPACE NAME | ELEMENT | LOCATION | DESCRIPTION | STATUS LABEL | ID | SUPPORTING DOCS |
|---|---|---|---|---|---|---|---|
| | N/A | Classroom D106 | | Poor caulking workmanship | Open | 00059 | |

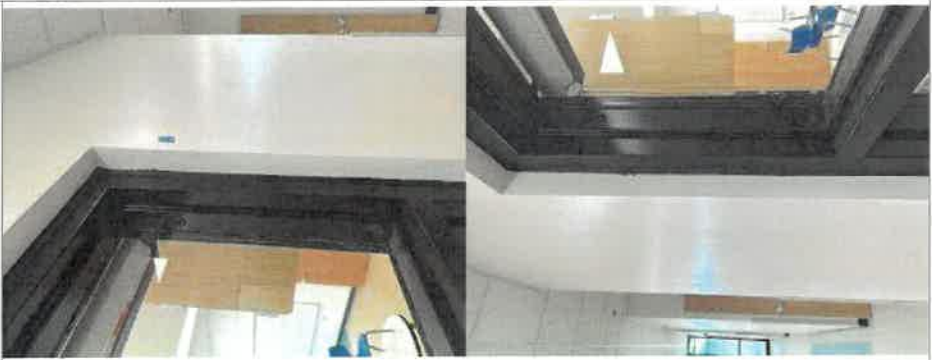
| SPACE NUMBER | SPACE NAME | ELEMENT | LOCATION | DESCRIPTION | STATUS LABEL | ID | SUPPORTING DOCS |
|---|---|---|---|---|---|---|---|
| | N/A | Corridor H103 | | Touch up drywall and paint at windows | Open | 00060 | |
