## Certificate of Substantial Completion

**PROJECT:** *(name and address)*  
2022-024.PRE - FRANKLIN CUB  
ACADEMY  
1049 Sloan Drive  
Franklin, IN 46131

# Site Visit Construction

## Interior/Exterior Punch List - 7/2/26

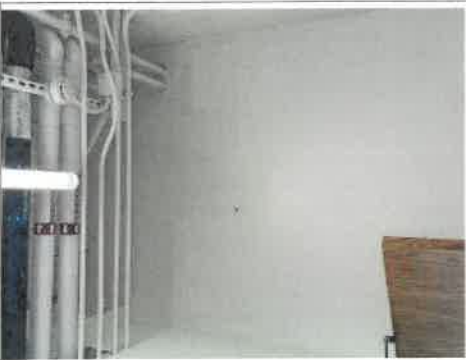
| SPACE NUMBER | SPACE NAME | ELEMENT | LOCATION | DESCRIPTION | STATUS LABEL | ID | SUPPORTING DOCS |
|---|---|---|---|---|---|---|---|
| | N/A | Janitor D100 | | Patch hole in drywall | Open | 0006<br>4 | |

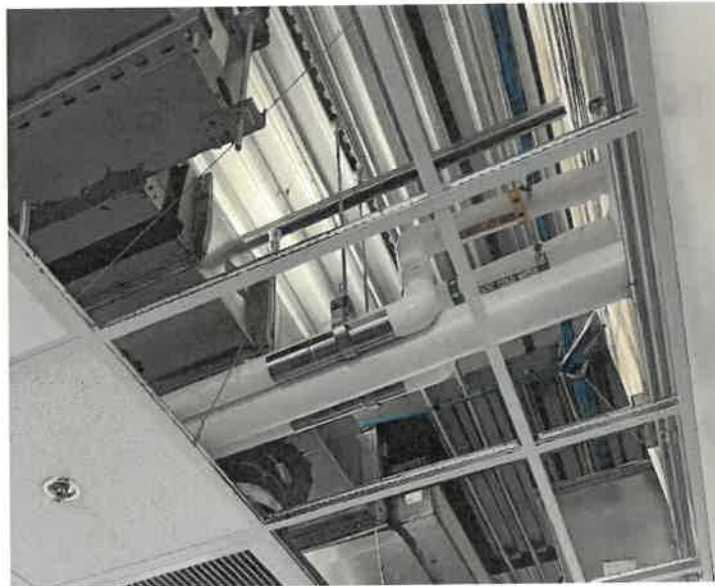
- Vent piping in unit B is not supported properly. Typical of all vent piping in unit B. Contractor shall support vent piping as required per specifications. Verify vent piping and ensure piping is supported as required.

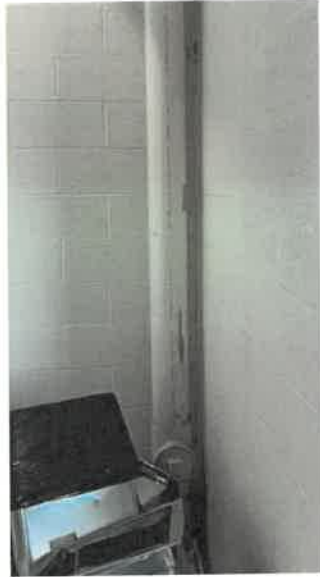
- Storm drops were not enclosed as per plans. Typical of all in unit A & B

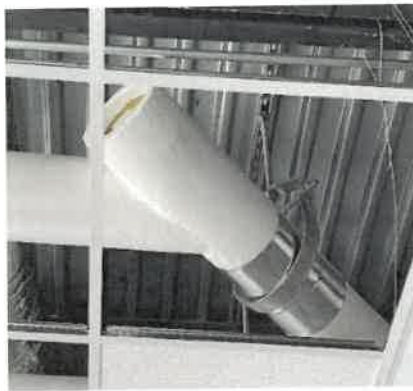
- Storm piping insulation going past C.O. Typical of all storm C.O.s in unit A & B
  - Accessing and opening the cleanout may result in potential staining or damage to the insulation.

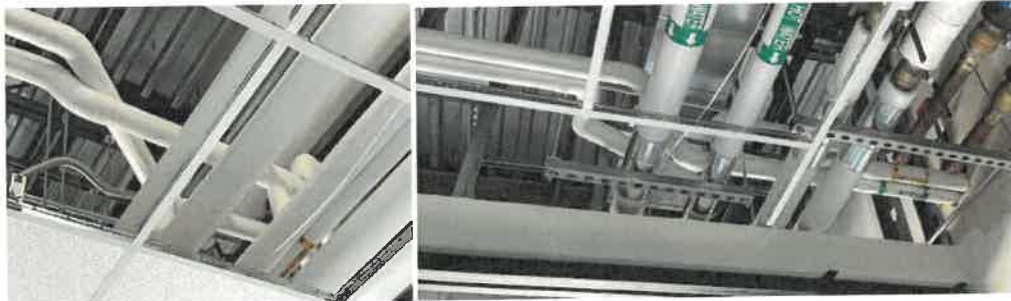
- Poor workmanship in the installation of domestic water piping.

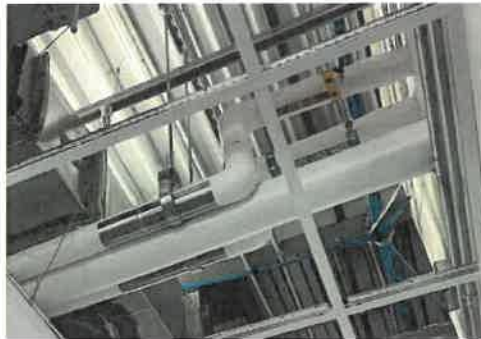
- Installation of some domestic water branch piping in unit B appears to create low point in the branch. Per specification, drain down ports are required to evacuate trapped water.

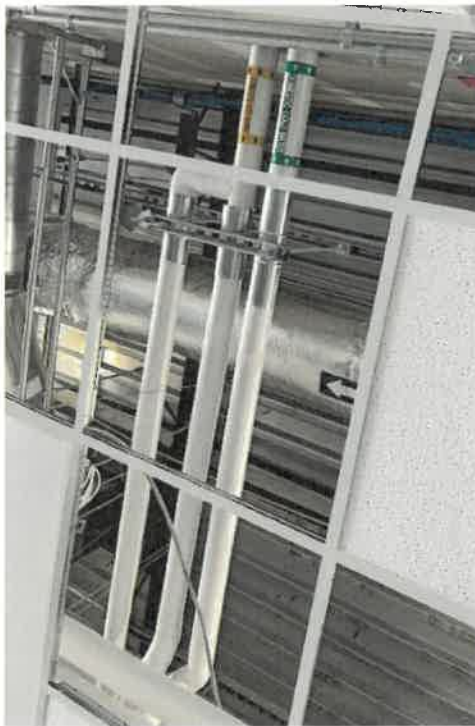
- HWR connection at single occupant RRs in unit B is not as indicated on plans. The design intent was for the HWR connection to be made in the RR chase closer to the lavatory HW connection. The installed HWR connection is above the ceiling in the corridor. Credit to the owner for the difference of piping and insulation installed. (Confirm if condition is true at all single occupant RRs i.e. unit C and D)

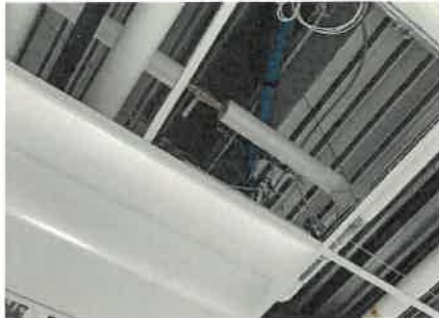
- Need to add isolation valves for future capped connections at the end of unit B. Valves are not on plans.
- Balance stations are missing from all HWR circuits. Typical of all HWR circuits in unit A & B.
- In many areas in unit A & B, valves were far from main branch off. Contractor shall located shut off valves as close as they can (were able) to the main branch off as required in specification.

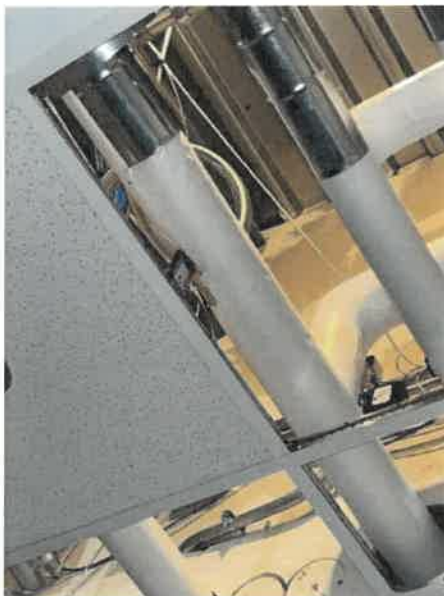
- Insulation torn/squished. Contractors shall replace insulation and ensure ceiling grid/tiles do not damage insulation.
- Unit A A109

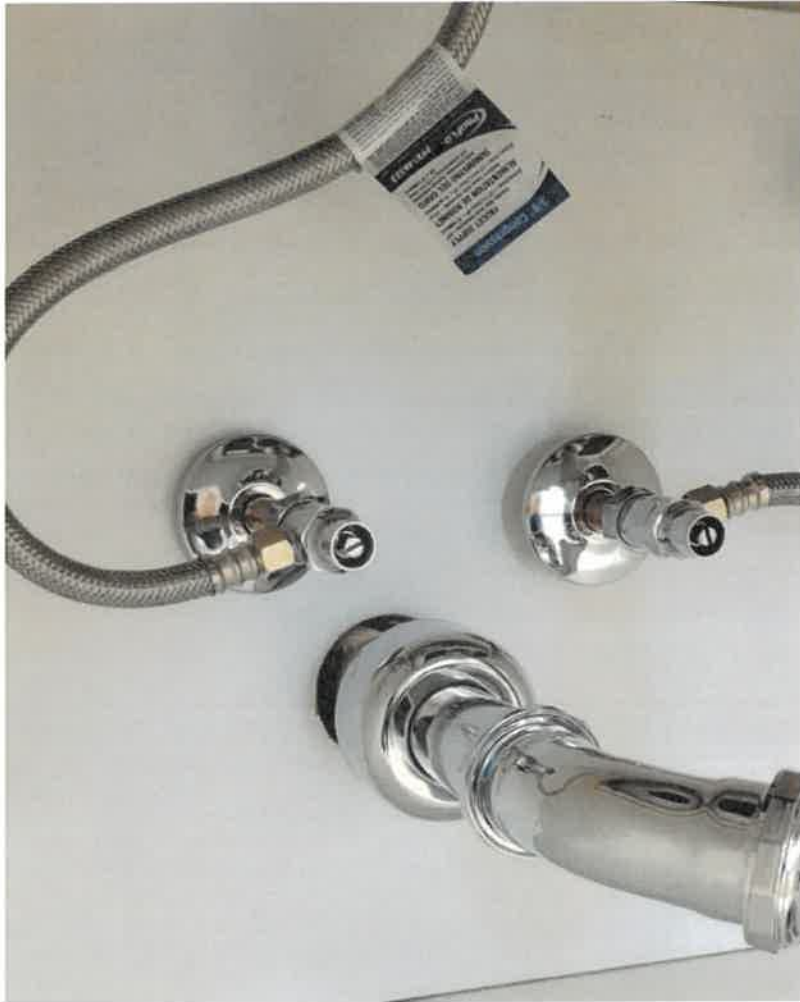
- i. Throughout – Multiple pipe and wall penetrations were observed to be missing escutcheons or wall plates as required by specifications.
- ii. Under sinks/lavatories – multiple piping penetrations were observed to not be concealed complete by escutcheons or were missing escutcheons all together as required by specifications.

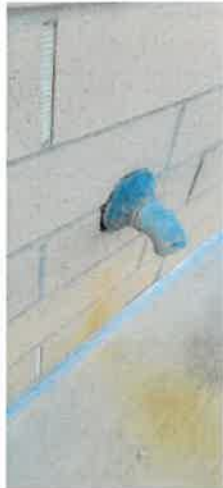
3. Test drain for sprinkler system installed near grease interceptor is not fully sealed around wall penetration.

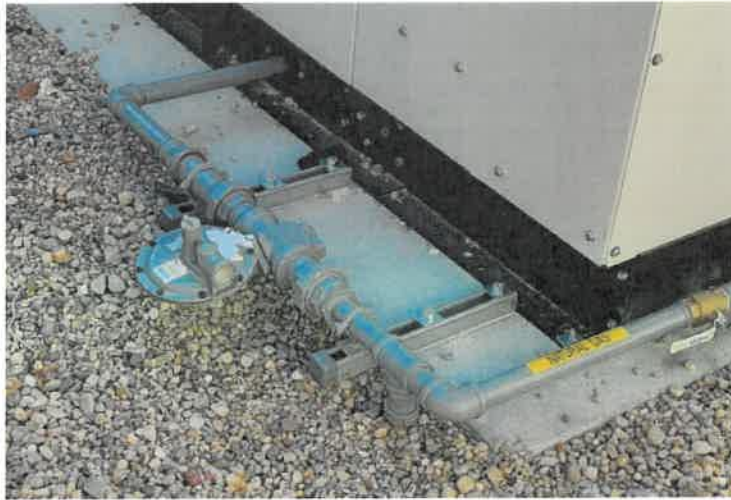
- a.
4. Gas piping that is routed to generator is not installed as per drawings with improper sediment trap configuration.
5. The elevation of the gas pressure regulator is low to the ground which will be easily covered by snow and prevent proper operation of the gas pressure regulator.

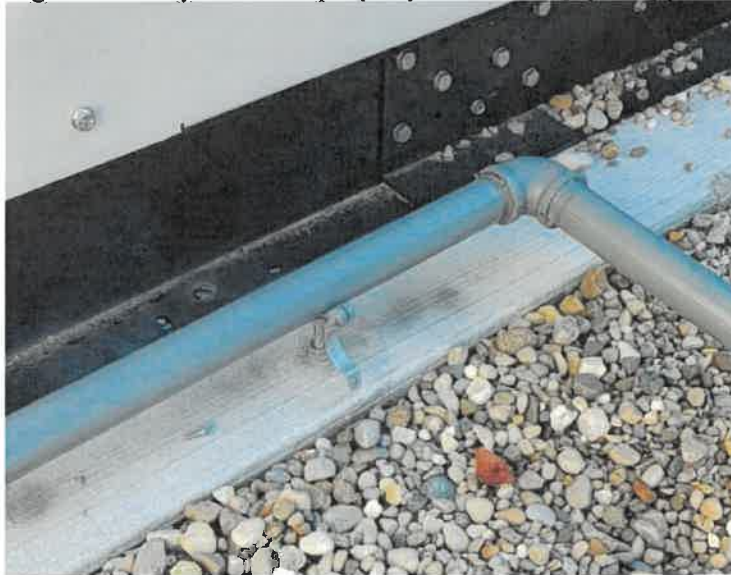
- a.
6. Gas piping in service yard is not properly secured to pipe supports.

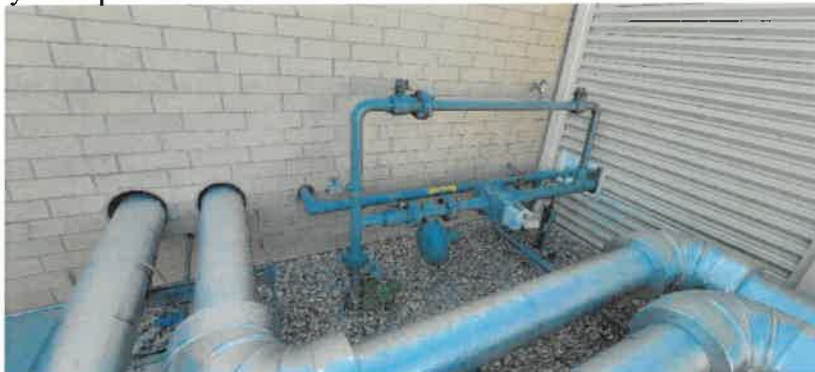
- a.
7. Gas meter service and nearby piping are not installed as per plans and severely limit service clearance and access to the meter. Coordinate service clearances with local utility company as required.

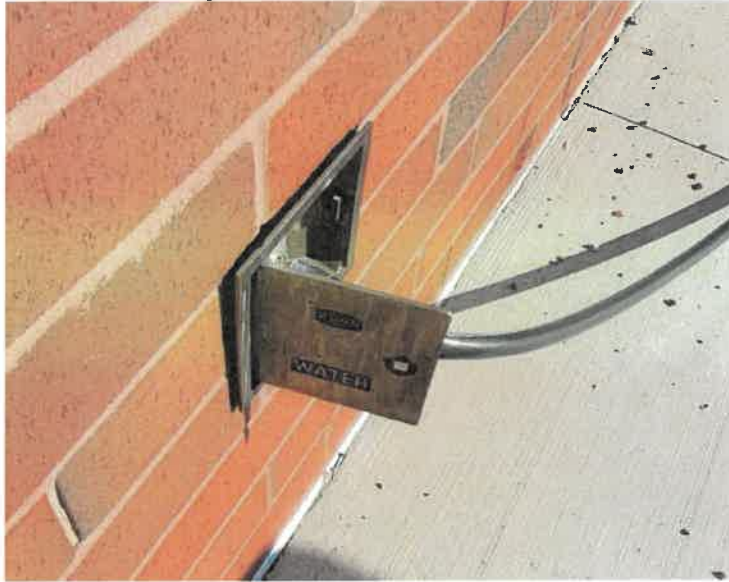
9. Multiple exterior wall hydrants were observed to not be sealed to the wall surface.

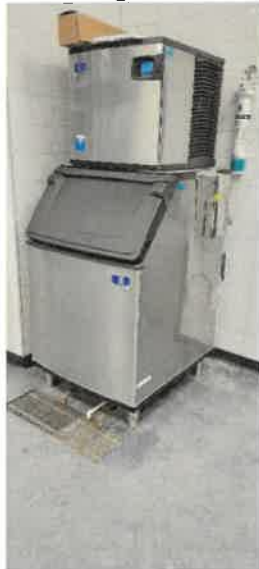
- a. FD-4 near the Ice Maker is missing or covered up that was intended to collect the drain lines instead of being routed to the front of the equipment.
- b. TD-1 did not appear to be properly installed with the flooring and it's flashing/trim around the edge of the drain. The flooring overlapped the drain over the top of the edges.

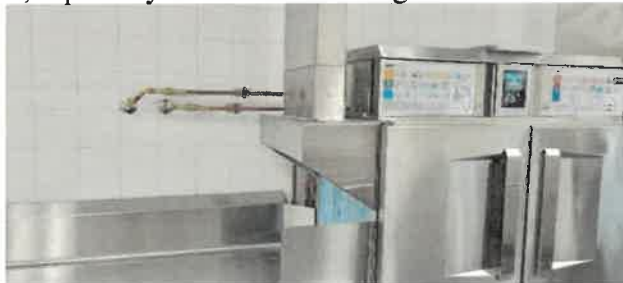
- c. All indirect waste piping was observed to be non-compliant with specifications and is currently PVC as opposed to Copper (required by specifications)
- d. Multiple fixture rough-in locations were observed to be not coordinated with the KEC equipment/fixtures leading to piping running exposed along the wall as was planned and shown on the drawings leaving them exposed to the kitchen elements, especially in the warewashing area.

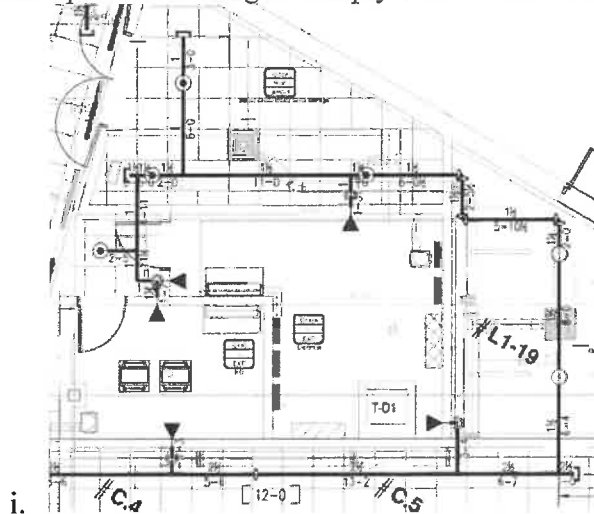
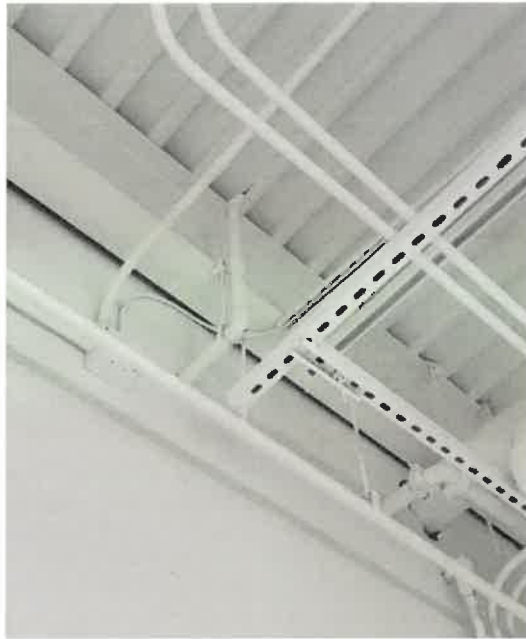
- a. Sprinkler piping in the vestibule shall be re-evaluated by the sprinkler contractor to determine if coverage is required above and below the ceiling clouds as per NFPA 13.
- b. At least one sprinkler head was observed to have the head taped up and covered. Ensure all sprinkler heads are compliant with NFPA 13 requirements for installation.
- c. Sprinkler piping was observed to be installed within electrical room when sidewall head sprinklers are required on drawings and shown on submitted plans. Update sprinkler routing to comply with contract documents.

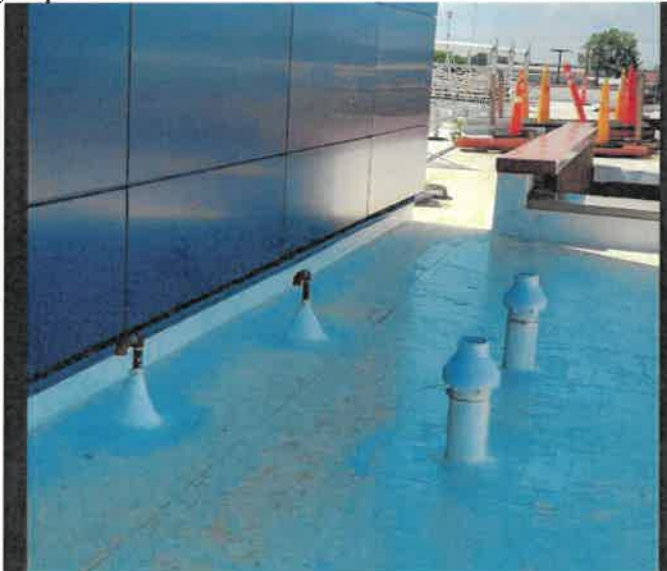
- a. Uncoated gas piping/fittings on roof exhibited heavy signs of corrosion.
- b. Gas regulator vent piping penetrations (presumably) near the domestic water heater combi-vent terminals were observed to be at the same elevation and close to the building edge leaving them prone to coverage by snow drift and re-draft into the combustion air intakes of the water heaters. The regulators shall be converted to vent limiting regulators or the vent piping and penetrations relocated to be at least 10' horizontally away from the intakes to comply with IFGC-2014 venting requirements.
