**WAUNAKEE COMMUNITY SCHOOL DISTRICT**

**WAUNAKEE COMMUNITY MIDDLE SCHOOL  
TRACK PAVEMENT CONDITION REPORT**

Project Number 26.053

October 5, 2026

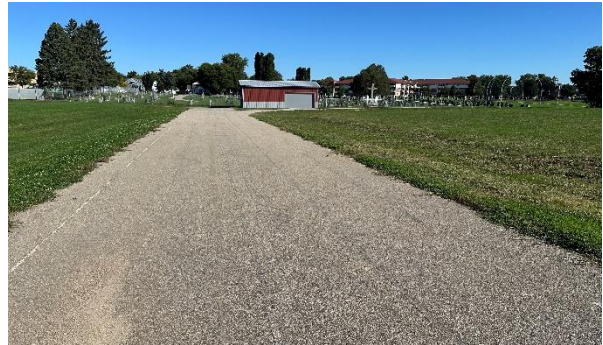
The running track is bare asphalt with extremely faded track lane striping. There is no rubberized surfacing.

1. No major asphalt surface defects were observed.
2. No rubberized track surfacing and running on bare asphalt is very hard on student athlete lower extremities and is highly recommended.
3. The useful life of the asphalt surface appears to be near with the presence of nearly all surface oils .
4. Vegetation has overtaken significant portions of lanes 1 and 6. In their current condition, they are unusable.

Photo 1: Worn Track Surfacing

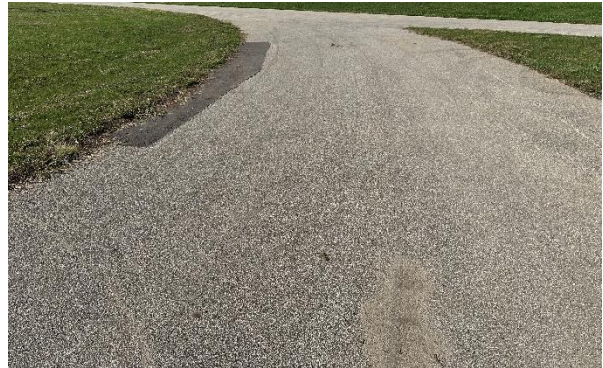
Settlement of the track was observed most severely along the north curve. There is no apparent rutting however distortion of the surface was observed in these locations. Because the underlying subgrade soils are frost-susceptible, and no apparent sub-surface drainage is present, it is possible some heaving occurs in the freeze / thaw portions of the year.

Photo 2: Surface Deformation – North Curve

Typical weathering and aging have caused the track asphalt surfacing to become brittle and cracks present allow for infiltration of water. The presence of frost susceptible soils, subsurface moisture, and freeze / thaw cycles have caused minor surface distortion, major and minor cracking of the asphalt surface.

Structural issues were observed such as subgrade settlement, or frost heaving, potentially caused by a lack of drainage on the north, south, and west sides of the track. Additional underdrain is recommended outside of the track, particularly on the west side where higher elevations.

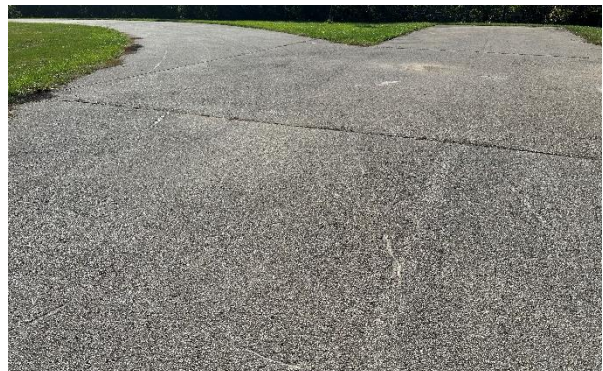
Some major traverse cracking was observed. Minor transverse and longitudinal cracking has also been documented. It appears no regular maintenance such as crack filling in the past and has proven successful.

No potholes were observed in the pavement however several patches were completed over time.

Photo 3: Longitudinal and Transverse Cracking
