NORTH SLOPE

BOROUGH SCHOOL DISTRICT

**ATQASUK
AREAWIDE MECHANICAL AND ELECTRICAL
BUILDING ASSESSMENT AND INVENTORY SURVEY REPORT**

August 19, 2024

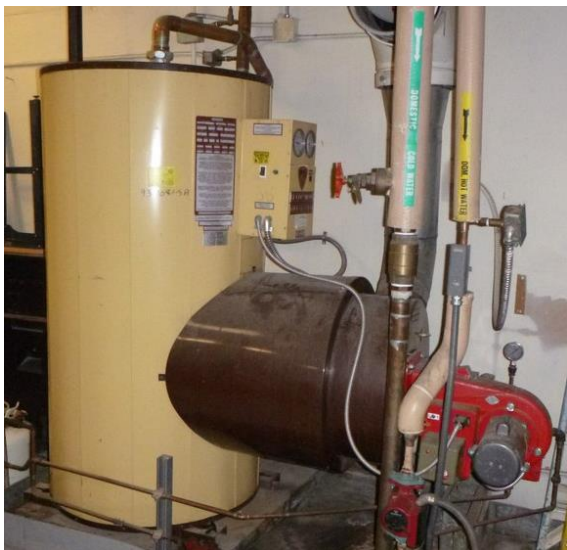
Domestic hot water is provided by one 175-gallon oil-fired water heater that is in poor condition. Due to its age replacement parts and maintenance will become costlier. It takes up considerable space in the mechanical room, has poor maintenance access and is not seismically braced. The unit also lacks a thermostatic mixing valve, creating a potential for scalding.

Photo M1 – Fuel Oil Water Heater

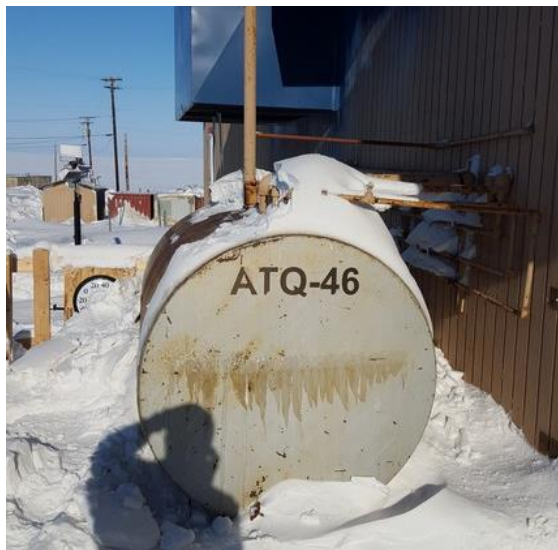
The condition of the fuel oil system is poor. The fuel oil storage tank appears to be single wall. Tank trim and placards do not meet current code requirements and the tank access is poor. No day tank is present because the fuel tank is directly outside the boiler room at the same elevation as equipment burners. The entire fuel oil system warrants replacement with a new UL-142 above ground double wall tank, new distribution piping and potentially a new day tank if the new fuel tank is at grade.

Photo M2 – Fuel Tank

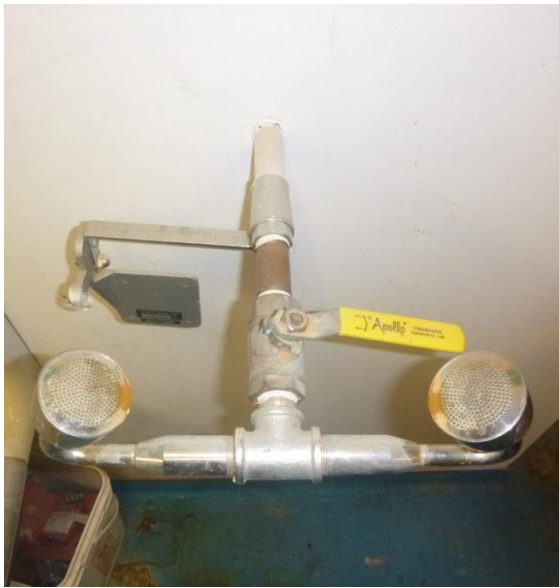
Emergency shower and eyewash fixtures in the pool mechanical room, metal shop and wood shop do not meet code requirements. They are generally lacking tempering valves, sufficient placards, activating levers, and are obstructed.

Photo M3 – Metal Shop Eyewash

The school plumbing fixtures, including emergency eyewash's, were replaced as part of the Phase 2 School Upgrades project with modern code compliant fixtures. Plumbing piping and equipment have remained unchanged since the 2017 report.

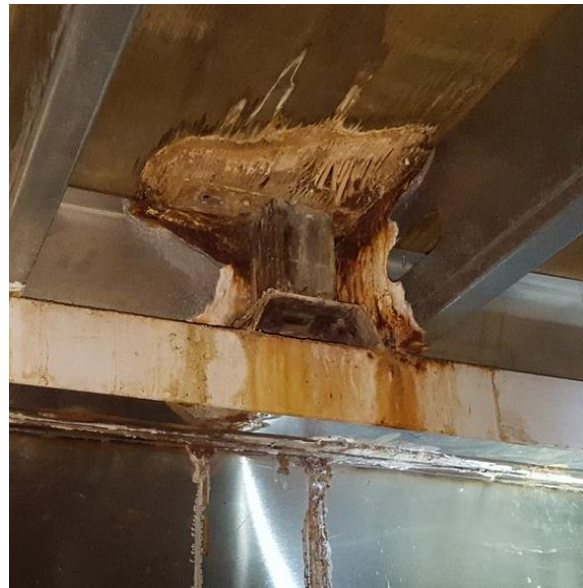
Photo M4 – Corrosion Under Pool Deck

The pool deck, the space below the pool deck and the pool equipment room are ventilated but showing signs of corrosion due to the humid environment.

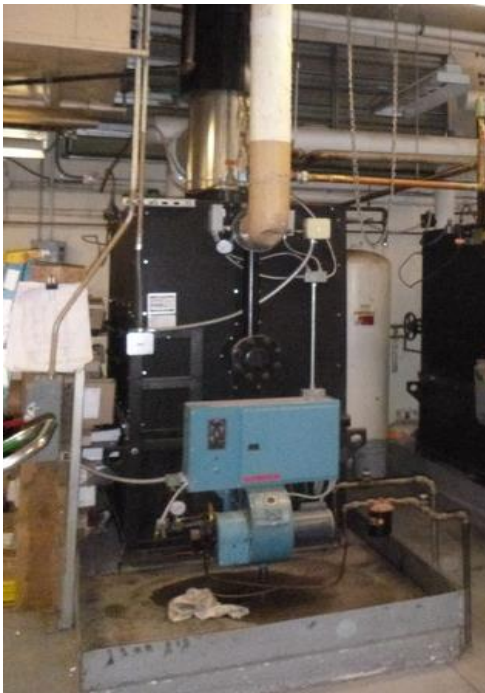
The primary heating source for the building is waste heat from the village power plant, which is transferred to the school through a plate and frame heat exchanger in the boiler room. The school also has two fuel oil cast iron boilers, each rated at 1,920,000 BTU/hr gross input. The boilers were installed in 2009 and appear to be in good condition but with considerable corrosion on the flues. The boilers are piped in a primary only system with two sets of system pumps piped in parallel for redundancy. The building heating pumps are constant volume. The piping as configured does not ensure even flow to each boiler and it does not provide minimum return water protection or minimum flow to the boilers. The piping configuration can lead to condensation of flue gases due low temperature, overheating of glycol solution and uneven system heating as each boiler receives part of the flow regardless of boiler operation. The circulation pumps are also piped such that they pump toward each other causing their respective check valves to slam hard and likely wearing out the motors from drastic changes in head pressure. The piping system should be replaced with a primary/secondary pumping system with variable flow secondary pumps. The primary/secondary pumping system would ensure adequate flow to each boiler, allow control system to flow water only through operating boiler and would provide energy savings with the variable speed secondary pumps. The variable speed secondary pumps would operate to match actual system demand, saving energy and improving overall system performance. This also allows an opportunity to correct the incorrect pump piping configuration. Supporting equipment such as expansion tanks, air separators, glycol storage/fill tanks, and other similar equipment will also be

Photo M5 – Typical Boiler

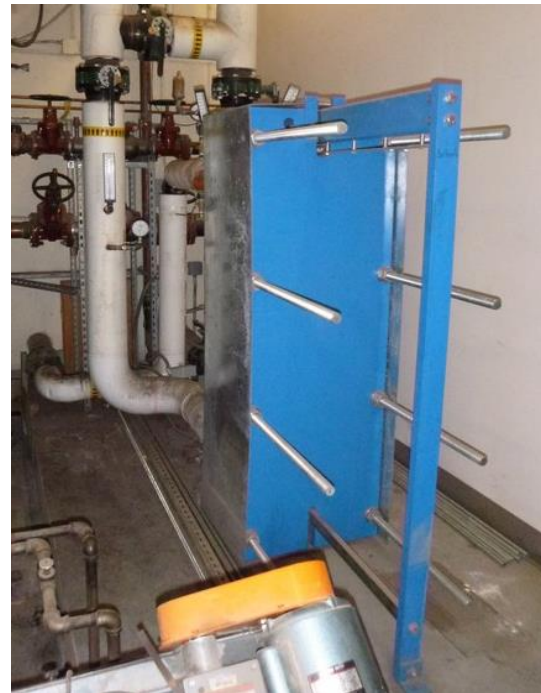
Photo M6 – Waste Heat Heat Exchanger

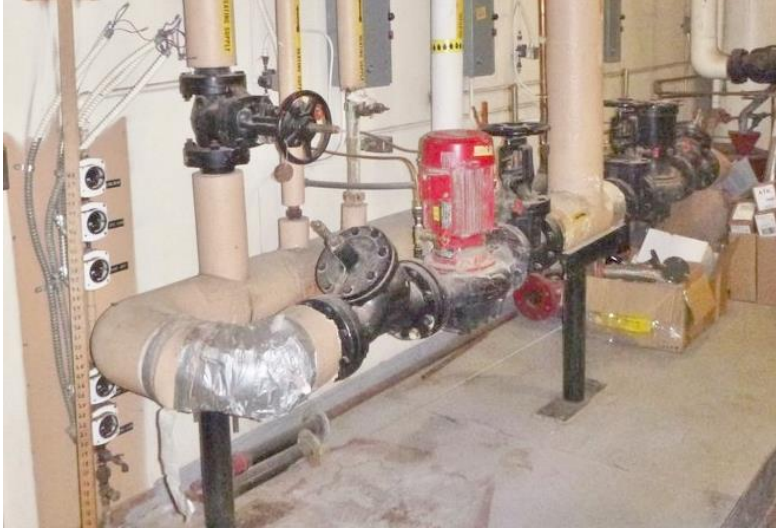
Photo M7 – Heating Pumps

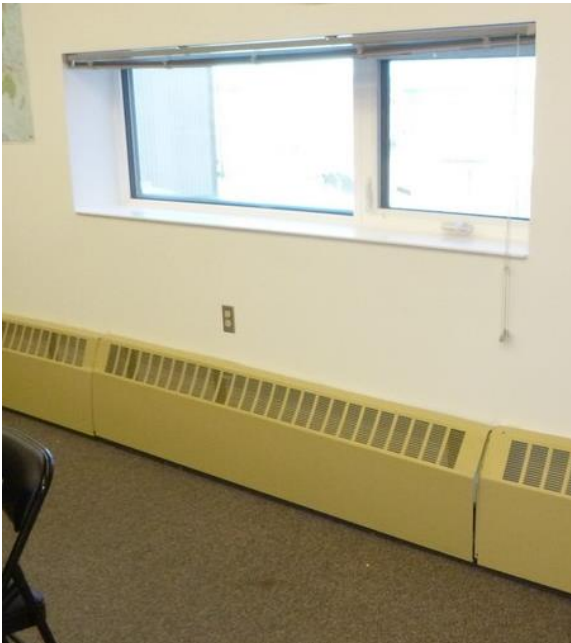
Terminal heating equipment in the building includes fintube baseboard with enclosures, cabinet unit heaters, and unit heaters. The equipment is generally in poor condition due to damaged enclosures and leaking joints, except for the secondary classroom baseboard enclosures, which are new.

Photo M8 – Fintube Enclosure Falling Off Wall

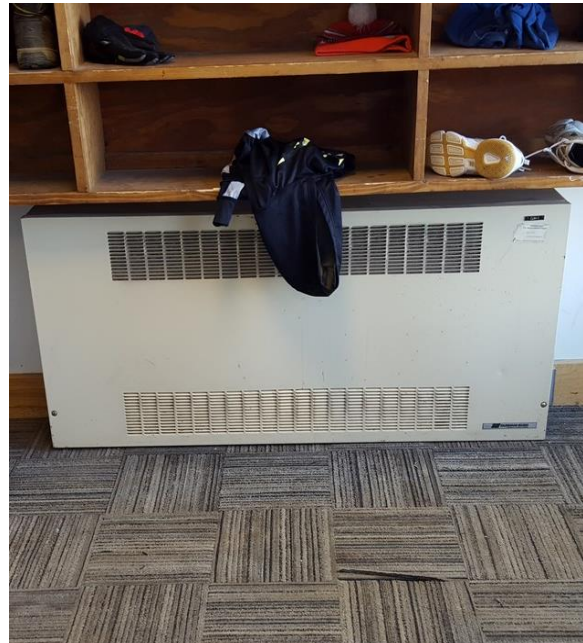
Photo M11 – Old Cabinet Unit Heater

The heating system itself remained unchanged since the 2017 inspection. Unit heaters along with associated isolation and control valves were replaced with new as part of the phase 2 renovation project. It was noted during the site visit by the maintenance personnel that balancing was never fully completed. New 3-way control valves have been installed at all the air handler heating coils.

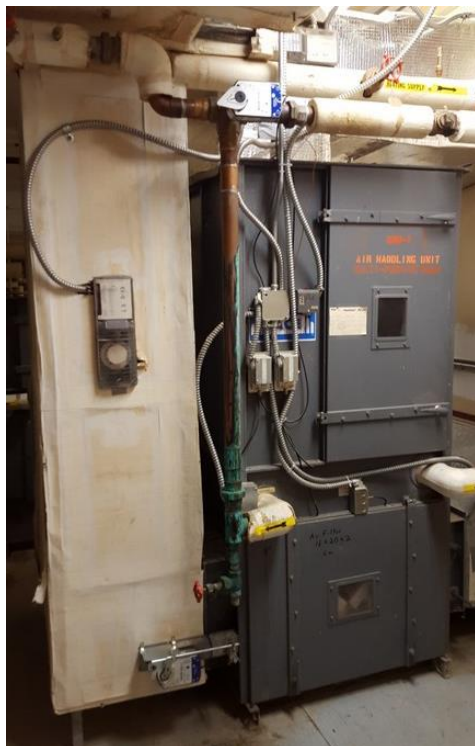
Photo M12 – Typical Original Air Handler

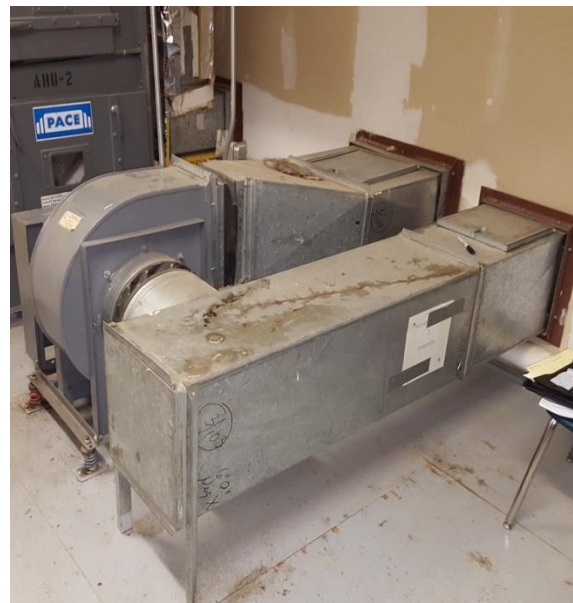
Photo M13 – Typical Original Fan

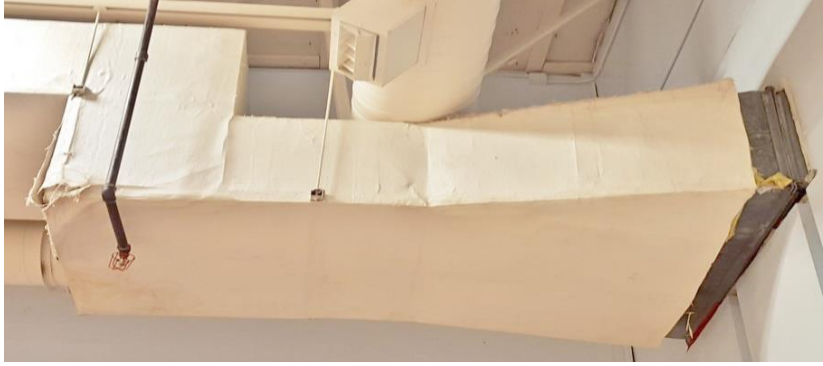
Photo M14 – Gym Outside Air Intake Duct

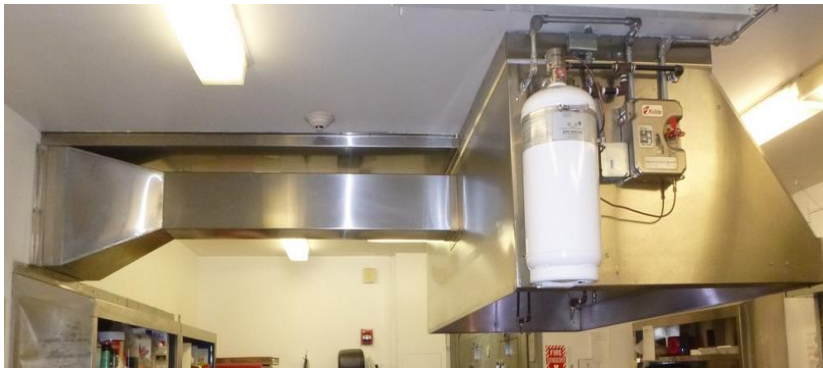
The school kitchen Type 1 hood has a sidewall mounted exhaust fan that also needs replaced. The Type 1 hood is too small to adequately cover the existing cooking equipment and should be replaced. In addition, if a small partition wall was constructed to mount the hood on the exhaust fan would be smaller due to less exposed hood perimeter. The grease duct does not meet code requirements for containment within a chase or fire rated insulation and does not have cleanouts. The duct needs to be replaced. The kitchen has a commercial dishwasher that does not have a code required steam and heat exhaust hood and fan. This will need to be added or the dishwasher replaced with a unit that does not require a hood.

Photo M15 – Type 1 Cooking Exhaust Hood

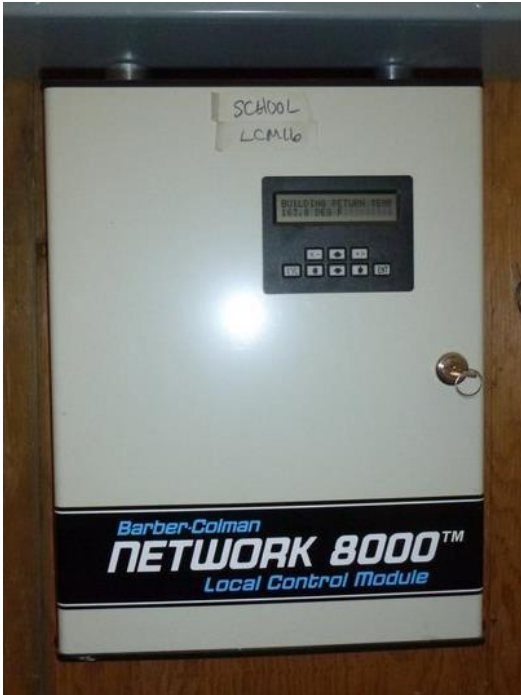
The control system utilized throughout the building is an older DDC system with some Barber Colman equipment and some Johnson Controls MetaSys equipment. The equipment is in poor condition and not controlling the equipment sufficiently. Equipment is running outside of normal occupied hours. Heating in the building is inconsistent. Many of the space temperature control devices have failed. Given the age of the system the costs of maintaining it will continue to increase due to equipment failure and scarcity of replacement parts. The existing control system should be replaced with a contemporary BACnet based direct digital control (DDC) system for proper environmental control, failure notifications and energy management.

Photo M14 – Barbar Colman Control Panel

The DDC system was upgraded to a modern system provided by LONG Building Technologies during the phase 2 remodel project. It was noted by maintenance personnel that they lack training on the DDC system and having issues with controlling the heating system.

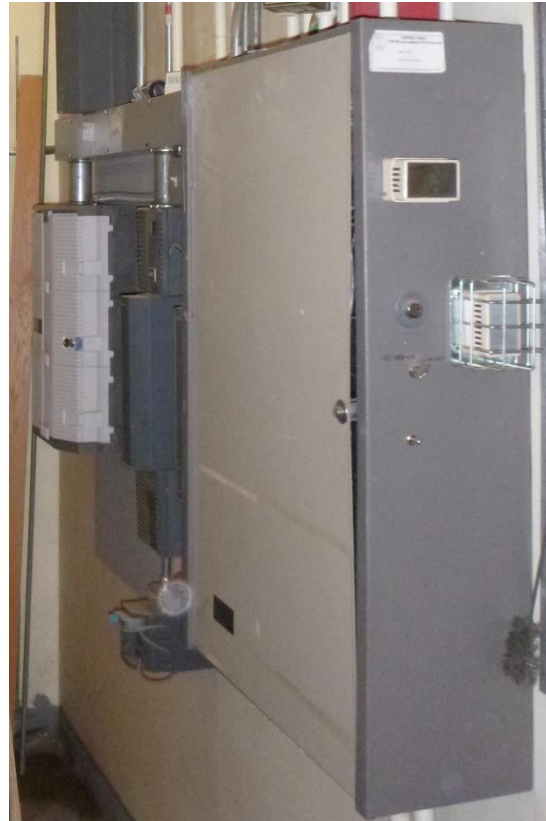
Photo M15 – Typical MetaSys Controllers

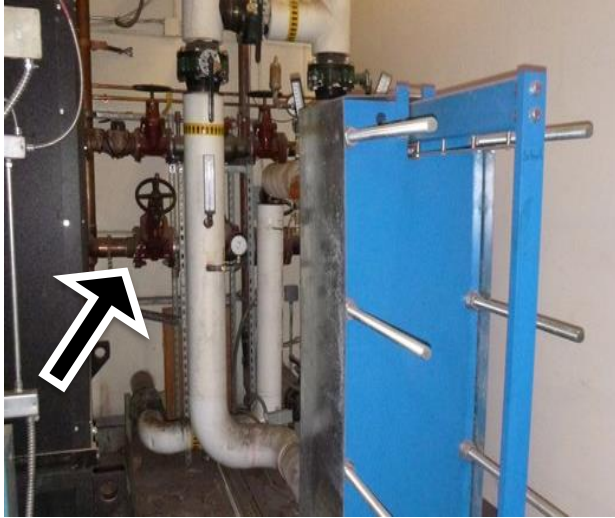
Photo M16 – Poor Backflow Prevention Access

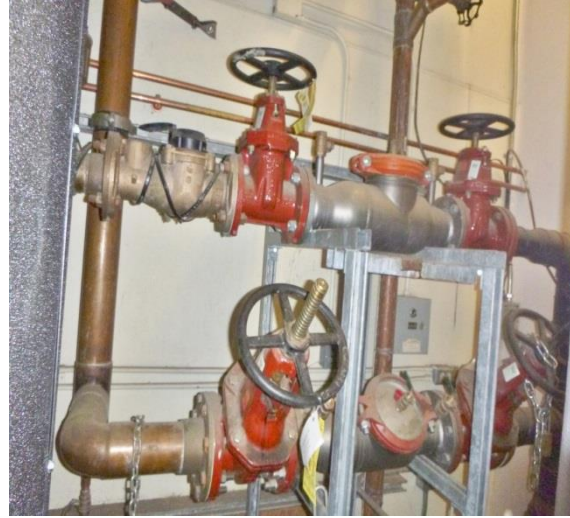
Photo M17 – Backflow Preventers

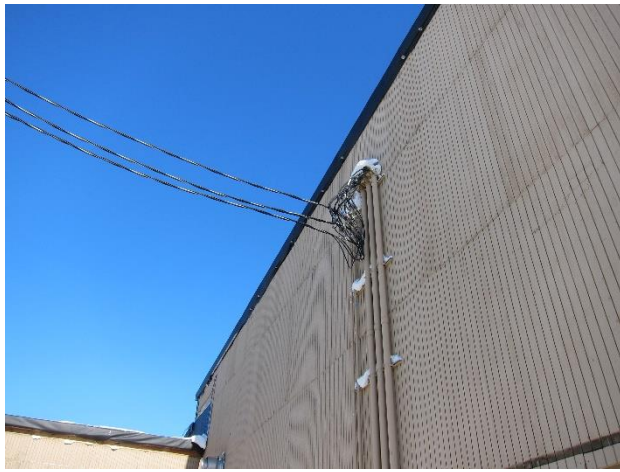
Photo E1 – Incoming Utility Service

The school electrical power service is supplied by the utility from a platform-mounted transformer located on the west side of the school (*Photo E1*). The service is fed from below the building to an interior switchgear which houses the CT enclosure, meter base, and 1,000A, 208V, 3p disconnect located in main electrical room (*Photo E2*). The main feeder was then routed into a 1,000A, 208V, 4p Automatic Transfer Switch located in the mechanical room. The transfer switch serves a 1,000A, 120/208V, 3p, 4W switchboard 'MDP' located in main electrical room and is fed from a 265kW generator. Between the Automatic transfer switch and 'MDP', there is a bypassed manual transfer switch and generator controller. The generator control panel and transfer switches are in poor condition and should be replace. The service switchgear and 'MDP' are Square D type Sw-1 switchboard. The distribution section serves all of the normal power panelboards located throughout the facility and have limited spare capacity for additional breakers. The Main switchgear is in average condition and could be changed out with the bi-passed manual transfer switch and generator controller but is not necessary.

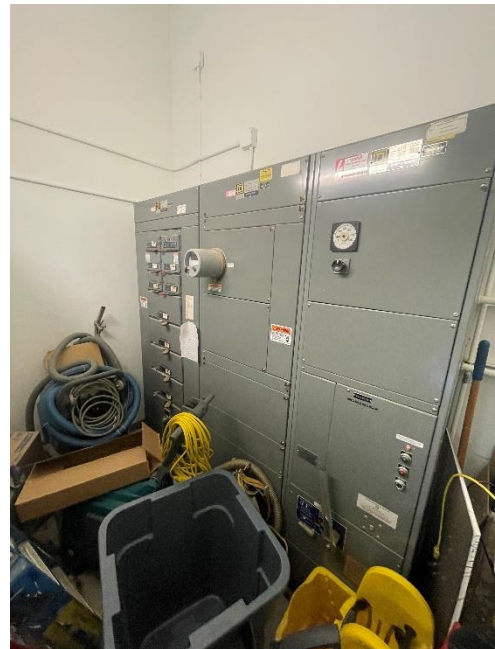
Photo E2– Service Entrance Switchgear

The power system has gone unchanged since the last inspection with the exception of a new ASCO 1200A, 208/120V, 3Φ Automatic Transfer Switch that replaced the old Automatic Transfer Switch, and it is in excellent condition. The remaining electrical distribution equipment is original to the building and in average condition for its age. The generator is original to the building and is nearing end of life. It would be recommended that a generator upgrade take place in the near future. Design drawings dated 2/25/19 include an add alt for the generator replacement and engineering for this work is complete. The main electrical room was being utilized as storage and is violating the equipment's NEC working space. It would be recommended removing all stored items from the main electrical room.

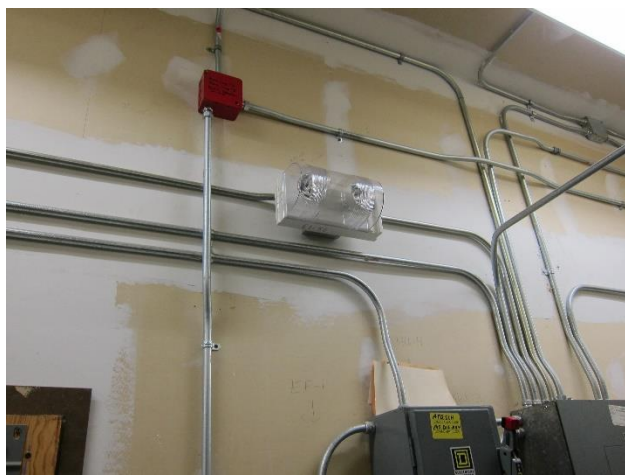
Photo E3 – Building Raceway

The typical branch wiring system in the facility consists of ½" electrical metallic conduit with copper building wire with (Photo E3). It is assumed that some of the older circuits utilized the conduit for a ground and did not contain a separate equipment grounding conductor, however, the panels were not opened during the site visit so this information could not be verified.

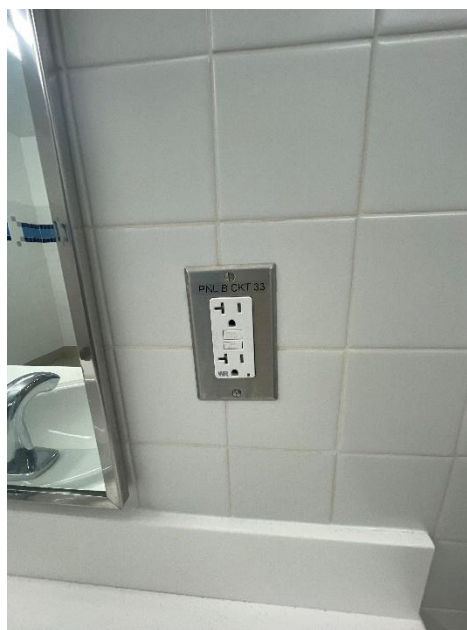
Photo E4 – Typical Receptacle

The recent renovation replaced 80% of the receptacles and most wiring devices in the building. The new devices consisted of white NEMA 5-20R receptacles and 20A, 120V light switches with stainless steel wallplates. In general, they are in excellent condition. (Photo E4) is a typical device in the building.

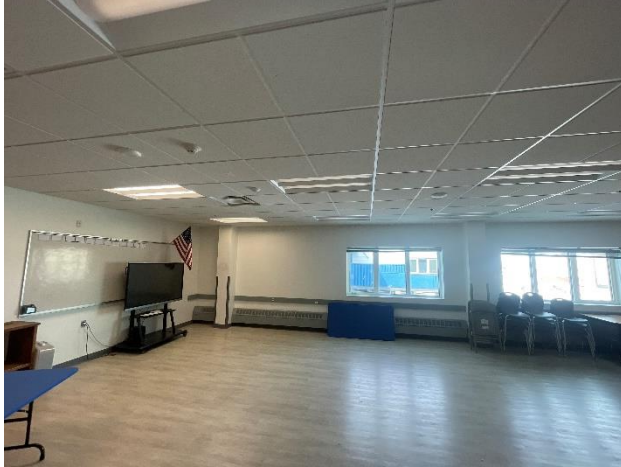
Photo E5– Interior Light fixtures

The recent renovation upgraded the interior lighting to LED with automatic controls and dimming. The lights were installed less than 5 years ago and are in excellent condition. (Photo E5)

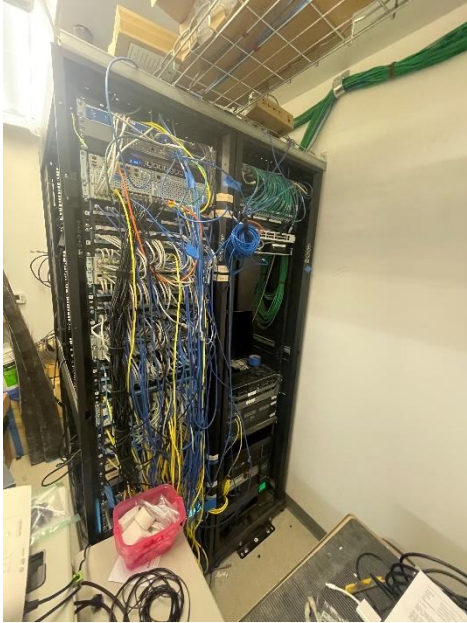
Photo E6– Telecommunication Racks

The building telecommunication system has gone through upgrades in the recent renovation. New Cat 6 cabling has been provided throughout the building with new data jacks. The new cabling and wall jacks are in excellent condition. The data rack for the building is messy and could benefit from increased cable management.

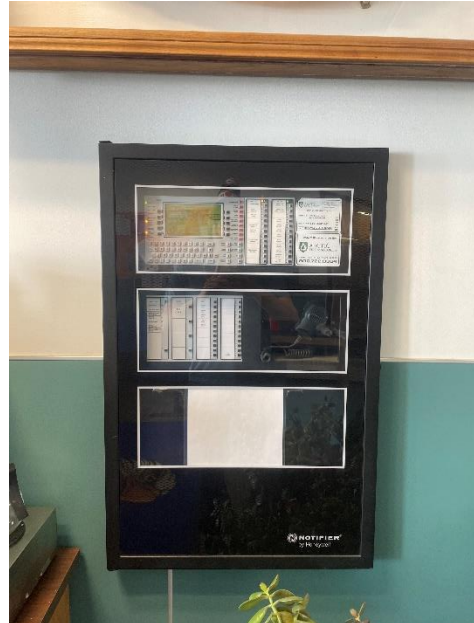
Photo E7– Fire Alarm Control Panel

The fire alarm system has been upgraded since the previous inspection. The fire alarm system consists of an addressable voice evacuation fire alarm System. The Fire Alarm Control Panel ‘FACP’ is located in the near the main entry and in excellent condition. Device type has been upgraded throughout the building and replaced in similar locations. The Fire alarm system is in excellent condition.

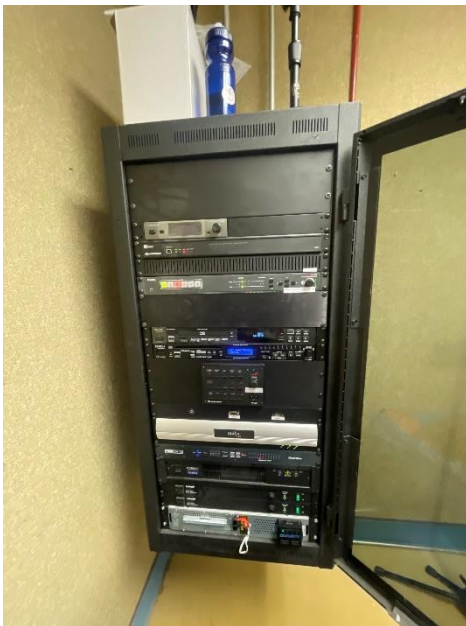
Photo E8 Gymnasium Sound System

The gymnasium sound system is located in a storage room connected to the gym. The sound system appears to be new and in excellent condition. *(Photo E8)*
