Facilities Management Services

Facility Improvement Measures Wausau - Riverview Elementary School

South Mountain Facility Analysis

Wausau School District - South Mountain ES

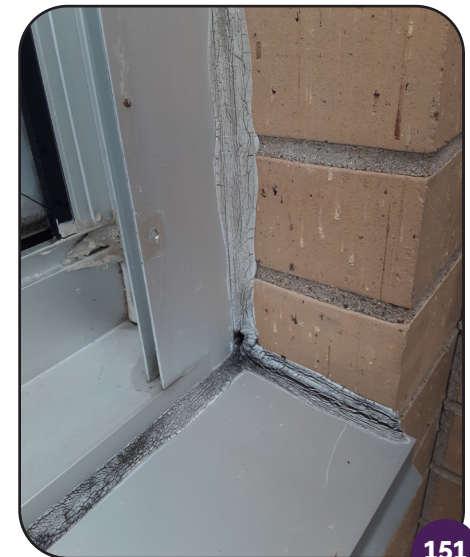
Building System	General Description	Recommendation	Cost Estimate
Exterior Building	Exterior wall bricks mildew stained.	Investigate cause and correct. Clean bricks.	\$14,000
Exterior Building	Exterior gym wall holding water.	Investigate cause and correct.	\$22,000
Exterior Building	Exterior wall control joints failed.	Fill and paint.	\$12,000
Exterior Building	Exterior window caulk failed.	Remove failed caulk and replace.	\$28,000

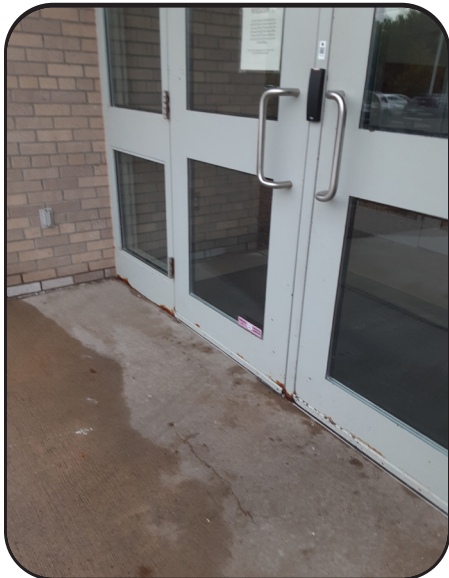
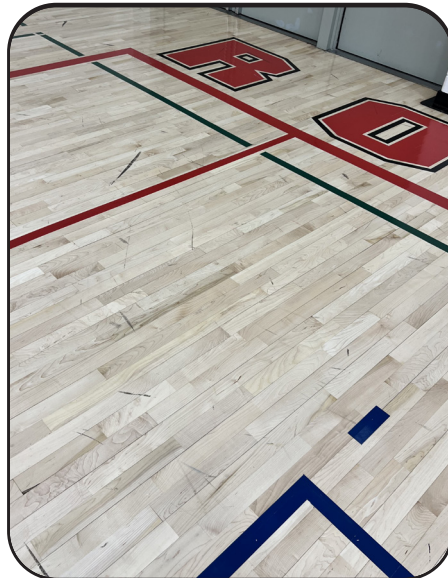
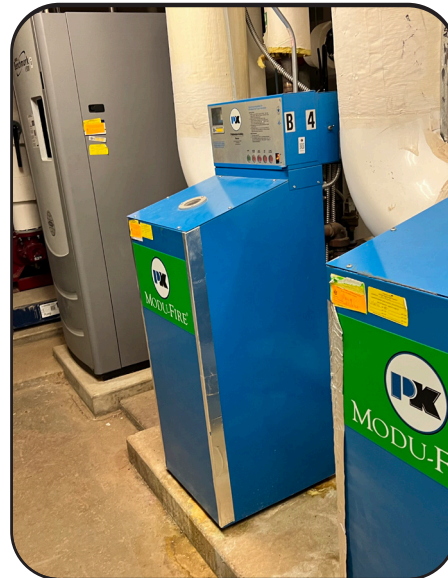
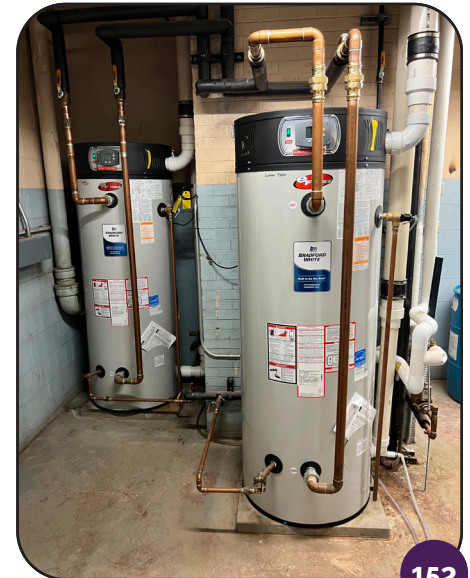
Building System	General Description	Recommendation	Cost Estimate
Exterior Building	Store front metal frames rusted.	Replace metal frames, windows, and doors.	\$6,800
Interior - Gym Flooring	Although in good overall condition, the main gym floor is scuffed and scratched.	Maintain a wood floor refinishing cycle, recommended every 5-10 years dependent on use and condition.	\$25,000
Mechanical - Boilers	Riverview Elementary is partially heated by two 20 year old standard efficiency boilers, each 1MBTU, and one 1.5MBTU newer condensing boiler. The PK boilers are holding up well, however approaching their expected useful life, and inefficient to today's standards.	Review necessary boiler plant size and work this plan into any overall HVAC modifications being considered. If the PK boiler(s) are necessary, plan to replace these boilers in the next 3-8 years.	\$225,000
Mechanical - Insulation	Missing and loose pipe/valve insulation. Recent domestic hot water project was never reinsulated.	Replace and repair missing and loose insulation.	\$3,000

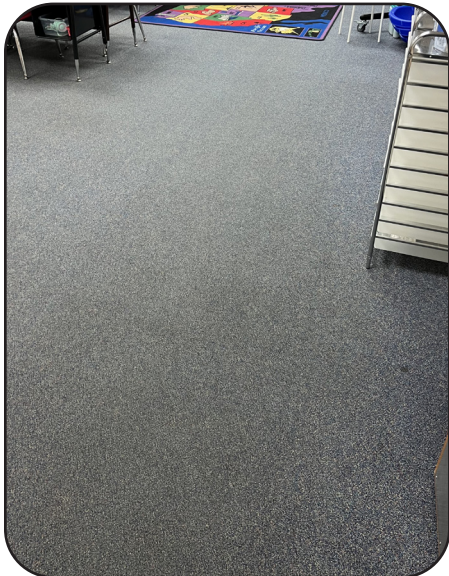
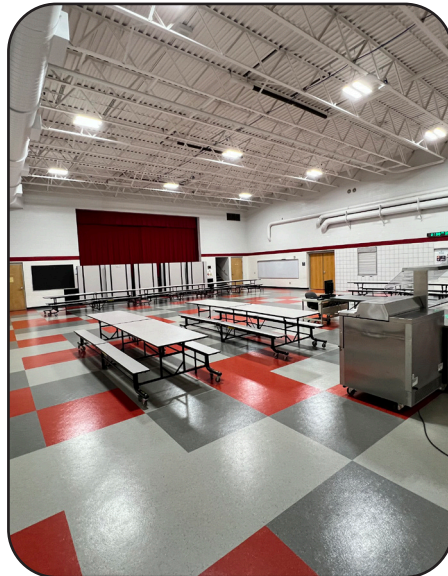
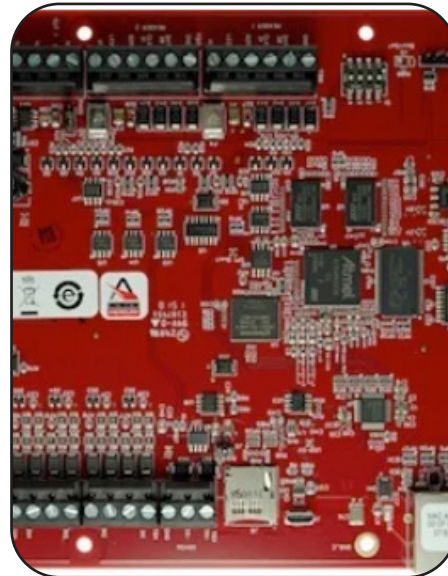
Building System	General Description	Recommendation	Cost Estimate
Interior - Flooring	Although most of the facility flooring is in good condition, spot areas of traffic worn carpeting are evident.	Replace stained and foot traffic worn carpeting as desired. Pricing given to address 5,000 sq ft of carpet.	\$40,000
Mechanical - Multi Ceiling Fans	No Multipurpose room destratification fans are present. Ceiling fans in high ceiling spaces help distribute heat from the ceiling to the occupants in winter, and can help maintain comfort in spring/fall.	Install destrat fans. Include schedulable control through the DDC system so fans can automatically turn on and off as desired.	\$20,000
Electrical - Door Access	Card Access systems across the district are in need of upgrade to their board controllers. Information was compiled through district IT interviews and recommended per school individual need.	Replace HID Vertx boards to Mercury LP1502's.	\$14,000

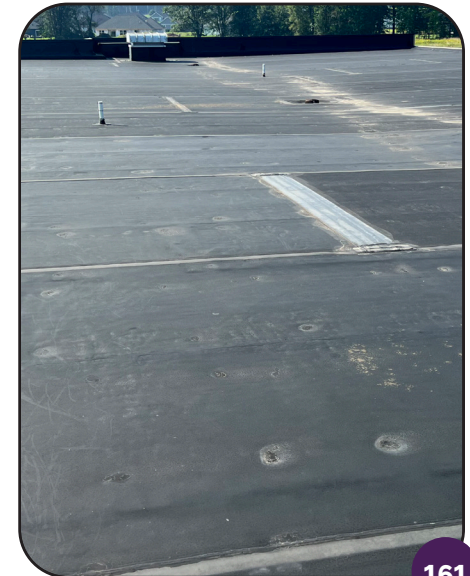
Building System	General Description	Recommendation	Cost Estimate
Site & Landscape	Set routine asphalt maintenance schedule with area rotation.	Continue crack clean and crack fill as needed. Include every 3-5 years seal, and repaint asphalt.	\$5,500
Site & Landscape	Dumpsters on asphalt.	Install concrete pads for dumpsters.	\$6,800
Site & Landscape	Planter mulch above and blocking exterior wall weeps and runoff away from building.	Refresh and retain mulch to an elevation lower than wall weeps, drip edges, border, walk, or turf. Consider crushed gravel in lieu of mulch in planters.	\$2,000
Exterior Building Roofing	Roof sections A-E are 27 years old, out of warranty, and past their expected useful life. Inspection showed peeling seams, failing patches, and evidence of ponding water. Parapet stretching and failures needing patching have occurred.	Replace sections A-E in the next 1-5 years with an adhered 60 mil black EPDM 20 year warranty roof. Recommend completing all roofs at once.	\$437,000

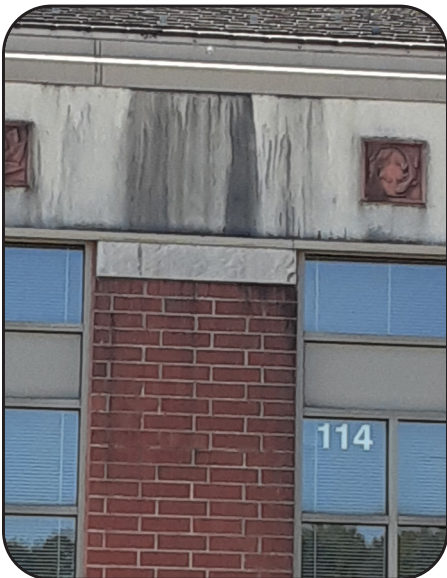
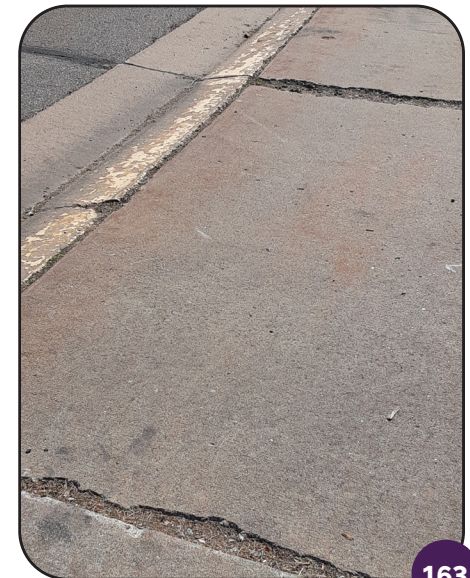
Building System	General Description	Recommendation	Cost Estimate
Exterior Building	Exterior upper library wall just under roof edge severely stained. Immediate observation for visitors to site.	Identify and eliminate cause. Clean stained wall areas.	\$35,000
Site & Landscape	Asphalt parking area has failed.	Replace parking lot. Ensure adequate below grade base fill is added. (Especially around edges of lot area and drive entries).	\$92,000
Site & Landscape	Concrete walk slabs cracked.	Replace cracked concrete walk slabs.	\$18,000
Site & Landscape	Many concrete walk slabs joints have deteriorated.	Replace concrete walk concrete slabs with deteriorated joints.	\$35,000

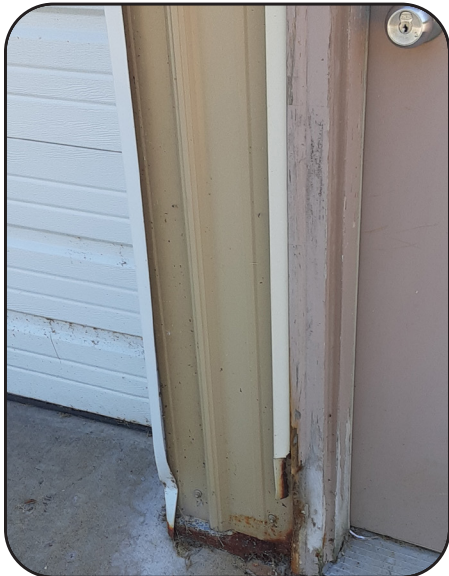
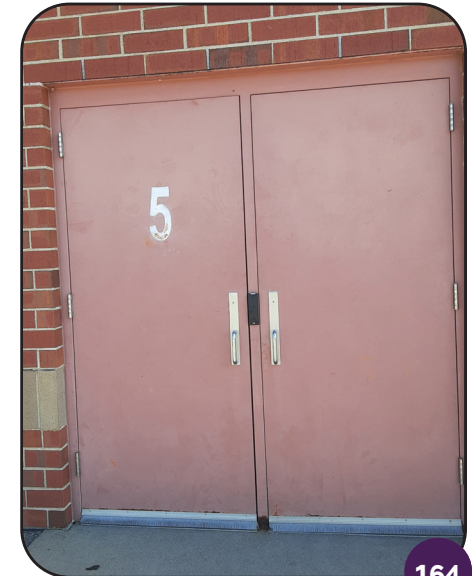
Building System	General Description	Recommendation	Cost Estimate
Site & Landscape	Outbuilding storage door frames damaged (Overhead & pass through).	Repair both overhead and pass through door frames.	\$1,000
Site & Landscape	Existing perimeter fencing is too low.	Replace 4' fence with 6' fence.	\$24,000
Site & Landscape	Standing water between two building sections.	Add yard rains under service drive to site runoff area.	\$18,000
Exterior Building	Exterior metal doors faded and frames rusted.	Prepare, paint, and repair frames. Replace if frame bases are not repairable.	\$25,000

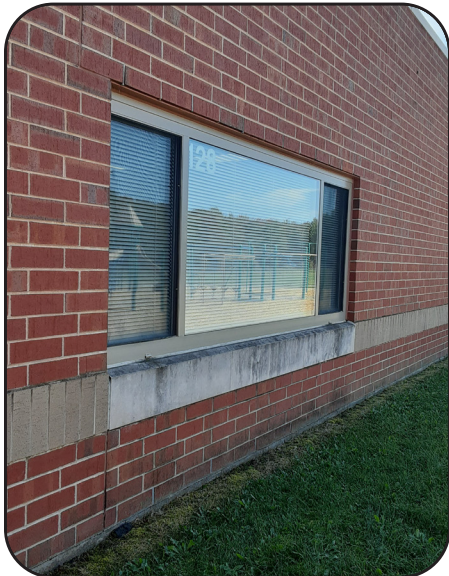
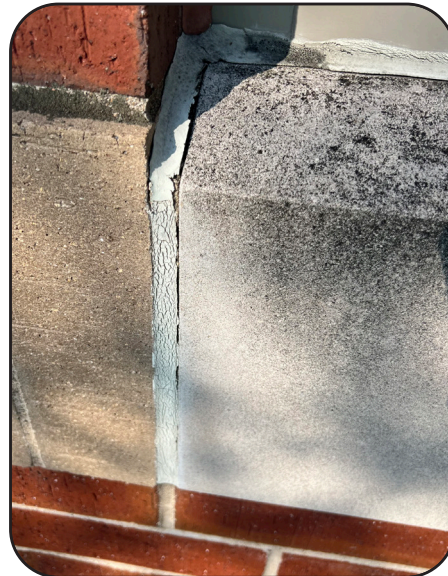
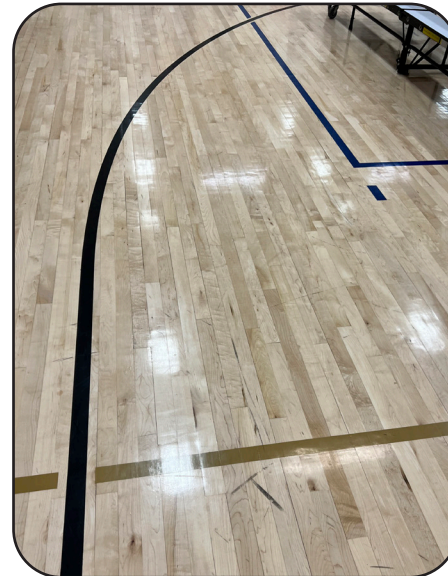
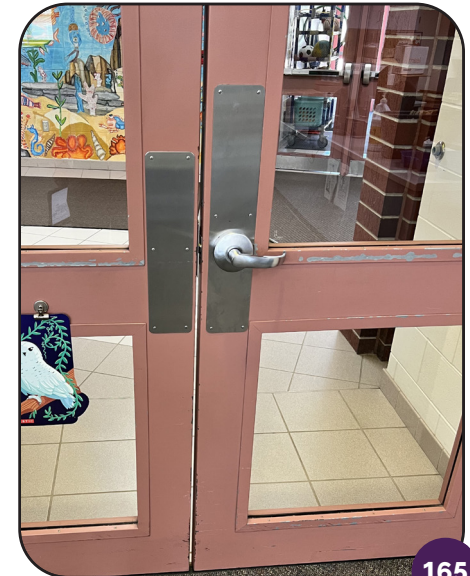
Building System	General Description	Recommendation	Cost Estimate
Exterior Building	Exterior stone window sills stained.	Professionally clean stained window sills.	\$10,000
Exterior Building	Exterior stone window sills caulk deteriorated.	Remove failed caulk and replace.	\$8,500
Interior - Gym Flooring	Although in good overall condition, the main gym floor is scuffed and scratched, the gym is also used as a lunchroom in this facility.	Maintain a wood floor refinishing cycle, recommended every 5-10 years dependent on use and condition.	\$25,000
Interior - Painting	Wear and tear was seen in several areas across the facility with minor painting needed. Photo shown from IMC.	Remove, prep, and paint steel doors needing attention. Repair and paint damaged walls.	\$5,000

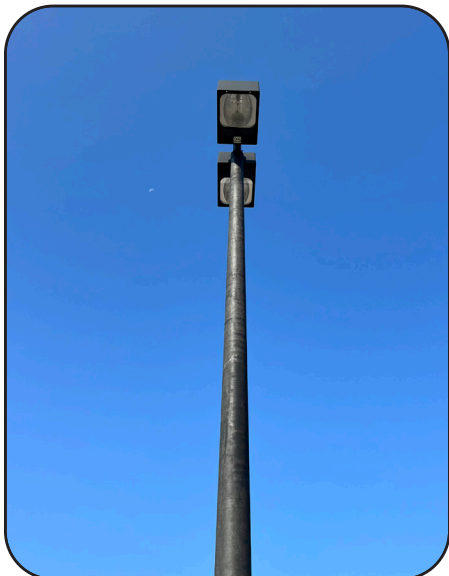
Building System	General Description	Recommendation	Cost Estimate
Site & Landscape	Existing parking area pole lighting non-LED.	Replace non-LED Lighting with LED.	\$8,500

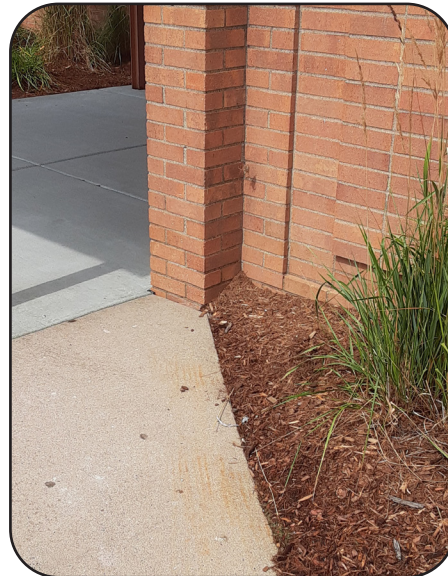
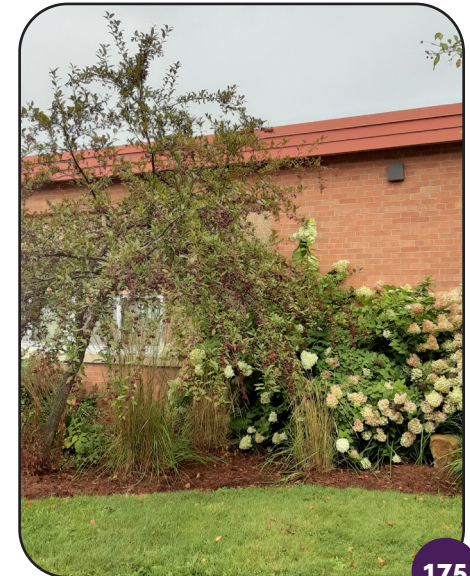
Building System	General Description	Recommendation	Cost Estimate
Site & Landscape	Set routine asphalt maintenance schedule with area rotation.	Continue crack clean and crack fill as needed. Include every 3-5 years seal, and repaint asphalt.	\$5,500
Site & Landscape	Mulch washing out on to walks.	Annually or more often if needed refresh and retain mulch to an elevation lower than border, walk, or turf. Consider crushed gravel in lieu of mulch planters along walks and buildings.	\$3,500
Site & Landscape	Mulch filling storm drain basin inside of planters.	Add screen between drain cover and basin. Clean screen seasonally.	\$1,000
Site & Landscape	Increase routine planters landscaping maintenance.	Annually or more often if needed prune, thin, and remove invasive vegetation in planters and around building perimeters, fencing, hardscape surface edges, utility supply areas.	\$5,000

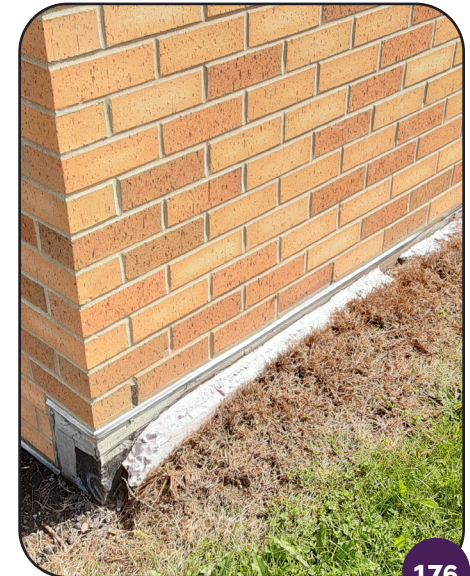
Building System	General Description	Recommendation	Cost Estimate
Exterior Building Roofing	Roof sections A-M are all between 22-27 years old. All sections are out of warranty and have been problematic. Some sections appear in worse condition than others. Some sections are holding water, others with fastener backout, stretching the membrane significantly. Many of these roofs are also .045 mil, a substandard thickness prone to issues.	Replace sections A-M in the next 1-5 years with an adhered 60 mil black EPDM 20 year warranty roof. Recommend completing all roofs at once.	\$622,000
Exterior Building	Exterior door threshold concrete gap.	Fill, caulk, and seal gap to make a smooth transition to landing.	\$2,500
Exterior Building	Entrance metal beam rusty and paint missing.	Prepare and apply durable weather/salt proof coating.	\$1,000
Exterior Building	Exposed foundation wall insulation and waterproofing.	Re-adhere and waterproof foundation wall insulation below exposed grade. Back fill with traffic bond (sharp edged crushed gravel) to lock up water resistant protection along wall and above insulation.	\$13,500

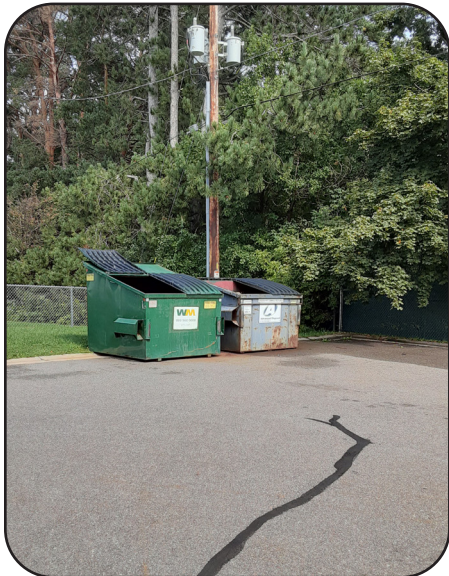
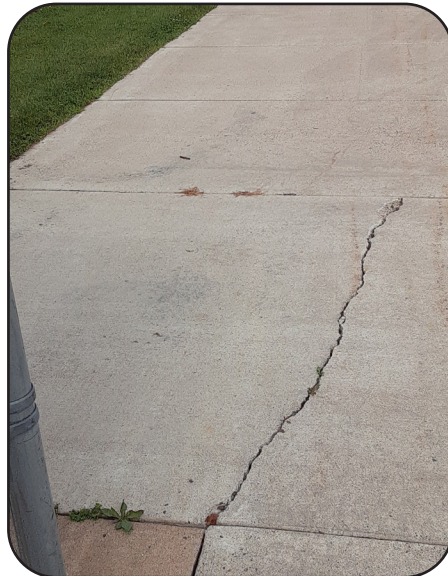
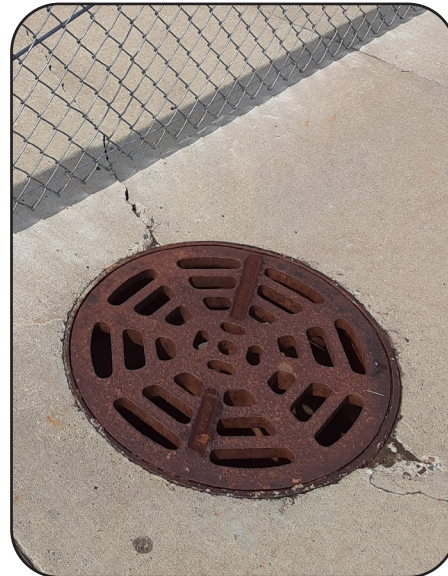
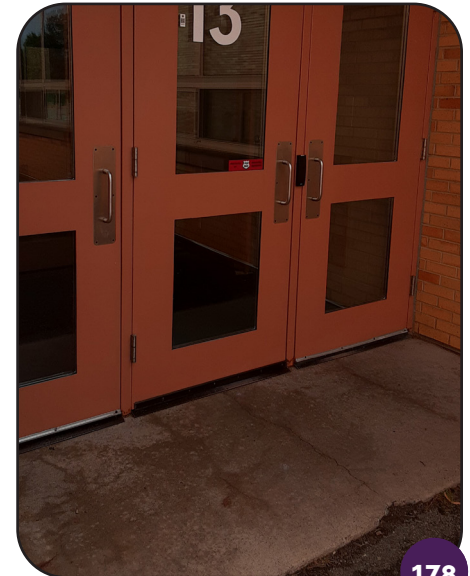
Building System	General Description	Recommendation	Cost Estimate
Site & Landscape	Dumpsters on asphalt	Install concrete pads for dumpsters.	\$6,800
Site & Landscape	Multiple walk concrete slabs with transitional and divided cracks.	Replace cracked concrete walk slabs.	\$23,000
Site & Landscape	Cracked concrete walk around storm drain.	Cut joints and patch.	\$1,000
Site & Landscape	Cracked concrete door landing.	Replace, patch, cut, grind and/or mud jacking as needed.	\$17,500

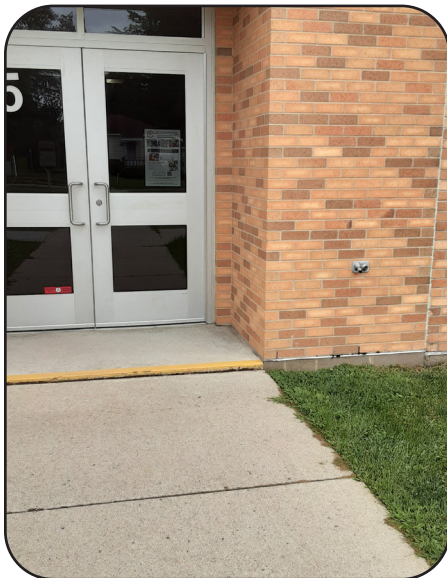
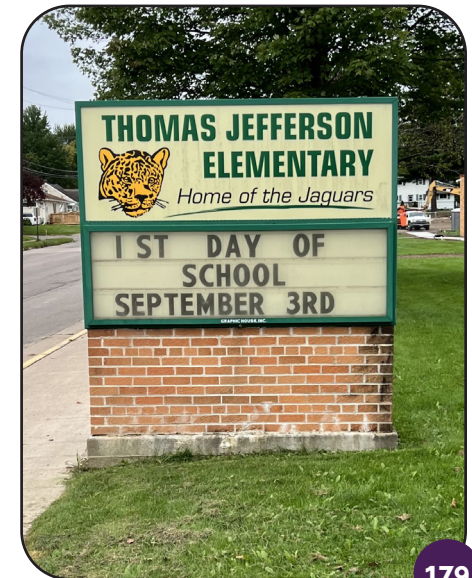
Building System	General Description	Recommendation	Cost Estimate
Site & Landscape	Uneven transition between concrete door landing and walk.	Replace, patch, cut, grind and/or mud jacking as needed.	\$17,500
Site & Landscape	Building perimeter and hardscape gaps.	Back fill gaps with sand and backer rod. Caulk and seal with appropriate joint filler. Heat melt in place material recommended for smooth, clean appearance.	\$3,500
Site Utilities	Gas valve on side of building not secured inside of fencing and potential climbing assistance to roof.	Enclose, secure valve access, and eliminate potential climbing assistance.	\$4,500
Site Utilities	Failed front sign base.	Replace base and upgrade sign. Consider complete upgrade replacement for sign.	\$35,000

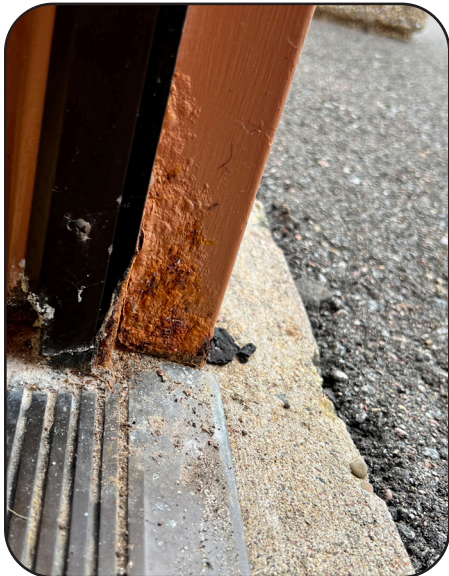
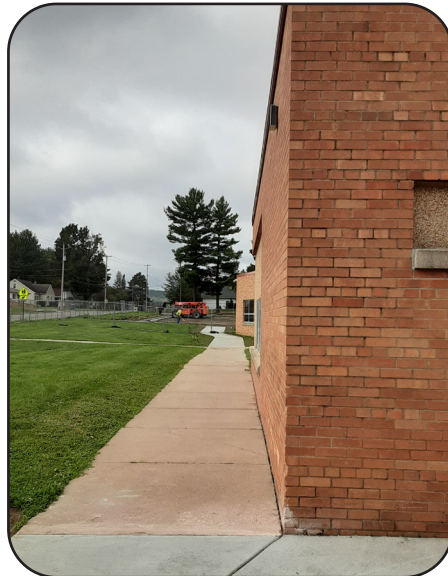
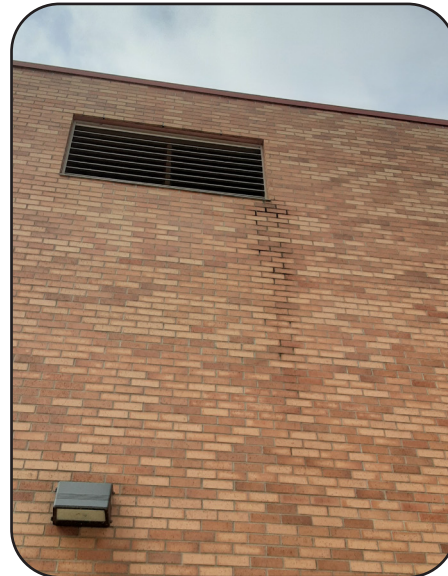
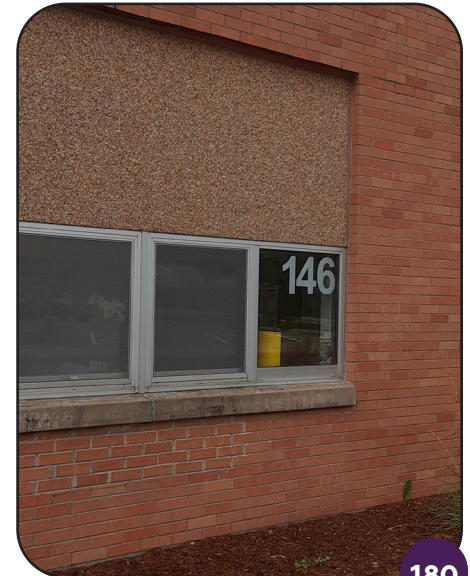
Building System	General Description	Recommendation	Cost Estimate
Exterior - Doors	Although minimal, some sets of exterior steel doors are deteriorating. One set of gym doors is rusting through.	Complete a through facility exterior door inventory and replace as necessary. Expect to replace several door sets in the next 1-5 years.	\$20,000
Exterior Building	Tuck pointing and masonry repairs needed. Stained with face brick with open, missing, and deteriorating mortar.	Re-tuck walls, replace missing and damaged masonry, and professionally clean stone and bricks.	\$45,000
Exterior Building	Exterior wall metal louver stains on face brick.	Professionally clean walls and seal. Repaint or replace rusting wall louver.	\$5,500
Exterior Building	Stained exterior window sills.	Professionally clean wall sills and decorative stone.	\$8,500

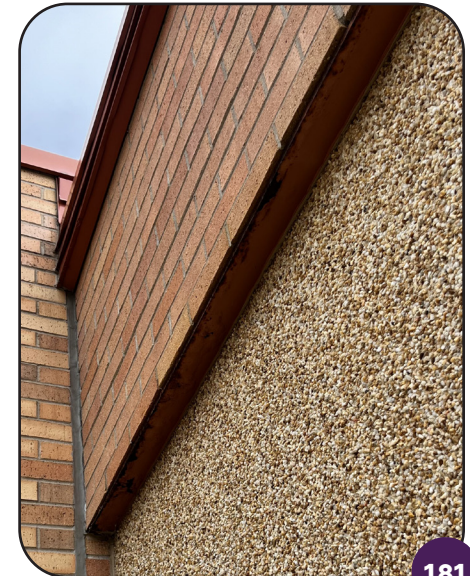
Building System	General Description	Recommendation	Cost Estimate
Exterior Building	Failed and missing window caulk, joint compound, and sealant.	Remove failed and around areas of missing caulk. Re-caulk without blocking or sealing weeps.	\$15,000
Exterior Building	Stone window sills deteriorating.	Patch and seal, or replace. Consider completion with major sill restoration project.	\$45,000
Exterior Building	Window sills internal reinforcing steel exposed.	Patch and seal or replace. Consider completion with major sill restoration project.	\$15,000
Exterior Building	Window steel lintels rusty.	Prepare and paint with weather resistant coatings. Consider completion with major sill restoration project.	\$28,000

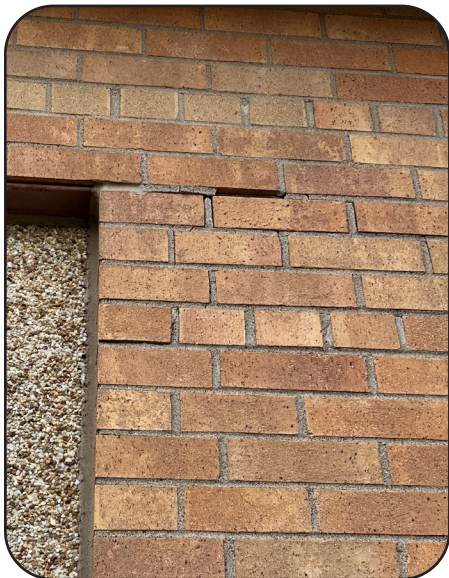
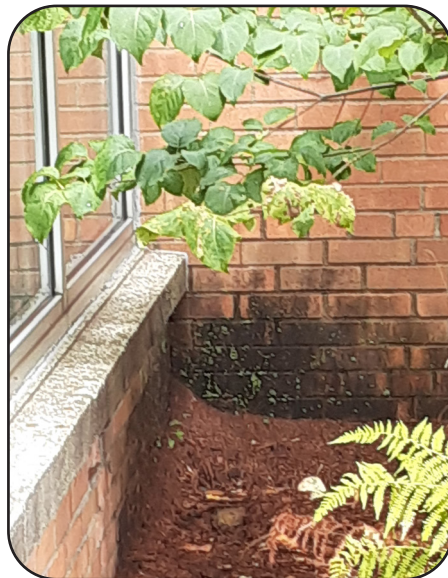
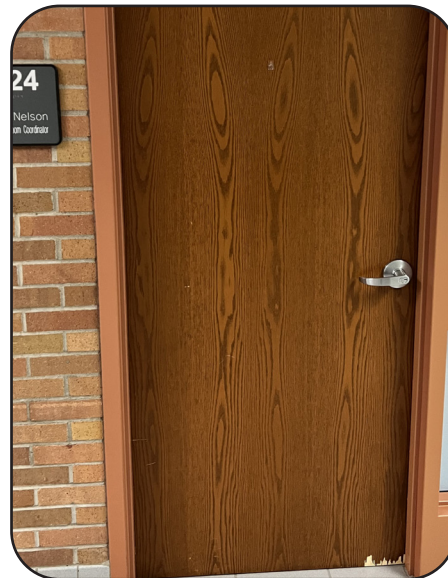
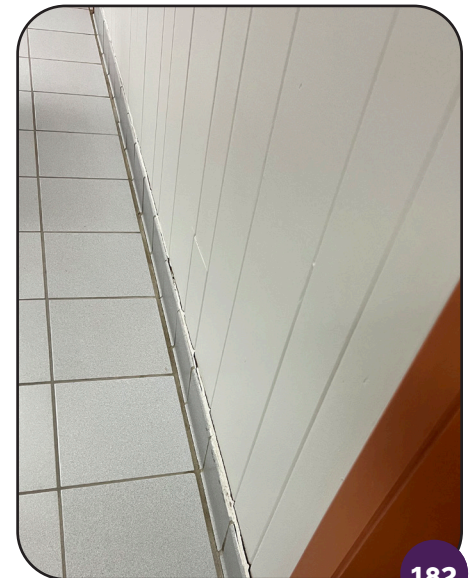
Building System	General Description	Recommendation	Cost Estimate
Exterior Building	Windows lintels loose at brick face union.	Tuckpoint lintel unions and adjacent mortar on brick face. Consider completion with major sill restoration project.	\$18,000
Exterior Building	Exterior wall mildew stains from roof edge scupper discharge.	Extend or modify scupper to prevent staining. Professional clean face brick.	\$5,000
Interior Wood Doors	A fair amount of original and later vintage wood doors throughout the facility are in poor condition; de-laminating, stained, and chipped.	Replace aged and damaged interior wood doors. Estimate given for 30 doors.	\$37,500
Interior - Wall Base	A minimal amount of ceramic wall base was noted failing from the wall surface joint. Walls in this area are constructed of wood paneling, the failure is likely due to wall movement.	Until an aesthetic improvement is made to remove the paneling, scrape and grind the mortar joint and run a flexible caulk joint along the upper tile edge.	\$3,500

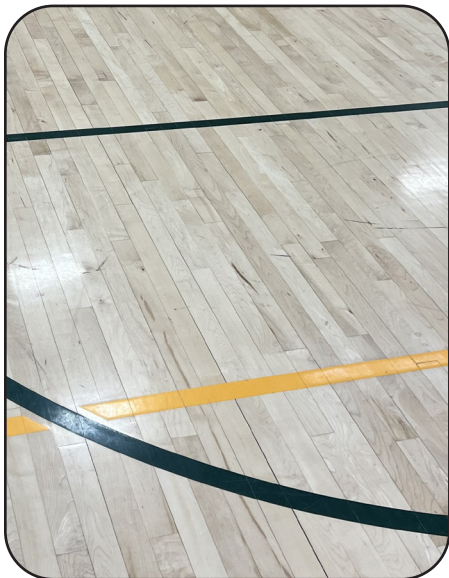
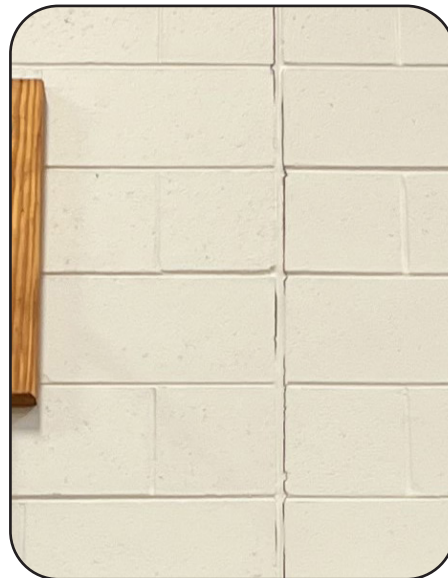
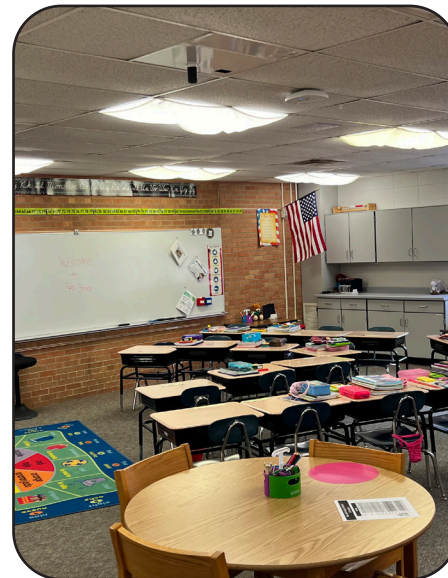
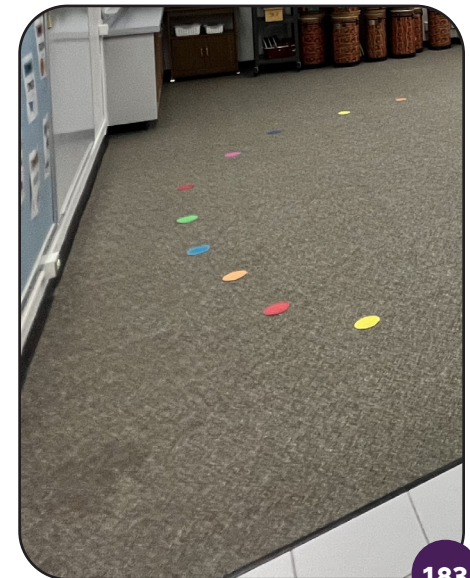
Building System	General Description	Recommendation	Cost Estimate
Interior - Gym Flooring	Although in good overall condition, the main gym floor is scuffed and scratched.	Maintain a wood floor refinishing cycle, recommended every 5-10 years dependent on use and condition.	\$25,000
Interior - Gym Control Joints	Interior caulk control joints of the gym masonry wall are dried and cracked, allowing infiltration, and no longer performing as designed.	Remove old caulk, clean and prep the joint, install new.	\$7,500
Interior -Ceilings	Several classrooms have not been updated to 2x2 ceiling tile. This tile was stained and showing it's age.	Replace classrooms with 2x4 ceiling tile with 2x2 tile in conjunction with a lighting upgrade project.	\$20,000
Interior - Flooring	Although minimal, several classrooms were noted having stained and dated carpeting.	Replace carpeting as needed, test flooring for hazardous materials prior. Pricing given for five classrooms without abatement needed.	\$30,000

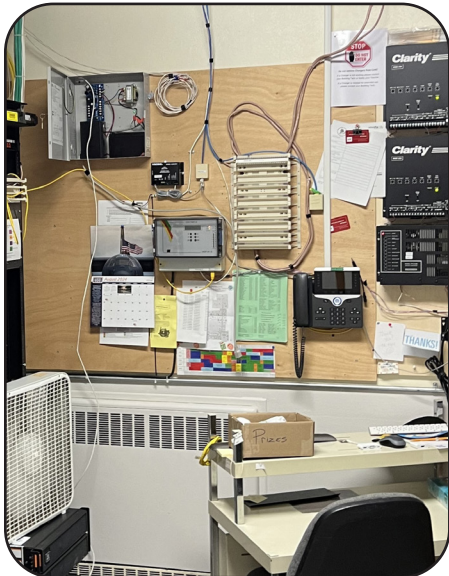
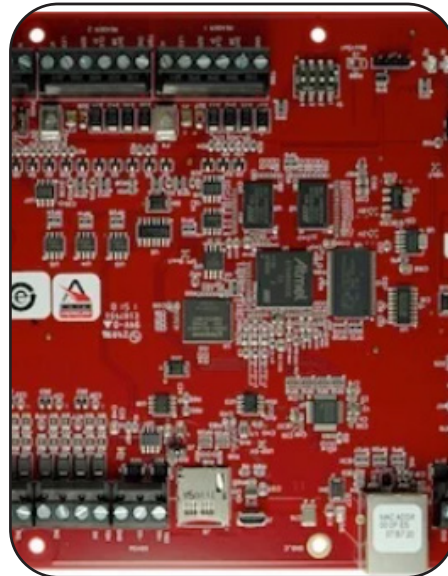
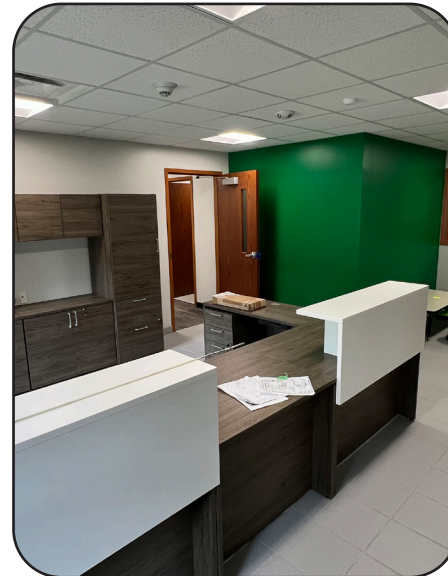
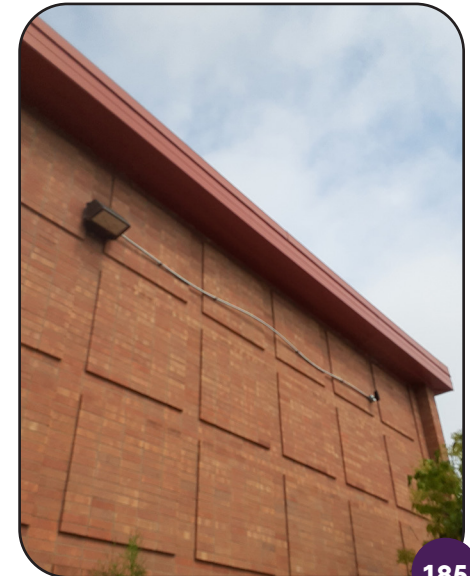
Building System	General Description	Recommendation	Cost Estimate
Electrical - Bell/PA & Communication	PA/Bell/Clock/mass communication systems due for upgrade. Existing system is obsolete using decades old technology.	Replacement recommended with the district's Single-wire system standard.	\$258,000
Electrical - Door Access	Card Access systems across the district are in need of upgrade to their board controllers. Information was compiled through district IT interviews and recommended per school individual need.	Replace HID Vertx boards to Mercury LP1502's.	\$10,000
Electrical - Security Cameras	Through district IT staff interviews, certain schools were identified as in need of camera investment. Recommendations based on individual need per school.	Replace obsolete cameras and or add new.	\$18,000
Electrical	Exterior wall pack conduit bent.	Straighten and reinforce attachment.	\$1,000

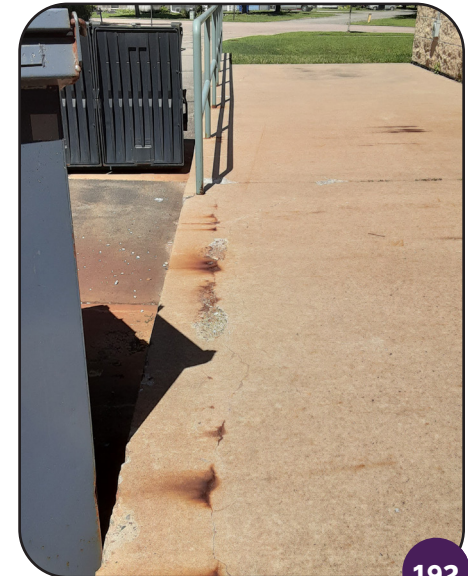
Building System	General Description	Recommendation	Cost Estimate
Site & Landscape	Concrete dock slabs cracked.	Replace cracked concrete slabs. Consider replacement with comprehensive dock upgrade/replacement project.	\$27,000
Site & Landscape	Concrete dock stairs post base open and cracked.	Cut and repair. Consider complete stair replacement along with comprehensive dock upgrade/replacement project.	\$7,500
Site & Landscape	Deteriorated concrete joints between dock and dock walk ramp.	Replace slabs with open or deteriorated joints. Consider replacement with comprehensive dock upgrade/replacement project.	\$12,500
Site & Landscape	Concrete dock walk ramp rebar exposed.	Replace slabs with exposed repair and cracks to underlying rebar. Consider replacement with comprehensive dock upgrade/replacement project.	\$27,000

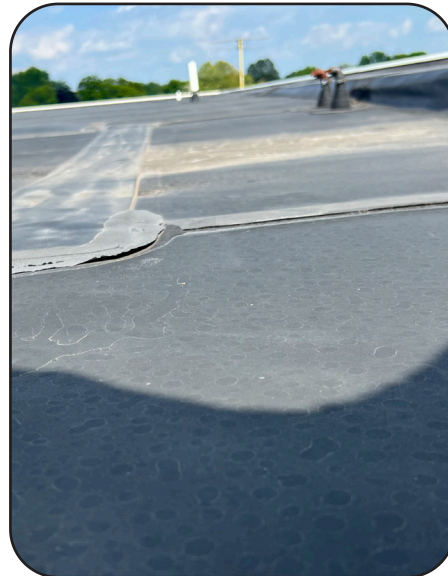
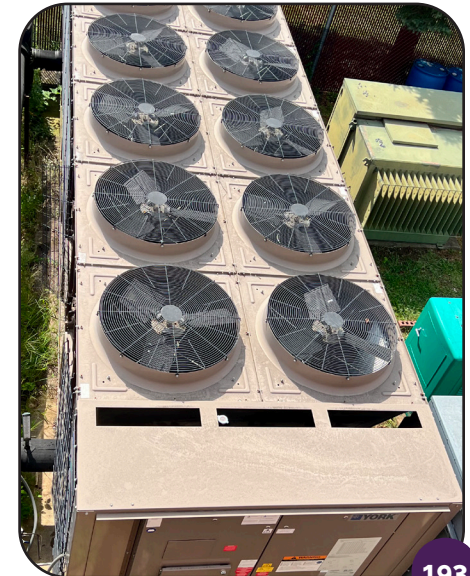
Building System	General Description	Recommendation	Cost Estimate
Site & Landscape	Storm water culvert open.	Add guard and large debris grates on culvert inlets and outlets.	\$1,000
Exterior Building Roofing	Roof sections A-E are 27 years old, out of warranty, and past their expected useful life. Inspection showed peeling seams, failing patches, and evidence of ponding water. Scupper outlets appear to be improperly pitched, draining water on the building under normal circumstances.	Replace sections A-E in the next 1-5 years with an adhered 60 mil black EPDM 20 year warranty roof. Recommend completing all roofs at once.	\$430,000
Exterior - Upper Gym	Upper gym roof/ceiling edge stained per air and moisture infiltration. Observed areas around gym block windows with similar conditions.	Investigate and eliminate cause. Clean and remove stains. .	\$14,500
Mechanical	The GD Jones chiller has had a major failure and is in need of replacement.	As of the writing of this audit, the unit was budgeted for and scheduled for replacement prior to next cooling season. Cost estimate provided as a placeholder.	\$1,000

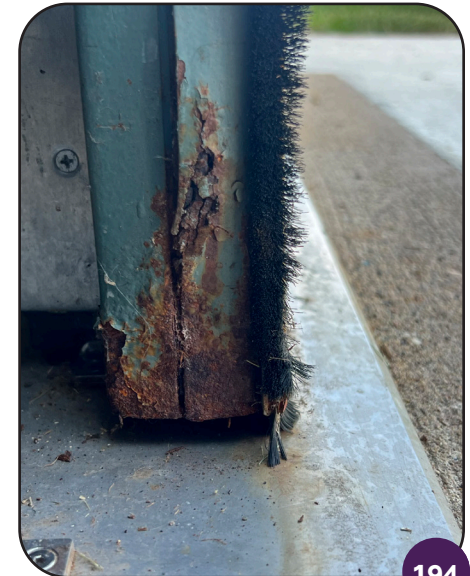
Building System	General Description	Recommendation	Cost Estimate
Site & Landscape	Set routine asphalt maintenance schedule with area rotation.	Continue crack clean and crack fill as needed. Include every 3-5 years seal, and repaint asphalt.	\$6,500
Site & Landscape	Multiple walk concrete slabs with transitional and divided cracks.	Replace cracked concrete walk slabs.	\$16,000
Site & Landscape	Dumpsters concrete slab stained.	Professional clean to remove rust stains.	\$4,500
Exterior - Doors	Although minimal, some sets of exterior steel doors are deteriorating. One set of gym doors is rusting through.	Complete a through facility exterior door inventory and replace as necessary. Expect to replace several door sets in the next 1-5 years.	\$20,000

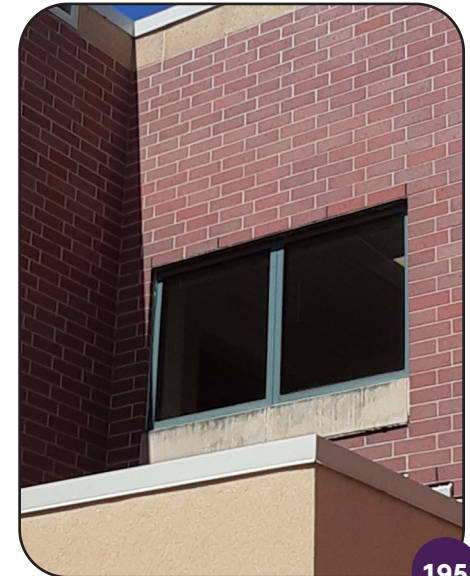
Building System	General Description	Recommendation	Cost Estimate
Exterior - Entry structure	The high-ceiling pyramid roof structure is in need of maintenance. Mildew, EIFS, flashings, caulk, paint, and skylight all have deficiencies. Roofing appears to overlap the bottom EIFS joint which would trap water below the roof membrane.	Perform general maintenance on the structure. Properly terminate roof below EIFS when re-roofing the facility. Replace aged inefficient skylight with glass or opaque panel. Pressure wash, caulk, paint, and reflash metals. Consider replacing EIFS with masonry.	\$50,000
Exterior - Gym Block Window	Area around gym block windows stained per air and moisture infiltration. Observed areas around gym roof edge with similar conditions.	Investigate and eliminate cause. Clean and remove stains. .	\$8,500
Exterior Building	Exterior window lintels rusting.	Prepare and paint with durable weatherproof coating.	\$20,000

Exterior Building	Stained exterior window sills.	Verify cause and remedy. Professionally clean wall sills and decorative stone. Consider completion as more extensive exterior wall corrective project.	\$12,500

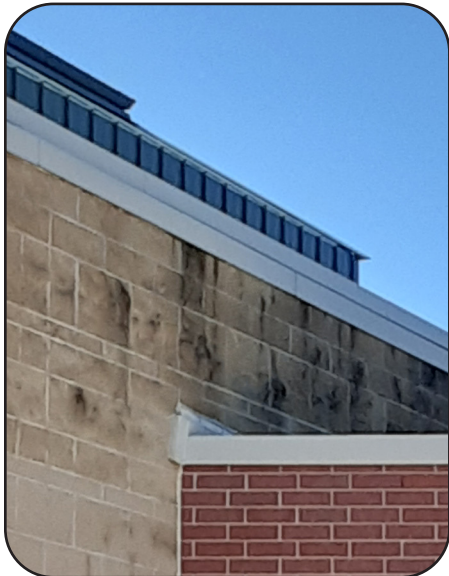
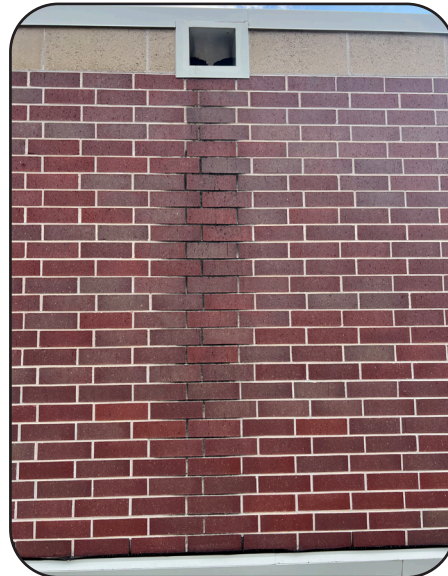
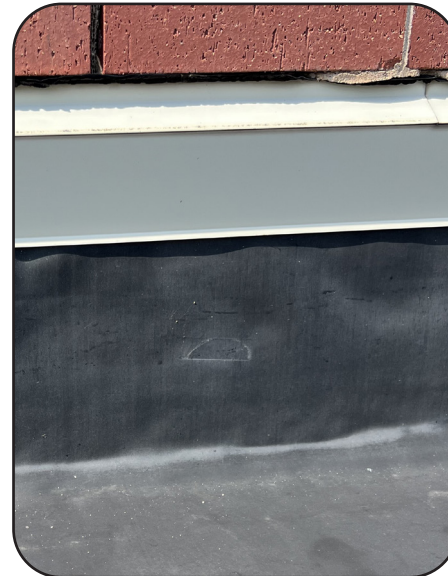
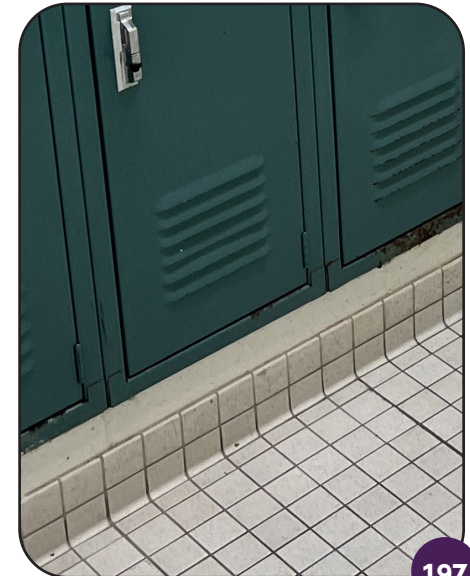
Building System	General Description	Recommendation	Cost Estimate
Exterior Building	Exterior wall block and mortar stained.	Professionally clean walls. Consider completion as more extensive exterior wall cleaning project.	\$5,000
Exterior Building	Exterior wall scupper discharge stain.	Extend, enclose, or modify scupper to eliminate stain cause. Professionally clean wall.	\$5,800
Exterior Building	Exterior wall flashing transition mortar missing and deteriorating.	Tuck point above and under flashing. Replace with waterproofed flashing to direct water to roof membrane.	\$23,000
Interior - Lockers	The small sections of lockers in gym bathrooms are beginning to rust.	Properly prep and repaint lockers for extended life.	\$4,000

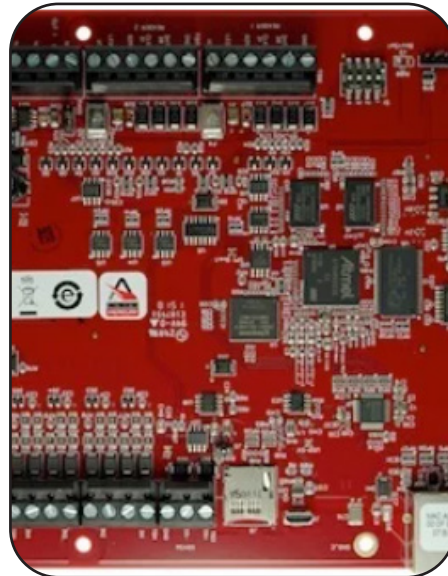
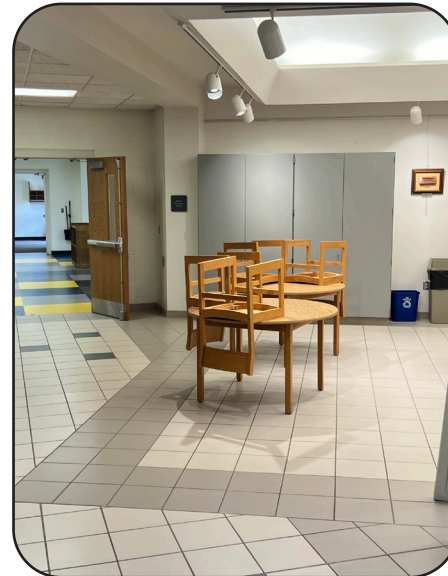
Building System	General Description	Recommendation	Cost Estimate
Electrical - Bell/PA & Communication	PA/Bell/Clock/mass communication systems due for upgrade. Existing system is obsolete using decades old technology.	Replacement recommended with the district's Single-wire system standard.	\$270,000
Electrical - Door Access	Card Access systems across the district are in need of upgrade to their board controllers. Information was compiled through district IT interviews and recommended per school individual need.	Replace HID Vertx boards to Mercury LP1502's.	\$8,000
Electrical - Security Cameras	Through district IT staff interviews, certain schools were identified as in need of camera investment. Recommendations based on individual need per school.	Replace obsolete cameras and or add new.	\$12,000

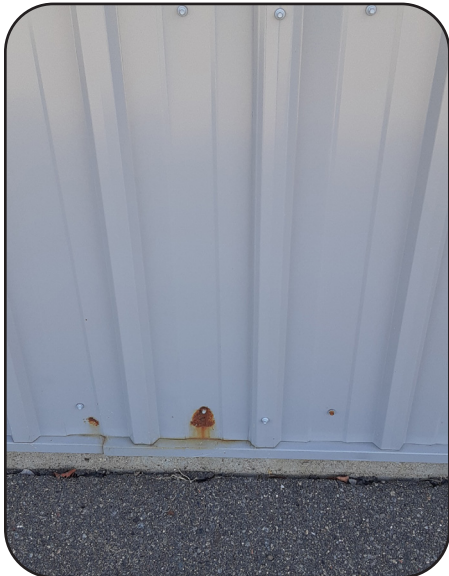
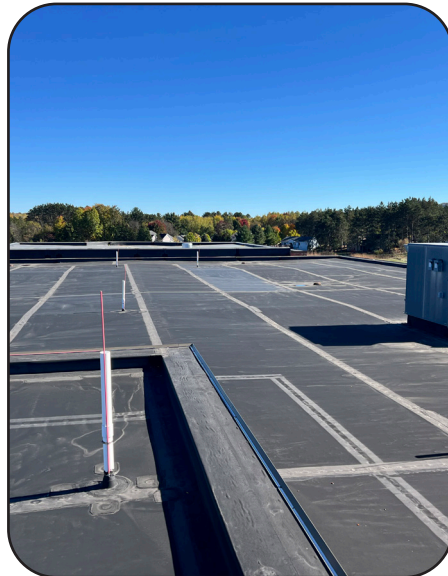
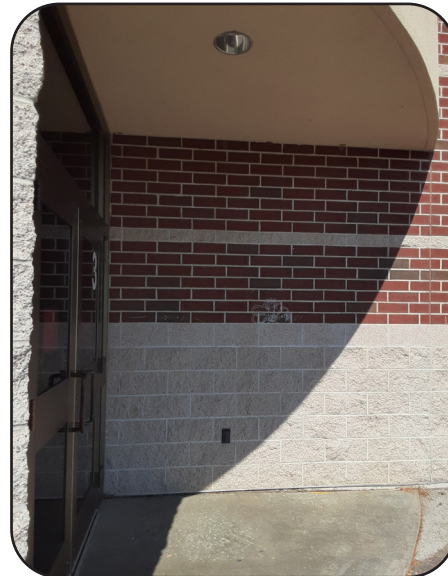
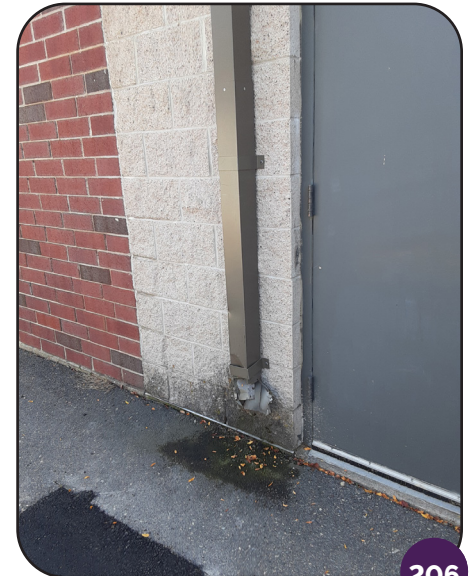
Building System	General Description	Recommendation	Cost Estimate
Site & Landscape	Metal shed lower panel fastener areas rusty.	Prepare and paint with durable weatherproof coating.	\$1,000
Exterior Building Roofing	Roof sections A-D are all 24 years old and out of warranty, these roofs are at their expected useful life. Large sheet patches were seen during roof inspection, along with frequent poor condition seams and seam patches. Several ceiling tiles were water stained throughout the building.	Replace sections A-D in the next 1-5 years with an adhered 60 mil black EPDM 20 year warranty roof. Recommend completing all roofs at once.	\$507,000
Exterior Building	Exterior wall brick paint stained.	Professionally clean walls. Consider completion as more extensive exterior wall cleaning project.	\$1,000
Exterior Building	Exterior wall downspout extension missing and wall staining.	Replace downspout extension to eliminate stain cause. Professionally clean wall. Consider completion as more extensive exterior wall cleaning project.	\$2,000

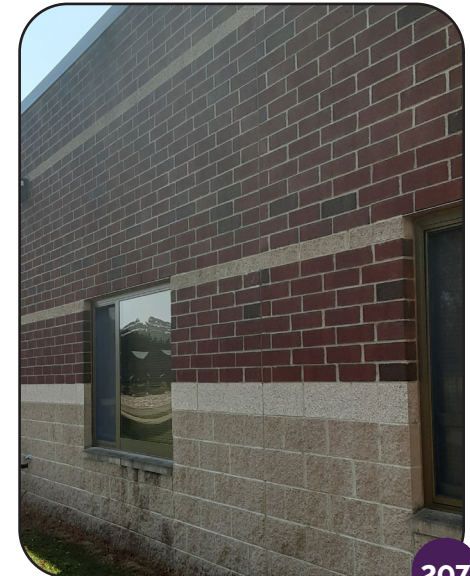
Building System	General Description	Recommendation	Cost Estimate
Site & Landscape	Set routine asphalt maintenance schedule with area rotation.	Continue crack clean and crack fill as needed. Include every 3-5 years seal, and repaint asphalt.	\$8,800
Site & Landscape	Concrete door landing deteriorating	Replace concrete door landing.	\$8,500
Site & Landscape	Utility hardscape area open.	Close exposed hardscape areas.	\$12,500
Exterior Building	Exterior wall block and mortar stained.	Professionally clean walls. Consider completion as more extensive exterior wall cleaning project.	\$5,000

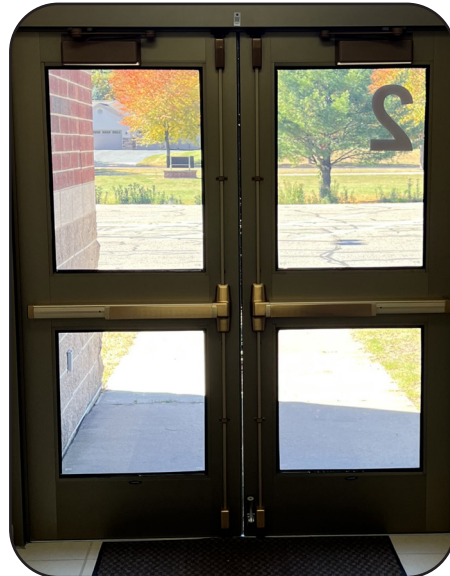
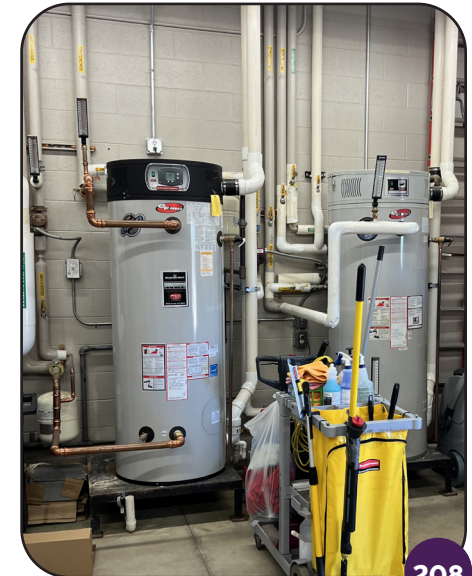
Building System	General Description	Recommendation	Cost Estimate
Exterior Building	Stained exterior window sills.	Professionally clean wall sills. Consider completion as more extensive exterior wall corrective project.	\$9,500
Exterior Doors	Although doors are in good condition, several door sets with no center mullion were noted with large air gaps between.	Inspect all exterior doors and perform a whole building door weather stripping and door sweep replacement as necessary.	\$5,000
Interior - Flooring	Although minimal, several areas were noted having cracked and gapped VCT. Area shown in staff lounge.	Repair damaged VCT tile, consider replacement with a superior product. Floor tile patches will likely stand out unless full surface is replaced.	\$5,000
Mechanical - Pipe Insulation	Missing and or damaged pipe insulation was noted in various locations around the building.	Insulate DHW piping up to water heaters. Missing insulation was also noted near the boilers. Replace any damaged or missing pipe insulation found elsewhere. Pricing given for minimal work noted in mechanical rooms.	\$5,000
