Facilities Management Services

Facility Improvement Measures Wausau - Riverview Elementary School

South Mountain Facility Analysis

Wausau School District - South Mountain ES

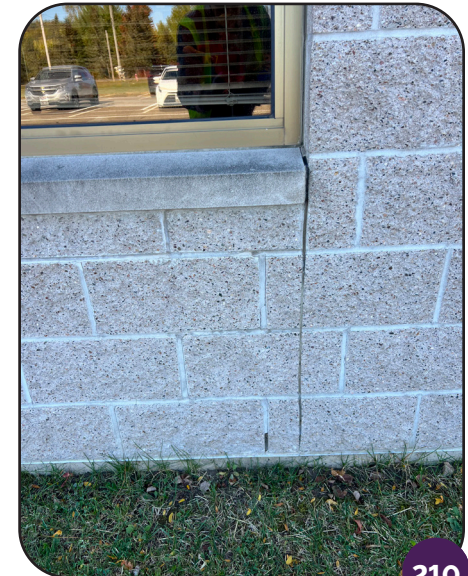
Building System	General Description	Recommendation	Cost Estimate
Site & Landscape	Multiple walk concrete slabs with transitional and divided cracks.	Replace cracked concrete walk slabs.	\$12,000
Site & Landscape	Concrete roll over curb deteriorating	Replace concrete curb.	\$7,500
Site & Landscape	Dumpsters concrete slab stained.	Professional clean to remove rust stains.	\$4,500
Exterior Building	Exterior window caulk missing and failing.	Remove failed and missing caulk. Re-caulk without blocking or sealing weeps.	\$18,000

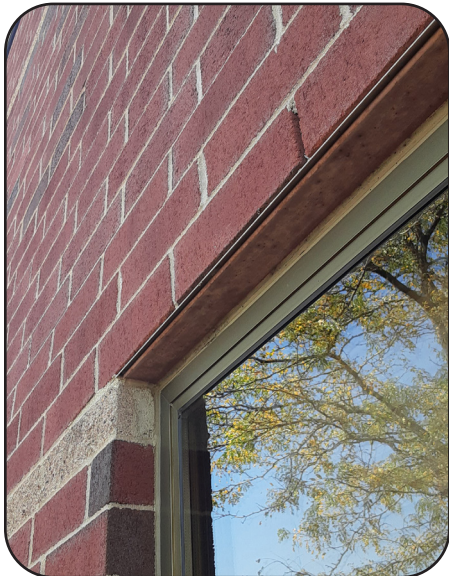
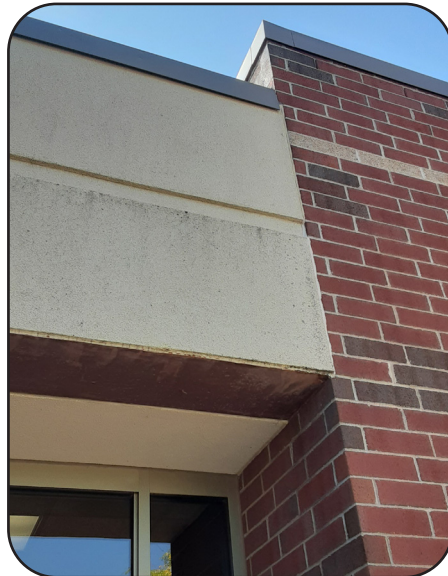
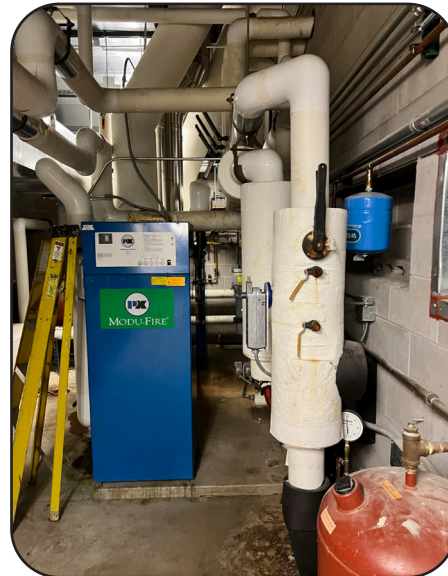
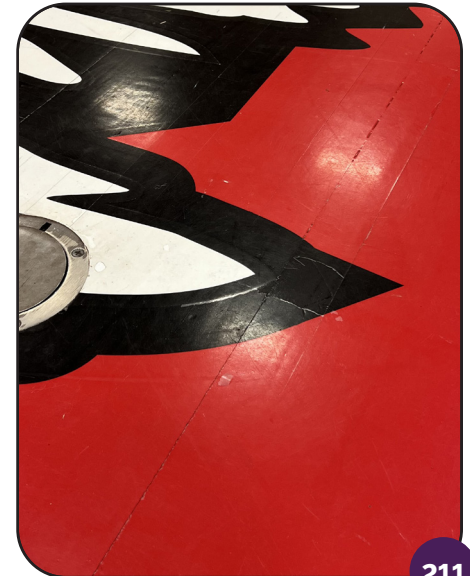
Building System	General Description	Recommendation	Cost Estimate
Exterior Building	Exterior window lintels rusting.	Prepare and paint with durable weatherproof coating.	\$22,000
Exterior Building	Exterior door lintels rusting.	Prepare and paint with durable weatherproof coating.	\$16,000
Mechanical - Boilers	Stettin is heated with two 2005 vintage 1.5MBTU standard efficiency boilers.	Expect to replace the boilers and pumps in the next 5-10 years with high efficiency condensing boilers.	\$250,000
Interior - Gym Flooring	The Stettin gym floor is in good condition but in need of maintenance. Surface finishing is de-laminating and larger cracks are forming between wood floor boards.	Perform a full refinishing and restriping in the next 1-2 years. Maintain a wood floor refinishing cycle, recommended every 5-10 years dependent on use and condition.	\$25,000
