Geneva Community Unit School District #304  
Operations and Maintenance  
7 Year Capital Improvement Plan

February 25, 2019

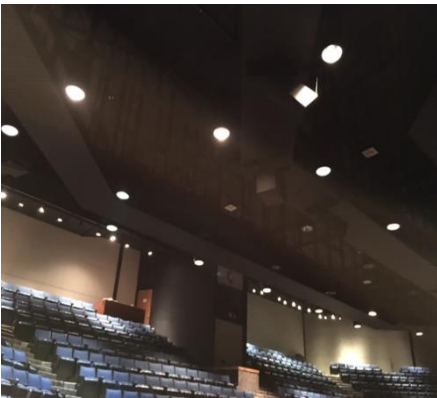
## Auditorium Lighting Replacement

Parts for lighting panel are becoming obsolete and starting to fail.

Replace with energy efficient fixtures and lighting panel.

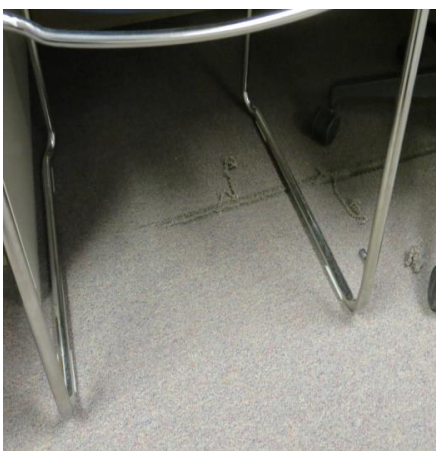
## Carpet

The carpet is starting to fray and cause trip hazards.

Carpet will need to be replaced.

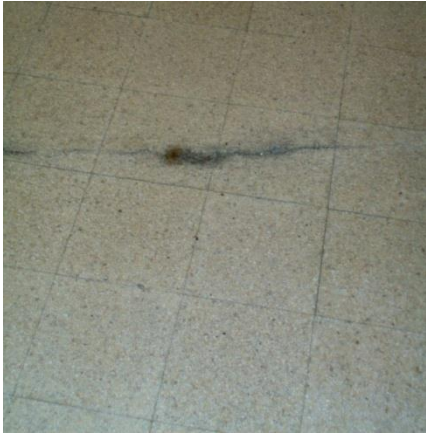
## Flooring

Existing quartz tile is cracking and has faded.

Replace tile in phases.

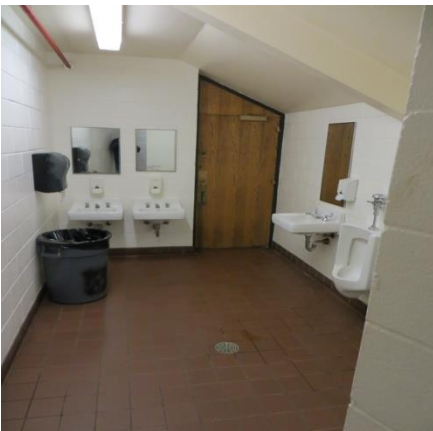
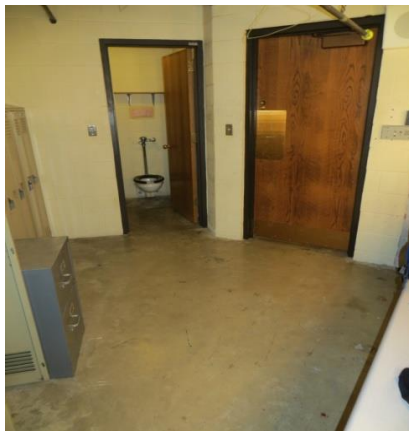
## Cafeteria and Stagecraft Bathrooms

Bathrooms are 44 years old.

Showing significant wear.

Need to update.

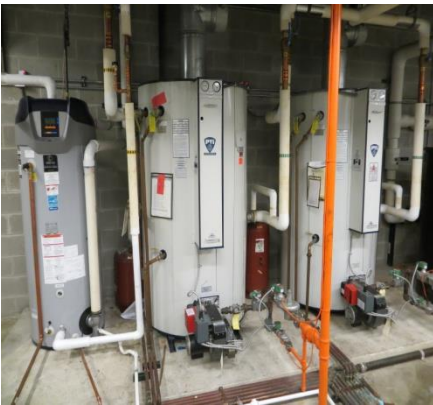
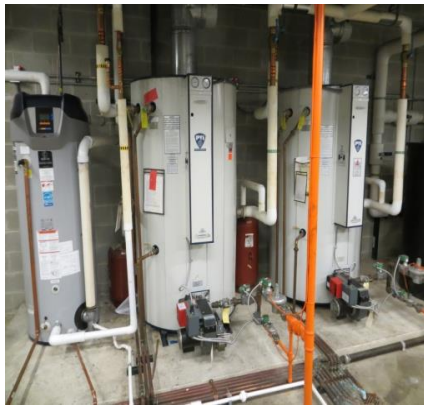
## Hot Water Heaters

The two 500 gallon PVI water heaters are nearing the end of their life cycle.

Replacement will be needed within the next seven years.

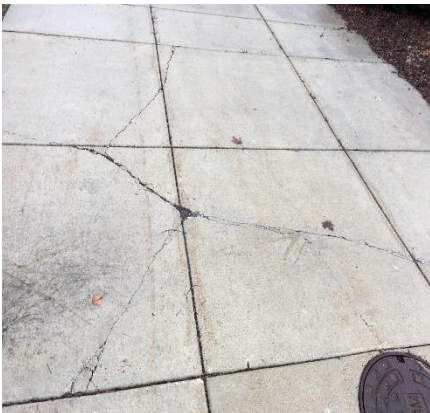
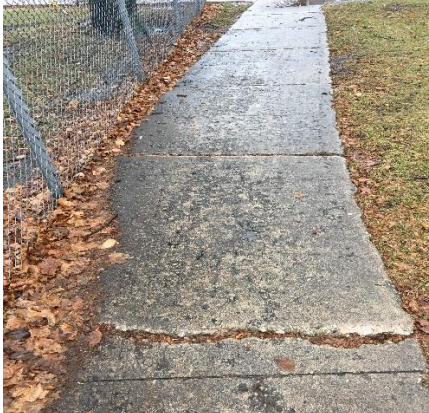
### Concrete Sidewalk and Curbs

Several areas are starting to show cracking and spalling.

Repair or replace damaged sections.

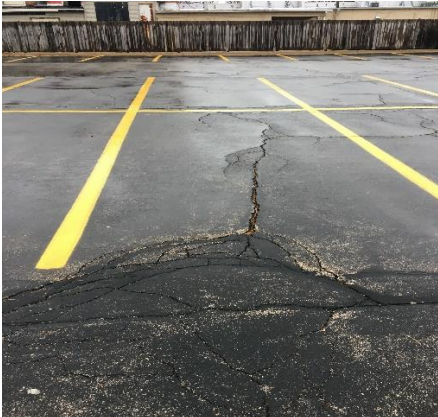
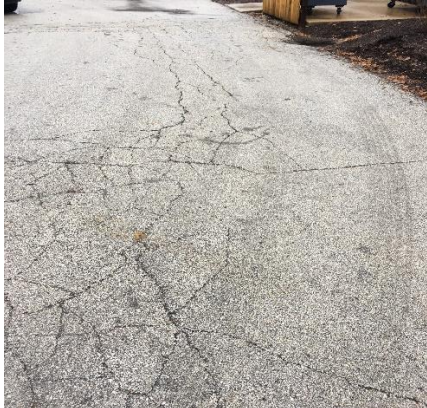
### Parking lot

Several areas with extreme cracking.

Sealcoating and crack filling will be needed.

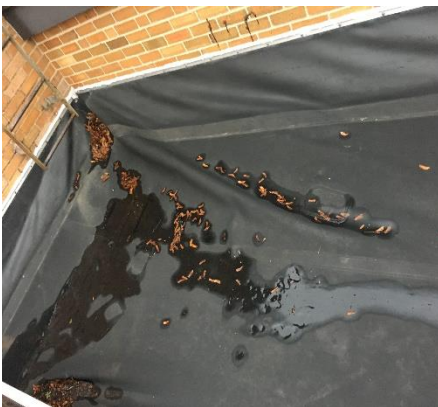
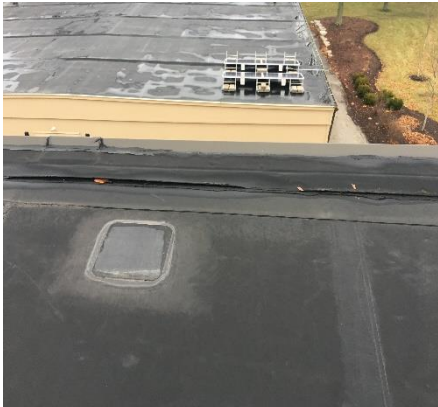
### Roof

The roof is 18+ years old and many sections are in poor condition.

Roof replacement/restoration will be needed in the next one to three years.

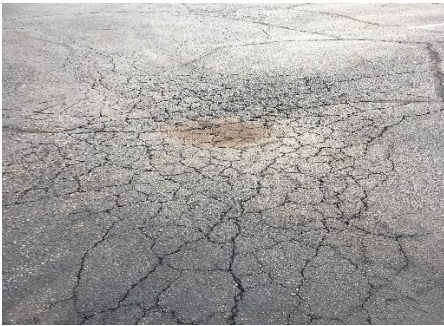
## Parking lot

Several areas with extreme cracking.

Sealcoating and crack filling will be needed.

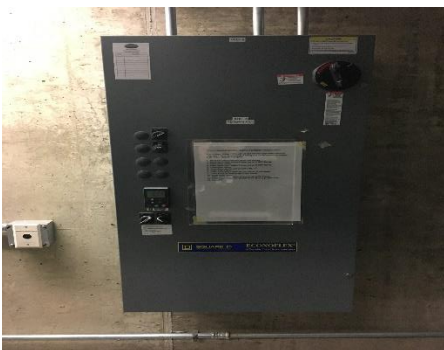
## Variable Frequency Drive (VFD)

Needs replacing in the next 5 years.

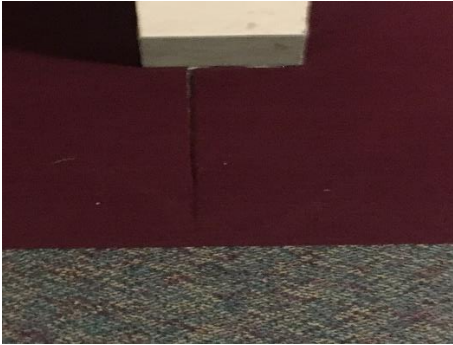
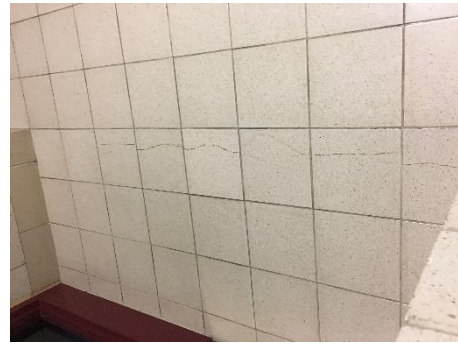
## Flooring Replacement

Carpet is starting to show wear and seams are starting to pull apart.

Life cycle of carpet is 12-20 years.

Tile is lifting and cracking in several area.

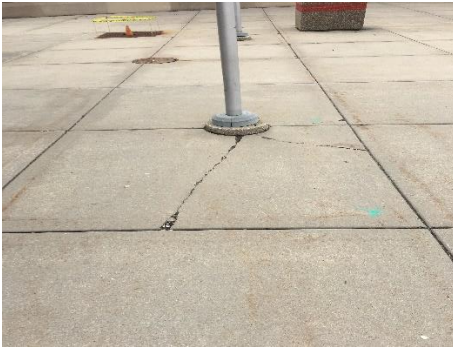
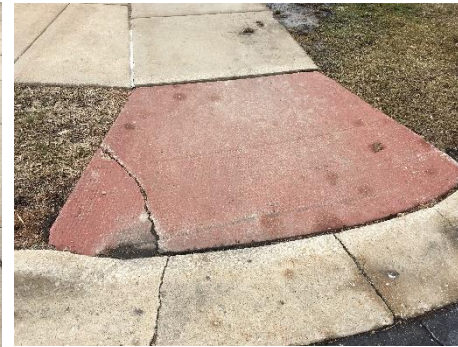
## Sidewalk and Curbs

Several areas are starting to show cracking and wear.

Repair or replace damaged sections.

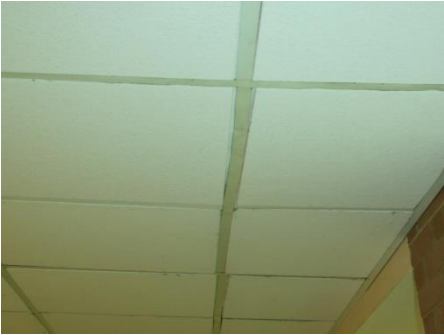
## Ceiling Tile

Ceiling grid and tile are starting to show excessive discoloration and wear.

Replace ceiling grid and tile.

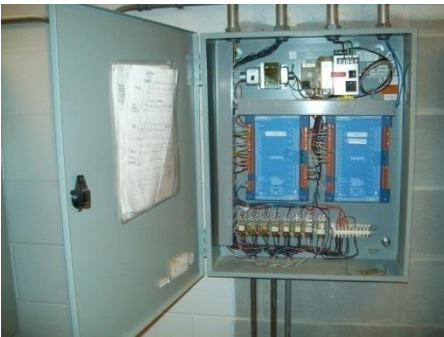
## Lon Controller

Lon controls throughout the building.

Outdated and costly to repair.

Replace Lon to BACnet.

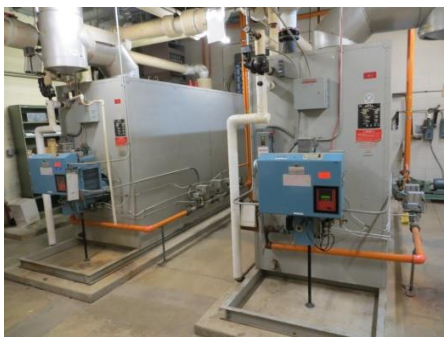
## Boiler Replacement

25-year old boilers are inefficient and nearing the end of their estimated service life as per ASHRAE.

Replace with new high efficiency boilers.

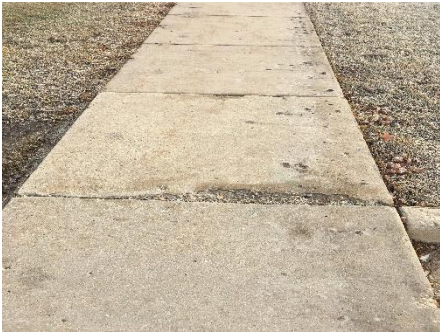
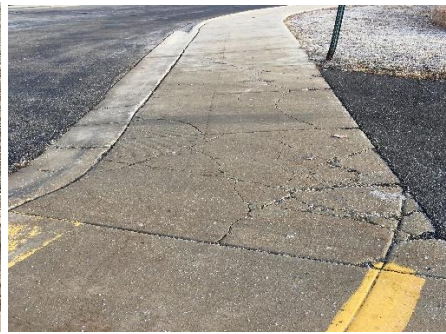
### Concrete Sidewalk and Curbs

Several areas are starting to show cracking and spalling.

Repair or replace damaged sections.

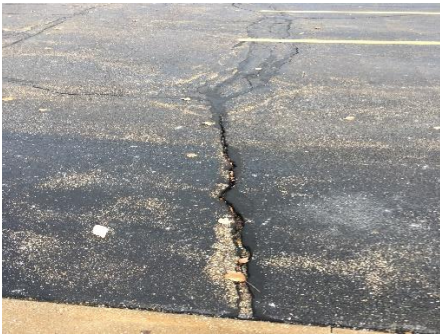
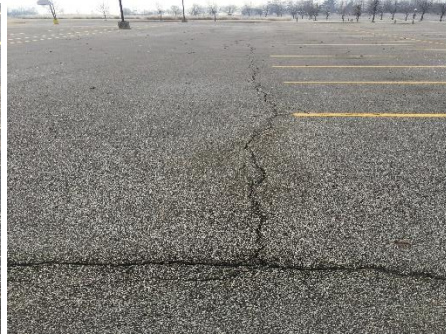
### Parking lot

Several areas with extreme cracking.

Sealcoating and crack filling will be needed.

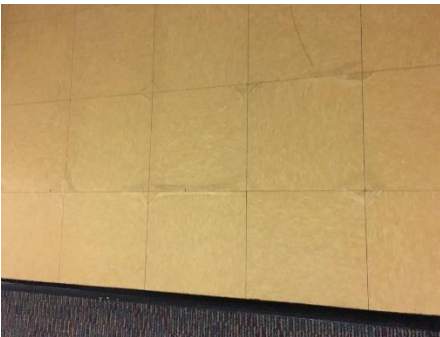
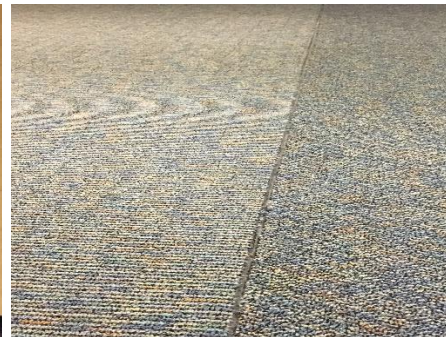
### Flooring Replacement

Carpet is starting to show wear and seams are starting to pull apart.

Tile is lifting and cracking in several areas.

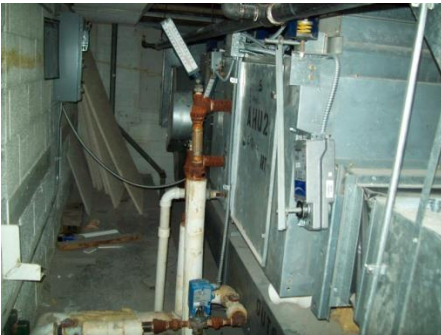
## Air Handling Unit

Needs rebuilding or possible replacement.

New motor, shaft, bearings and controls needed.

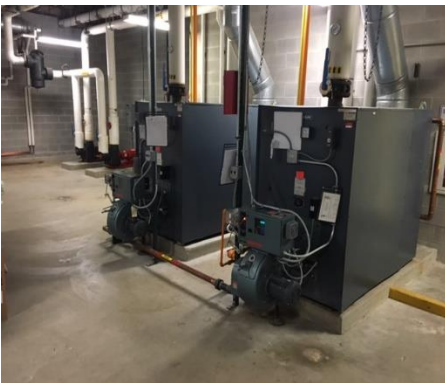
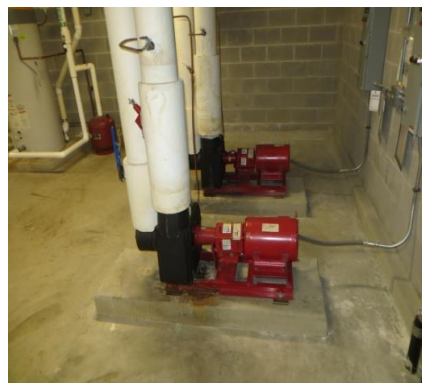
## Boiler and Secondary Pumps Replacement

20 years old boilers and pumps nearing end of their estimated service life as per ASHRAE.

Need to be replaced with energy efficient design.

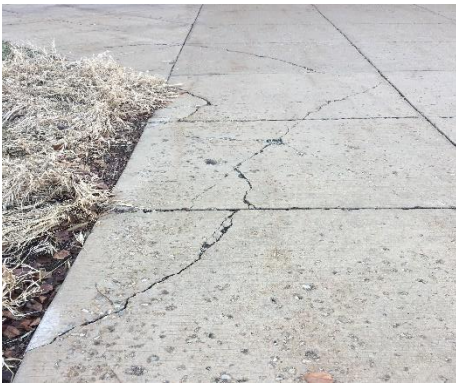
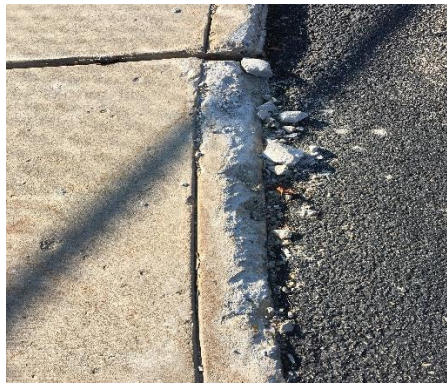
## Sidewalk and Curbs

Several areas are starting to show cracking and wear.

Repair or replace damaged sections.

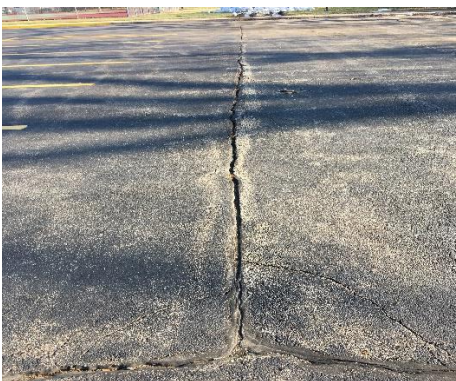
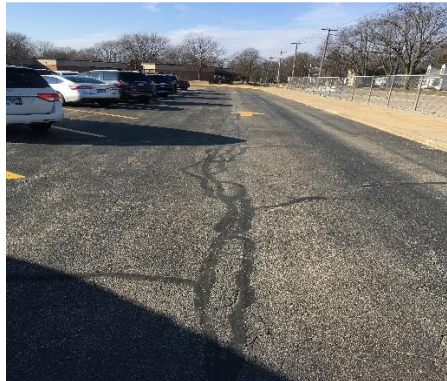
## Parking lot

Several areas with extreme cracking.

Sealcoating and crack filling will be needed.

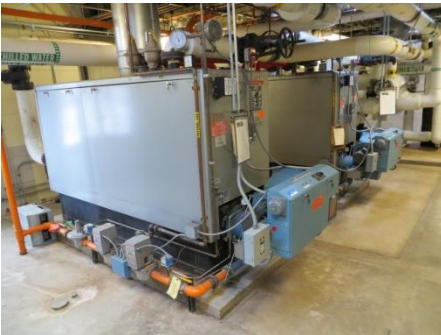
## **Boiler Replacement**

29-year old boilers are inefficient and nearing the end of their estimated service life as per ASHRAE.

Replace with new high efficiency boilers.

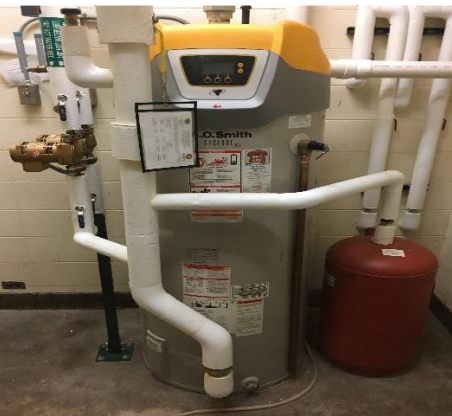
## **Hot Water Heater**

The 100- gallon A.O. Smith water heater is nearing the end of its life cycle.

Replacement will be needed.

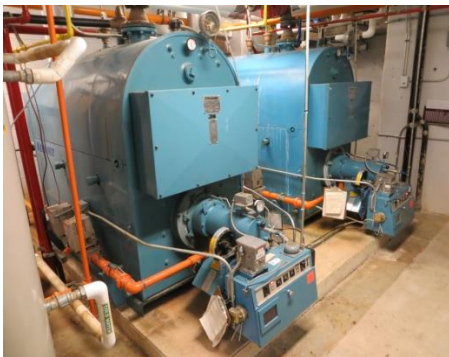
## Boiler Replacement

Boilers are 23 years old and original to the building.

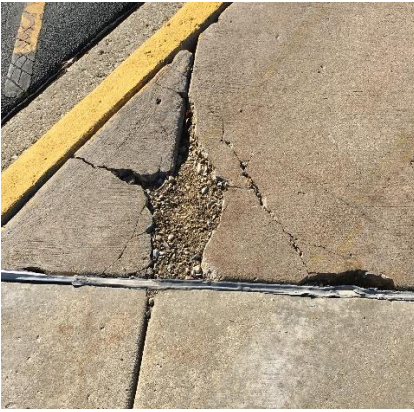
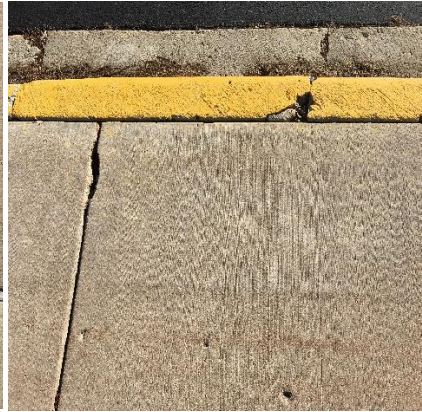
## Sidewalk and Curbs

Several areas are starting to show cracking and wear.

Repair or replace damaged sections.

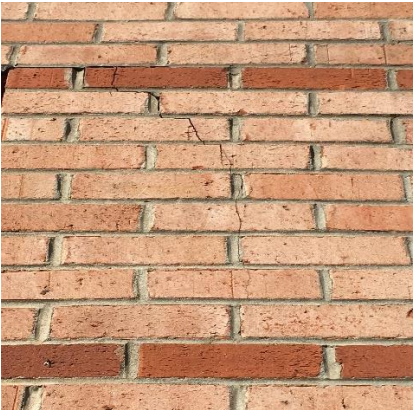
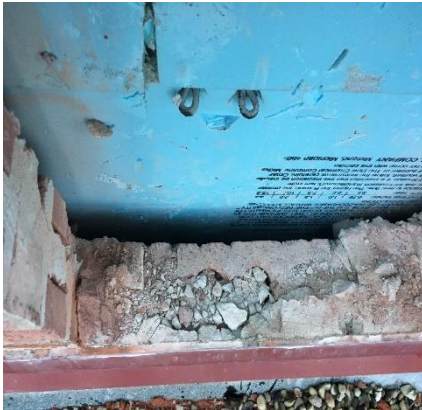
## Tuckpointing and Flashing

Cracked and missing mortar joints and bricks will need to be repaired.

Failed flashing will need to be removed and replaced.

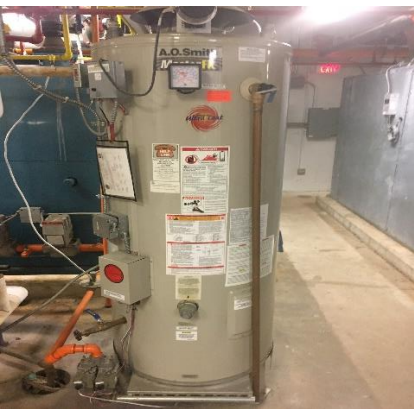
## Hot Water Heater

The 75- gallon A.O. Smith water heater is nearing the end of its life cycle.

Replacement will be needed.

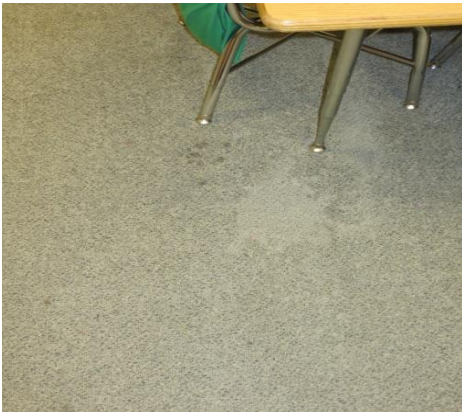
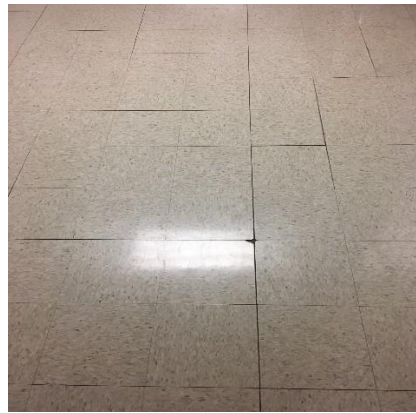
## **Flooring Replacement**

Carpet is starting to show wear and staining that we are unable to remove.

Tile is lifting and cracking in several areas.

Flooring will need to be replaced.

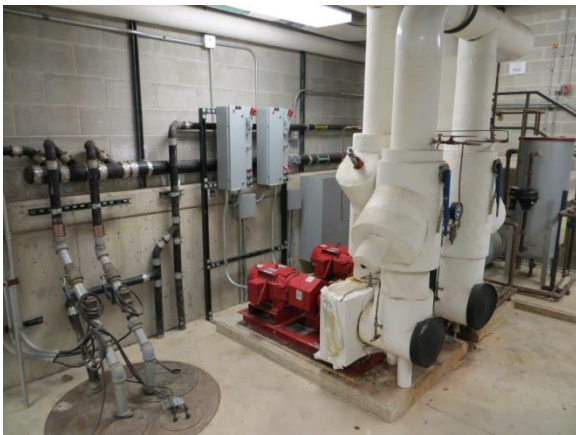
## **Chilled Water Pumps (2) – Add VFD**

Variable Frequency Drives will greatly increase energy efficiency and lengthen the life of the pumps.

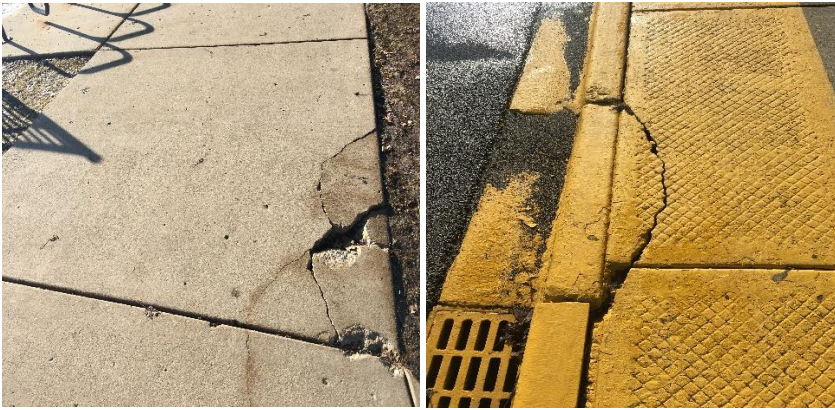
## Sidewalk and Curbs

Several areas are starting to show cracking and wear.

Repair or replace damaged sections.

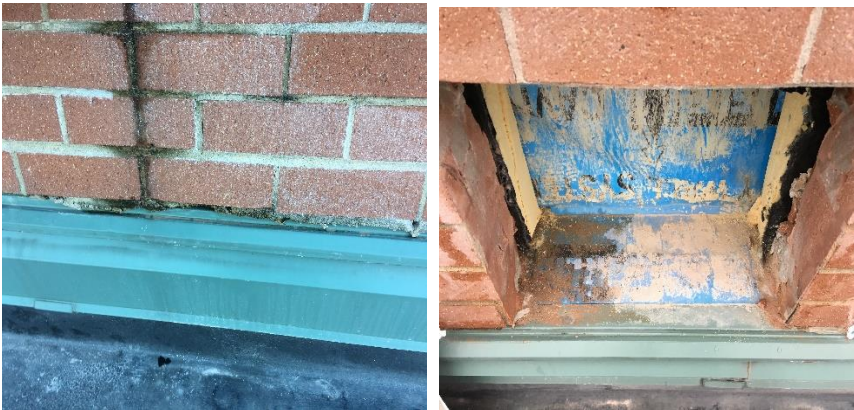
## Tuckpointing and Flashing

Cracked and missing mortar joints and bricks will need to be repaired.

Failed flashing will need to be removed and replaced.

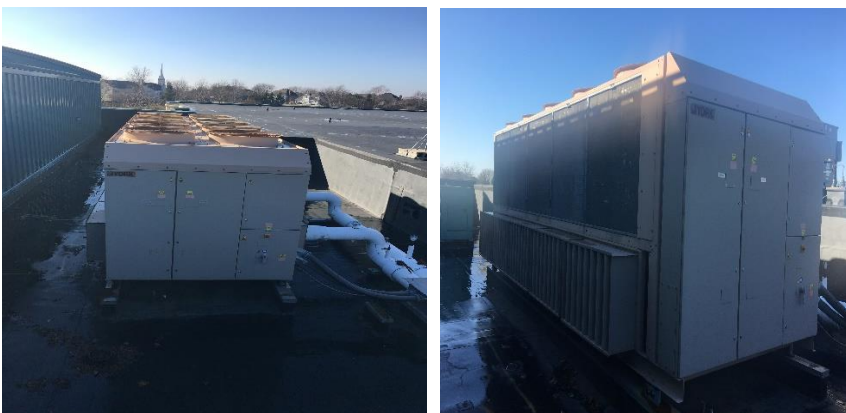
## Chiller

16 years old chiller and nearing the end of its service life as per ASHRAE.

Repairs are becoming more frequent.

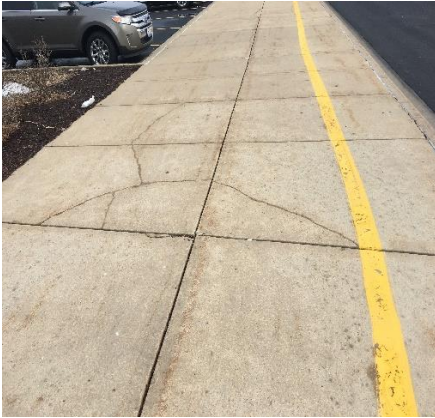
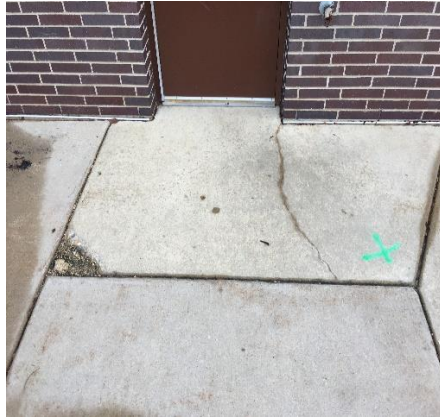
## Sidewalk

Several areas are starting to show cracking and wear.

Repair or replace damaged sections.

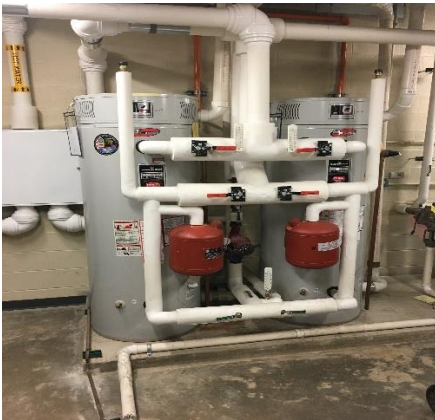
## Hot Water Heaters

The two 100- gallon Bradford White water heaters are nearing the end of their life cycle.

Replacement will be needed within the next two to five years.

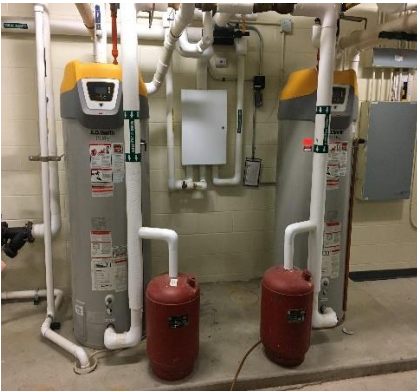
### **Hot Water Heaters**

The two 100- gallon A.O. Smith water heaters are nearing the end of their life cycle.

Replacement will be needed within the next three to seven years.

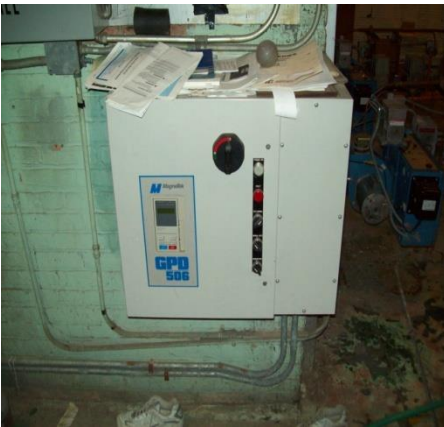
## Variable Frequency Drive

VFD has failed and needs to be replaced.

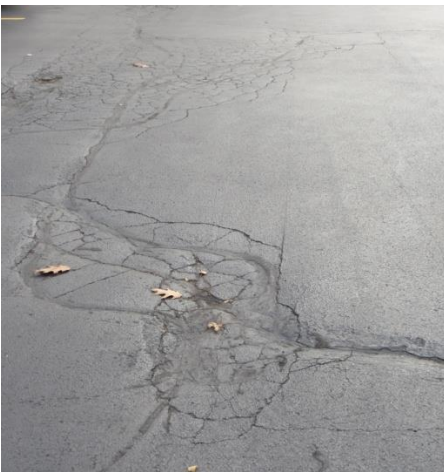
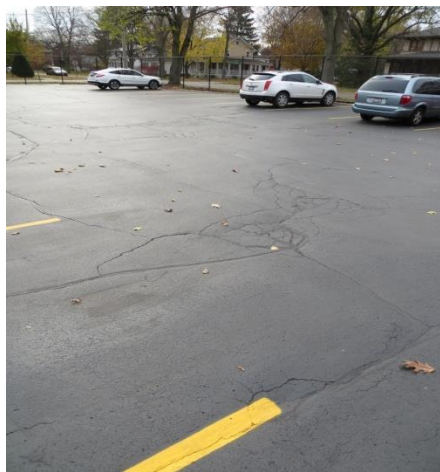
## Parking Lot

Several areas with extreme cracking.  
Resurfacing will be needed.

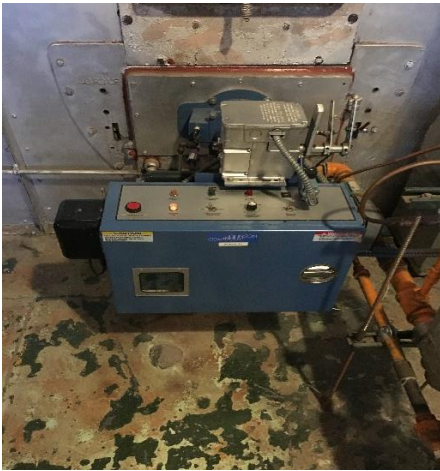
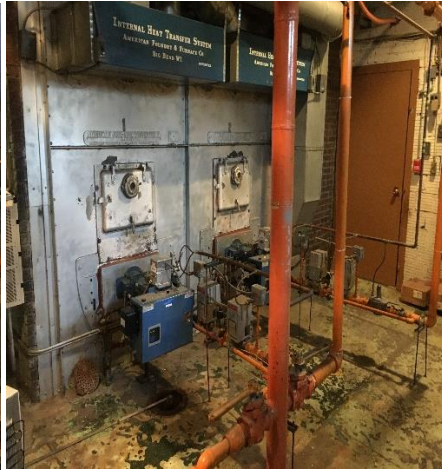
## Forced Air Furnace Burners

Burners are 18 years old.

Nearing the end of their estimated service life as per ASHRAE.

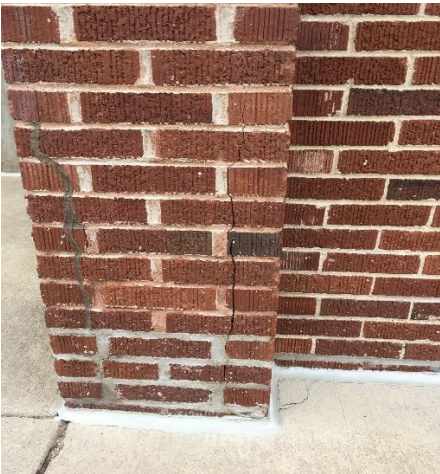
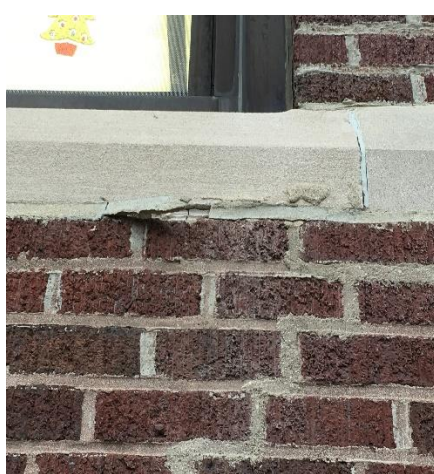
## Tuckpointing

Cracked and missing mortar joints and bricks will need to be repaired.

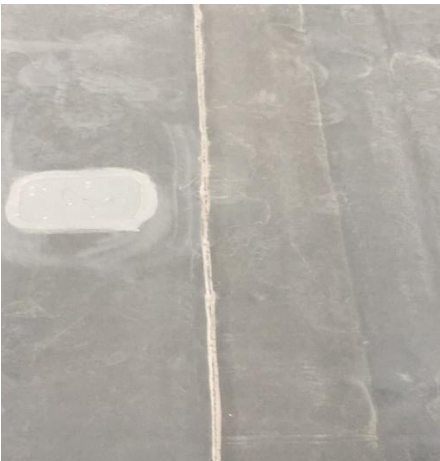
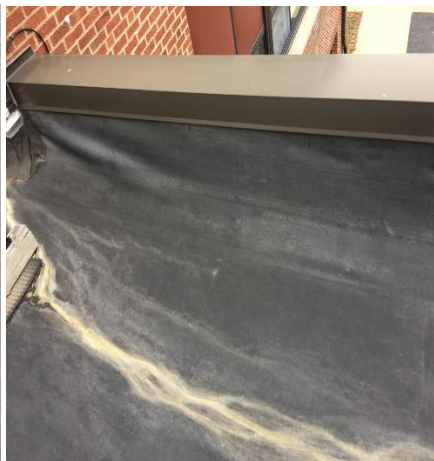
## Roof

The roof is 16 years old and many sections are in poor condition.

Roof replacement will be needed in the next two to four years.

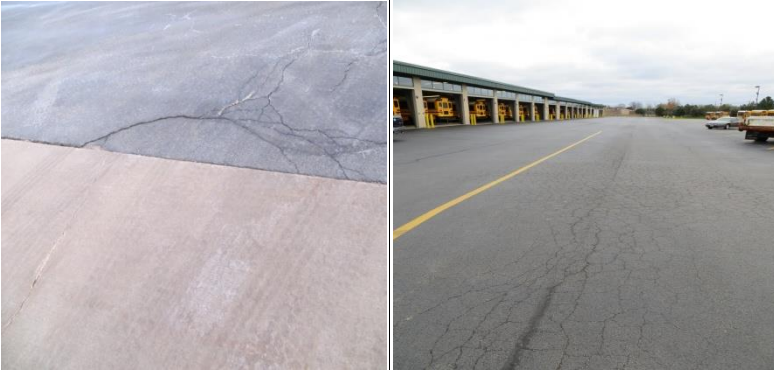
## Parking Lot

Pavement starting to crack and breakdown.

Resurfacing and drainage improvements will be needed in the next two years.

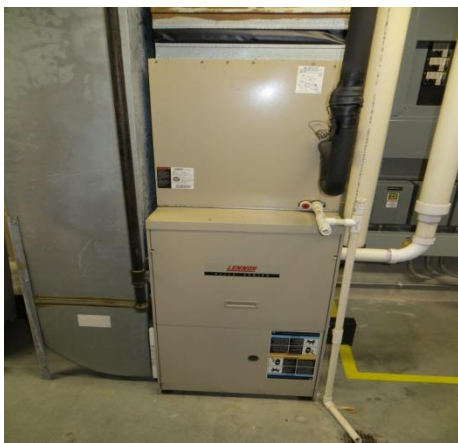
## HVAC Split System

The 3 Lennox split systems are nearing their ASHRAE recommended service life.

Replacement will be needed within the next seven years.

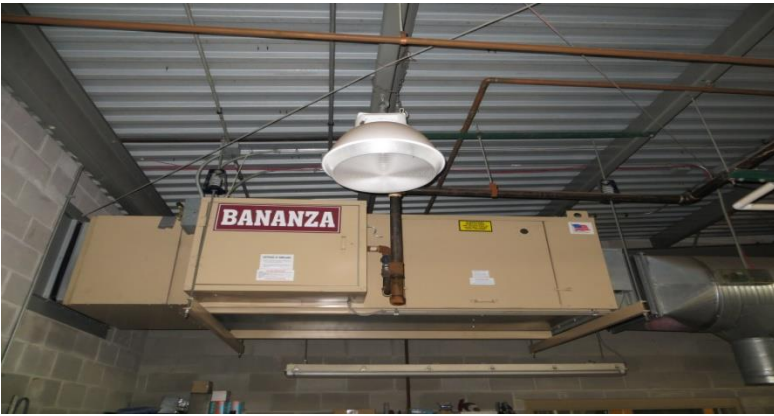
## Air Handling Unit

The three Bananza make-up air units are nearing their ASHRAE recommended service life.

Replacement will be needed within the next seven years.

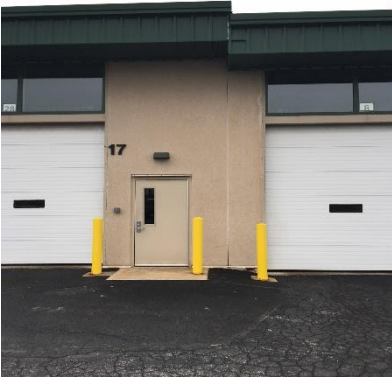
## Architectural Precast Wall Panel

The exterior architectural precast wall panel has cracked and will need to be replaced.

Replacement will be needed within the next two years.

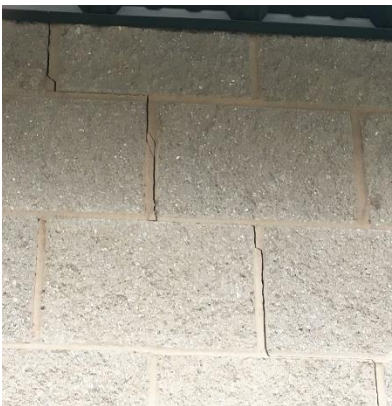
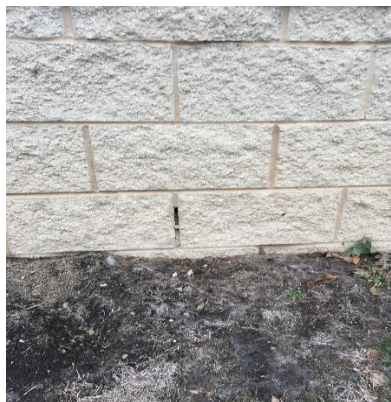
## Tuckpointing

Cracked and missing mortar joints will need to be repaired.
