TIKIGAQ

**POINT HOPE SCHOOL
MECHANICAL AND ELECTRICAL
BUILDING ASSESSMENT AND INVENTORY SURVEY REPORT**

August 19, 2024

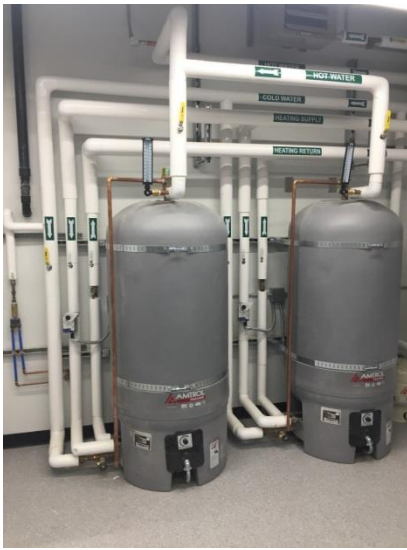
Photo M1 – Gym Addition Hot Water Generators

Domestic hot water is provided by hot water generators that are in good condition. Two hot water generators are located in the gym addition fan room, they serve the gym addition locker and toilet rooms. Three hot water generators are located in the mechanical room above the pool locker rooms. These hot water generators serve the kitchen, pool locker rooms, administration and high school wing of the school. The hot water generators were installed in 2015 and 2016 during the Phase II renovation/addition project. Two additional hot water generators will be installed during the Phase IV renovation. The hot water generators will be located in the Voc-ed mezzanine and the utility room serving the elementary wing toilet rooms.

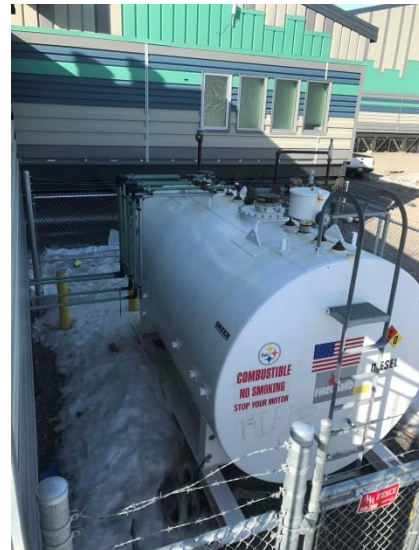
Photo M2 – School Fuel Tank

The fuel system for the building includes a double wall fuel tank and double wall day tank. Both day tanks are in good condition and were installed in 2015 during the Phase II renovation/addition project.

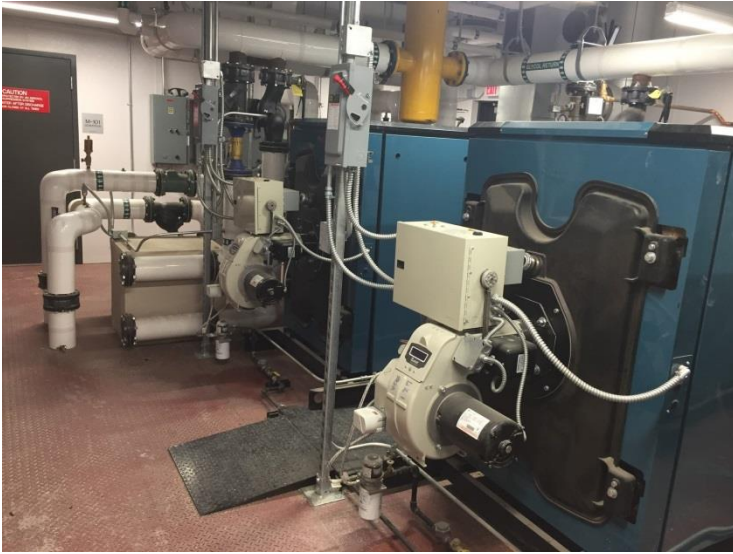
Photo M3 – Boiler System

The heating system consists of three fuel oil three pass cast iron sectional boilers. The boilers are Burnham MPC-13 boilers rated at 2,137,000 BTU/hr gross output each. The boilers are in good condition, the boilers were installed in 2015 during the Phase II renovation/addition project. The boilers are piped primary/secondary with one boiler circulation pump per boiler and two variable speed circulation pumps serving the building. The building circulation pumps operate in lead/lag configuration alternating to equalize run time. The piping in the building room consists of steel and copper piping.

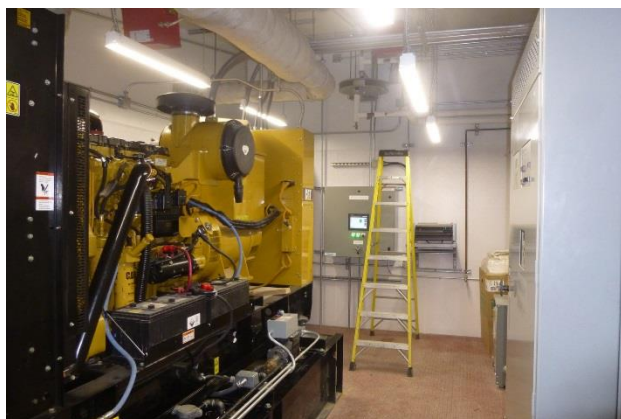
Photo E2– Generator

The emergency side of the ATS connects to a 250kW, 480V, 3-Phase standby diesel generator (*Photo E2*) which provides backup power to the entire school. This generator is a Caterpillar Model #C9 ATAAC, diesel-fired engine generator set located in the new Mechanical Building. The generator was relocated from the old Itinerant Housing building in 2015 and is in good condition. There is an automatic load shedding panel located in the same room as the generator that is programmed to drop the main

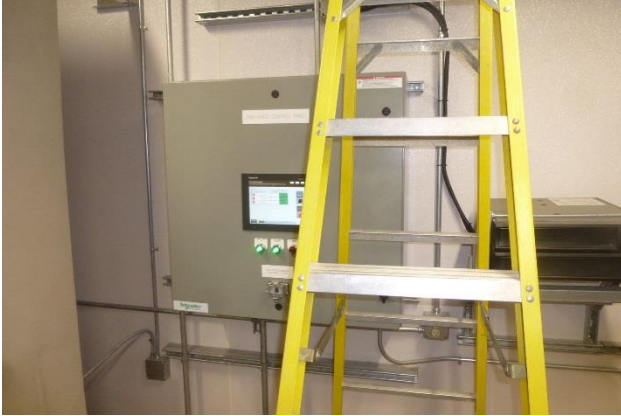
Photo E3 – Load Shed Control Panel'

contactors upstream of Voc-Ed Panels 'WS' and 'ES' as well as Kitchen Panels 'K1' and 'K2' to prevent overloading of the generator (*Photo E3*).

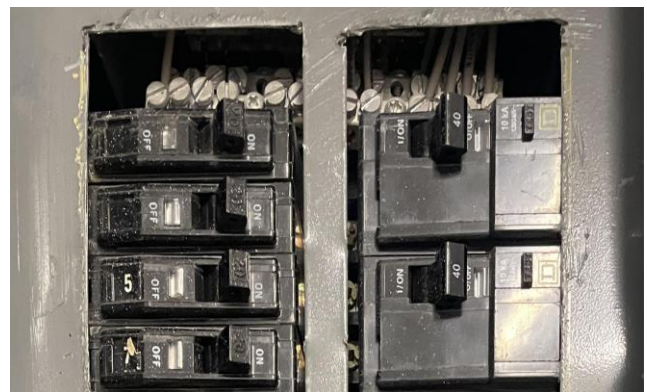
Photo E5a – Panel 'H'

Panel 'H' is in need of repair, see photo E5a.

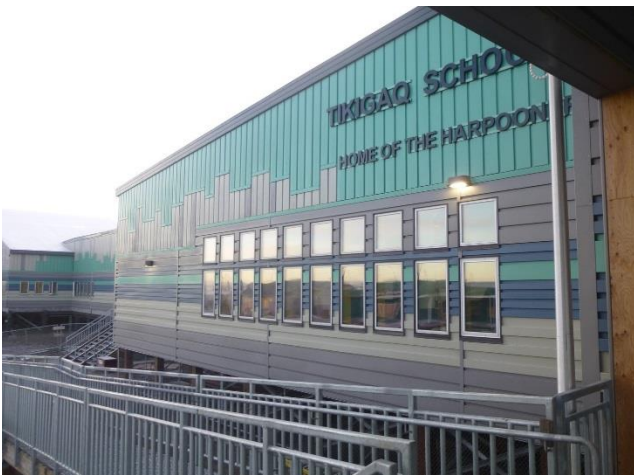
Photo E10 – Exterior Lighting

Exterior building-mounted lights are in poor condition and need to be replaced.
