FACILITIES PRIORITY REPORT

April 2024

Photo Report

Client: Molalla SD

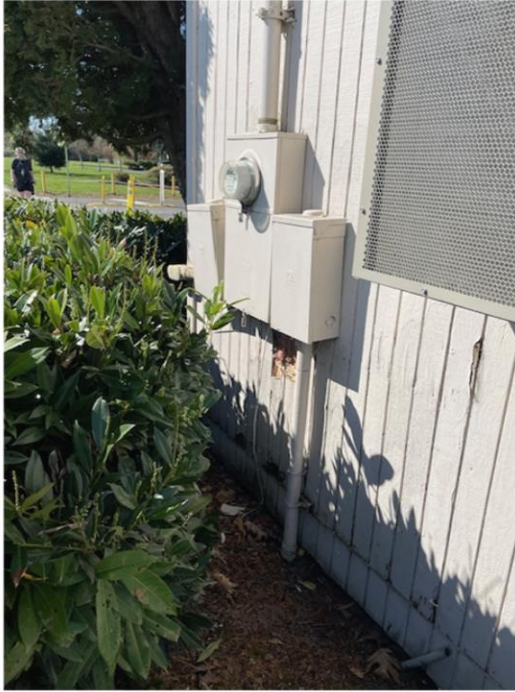
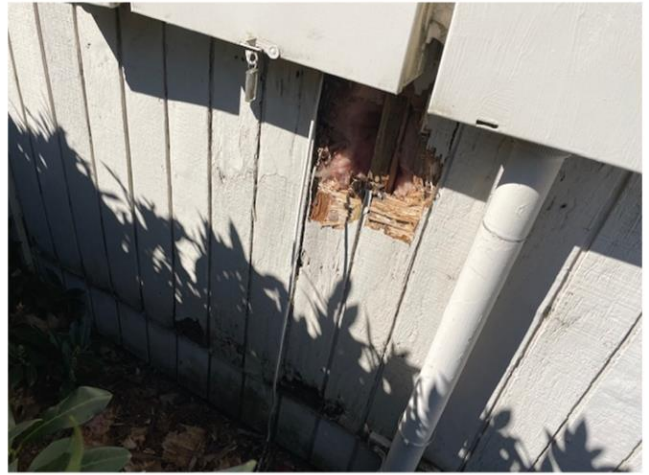
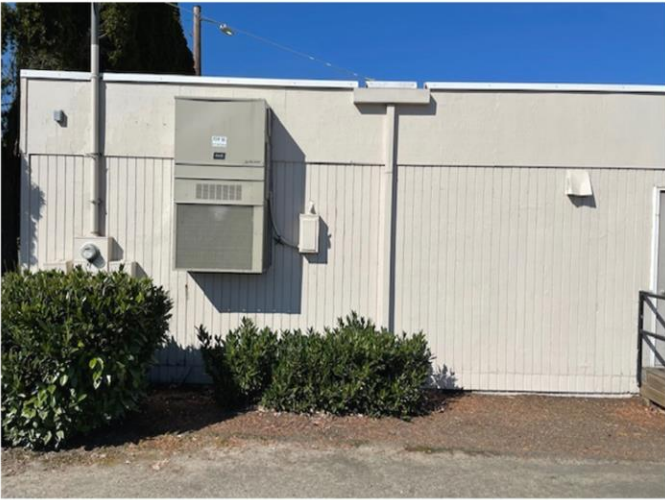
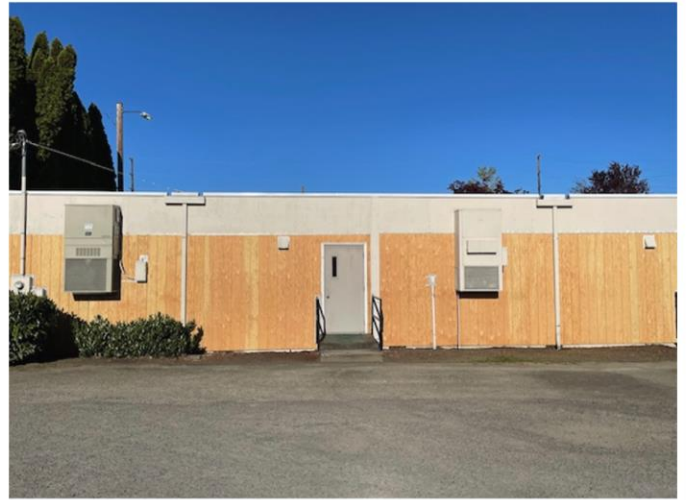
Mulino Siding

- Replaced siding on East side of modulars

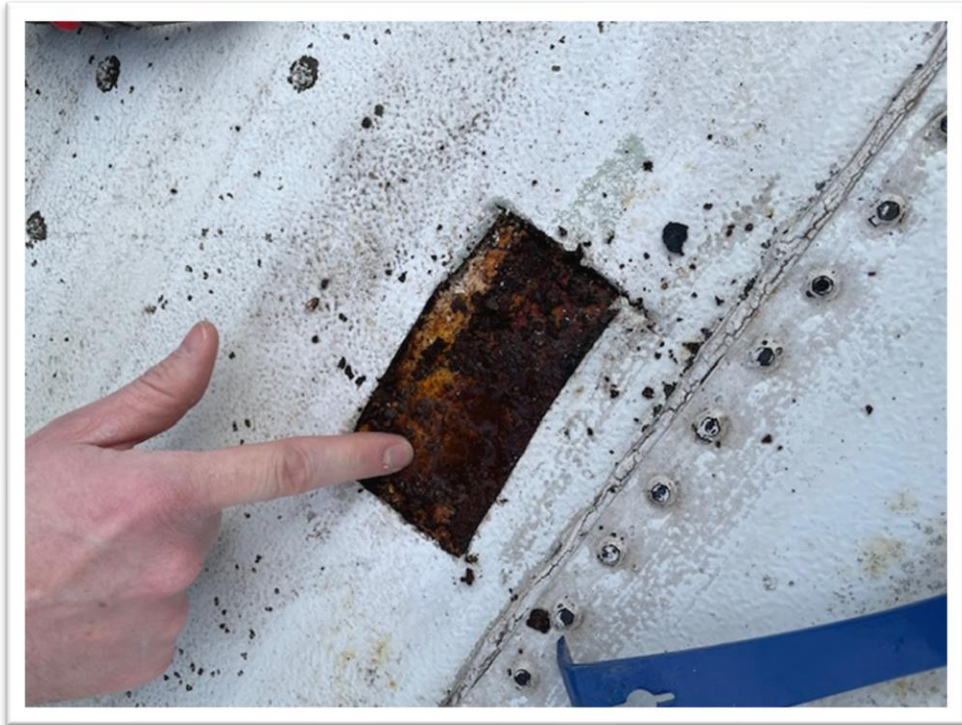
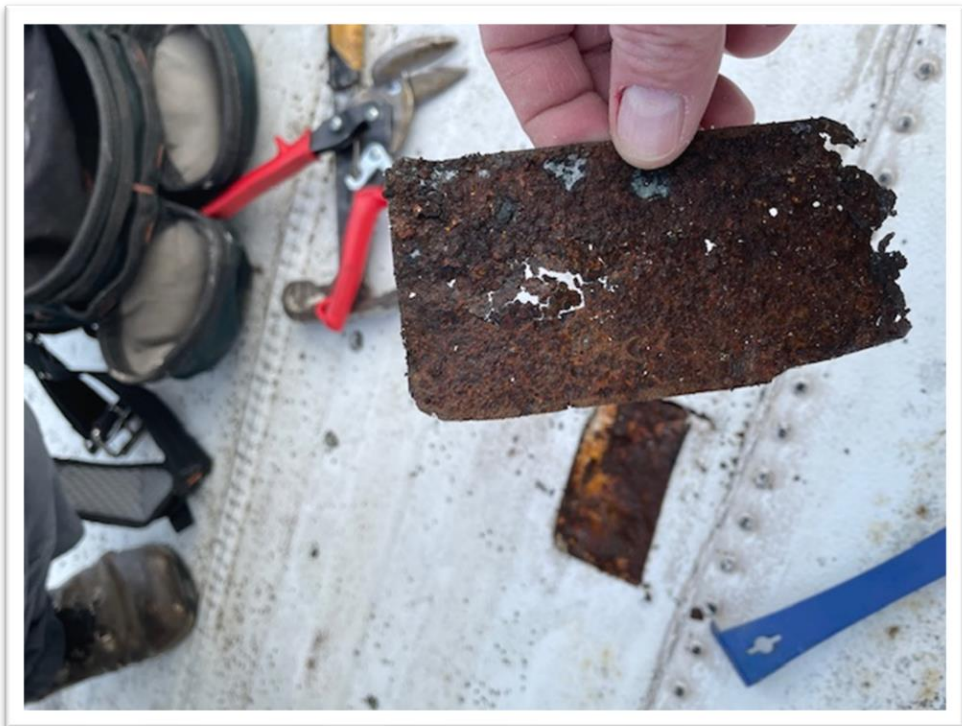
Deteriorating Metal Roof at MHS and MRMS

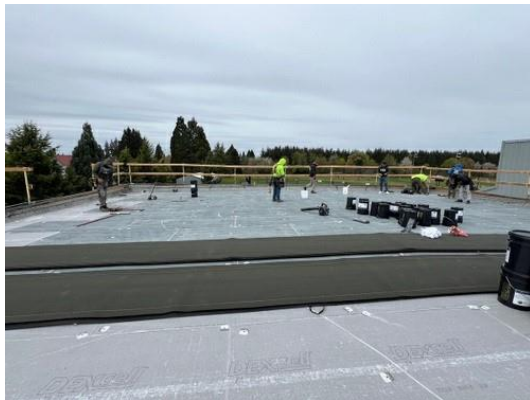
Photo 1

Field overview: metal plates and mechanical fasteners being utilized to adhere coverboard to existing roof in accordance with wind up-lift calculations.

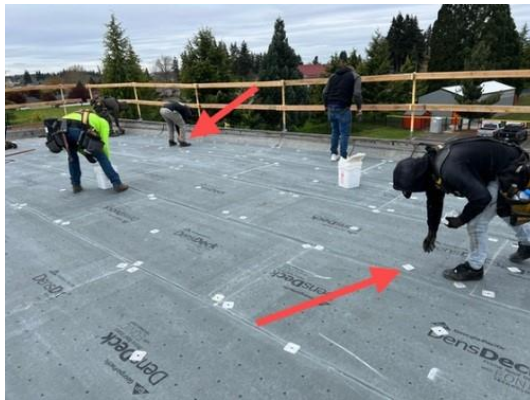
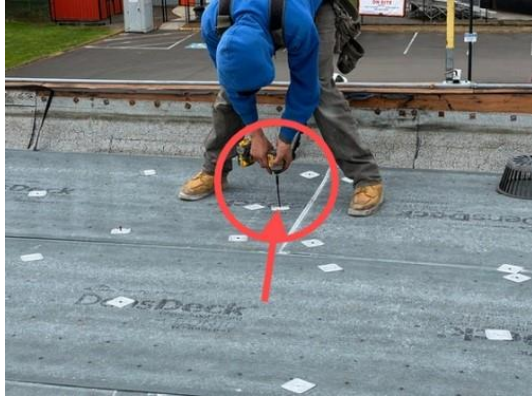
Photo 2

Coverboard being installed with mechanical fasteners in accordance with application guidelines and wind up-lift calculations. Subsequent photos attached below.

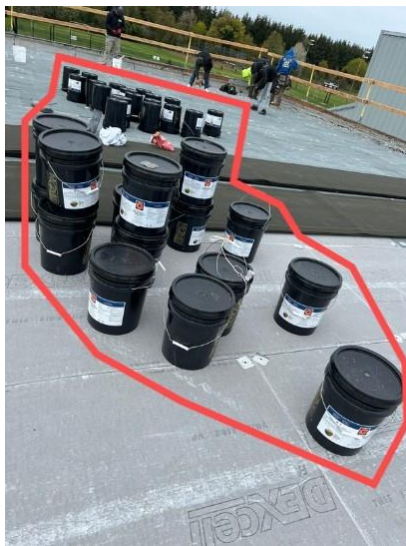
Photo 4

Materials are being staged in a neat and orderly fashion to maintain job-site cleanliness. Subsequent photo attached below.

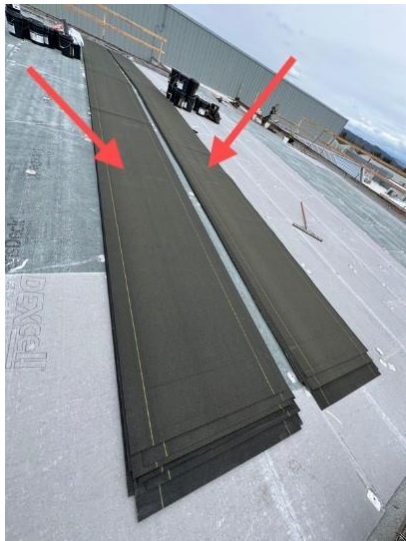
Photo 5

Continued.
Base sheets rolled out, allowing any wrinkles to relax prior to installation.

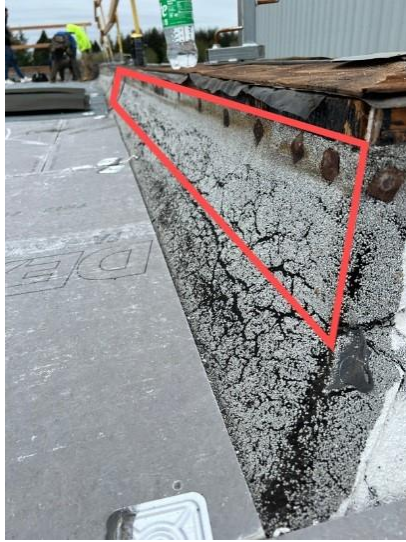
Photo 6

Existing base flashings to be removed prior to installation of new base flashings.

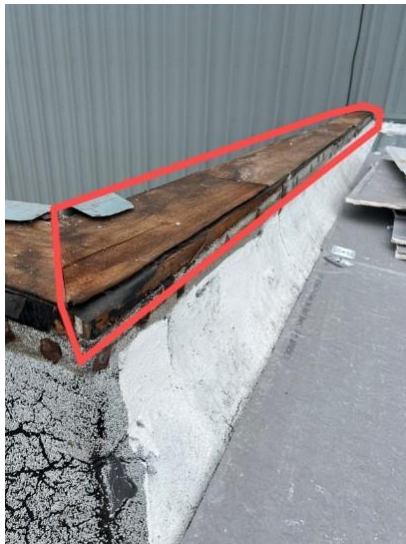
Photo 7

Coping cap has been removed and will be reinstalled upon completion.

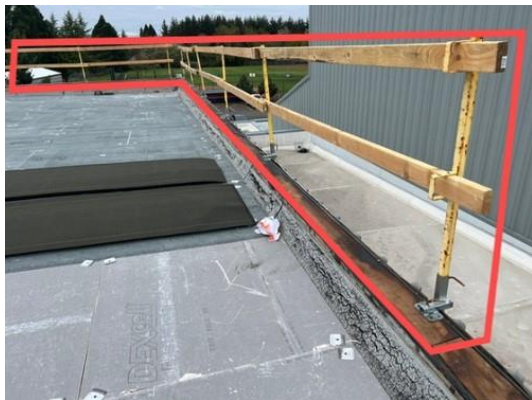
Photo 8

Safety railing has been installed around perimeter in accordance with safety practices and expectations coordinated at the pre-construction meeting.

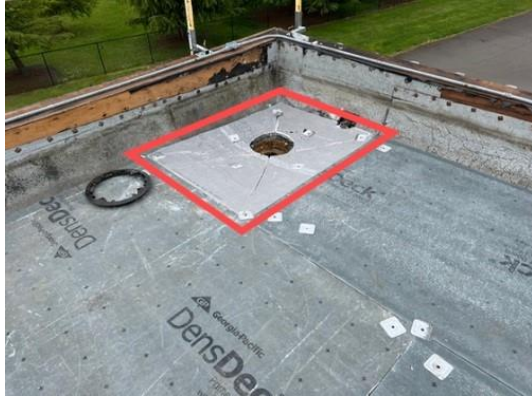
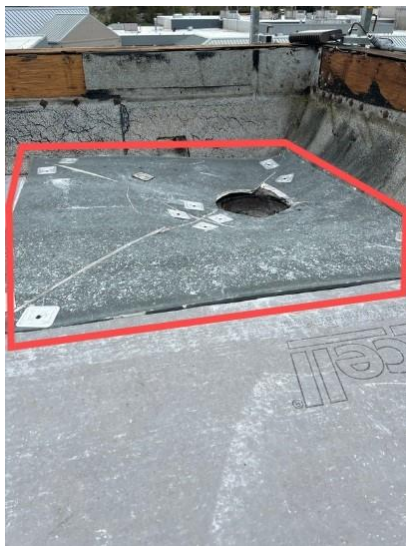
Photo 9

Overview of drain sump with installed coverboard, prior to installation of base sheet.

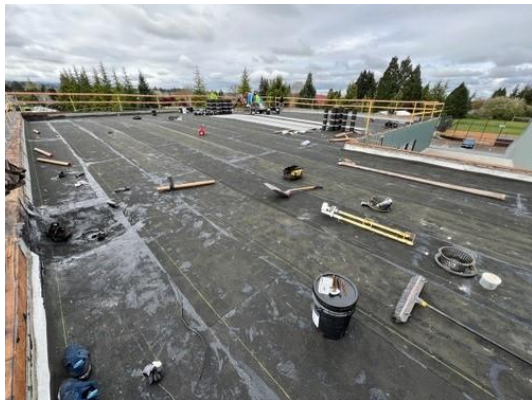
Photo 1

Field overview: base sheet fully installed; awaiting cap sheet installation.

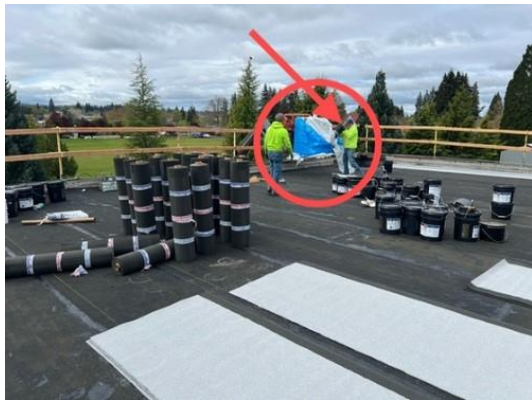
Photo 2

Materials loaded to the roof utilizing reach fork and by hand in accordance with the instructions and expectations coordinated at the pre-construction meeting.

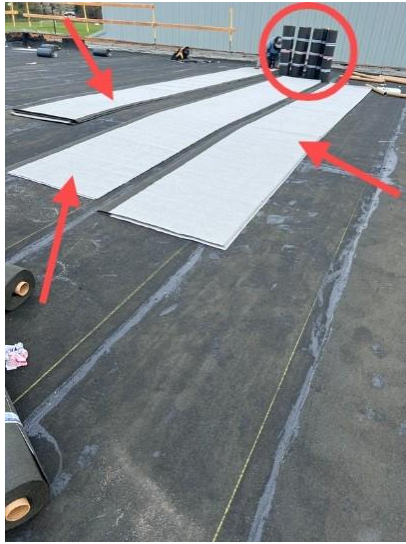
Photo 3

Cap sheet rolled out, allowing any wrinkles to relax prior to installation.

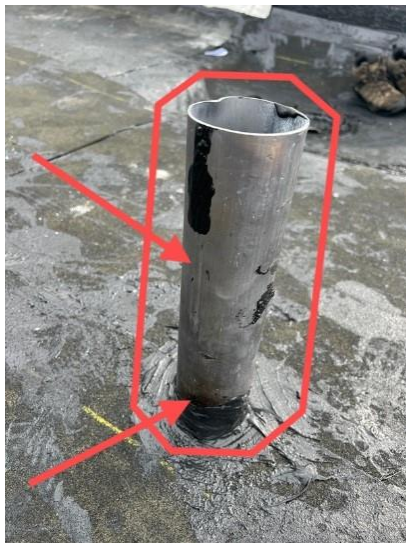
Photo 4

Pipe penetration flashed with primed lead flashing prior to the application of the multi-ply reinforcement detail per Garland standard.

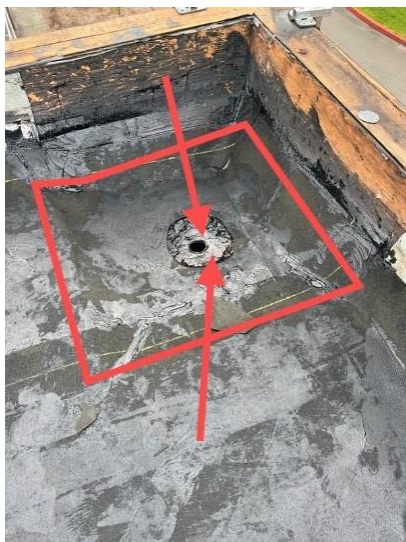
Photo 5

Drain with primed lead pan installed in accordance with Garland details and application guidelines.

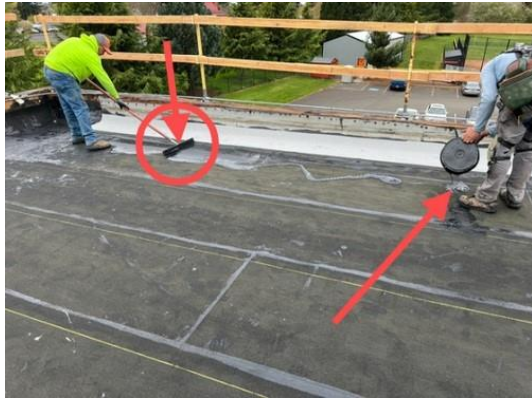
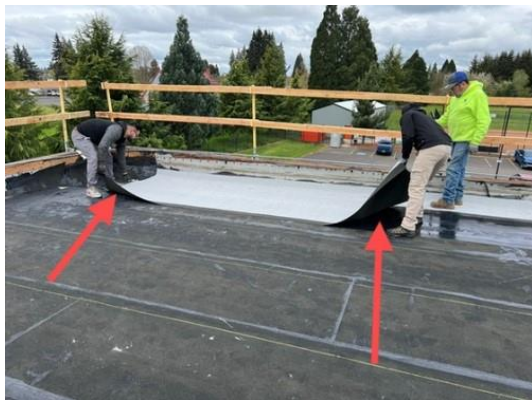
Photo 6

StressPly Plus FR Mineral being installed with 3/8" notched squeegee utilizing Greenlock Plus membrane adhesive at 2-2.5 gal./100 sq. ft. (0.82- 1.02 L/m²) as listed in the specification and application guidelines. Subsequent photo attached below.

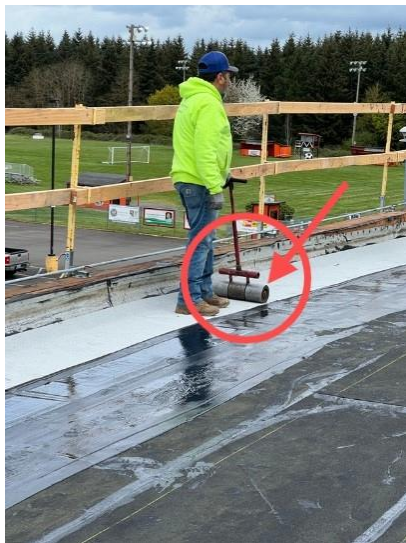
Photo 8

Weighted roller utilized to ensure proper adhesion is achieved.
