NORTH STAR
CONTRACTING

Inspection Report

Menahga Public School
Menahga Public School - 216 Aspen Ave S
216 Aspen Ave S
Menahga, MN 56464

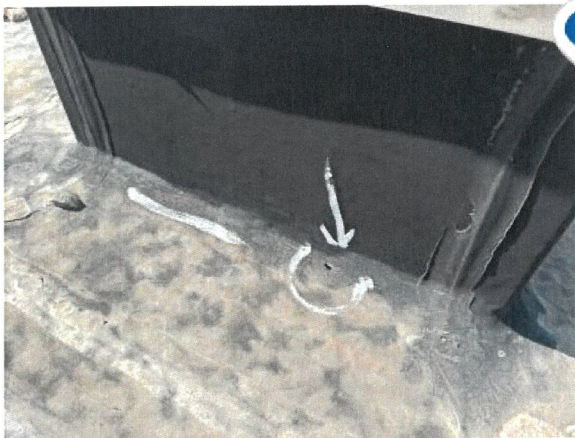
Curb - Exhaust fan curb (Emergency)

Need to reflash in existing curb due to damaged membrane flashing.

Flash in curb with appropriate materials per manufacturer's installation recommendation's.

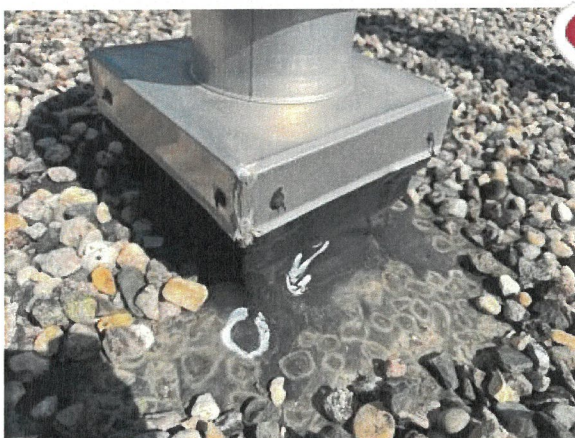
Curb - Exhaust fan curb (Emergency)

Need to reflash in existing curb due to damaged membrane flashing.

Flash in curb with appropriate materials per manufacturer's installation recommendation's.

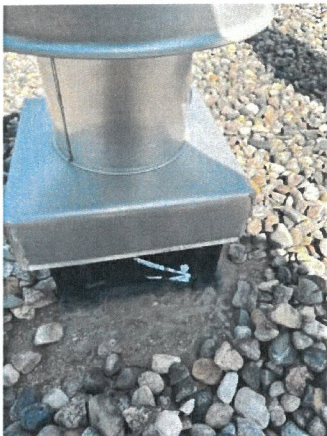
3

Base Flashing Lap (Emergency)

Open lap in base flashing.

We will clean and prime lap then install new patch to ensure water tightness.

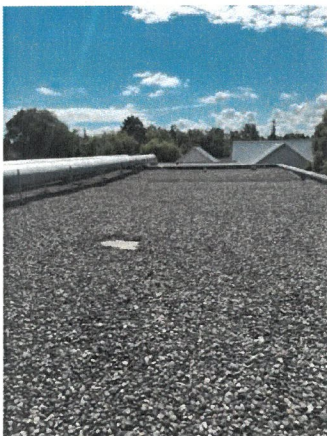
4

Leak Location (Emergency)

Confirmed or potential leak location needs to be investigated.

Repair roof area using compatible roofing materials for the type of existing roof where the leak is located and according to minimum industry standards.

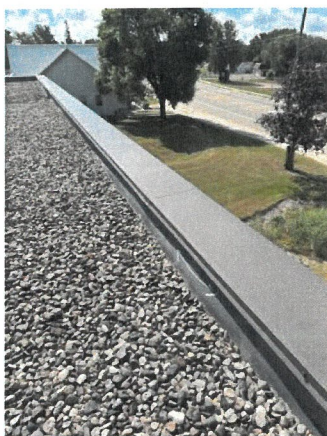
5

Membrane - Bridging

Membrane has come loose and is bridging at an angle change in the roof system.

Cut membrane at angle change. Secure roof membrane to deck or wall. Reflash wall or curb flashing.

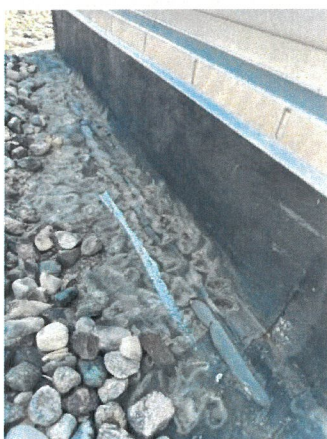
6

Curb - Roof Hatch curb (Emergency)

Need to reflash in existing curb due to damaged membrane flashing.

Flash in curb with appropriate materials per manufacturer's installation recommendation's.

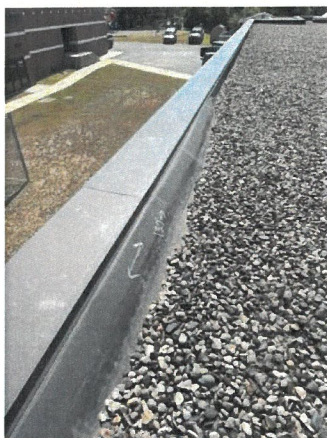
Membrane - Bridging

Membrane has come loose and is bridging at an angle change in the roof system.

Cut membrane at angle change. Secure roof membrane to deck or wall. Reflash wall or curb flashing.

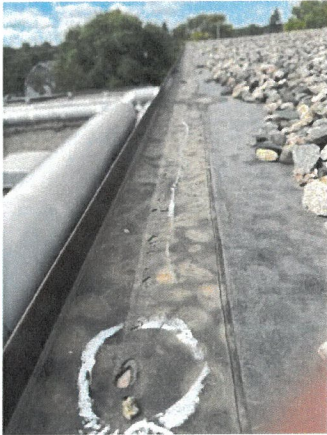
1

Perimeter - Metal Edge - Strip In (Emergency)

Roof membrane has separated from metal edge. If the metal edge strip in is failing it can allow water to infiltrate and damage the roof system, deck and building interior.

Remove the loose membrane, secure metal edge joint, clean and prime metal and install new material that extends 3-12" onto roof to ensure water tightness.

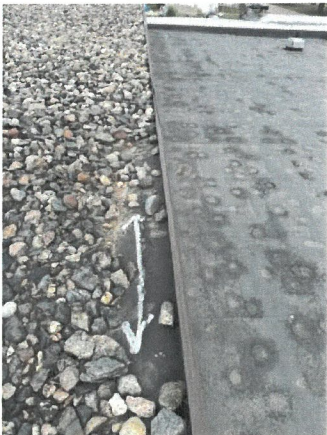
2

Perimeter - Metal Edge - Strip In (Emergency)

Roof membrane has separated from metal edge. If the metal edge strip in is failing it can allow water to infiltrate and damage the roof system, deck and building interior.

Remove the loose membrane, secure metal edge joint, clean and prime metal and install new material that extends 3-12" onto roof to ensure water tightness.

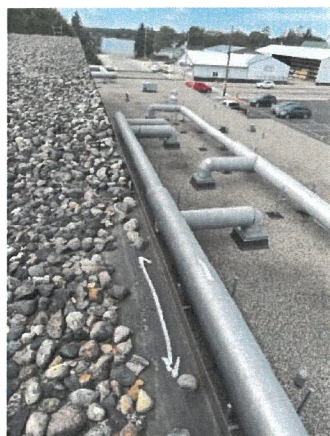
Perimeter - Metal Edge - Strip In (Emergency)

Roof membrane has separated from metal edge. If the metal edge strip in is failing it can allow water to infiltrate and damage the roof system, deck and building interior.

Remove the loose membrane, secure metal edge joint, clean and prime metal and install new material that extends 3-12" onto roof to ensure water tightness.

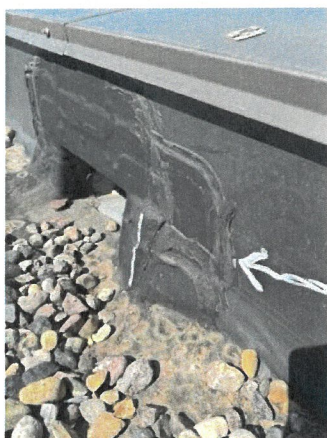
Drainage - Drains/Scupper Open Membrane (Emergency)

Open membrane laps at scupper / drain is open.

We will clean prime and seal open laps to ensure water tightness.
