NORTH SLOPE

**ANAKTUVUK PASS
AREAWIDE MECHANICAL AND ELECTRICAL
BUILDING ASSESSMENT AND INVENTORY SURVEY REPORT**

August 19, 2024

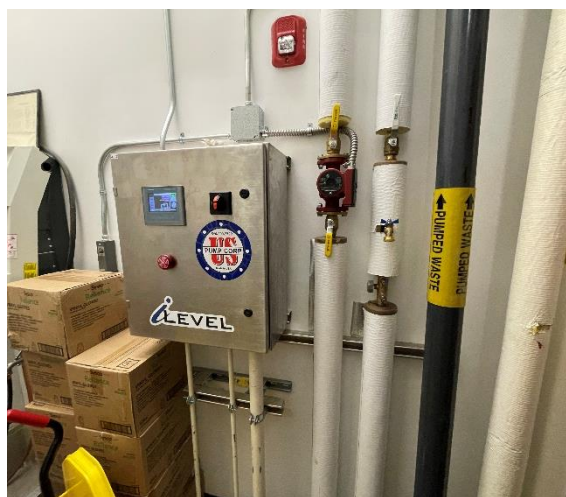
Photo M1 – Lift Station Panel

The sanitary sewer issues previously noted have been resolved. The sanitary sewer system was demolished and re-built in 2022 and is in good condition. The building is gravity drainage to four lift stations. The lift stations are where recently installed and are in good condition. The waste piping was also replaced in 2022 and is in good condition.

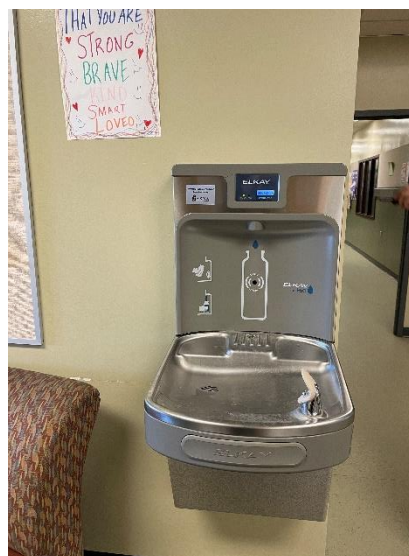
Photo M2 –Drinking Fountain

The drinking fountains in the school were recently replaced with combination drinking fountains / water bottle fillers and are in good condition.

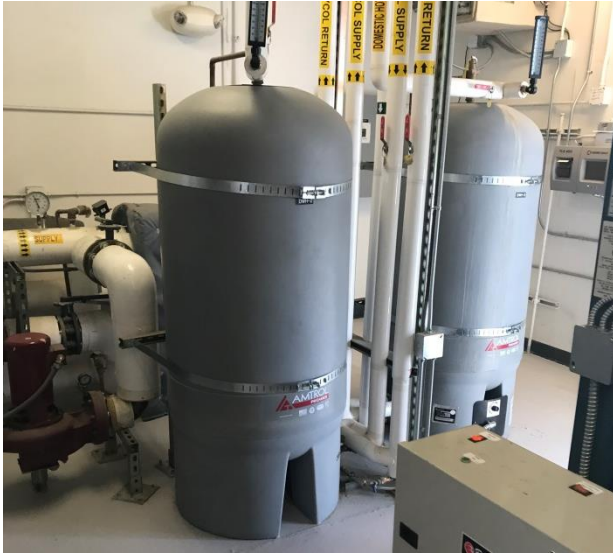
Photo M3 – School Hot Water Generators

Domestic hot water is provided by three hot water generators that are in good condition. They were installed during the renovation in 2012.

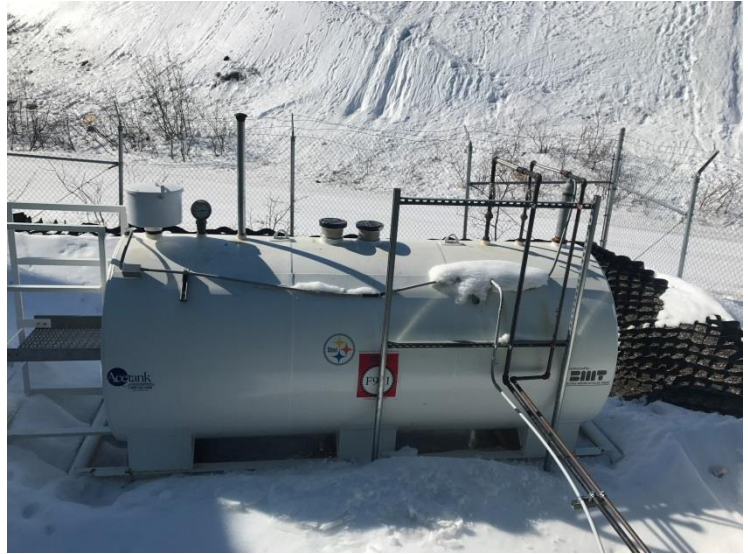
Photo M4 – Fuel Tank

The fuel oil tank, day tank and piping are in good condition, the fuel system was installed during the 2012 renovation.

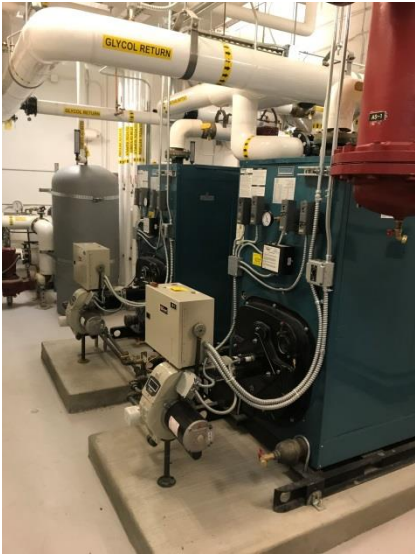
Photo M5 – Boilers

The heating system consists of two fuel oil cast iron sectional boilers. The boilers are rated at 1,100,000 BTU/hr gross output each. The boilers were installed in the 2012 renovation project. The boilers are in good condition. The boilers are piped in a primary/secondary with a circulation pump per boiler and seven pumps serving the building. The building heating pumps CP-5A/5B and CP-3A/3B have variable frequency drives; the rest of the pumps are constant volume. CP-3A/3b, CP-4A/4B and CP-5A/B operate in a lead/lag configuration. The pumps powered by VFDs will not automatically start after a power outage or when switching back to normal power after being on the generator. CP-3A/B and CP-5A/B are critical to the schools heating system and must be manually restarted. There were signs of leaks at the pump seals in multiple locations. The piping in the boiler room consists of steel and copper piping. The piping outside of the boiler room is nearing the end of its useful life expectancy. The piping in the fan rooms was in poor condition.

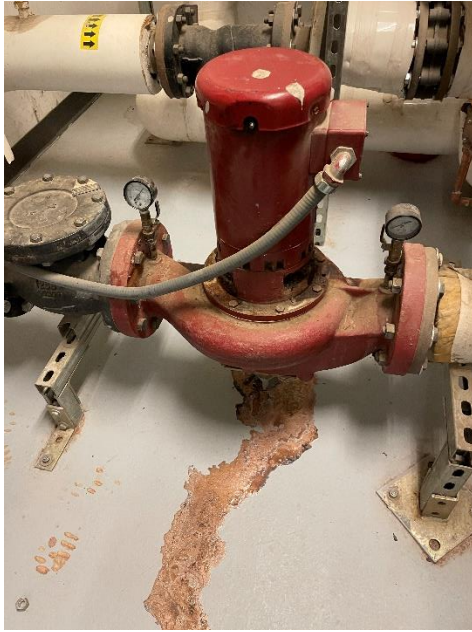
Photo M7 – Heat Recovery Pump

The boiler system is supplemented by a waste heat recovery heat exchanger and a 250-gpm heat recovery injection pump. The heat recovery pump seals have leaked, the pump is in poor condition and near the end of its useful life expectancy. There is older heat recovery piping that is unused and abandoned in place, the old piping should be demolished. The heat recovery piping through floor penetrations are not sleeved and sealed. The piping through floor penetrations should be sleeved and sealed.

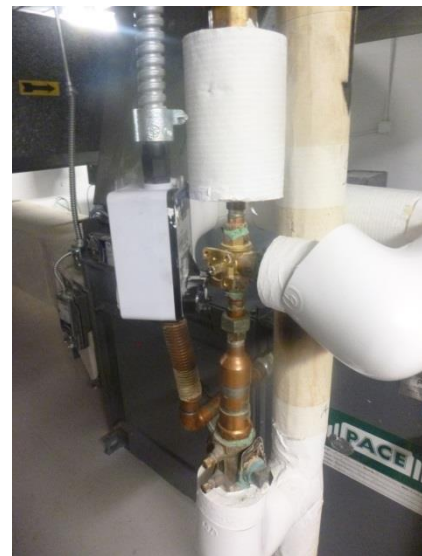
Photo M14 – AHU-1 Disconnected Control Actuator

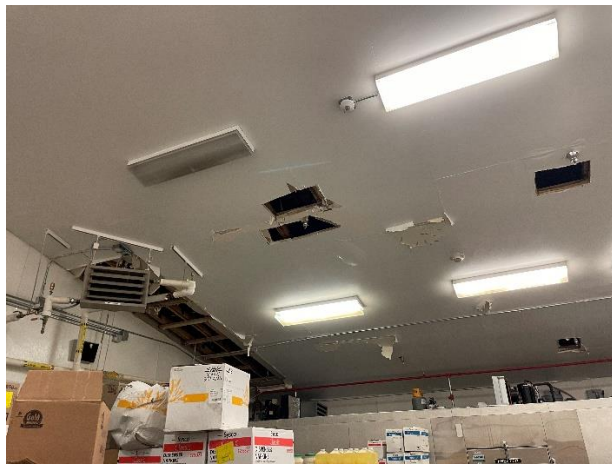
The kitchen storage area (rm 141) had numerous openings in the ceiling that assumed to have been caused by a leaking sprinkler system.

Photo M15 – Kitchen Storage Ceiling Leak Damage

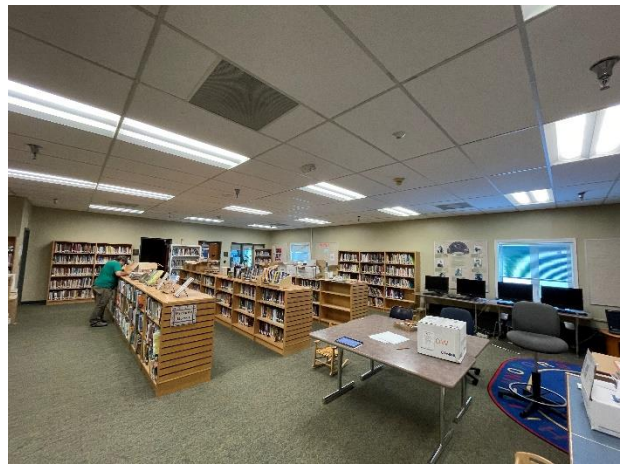
Photo M16 – Typical Sprinkler Heads

The fire protection system is a wet sprinkler system and is supplied from the city water utility. The system is in fair condition. No issues were reported with the system. The sprinkler heads are not quick response required by IBC for use in school occupancies. The sprinkler heads should be replaced with quick response heads. The cold storage room adjacent is protected by a glycol sprinkler system. Glycol sprinkler systems with the concentration required for freeze protection in Northern Alaska are no longer allowed by NFPA 13. The sprinkler system should be replaced with a dry pipe sprinkler system.

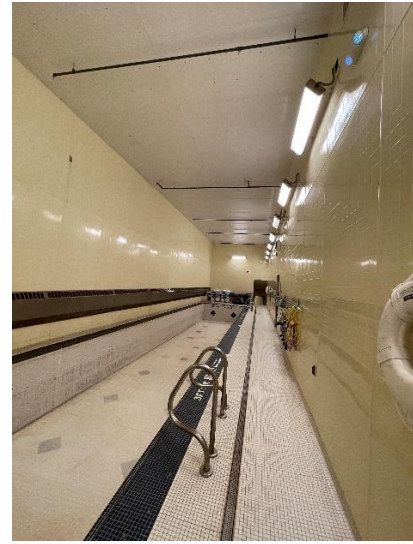
Photo M20 – Pool

The pool was drained and out of commission during our site visit. Work was in progress to repair the pool equipment.

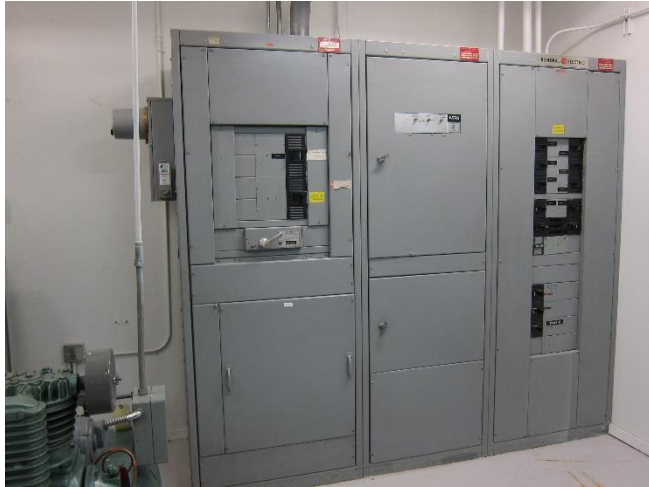
Photo E1 – Service Entrance Switchgear

The school electrical power service is supplied by the utility from a pole-mounted transformer located on the North side of the school. The service is fed from above the ceiling to a meter mounted to the side of the main switchgear. The interior switchgear houses the CT enclosure, an 800A, 208V, 3p disconnect, located in main electrical room (*Photo E1*). The main feeder was then routed into a 400A, 208V, 4p Automatic Transfer Switch next to the service entrance switchgear. The transfer switch serves a 400A, 120/208V, 3φ, 4W switchboard 'MDP' located next to it and is fed from a 175kW generator. The service switchgear and 'MDP' are General Electric AV-Line switchboard. The distribution section serves all of the normal power panelboards located throughout the facility and has little to no spare capacity for additional loads.

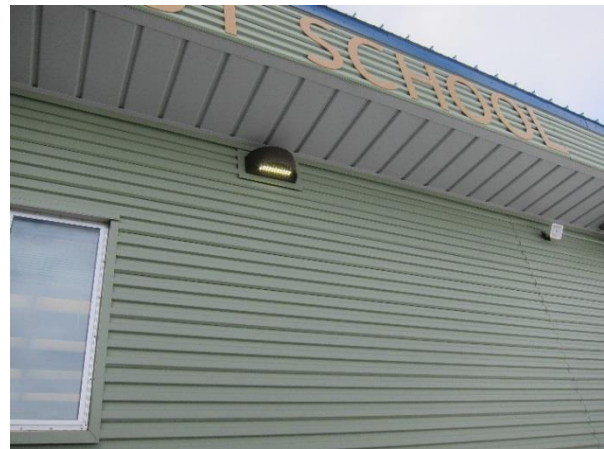
Photo E5 – Exterior Lights

The exterior fixtures are in good condition, because they were update to LEDs in 2009 (*Photo E5*). The exterior lighting controls do not turn the light fixtures off. This is probably due to a non-functioning or bypassed photocell. Lighting control panel when used manually turns lights off.

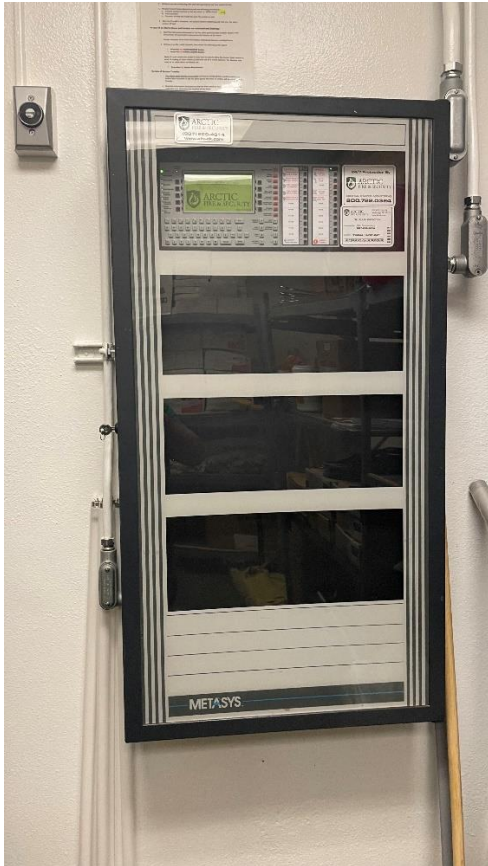
Photo E8a – Notifier FACP

Arctic Fire and Safety has recently updated the FACP with a new Notifier system, in the existing Metasys enclosure, along with annunciation devices. Original smoke detectors remain which are compatible with the new system controller. The new FACP is ready to be upgraded to the new code required voice evacuation system. New system is using the old Metasys enclosure. (Photo E8a).

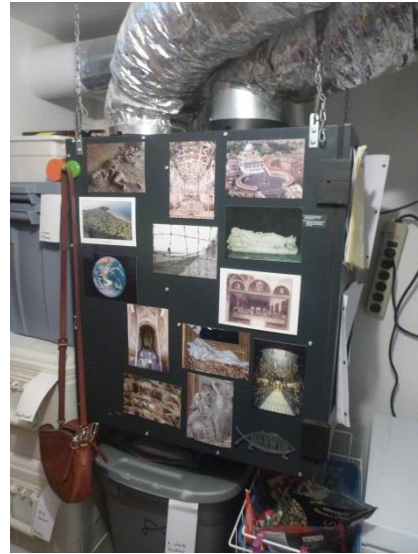
Photo M2 – Heat Recovery Ventilator Unit C

Ventilation is provided by three HRVs, one Venmar HRV is installed to serve each unit. The HRVs do not have preheat coils and have limited capacity for operation in the winter. The HRVs were not operating when we were on-site.

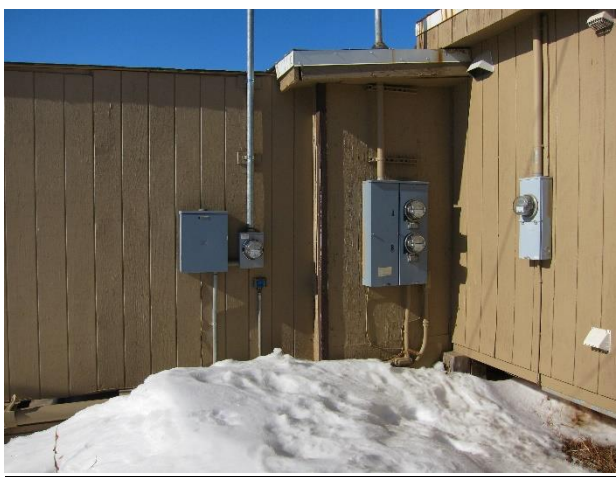
Photo E2 – Electrical Service Entrance

200A,240V,1ph service for the building and a separate weatherhead and 100A,240V,1ph service for the standard NSB sewer heat trace service (*Photo E2*).

All of the electrical distribution equipment appeared to be in good shape however no arc fault protection was provided. Replace the Cutler Hammer panel with a Square D panel in order to be consistent and parts can be interchanged between panels.

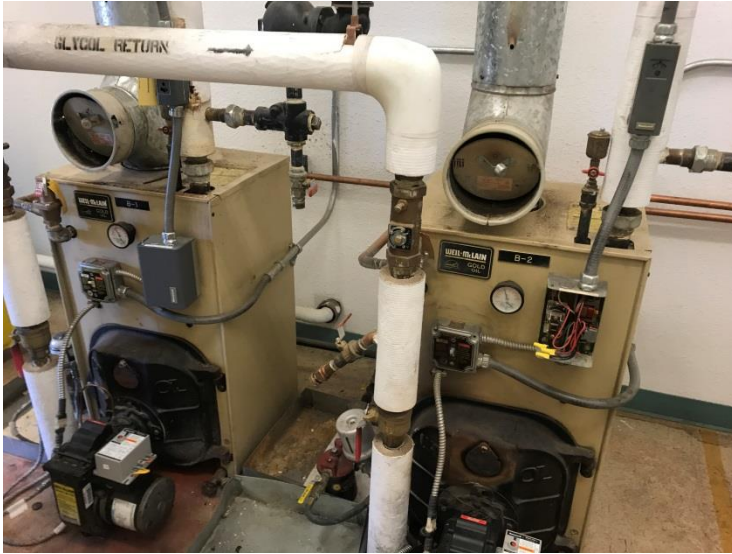
Photo M1 – Boilers

The heating system consists of two fuel oil cast iron sectional boilers. The boilers are rated at 126,000 BTU/hr gross output each. The boilers are in fair condition, the boilers are near the end of their useful life expectancy. The boilers are piped with two circulation pumps intended to operate lead/lag to circulate glycol to the building. The buildings circulate glycol to fintube in each of the units with zone control valve's location in the boiler room. The piping in the boiler room consists of insulated copper piping. There were visible signs of leaks on the piping, the valves and piping are at the end of their useful life expectancy.

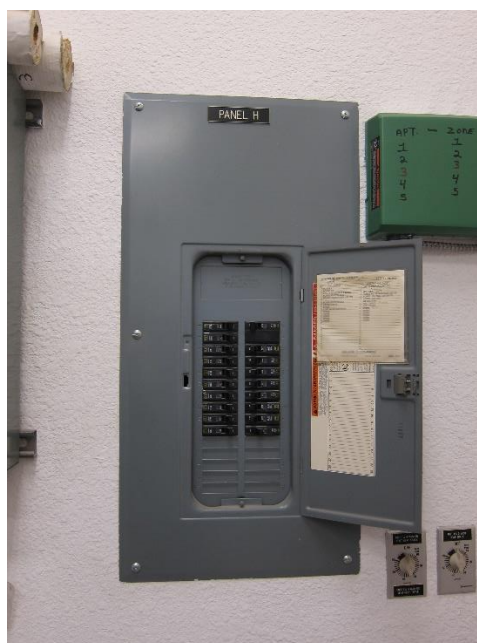
Photo E2 – Typical Panel

The boiler room panel is Square D 60A, 240V, 1ph, panel. The typical unit #1-#5 loadcenters were 60A,240V,1ph, Square D. (*Photo E2*) All of the electrical distribution equipment appeared to be original to the building and is past its useful life. No arc fault protection is provided.

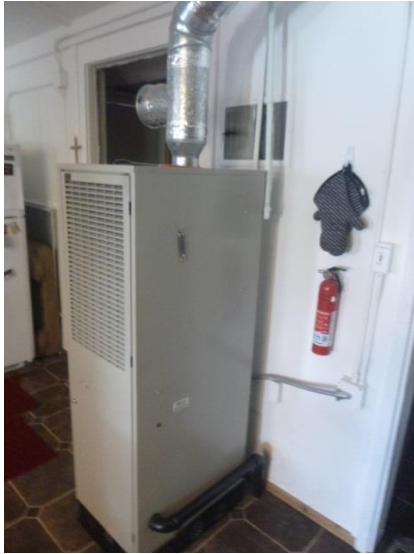
Photo M1 – Furnace

The heating system consists of one fuel oil furnace located in the living room. The furnace is rated at 60,000 BTU/hr gross output. The furnace is in good condition, the furnace reported to have been installed in 2014. The furnace is not located in a 1-hr rated room.

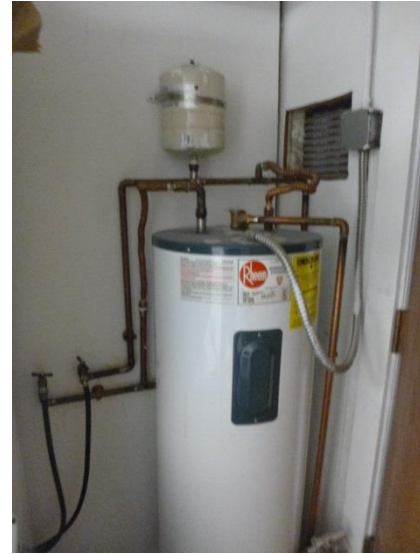
Photo M2 – Electric Water Heater

Domestic hot water is provided by an electric water heater. The electric water heater was in good condition and had been replaced recently.

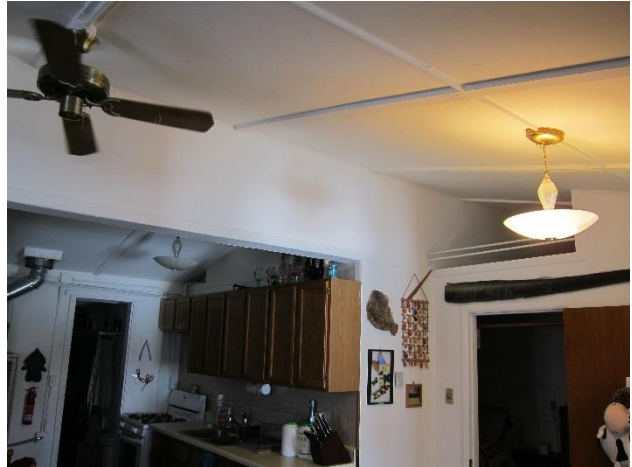
Photo E2 – Interior Lighting

The lighting throughout the facility consists primarily of incandescent fixtures with Compact Fluorescent Lamp (CFL) screw-in replacement lamps and T8 fluorescent type in the bedroom. *(Photo E2)*. Most of the light fixtures are original to the building and in below average to poor shape. The lighting is switched with local 15A,120V line voltage switches. The bathroom light is hanging by exposed wires and should be replaced as soon as possible.

The bathroom light has been repaired.

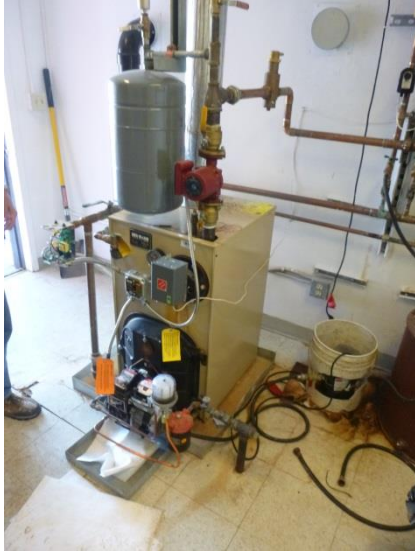
Photo M1 – Boiler

The heating system consists of one fuel oil cast iron sectional boiler. The boiler is rated at 184,000 BTU/hr gross output. The boiler is in good condition, the boiler was installed in 2013. The boiler has a single circulation pump that circulates hot glycol to fintube in each unit of the building. The zone control valves are located in the boiler room. The piping in the boiler room consists of uninsulated copper piping. There were visible signs of leaks on the piping, some of the piping was replaced in 2013 with the new boiler. The room was very warm, the combustion air system does not comply with code.

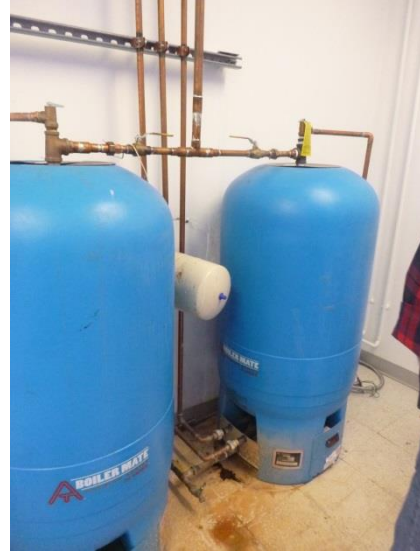
Photo M2 – Hot Water Generators

Domestic hot water is provided by two hot water generators. The hot water generators are located in the boiler room. One HWG is in fair condition, the second HWG was off and appeared to be leaking. The hot water generator is at the end of its useful life expectancy.

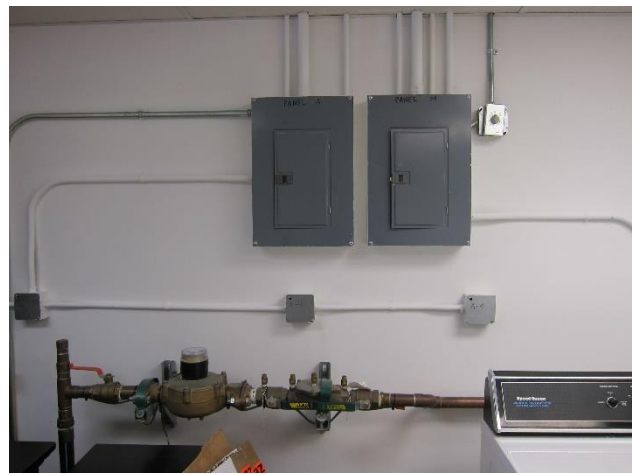
Photo E2 – Typical Panel

The typical loadcenters were 60A,240V,1ph, Square D. (*Photo E2*) All of the electrical distribution equipment appeared to be original to the building and is past its useful life. Panel A and M had working clearance code violations with the washer and the water main. No arc fault protection is provided throughout the building.
