Geneva Community Unit School District #304
Operations and Maintenance
5 and 7 Year Capital Improvement Plans

Finance Committee Meeting
March 10th 2014

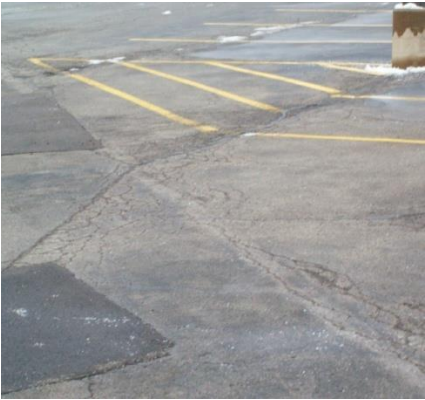
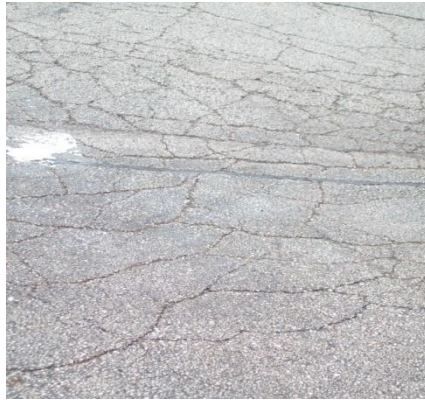
Center Street Parking Lot

Cracks and patches throughout lot.

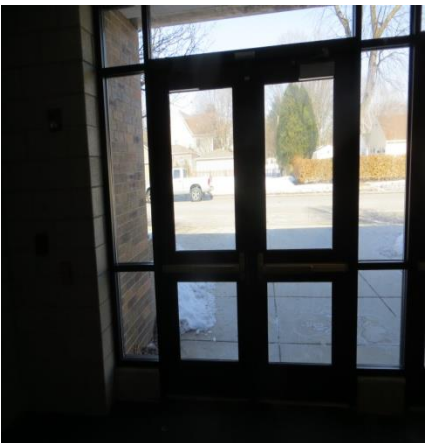
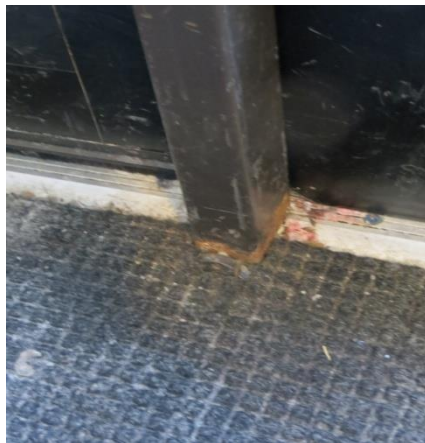
Center Street Doors

Frames starting to rust through.

Replace with heavy duty exterior doors.

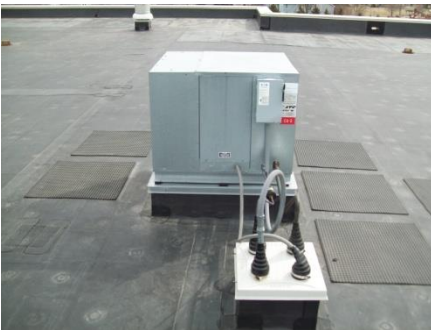
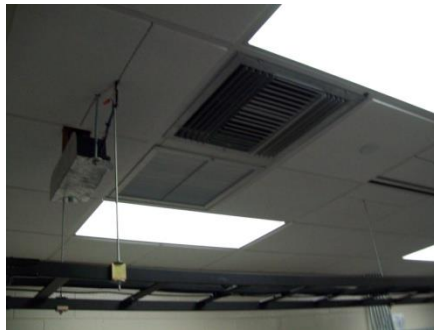
IT Server A/C

Oversized for heat load of space.

Cycles on and off continually causing condensation issues and premature equipment failure.

Replace with properly sized unit.

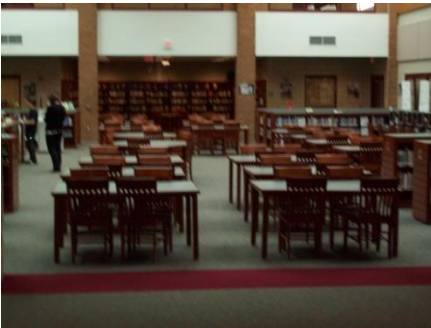
LMC

AHU is undersized for space.

Only 2 VAV boxes serving the space.

Recommend increasing the capacity of the AHU and adding 4-6 VAV boxes with controls to increase comfort and control humidity.

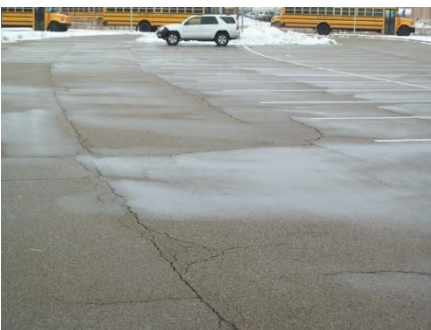
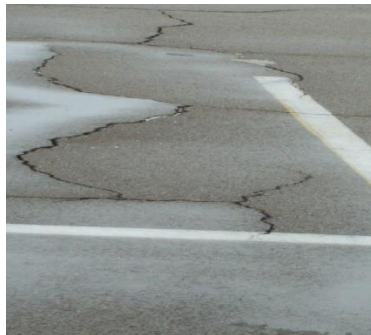
Parking Lot

Multiple deep cracks.

Crack filling and seal coating will extend the life of the parking lot.

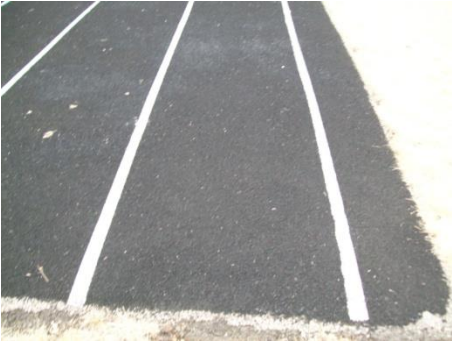
Track – installed in 2005

Track resurfacing is normally required every 8-10 years.

Excessive wear spots are apparent.

Resurfacing will be needed this year.

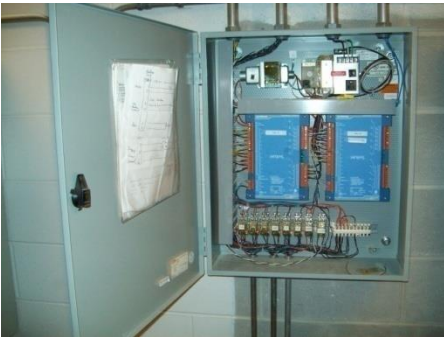
Lon Controller

Lon controls throughout the building.

Outdated and costly to repair.

Replace Lon to Bacnet.

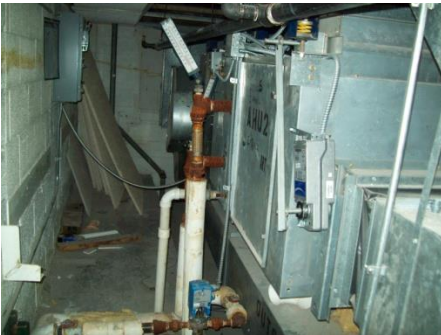
Air Handling Unit

Needs rebuilding or possible replacement.

New motor, shaft, bearings and controls needed.

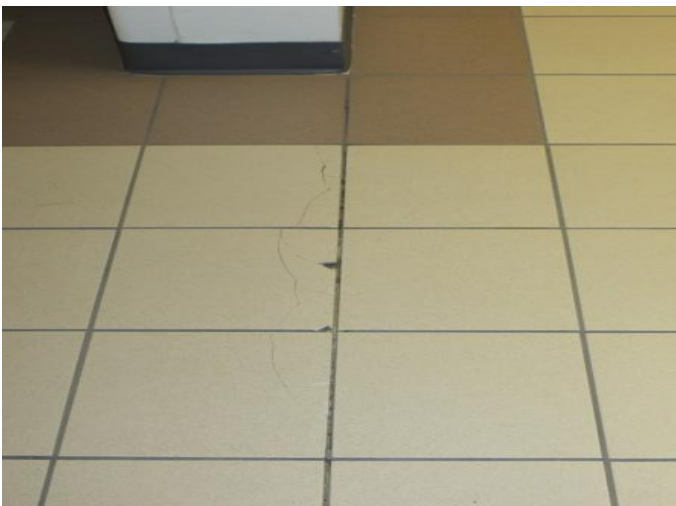
Floor Tile

Damaged floor tile that will need to be replaced with expansion joints.

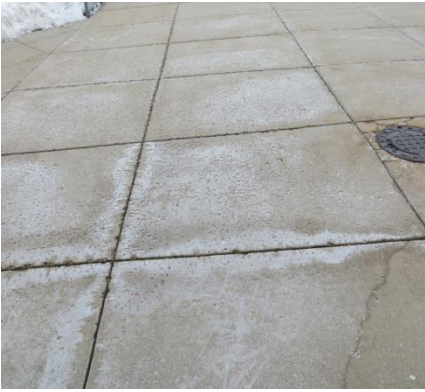
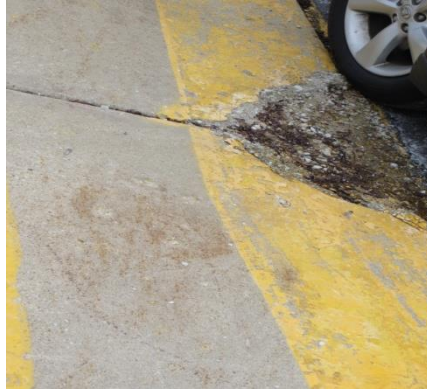
Sidewalk

Replace cracked and spalling sidewalk sections.

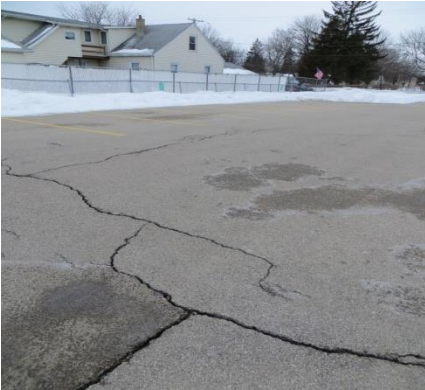
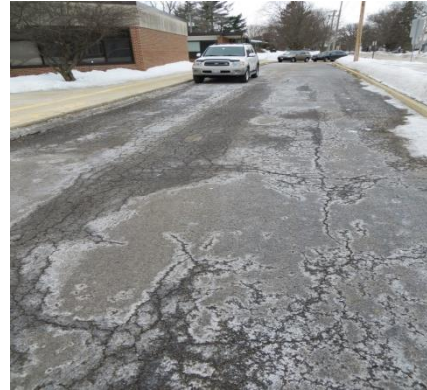
Parking Lot

Multiple deep cracks.

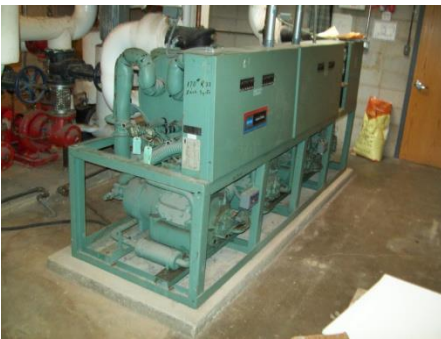
25 year old Chiller is inefficient and repairs are becoming more frequent.

Replace with new chiller.

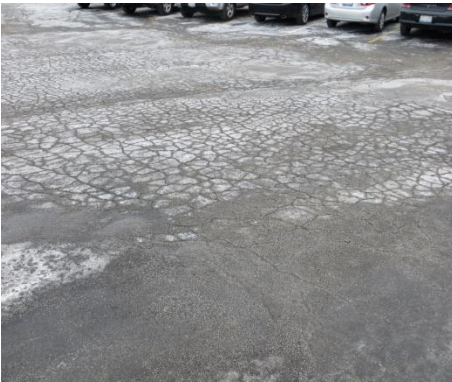
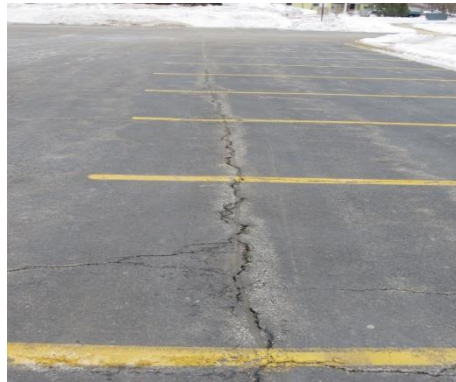
Parking Lot

Multiple deep cracks.

Resurfacing will be required.

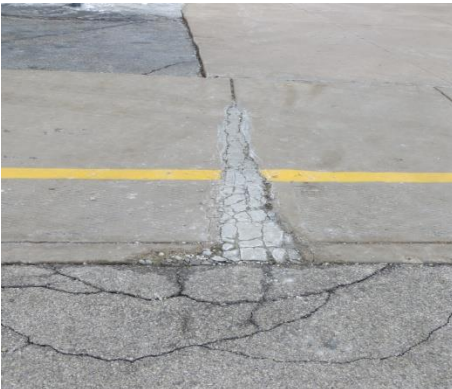
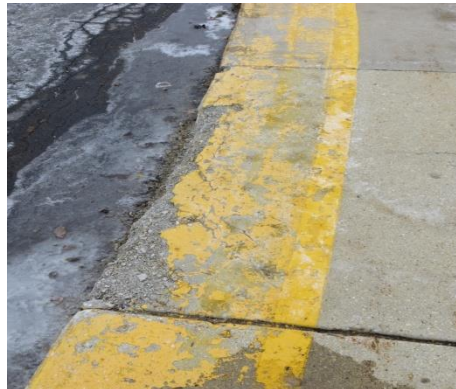
Sidewalks

Cracked and spalling sidewalk sections will need to be replaced.

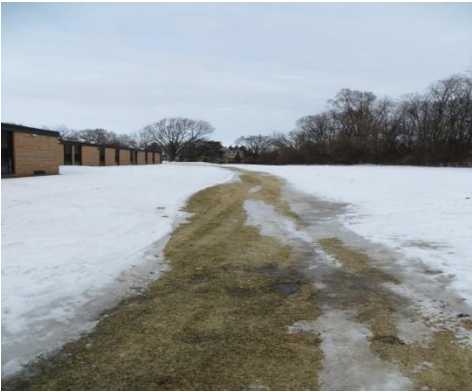
No access on East side of building.

Adding a paved Fire Lane for snow removal and First Responders.

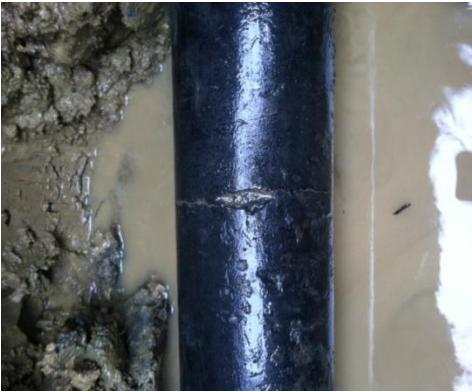
Water Main Replacement

Replace water main section that has cracked three times over the past five years.

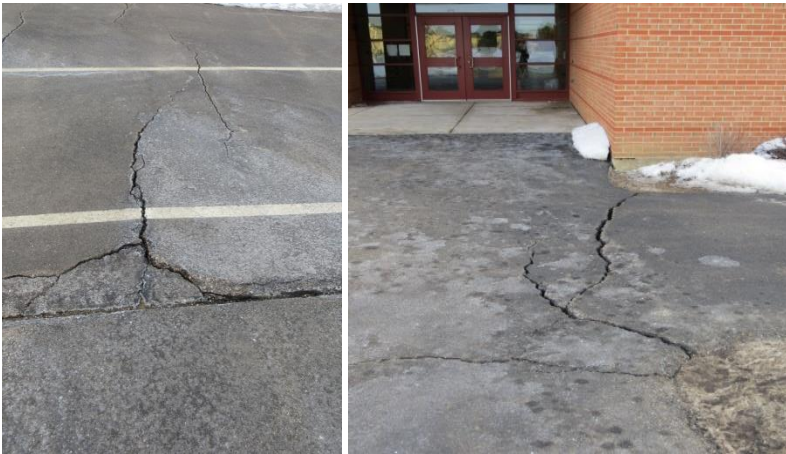
Fire Lane

Multiple deep cracks.

Seal coating and crack filling was done two years ago to extend life of the playground and 5th grade wing entrance.

Resurfacing or replacing damaged sections will be required this year.

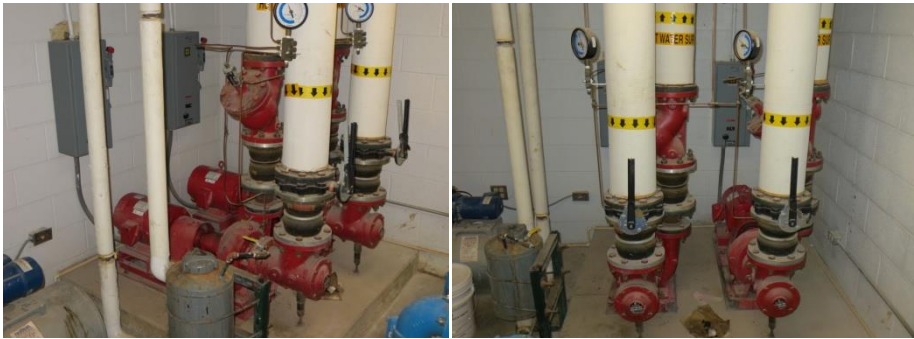
Primary and Secondary Boiler Pumps

Original to the building.

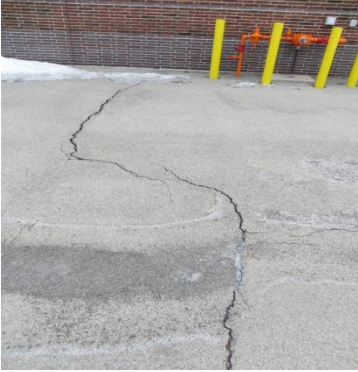
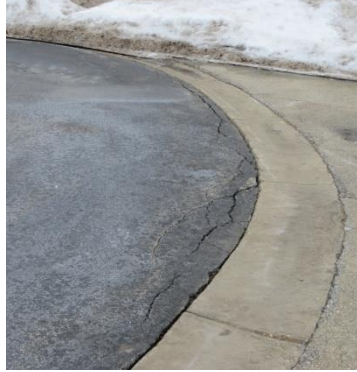
Parking Lot

Several areas are showing cracks and heaving.

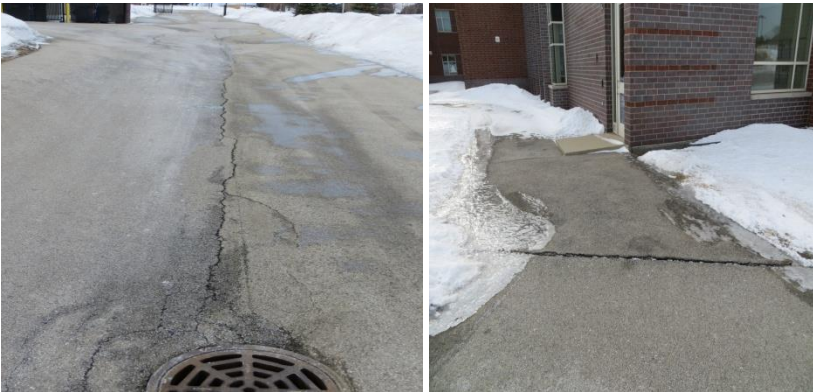
Parking Lot

Several areas are starting to show cracking.

Crack filling and seal coating will be needed within the next five years.

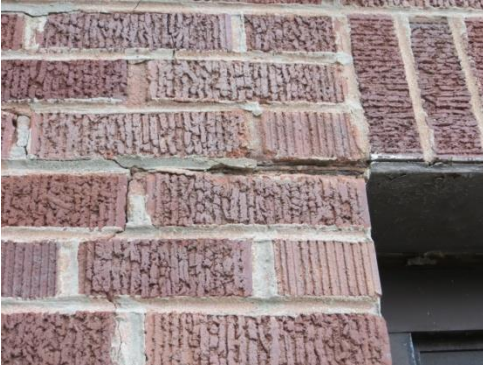
Tuck-pointing

Cracks and missing mortar joints will need to be repaired.

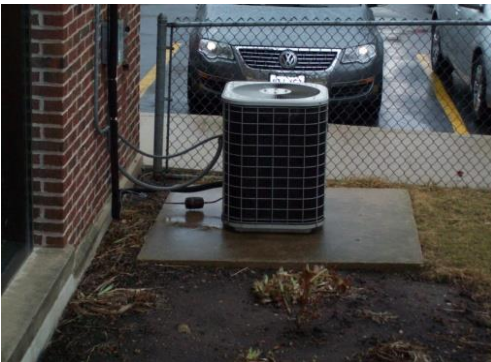
Fan Coil Condensing Unit

The entire building is cooled with fan coil units.

Several are beginning to fail and most will need to be replaced in the next 5 years.

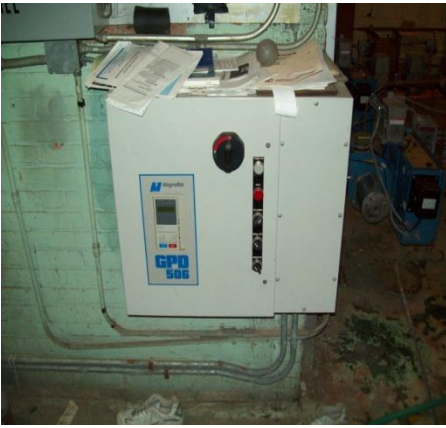
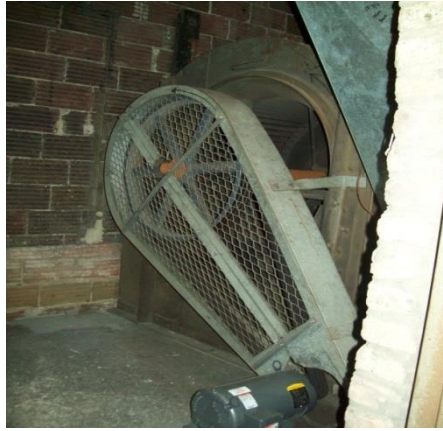
VFD and Fan for the Furnace

VFD doesn't work and fan for furnace is at least 35 years old.

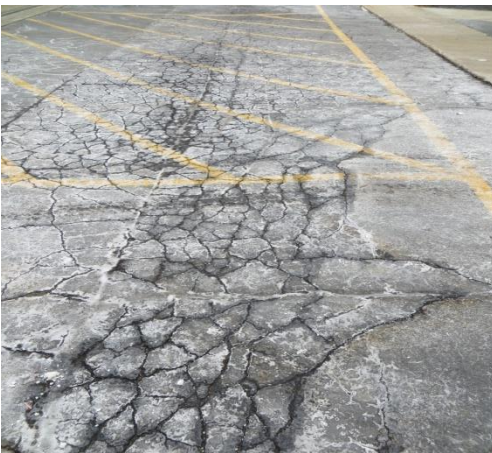
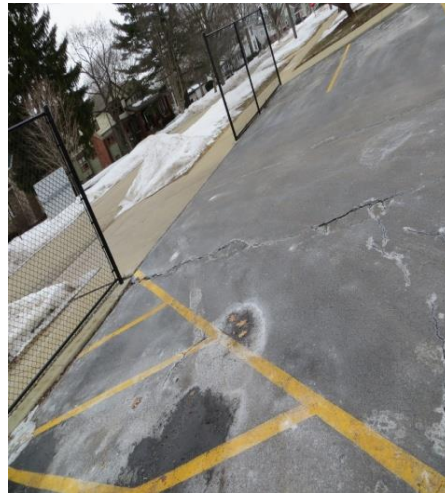
Parking lot

Several areas with extreme cracking.
Resurfacing will be needed.

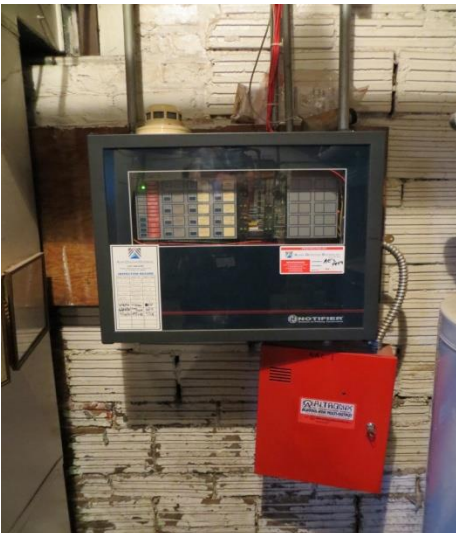
Fire Alarm System

Notifier 5000 fire alarm panel will need to be updated to meet current NFPA code requirements.

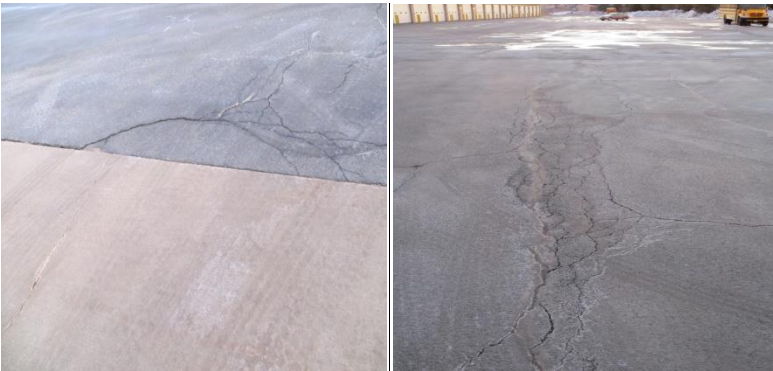
Parking Lot

Several areas starting to show cracking.

Crack filling and seal coating needed again this year due to the extreme winter.
