Facility Condition Assessment

Granby Memorial Middle School FCA

321 Salmon Brook Street

May 12, 2025 | Project Number: FR256003

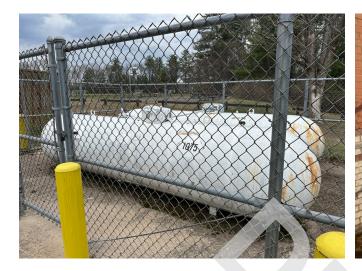
Chain link fence surrounding propane tank at the loading dock area.

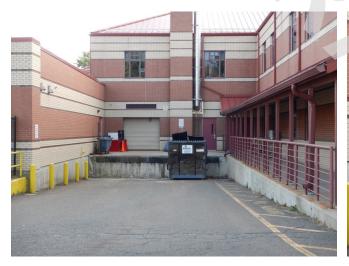
Loading dock area.

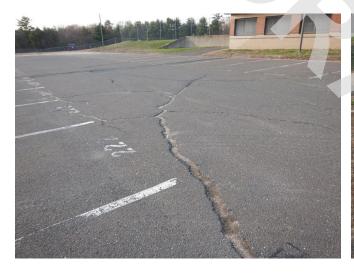
- The asphalt paving is in generally fair condition, with faded striping, linear cracking, alligator cracking, and potholes. Crack sealing, sealcoating and restriping of the paving, with limited full-depth patching of deteriorated areas of the asphalt paving is anticipated during the evaluation period and a cost is included in the Replacement Reserves.

Linear cracking at the parking lot.

- Limited full-depth repair of asphalt paving.
- Crackseal, sealcoat, and restripe asphalt paving.
- Limited concrete paving replacement.
- Partial replacement of brick pavers.

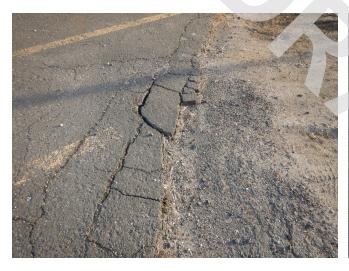
Asphalt vehicular pavement damage.

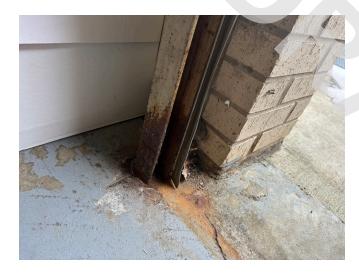
The coiling overhead doors are in generally fair condition. Based on the expected useful life and the observed condition of the overhead doors, replacement of the overhead doors is anticipated during the evaluation period and a cost is included in the Replacement Reserves.

Corrosion on base of roll-up door in maintenance room.

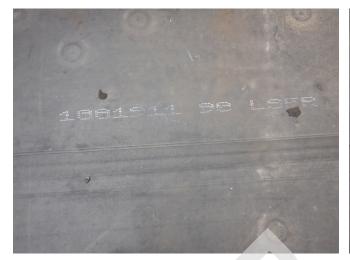
EDPM roof membrane.

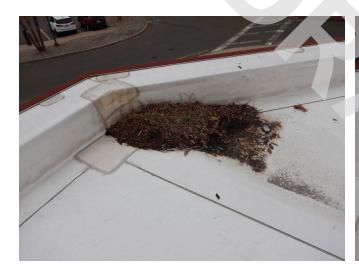
- The fully-adhered, single-ply TPO membrane is in generally fair to poor condition. Terracon observed tenting and ponding. Replacement of the TPO roof is anticipated during the evaluation period and a cost is included in the Replacement Reserves..

- Terracon observed ponding throughout the TPO roof. The Site Contact did not report ongoing roof leaks; however, ponding water increases the likelihood of future roof leaks. Adjusting the slope of the roof covering in the area of ponding is anticipated prior to roof replacement and a separate costs are not included in the Cost Tables.

Ponding at the gym TPO membrane.

Replace single-ply TPO roof membrane assembly.

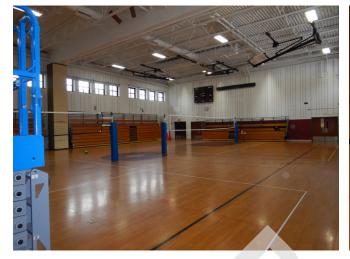
Overview of the Gymnasium.

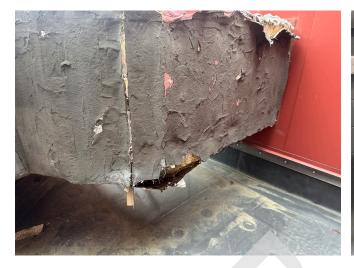
Typical condition of exterior ductwork, note deterioration of external coating/insulation.

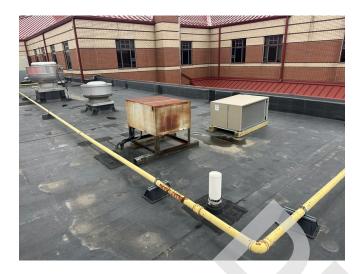
Typical roof-mounted equipment. Note surface corrosion on natural gas piping.

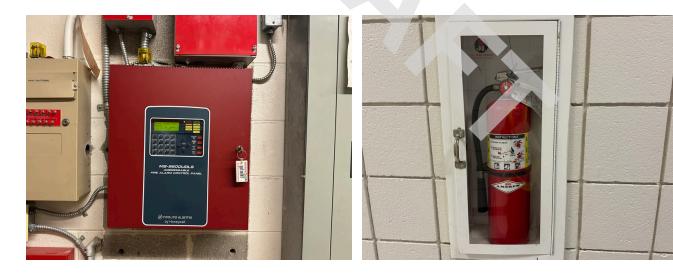
FACP.

Anticipated replacement of the FACP and a portion of the associated devices.
