ASD Lincoln School – Initial Evaluation

ARCHITECT/STRUCTURAL FIELD REPORT

Project:		ASD Lincoln School, 320 Beach Street, Ashland, OR 97520				
Meeting Name:		Site Visit and Architectural Assessment	% Completion:	NA		
Date of Meeting:		08/21/2025	Time:	12:05 PM	Weather:	95°, sunny
Report Prepared By:		Christopher Brown AIA	Location:	ASD - Lincoln School		
Attendance at Meeting						
✓	Name	Company / Role		E mail		
	Chris Brown	Principal Architect – arkitek:design&architecture		Arkitek@arkitek.us		
	Steve Mitzel	ASD Executive Director of Operations		Steve.Mitzel@ashland.k12.or.us		
	Dr. Joseph Hatrick	ASD Superintendent		Joseph.Hatrick@ashland.k12.or.us		
	Mark Shay	Deputy Chief - Fire Marshal		Mark.Shay@ashland.or.us		
	Cameron Harris	Ciota Engineering PC		Cameron@ciotaengineering.com		
	Robby Moles	ASD Facilities & Maintenance Director		Robby.Moles@ashland.k12.or.us		
	Martin Meyer	Senior Architect– arkitek:design&architecture		Martin@arkitek.us

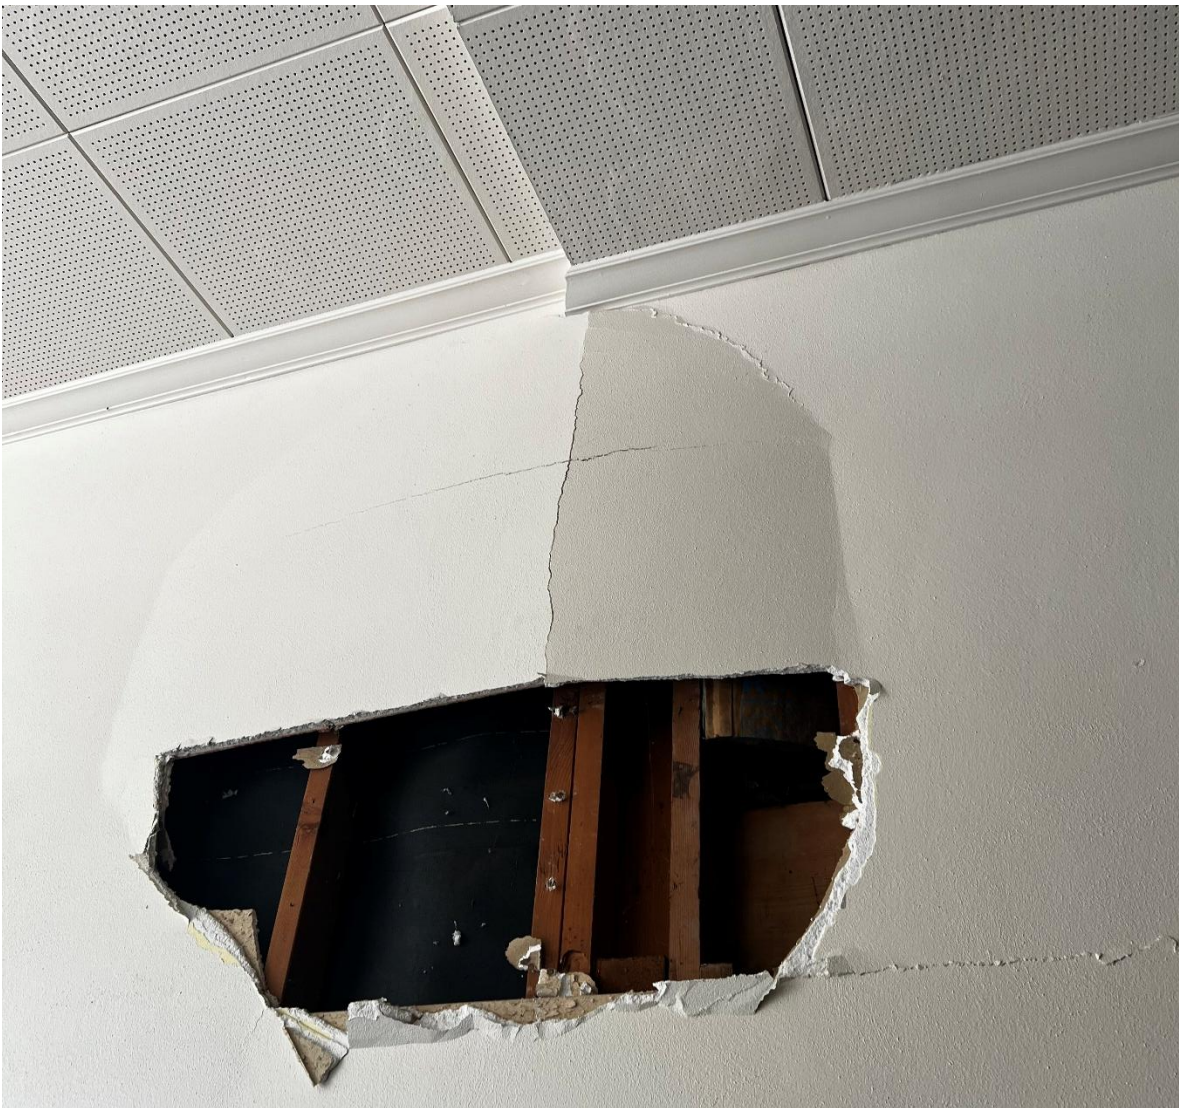
Photo #1 Looking North. Indicates the buckling of the Gypsum Wall Board(24"x36") in the Corridor adjacent to the Stage and the Teacher Work Room (per original blueprint).

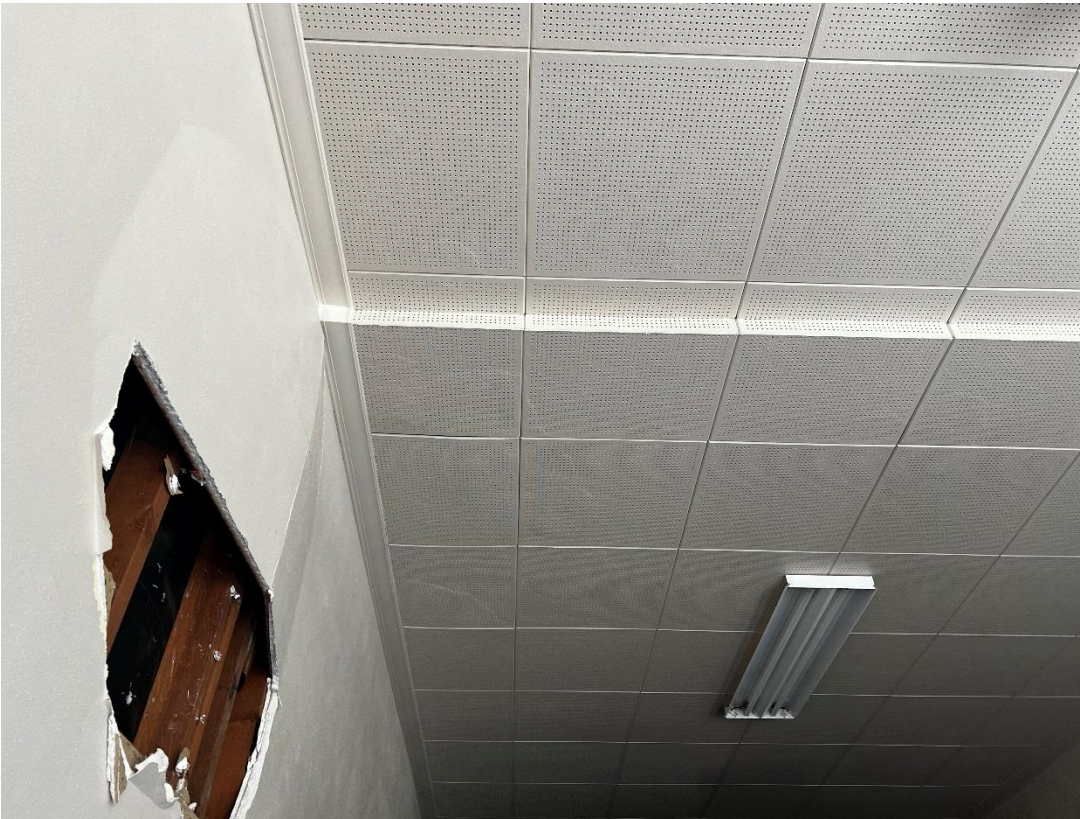
Photo #2 Looking Northeast. Indicates the buckling in the Gypsum Wall Board showing the depth out of plumb.

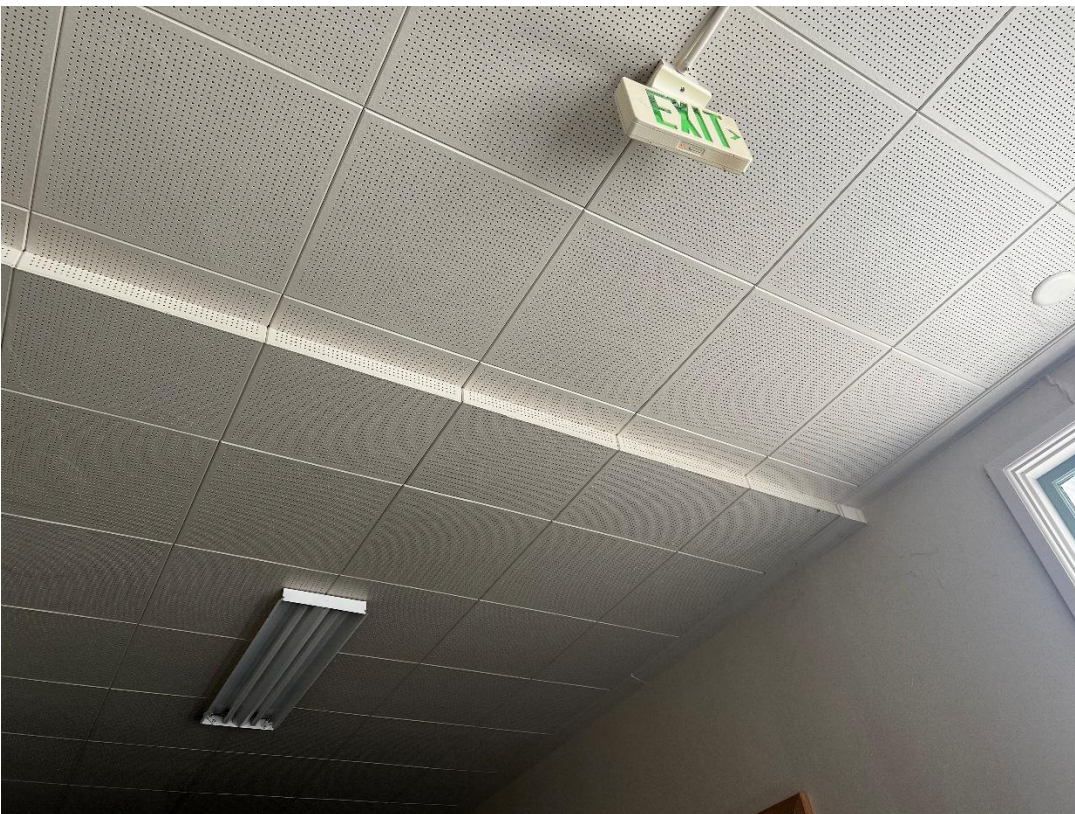
Photo #3 Looking Northwest, across the Corridor from the buckle. It indicates the purposeful change in the ceiling plane spanning the corridor.

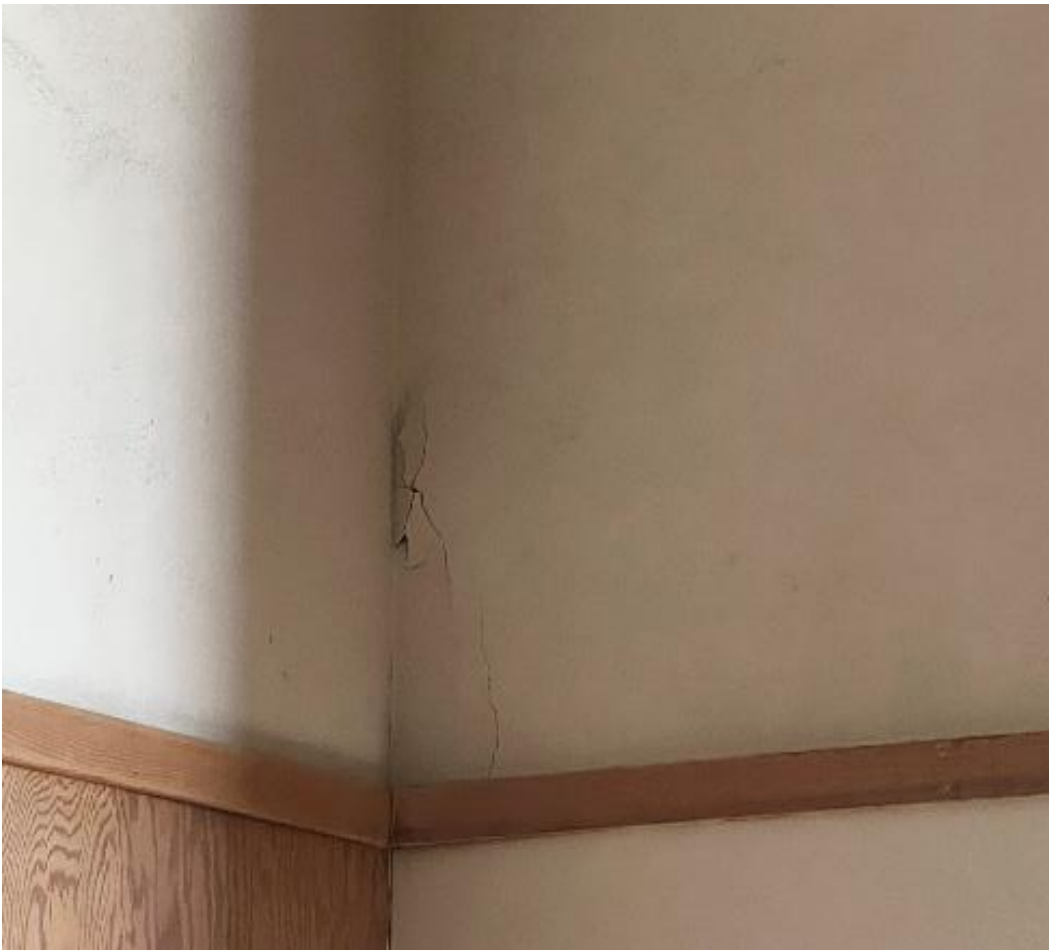
Photo #4 Looking west. This shows a plaster crack indicating minimal building movement.

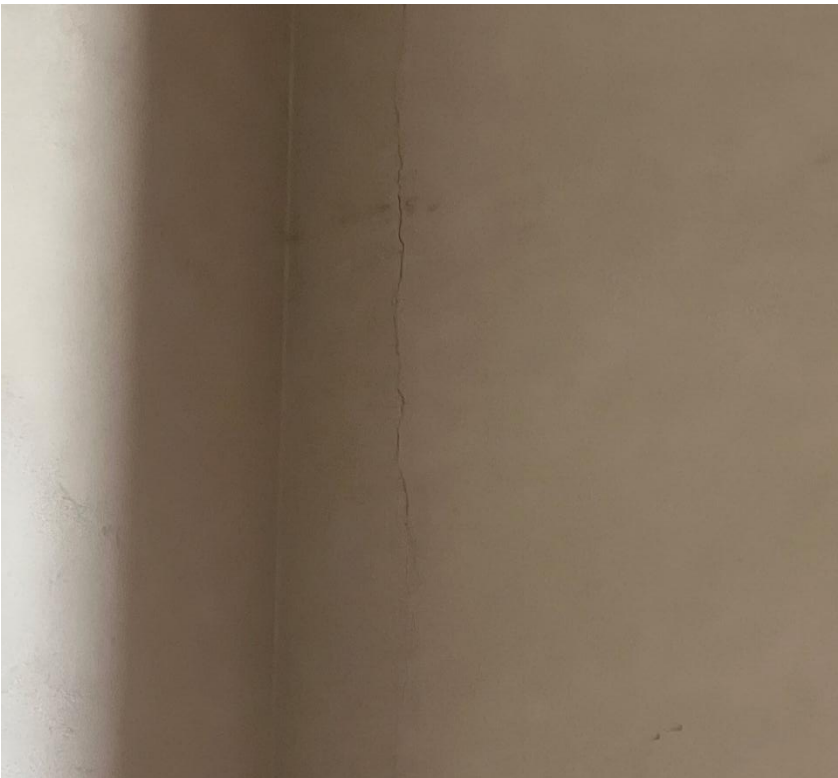
Photo #5 Looking west. This shows a plaster crack indicating minimal building movement.

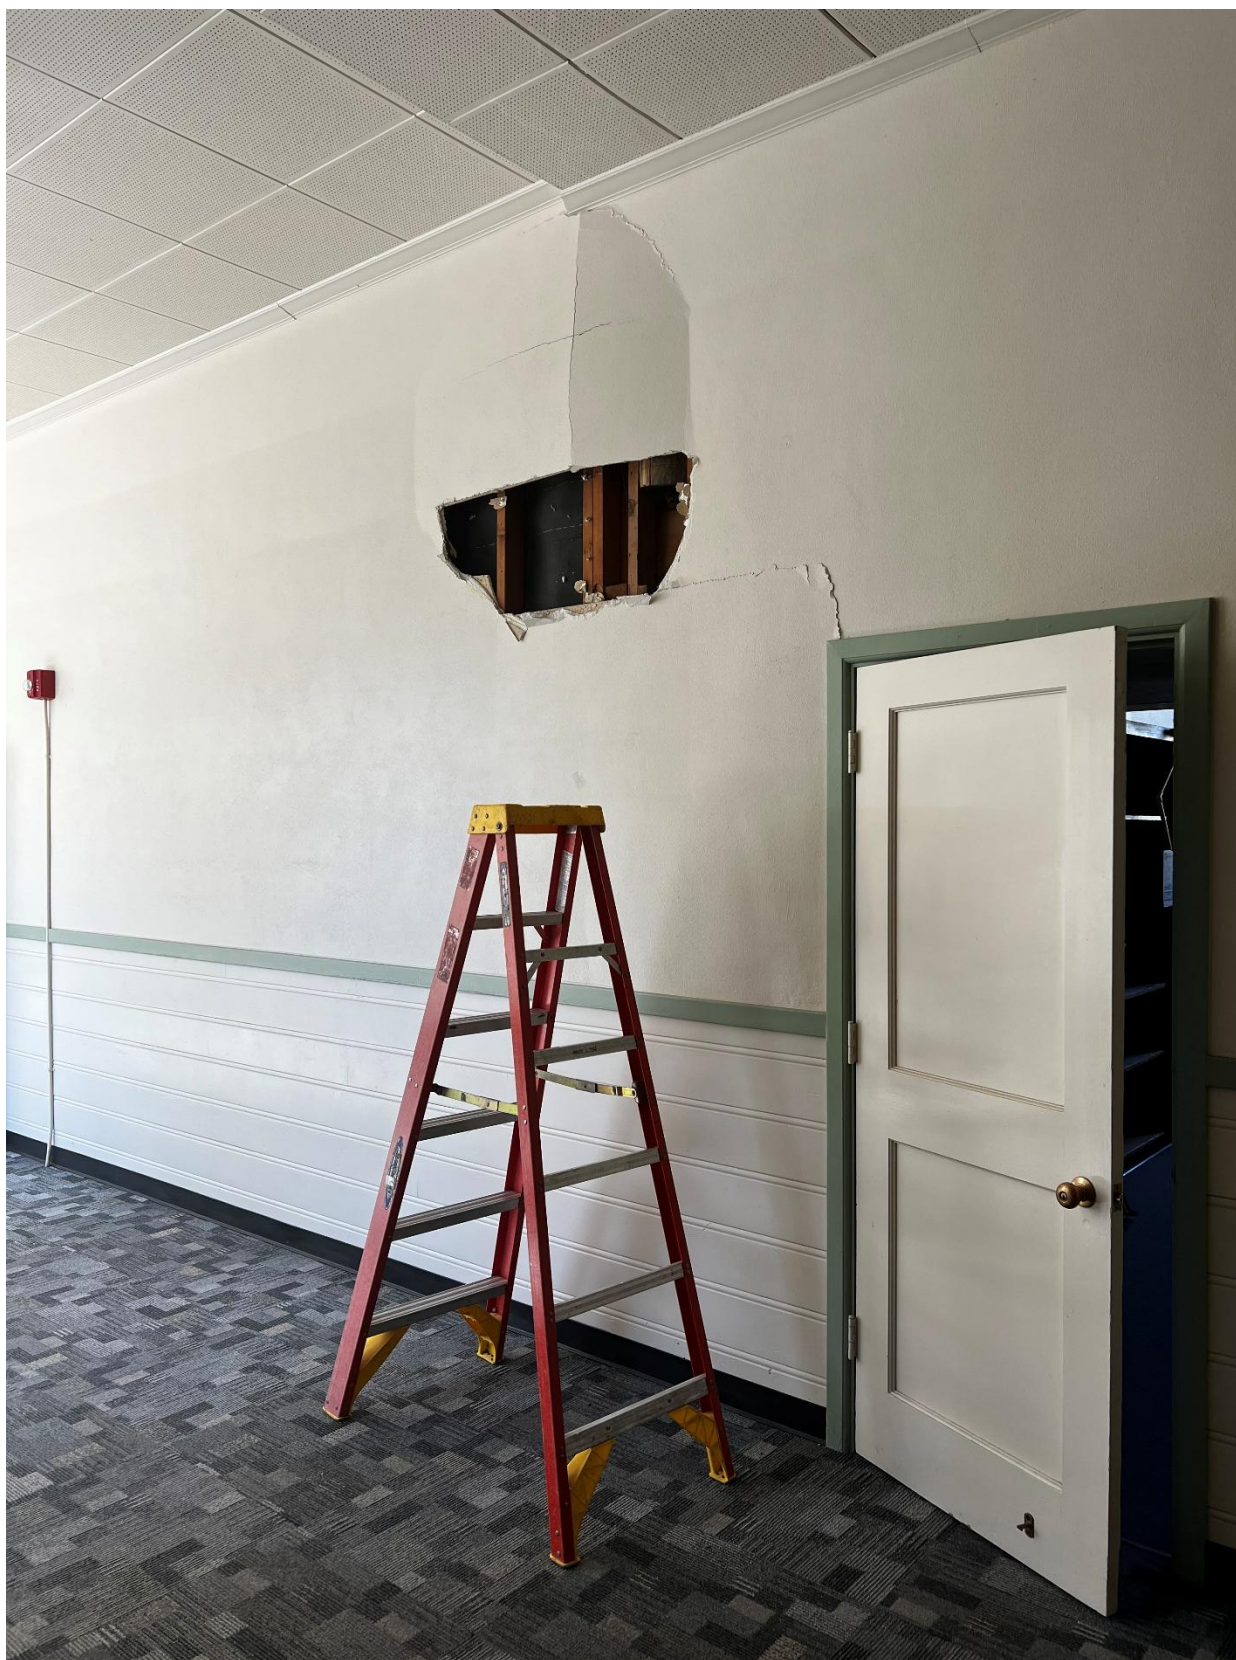
Photo #6 Looking Northeast. Indicates the context of the buckle outside of 'Teachers Break Room'(per original blueprint)

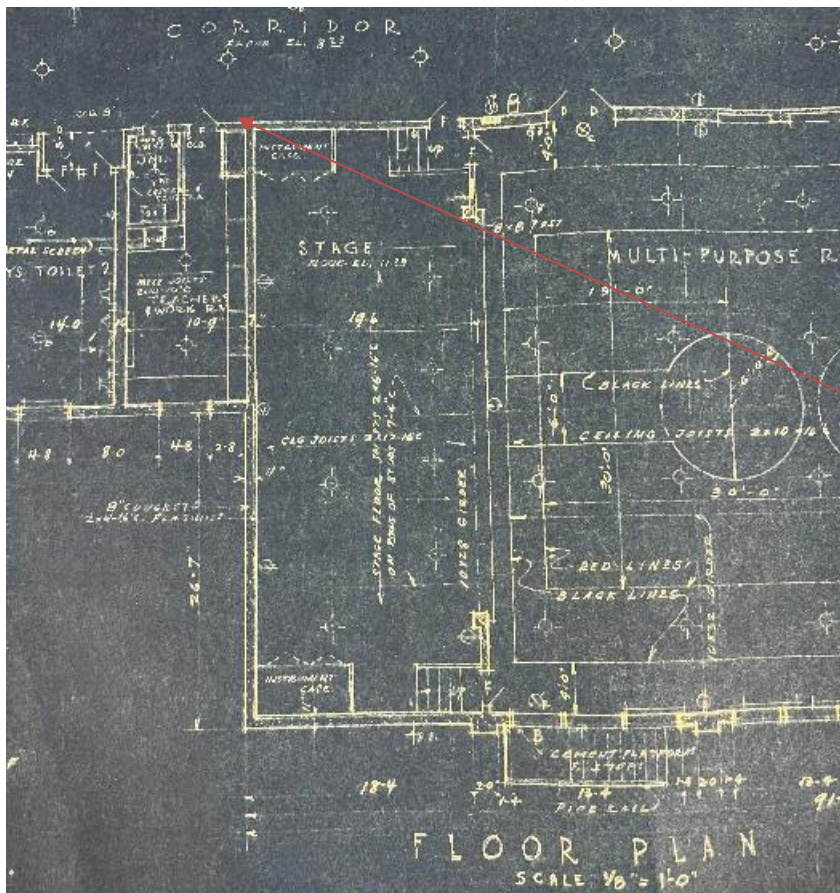
Location of buckle

Photo #7 Original Blueprint. Floor Plan indicates location of the buckle.

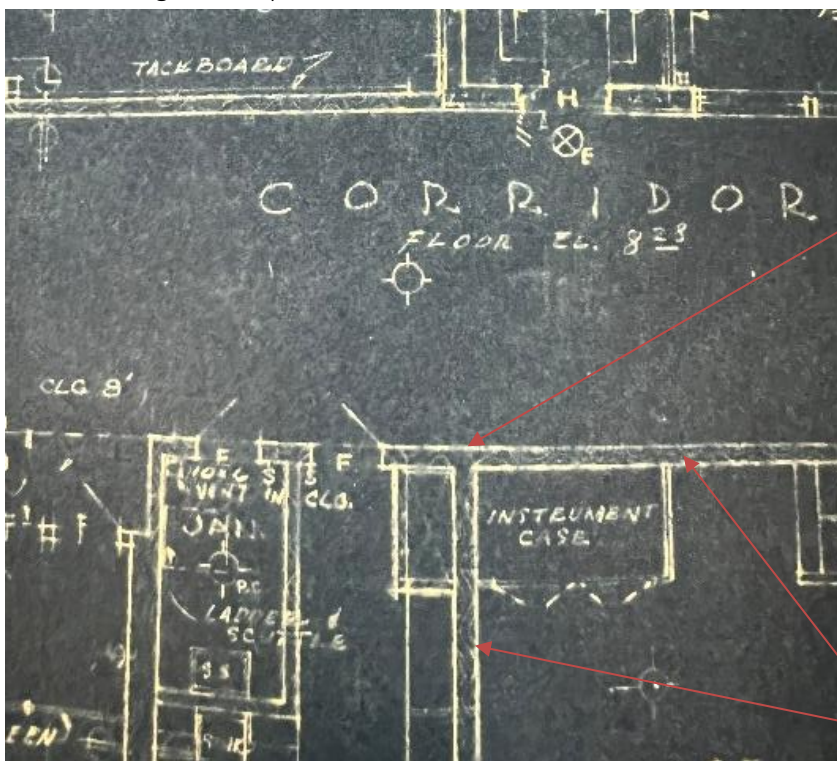
Location of the buckle

Location of Gymnasium walls that project up through the east wing and corridor roof.

Photo #8 Original Blueprint. Enlarged plan indicates location of the buckle.

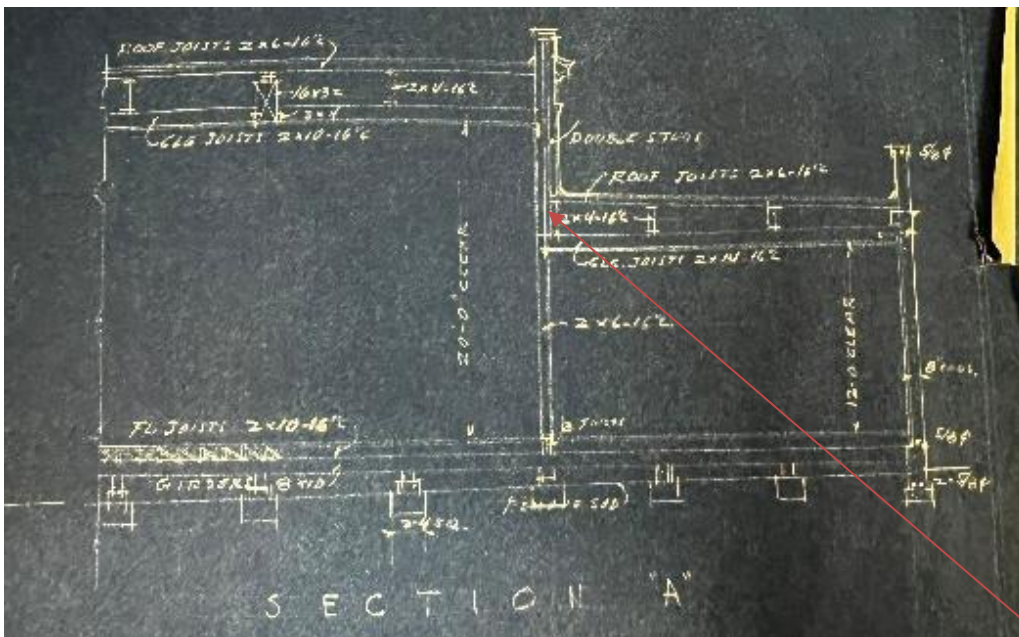
Photo #9 Original Blueprint. Indicates a building cross section looking north.

These are the areas of the buckle below. The change in a building plane provides for opportunities for the membrane to open up due to expansion and contraction.

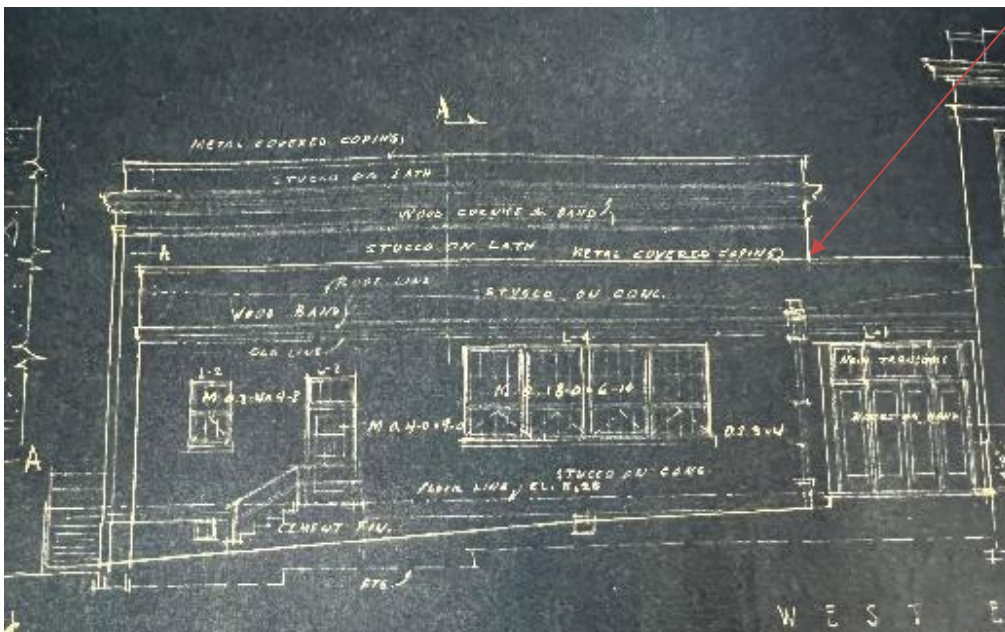
Photo #10 Original Blueprint. Indicates a building elevation looking south.

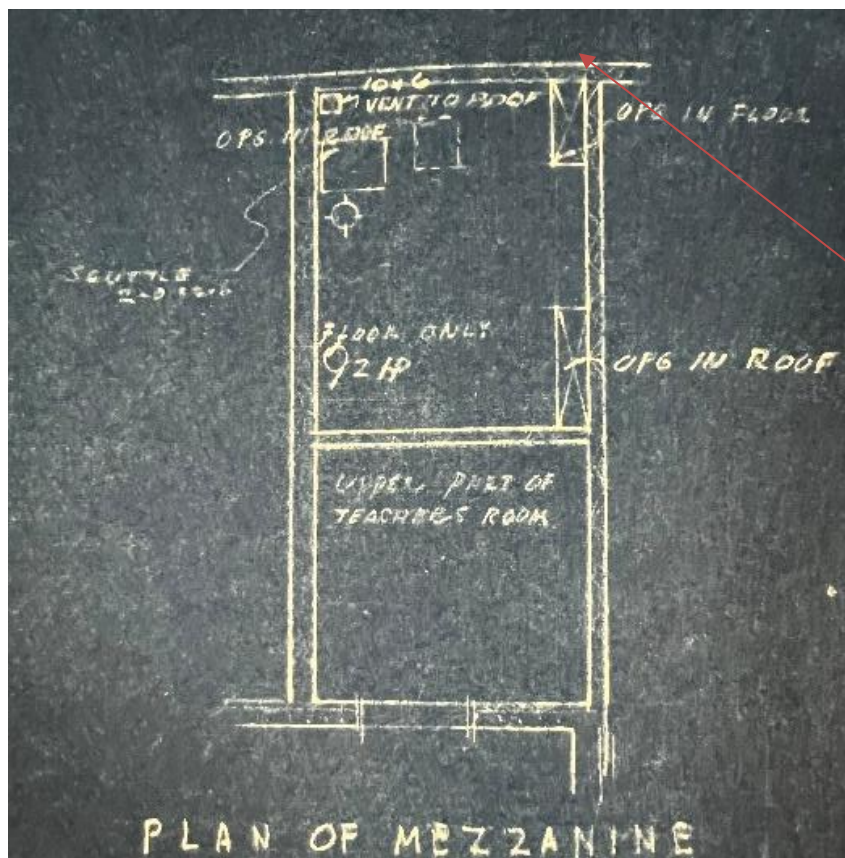
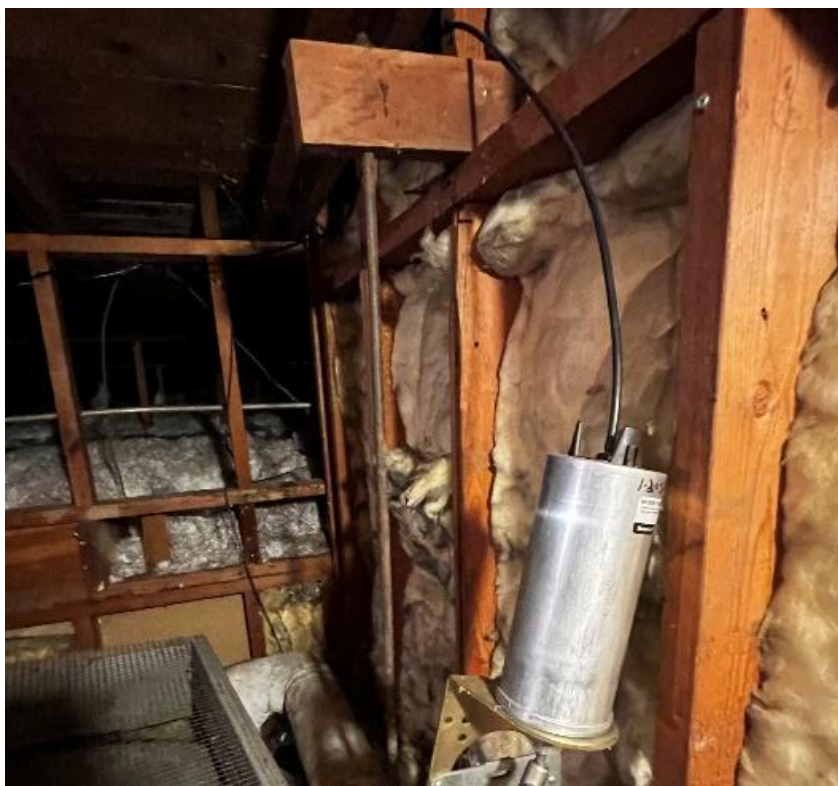
Location of the buckle

Photo #11,12 Looking Southwest. Indicates the mechanical equipment (lower left) in the mezzanine above the buckle.

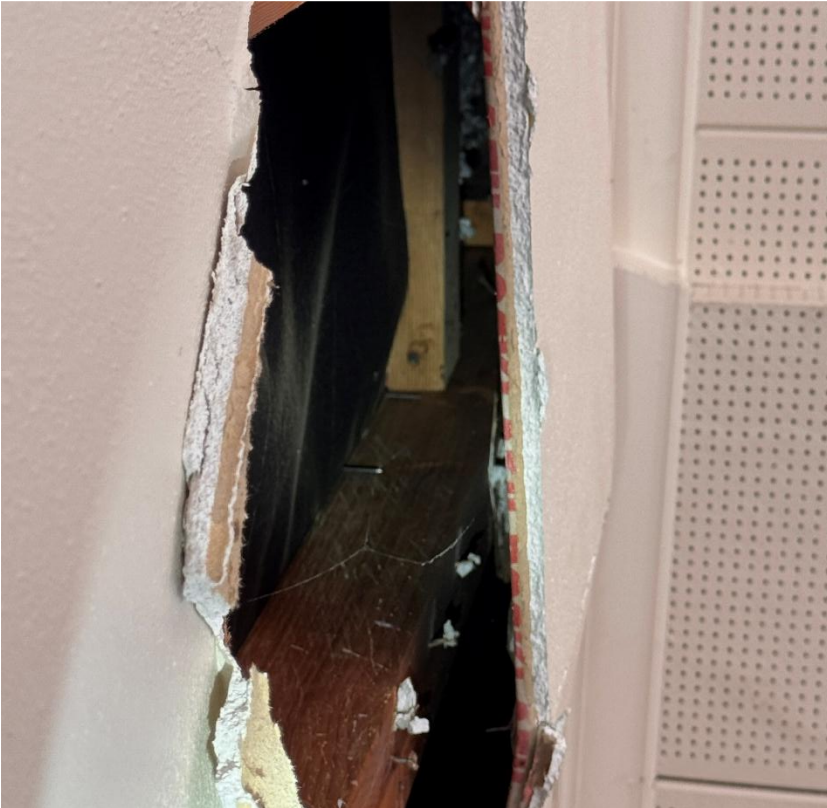
1. Visible beyond the framing cavity(behind the buckled Gypsum wallboard) there is more recent framing near the height of the ceiling.
2. Lowered acoustical ceiling in the Teachers Workroom(adjacent to 'buckle') has existing water damage staining
3. In the Teachers Workroom; valance at the ceiling plane(east) has an 18 inch crack adjacent to downspout leader at that location.
4. Up in the mezzanine where air handling equipment is located, there is minimal water intrusion evidence.
5. The jam at the door into the Teacher Workroom is obviously skewed as you can't shut the door.

Photo #13 Looking Northeast. Refer to note #10 above. This recent framing is intriguing as it may indicate an intentional repair near the ceiling level.

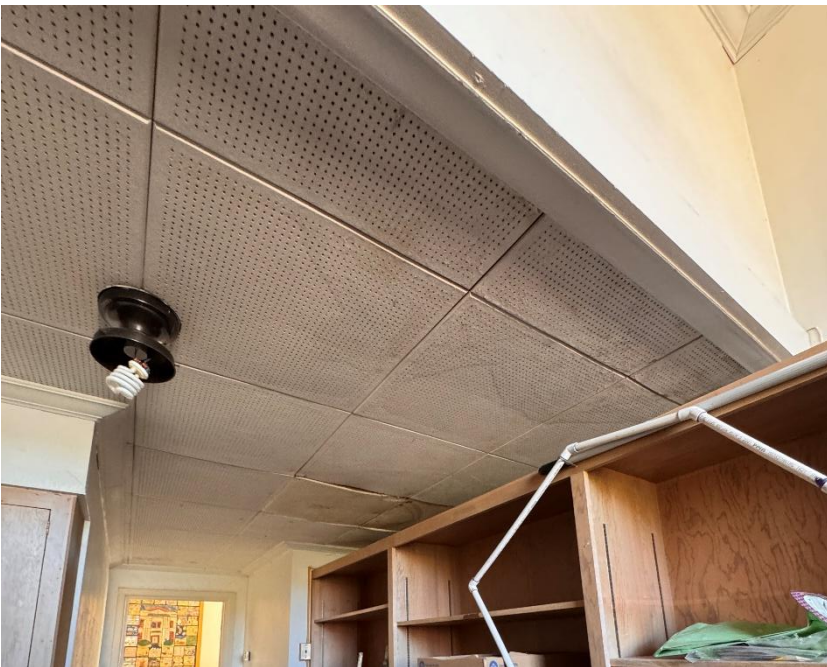
Photo #14 Looking Southwest. The buckle is on the outside of this wall. The water stains at acoustic ceiling may indicate water from outside or from the HVAC equipment in the mezzanine above.

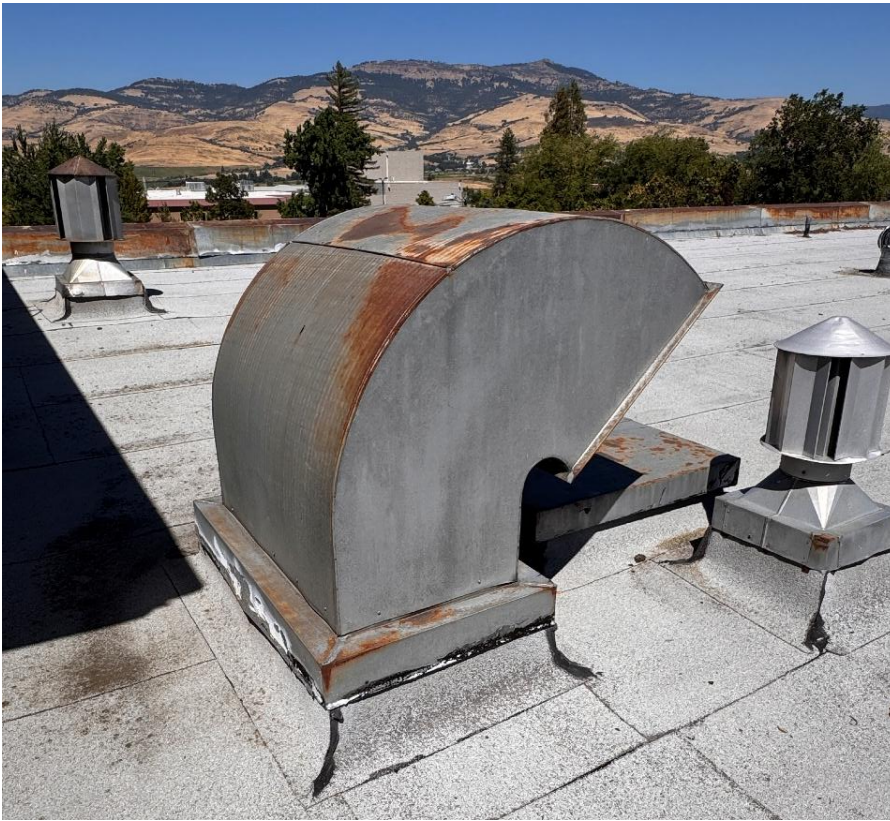
Photo #15. Looking Northeast. Refer to Photos #9 & #10. The corner of the Gymnasium that pops up above the corridor and the east wing is just to the left of this photo.

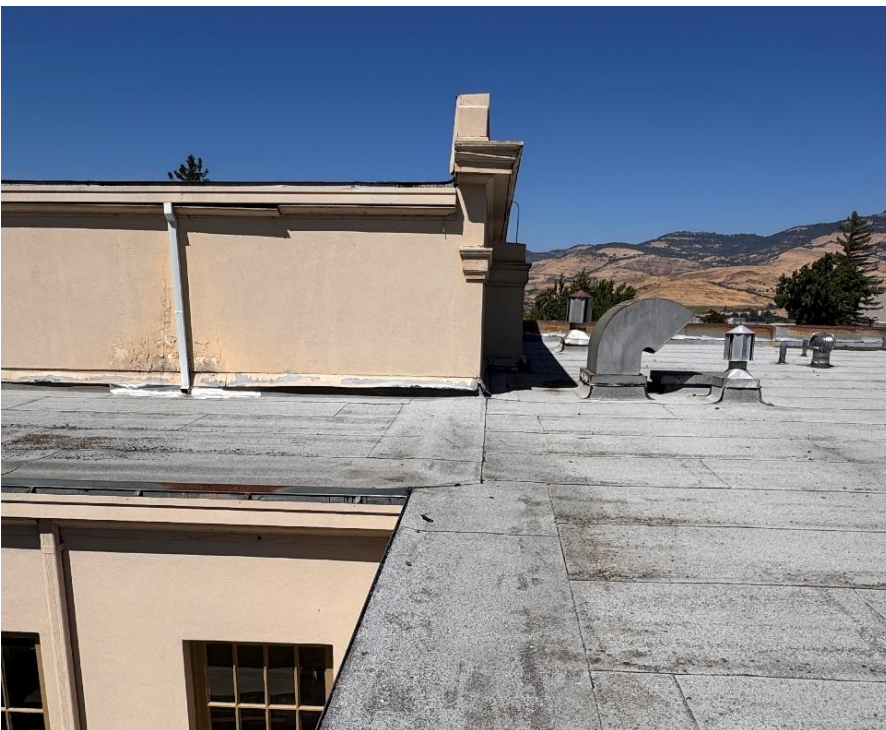
Photo #16. Looking North. Refer to Photos #9 and #10. Note the hump from this lower eave to the corner of the gym indicating movement. The buckle is directly below the corner of the gym.

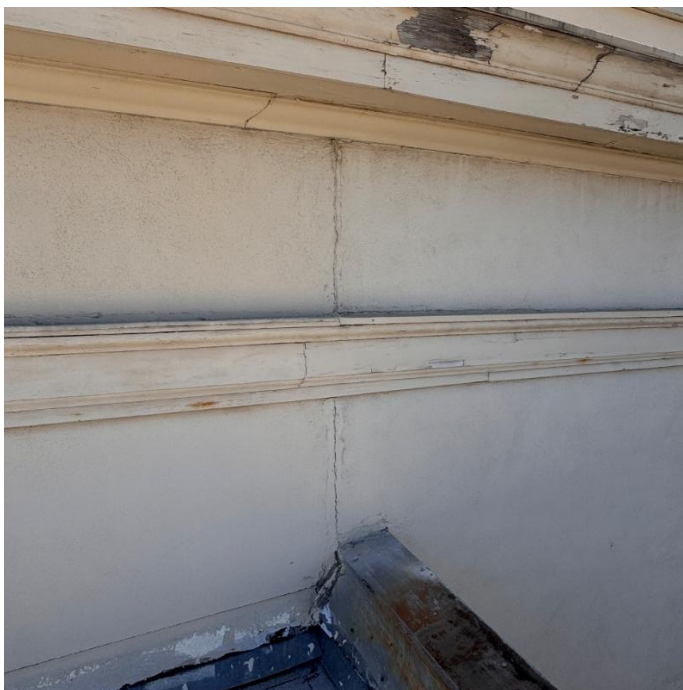
Photo #17. Looking Northwest. Refer Photos #9 and #10. This crack is at a location that is common to buildings indicating expected expansion and contraction.

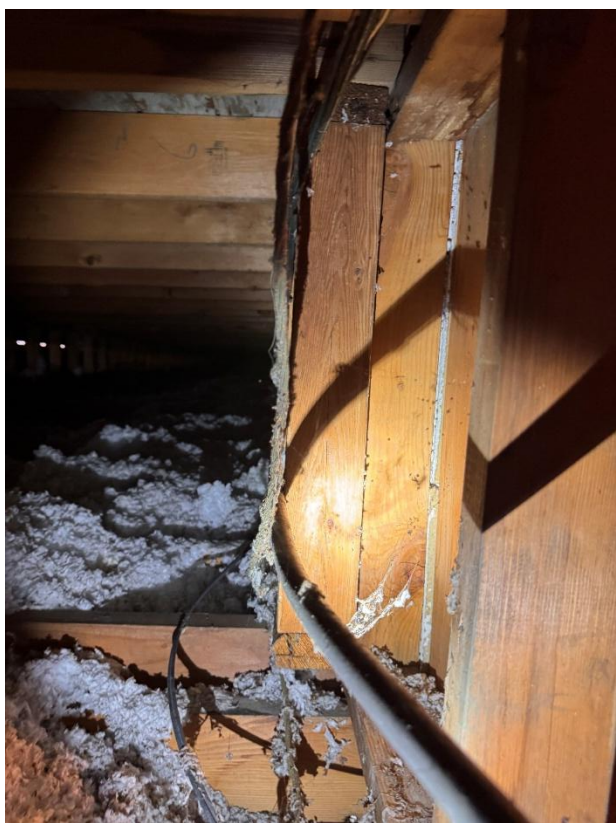
Photo #18. Looking West. This picture indicates a stooled-up frame wall running west the length of the gymnasium. It bears on the ceiling framing and continues up underneath the roof framing.
