Geneva CUSD 304 5-Year Capital Improvement Plan 2013

Geneva Community Unit School District #304

April 8, 2013

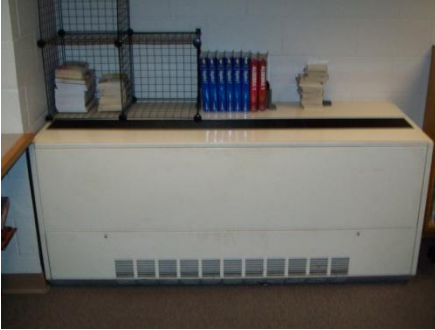
Unit Ventilator in B Hallway - 13

Oversized, cycles on/off frequently causing humidity and comfort issues.

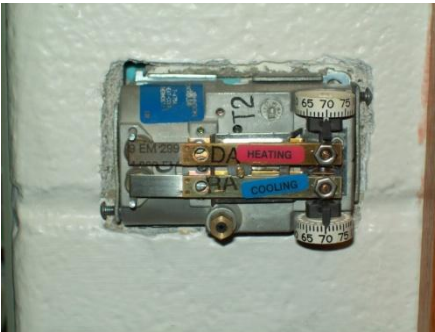
Controls

Pneumatic to Digital conversion allowing for tighter control of temperature, setback features, alarming feature and will be computer based.

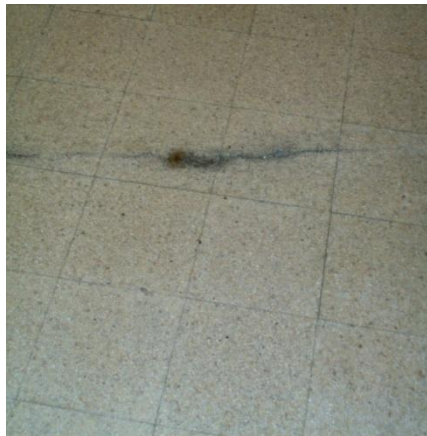
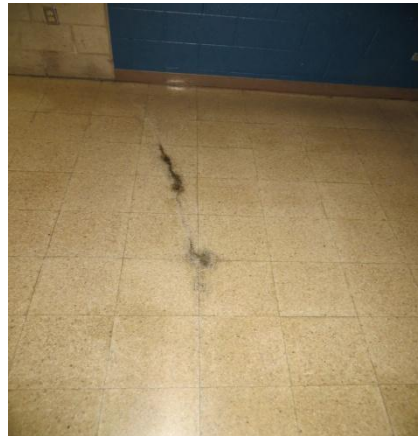
Flooring

Existing quartz tile is cracking and has faded. Creates trip hazards.

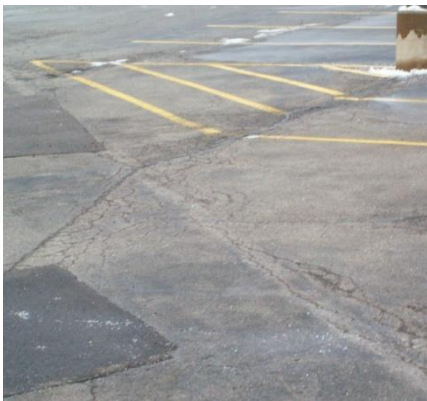
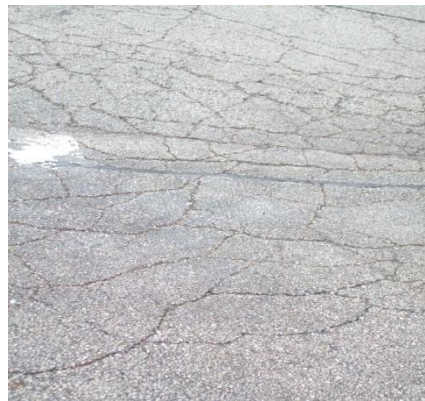
Burgess Parking Lot

Cracks and patches throughout.

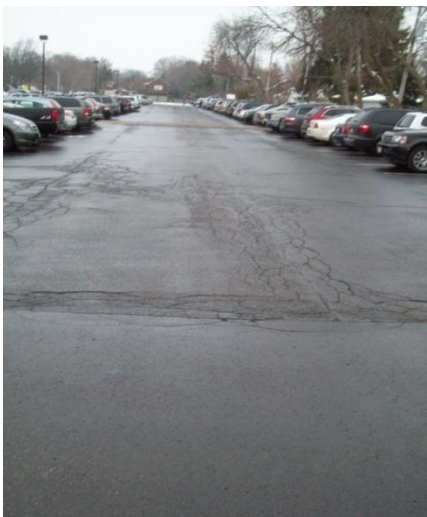
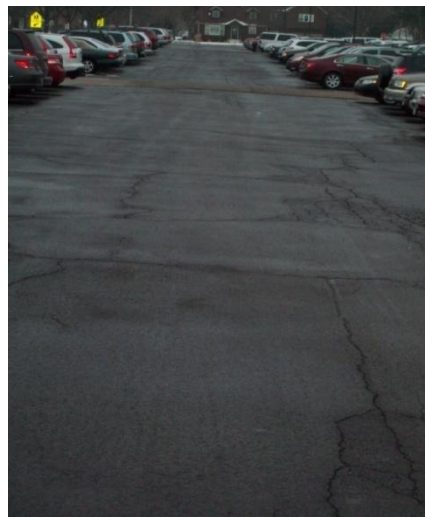
McKinley Parking Lot

Deep cracks throughout.

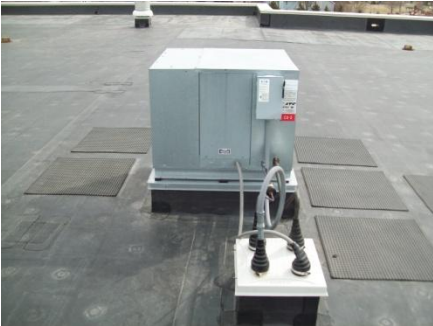
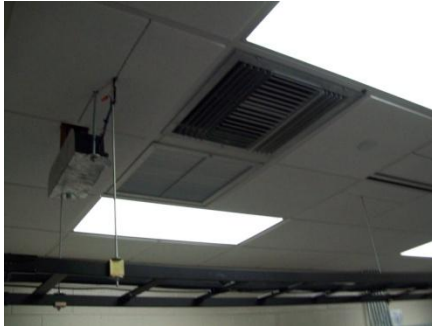
IT Server A/C

Oversized for heat load of space. Cycles on and off continually causing condensation issues and premature equipment failure.

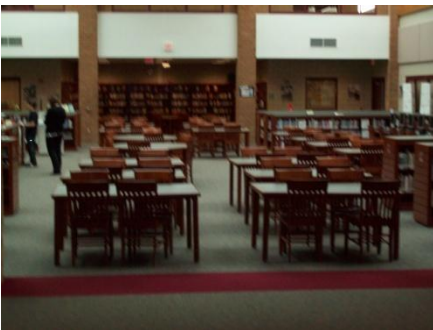
LMC

AHU is undersized for space. Only 2 VAV boxes serving the space.

Recommend increasing the capacity of the AHU and adding 4-6 VAV boxes with controls to increase comfort and control humidity.

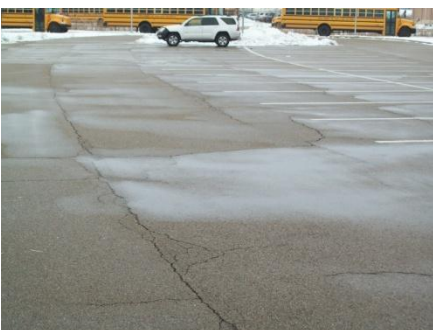
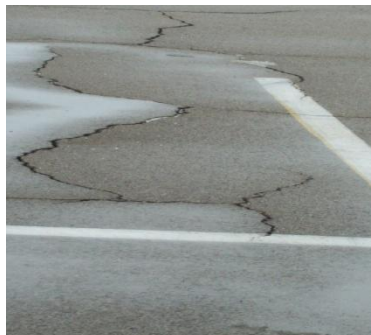
Parking Lot

Multiple deep cracks. Seal coating and crack filling was done last summer to extend life of parking lot. Resurfacing may be required within 5 years.

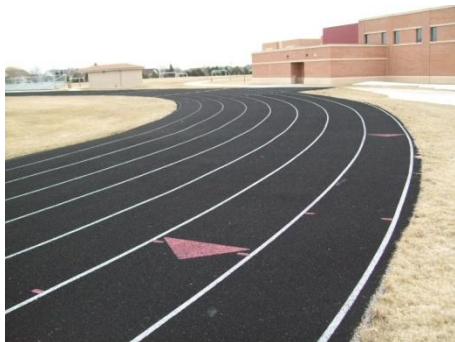
Track – installed in 2005

Track resurfacing is normally required every 8-10 years. Excessive wear spots are apparent.

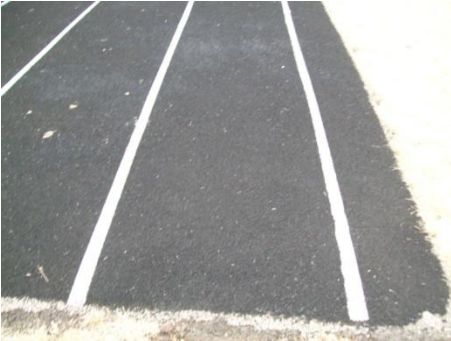
Track – installed in 2005

Track resurfacing is normally required every 8-10 years. Excessive wear spots are showing through.

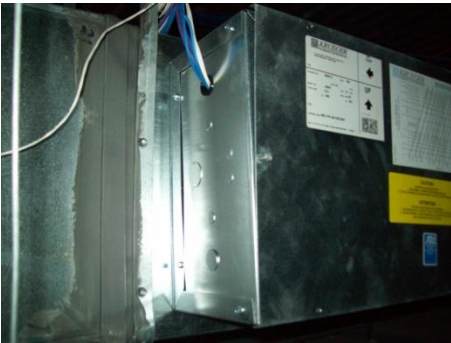
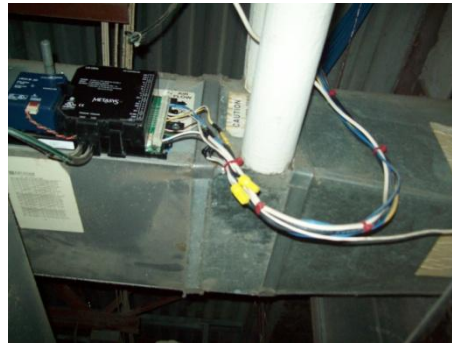
VAV Box

First Box-No Reheat coil and piping

Second Box-Reheat coil with supply/return hot water piping with controls

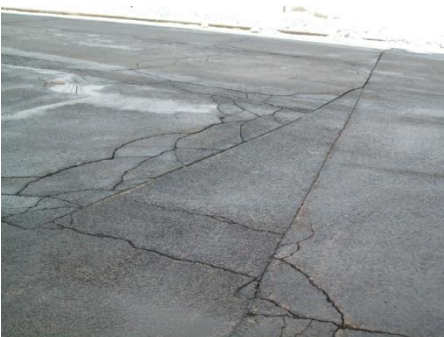
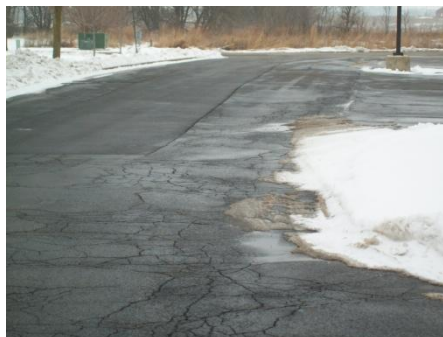
Parking Lot

Cracks filled and lot seal coated three years ago.

Partial patching seen on right picture.

Resurfacing needed this year.

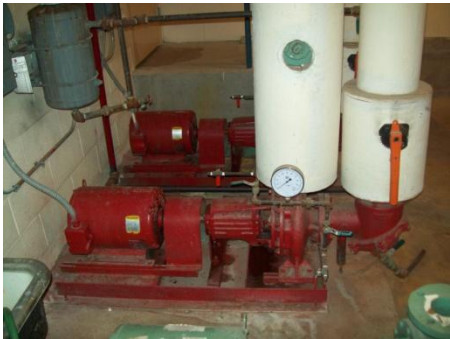
Primary and Secondary Boiler Pumps

Original to the building. Need replacing with energy efficient design and variable frequency drives for increased energy efficiency.

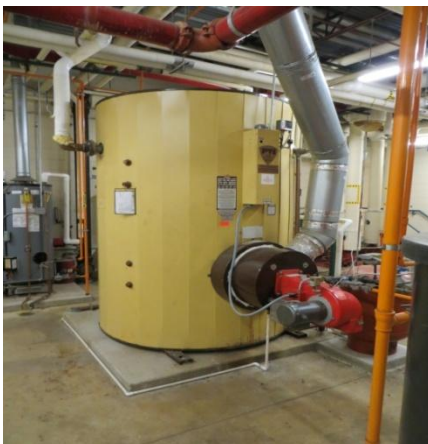
Domestic Hot Water Heater

Original 1500 gallon water heater has exceeded its life span of 10-15 years. Plan on replacing in the next 5 years with a more efficient and properly sized water heater. **On March 8th the heat exchanger cracked causing a pinhole leak. We received 3 proposals to replace the water heater for an emergency install.**

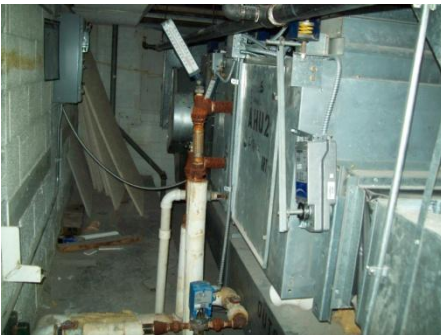
Air Handling Unit

Typical of three. Needs rebuilding or possible replacement.

New motor, shaft, bearings and controls needed

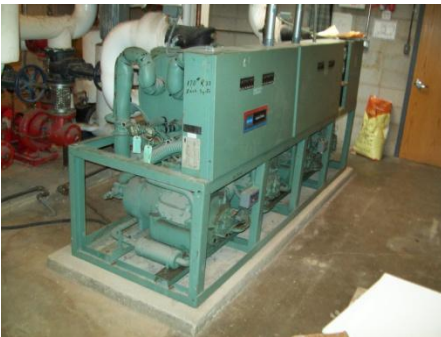
24 year old Chiller is inefficient and repairs are becoming more frequent.

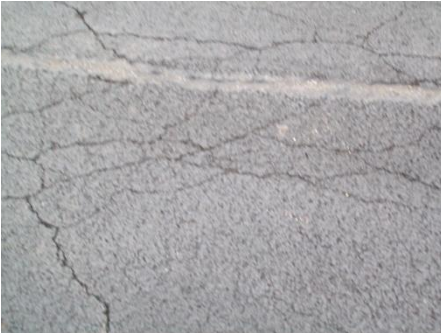
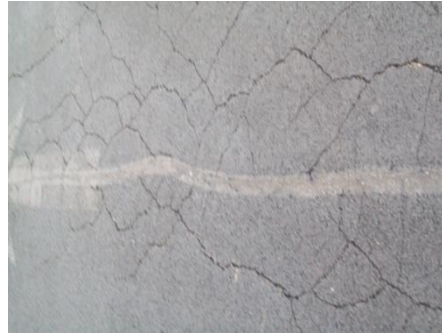
Parking Lot

Multiple deep cracks. Resurfacing will be required in the next five years.

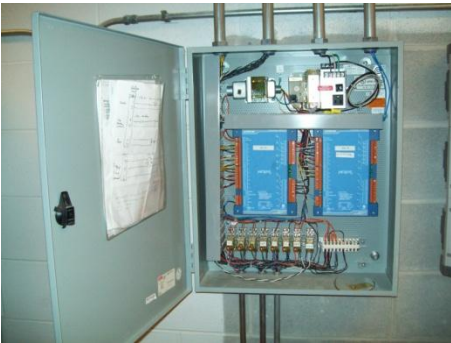
Lon Controller - Lon controls throughout the building

Outdated and costly to repair

Doesn't communicate with the rest of the District's controls communication protocol

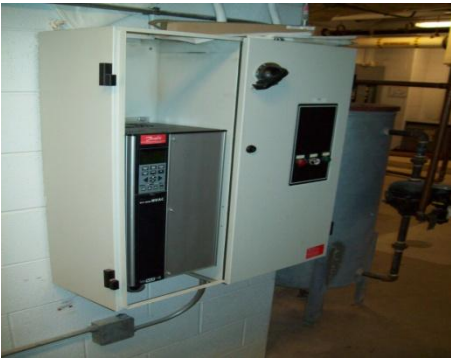
Variable Frequency Drive (VFD)

Needs replacing in the next 5 years.

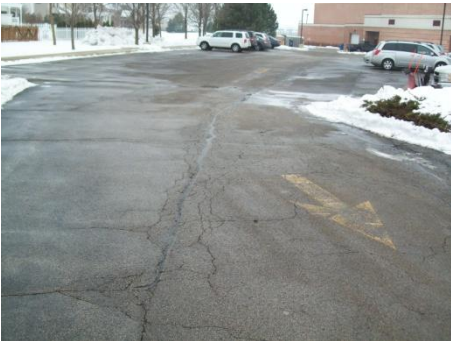
Parking Lot

Multiple deep cracks. Seal coating and crack filling was done two years ago to extend life of parking lot. Resurfacing will be required this year.

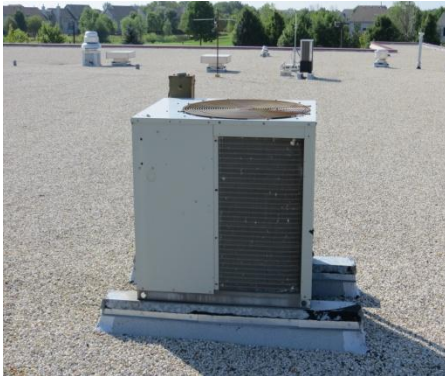
Work Room HVAC System

Original to the building. Work room condensing unit and evaporator coil are nearing the end of life cycle and will need to be replaced within the next five years.

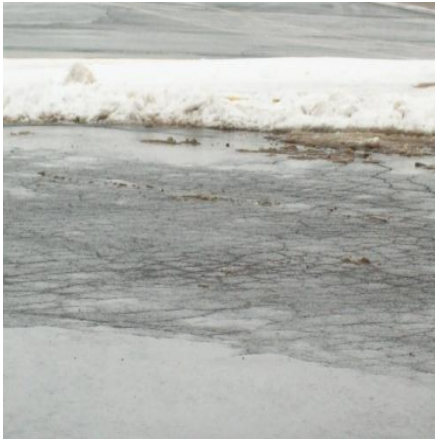
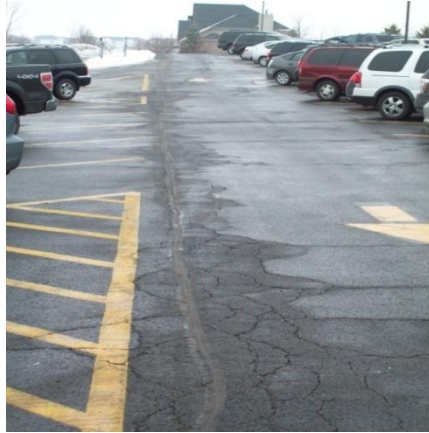
Parking Lot

Multiple deep cracks. Cracks filled and seal coated last summer. Will need major patching or replacement. Has a drainage issue as well.

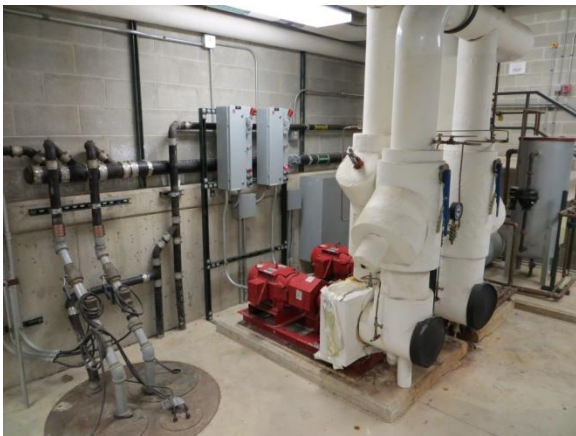
Chilled Water Pumps (2) – Add VFD

Variable Frequency Drives will greatly increase energy efficiency and lengthen the life of the pumps.

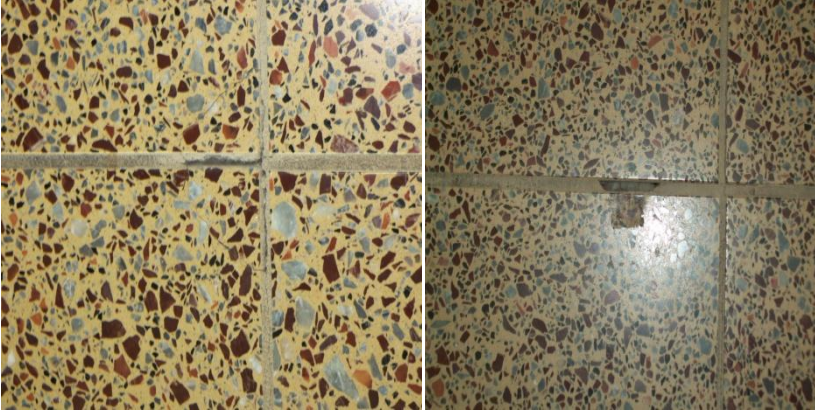
Floor Tile

Terrazzo tile repair/replacement. Tile did not properly bond to the floor and is cracking.

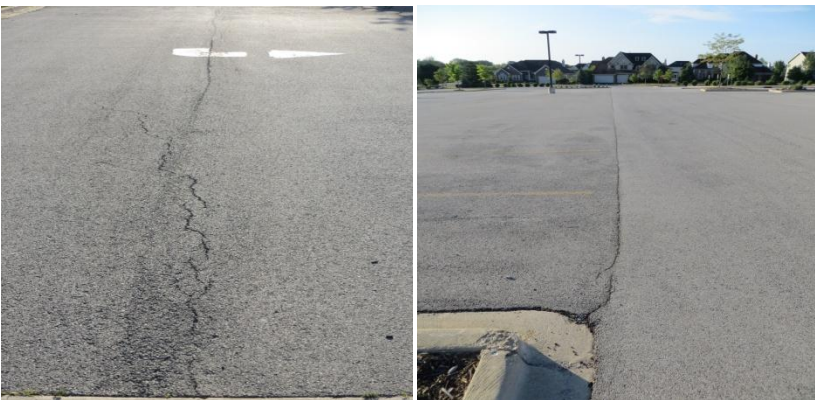
Parking Lot

Several areas starting to show cracking. Crack filling and seal coating will be needed within the next five years.

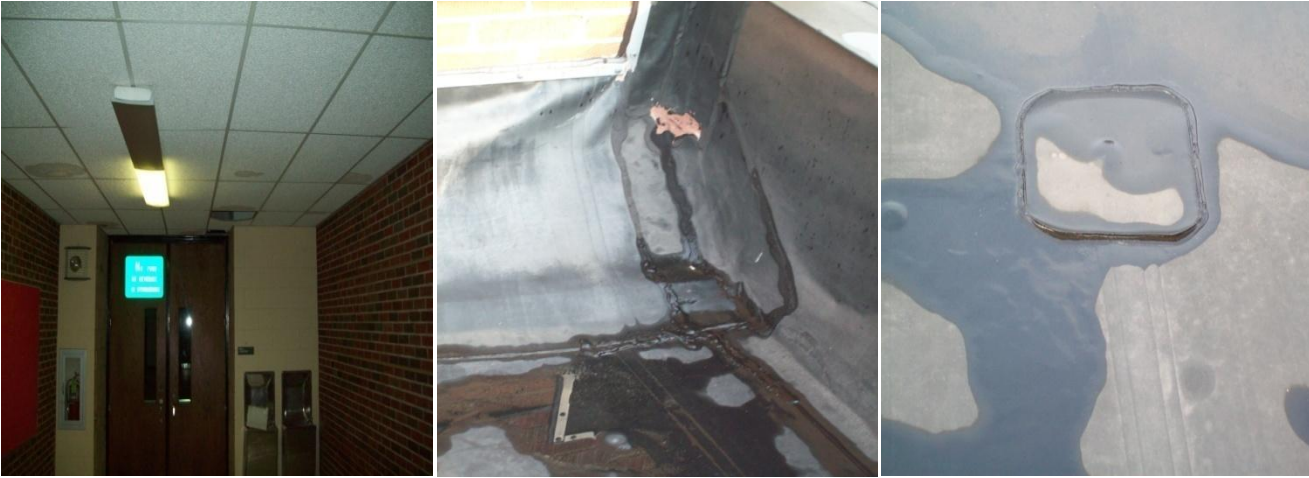
The original **roof** was constructed with single-ply membrane roofing with rigid insulation on wood decking on wood rafters and steel beams. The additions are single-ply membrane roofing with rigid insulation on steel decking on steel joists and beams. Most of the roof is in good condition. Regular maintenance will prolong the life of the good roof. According to the life-safety report of 2005, approximately 20% of the roof needs replacing. We are experiencing leaks in these areas, including the cafeteria area.

Roof – Several leaks throughout. Rubber membrane is beginning to fail, patches are coming apart.

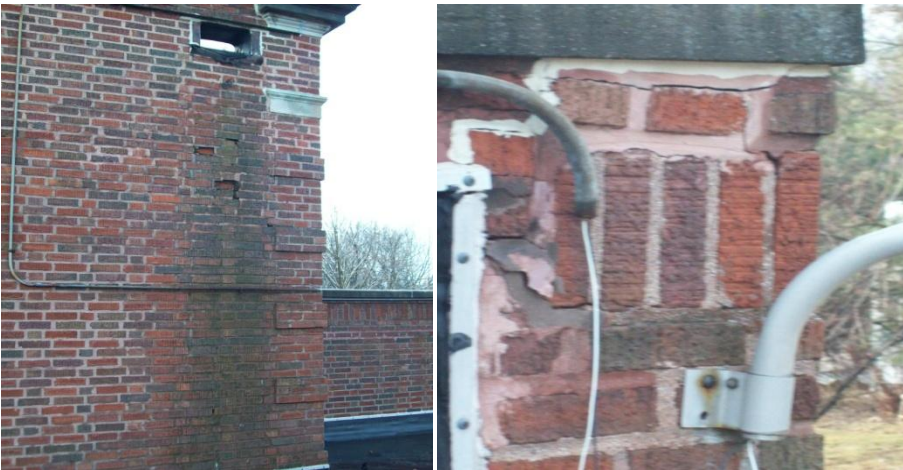
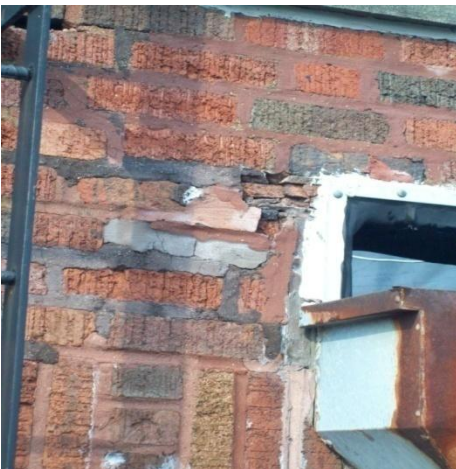
The **exterior** was originally constructed of solid masonry bearing walls with face brick. The additions are masonry cavity walls with face brick on the exterior and concrete block on the interior. The exterior brick is generally in good condition. Some areas need to be **tuckpointed**, especially in the courtyard area to the south, where water has infiltrated into a classroom causing deteriorating plaster. The plaster fascias in the 1968 and 1974 additions show signs of wear and are in need of repair.

Tuck Pointing – Much of the outside brickwork needs tuck pointing. Many cracks and disintegrating brick allow moisture in the building leading to crumbling plaster.

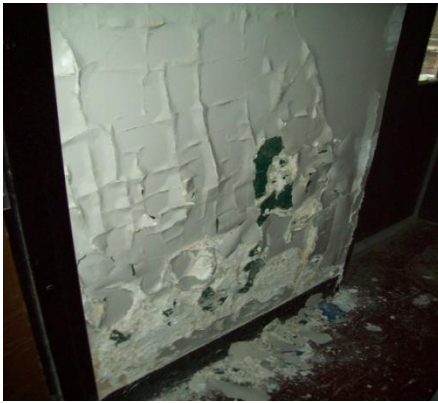
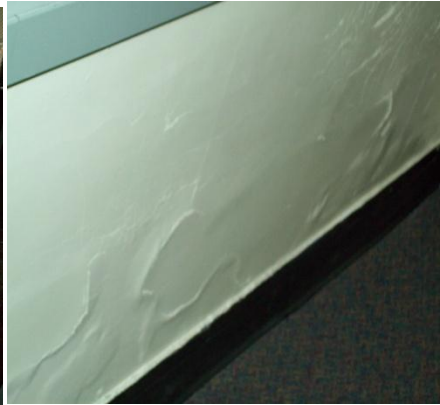
Crumbling Plaster

Due to moisture getting into the building

Tuck Pointing will alleviate this problem

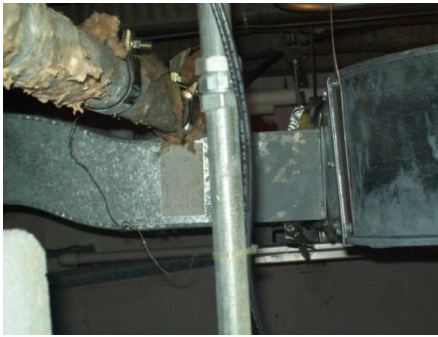
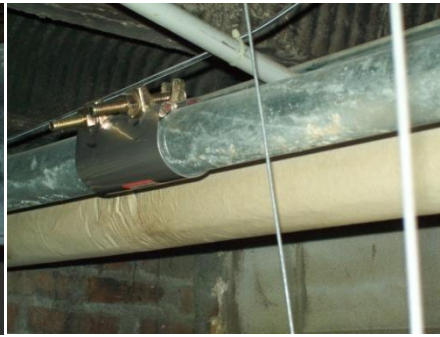
Domestic Water Piping

The building's **domestic water system** is galvanized steel piping. There are many leaks that have been repaired with clamps and the scale build up has reduced pressure and flow availability and the entire system needs to be replaced. The water fountains throughout the building are not ADA compliant.

Utilized pipe clamps to stop leaks throughout.

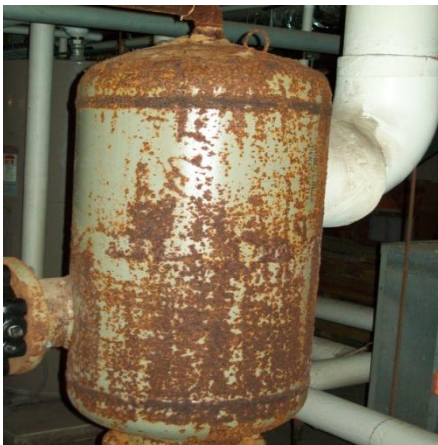
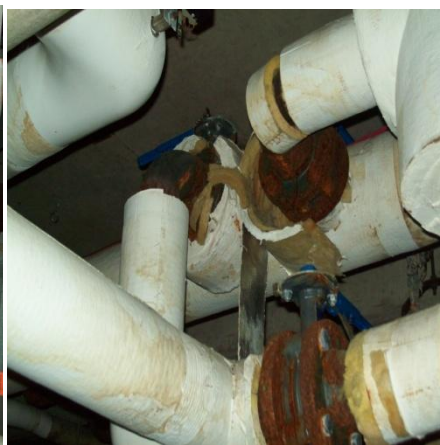
HVAC Piping

Air separator, heating valves and pipe showing signs of excessive rust.

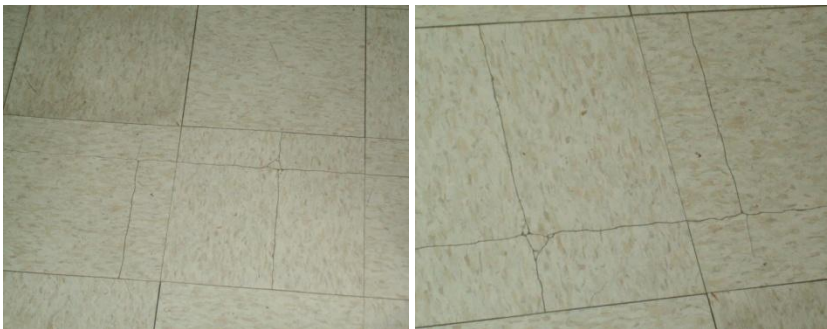
Floor Tile

12" x 12" VCT over 9" x 9" Asbestos tile. Tile is cracking and the 9 x 9 is showing through. Will have to be encapsulated or remediated.

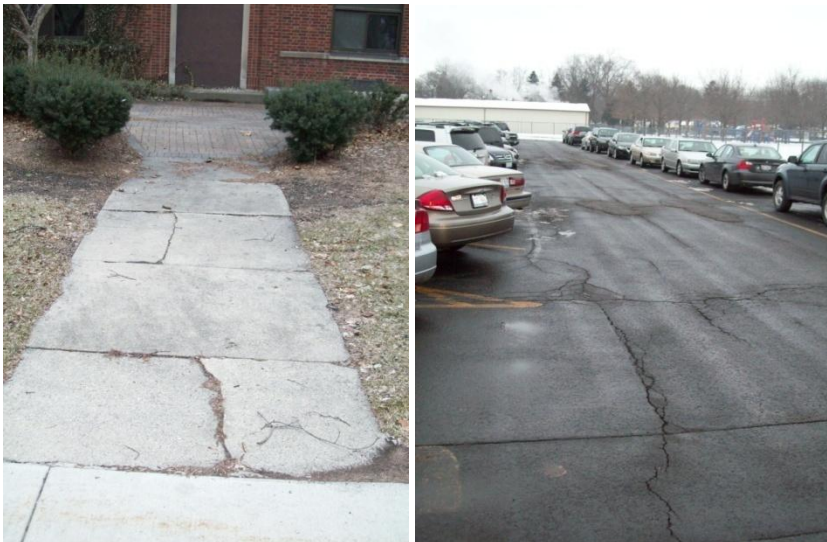
Sidewalk and Parking Lot

The surrounding concrete **sidewalks** show cracking and spalling and repairs are needed. The **parking lot** to the northeast was patched and seal coated last summer, but will need to be resurfaced in the next five (5) years.

Sidewalks are in need of repair or replacement.

Parking lot is in need of patching or replacement. Was patched and seal coated last year.

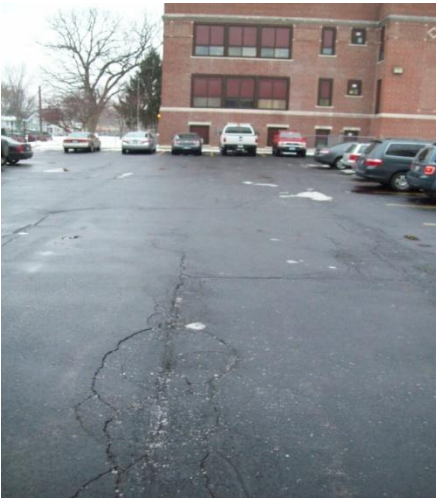
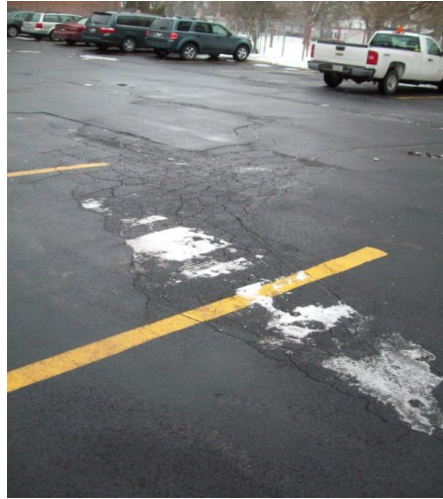
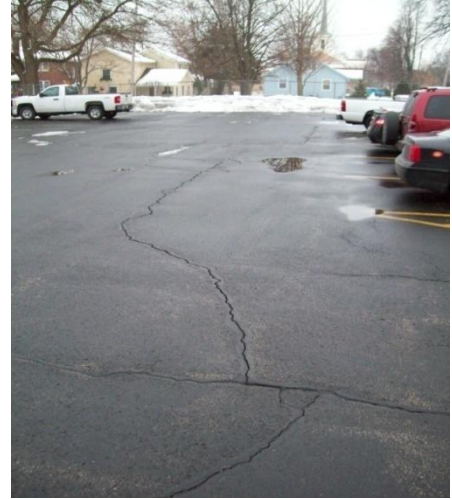
Parking Lot

Several areas need patching. The entire lot may need to be replaced within 5 years.

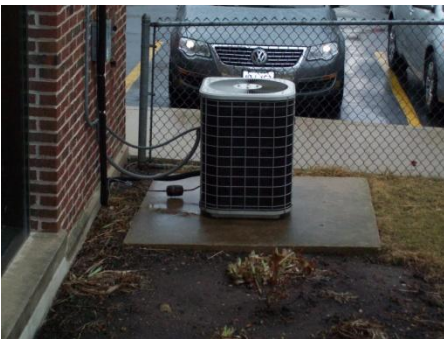
Typical Condensing Unit

The entire building is cooled with individual residential condensing units. Several are beginning to fail and most will need to be replaced in the next 5 years.

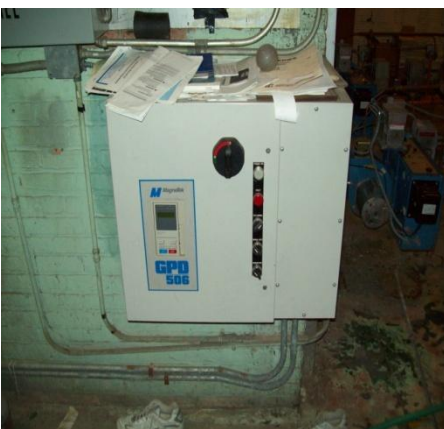
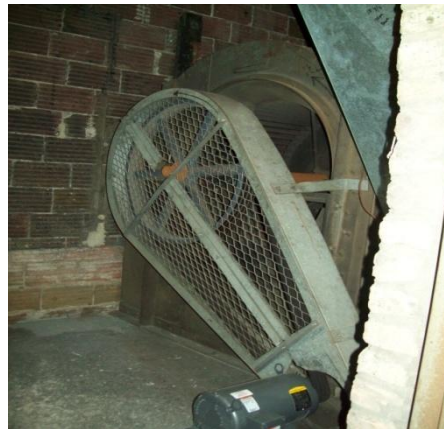
VFD and Fan for the Furnace

VFD doesn't work and fan for furnace is at least 35 years old.

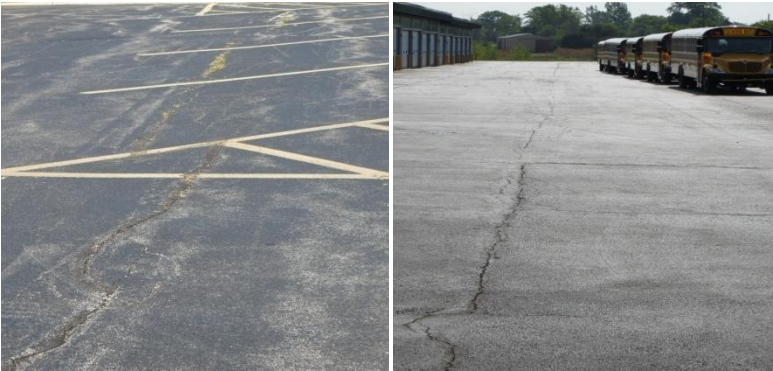
Parking Lot

Several areas starting to show cracking. Crack filled and seal coated two years ago. Crack filling and seal coating within the next five years.
