# Additional Observations @ Administration Building, Lincoln Hall and Rutledge Hall

6950 E Prairie Rd, Lincolnwood, IL 60712

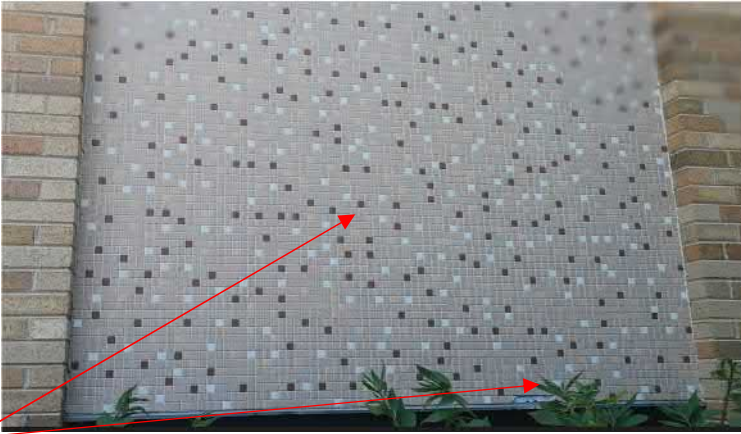
*Figure 1: Some tiles coming off at the base that need to be replaced with new. All tile accent fields in need of a 'mortar wash'.*

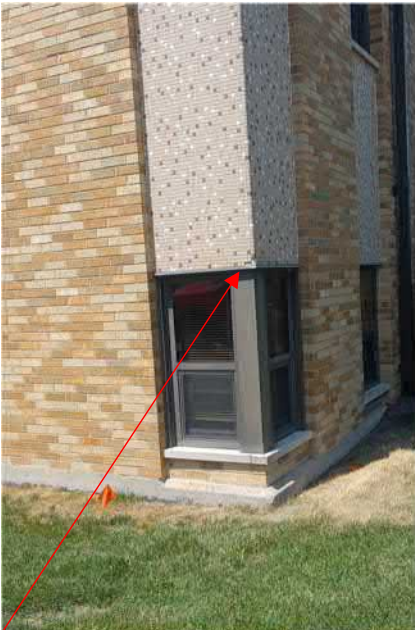
*Figure 2: Some tiles coming off at the base that need to be replaced with new. All tile accent fields in need of a 'mortar wash'.*

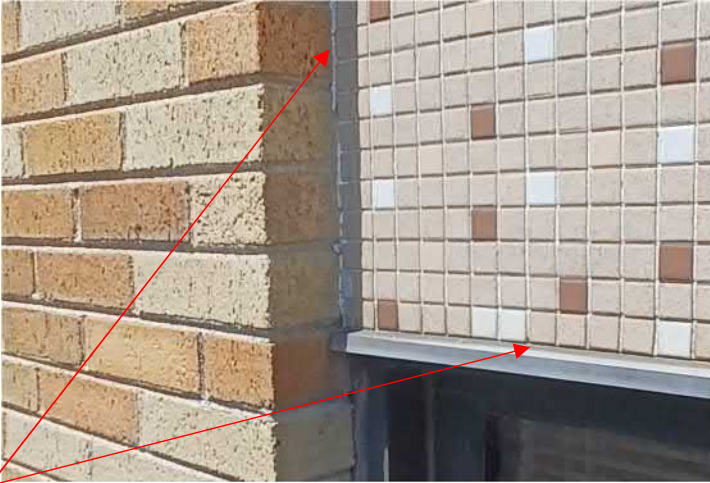
*Figure 3: Tile accent fields in need of a 'mortar wash'. Corners will need to be resealed. Brick masonry in generally good repair.*

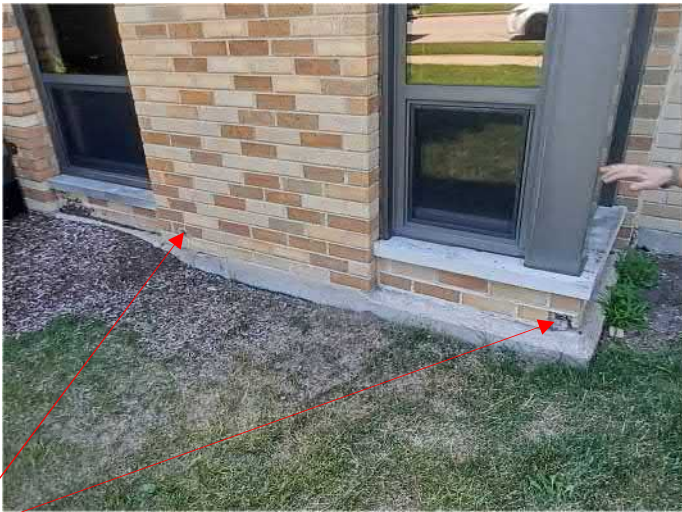
*Figure 4: Some broken bricks and mortar joints in need of repair. Cast stone sills, in need of power washing and re-pointing and sealing of joints.*

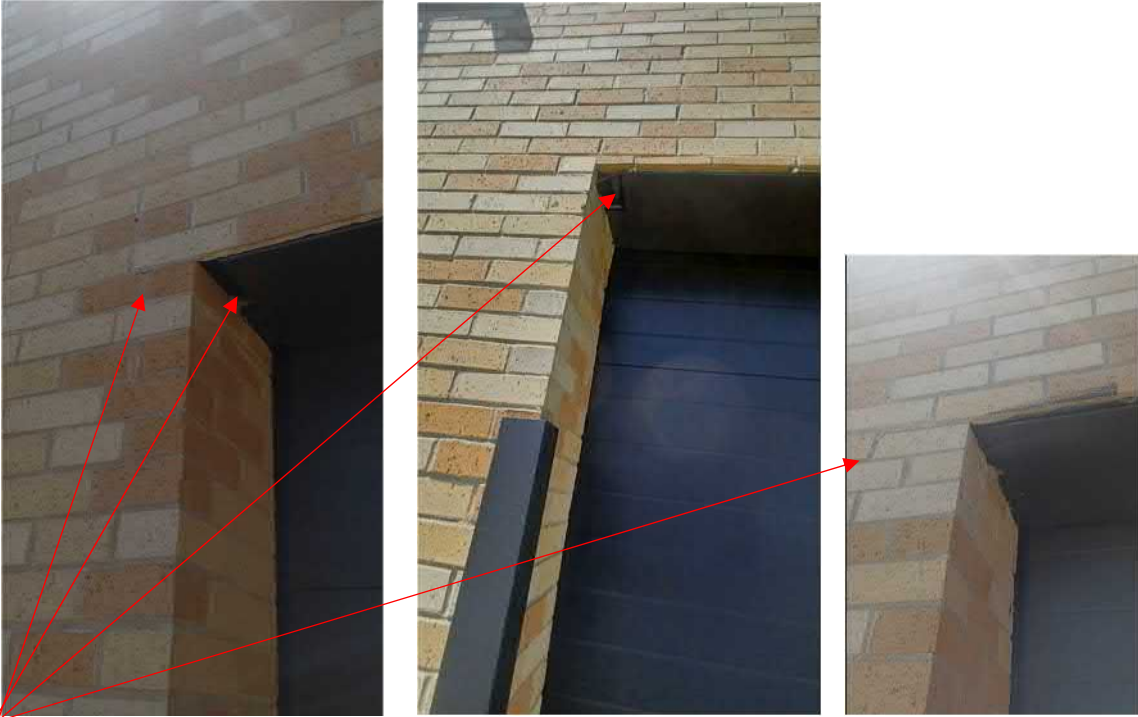
Figure 5: Some cracking mortar and bricks at bearing ends of lintels. Brick ledge/plate several inches short of wall @ over head doors.

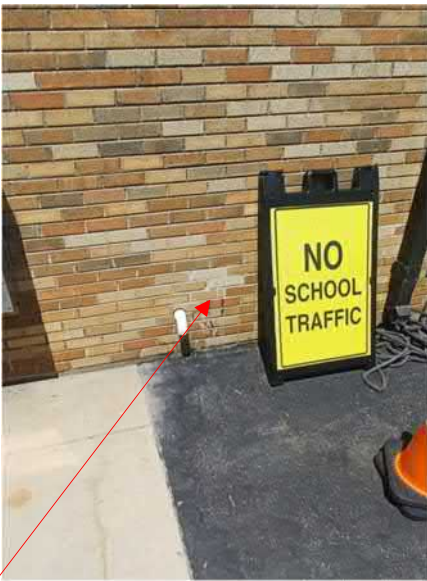
Figure 6: Small area of brick needing tuckpointing and cleaning.

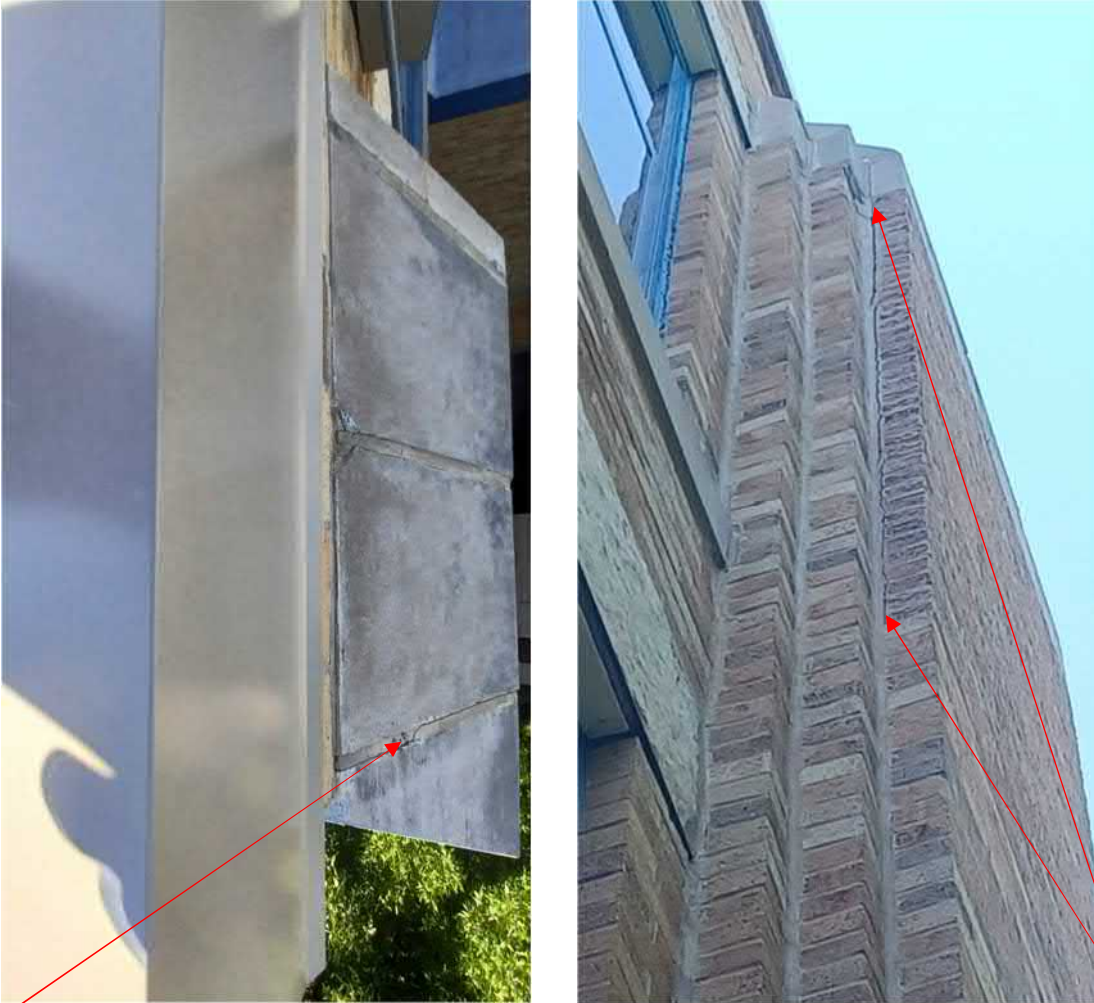
Figure 7: Top, stone cap of brick pier, some cracking of mortar joints, tuckpointing of large crack in joints will be needed. East side of pier, large crack at the top of the pier. Possible separation of bricks, anchor failure etc., more investigation required.

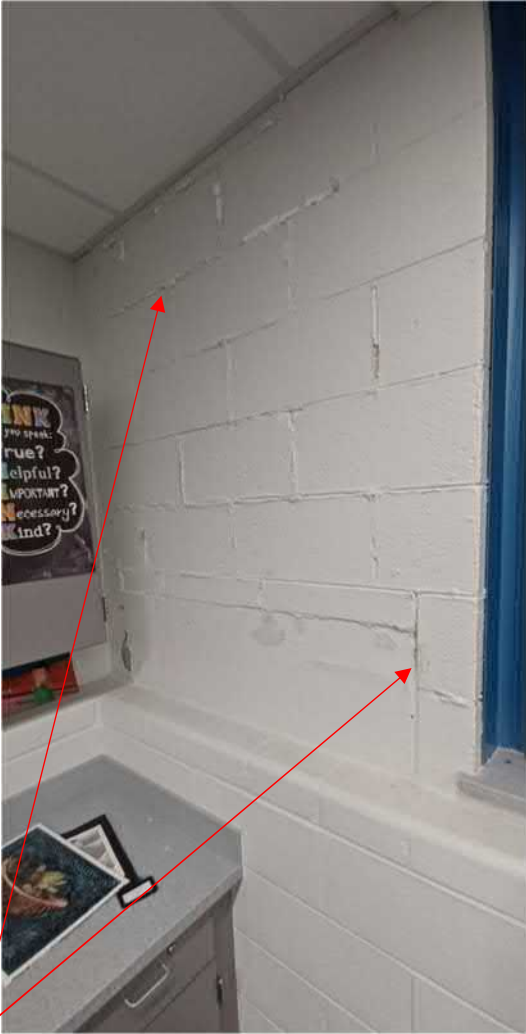
Figure 8: Water damage evident at interior CMU, in classroom @ bottom of brick pier.

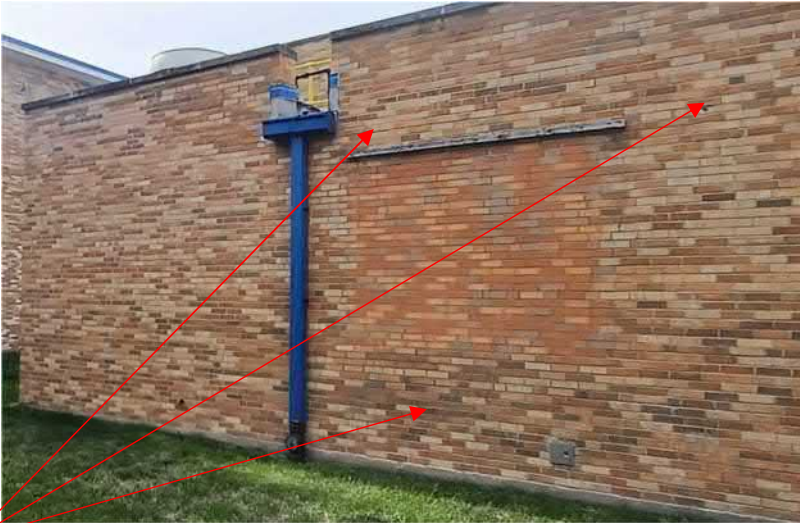
*Figure 9: Area of brick in need of tuckpointing. Broken brick in need of replacement. Cast stone 'intel' in need of power washing and joints tuck pointed and sealed. note: Stone parapet caps (above) will be capped in metal when roofing is replaced in the future.*

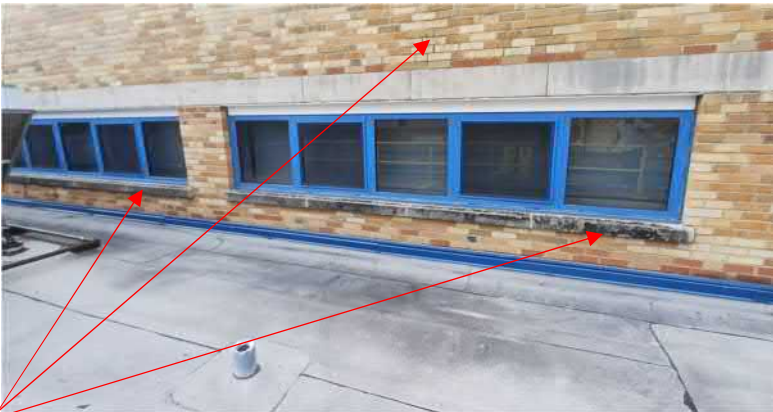
*Figure 10: Areas of brick and cast stone sills (around roof #10, and in the courtyard) in need of tuckpointing, power washing and sealing.*

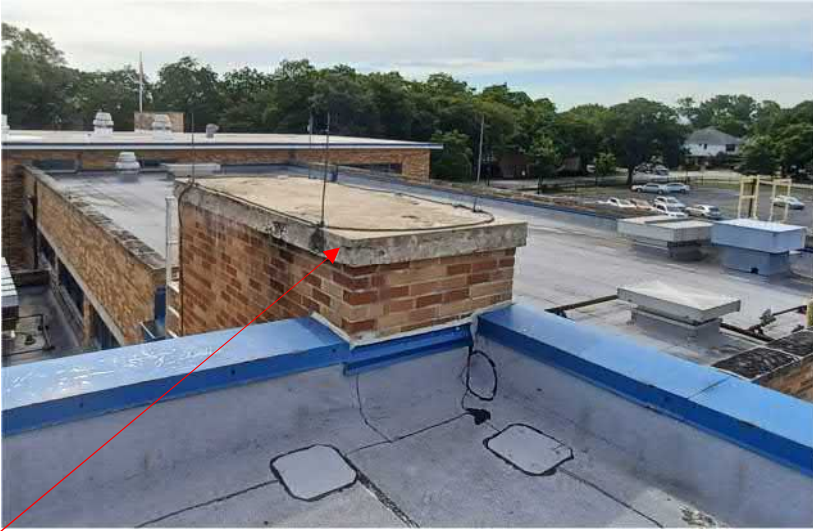
Figure 12: Deteriorating stone chimney cap, (To be replaced in base bid master planning work.)

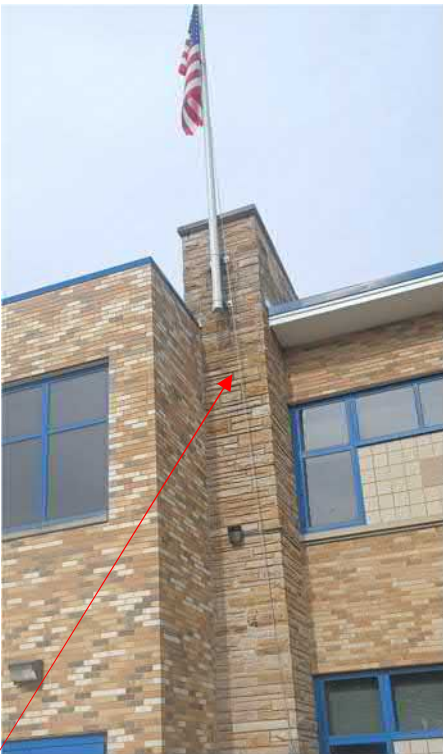
Figure 13: Limestone pier/parapet on the roof, as seen from below.

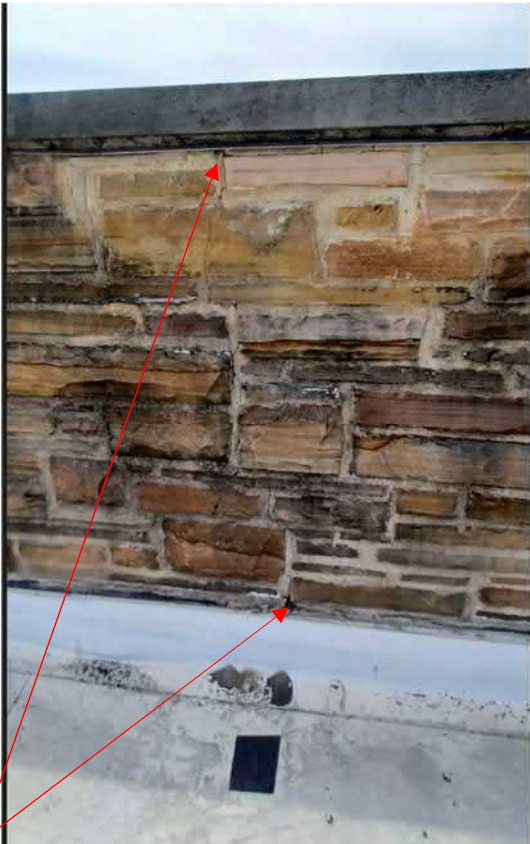
Figure 15: Areas of cracked and broken limestone in need of repair, tuckpointing and cleaning.
