Site Findings for Daniel Wright

Site Findings for Sprague

Site Findings for Half Day

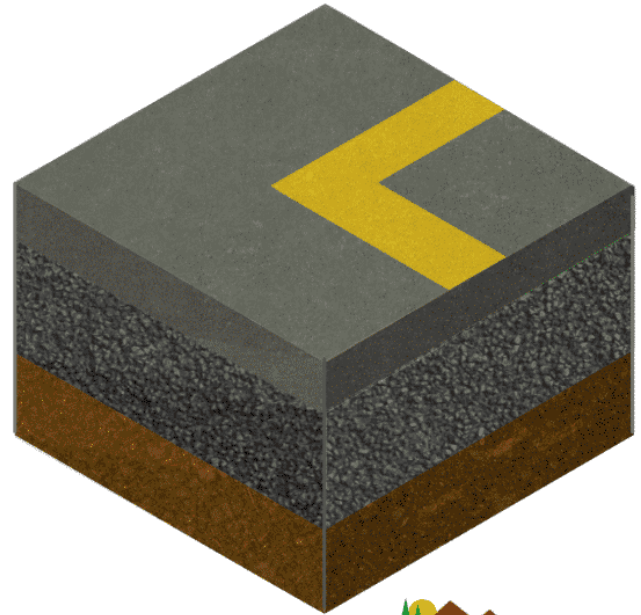
TYPICAL ASPHALT PARKING LOT Cross Section

“Alligator Cracking” and potholes like we find at Daniel Wright are indicative of an eroding compacted aggregate subgrade.

Once the subgrade material is impacted, gross removal is necessary to reconstruct the subgrade before new asphalt is laid.

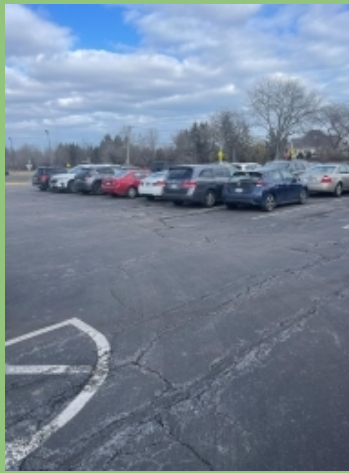
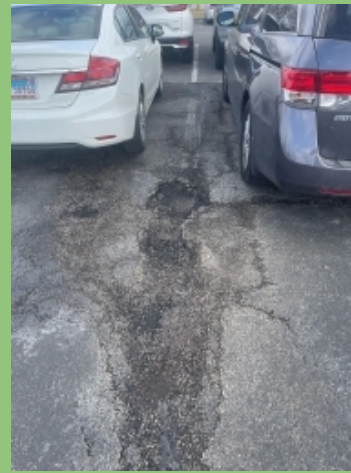
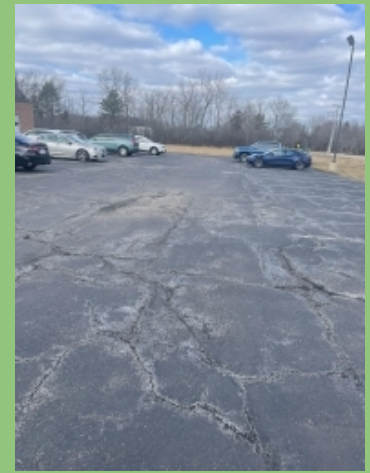
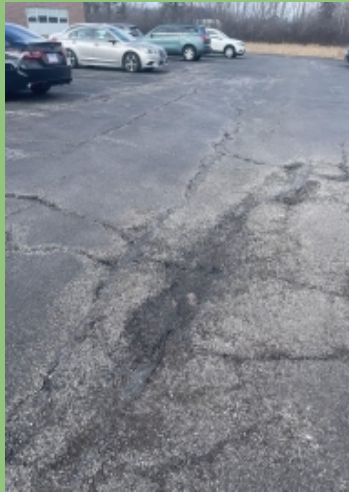
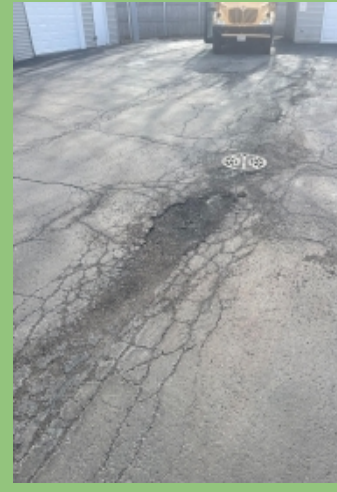
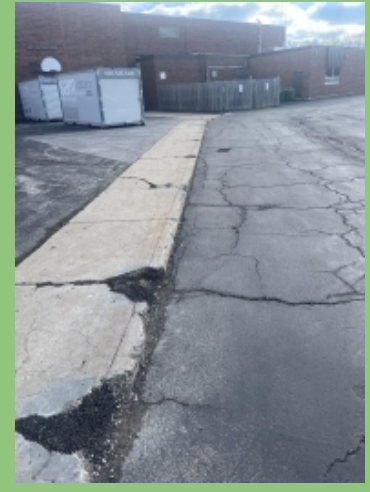
This winter has revealed that the deterioration of the parking areas at Daniel Wright has worsened exponentially.

The parking lots and sidewalks are showing signs of severe disrepair and are in need of replacement.

The current condition of these lots indicate that a complete reconstruction will be needed. Less invasive methods would not be effective at this point.

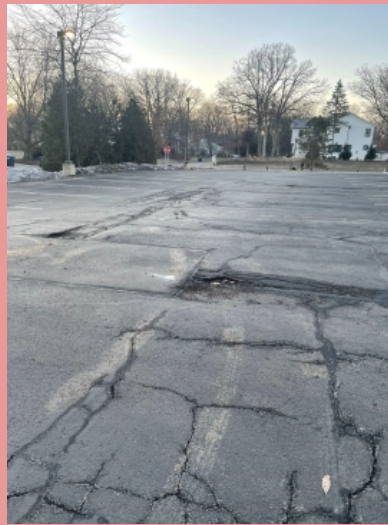
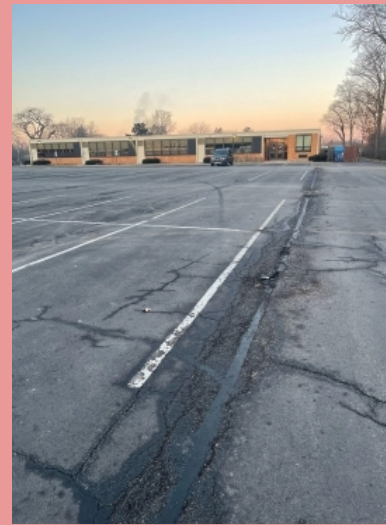
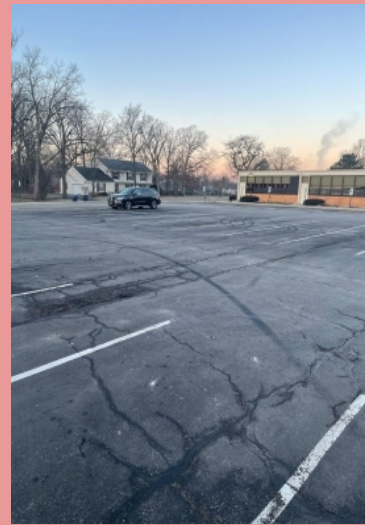
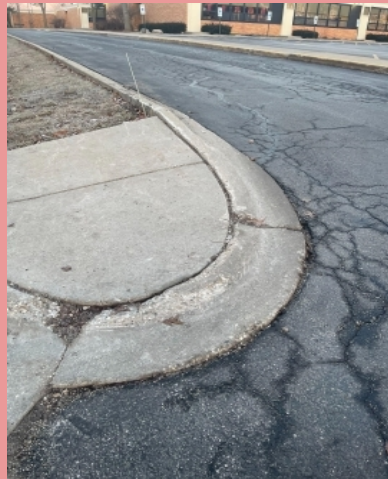
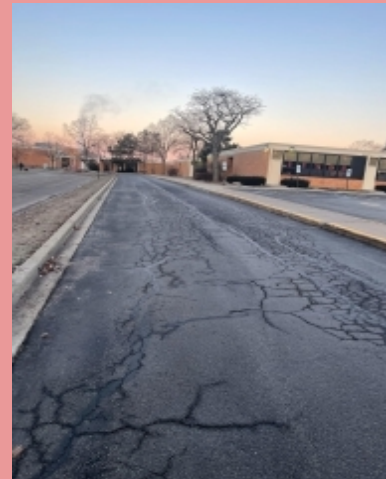
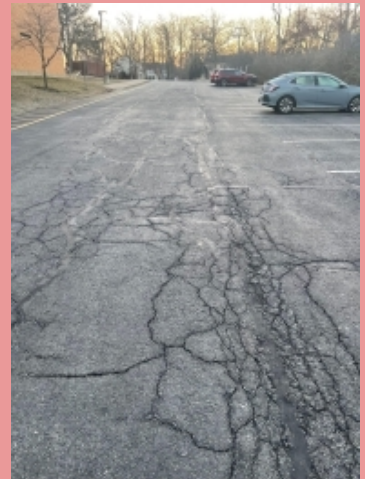
The parking areas at Sprague continue to endure challenges. All parking areas show signs of excessive wear and indicate replacement is necessary.

Direct replacement may not be our best option here as we know the parking areas are in need of the following:

- Additional spaces (up to 25)
- Traffic flow redesign
- Reconstruction of bus lane
- Stormwater detention considerations that come with expansion

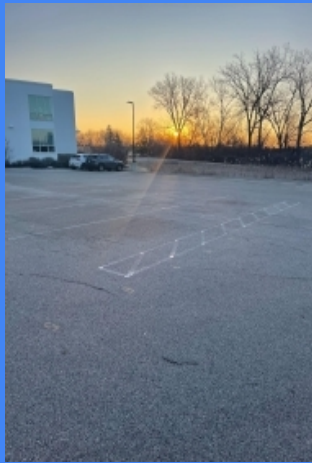
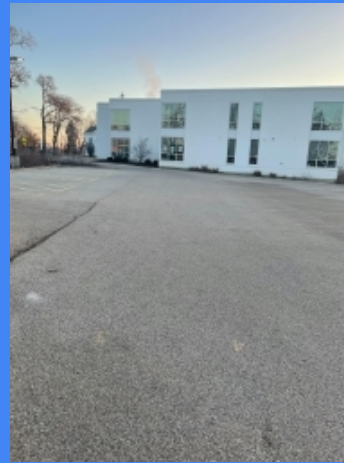
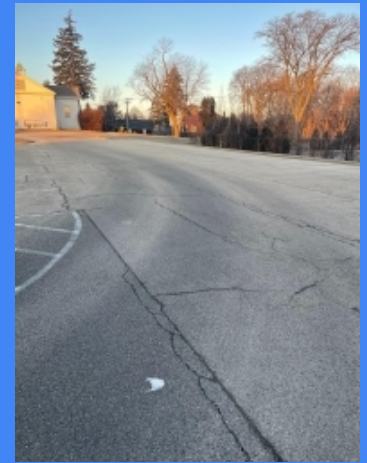
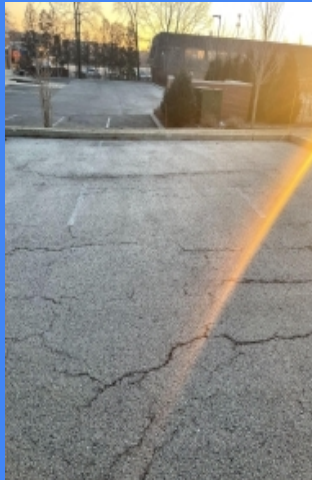
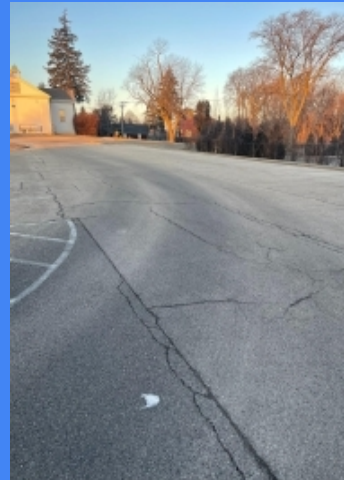
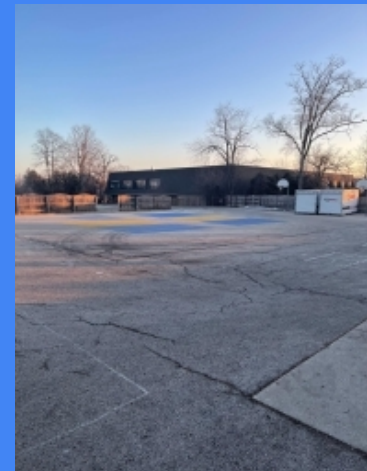
The parking surfaces at Half Day School are in overall good condition. The application of seal coating (pavement rejuvenation) would help extend the life of the current surfacing.

The hard play area, also used for bus drop off, is in slightly worse condition from the constant bus traffic and its replacement will need to be considered in the near future.

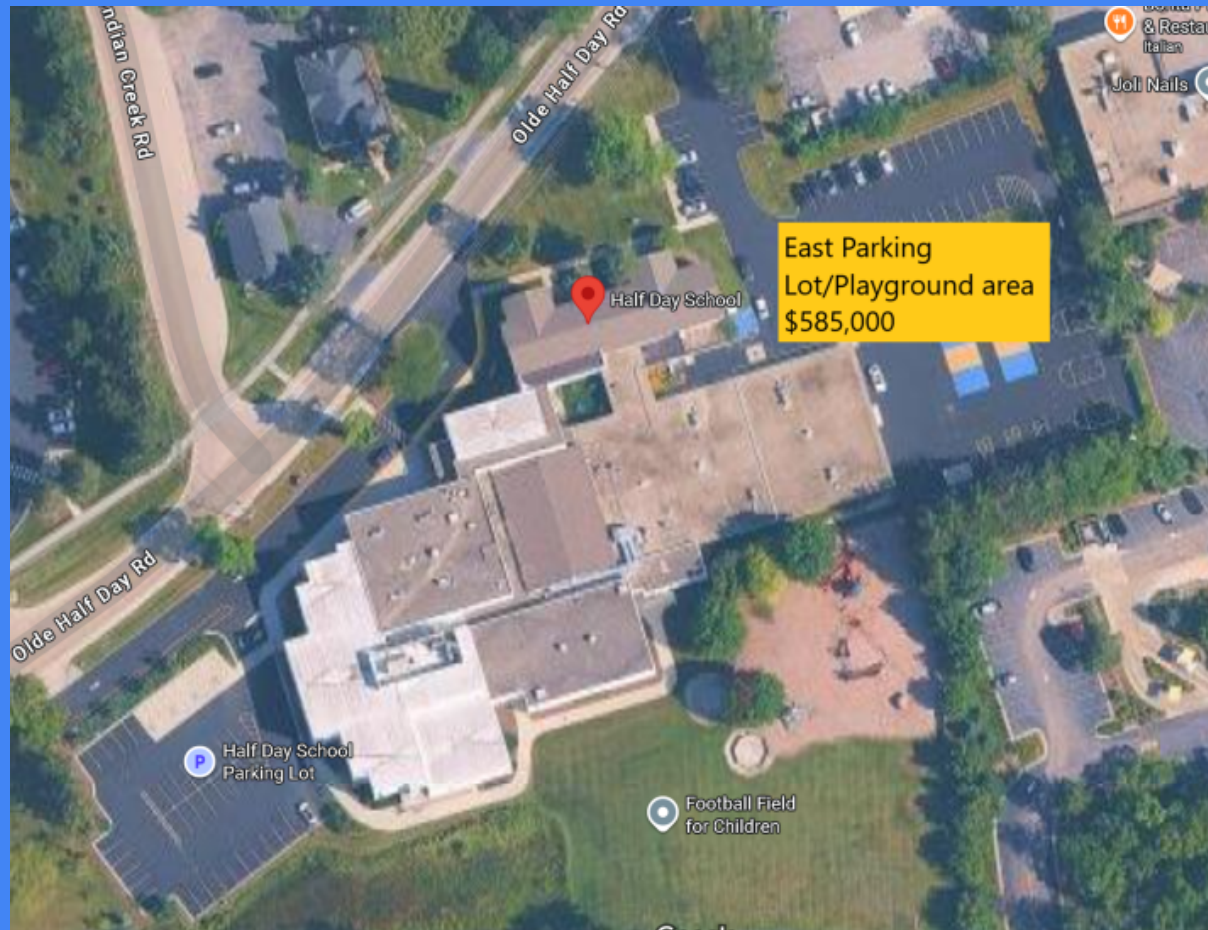
The parking surfaces at Half Day School that would benefit from replacement is the East lot/Playground area.

This area experiences more wear and tear than the west lot due to the bus drop off area, garbage dumpster locations, and receiving most deliveries on this side of the building.

Estimated cost to replace this area of parking lot is \$585,000.
