Geneva Community Unit School District #304
Operations and Maintenance
7 Year Capital Improvement Plan

Board of Education

February 26, 2018

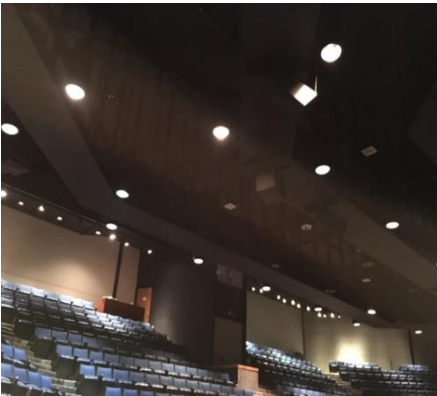
Auditorium Lighting Replacement

Parts for lighting panel are becoming obsolete and starting to fail.

Replace with energy efficient fixtures and lighting panel.

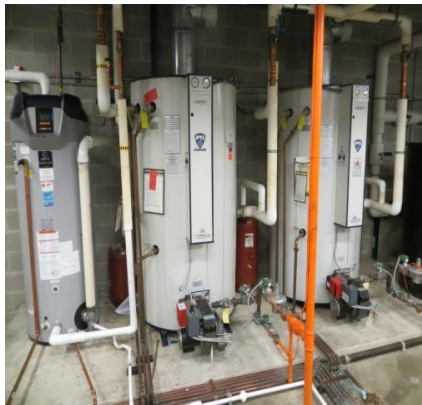
Hot Water Heaters

The two 500 gallon PVI water heaters are nearing the end of their life cycle.

Replacement will be needed within the next seven years.

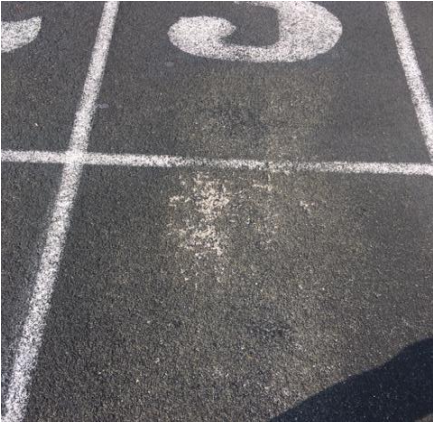
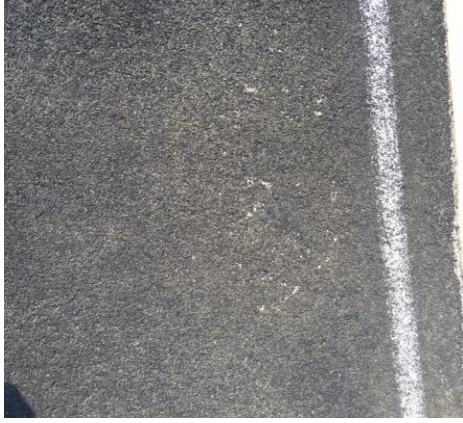
Track Resurface

The track is starting to show excessive wear and nearing the end of its estimated life cycle.

Replacement will be needed this year.

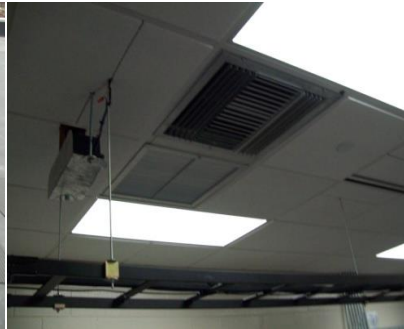
IT Server A/C

Oversized for heat load of space.

Cycles on and off continually causing condensation issues and premature equipment failure.

Replace with properly sized unit.

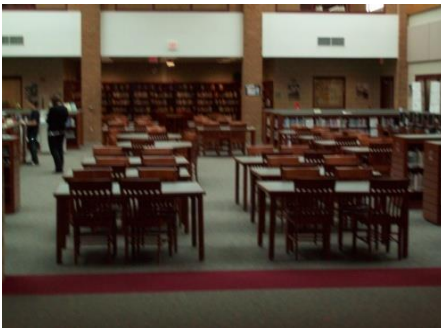
LMC

AHU is undersized for space.

Only two VAV boxes serving the space.

Recommend increasing the capacity of the AHU and adding four to six VAV boxes with controls to increase comfort and control humidity.

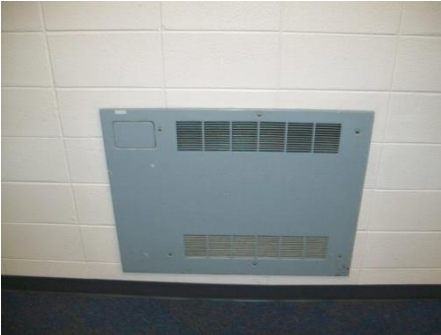
Cabinet Unit Heaters

9 units are over 22 years old.

Replace with energy efficient units.

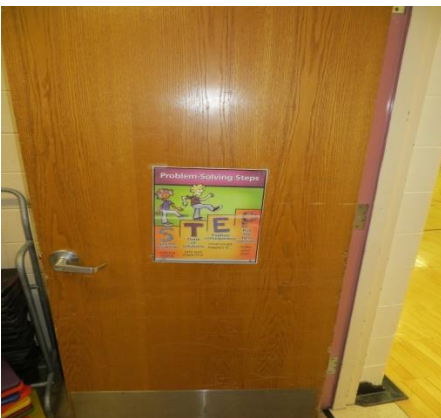
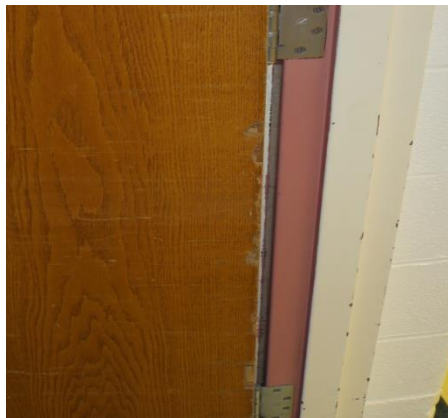
Interior Doors

Several doors in the building are damaged and in need of replacement.

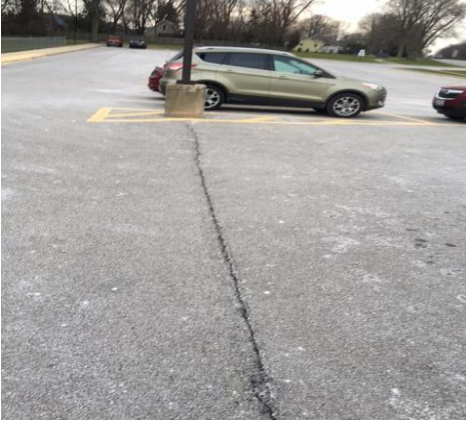
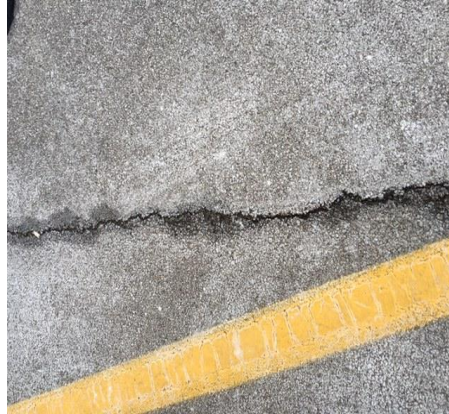
Parking Lot

Several areas are starting to show cracking and wear.

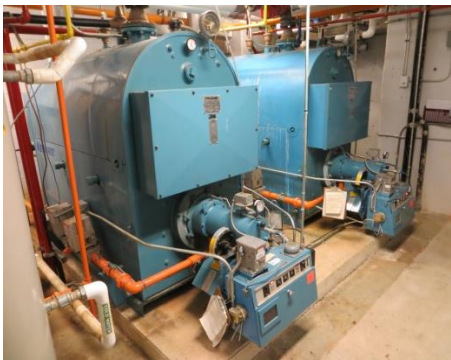
Boiler Replacement

Boilers are 22 years old and original to the building.

Nearing the end of their estimated service life as per ASHRAE.

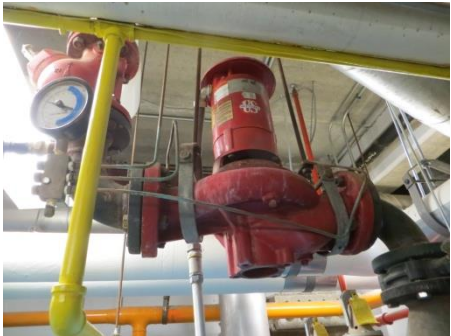
Primary Boiler Pumps

Original to the building.

Need replacing with energy efficient design.

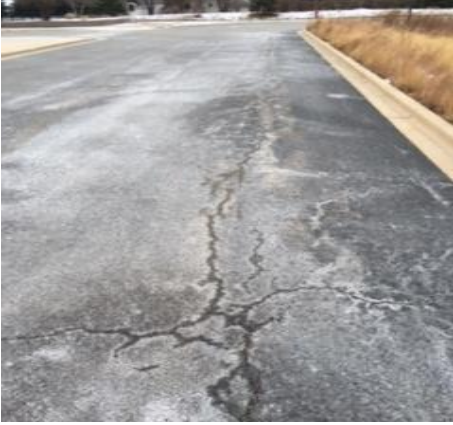
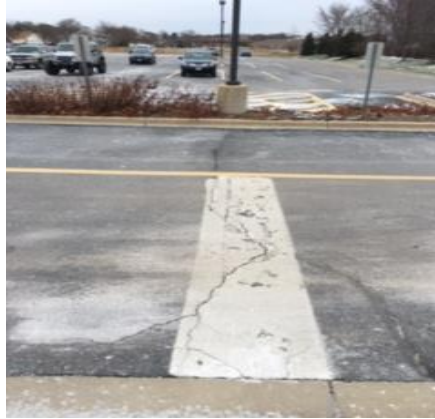
Parking Lot

Several areas are starting to show cracking and wear.

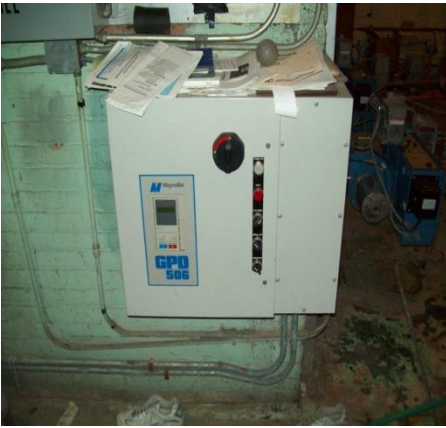
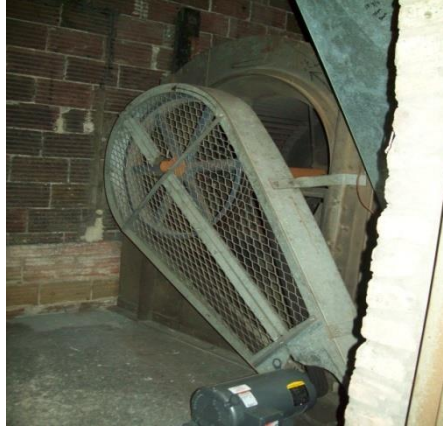
VFD and Fan for the Furnace

VFD doesn't work and the fan for the furnace is at least 39 years old.

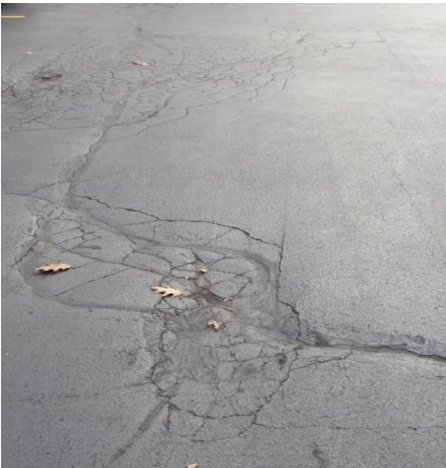
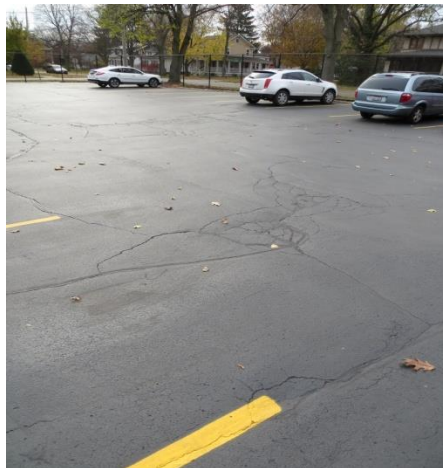
Parking lot

Several areas with extreme cracking.

Resurfacing will be needed.
