Brackett ISD Annex Facilities Assessment

July, 2014

Brackett ISD Annex

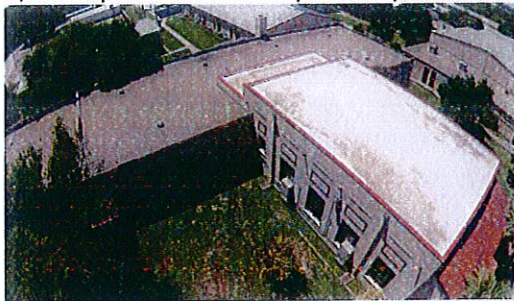
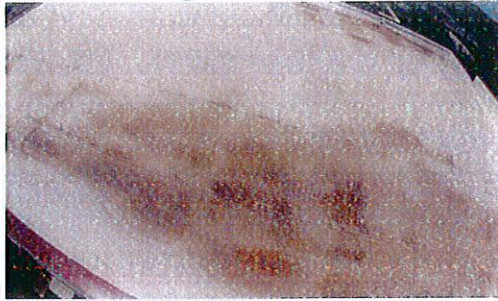
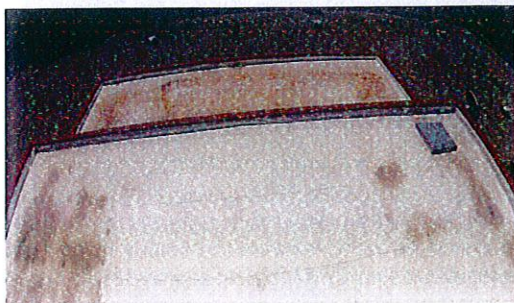
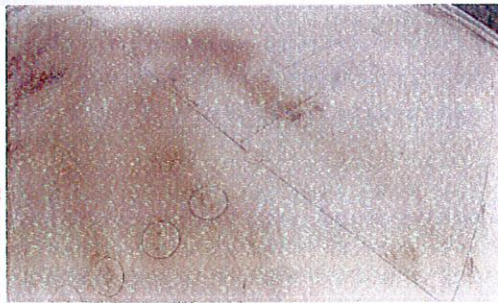
- 3,300 square feet of vinyl roof system over auditorium in good condition.

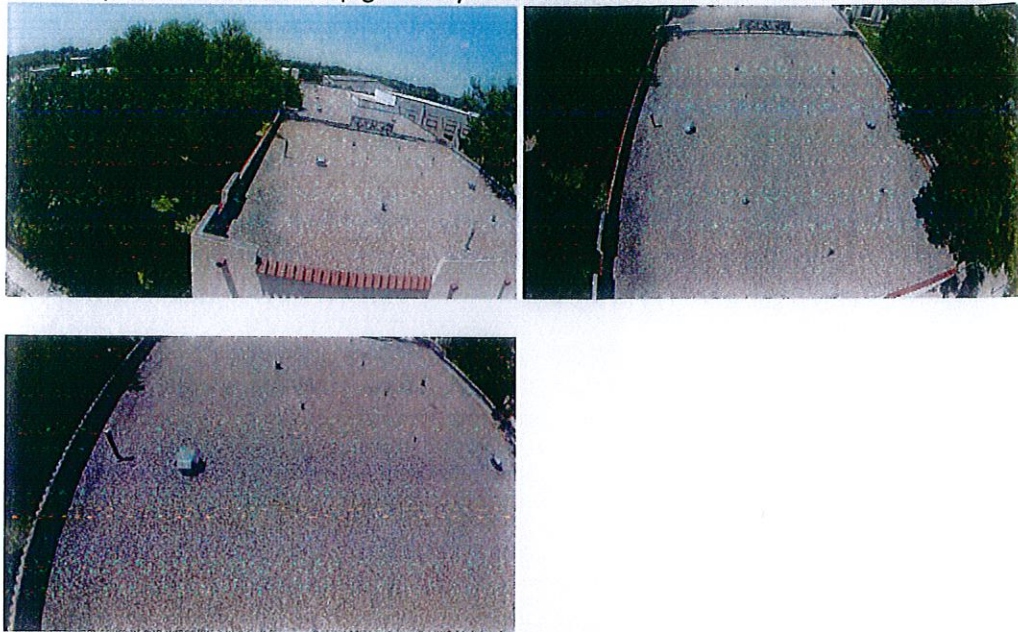
- 9,700 square feet of built-up gravel system over halls and classrooms in condition.

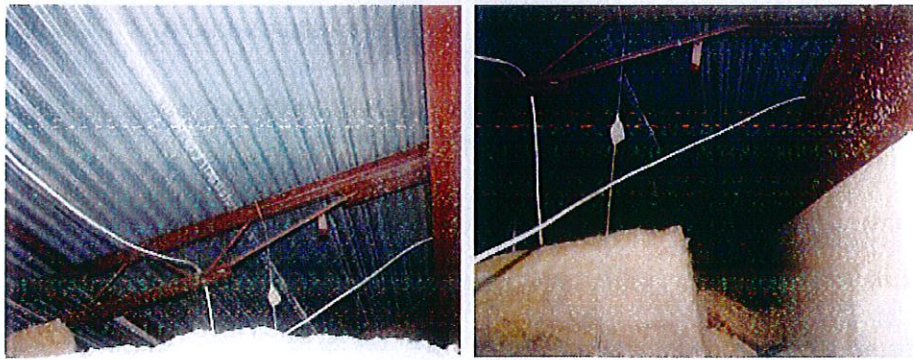
- Above ceiling on the north end of the hall. Metal roof deck appears to be in good condition.

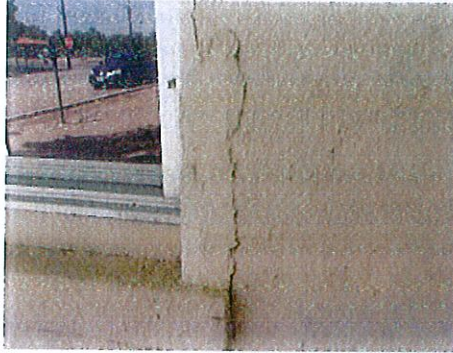
Crack at northwest

- Minor cracks throughout the exterior concrete stucco finish. Repair and maintain as necessary to prevent rain penetration.

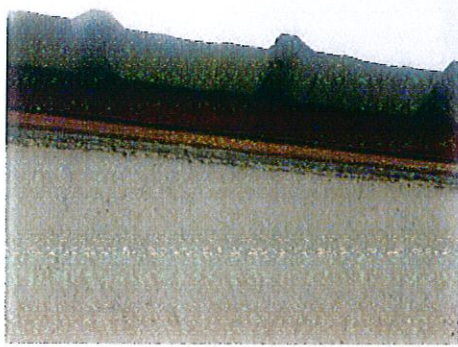
- Rotting fascia on west side of science storage room. Replace immediately to prevent energy loss, entry for pests, and rain penetration.

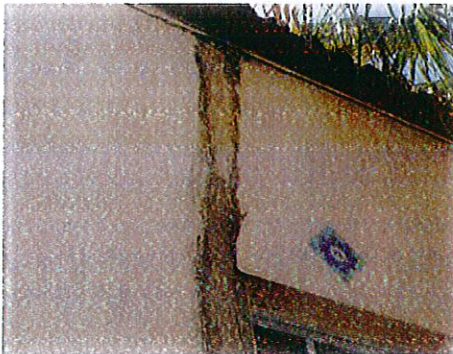
- Gutter leaking and staining exterior concrete stucco finish. Seal gutters and pressure wash stucco.

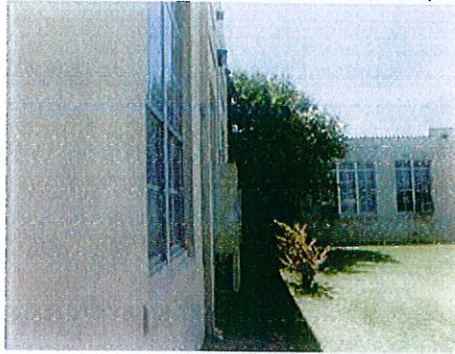
- Trim trees from walls and roofs to prevent damage to roof lines and fascia.

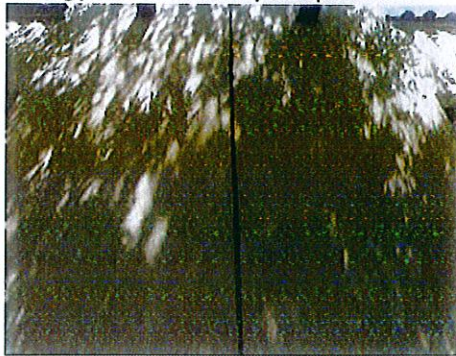
- Expansion joint at northeast should be filled to maintain integrity of joint, prevent energy loss and entry for pests.

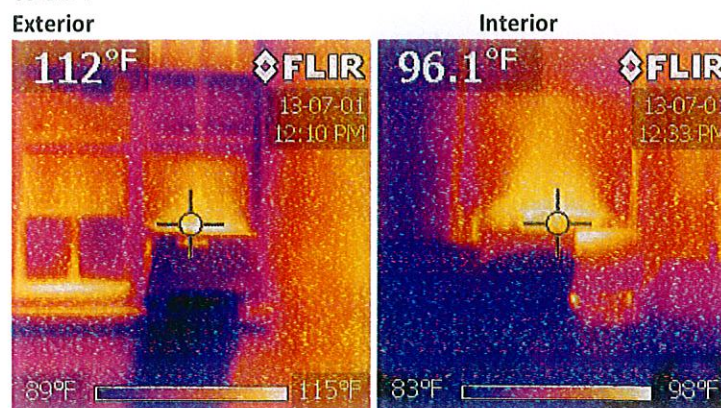
- Aluminum single pane windows – Most are in fair/good condition. Failing windows should be immediately replaced to prevent energy loss and access for pests to enter the building. Consider replacing all windows with double pane Low-E rated windows during in future major renovation. Return on investment for window replacements is 20 + years so it should only be done when other major renovations are occurring.

Room #8 – The thermal imagery pictures below showing a temperature range from the exterior of the window from 89° to 115° and the interior of the window from 83° to 98°.

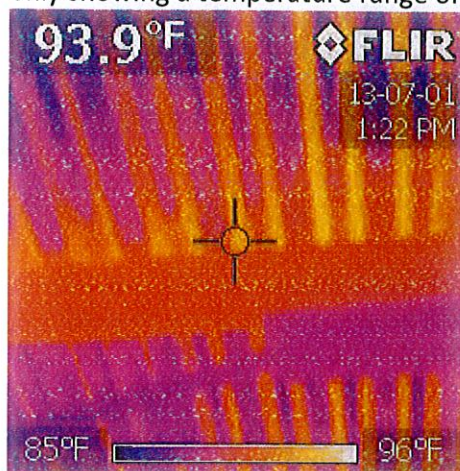
- Thermal image of the roof deck at the north end of the hall in good condition and only showing a temperature range of 85° to 96°.

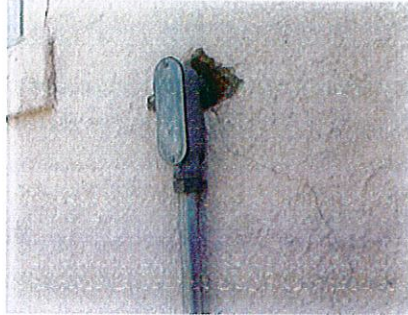
- Some electrical retrofits have occurred in 1990 when wall hung Bard units were installed in the auditorium, another around 2002, and approximately a year ago. However, it doesn't appear that all building wire was upgraded or replaced and should be considered.

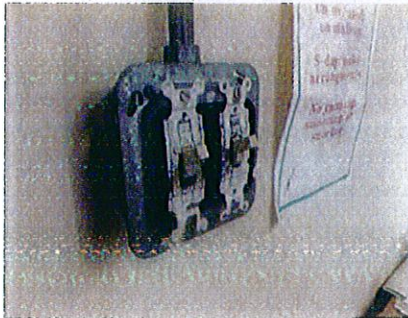
- Missing switch plate should be covered for student safety and to prevent arching.

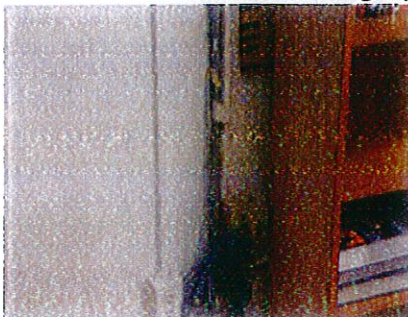
- Ms. Frerich's Classroom – Data cable is not ran in conduit. All data should be ran in conduit to maintain data integrity.

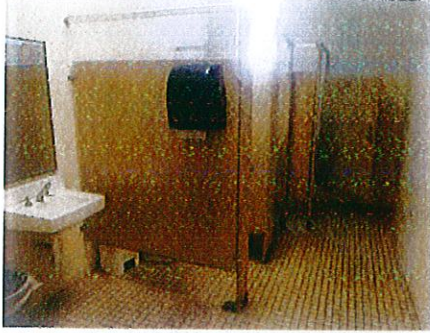
- Girls Restroom

- 3 Commodes in fair condition but should be replaced soon.
- Partitions are in poor condition and should be replaced.
- 2" x 2" ceramic tile is stained and in poor condition. Consider replacing with epoxy floor system to minimize maintenance and maintain an acceptable finish.
- Walls are concrete stucco and 4" x 4" ceramic tiles and are in need of repairs and paint. Consider replacing the ceramic tile with plastic laminate or fiberglass reinforced panels to minimize maintenance.

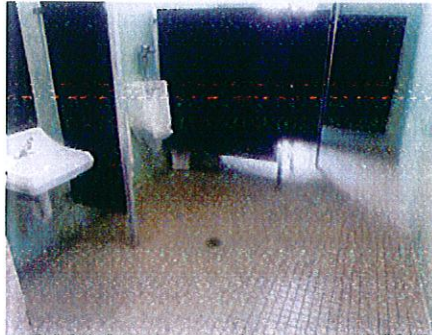
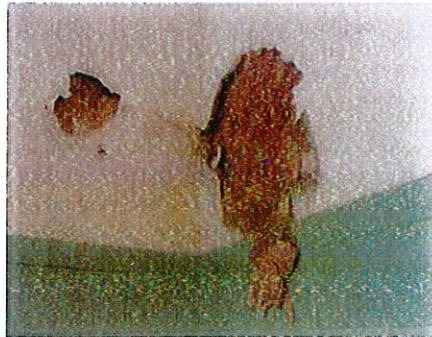
- Boys Restroom

- 2 Commodes are in fair condition but should be replaced soon.
- Walls are concrete stucco and 4" x 4" ceramic tiles and are in need of repairs and paint. Consider replacing the ceramic tile with plastic laminate or fiberglass reinforced panels to minimize maintenance.

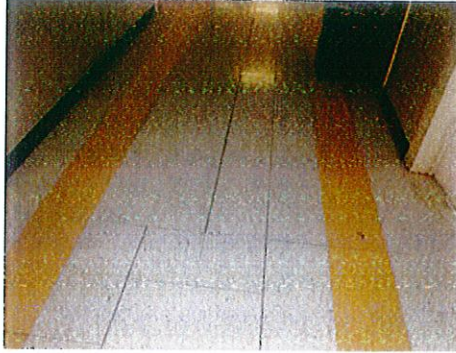
- Gaps and separation occurring throughout the 12" vinyl composition tile (VCT) floor in the hall. Replace VCT.

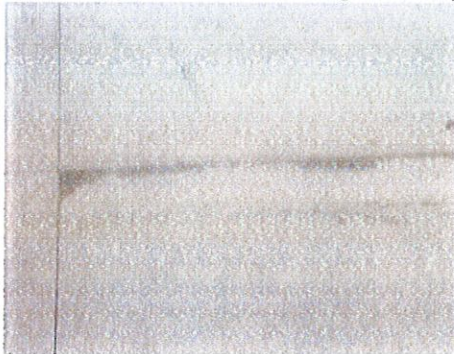
- Classroom 1 – Carpet is worn and stained and should be replaced with carpet tiles allowing individual tiles to be replaced in the future.
- Ms. Frerich's Classroom – 9" VCT flooring is chipped. Typically, 9" VCT is asbestos containing. Consider abating or encapsulating with carpet tile.

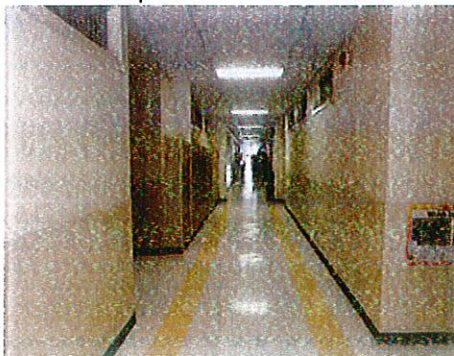
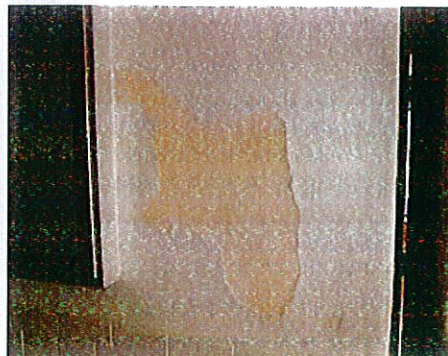
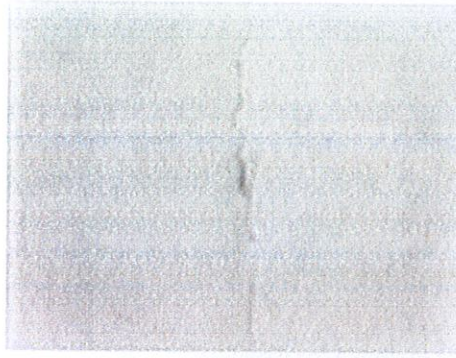
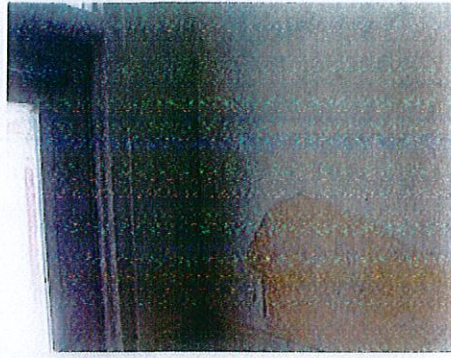
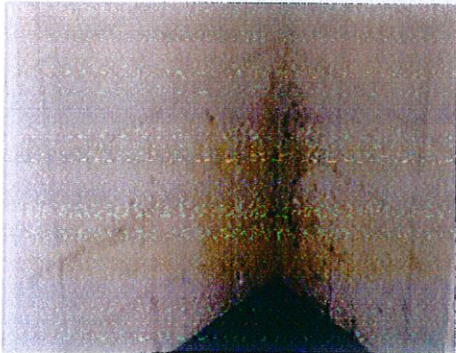
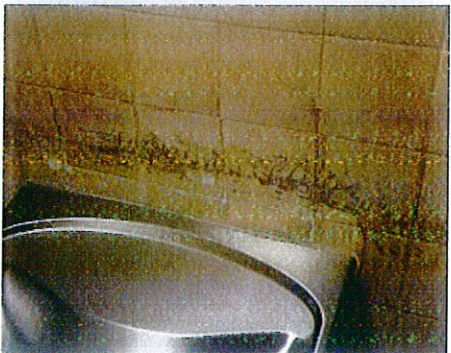
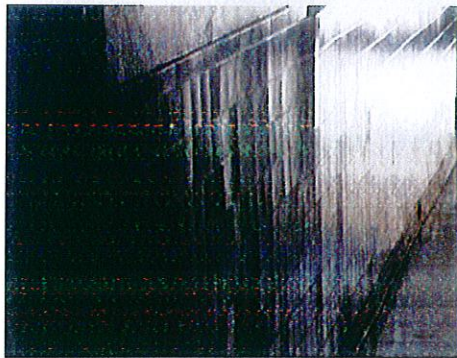
- Walls are concrete stucco and 4" x 4" painted ceramic tiles that are chipping and shifting due to wall movement. Consider replacing with plastic laminate or fiberglass reinforced panels to minimize maintenance.

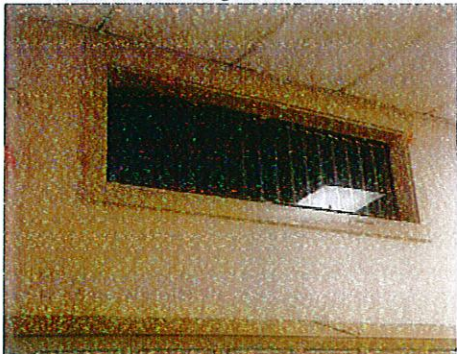
- Consider enclosing interior transom windows in hall for noise insulation.
