Geneva Community Unit School District #304  
Operations and Maintenance  
7 Year Capital Improvement Plan

January 23, 2017

## Introduction

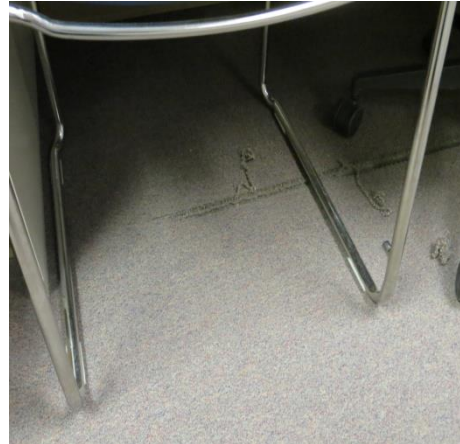
## Carpet

The carpet is starting to fray and cause trip hazards.

Carpet will need to be replaced.

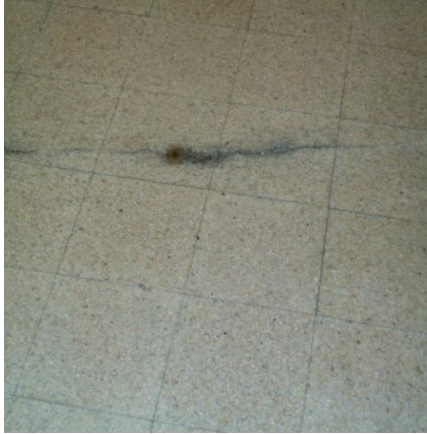
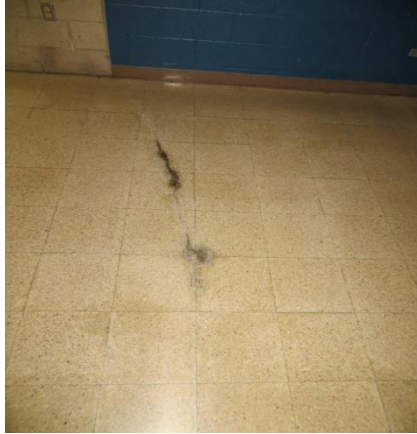
## Flooring

Existing quartz tile is cracking and has faded.

Replace tile in phases.

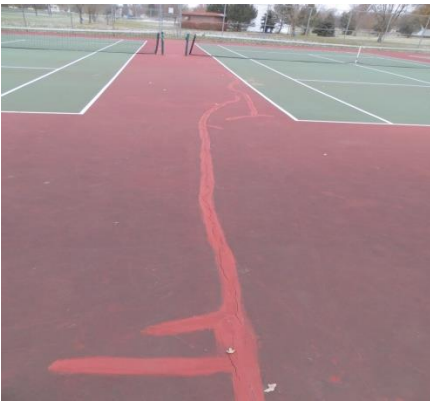
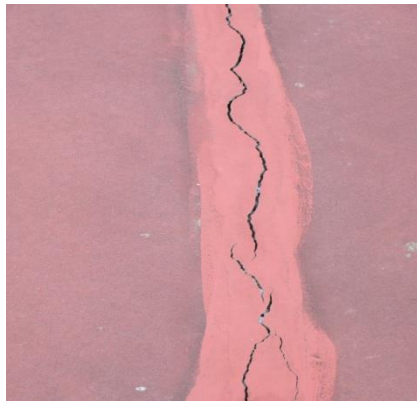
## Tennis Court Resurface

Cracks and patches throughout courts.

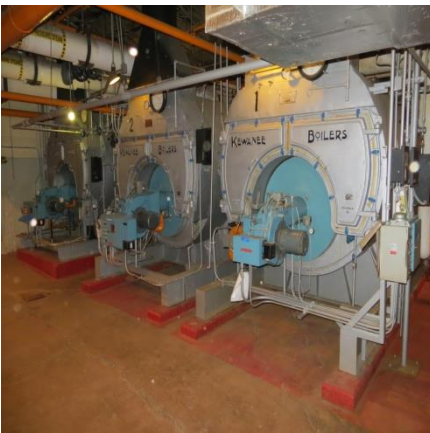
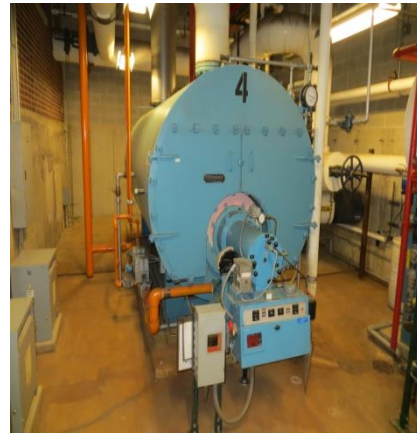
## Boiler Replacement

Breakdowns and repairs are becoming more frequent and costly.

Replace steam boilers with hot water boilers for energy efficiency.

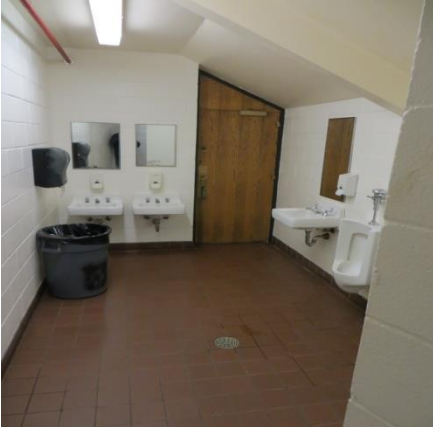
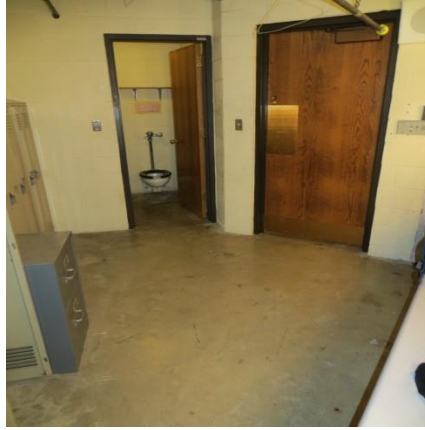
## **Cafeteria and Stage Craft Bathrooms**

Bathrooms are 42 years old.

Showing significant wear.

Need to update.

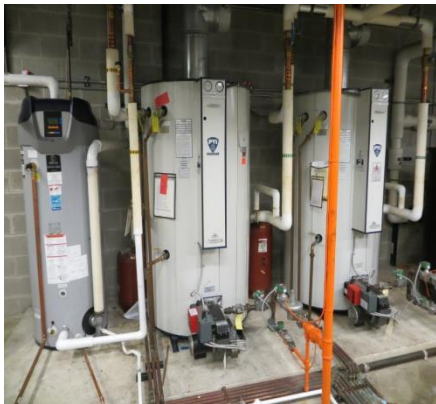
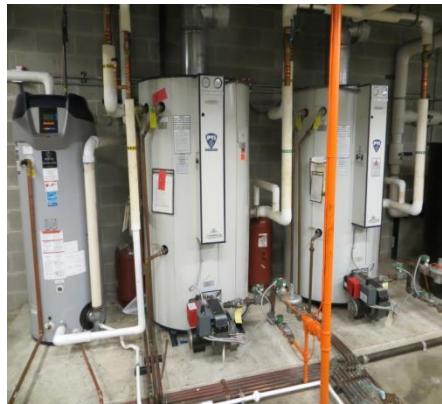
## **Hot Water Heaters**

The two 500 gallon PVI water heaters are nearing the end of their life cycle.

Replacement will be needed within the next seven years.

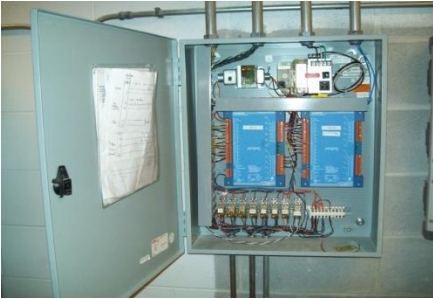
## Lon Controller

Lon controls throughout the building.

Outdated and costly to repair.

Replace Lon to BACnet.

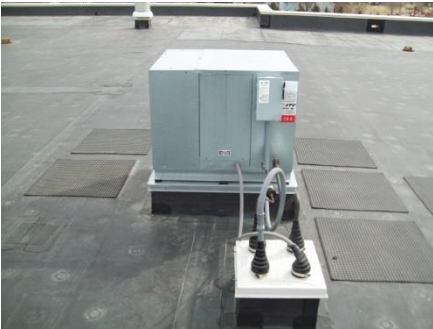
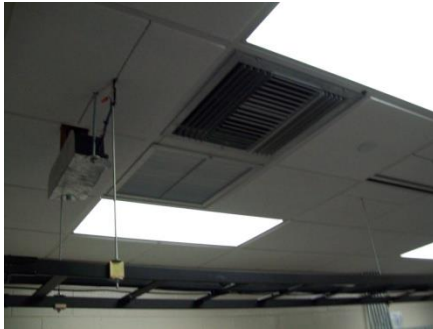
## IT Server A/C

Oversized for heat load of space.

Cycles on and off continually causing condensation issues and premature equipment failure.

Replace with properly sized unit.

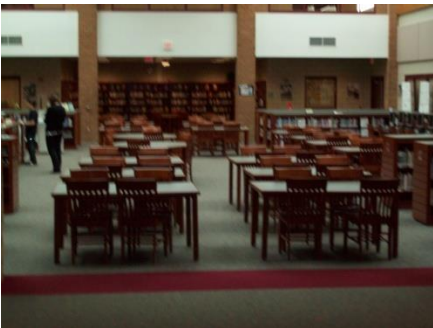
## LMC

AHU is undersized for space.

Only two VAV boxes serving the space.

Recommend increasing the capacity of the AHU and adding four to six VAV boxes with controls to increase comfort and control humidity.

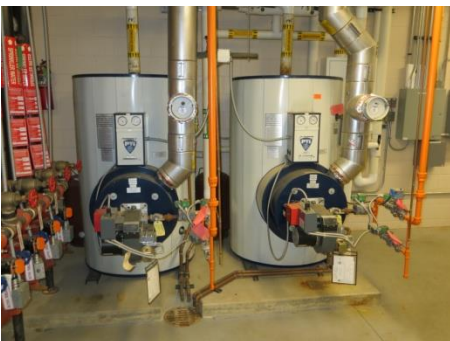
## Hot Water Heaters

The two 300 gallon PVI water heaters are nearing the end of their life cycle.

Replacement will be needed within the next seven years.

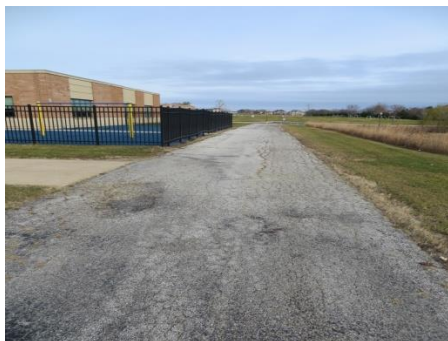
### **Fire Lane**

Pavement starting to show excessive cracking and breakdown.

Will need to be resurfaced.

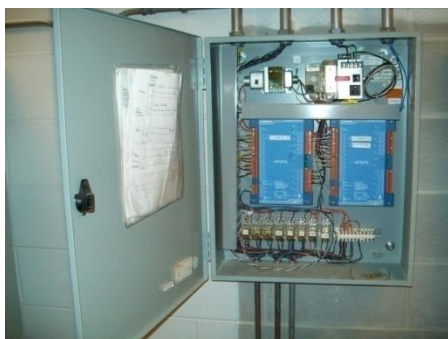
### **Lon Controller**

Lon controls throughout the building.

Outdated and costly to repair.

Replace Lon to BACnet.

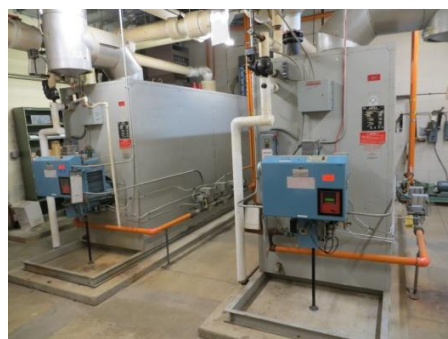
### **Boiler Replacement**

23-year old boilers are inefficient and nearing the end of their estimated service life as per ASHRAE.

Replace with new high efficiency boilers.

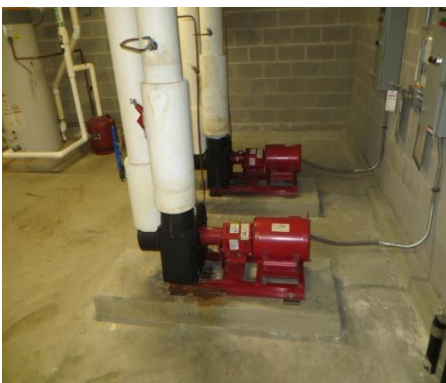
## **Secondary Pumps**

18 years old and nearing end of their estimated service life as per ASHRAE.

Need to be replaced with energy efficient design.

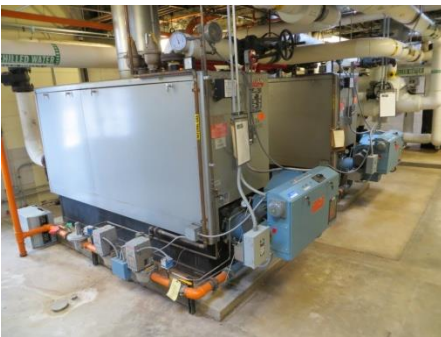
## Boiler Replacement

27-year old boilers are inefficient and nearing the end of their estimated service life as per ASHRAE.

Replace with new high efficiency boilers.

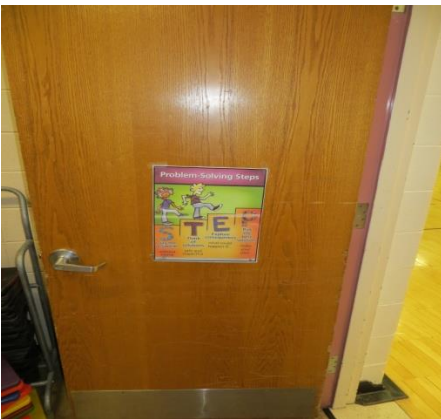
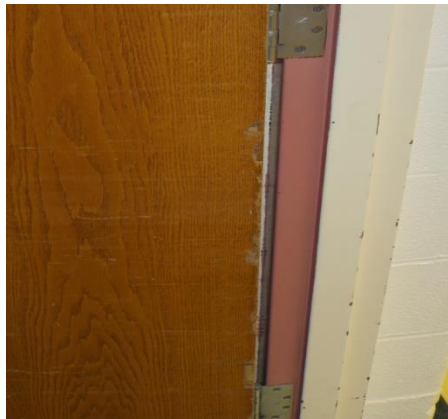
## Interior Doors

Several doors in the building are damaged and in need of replacement.

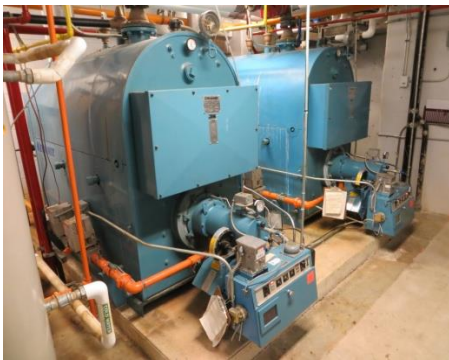
## **Boiler Replacement**

Boilers are 21 years old and original to the building.

Nearing the end of their estimated service life as per ASHRAE.

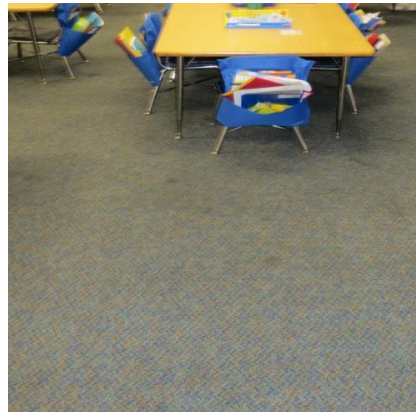
## **Carpet Replacement**

Carpet is starting to show wear and staining that we are unable to remove.

Life cycle of carpet is 12-20 years.

Carpet will need to be replaced.

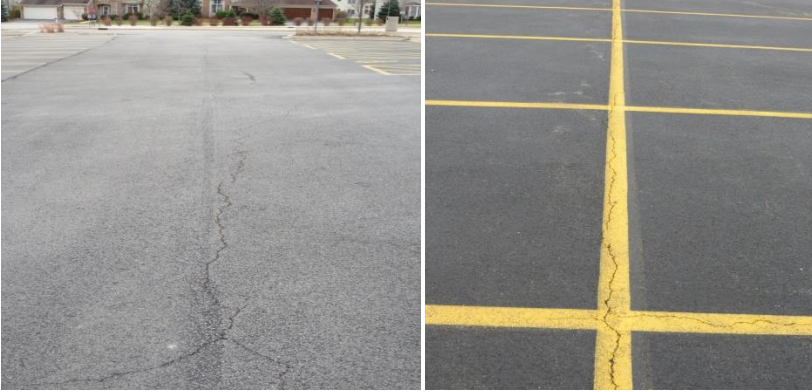
### **Parking Lot**

Several areas are starting to show cracking.

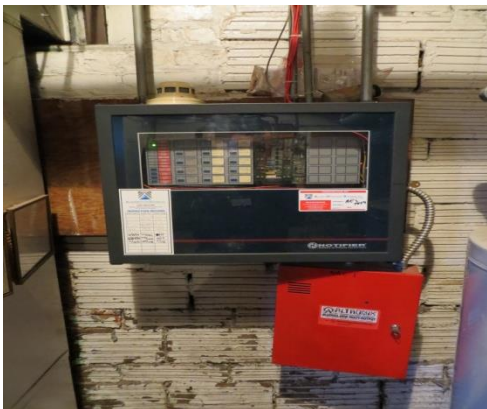
## Fire Alarm System

Notifier 5000 fire alarm panel will need to be updated to meet current NFPA code requirements.

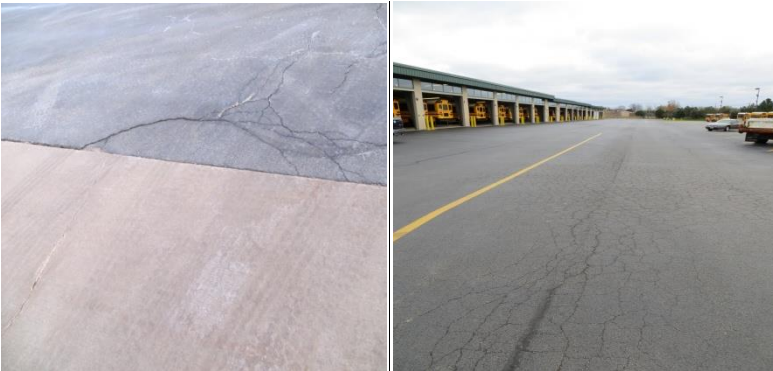
### Parking Lot

Pavement starting to crack and breakdown.

Resurfacing will be needed in the next two to three years.

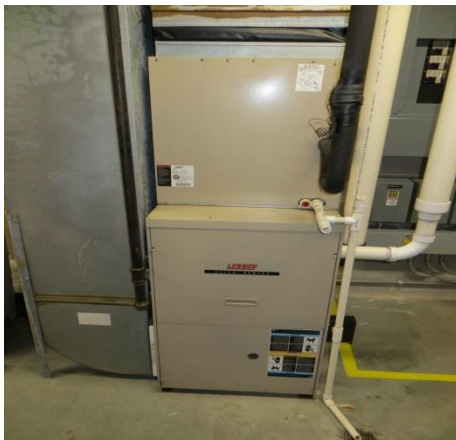
### HVAC Split System

The 3 Lennox split systems are nearing their ASHRAE recommended service life.

Replacement will be needed within the next seven years.

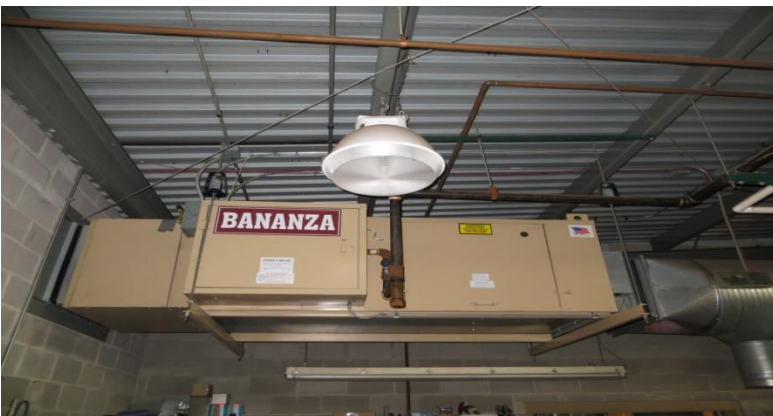
### Air Handling Unit

The three Bananza make-up air units are nearing their ASHRAE recommended service life.

Replacement will be needed within the next seven years.
