Photo Report

Client: Pana CUSD #4

Facility: Pana High School

Report Date: 12/04/2020 Title: Valley Damage Report

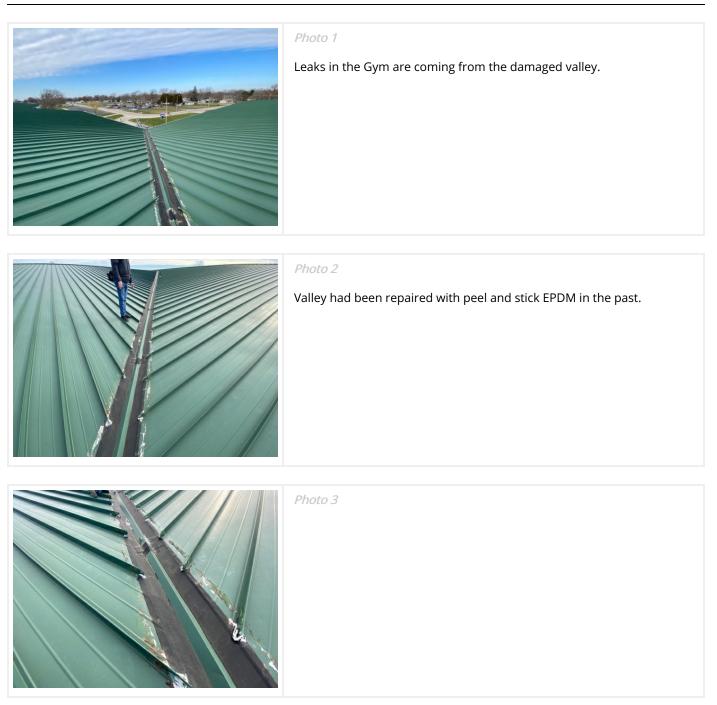
Photo 4

Rusted valley and end of panel. The EPDM actually trapped moisture causing the panels and valley closure to rust.
