# CERTIFICATE OF SUBSTANTIAL COMPLETION

**PROJECT:**  
Galveston College Northern Building West and East Stairwell  
Window Replacement  
4015 Avenue Q  
Galveston, TX 77550

**PUNCH LIST  
WINDOW REPLACEMENT**

**GALVESTON COLLEGE: NORTHEN BUILDING  
2250 41<sup>ST</sup> STREET  
GALVESTON, TEXAS  
PCI PROJECT NO. 11459.18**

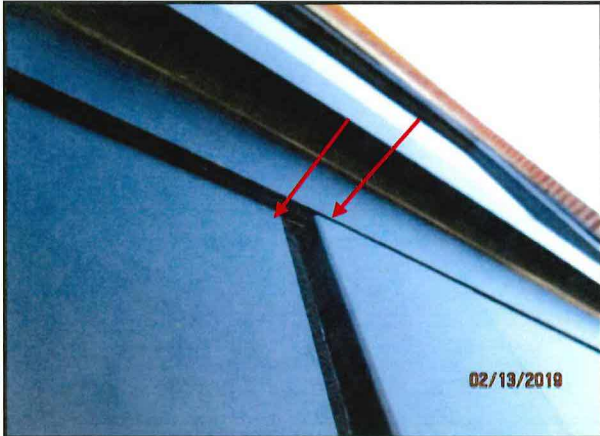
1. Adjacent doors were not aligned with one another at the West entrance (Photograph 1).
2. Door panic hardware was not adjusted properly (door hardware scraped when operating doors) at all locations.

1. DOOR LEAFS NOT ALIGNED

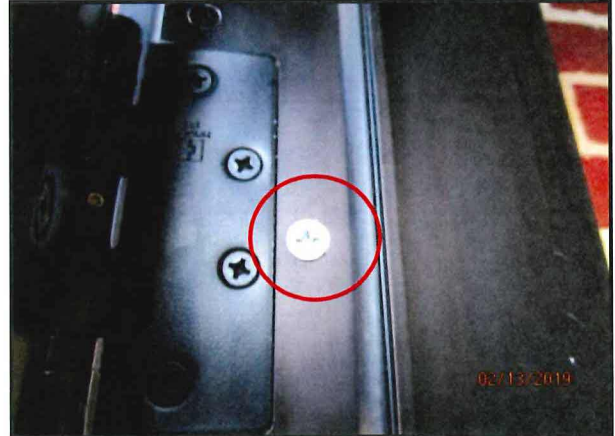
4. Color of fasteners at door sub-frames do not match color of frames (Photograph 2).
5. Remnants of existing sealant on exterior walls adjacent to new curtain wall frames (Photographs 3 and 4).

2. FASTENER HEAD FINISH DOES NOT MATCH  
ADJACENT FRAMING

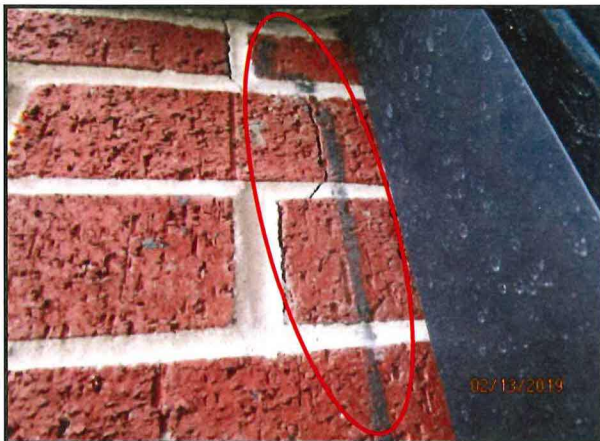
3. REMNANTS OF SEALANT ON SURFACE OF  
EXTERIOR BRICK VENEER

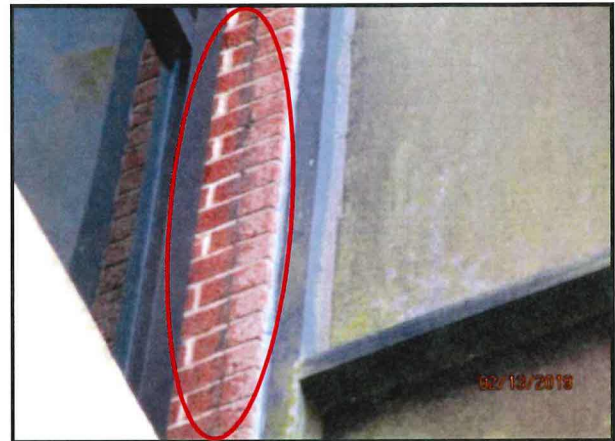
4. REMNANTS OF SEALANT ON SURFACE OF  
EXTERIOR BRICK VENEER

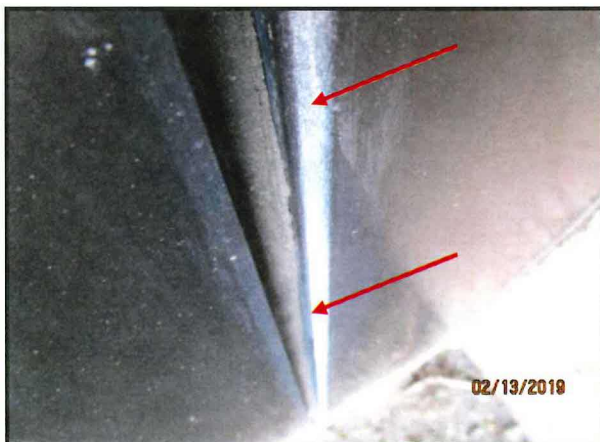
6. Damaged finish (fractured and discolored finish) at outside corners of formed sheet aluminum closures (Photographs 5 and 23).
7. Low voltage wires exposed (not encased in conduit or covers/closures) at West and East card reader entry doors (Photograph 6).

5. DAMAGED FINISH AT OUTSIDE CORNER  
OF SHEET ALUMINUM CLOSURE

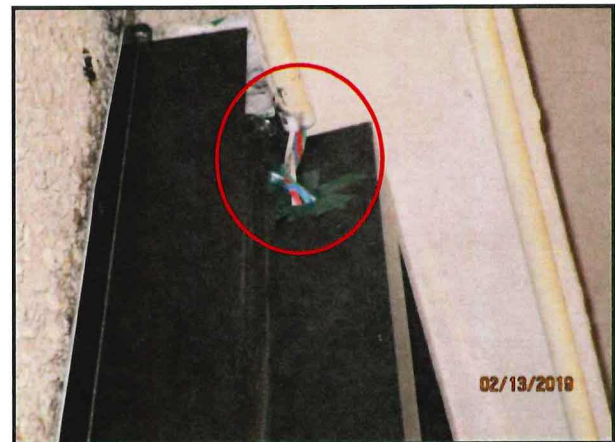
6. UNPROTECTED ELECTRICAL WIRES (wiring  
not encased within conduit or closure)

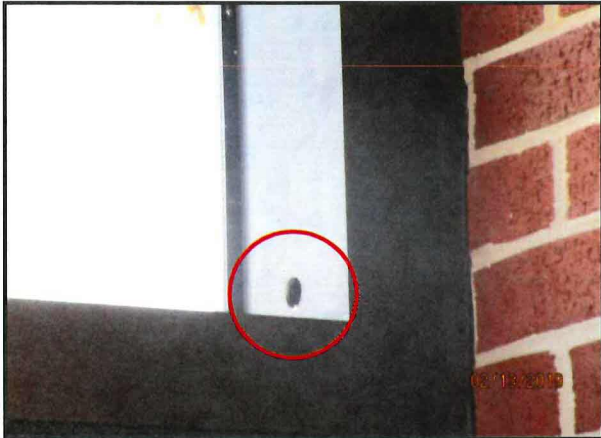
8. A hole observed in curtain wall frame above West entry door (Photograph 7).
9. Interior glazing gasket misaligned (not flush with horizontal surface of curtain wall frame) at various locations (Photograph 8).

**7. HOLE IN CURTAIN WALL FRAME**

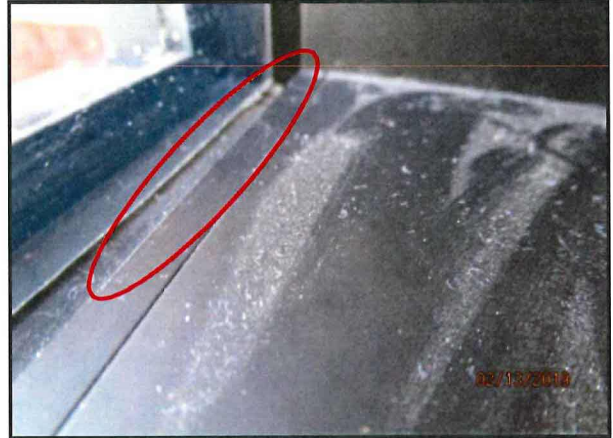
**8. MISALIGNED INTERIOR GLAZING GASKET**

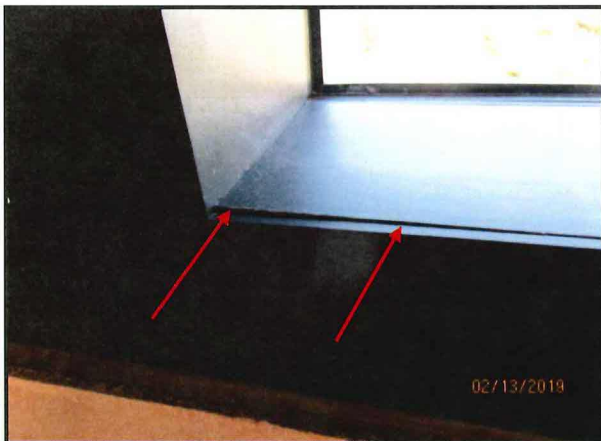
10. Curtain wall sill snap covers not fully engaged to curtain wall framing at various locations (Photograph 9).
11. Stains on interior walls adjacent to curtain wall framing at various locations (Photograph 10).

**9. INTERIOR SNAP COVER NOT ENGAGED TO CURTAIN WALL FRAME**

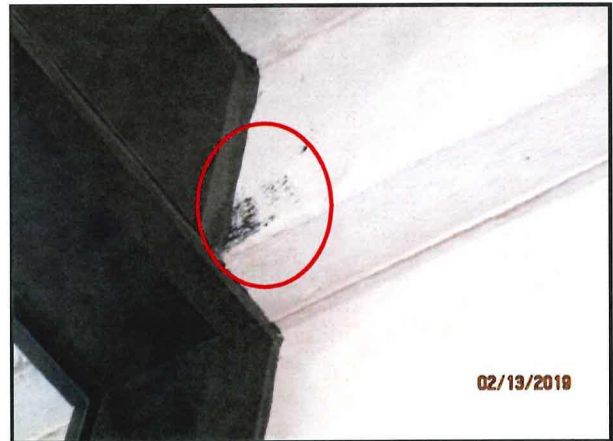
**10. STAIN ON INTERIOR WALL**

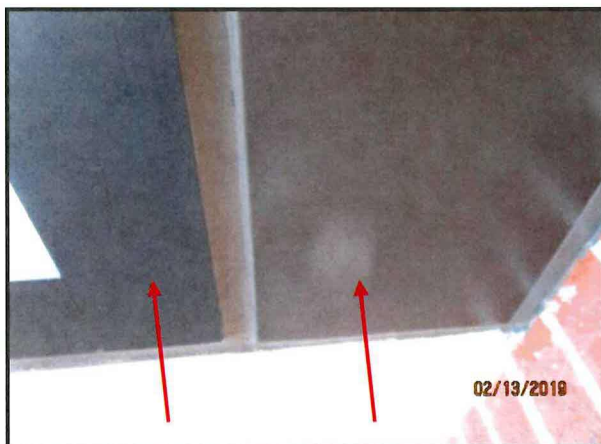
12. Color variation between curtain wall framing and adjacent sheet aluminum closures (Photograph 11).
13. Debris observed on window ledge at level 2 below North elevation window at East stairwell (Photograph 12).

**11. COLOR VARIATION BETWEEN CURTAIN WALL FRAME AND SHEET ALUMINUM CLOSURE**

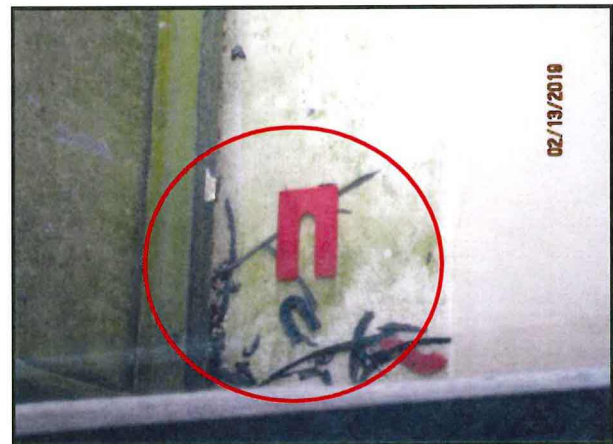
**12. DEBRIS ON EXTERIOR WINDOW LEDGE AT LEVEL 2**

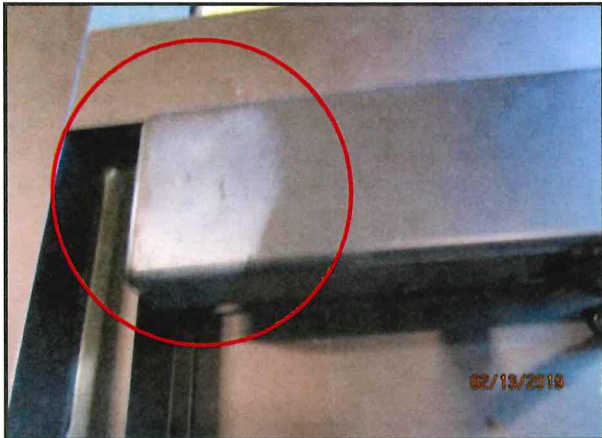
14. Discolored finish on cover of door closer West entry door at East stairwell (Photograph 13).
15. Backer rod and sealant not installed at interior head of level one curtain wall window on South elevation of East stairwell (Photograph 14).

**13. DISCOLORED FINISH ON DOOR CLOSURE COVER**

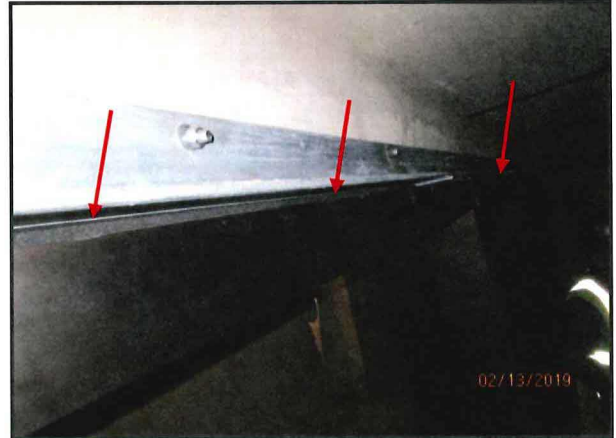
**14. MISSING SEALANT AT TOP OF WINDOW AT INTERIOR**

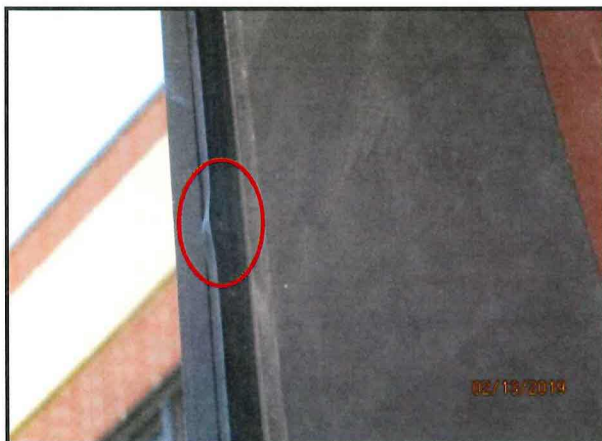
16. Disengaged glazing gasket at exterior face of curtain wall window on North elevation at East stairwell (Photograph 15).
17. Fasteners missing (improperly located hole?) in threshold at East door of East stairwell (Photograph 16).

**15. DISINGAGED EXTERIOR GLAZING GASKET**

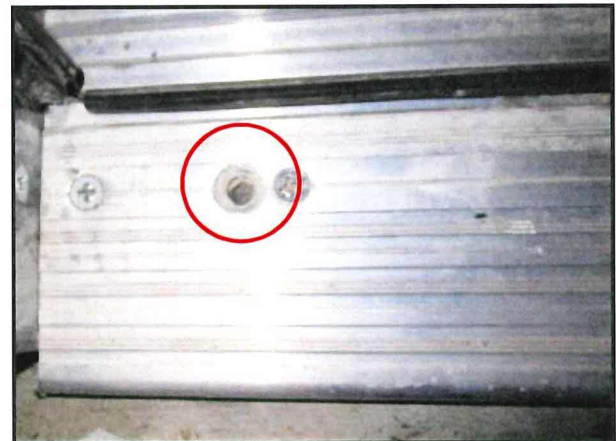
**16. MISSING FASTENER IN DOOR THRESHOLD**

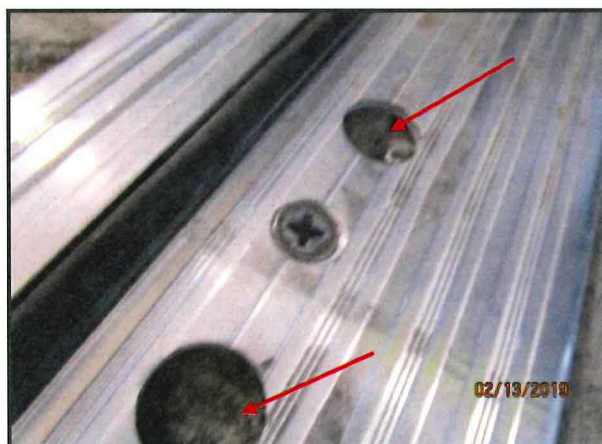
18. Thresholds not set into full bed of sealant (no sealant at exterior portion of threshold aligning with door frame perimeter sealant location).
19. Concrete floor slab not drilled out at vertical panic rod insert locations for door (Photograph 17).

**17. CONCRETE NOT DRILLED OUT AT DOOR PANIC ROD INSERT LOCATIONS**

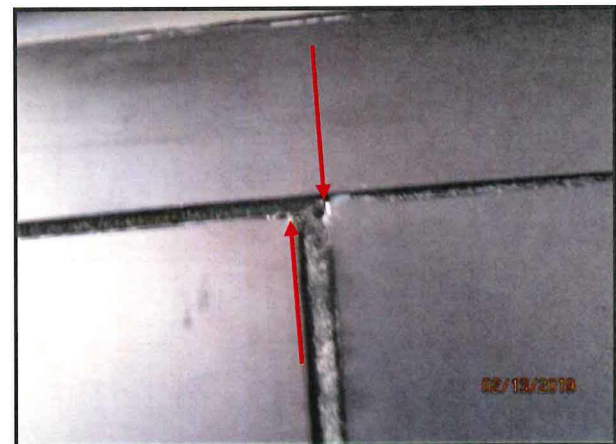
20. Tops and bottoms of adjacent door leafs misaligned (one leaf higher than the other) (Photograph 18).
21. Exterior sealant weep tubes extended beyond exterior surface of curtain wall frame approximately 3/4-inch (Photograph 19).

**18. TOP OF ADJACENT DOORS MISALIGNED**

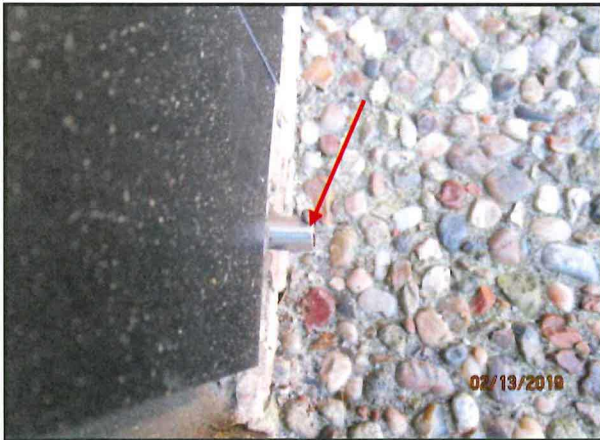
19. WEEP TUBE PROTUDING OUT FROM CURTAIN WALL FRAME

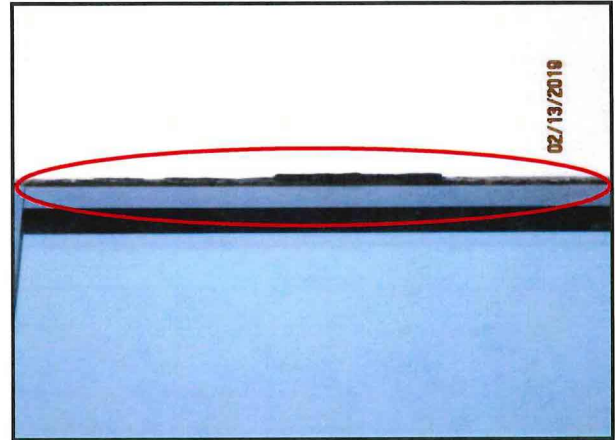
22. Top of wall opening damaged or stained at curtain wall on level 2 at North elevation of East stairwell (Photograph 20).
23. Construction related debris on ground beneath recently installed curtain wall windows (Photograph 21).

20. DAMAGED/STAINED AREA AT WALL OPENING

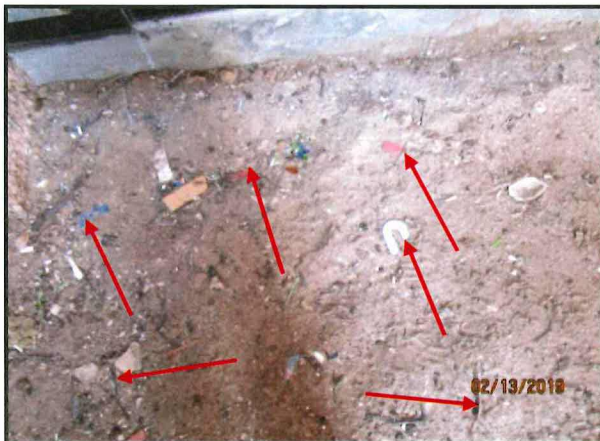
21. CONSTRUCTION RELATED DEBRIS ON GROUND

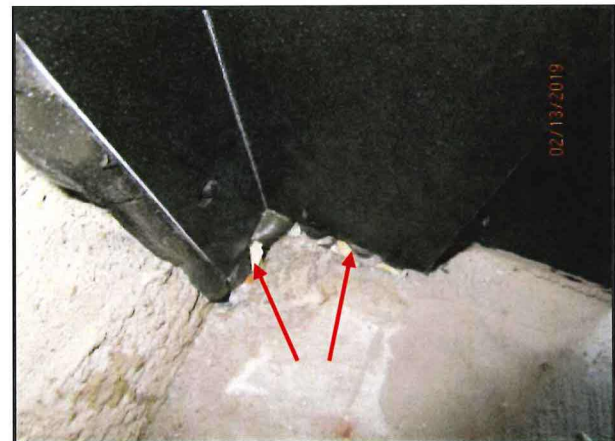
24. Inadequate sealant (sealant installed flush with top of floor slab and sealant not tooled) at bottom of sheet aluminum jamb closure at interior of entry on West elevation of East stairwell (Photograph 22).

22. INADEQUATE SEALANT AT BOTTOM OF SHEET METAL CLOSURE

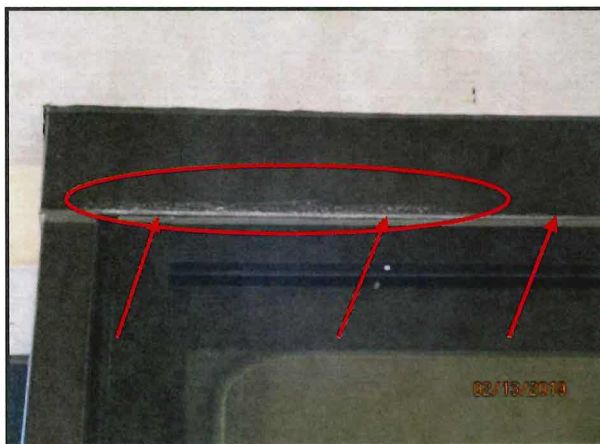
25. Damaged/stained sheet aluminum closure at top of curtain wall frame above entry doors at West elevation of East stairwell (Photograph 23).
26. Damaged weather-stripping on entry doors at East stairwell (Photograph 24).

23. DAMAGED FINISH AT OUTSIDE CORNER OF SHEET ALUMINUM CLOSURE; STAINING ON SHEET ALUMINUM CLOSURE

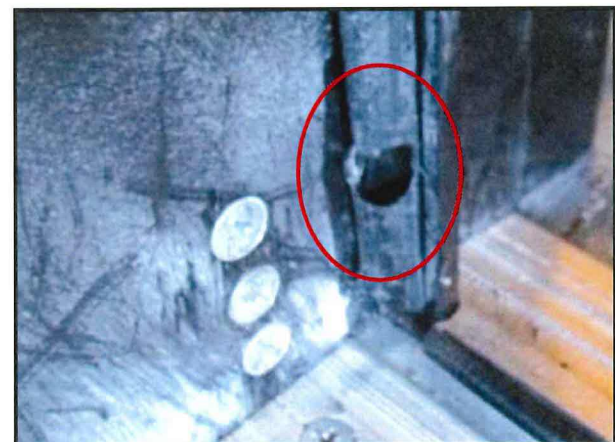
24. DAMAGED WEATHERSTRIPPING ON DOOR
