Menahga Public School
Menahga Public School - 216 Aspen Ave S
216 Aspen Ave S
Menahga, MN 56464

Summary

Section: Section D

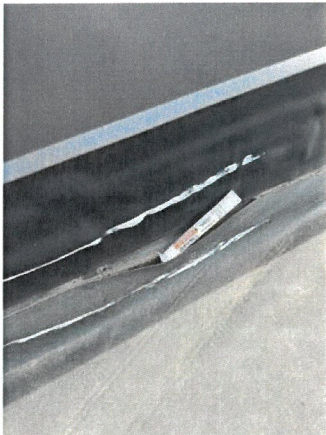
Base Flashing - Damaged (Emergency)

Quantity: 25 LF

Deficiency:

Damaged, missing, or faulty flashing is allowing water to infiltrate.

Corrective Action:

Install new flashing according to industry standards.

Estimated Repair Cost:

\$750

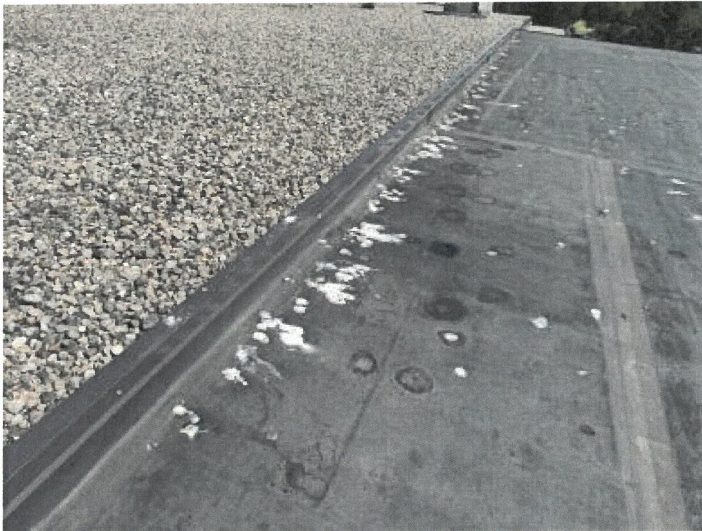
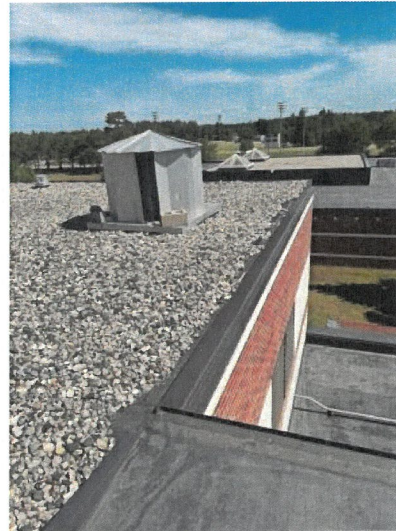
Bird Droppings-Contaminating Roof area

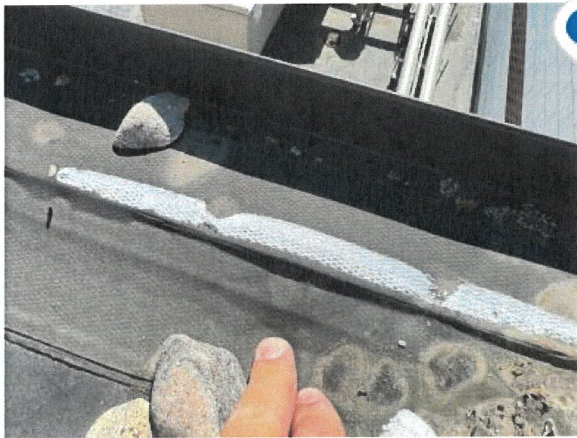
1

Perimeter - Metal Edge - Strip In (Emergency)

Quantity: 30 LF

Deficiency:

Roof membrane has separated from metal edge. If the metal edge strip in is failing it can allow water to infiltrate and damage the roof system, deck and building interior.

Corrective Action:

Remove the loose membrane, secure metal edge joint, clean and prime metal and install new material that extends 3-12" onto roof to ensure water tightness.

Estimated Repair Cost:

\$1,350

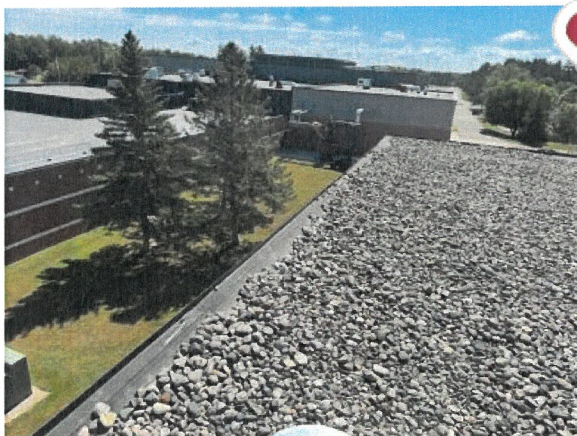
2

Perimeter - Metal Edge - Strip In (Emergency)

Quantity: 50 LF

Deficiency:

Roof membrane has separated from metal edge. If the metal edge strip in is failing it can allow water to infiltrate and damage the roof system, deck and building interior.

Corrective Action:

Remove the loose membrane, secure metal edge joint, clean and prime metal and install new material that extends 3-12" onto roof to ensure water tightness.

Estimated Repair Cost:

\$2,250

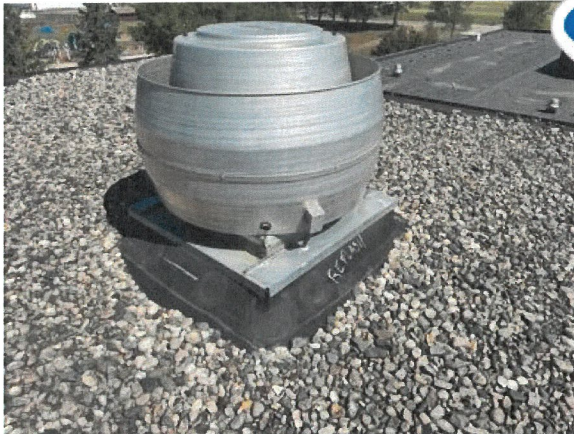
Curb - Exhaust fan curb

Quantity: 1 EA

Deficiency:

Need to reflash damaged/bridging membrane at existing curb.

Corrective Action:

Flash in curb with appropriate materials per manufacturer's installation recommendation's.

Estimated Repair Cost:

\$620

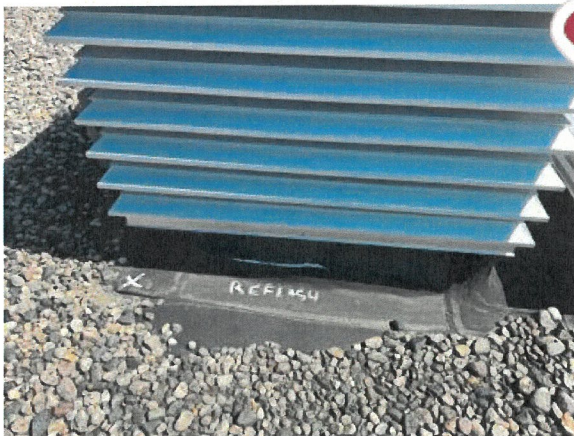
Curb - Exhaust fan curb (Emergency)

Quantity: 1 EA

Deficiency:

Need to reflash damaged/bridging membrane at existing curb.

Corrective Action:

Flash in curb with appropriate materials per manufacturer's installation recommendation's.

Estimated Repair Cost:

\$620

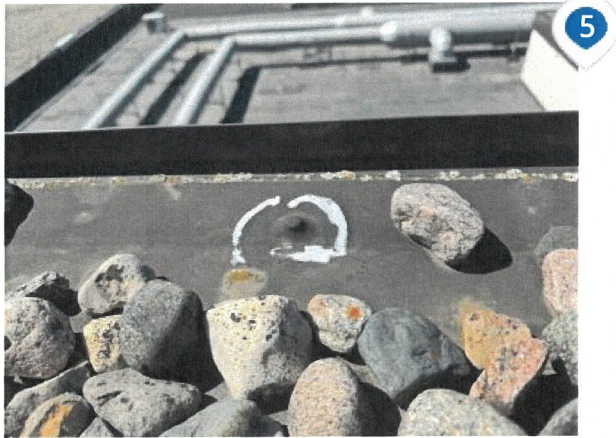
Fastener: Backed Out

Quantity: 1 EA

Deficiency:

The fastener has backed out enough to apply tension to the membrane surface for which it is holding down and could pop through the membrane one of several ways.

Corrective Action:

Remove and reinsert a larger diameter fastener and patch the membrane with the same manufacturer's type membrane or the industry acceptable method for the type of membrane if not under a warranty.

Estimated Repair Cost:

\$190

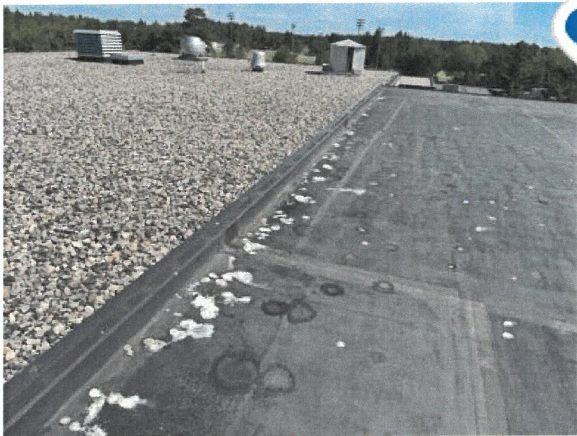
Membrane - Contamination (Excessive bird droppings)

Quantity: 70 LF

Deficiency:

Contamination occurs from sources such as acid excrement/rain, grease vents, mechanical oils, etc.

Corrective Action:

Install Bird spikes to prevent further damage.

Estimated Repair Cost:

\$1,260

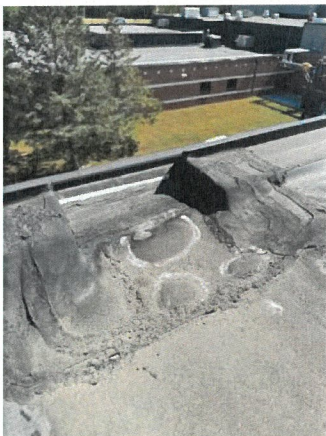
Drainage - Open Seam Drain/Scupper (Emergency)

Quantity: 1 EA

Deficiency:

Open membrane seams or blisters at scupper / drain can allow water to migrate into the building.

Corrective Action:

Clean, prime(prepare) and seal open laps to ensure water tightness using materials compatible with the existing roofing system.

Estimated Repair Cost:

\$310
