Wausau School District

Facility Assessment

September 2024

CESA 10 Facilities Management

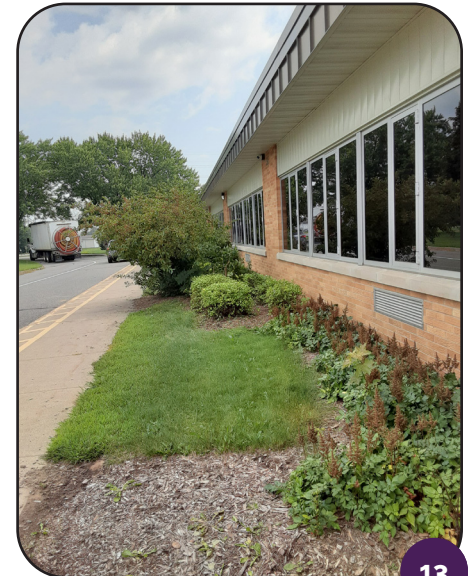
Building System	General Description	Recommendation	Cost Estimate
Site & Landscape	Invasive vegetation in asphalt cracks.	Remove vegetation, crack clean, and crack fill as per common practice in district.	\$1,000
Site & Landscape	Open gaps and deteriorated joints between several concrete slabs.	Replace slabs with open or deteriorated joints.	\$8,500
Site & Landscape	Substantial crack-filled areas without top sealing.	Continue to crack clean and crack fill as needed. Approximately every 3-5 years additionally seal and repaint asphalt.	\$7,500
Site & Landscape	Increase routine planters and mulch landscaping maintenance.	Annually or more often if needed remove vegetation around building perimeters, fencing, hardscape surface edges, utility supply areas, and planters. Refresh and retain mulch to an elevation lower than border, walk, or turf. Consider crushed gravel in lieu of mulch in planters.	\$5,000

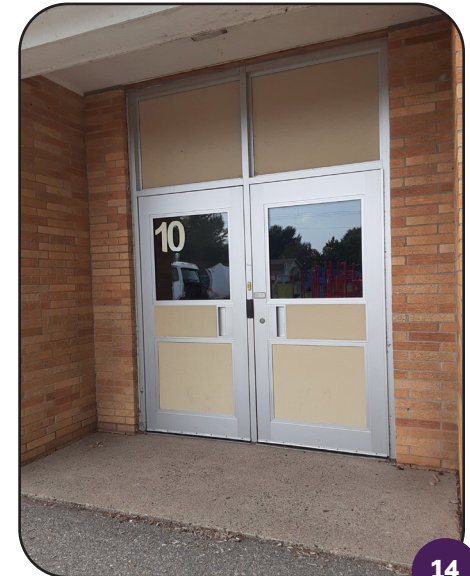
Building System	General Description	Recommendation	Cost Estimate
Site & Landscape	Outbuilding shed painted wood trim and door frames paint peeling.	Prepare and repaint. Consider replacing with metal or cladding where possible.	\$2,500
Exterior Building	Open ground level roof drain pipe connector.	Refit and repair connection.	\$1,000
Exterior Building	Open roof edge fascia flashing joint.	Refit, repair, and seal flashing joint.	\$1,000
Exterior Building	Exterior exit soffit and fascia paint peeling.	Prepare and paint. Consider cladding.	\$1,800

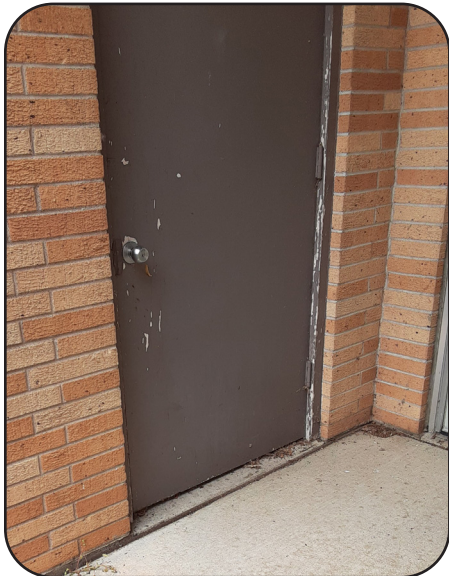
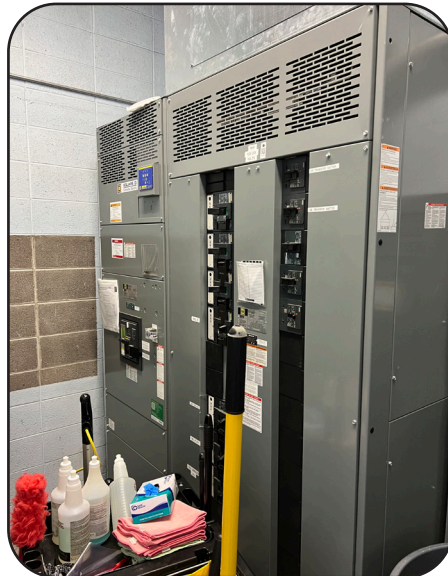
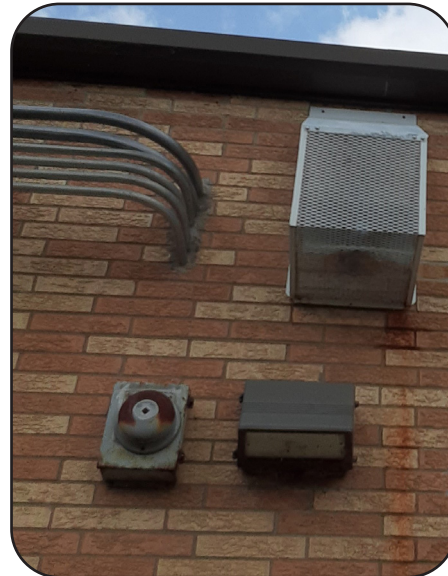
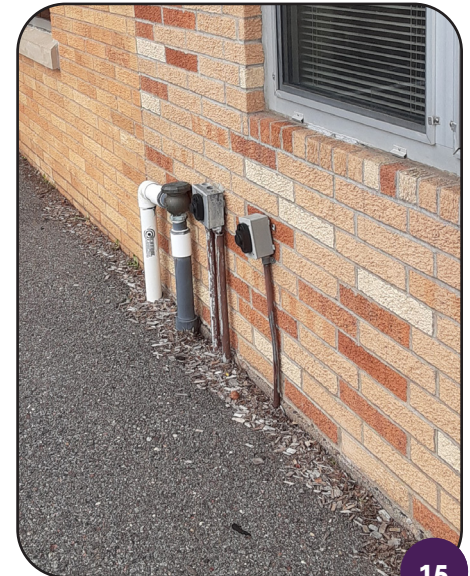
Building System	General Description	Recommendation	Cost Estimate
Exterior Building	Exterior wood door and frame paint peeling.	Prepare and paint. Consider replacing with steel door and frame.	\$2,000
Interior - Storage Safety	Storage of excess furniture was noted in basement storage rooms, along with mop buckets in a small mechanical closet aside electric motors. Along with freeing up storage space and setting best practice for facilities personnel, cluttered spaces such as this create a fire hazard.	Clean, organize, and purge. Keep mechanical and electrical room spaces used only for their intended purpose, and never store water next to open electrical equipment.	\$1,000
Electrical	Exterior wall bell rusty.	Prepare and repaint. Consider replacing with newer weather resistant bell.	\$1,000
Electrical	Loose junction box and conduit on exterior wall.	Secure box and conduit. Replace if needed.	\$1,000

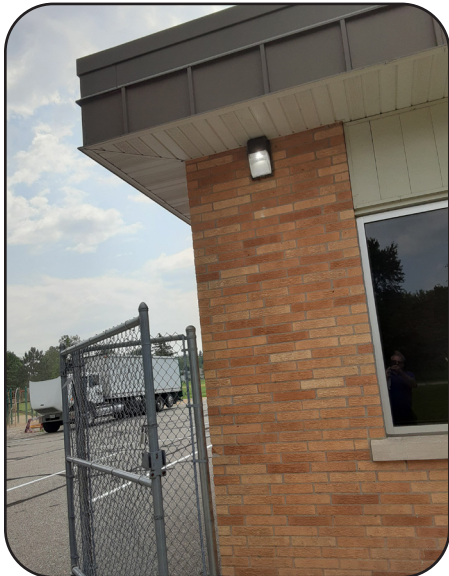
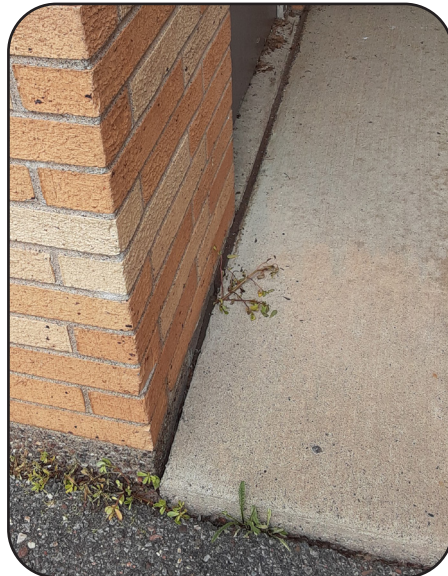
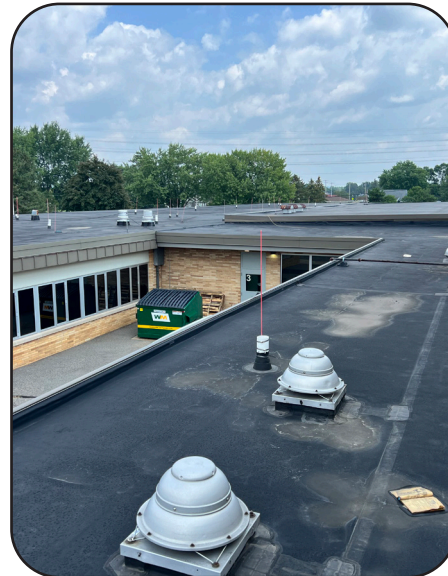
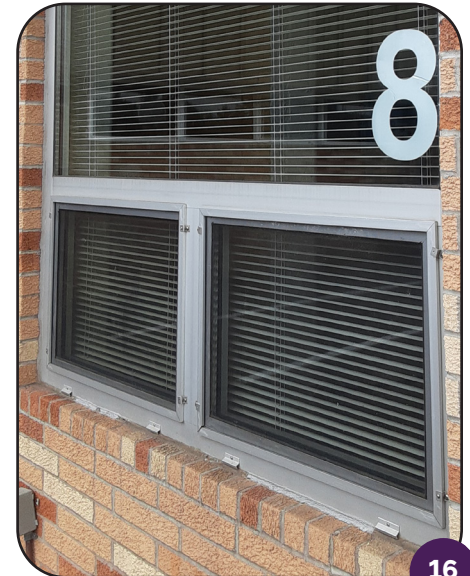
Building System	General Description	Recommendation	Cost Estimate
Electrical	Exterior wall packs on during daylight hours.	Investigate schedule and/or sensor to determine cause. Clean sensors and reset to appropriate schedule.	\$1,000
Site & Landscape	Open transition gaps between exterior walls and concrete/asphalt walks, landings, and drives.	Back fill gaps with sand and backer rod. Caulk and seal with appropriate joint filler. Heat melt in place material recommended for smooth, clean appearance.	\$5,000
Exterior Building - Roofing	Roof section A is 18 years old and 3 years beyond its warranty period. This roof is showing signs of degradation. Significant ponding water was noted in some areas.	Replace roof section A in the next 1-5 years with an adhered 60 mil black EPDM 20 year warranty roof.	\$275,000
Exterior Building	Failed and missing window caulk, joint compound, and sealant.	Remove failed and around areas of missing caulk. Re-caulk without blocking or sealing weeps.	\$1,000

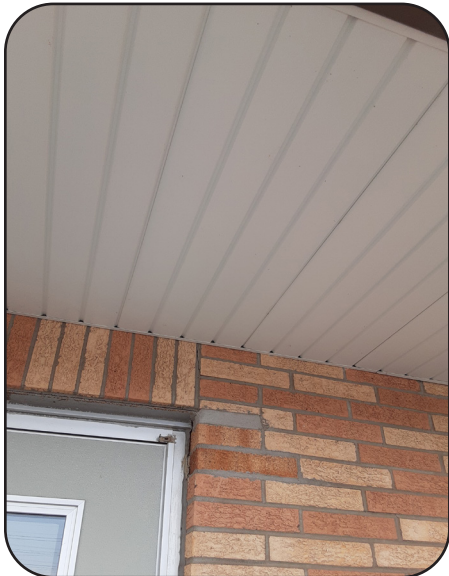
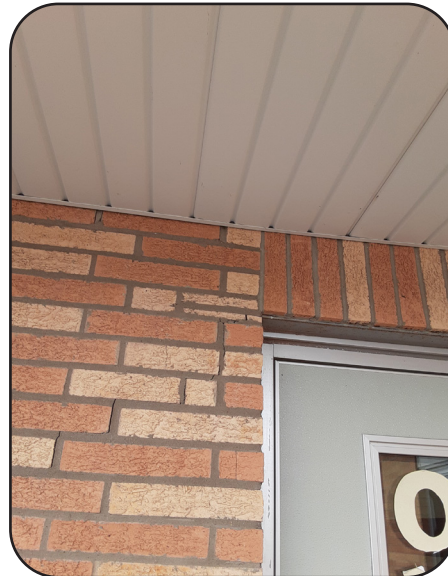
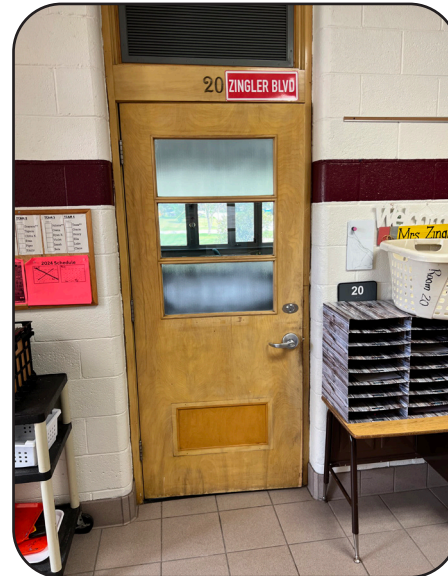
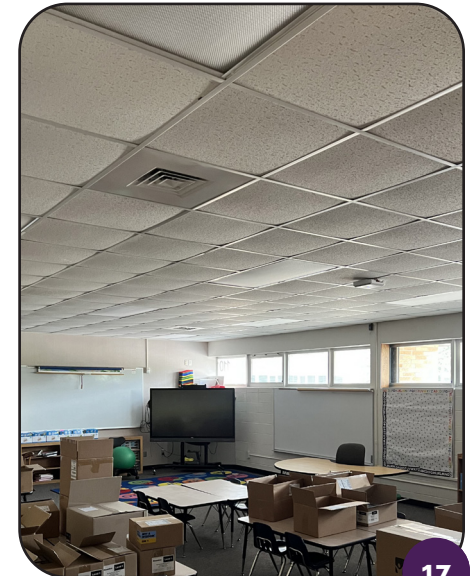
Building System	General Description	Recommendation	Cost Estimate
Exterior Building	Exterior door frame gap.	Fill, caulk, and seal gap.	\$1,000
Exterior Building	Tuck pointing repairs needed. Below grade face brick spalling, corner brick chipped and spalling, lower wall brick cracking and deteriorating, face brick step cracks, open wall base, and deteriorated wall joints.	Re-tuck walls and exterior masonry.	\$85,000
Interior - Wood Doors	Many of the older wood doors throughout the facility are in poor condition; de-laminating, stained, and chipped.	Replace aged and damaged wood doors. Estimate given for 20 doors.	\$25,000
Interior - Acoustical Ceiling	Much of the southern portion of the building has drastically sagging ceiling tile due to past HVAC moisture issues in the facility. This is evident throughout the facility but not to the extent in the south.	Replace ceiling tile in conjunction with a whole building lighting project. Estimate given for 12,000 sq ft, rooms 101-110 area.	\$36,000

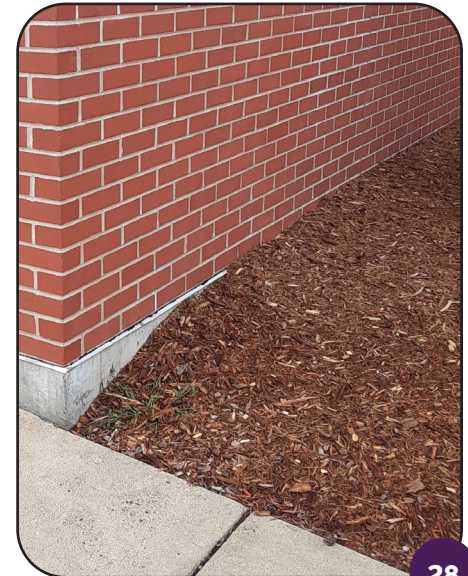
Building System	General Description	Recommendation	Cost Estimate
Site & Landscape	Cracks across asphalt walking path areas.	Clean and fill cracks. Schedule every 3-5 years crack clean, seal, and repaint asphalt.	\$3,500
Site & Landscape	Concrete stairs post base open and cracked.	Cut and repair. Consider stair replacement.	\$2,500
Site & Landscape	Uneven hardscape transitions.	Realign, replace, patch, cut, grind and/or mud jacking as needed.	\$12,000
Site & Landscape	Mulch filled above exterior brick wall drip edge.	Refresh and retain mulch to an elevation lower than wall weeps, drip edges, border, walk, or turf. Consider crushed gravel in lieu of mulch in planters.	\$1,500

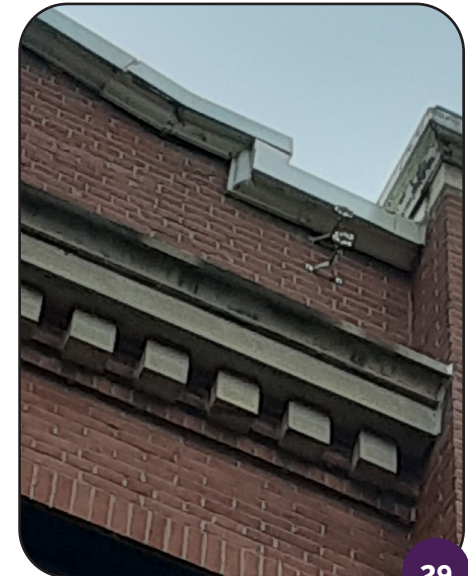
Building System	General Description	Recommendation	Cost Estimate
Exterior Building	Building perimeter wall base concrete and stone curbs cracked.	Fill, patch, and seal cracks. Consider completion as more extensive exterior wall corrective project.	\$18,000
Exterior Building	Exterior wall base open mortar.	Fill, patch, and seal openings. Consider completion as more extensive exterior wall corrective project.	\$18,000
Exterior Building	Wall mildew stains above covered exits.	Verify cause and remedy. Remove stains. Consider completion as more extensive exterior wall corrective project.	\$3,700
Exterior Building	Missing masonry drip edge bricks.	Replace missing bricks, caulk, and seal top surfaces. Consider completion as more extensive exterior wall corrective project.	\$5,000

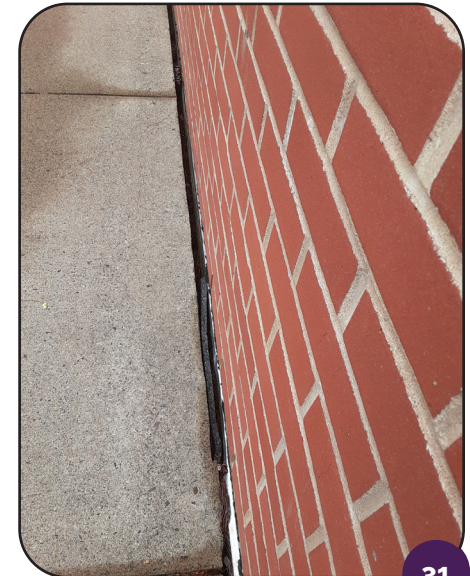
Building System	General Description	Recommendation	Cost Estimate
Site & Landscape	Multiple walk concrete slabs with transitional and divided cracks.	Replace cracked concrete walk slabs.	\$25,000
Site & Landscape	Drive concrete curbs cracked and open.	Replace, patch, cut, grind and/or mud jacking as needed.	\$17,500
Site & Landscape	Open concrete planter curb and stair base.	Patch and seal curb and base. Consider replacement with stairs replacement.	\$1,500
Site & Landscape	Open gaps between hardscapes and exterior wall perimeters.	Back fill gaps with sand and backer rod. Caulk and seal with appropriate joint filler. Heat melt in place material recommended for smooth, clean appearance.	\$7,500

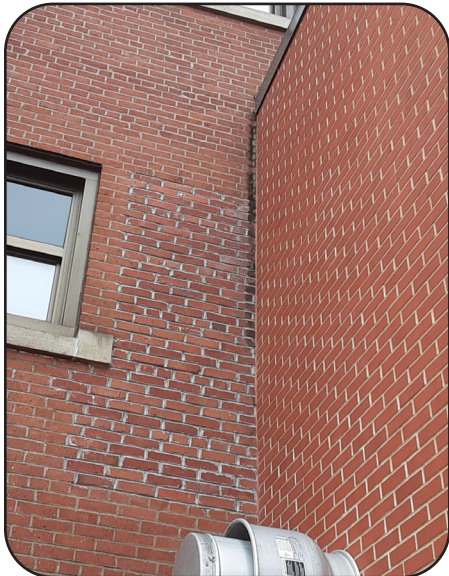
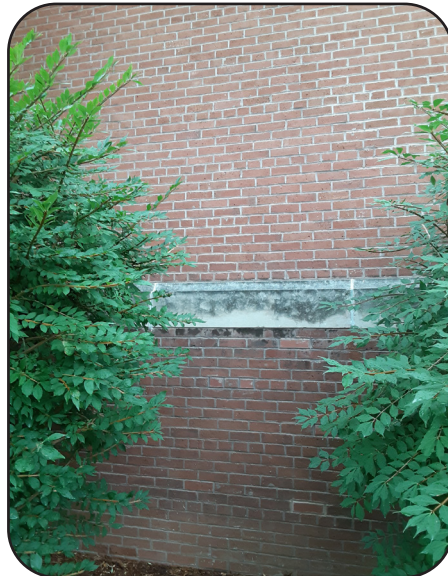
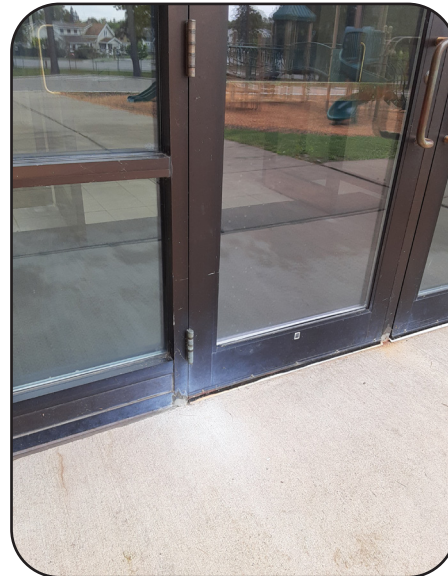
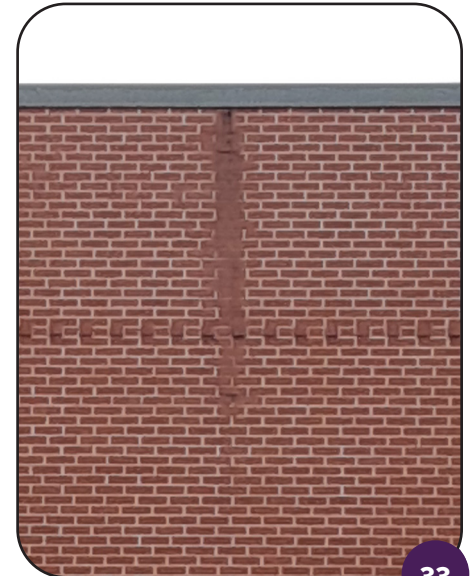
Building System	General Description	Recommendation	Cost Estimate
Exterior Building	Upper wall to roof edge corner joint deteriorated and stained.	Verify cause and remedy for staining. Remove joint material and replace. Clean stains. Consider completion as more extensive exterior wall corrective project.	\$5,000
Exterior Building	Stained exterior wall sills and decorative stone.	Verify cause and remedy. Professionally clean wall sills and decorative stone. Consider completion as more extensive exterior wall corrective project.	\$12,500
Exterior Building	Failing aluminum door frames.	Replace doors and frames.	\$15,000
Exterior Building	Below roof edge flashing stain.	Verify and remedy cause. Remove stain.	\$1,000

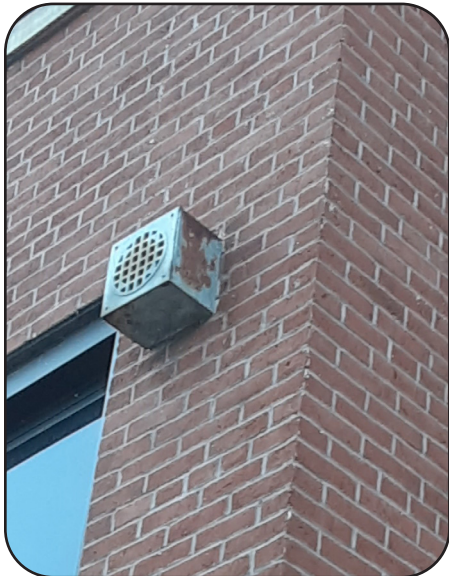
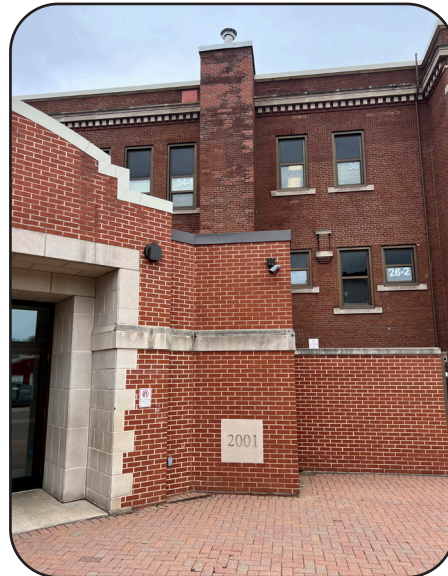
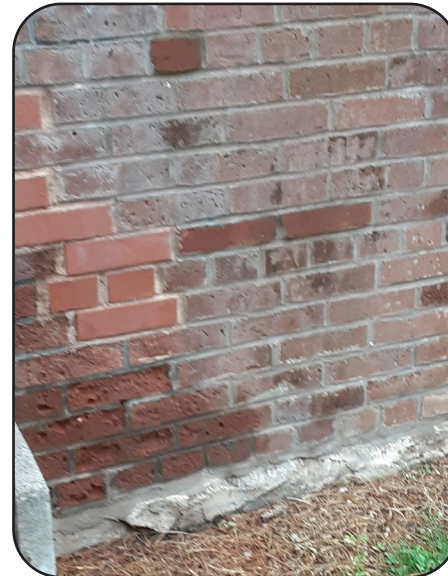
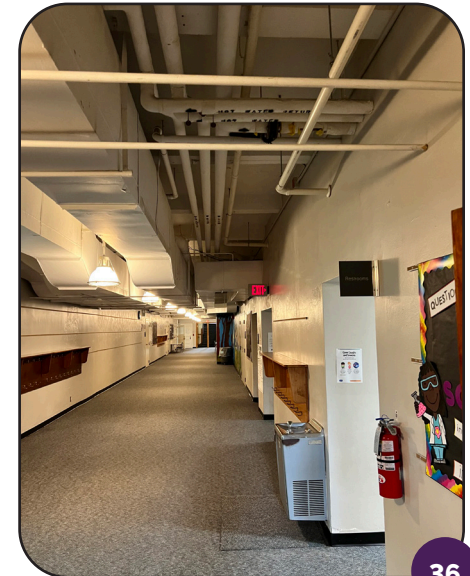
Building System	General Description	Recommendation	Cost Estimate
Electrical	Exterior wall bell/speaker box rusty.	Prepare and repaint. Consider replacing with a newer, weather-resistant bell.	\$1,000
Exterior Building	Tuck pointing and masonry repairs needed. Severely stained with face brick spalling, corner brick chipped spalling, lower perimeter stone cracking and deteriorating, open wall base, missing bricks, and damaged decorative stone.	Re-tuck walls, replace missing and damaged masonry, and professionally clean stone and bricks. (Several specific examples listed with pictures)	\$250,000
Exterior Building	Discolored exterior wall brick and mortar.	Professionally clean walls. Consider completion as more extensive exterior wall corrective project.	\$25,000
Interior - Ceilings	By in large, ceilings across the facility are in excellent condition. The main corridor hall of ground floor is open, revealing exposed piping, valves, conduit, and ductwork.	Install a drop ceiling in the ground floor corridor, as high as possible, to conceal potentially dangerous utilities and improve aesthetics.	\$7,500

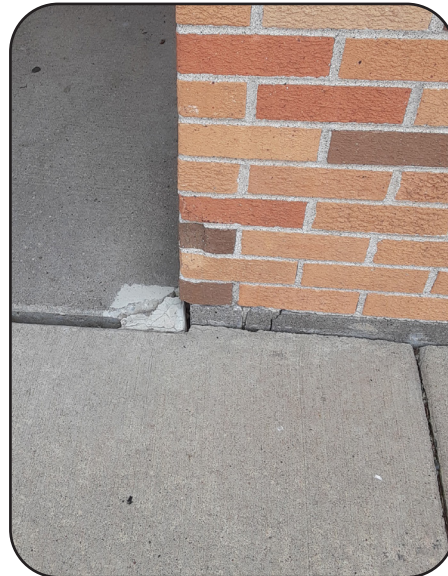
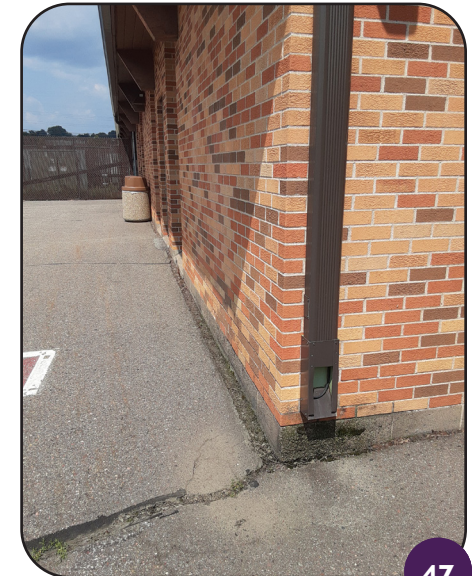
Building System	General Description	Recommendation	Cost Estimate
Exterior Building	Entrance metal beam rusty and paint missing.	Prepare and apply durable weather/salt proof coating.	\$1,000
Exterior Building	Exterior wall base brick and foundation cracked and open.	Fill, patch, and seal openings.	\$2,500
Interior - Kiln Safety	Art kiln is located within a janitorial closet with materials stacked on and around the kiln. Exhaust measures taken for the kiln are in poor condition and mismatched duct size.	If the kiln is to remain in the janitorial closet, clean and organize the space. Refurbish exhaust ductwork.	\$2,000
Site & Landscape	Open gaps between hardscapes and exterior wall perimeters.	Back fill gaps with sand and backer rod. Caulk and seal with appropriate joint filler. Heat melt in place with material recommended for smooth, clean appearance.	\$5,500

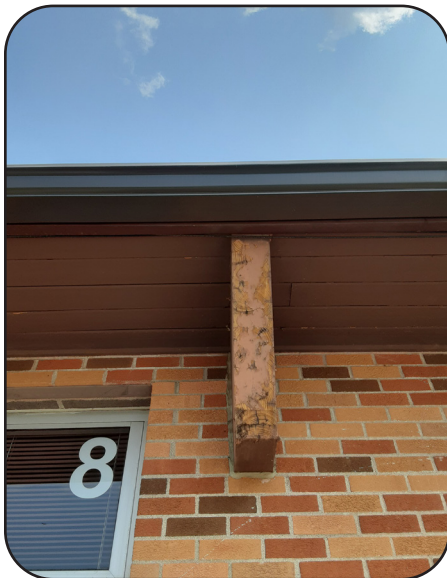
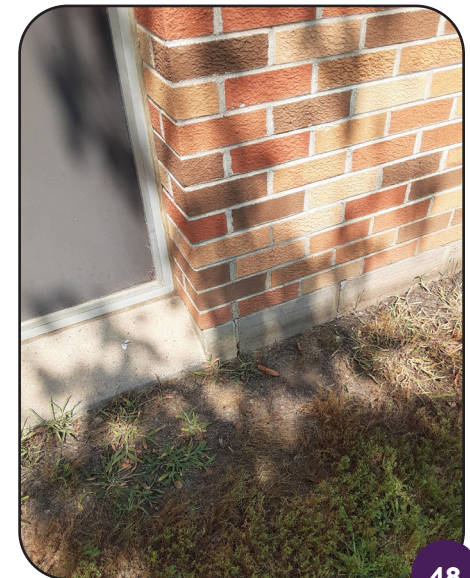
Building System	General Description	Recommendation	Cost Estimate
Exterior Building - Exposed Wood	Exposed wood beam roof outlookers across the facility are deteriorating.	Minimal examination shows little evasive rot. No rot was known to have transferred across into the building. Have an exterior professional examine each outlooker. Likely remedy is to clean, prep, and paint. Follow up by roofing contractor encapsulating the outlookers in metal flashing and caulk.	\$60,000
Exterior Building - Caulk	Although not rampant across the facility, some building exterior caulk at soffit joints and mechanical louvers is well past its life.	Perform a thorough examination of all exterior caulking and replace where necessary.	\$20,000
Exterior Building	Wood soffit paint peeling.	Prepare and paint. Consider cladding soffits with metal to extend life and reduce maintenance.	\$12,000
Exterior Building	Exterior wall base foundation blocks mortar open.	Patch, caulk, and seal.	\$1,500

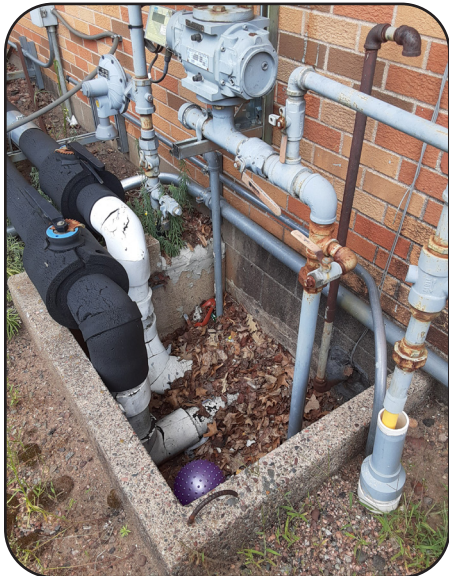
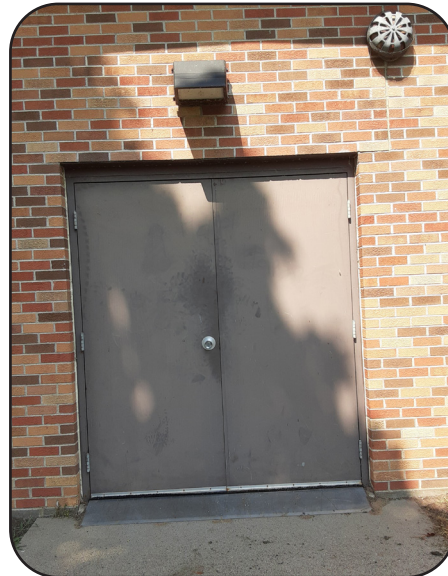
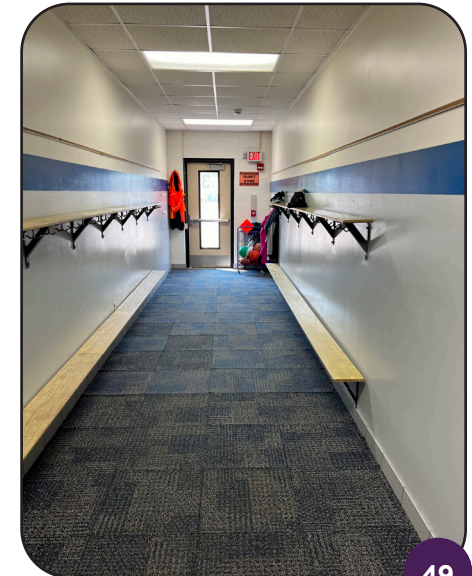
Building System	General Description	Recommendation	Cost Estimate
Exterior Building	Debris in pipe well/chase.	Remove debris. Seasonally clean well. Consider cover panel or filling with permeable and easy to remove material (clean sand or pea gravel).	\$1,000
Exterior Building	Exit metal door and frame faded and paint peeling.	Prepare and paint.	\$5,000
Interior - Ceilings	Several classrooms were noted to have stained and pillowed/curling ceiling tile, this was not the condition in the majority of the school. However, with the overhead HVAC renovation measure being recommended, all ceiling tile in the facility will need to be replaced, along with tile added where there is none.	Complete a full facility new acoustical ceiling tile project, paired with an HVAC renovation. If the HVAC project does not occur, budget to replace three classrooms in the next 2 years.	\$90,000
Interior - Flooring	The majority of the flooring throughout the school is in very good condition. One corridor was noted to have carpet tile not holding well with raised seams.	Budget to replace minimal carpeting in the school in the next 2-5 years.	\$15,000

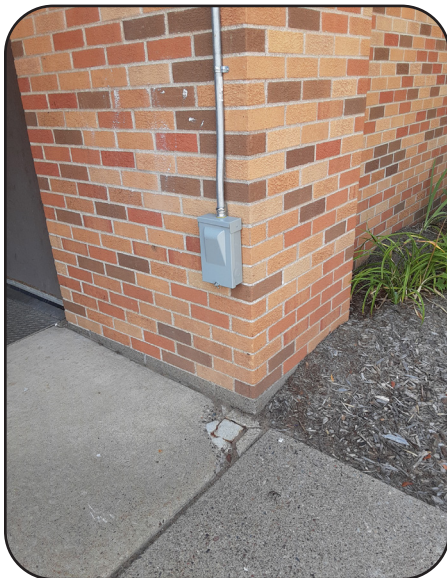
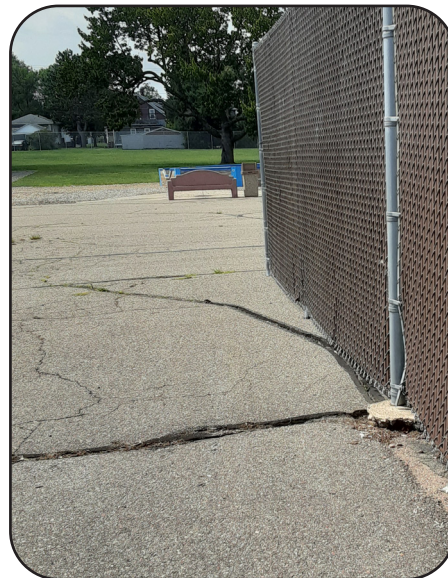
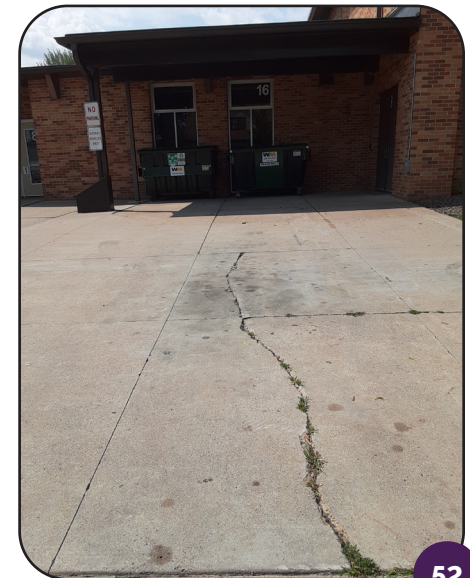
Building System	General Description	Recommendation	Cost Estimate
Site & Landscape	Cracked concrete slab corner.	Cut and patch.	\$1,000
Site & Landscape	Raised fence post concrete base.	Resent fence post. Consider raising elevation inside of fence to back fill around base and set slope away from inside of fence.	\$1,000
Site & Landscape	Significant cracks (alligator) on asphalt drive and parking area. Predecessor to failed top asphalt layers.	Mill and resurface poor asphalt surface areas.	\$25,000
Site & Landscape	Multiple drive concrete slabs with transitional and divided cracks.	Replace cracked concrete drive slabs. Ensure below grade fill and slab thickness is appropriate for larger trucks (garbage & food delivery).	\$20,000

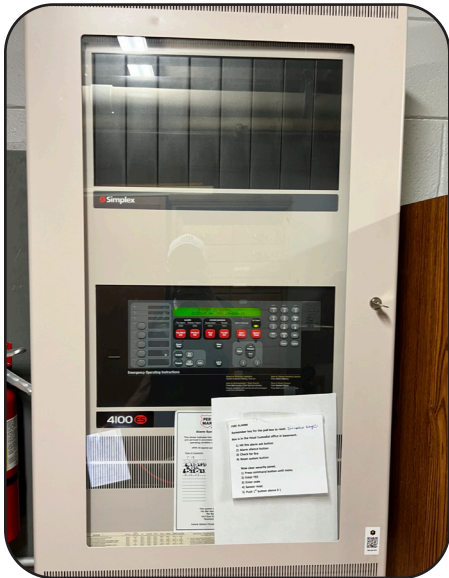
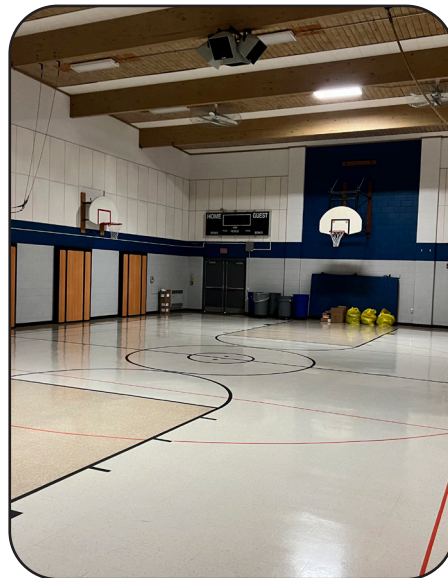
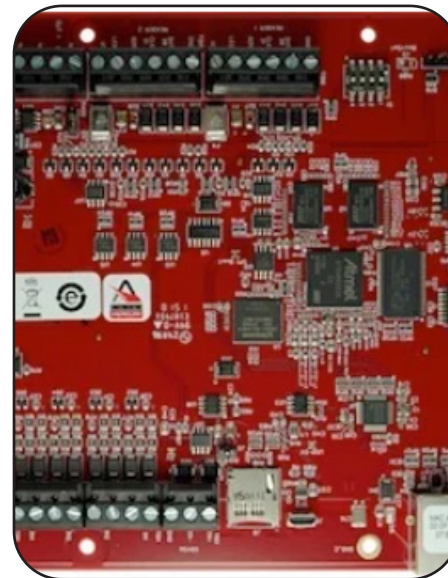
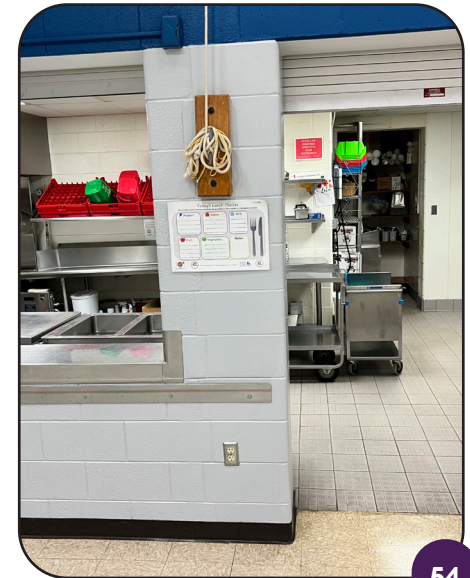
Building System	General Description	Recommendation	Cost Estimate
Electrical - Fire Panel	Fire panel at end of expected usable life.	Replace or upgrade to Edwards standard.	\$101,250
Interior - Gym Floor	Although the gym floor is VCT, the floor is holding up well for it's age.	Consider replacing the gym floor with a softer synthetic poured floor.	\$100,000
Electrical - Door Access	Card Access systems across the district are in need of upgrade to their board controllers. Information was compiled through district IT interviews and recommended per school individual need.	Replace HID Vertx boards to Mercury LP1502's.	\$8,000
Interior - Kitchen	The serving kitchen is in very good condition and well maintained, however small, with virtually no storage space.	Consider a renovation of the kitchen/PE storage/PE Office space to allow for additional food service storage.	\$300,000

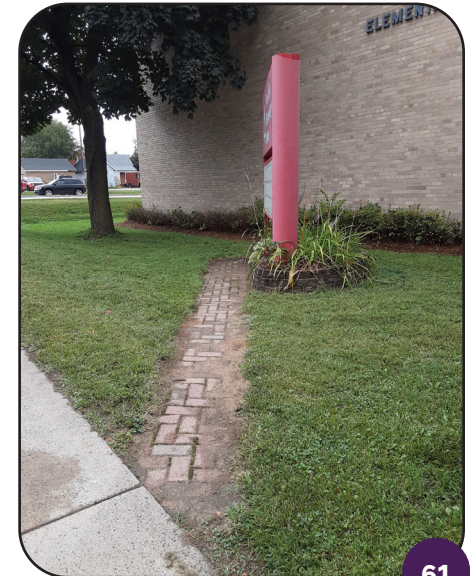
Building System	General Description	Recommendation	Cost Estimate
Site & Landscape	Substantial crack-filled areas without top sealing.	Continue to crack clean and crack fill as needed. Approximately every 3-5 years additionally seal and repaint asphalt.	\$7,500
Site & Landscape	Open gaps and deteriorated joints between several concrete slabs.	Replace slabs with open or deteriorated joints.	\$18,500
Site & Landscape	Invasive vegetation inside of dumpster fence.	Annually, or more often if needed, remove vegetation around building perimeters, fencing, hardscape surface edges, utility supply areas, and planters.	\$1,400
Site & Landscape	Sand covering path pavers.	Clear and remove sand seasonally.	\$1,000

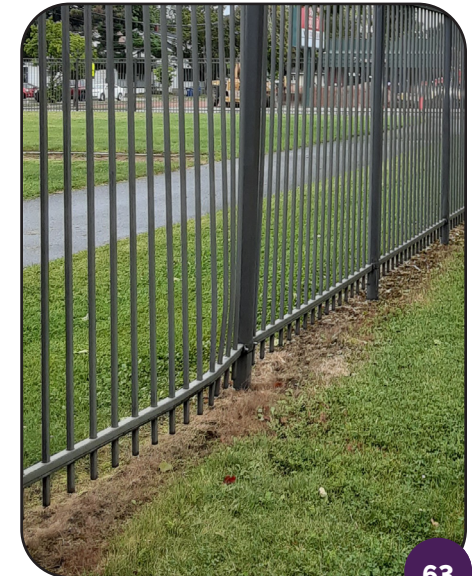
Building System	General Description	Recommendation	Cost Estimate
Interior - Kitchen Equipment	The kitchen is functioning well for the current school capacity. Equipment however is aging and beginning to cause downtime.	Invest in new kitchen equipment over the next 2-10 years.	\$75,000
Site & Landscape	Multiple walk concrete slabs with transitional and divided cracks.	Replace cracked concrete walk slabs.	\$23,000
Site Utilities	Gas valve on side of the building not secured inside fencing.	Enclose and secure valve access.	\$4,500
Site & Landscape	Minor bent fence pickets in perimeter fencing.	Repair bent pickets.	\$1,000

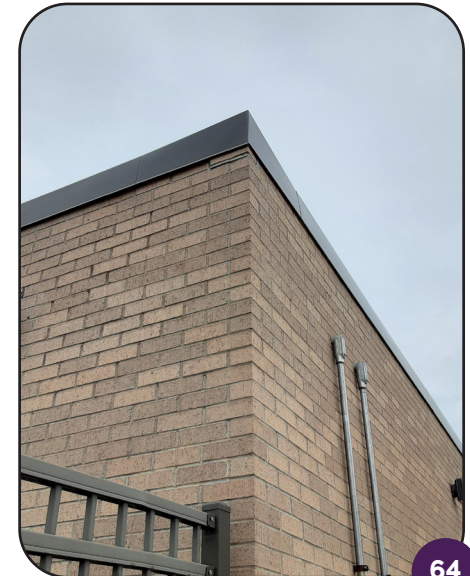
Building System	General Description	Recommendation	Cost Estimate
Exterior Building - Roofing	Roof sections E & F are 19 years old and out of warranty. Both sections are holding ponding water but no major leaks were reported.	Replace roof sections E & F in the next 1-5 years. Correct insulation elevation for proper drainage of roof sections. Recommend a 60 mil 20 year adhered black EPDM membrane.	\$112,000
Exterior Building	Exterior wall vertical pipe unguarded and rusty.	Prepare and coat pipe with weather durable coatings. Consider guarding pipe to eliminate use as climbing assistance to adjacent roof.	\$2,000
Exterior Building	Exterior wall open wall base metal flashing.	Remove, seal, and replace.	\$3,800
Exterior Building	Exterior wall loose roof edge corner brick.	Stabilize area, repair, and replace.	\$5,500

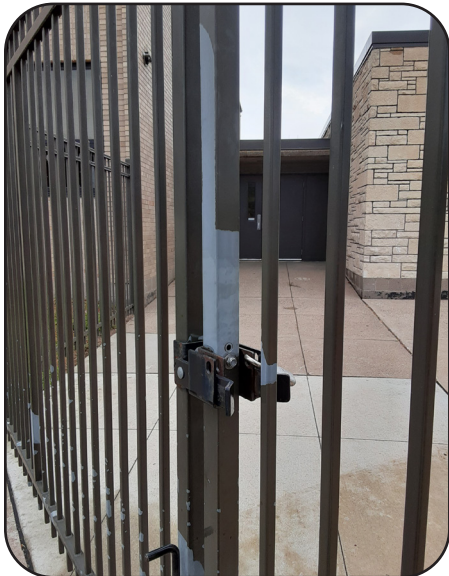
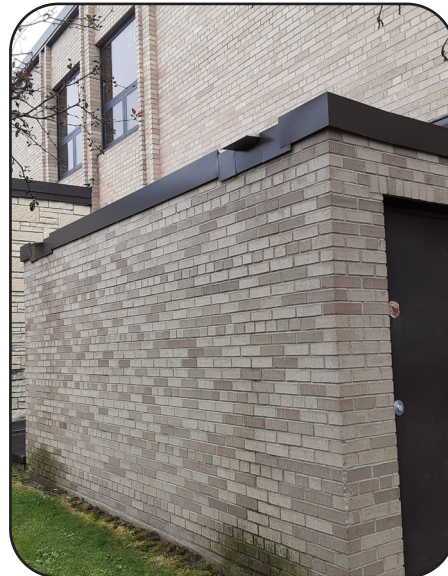
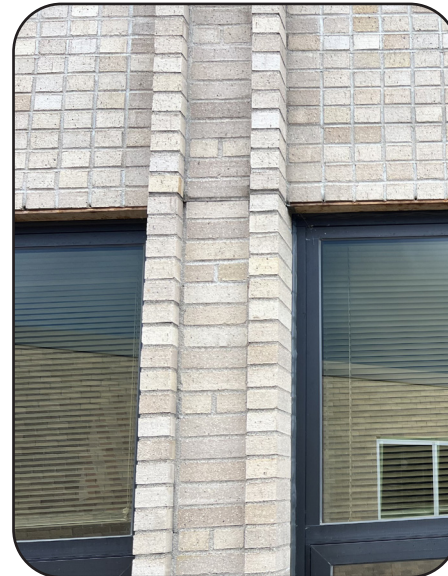
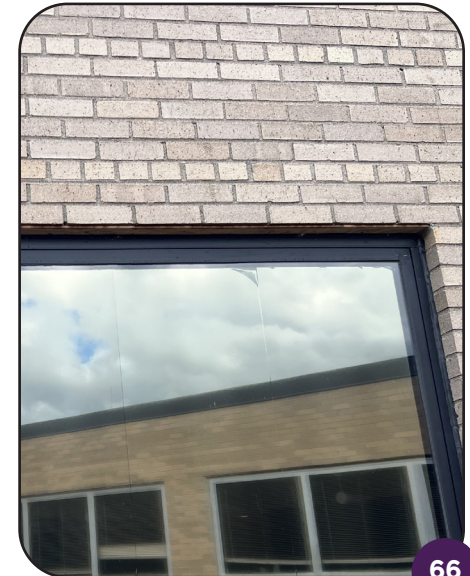
Building System	General Description	Recommendation	Cost Estimate
Site & Landscape	Fence paint missing and peeling.	Prepare and coat with weather durable coatings. Consider electrostatic painting of high use, metal-on-metal areas.	\$20,000
Exterior Building	Exterior wall brick and mortar stained.	Professionally clean walls. Consider completion as more extensive exterior wall corrective project.	\$25,000
Exterior Building	Exterior tuck pointing repairs needed. Masonry, concrete, and expansion joint deteriorating; face brick repair, open mortar joints, and door and window lintels.	Re-tuck walls and exterior masonry.	\$170,000
Exterior Building	Exterior window and door de-laminating glazing film.	Repair or replace de-laminated and damaged window and door glazing film.	\$26,000

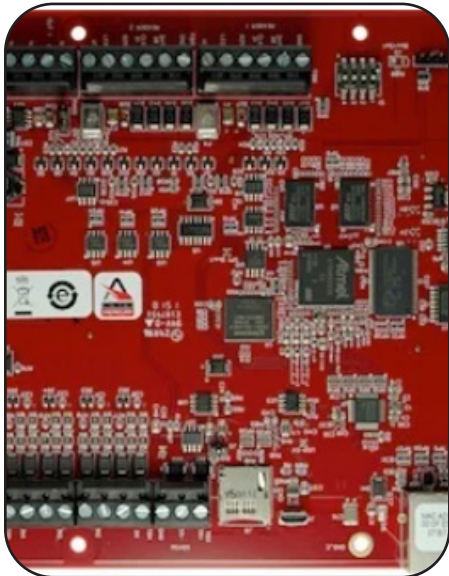
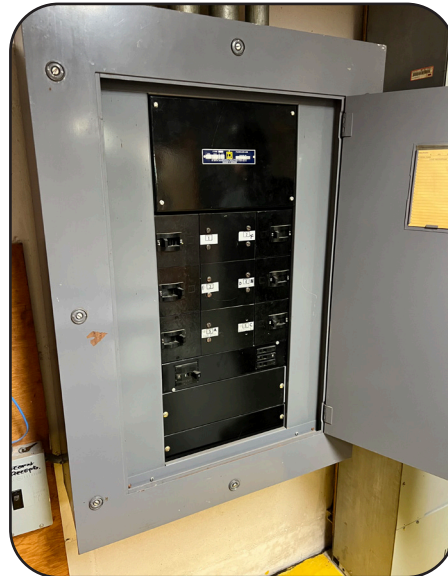
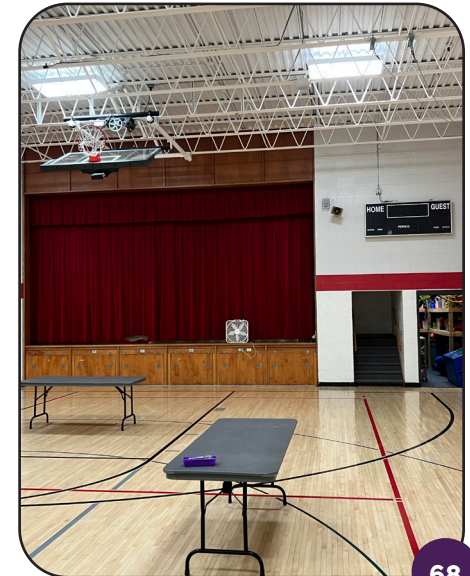
Building System	General Description	Recommendation	Cost Estimate
Electrical - Door Access	Card Access systems across the district are in need of upgrade to their board controllers. Information was compiled through district IT interviews and recommended per school individual need.	Replace HID Vertx boards to Mercury LP1502's.	\$8,000
Electrical - Main Service	Subsequent breakers downstream from the main breaker are original 1965. These components are 60 years old, beyond their expected life and obsolete. Parts will be very difficult to find if problems arise.	Replace all original subpanels and disconnects downstream of the main.	\$100,000
Electrical - Main Service	The electrical main is 33 years old, and obsolete. Parts will be difficult to find if problems arise.	Replace main breaker in the next 5-10 years.	\$150,000
Interior - Stage Renovation	The stage area off the gym is original and dated. Stage curtain appears to be original and of a combustible materials commonly called out by insurance for replacement.	Renovate the space into usable square footage, consider removing the curtain entirely if never used.	\$150,000

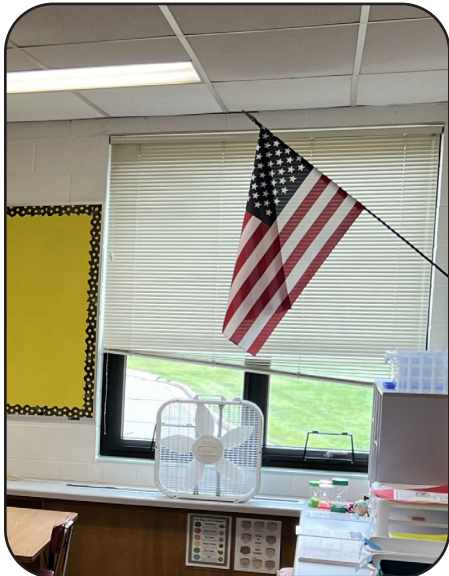
Building System	General Description	Recommendation	Cost Estimate
Interior - Window Treatments	Window treatments were observed as being low quality for a school and often damaged.	Replace plastic blinds with roller shades across the school.	\$30,000
Mechanical - Air Conditioning	The facility is mainly unairconditioned, creating an uncomfortable environment for teaching and learning.	Install chilled water based air conditioning. Pricing given assuming the large HVAC renovation recommendation occurs simultaneously.	\$600,00
