## **PROJECT REPORT**

Date: October 25, 2013  
STR Project Number: 13123

### **District Administration Building Assessment**

### **Board of Education of Oak Park Elementary School District 97**

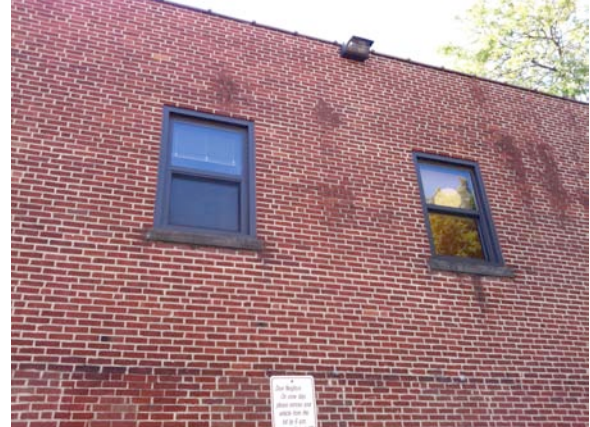
<p><b>North Exterior Wall:</b> Tuckpointing is required as well as investigation of the flashing and wall assembly to determine if water is draining properly in cavity.</p>
<p>DC82</p>

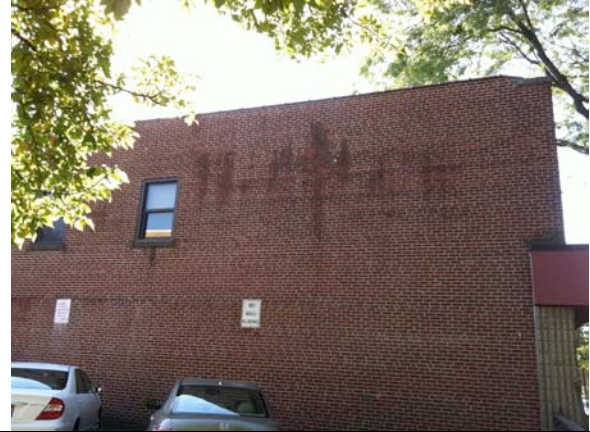
<p><b>North Exterior Wall:</b> Tuckpointing is required as well as investigation of the flashing and wall assembly to determine if water is draining properly in cavity.</p>

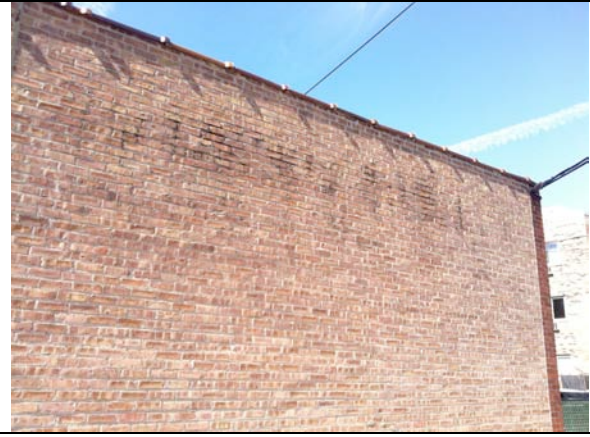
<p><b>East Exterior Wall:</b> Tuckpointing is required as well as investigation of the flashing and wall assembly to determine if water is draining properly in cavity.</p>

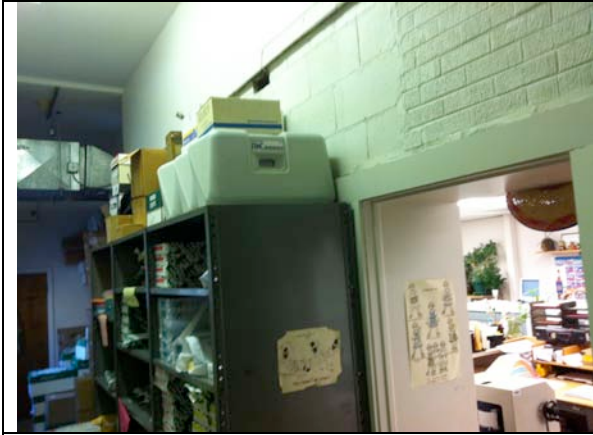
**Storage Room 111A:**  
Existing penetration through wall is not fire-sealed. Also there is no rated door assembly between the storage room and the Print Shop.

- A4** ABATE ASBESTOS CONTAINING FLOORING MATERIAL IN STORAGE 111A AND JANITOR'S CLOSET 125
- A5** REPAIR CRACKED GYPSUM BOARD ABOVE DOOR TO OFFICE 119
- A6** PROVIDE FIRE STOPPING AT WALL PENETRATION IN STORAGE ROOM 111A

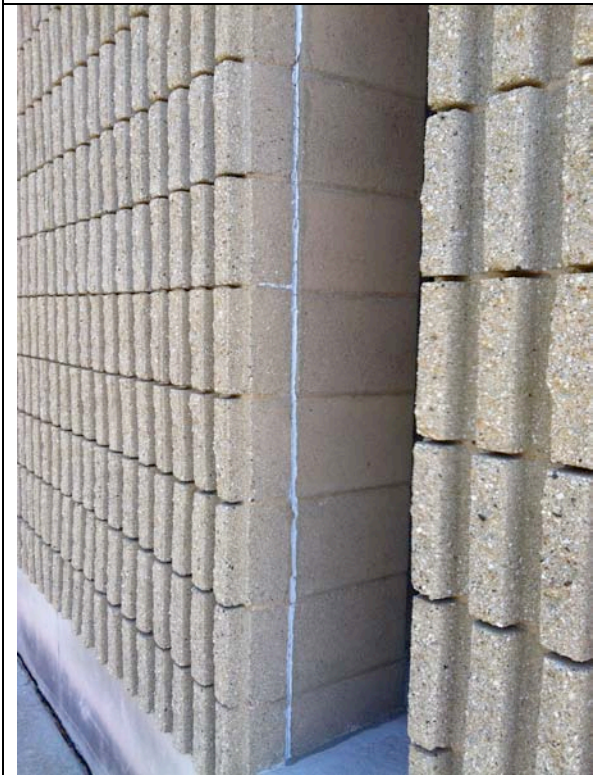
**Exterior Windows – typical West and South:**  
Sealant at the window perimeter and at the joint between inner and outer masonry is failing and should be removed and replaced.

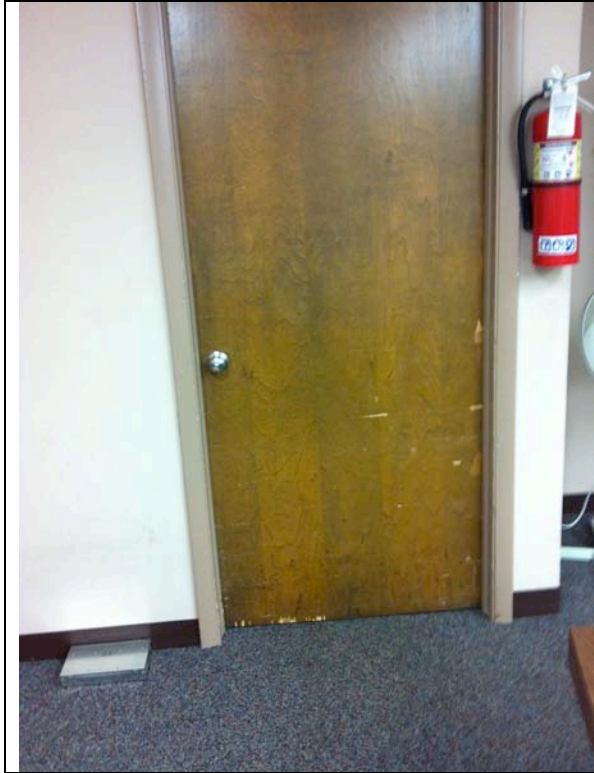
**Conference Room 104:**

This door is damaged and should be replaced with a rated assembly as it leads to an egress Vestibule.

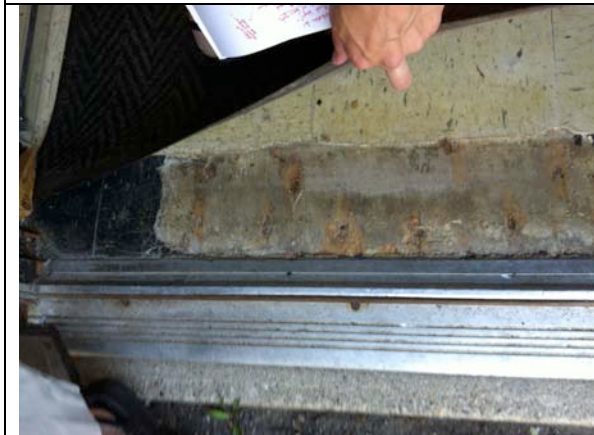
**Northwest Exit Door:**

The threshold is deteriorating and the flooring adjacent to the threshold is non-existent.

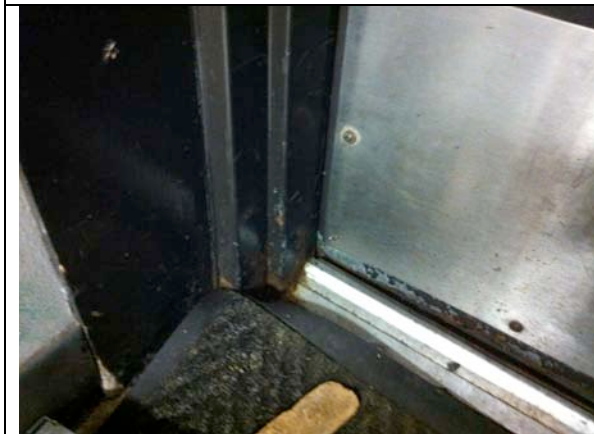
**Northwest Exit Door:**

Frame and door are rusting.

Also – please note that this egress door does not meet required ADA clearances. However, given the constraints of the adjacent room construction, we have not included this in the estimate.

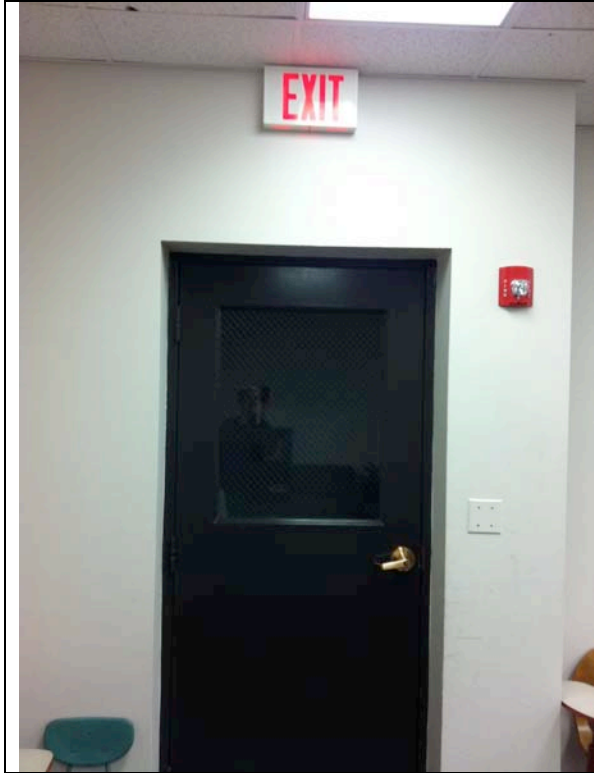
**Door in Reception 101 leading to NE Stair:**  
This door does not swing in the direction of egress. In order to provide proper swing, a small vestibule should be constructed so that the door swings into the stair but does not impede the egress of those exiting the stair.

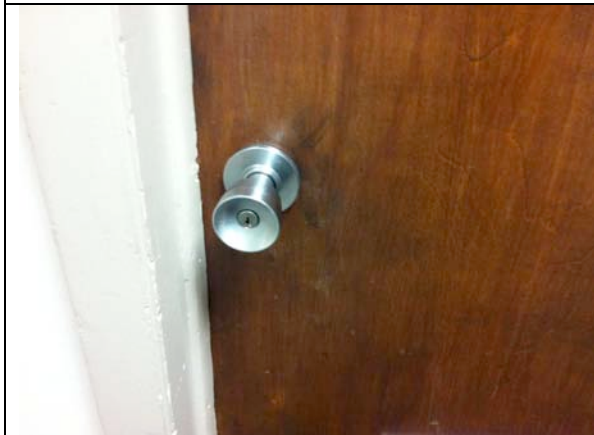
**Typical of All Doors:**  
Door handles do not meet ADA requirements. These knob type handles should be replaced with lever type.

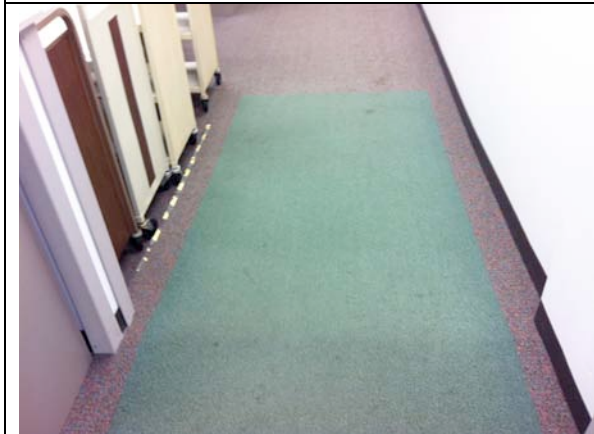
**Open Office 109 – Ramps:**  
A tactile warning strip should be installed at the top and bottom and exposed edges of the ramp. (The height of the rise of the ramp does not require a handrail.)

- A2** PROVIDE TACTILE WARNING STRIPS AT THE EDGES AND TOP AND BOTTOM OF RAMP IN OPEN OFFICE 109
- A3** REPLACE DAMAGED WOOD DOOR AT CONFERENCE 104 TO VESTIBULE 106 - ASSEMBLY SHALL BE 1HR RATED  
ALSO PROVIDE MISSING DOOR AT STORAGE 111A TO PRINT SHOP

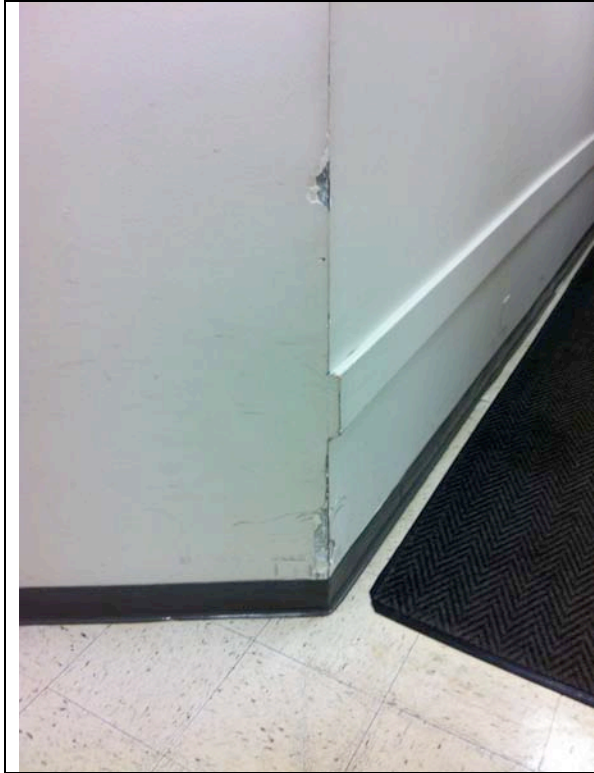
**Typical Finishes:**  
Painted gypsum board is showing wear requiring touch up paint and patching in several locations.

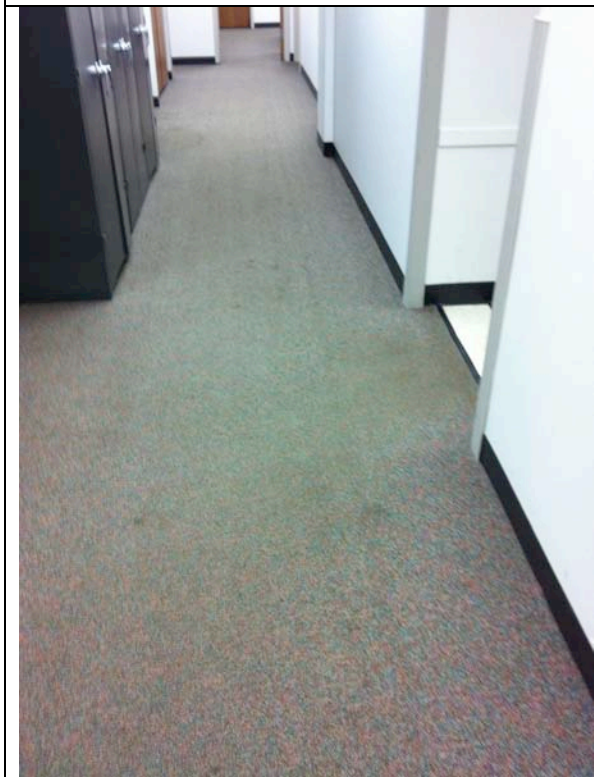
**Typical Finishes:**  
Carpeting is showing wear with evidence traffic flow and stains and worn down areas.

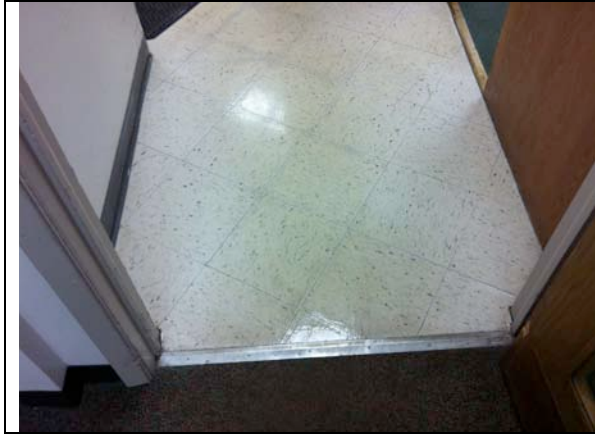
**Typical Finishes:**

Vinyl tile is also showing wear and in need of replacement.

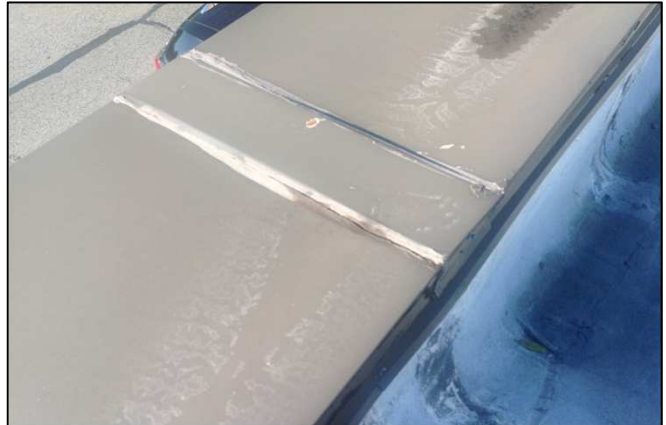
**Defect Description:**

Failing sealant remove and install new sealant.

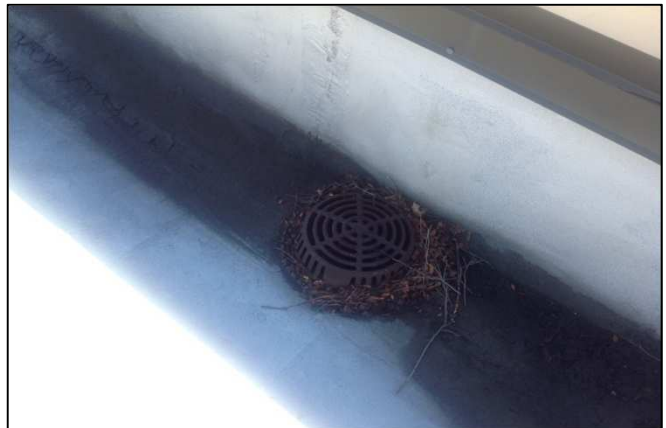
**Defect Number: 1.2.1**

Bag and remove roofing debris.

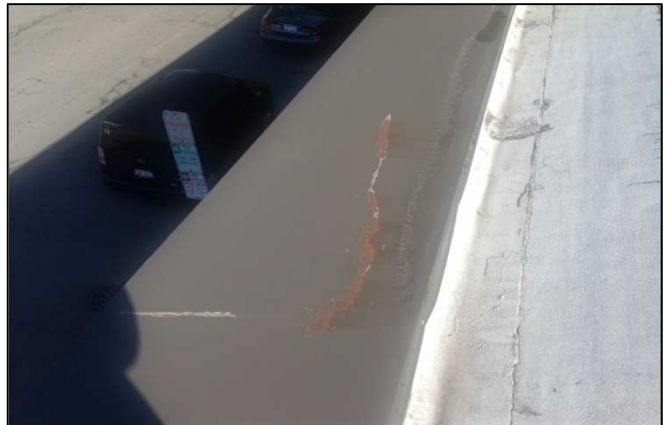
**Defect Number: 1.3.104**

At all damaged surface marks retouch with proper paint to match existing color.

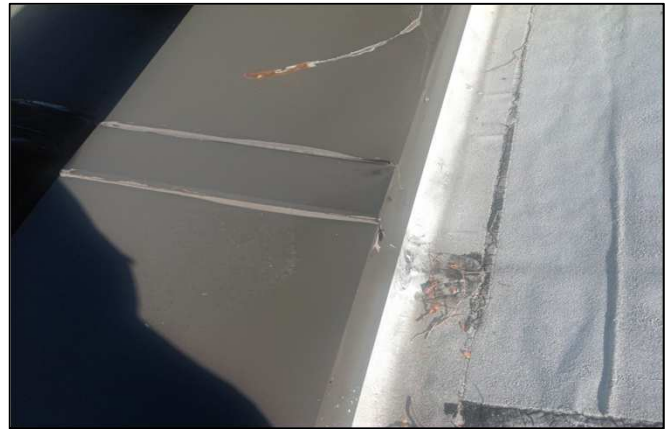
**Defect Number: 1.4.104**

At all damaged surface marks retouch with proper paint to match existing color.

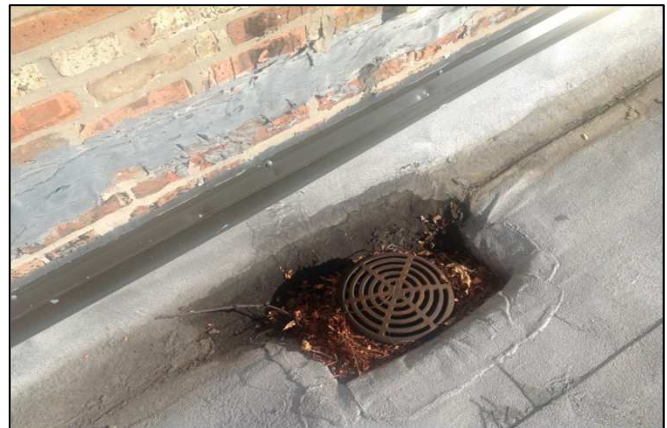
**Defect Number: 1.5.1**

Bag and remove roofing debris.

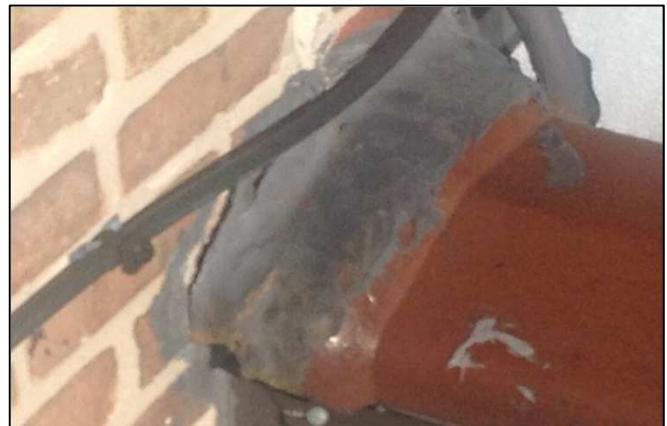
**Defect Number: 1.6.103**

Remove existing sealant and replace with new.

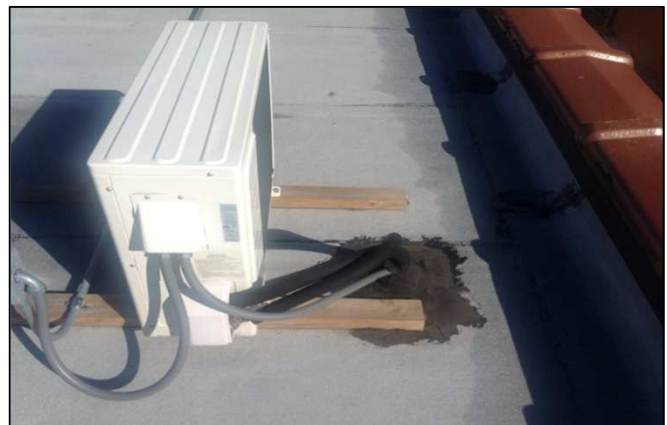
**Defect Number: 1.7.529**

Missing clamping rings at the conduit penetration install clamping rings

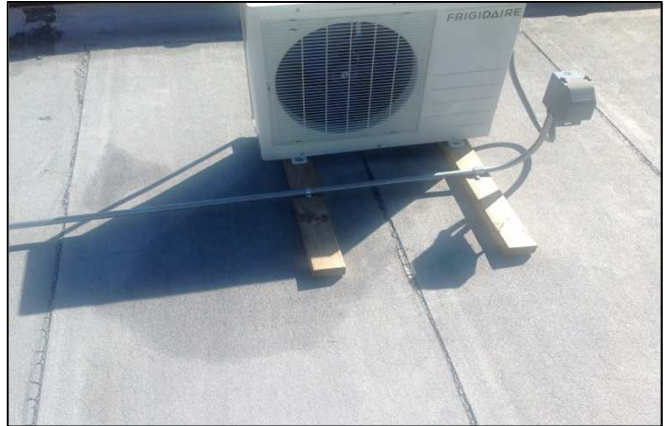
**Defect Number: 1.8.510**

Install missing protection pads under wood rails

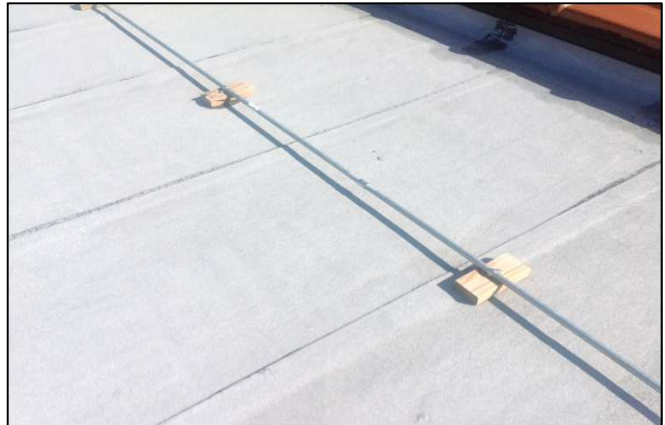
**Defect Number: 1.9.510**

Install missing protection pads under wood rails

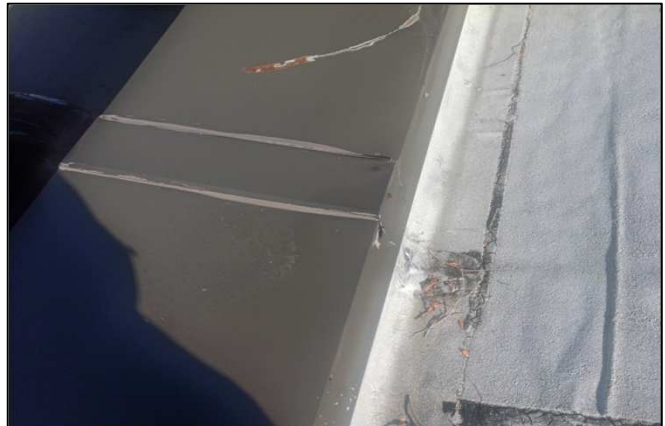
**Defect Number: 1.10.101**

Re-tighten loose sheet metal flashing.

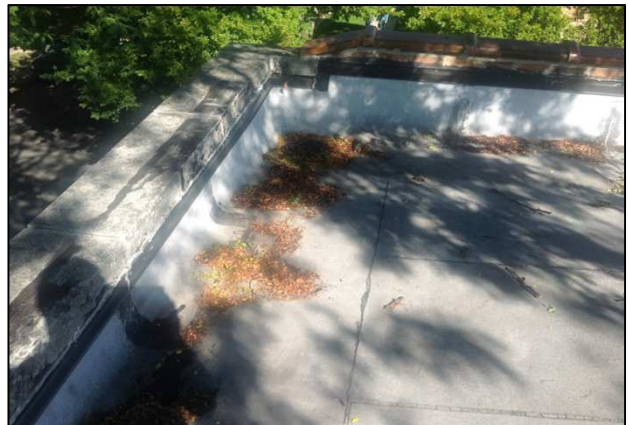
**Defect Number: 2.1.1**

Bag and remove roofing debris.

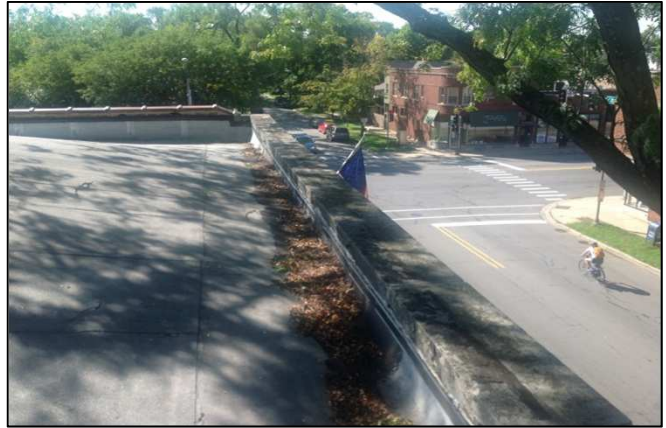
**Defect Number: 2.2.1**

Bag and remove roofing debris.

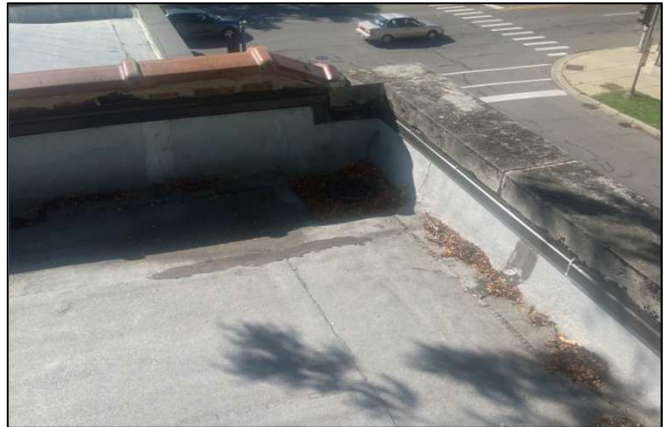
**Defect Number: 2.3.1**

Bag and remove roofing debris.

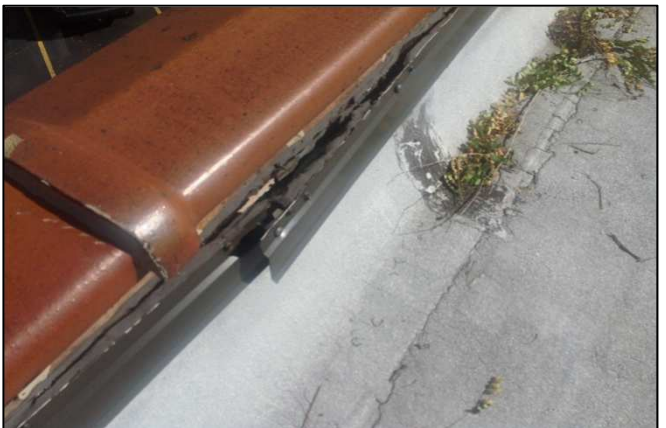
**Defect Number: 2.4.101**

Re-attach loose sheet metal flashing and apply new sealant.

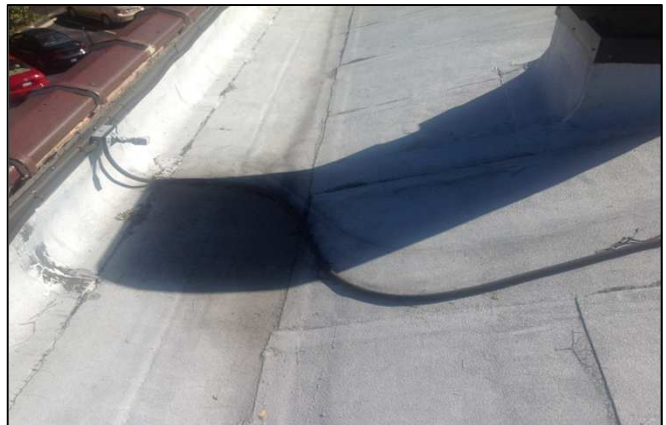
**Defect Number: 2.5.597**

Missing pipe supports for cable. Install new pipe supports

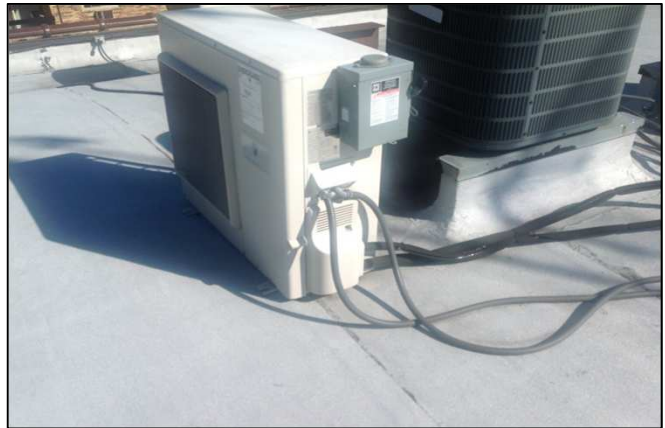
**Defect Number: 2.6.510**

Missing protection pads, install new support rails over protection pads.

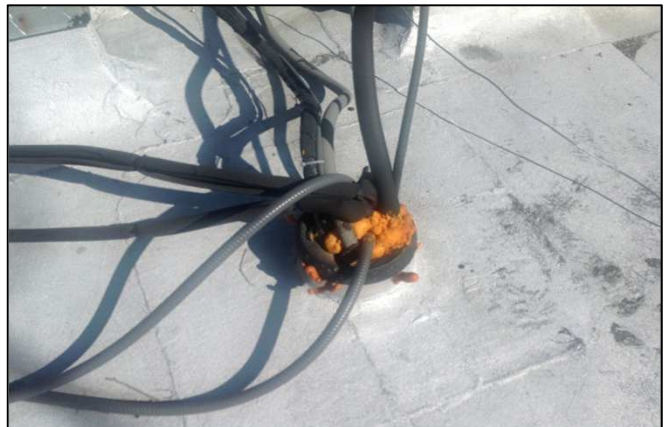
**Defect Number: 2.7.529**

Install missing clamping rings and new portal cover.

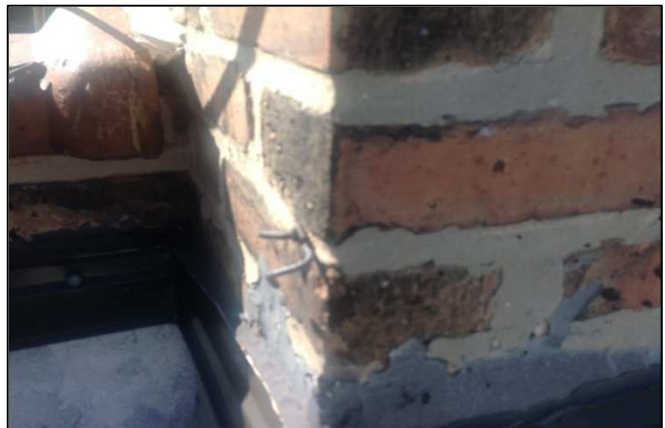
**Defect Number: 2.8.103**

Install missing sealant at opening between wall and coping.

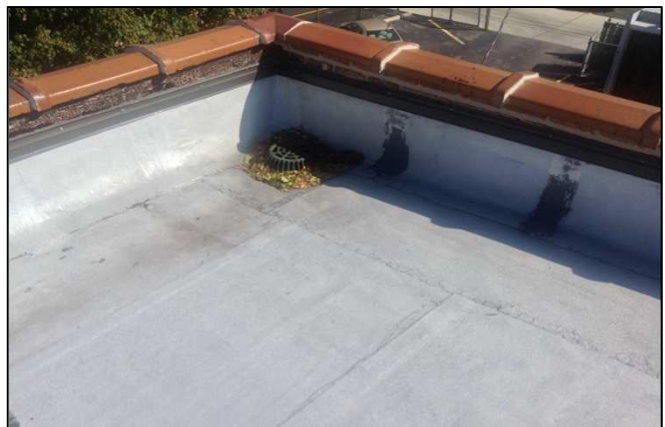
**Defect Number: 2.9.1**

Bag and remove roofing debris.

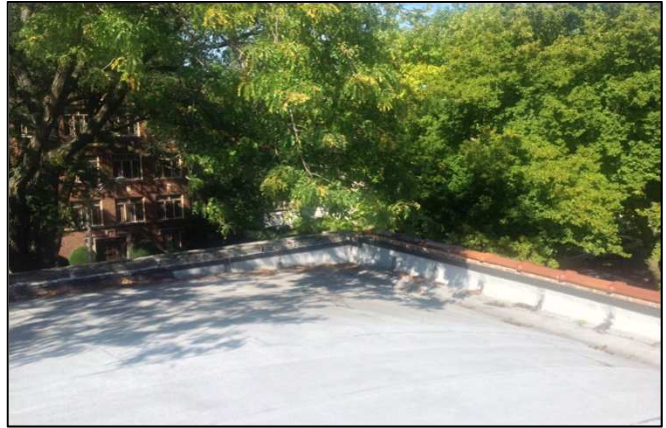
**Defect Number: 2.10.538**

Trim back tree limbs

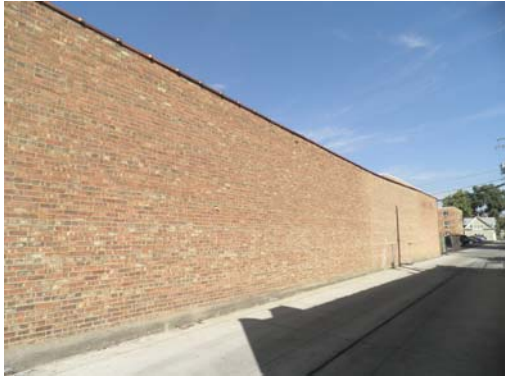
East Masonry Wall is in Good Condition
