C.E.S.A. 10
 Facilities Management Services

Facility Improvement Measures Wausau - Hewitt-Texas Elementary School

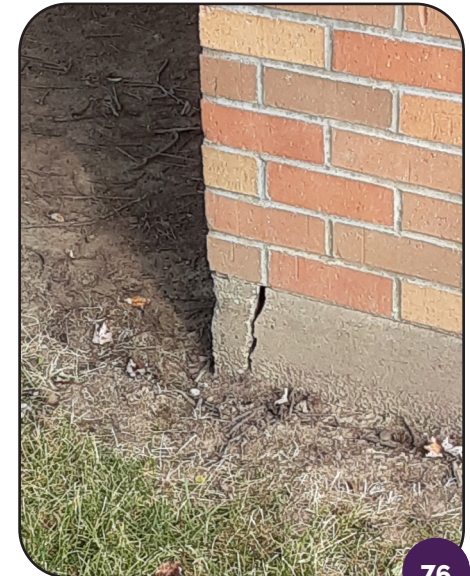
Building System	General Description	Recommendation	Cost Estimate
Site & Landscape	Concrete entrance landing raised edge transition to walk.	Replace, patch, cut, or grind to eliminate trip hazard.	\$85,00
Exterior Building	Soiled soffits between outlookers.	Clean and paint where needed.	\$5,500
Exterior Building	Exterior wall EIFS blemishes and paint discoloration.	Skim patch and paint to match existing.	\$1,000
Exterior Building	Exterior wall base below face brick cracked and open.	Patch and seal.	\$4,500

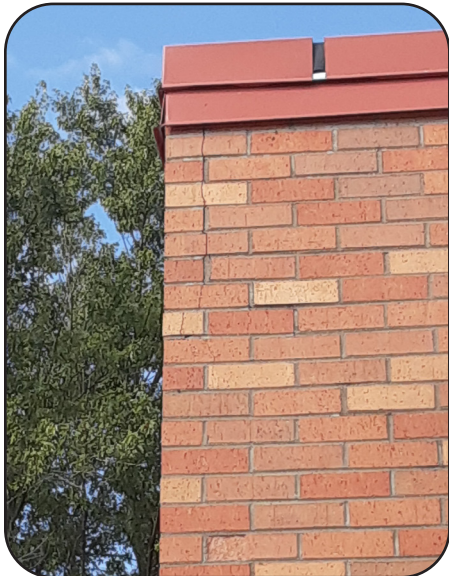
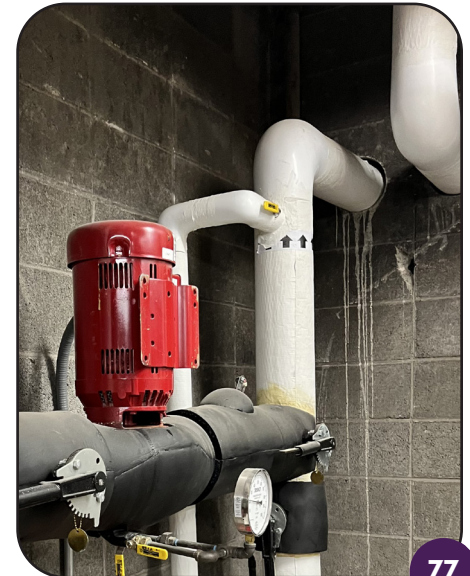
Building System	General Description	Recommendation	Cost Estimate
Exterior Building	Open roof edge flashing.	Add metal flashing to close opening.	\$1,000
Exterior Building	Exterior wall roof drain discharge wall stains.	Clean stains. Consider extending discharge away from brick face.	\$1,000
Interior - Kiln Safety	Art kiln is housed along with combustible materials.	Clean and organize the space. Store combustibles appropriately a safe distance away.	\$500
Interior - Wall Patching	Minor CMU block wall patching is needed in the boiler room. Determine if walls are fire rated.	Patch masonry and seal penetrations with caulk for noise. If a fire wall is present, properly seal with fire caulk.	\$2,000

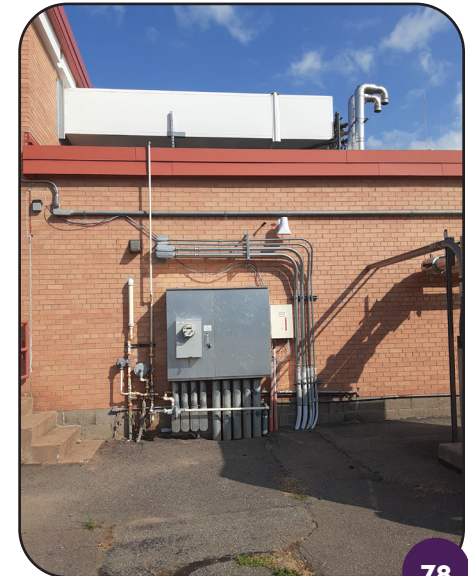
Building System	General Description	Recommendation	Cost Estimate
Site & Landscape - Trees	One tree on the south side of the facility is overhanging the roof, too close to the building. Trees overhanging the building shed leaves on the roof which block roof drains, create mold and mildew on the building, allow a path for intruders to access the roof creating a security hazard.	Take down the tree and remove remaining stump.	\$3,000
Site & Landscape	Dumpsters on asphalt.	Install concrete pads for dumpsters.	\$6,800
Site & Landscape	Propane pipe tubing unprotected on side of building.	Isolate or guard pipe tubing.	\$1,000
Site & Landscape	Electrical service supply meter and cabinet unprotected and providing potential climbing assistance to roof.	Fence in to isolate. Consider fencing with other adjacent HVAC and generator mechanical equipment.	\$3,000

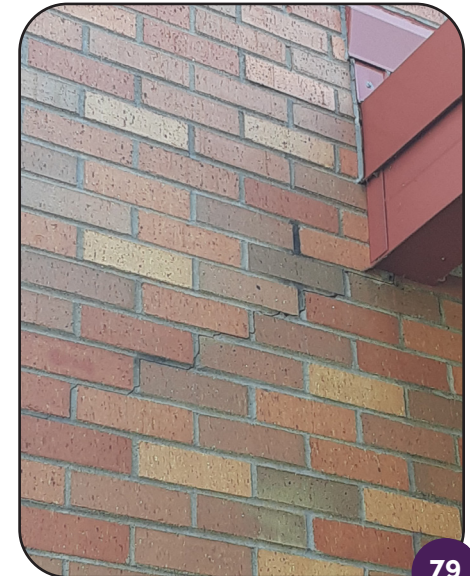
Building System	General Description	Recommendation	Cost Estimate
Site & Landscape	Mechanical equipment (HVAC & generator) unprotected.	Fence in to isolate. Consider fencing with adjacent electrical supply meter and cabinet.	\$6,500
Exterior Building - Roofing	Roof sections B-D are 23 years old and many years out of warranty period. The roofs are showing signs of degradation, slightly ponding water and frequent patches were observed.	Replace roof sections B-D in the next 2-5 years with an adhered 60 mil black EPDM 20 year warranty roof.	\$192,000
Exterior Building	Open narrow soffit area under roof edge.	Seal and paint. Consider cladding to close open areas.	\$12,000
Exterior Building	Exterior wall step cracks at exit overhang.	Investigate and eliminate cause. Tuck point bricks and mortar.	\$18,500

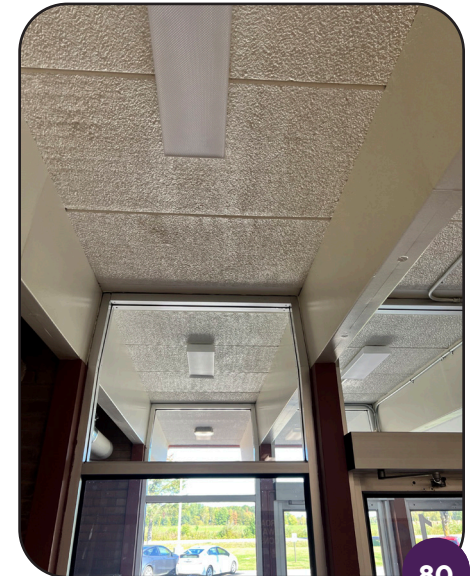
Building System	General Description	Recommendation	Cost Estimate
Exterior Building	Exterior wall low corner bricks cracked.	Replace and tuck point.	\$3,800
Interior - Wood Doors	Minimal older interior wood doors throughout the facility are showing age; de-laminating, stained, and chipped.	Replace aged and damaged interior wood doors. Estimate given for 5 doors.	\$7,500
Electrical	Minimal original construction 1961 obsolete electrical subpanels were noted throughout the facility. If failures arise, replacement breakers will be difficult to find.	Replace panels and breakers. Ensure functional locking enclosure doors are in place.	\$20,000
Electrical	Although interior lighting in the facility has mainly been completed, spot small areas around the entrance look to still be fluorescent.	Complete remaining lighting conversion.	\$5,000

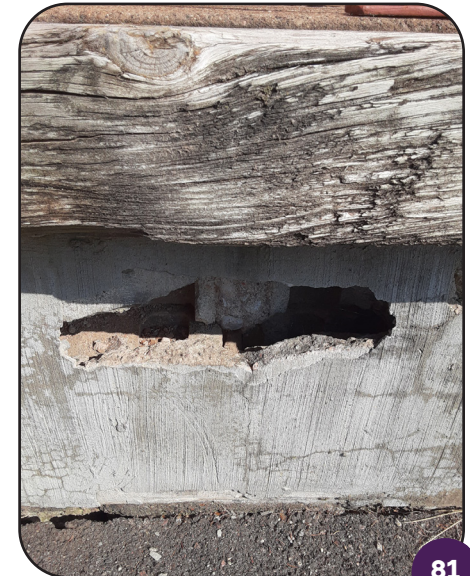
Building System	General Description	Recommendation	Cost Estimate
Site & Landscape	Asphalt drive too narrow. Drive off area formed on edge.	Widen asphalt drive.	\$15,500
Site & Landscape	Multiple walk concrete slabs with transitional and divided cracks.	Replace cracked concrete walk slabs.	\$6,000
Site & Landscape	Missing insulation and unprotected tubing on side of building.	Isolate or guard pipe tubing.	\$1,000
Site & Landscape	Dock wall and bumper deteriorating.	Replace wall and bumpers.	\$14,500

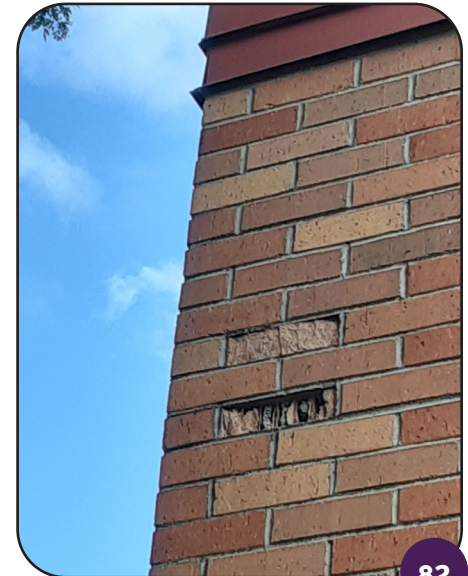
Building System	General Description	Recommendation	Cost Estimate
Site & Landscape	Dock metal wall panel base rusting.	Patch, repair, and paint or replace.	\$7,500
Site & Landscape	School sign due for upgraded replacement.	Replace sign.	\$12,500
Exterior Building	Wall top concrete edge cracked.	Patch, seal, and paint.	\$4,000
Exterior Building	Exterior wall face bricks spalling in multiple areas.	Replace and tuckpoint spalling bricks.	\$75,000

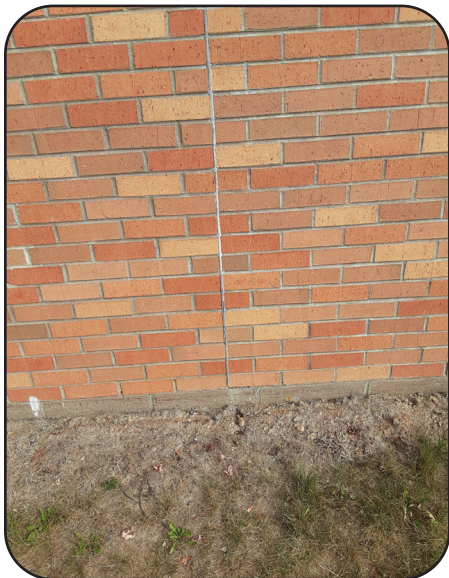
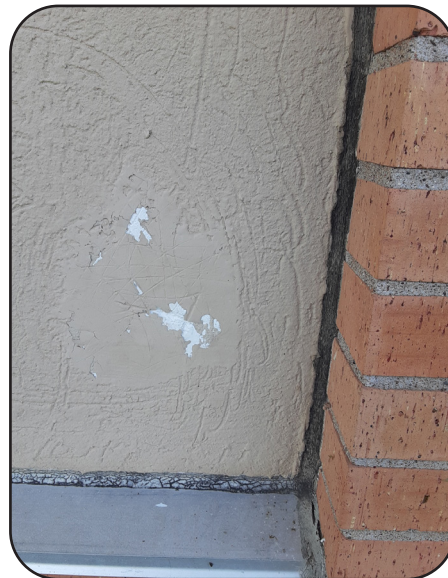
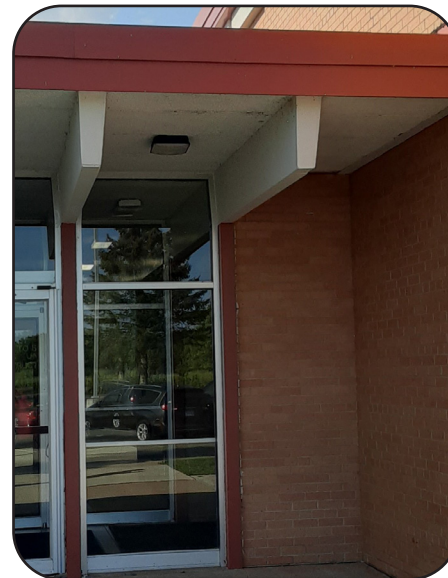
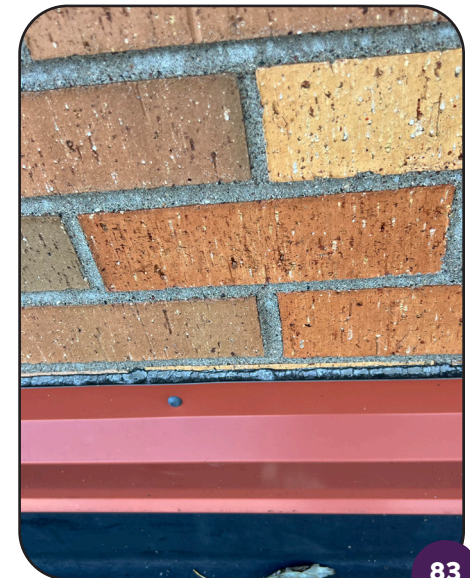
Building System	General Description	Recommendation	Cost Estimate
Exterior Building	Exterior wall expansion joint deteriorated caulk.	Remove existing and replace joint material.	\$12,500
Exterior Building	Exterior wall corner caulk between face brick and EIFS deteriorated.	Remove existing and caulk.	\$14,000
Exterior Building	Exterior door frame caulk deteriorated.	Remove existing and caulk.	\$2,500
Exterior Building	Exterior flashing caulk deteriorated.	Remove existing and caulk.	\$4,000

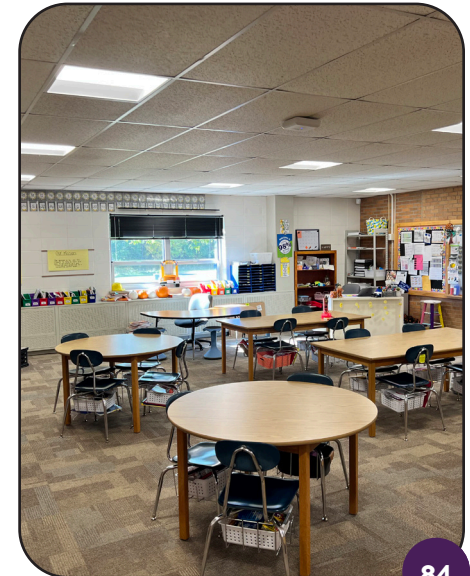
Building System	General Description	Recommendation	Cost Estimate
Exterior Building	Exterior window lintels rusted and loose.	Coat to prevent rust and tuckpoint around lintels.	\$20,000
Exterior Building	Exterior window sills stained under drip edges.	Clean edges and bricks.	\$2,500
Exterior Building	Exterior wall drinking fountain located next to large outdoor HVAC equipment.	Relocate drinking fountain.	\$3,000
Interior - Acoustical Ceiling	Most of the buildings acoustical ceiling is in good condition. A small section on the east end has 2x4 tile beginning to sag and show its age.	Replace ceiling in the newer addition in the next 5-10 years.	\$12,500

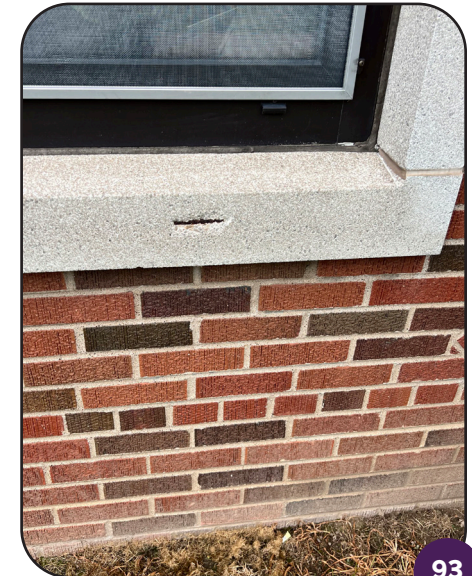
Building System	General Description	Recommendation	Cost Estimate
Exterior Building	Unsecured cable from roof into brick face.	Secure cable in fixed conduit.	\$1,000
Exterior Building	Unsecured fiber cable from ground to roof.	Secure cable in fixed conduit.	\$3,500
Exterior Building	Upper decorative stone belt piece missing.	Replace missing stone. Seal and weather proof.	\$14,500
Exterior Building	Stone window sill rebar steel exposed.	Patch surface.	\$1,000

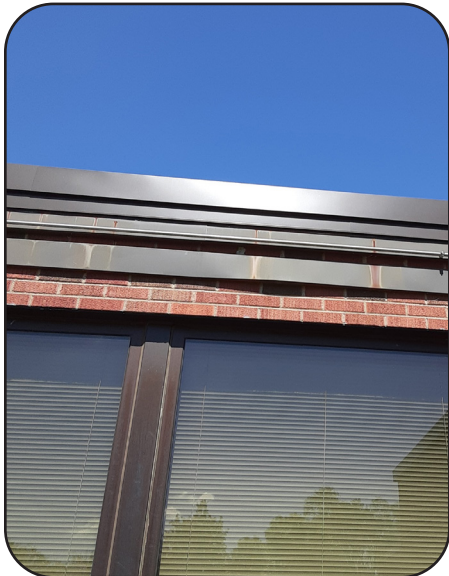
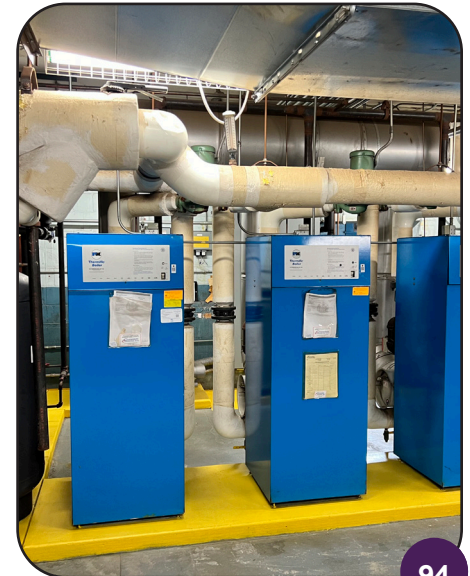
Building System	General Description	Recommendation	Cost Estimate
Exterior Building	Flashing fasteners rusting and staining metal flashing.	Clean metal flashing and replace fasteners with non-ferrous replacements.	\$1,000
Interior - Multi-Roof Deck	The wood roof deck of the multipurpose room is showing water damage from the interior.	Hire a structural engineer to closely examine the damage from a lift and determine the urgency. Examine both decking and wooden beams. If the structure does not pose an immediate danger, replace deck with steel decking during re-roofing of roof D, which should be reroofed at any time. Urgency and pricing given for structural examination. Deck replacement included in roof D FIM.	\$7,500
Mechanical - Pipe Insulation	Missing and/or damaged pipe insulation was noted in various locations around the building. Although the missing insulation pictured in room 114 does not appear to be asbestos containing, the exposed pipe can pose a burn hazard and should be addressed immediately.	Replace damaged and missing pipe insulation. Address issues in child areas as soon as possible. Presence of asbestos and abatement needed can drastically change pricing. Pricing given for spot replacement seen around the building, not for potential abatement.	\$10,000

Mechanical - Boilers	John Marshall ES is heated by three 34-year-old standard efficiency atmospheric boilers, each 1.5MBTU. The boilers have held up well, however are beyond their expected useful life and are inefficient to today's standards.	Replace the boilers and pumps in the next 1-3 years with high efficiency sealed combustion air condensing boilers. Test nearby materials for hazardous materials.	\$325,000

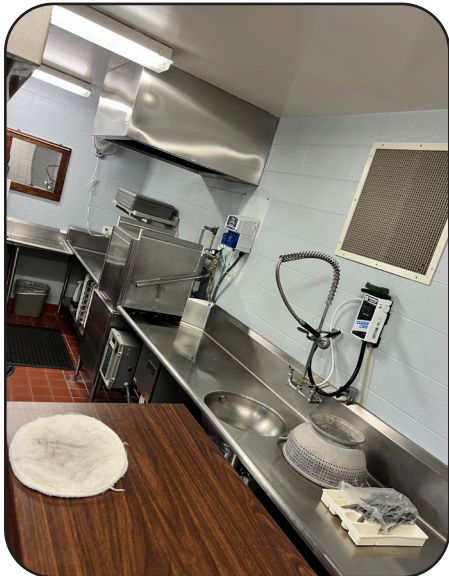
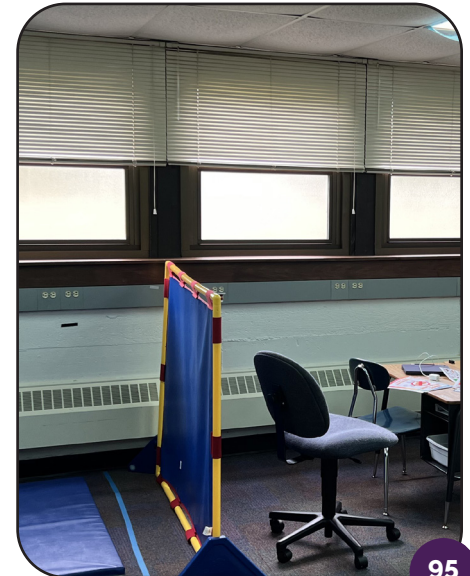
Building System	General Description	Recommendation	Cost Estimate
Mechanical - Kitchen Cooling	It was noted during staff interviews that the kitchen area is hot. Air conditioning was provided to this area in the 2016 mechanical renovation and it should be cooled.	Balance the final S-1 diffuser to the kitchen to ensure proper air flow at the end of the line. Ensure no short cycling is occurring with incoming air being immediately exhausted.	\$3,000
Mechanical - Air Conditioning	Outdoor mechanical equipment directly on ground slab with no drainage or protective clearance.	Raise equipment on a stand, rack, or curb to protect from ice, water, and debris.	\$2,500
Plumbing - Domestic Hot Water	The two 100 gallon gas fired atmospheric water heaters in the boiler room are 35 years old and 15-10 years beyond their expected useful life.	Replace water heaters with sealed combustion/power exhaust high efficiency units within the next 1-3 years.	\$15,000

Electrical - Classrooms	Room 114 was formerly a computer lab re-purposed to a new child space. Many surface mount outlets are present at finger height creating a safety hazard. Avoiding surface mount electrical in a facility of this vintage will be difficult without constructing a furring wall.	Eliminate unnecessary outlets and mount at an appropriate height with tamper proof outlets.	\$10,000

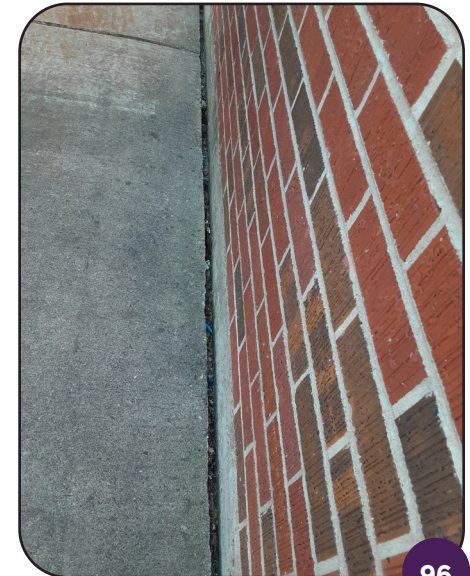
Building System	General Description	Recommendation	Cost Estimate
Site & Landscape	Concrete curb sinking.	Replace or mud jack to elevate.	\$1,000
Site & Landscape	Concrete exit door landing raised edge and cracked.	Replace with smooth transition to walk concrete.	\$3,500
Site & Landscape	Wide concrete land slab gaps.	Back fill gaps with sand and backer rod. Caulk and seal with appropriate joint filler. Heat melt in place material recommended for smooth, clean appearance.	\$8,500
Site & Landscape	Building perimeter transition to hardscape gaps.	Back fill gaps with sand and backer rod. Caulk and seal with appropriate joint filler. Heat melt in place material recommended for smooth, clean appearance.	\$5000

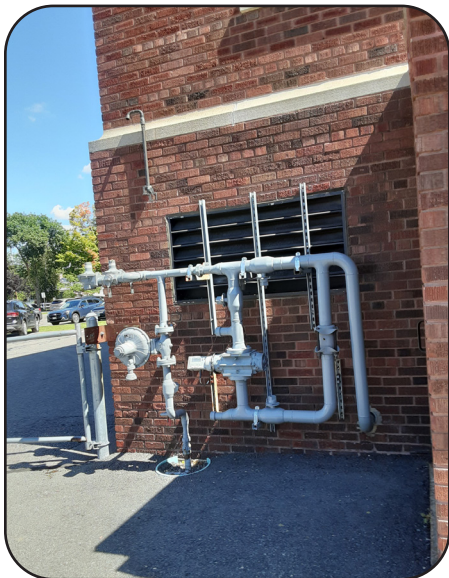
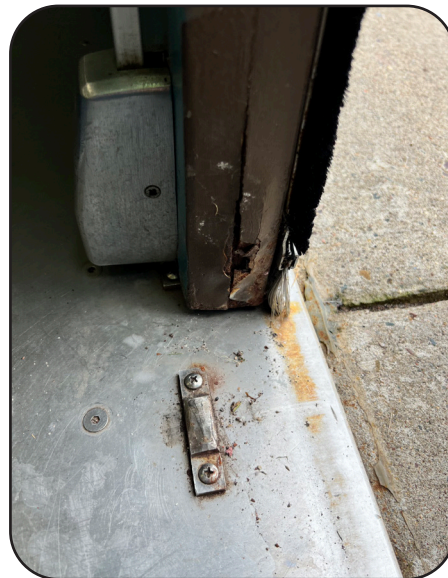
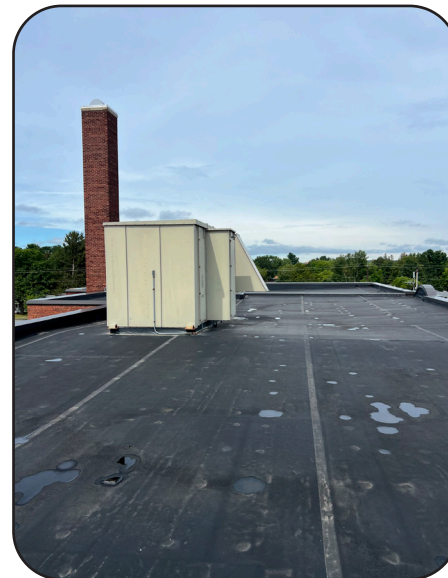
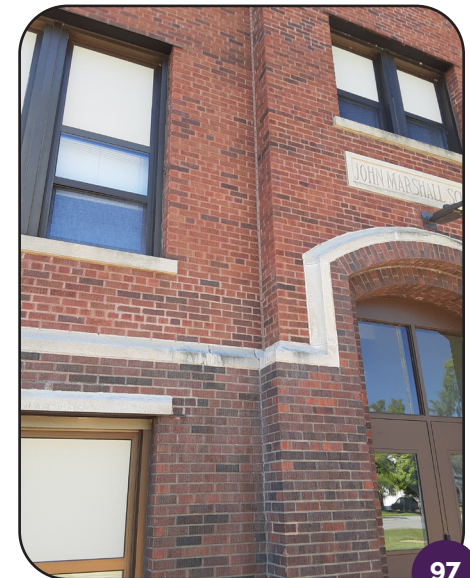
Building System	General Description	Recommendation	Cost Estimate
Site & Landscape	Gas valve on side of building not secured inside of fencing.	Enclose and secure valve access.	\$4,500
Exterior - Doors	Some sets of exterior steel doors are deteriorating. Triple door set #5 is pictured and is rusting through.	Complete a through facility exterior door inventory and replace as necessary. Expect to replace several door sets in the next 1-5 years.	\$20,000
Exterior Building - Roofing	Roof sections A-C are 18 years old. Roof sections E-H and L are between 21-24 years old, all out of warranty. The roofs appear to be holding up well but are mostly at their expected useful life.	Replace all roof sections in the next 3-7 years. Economies of scale will be seen with doing more at once, but some roofs could be deferred based on individual performance. Pricing given for all roofs.	\$277,000
Exterior Building	Decorative lower stone belt stained.	Clean decorative stone.	\$18,000

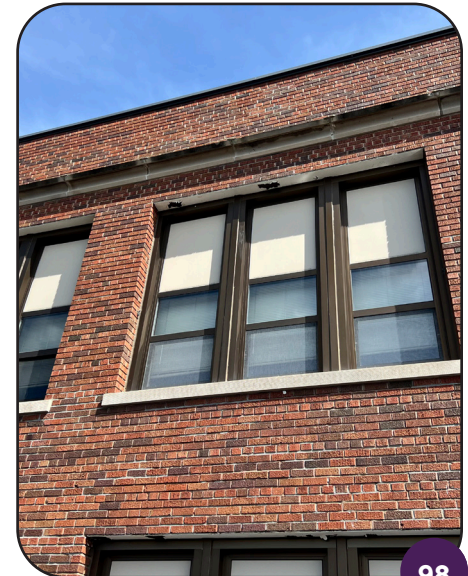
Building System	General Description	Recommendation	Cost Estimate
Exterior Building	Under side of decorated belt stained.	Clean decorative stone.	\$15,000
Exterior Building	Decorative stone belt cracked.	Verify permanence. Patch crack or replace.	\$3,500
Exterior Building	Stone window sills stained.	Clean sills.	\$8000
Exterior Building	Window lintels rusting and open.	Prepare and appropriately coat to prevent rust. Stabilize and close open or loose edges.	\$60,000

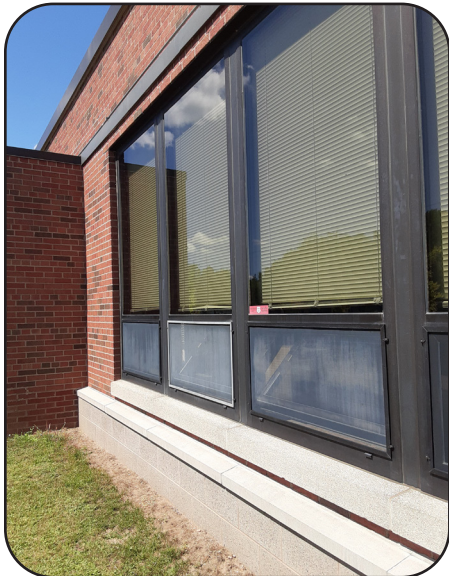
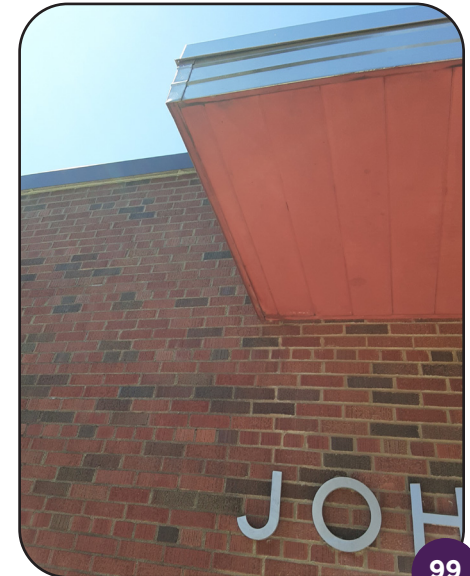
Building System	General Description	Recommendation	Cost Estimate
Exterior Building	Window screen frame colors mismatched.	Match screen frame color per each elevation.	\$6,000
Exterior Building	Outdoor overhead storage door frame and gasket edge damaged.	Repair and replace frame cladding and gaskets.	\$2,000
Exterior Building	Roof edge flashing open gap underneath. Wasp nesting observed under gaps.	Verify components inside of gap. Spray foam insulation to close openings.	\$3,000
Exterior Building	Main entrance over hang wood soffit due for repainting.	Prepare and repaint. Consider cladding to extend maintenance frequency.	\$5,500

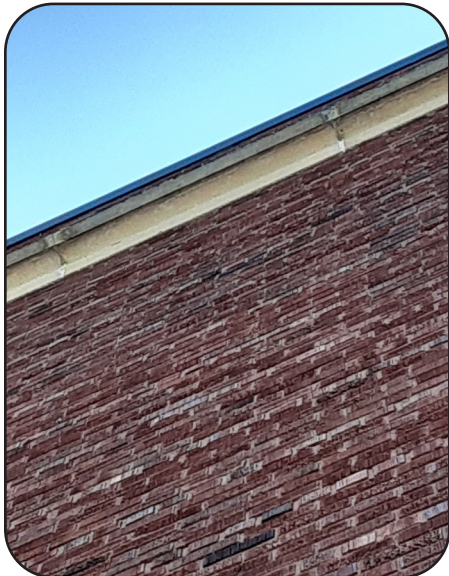
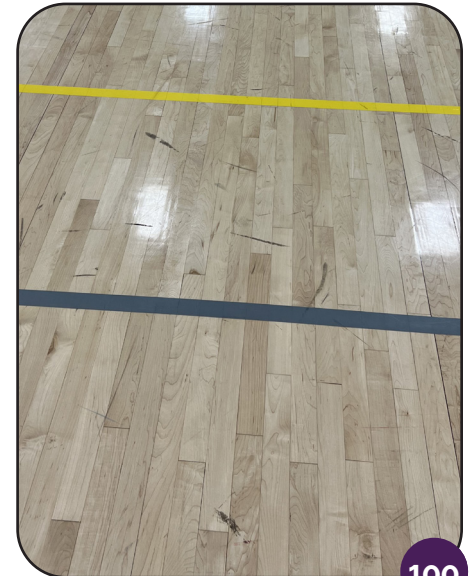
Building System	General Description	Recommendation	Cost Estimate
Exterior Building	Older face brick spalling.	Repair as part of larger masonry improvement project.	\$45,000
Interior - Secure Entrance	Although the entrance is secure with a vestibule and electronic vetting area, visitors are not directly routed through the office prior to being given access to the building. This can be accomplished cost effectively at John Marshall with the addition of a wall or storefront glass and door modifications.	Install secure entrance measures routing visitors through the office prior to being given access to the full school.	\$100,000
Interior - Windows	The original facility windows contain an upper opaque section, this fiber board is made of asbestos material and is unpainted from the inside, giving off an unfinished look to the classrooms.	The much more costly and recommended option is to abate the panels and replace with spandrel glass. Another option would be to paint the interior side of the asbestos panel. Pricing given for painting.	\$15,000

Interior - Gym Flooring	Although in good overall condition, the main gym floor is scuffed and scratched.	Maintain a wood floor refinishing cycle, recommended every 5-10 years dependent on use and condition.	\$25,000

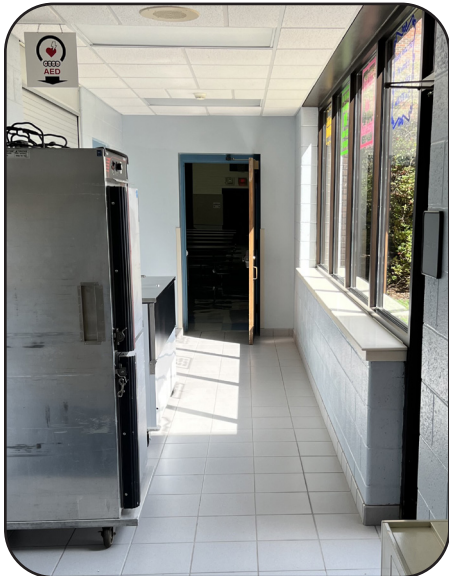
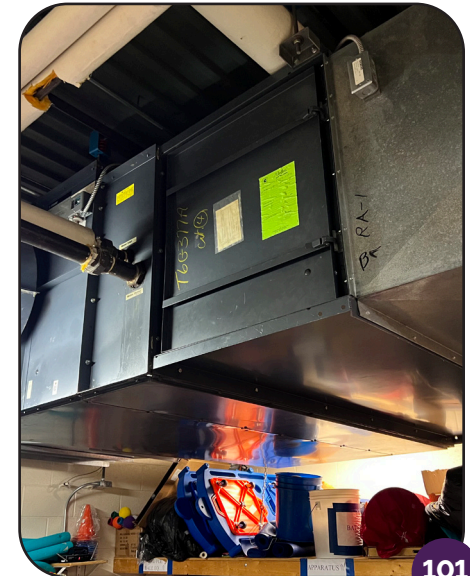
Building System	General Description	Recommendation	Cost Estimate
Interior - Lunch Flow	The single door and frame from the multipurpose room to the kitchen area creates a bottleneck for students getting through lunch.	Ensure the door is not a required fire door, it does not appear to be. Check for load bearing points. If acceptable, remove the door, frame, and surrounding wall to open up the entry.	\$10,000
Interior - Wood Doors	Minimal older interior wood doors throughout the facility are showing age; de-laminating, stained, and chipped.	Replace aged and damaged interior wood doors. Estimate given for 10 doors.	\$15,000
Interior - Ceilings	Ceilings in John Marshall are in good condition, however they all must come down if undertaking a major HVAC renovation.	Replace ceilings with mechanical renovation.	\$125,000
Mechanical - HVAC	Marshall is provided HVAC through a mix of air handling solutions ranging from 30 year old equipment in the original 3-story building to 50+ year old equipment in the 1955 wing. All beyond it's expected service life and not providing A/C. The multipurpose room's HVAC is modern with A/C.	Replace all air handling equipment in the facility with modern above ceiling VAV equipment. Take space within the school to create a new mechanical room in the 1955/89 wings. Replace the 1923 building RTU with modular penthouse rooftop equipment, and install new VAV's. The gym AHU likely has life remaining, but is ready for replacement by age, and must be replaced if moving to chilled water. Replace the 1999 renovation DX unit one-for-one. Leave the multipurpose equipment in place.	\$2,000,000

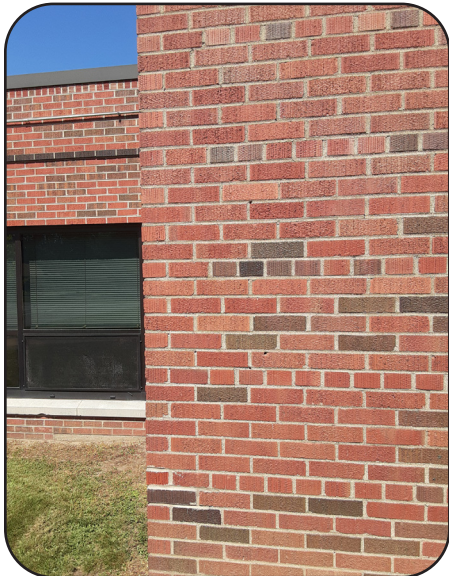
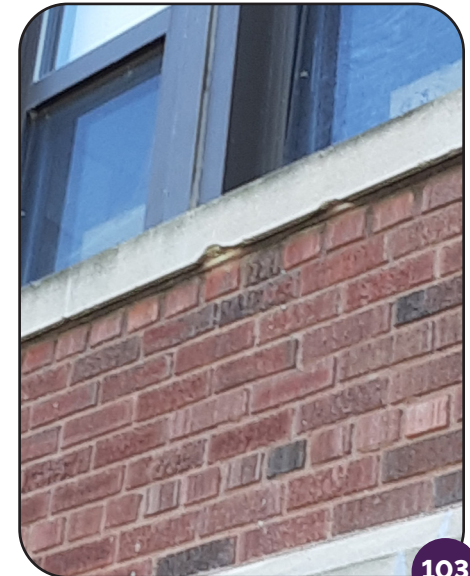
Building System	General Description	Recommendation	Cost Estimate
Exterior Building	Open face brick mortar.	Investigate and eliminate cause. Clean and remove stains.	\$6,500
Exterior Building	Conduit is sagging and was potentially used for climbing access to the roof.	Straighten conduit. Consider placing guards around conduit to deter potential use for climbing assistance.	\$5,500
Exterior Building	Limestone belt surface deteriorating.	Resurface decorative limestone.	\$35,000
Exterior Building	Stone window sills cracked.	Patch cracks or replace.	\$12,500

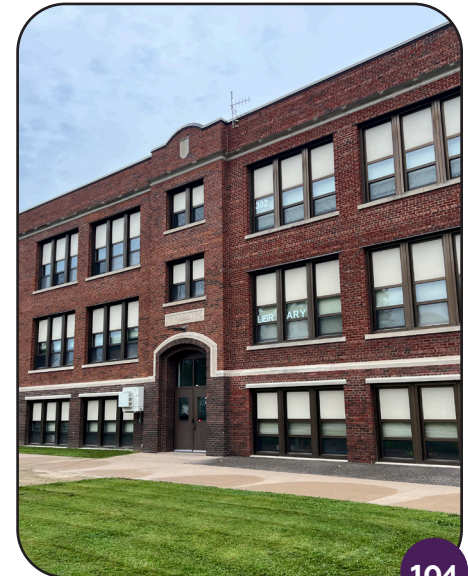
Building System	General Description	Recommendation	Cost Estimate
Exterior Building	Poor quality tuck pointing.	Redo poor quality work. Consider as add on to more extensive masonry work to reduce mobilization and down-time costs.	\$18,000
Exterior Building	Exterior wall base crack below brick face.	Repair or replace. Waterproof to prevent infiltration.	\$1,000
Exterior Building	Newer face brick spalling.	Repair as part of larger masonry improvement project.	\$35,000
Exterior Building	Window spandrel panels are asbestos cement boards.	Abate and replace.	\$82,000

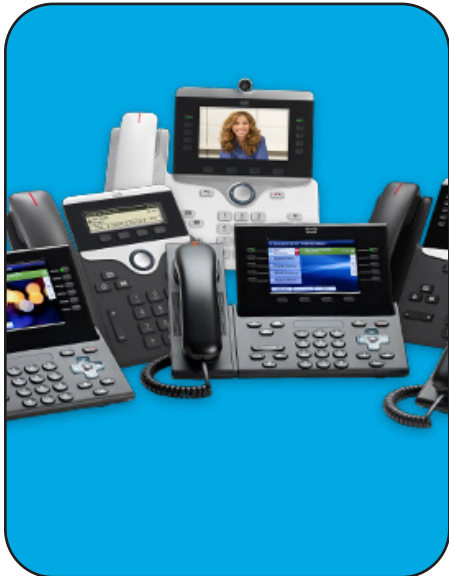
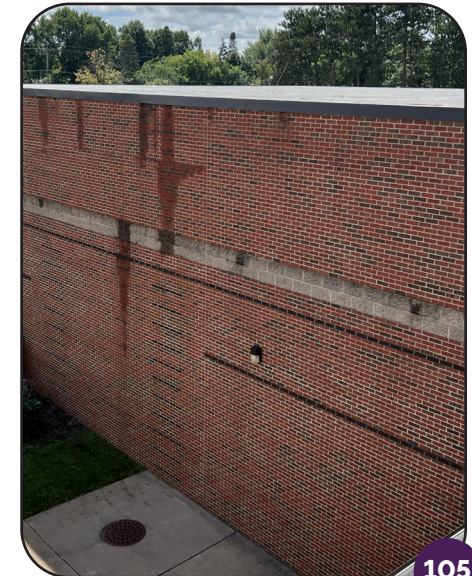
Building System	General Description	Recommendation	Cost Estimate
Electrical - Bell/PA & Communication	PA/Bell/Clock/mass communication systems due for upgrade. Existing system is obsolete using decades old technology.	Replacement recommended with the district's Single-wire system standard.	\$210,000
Electrical - Fire Panel	Fire panel at end of expected usable life.	Replace or upgrade to Edwards standard.	\$155,000
Electrical - Door Access	Card Access systems across the district are in need of upgrade to their board controllers. Information was compiled through district IT interviews and recommended per school individual need.	Replace HID Vertx boards to Mercury LP1502's.	\$8,000
Exterior Building -Gym Masonry Wall	The gym masonry wall is holding water. This water is at times transferring through to the interior of the gym. A horizontal crack has developed along the upper perimeter of the gym on three walls, likely related to the water infiltration.	Address crack that has developed with a flexible joint. Apply Tri-Siloxane to exterior split faced block section and continue to do so every 5-7 years.	\$50,000

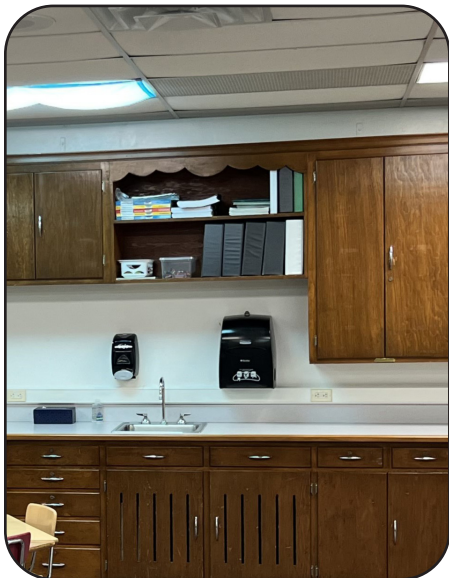
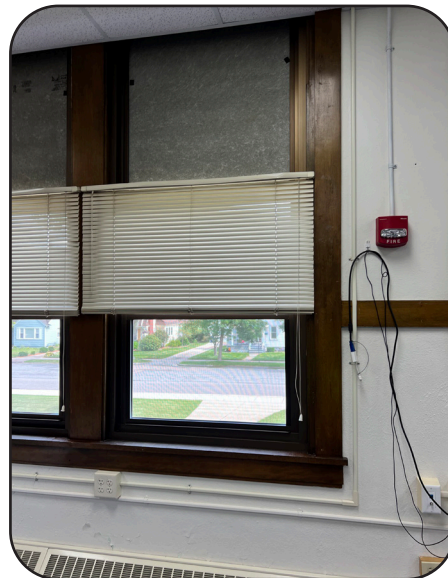
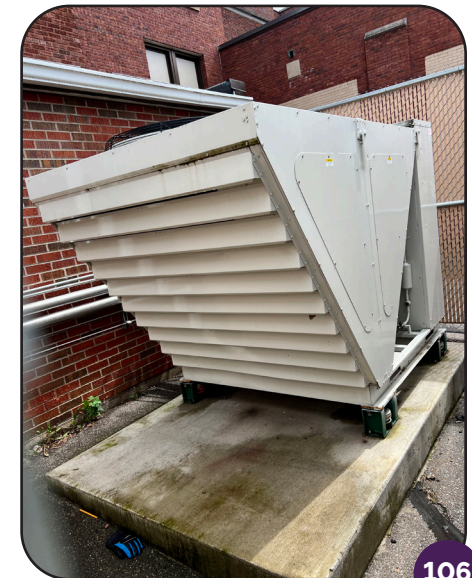
Building System	General Description	Recommendation	Cost Estimate
Interior - Classroom Casework	Casework throughout the facility is dated, much is original, wood paneling is present throughout the main entry corridors. Some casework is damaged and chipped.	Verify interior modifications will not affect historical designation. Replace classroom casework and corridor paneling as desired. Estimate for 15 classroom upgrades and corridor walls.	\$425,000
Interior - Window Treatments	Window treatments were observed as being of low quality for a school setting with some damaged.	Replace plastic blinds with roller shades across the school.	\$50,000
Interior - Kitchen Storage	The serving kitchen is in good condition and well maintained, however small, with little storage space and difficulties getting the kids through.	Consider a renovation of the kitchen serving and custodial office area, adding additional square footage to the east of the custodian office for food storage and custodian space. Open up the front of the kitchen wall to create a walk-thru tray line.	\$843,750

Mechanical - Air Conditioning	The facility is mainly unairconditioned, creating an uncomfortable environment for teaching and learning.	Install chilled water based air conditioning. Pricing given assuming the large HVAC renovation recommendation occurs simultaneously. Running chilled water and creating cooling duct space throughout Marshall in the 1923 building will be challenging, leading to added cost.	\$875,000

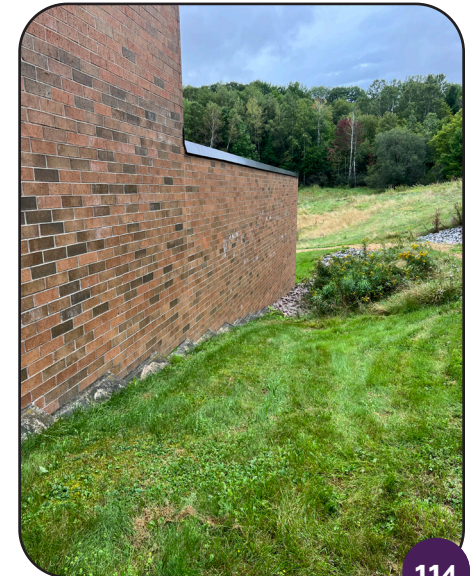
Building System	General Description	Recommendation	Cost Estimate
Site & Landscape	Substantial crack filled areas without top sealing.	Continue to crack clean and crack fill as needed. Approximately every 3-5 years additionally seal and repair asphalt.	\$6,500
Site & Landscape	Concrete landing for door #8 deteriorating and rebar exposed.	Replace concrete landing.	\$6,500
Site & Landscape	Exterior window sills at landscaping fill level.	Pull back grounds materials to create slope down and away from window sills.	\$3,500
Exterior Building	Paint on exterior brick wall.	Remove paint.	\$1,000

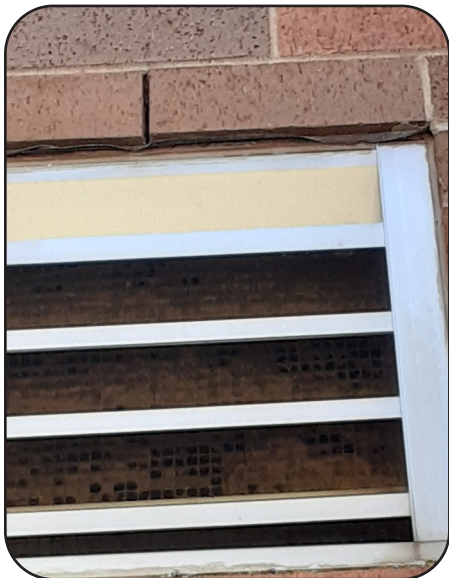
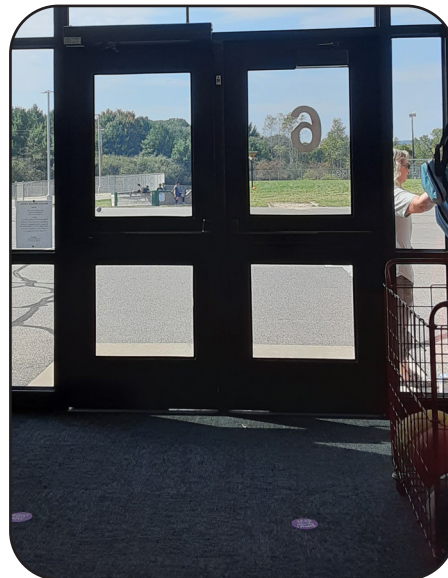
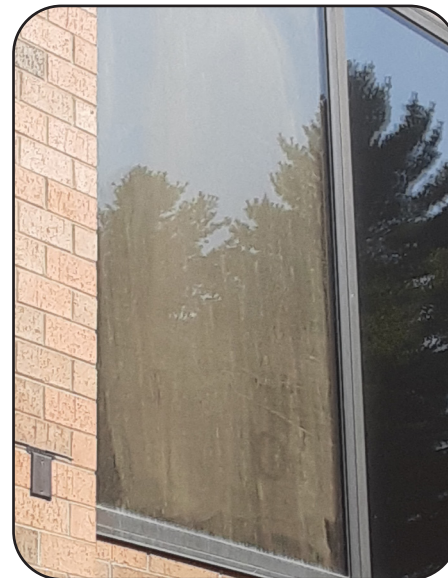
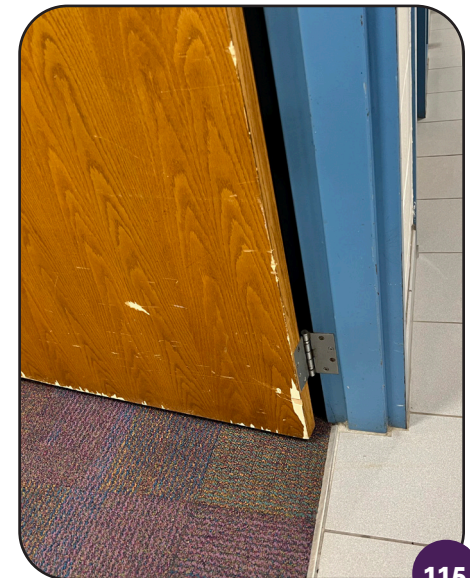
Building System	General Description	Recommendation	Cost Estimate
Exterior Building	Exterior wall louver screen heavily soiled.	Clean screen.	\$1,000
Exterior Building	Exit door weather stripping failed.	Replace open weather stripping.	\$1,000
Exterior Building	Clouded failed thermal window.	Repair or replace thermal window.	\$1,200
Interior - Wood Doors	Minimal older interior wooden doors throughout the facility are showing age; de-laminating, stained, and chipped. Image shown for room 108.	Replace aged and damaged interior wood doors. Estimate given for 10 doors.	\$15,000

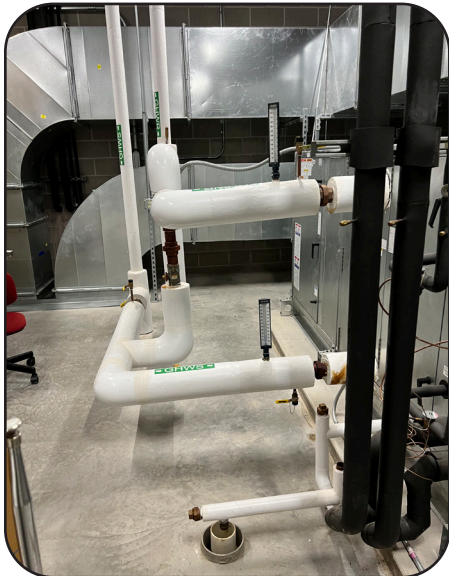
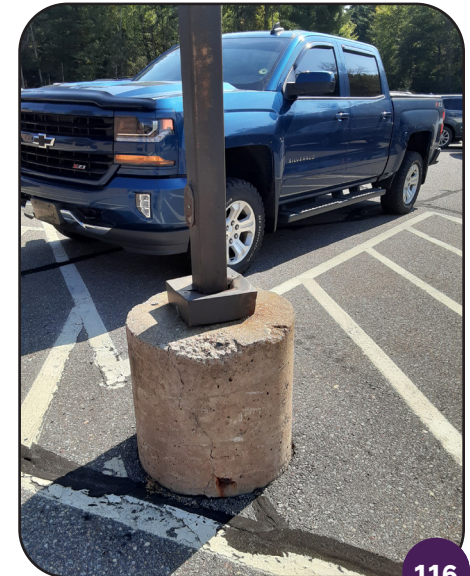
Building System	General Description	Recommendation	Cost Estimate
Mechanical - Piping	The hot water pipes to the large AHU above the 2016 addition are insufficiently supported and sagging.	Install drop support leg(s) to floor and re-insulate.	\$3,500
Electrical - Lighting Controls	Recent fluorescent to LED lighting conversions installed two-way dimming vs infinite slider dimming switches. The two choices leave teachers with either too bright or too dark of classrooms. Teachers are forced to cover new LED lighting with light filters.	Replace switches with slider dimmer control.	\$15,000
Electrical - Parking Lighting	Parking lot area lighting fixture has wasp nest blocking lens.	Check other fixtures. Remove nest and clean fixture lens.	\$1,000
Site & Landscape	Concrete light pole base cracked.	Patch crack. Consider painting with yellow warning paint.	\$1,000

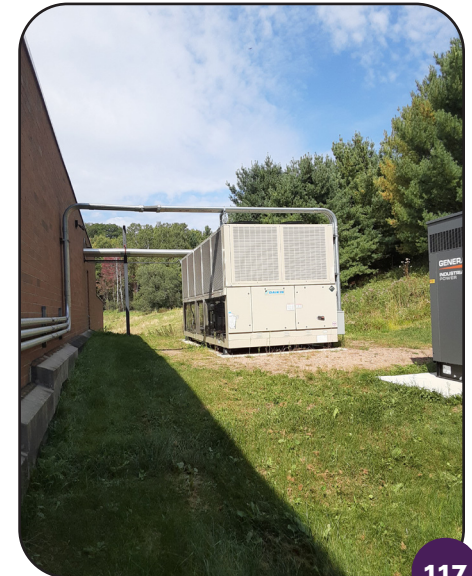
Building System	General Description	Recommendation	Cost Estimate
Site & Landscape	Concrete flag pole base deteriorating, rebar exposed, and metal pole collar bent.	Skim coat with weather-proof coating. Replace bent pole collar.	\$1,000
Site & Landscape	Concrete curbs cracked and pieces missing.	Replace cracked and failed concrete curbs.	\$20,000
Site & Landscape	Concrete stairs without handrails.	Add ADA-compliant handrails to outdoor concrete stairs.	\$2,500
Site & Landscape	Unsecured mechanical equipment area.	Fence to enclose and secure access.	\$7,500

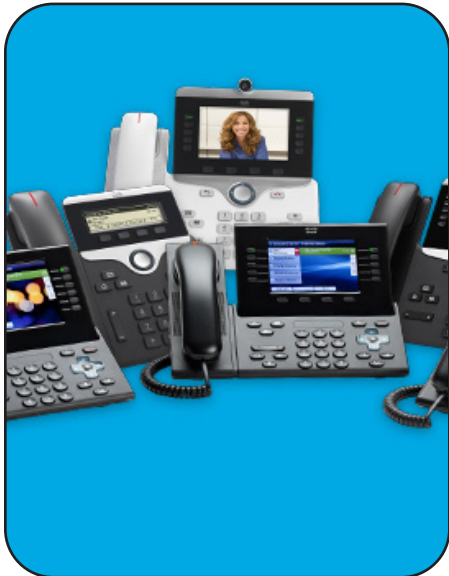
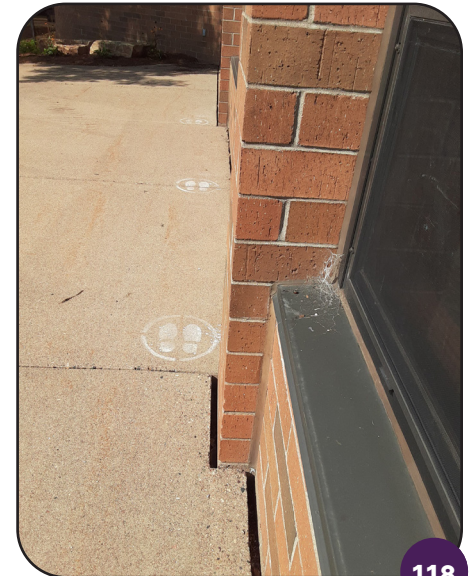
Building System	General Description	Recommendation	Cost Estimate
Electrical - Bell/PA & Communication	PA/Bell/Clock/mass communication systems due for upgrade. Existing system is obsolete using decades old technology.	Replacement recommended with the district's Single-wire system standard.	\$174,000
Site & Landscape	Unsecured gas valve and tree.	Enclose and secure valve access.	\$4,500
Site & Landscape	Gas supply pipe rusty.	Prepare and paint with appropriate coating.	\$1,000
Site & Landscape	Building perimeter and hardscape gaps.	Back fill gaps with sand and backer rod. Caulk and seal with appropriate joint filler. Heat melt in place material recommended for smooth, clean appearance.	\$3,500

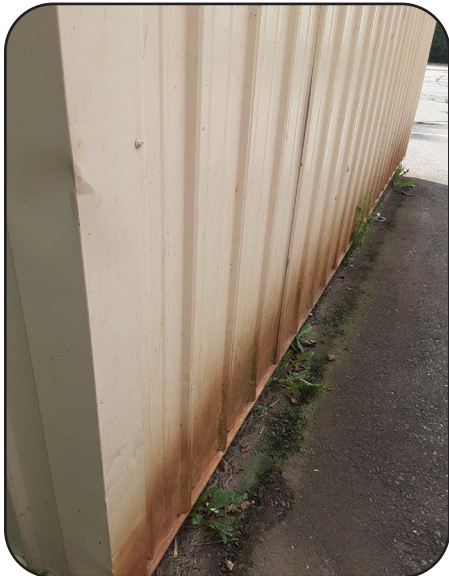
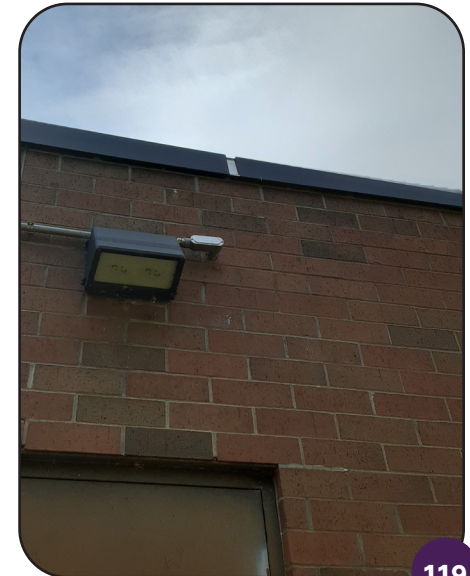
Building System	General Description	Recommendation	Cost Estimate
Site & Landscape	Metal outbuilding panel base rusty.	Prepare and paint.	\$1,500
Exterior - Doors	Although minimal, some sets of exterior steel doors and aluminum entrance doors are in rough shape.	Complete a thorough facility exterior door inventory and replace as necessary. Expect to replace several doors in the next 1-5 years.	\$20,000
Exterior Building - Roofing	One abandoned roof curb was identified being in place on section B after equipment removal. Roof penetrations allow avenues for new leaks, abandoned equipment and curbs should be removed and roofed over.	Demo roof curbs to deck, insulate, and roof over. Consider work done with re-roofing of section B if priority moves up in time.	\$3,000
Exterior Building	Open flashing along roof edge.	Add flashing metal and seal.	\$1,000

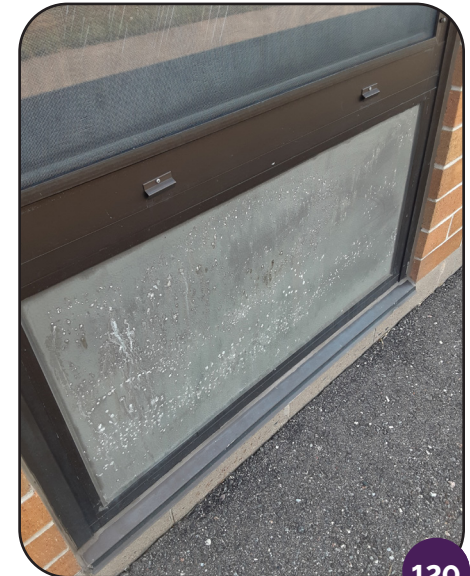
Building System	General Description	Recommendation	Cost Estimate
Exterior Building	Exterior wall corner joint caulk failed.	Remove existing failed joint compound and replace.	\$1,000
Exterior Building	Exit door lintel due for painting.	Paint lintel.	\$1,000
Exterior Building	Exterior metal door faded and discolored.	Paint door.	\$1,000
Exterior Building	Exterior window spandrel panels faded and spotted.	Paint panels.	\$1,000

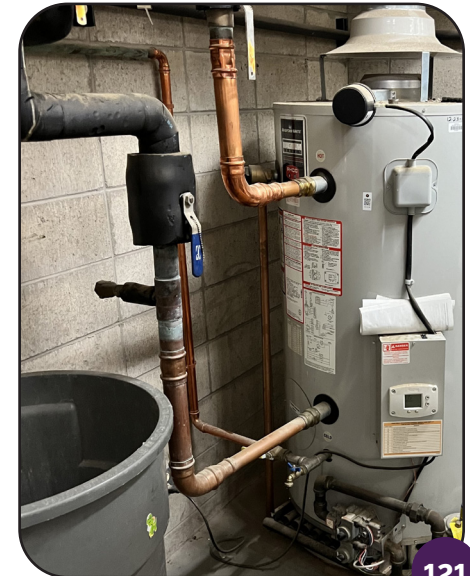
Building System	General Description	Recommendation	Cost Estimate
Interior - Ceilings	Although minimal, some rooms are showing signs of ceiling failure with rusted grid and stained tile.	Replace failing ceilings in minimal areas.	\$10,000
Interior - Stairwells	Minimal cosmetic upkeep needed in stairwells. Floor base, stair tread repair, and paint issues were noted.	Inspect and perform upkeep needed in stairwells.	\$5,000
Interior - Multi Floor	Although generally in good condition, the multipurpose gym floor is ready for a new paint and stripe.	Paint and stripe multipurpose floor.	\$15,000
Mechanical - Pipe Insulation	Missing and/or damaged pipe insulation was noted in various locations around the building.	Insulate DHW piping up to water heaters. Replace damaged and missing pipe insulation. Presence of asbestos and abatement needed can drastically change pricing. Pricing given for minimal work noted in mechanical rooms.	\$5,000

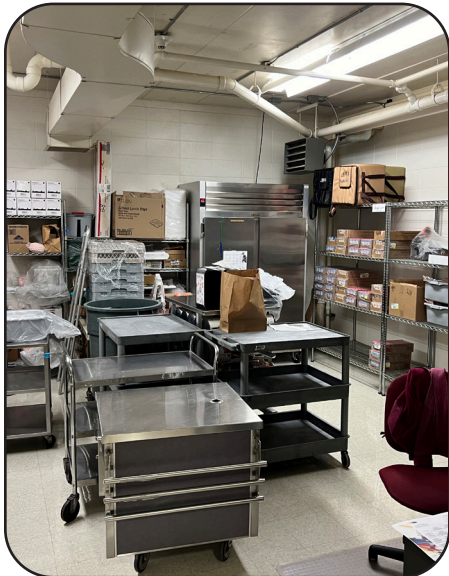
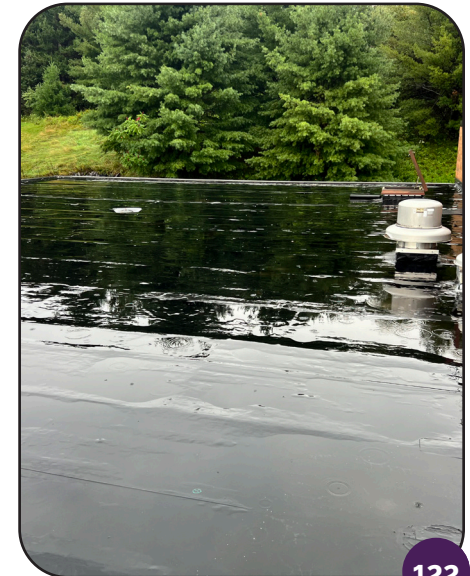
Building System	General Description	Recommendation	Cost Estimate
Electrical - Lighting	Although interior lighting in the facility has mainly been completed, small areas were spotted to still be fluorescent.	Complete remaining lighting conversation.	\$15,00
Site & Landscape	Concrete walk slabs cracked.	Replace cracked concrete walk slabs.	\$18,000
Site & Landscape	Concrete door landing raised creating trip hazard.	Replace or grind to smooth transition edge.	\$1,000
Exterior Building - Roofing	Roof section B is 17 years old and out of warranty. Roof section C is 14 years old and has one year of warranty remaining. Roofs appear in good condition and to be holding up well overall. Roof B is bubbling and has been patched.	Expect to replace roof section B in 5-10 years unless extensive leaking occurs.	\$230,000

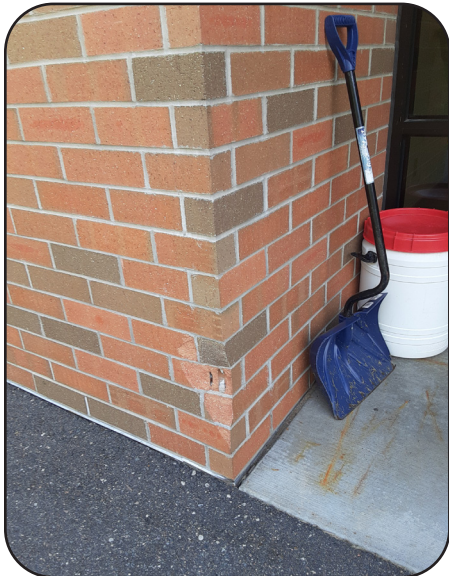
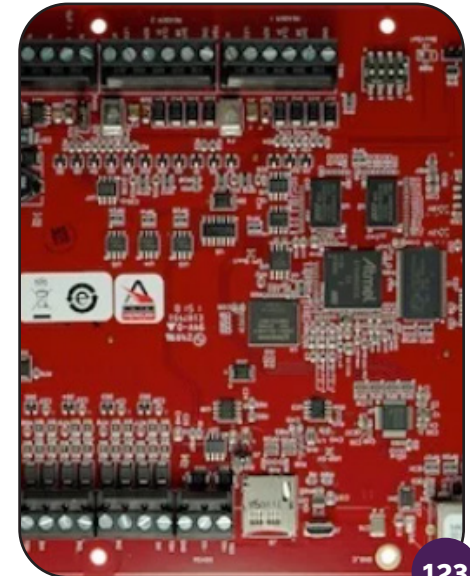
Building System	General Description	Recommendation	Cost Estimate
Exterior Building	Face brick corners chipped.	Replace bricks. Consider completing with other more extensive masonry projects.	\$2,500
Exterior Building	Exterior wall base brick cracked.	Replace bricks. Consider completing with other more extensive masonry projects.	\$2,000
Plumbing - Domestic Hot Water	The 80-gallon gas fired atmospheric water heater in the boiler room is 11 years old and approaching its expected useful life.	Replace water heater with a high efficiency direct combustion/power exhaust unit within the next 5-10 years.	\$10,000
Electrical - Door Access	Card Access systems across the district are in need of upgrade to their board controllers. Information was compiled through district IT interviews and recommended per school individual need.	Replace HID Vertx boards to Mercury LP1502's.	\$12,000
