C.E.S.A. 10
 Facilities Management Services

Facility Improvement Measures Wausau - Hewitt-Texas Elementary School

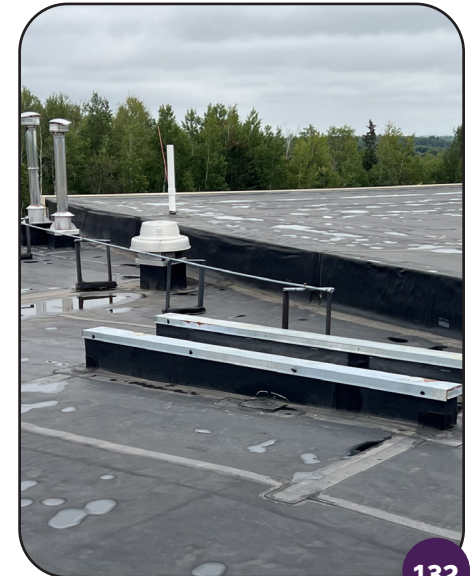
Building System	General Description	Recommendation	Cost Estimate
Site & Landscape	Substantial crack filled areas without top sealing.	Continue to crack clean and fill as needed. Approximately every 3-5 years additionally seal and repaint asphalt.	\$4,500
Exterior Building - Roofing	Roof sections B-E are all between 22-24 years old. All four sections are out of warranty and have been problematic. Section B is an externally pitched roof, however the last 10' of the roof edge is lower than the drip-edge, creating significant ponding. These roofs are .045 mil, a substandard thickness.	Replace sections B-E in the next 1-2 years with an adhered 60 mil black EPDM 20 year warranty roof. Add additional insulation on roof B so it properly sheds water to the gutters. Roof mounted utilities will need to be addressed in this project, mount pipe stands to deck with sealed boots.	\$333,000
Exterior Building - Roofing	The small maintenance storage shed needs a new roof.	Replace with asphalt shingle.	\$2,000

Exterior Building - Roofing	One abandoned roof curb was identified on section D, after equipment removal. Roof penetrations allow avenues for new leaks. Abandoned equipment and curbs should be removed and roofed over.	Demo roof curbs to deck, insulate, and roof over. Complete work with re-roofing identified. Demo abandoned conduit and pipe stands.	\$3,000

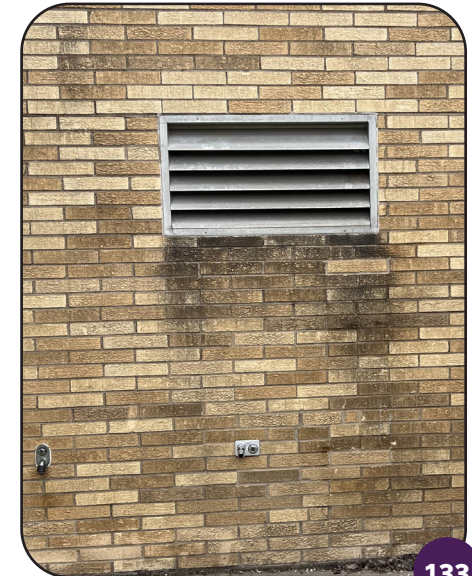
Building System	General Description	Recommendation	Cost Estimate
Exterior Building - Tuckpointing	Minor tuckpointing is needed across the facility. Areas of concern are around the northern entrance, and surrounding an old utility chase on the south side of the boiler room.	Have a masonry tuckpointing expert perform a whole-building inspection. Address problem areas at northern entrance and at lintels. If the utility duct can be removed, demo and fill - or tuckpoint. Brick replacement will be necessary at the mechanical chase if salvaging.	\$25,000
Exterior Building - EIFS Repair	EIFS damage and deterioration was noted on several panels.	Have an EIFS repair specialist address problem areas and repaint EIFS panels.	\$50,000
Exterior Building - EIFS Caulk	Exterior caulk joint between EIFS panels and masonry are in very poor condition.	Remove and re-caulk areas in conjunction with masonry and EIFS repair project.	\$10,000

Exterior Building	Exterior wall louver stains on bricks.	Investigate and eliminate cause. Clean bricks.	\$2,000

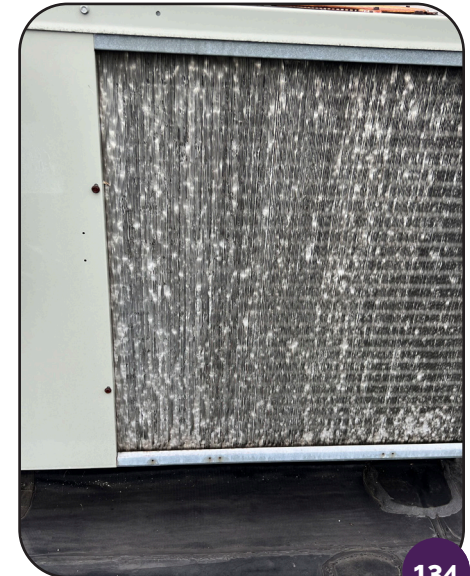
Building System	General Description	Recommendation	Cost Estimate
Exterior Building	Exterior wall unsecured cables and tubing.	Secure cables and tubing. Remove and discard if no longer in use.	\$1,000
Interior - Kiln Safety	Art kiln is housed in close proximity to combustible storage racking, creating a fire hazard.	Store combustible materials a safe distance away from kiln.	\$500
Interior - Wood Doors	Minimal older interior wood doors throughout facility are showing age; delaminating, stained, and chipped. Image shown is the kitchen door from gym.	Replace aged and damaged interior wood doors. Estimate given for 5 doors.	\$7,500
Mechanical - Rooftop Unit	The small office heating/cooling unit on the roof has significant hail damage and is 24 years old, at it's expected useful life.	Replace the unit in the next 1-3 years. Cooling efficiency gains will be seen with functional condensing unit fins. Consider running gas to the unit and switching to gas vs. electric heat for operating cost reductions.	\$12,000

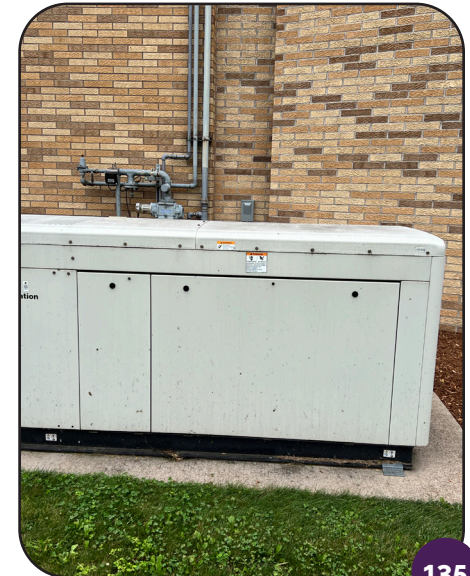
Building System	General Description	Recommendation	Cost Estimate
Electrical - Exterior Lighting	Exterior lighting appears to be deficient with no pole mount lighting observed. One broken building mounted light was noted.	Consider installing pole mounted security lighting at a high cost for student and staff security. Address any failed wall pack lighting replacing with LED.	\$5,000
Site & Landscape	Multiple walk concrete slabs with transitional and divided cracks.	Replace cracked concrete walk slabs.	\$15,000
Site & Landscape	Gas valve on side of building not secured inside of fencing. Piping to roof provides potential assistance for climbing.	Enclose and secure valve access. Eliminate climbing assistance access.	\$4,500
Site & Landscape	Unsecured mechanical equipment (generator) area.	Fence to enclose and secure access.	\$4,000

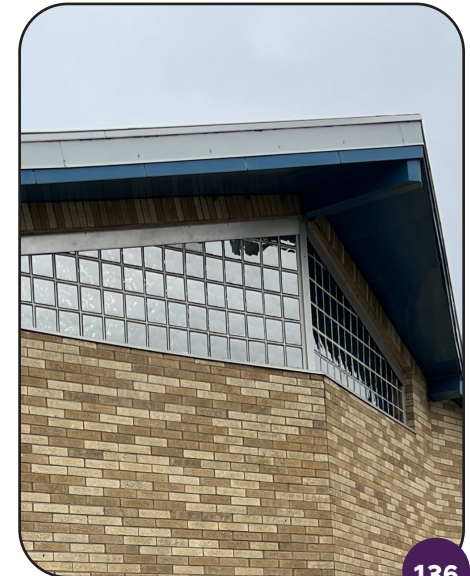
Building System	General Description	Recommendation	Cost Estimate
Interior - Multi Floor	Although generally in good condition, the multipurpose gym floor needs attention due to wear and tear.	Have synthetic floor installer in for extended maintenance, consider restriping.	\$10,000
Site & Landscape	Concrete walk stains from downspout discharge. Damaged downspouts short extensions.	Install under slab drainage discharge system. Clean stains.	\$18,000
Site & Landscape	Concrete door landings cracked	Replace concreted door landings.	\$8,500
Exterior Building Glass Block	The upper east end of the gym contains glass block to allow natural light into the space. Glass block is very inefficient as a building envelope material.	Remove and replace with a custom aluminum window or translucent panel.	\$15,000

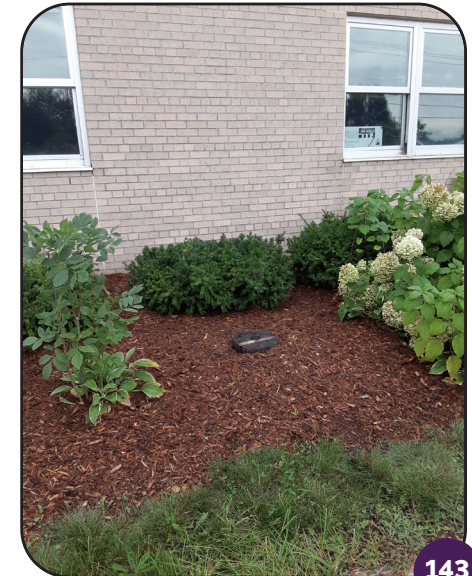
Building System	General Description	Recommendation	Cost Estimate
Site & Landscape Courtyard	Internal grass turf courtyard in state of disrepair. Vegetation along masonry walls will prematurely deteriorate the building and can block brick weep drainage..	Mow and landscape, install a 12" by 6" deep stone perimeter barrier with landscape fabric along building edge.	\$3,500
Site & Landscape - Trees	Two trees were noted overhanging the roof, close to the building. Trees overhanging the building: shed leaves on the roof which block roof drains, create mold and mildew on the building, and allow a path for intruders to access the roof creating a safety hazard.	Take down trees and remove remaining stumps.	\$3,500
Site & Landscape	Concrete walk stained.	Clean concrete walk.	\$1,500
Site & Landscape	Stump left in planters.	Remove stump.	\$1,000

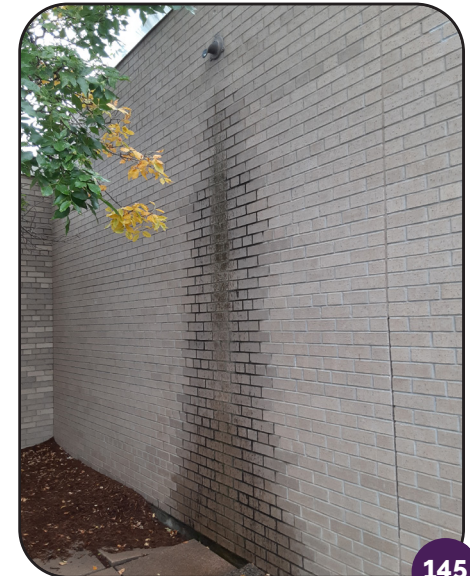
Building System	General Description	Recommendation	Cost Estimate
Exterior Building - Roofing	Kitchen condensing unit equipment was noted sitting on top of extremely rotted wood. Other rooftop equipment and pipe stands are also surface mounted on wood.	Swap kitchen equipment wood as an immediate step. Properly place any rooftop equipment or piping on appropriate roof curbs to deck or deck mounted pipe stands. Complete this endeavor during major roofing effort.	\$1,000
Exterior Building	Exterior roof flashings open.	Add flashing to close and seal.	\$1,000
Exterior Building	Roof flashing leaking and staining wall.	Investigate cause and correct. Seal flashing and clean wall.	\$2,500
Exterior Building	Roof scupper causing brick wall staining.	Extend scupper to prevent discharge on wall.	\$3,200

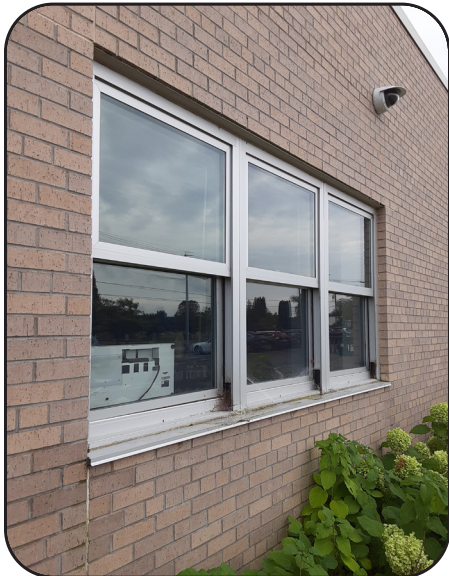
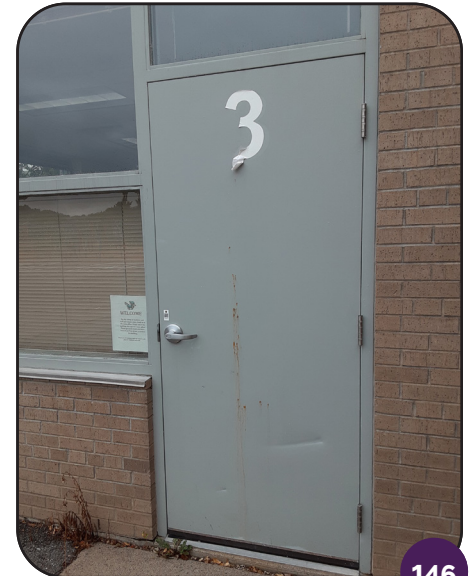
Building System	General Description	Recommendation	Cost Estimate
Exterior Building	Exterior window sills and frames soiled.	Clean frames and sills.	\$4,500
Exterior Building	Exterior wall base cracks.	Patch and seal base wall cracks.	\$2,500
Exterior Building	Exterior metal storage door rusted.	Replace metal doors and frames.	\$2,500
Exterior Building	Exterior metal door dented and rusted.	Repair dent and prepare and paint door.	\$1,000

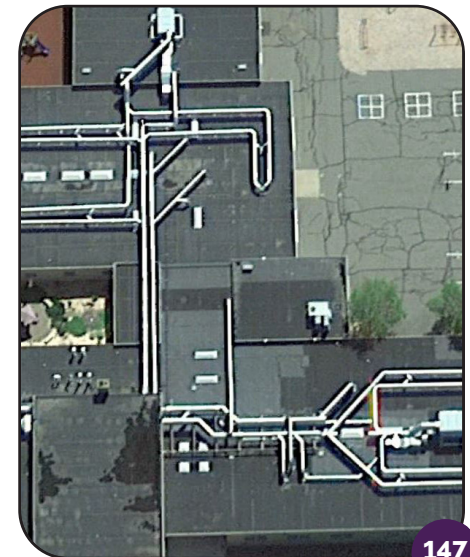
Building System	General Description	Recommendation	Cost Estimate
Interior - Storage Safety	Several storage spaces were noted to be over-packed and cluttered. Along with freeing up storage space and setting best practice for facilities personnel, cluttered spaces such as this create a fire hazard.	Clean, organize, and purge. Consider additional shelving.	\$1,000
Interior - Kiln Safety	Art kiln is stored along with cluttered combustible materials.	Clean and organize the space, store combustibles appropriately a safe distance away.	\$1,000
Mechanical - Boiler Maintenance	Leaky boiler circulation pumps along with disturbed likely asbestos insulation was observed in the boiler room.	Test for asbestos and abate if necessary. Perform boiler maintenance with new gaskets and potentially new pump(s). Re-insulate.	\$5,000
Mechanical - HVAC Renovation	Existing HVAC is largely accomplished through extravagant rooftop equipment along with exterior mounted ductwork and piping run on the roof. Much of this equipment is surface mounted on top of the roof rather than flashed roof curbs to deck. The hundred+ penetrations associated with this work has created a poor roofing condition, impossible to stay ahead of and impossible to reroof without major mechanical demolition.	Major HVAC renovation in all but the 2016 and 2022 additions. Eliminate rooftop duct and piping altogether. The two 1963 classroom wings will be challenging, traditional corridor supplied overhead HVAC is not possible without major construction. Two possible solutions are 4 RTU's for the two wings, or back to individual classroom unit vents style HVAC.	\$2,400,000

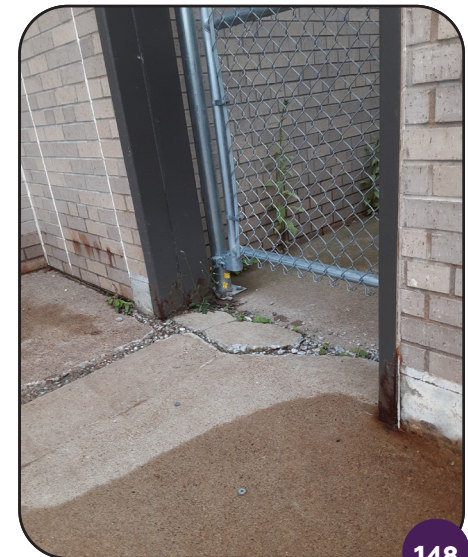
Building System	General Description	Recommendation	Cost Estimate
Electrical - Lighting Controls	The 2016 addition installed two-way dimming vs infinite slider dimming switches. The two choices leave teachers with either too bright or too dark a classroom. Teachers are forced to cover new LED lighting with light filters.	Replace switches with slider dimmer control.	\$10,000
Site & Landscape	Concrete curb deteriorating	Replace curbs.	\$18,000
Site & Landscape	Concrete roll over curb joints open.	Patch or replace curbs.	\$12,000
Site & Landscape	Concrete walk slab joints failed.	Replace concrete slabs.	\$17,000

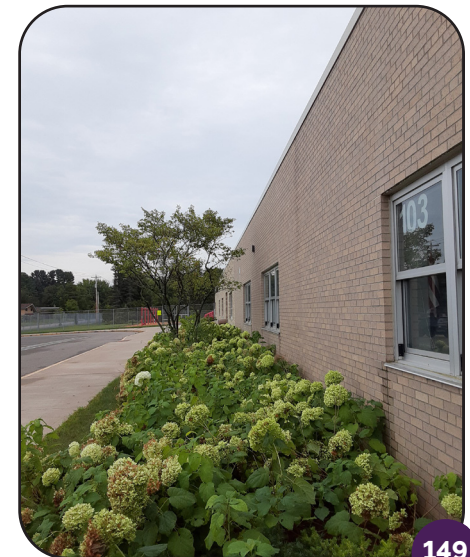
Building System	General Description	Recommendation	Cost Estimate
Site & Landscape	Concrete walk slabs cracked.	Replace concrete slabs.	\$22,000
Site & Landscape	Dock rusted and deteriorating.	Evaluate condition and uses. Replace dock.	\$25,000
Site & Landscape	Dumpsters on asphalt	Add concrete pads for dumpsters	\$12,800
Site & Landscape	Planter bushes too close to building.	Open area between bushes and building to prevent pests, infiltration, and screening from street view.	\$6,500

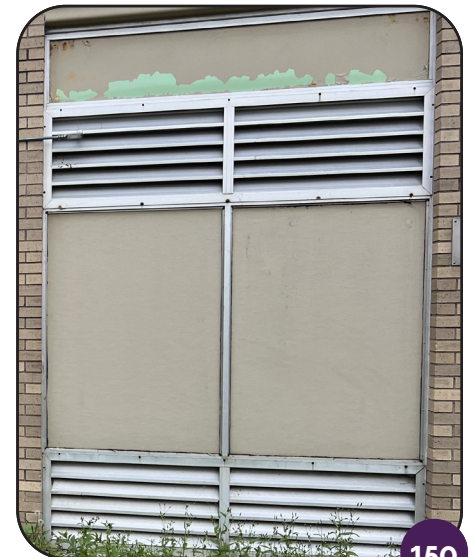
Building System	General Description	Recommendation	Cost Estimate
Site & Landscape	Unsecured gas tree and valve along building. Gas piping provides climbing assistance to roof.	Enclose gas tree, valve, and access to vertical pipe.	\$4,500
Site & Landscape	Unsecured mechanical equipment.	Enclose mechanical equipment.	\$10,000
Site & Landscape	Unsecured electrical generator.	Enclose generator.	\$7,500
Exterior Building - Wall Panel	The wall panel which houses mechanical louvers located in the interior courtyard is in poor condition and rusting through.	Replace the wall panel and louvers, reroute conduit through wall. This could be a new insulated solid panel, or brick & masonry (recommended). Pricing given for wall panel.	\$12,500
