Historic Old Central High School Independent School District 709 Facility Assessment

June 12th 2019

Executive Summary

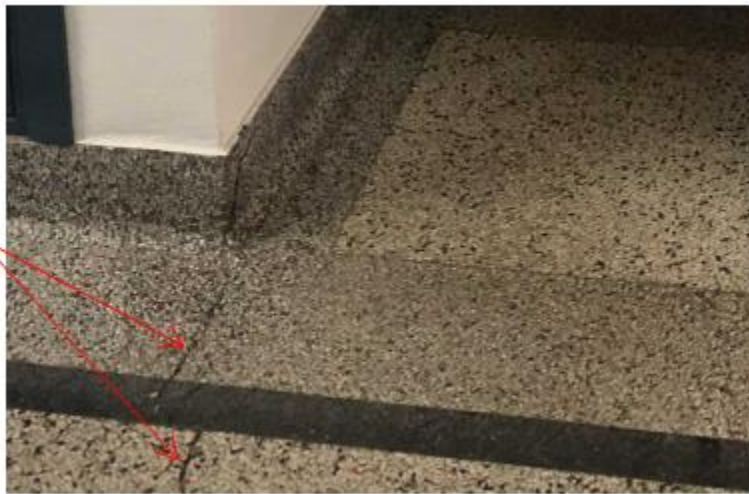
Terrazzo - Fair to Good Condition

- Terrazzo – in fair to good condition relative to the age (117 years). There are areas of cracking and patching / repairs not unexpected in terrazzo of this age. Most circulation (halls and stairs) and original bathrooms.

Typical example of
cracking

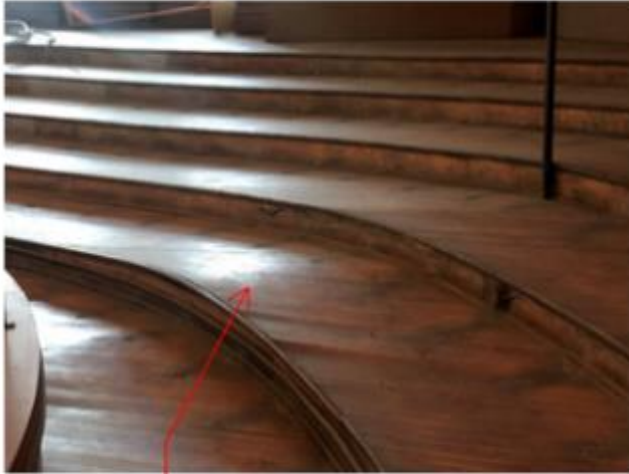
Wood - Poor to Fair Condition

Typical example of original wood floor in fair condition. Wood flooring likely continues under new carpet / VCT in many areas

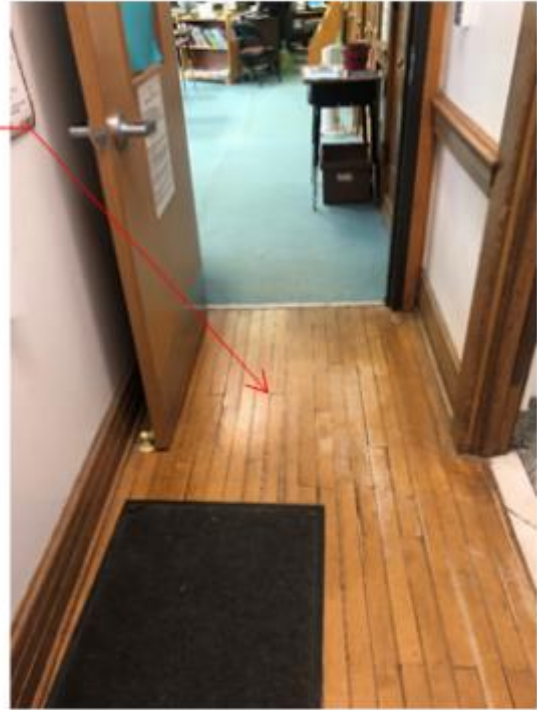
- Wood – Where exposed i.e. gymnasium floor in fair condition and upper balcony in board room in poor condition due to areas of water damage. It is assumed most classrooms have the original wood floor under either newer carpet or VCT. These locations were not exposed for examination.

Water damaged wood floor at balcony

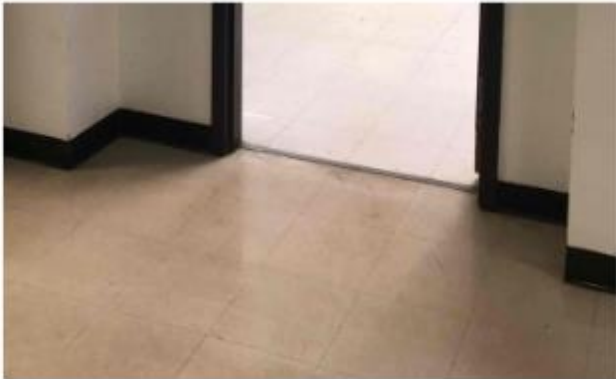
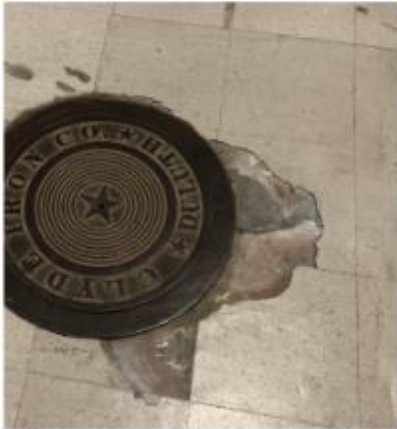
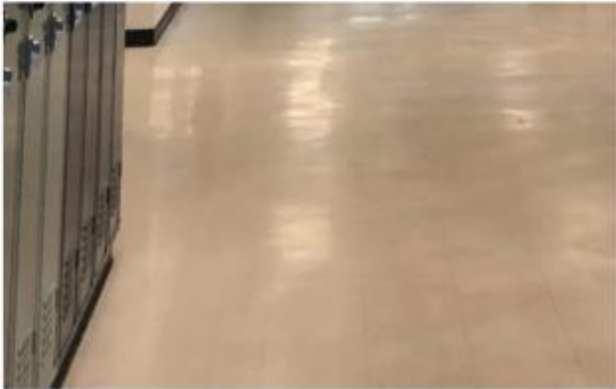
VCT (Vinyl Composition Tile) - Poor to Good Condition

- Ceramic / Porcelain Tile – Fair to good condition. Miscellaneous locations.
- VCT (Vinyl Composition Tile)- Condition ranges from poor to good. Most in ‘public’ areas were in good condition while poor conditions were observed in ‘nonpublic’ areas where maintenance priorities are lower. Most locations are likely 30 years old with some newer areas that had some miscellaneous improvements as spaces were revised and / or refreshed.

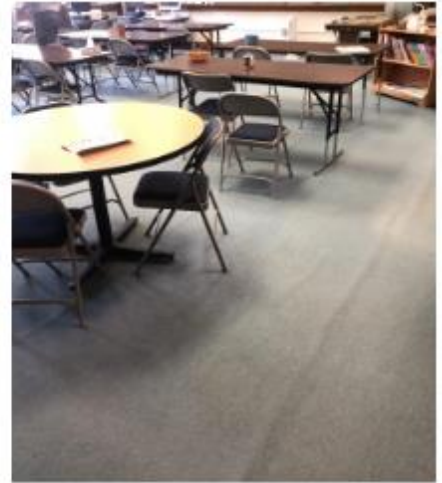
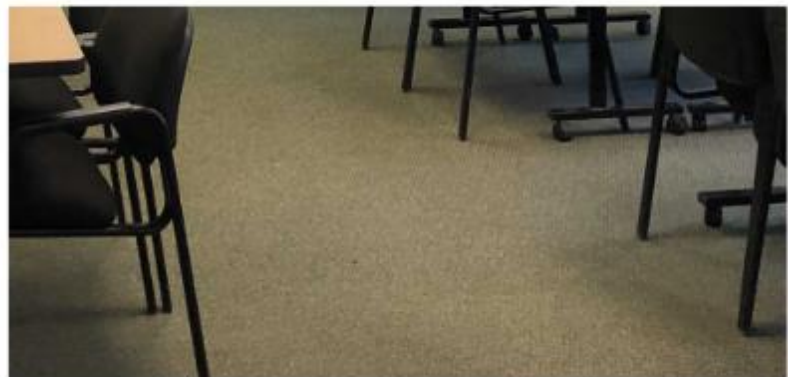
Carpet- Fair to Good Condition

- Carpet - Condition ranges from Fair to good. Most in ‘public’ areas were in good condition while poor conditions were observed in ‘nonpublic’ areas where maintenance priorities are lower. Most locations are likely 30 years old with some newer areas that had some miscellaneous improvements as spaces were revised and / or refreshed.

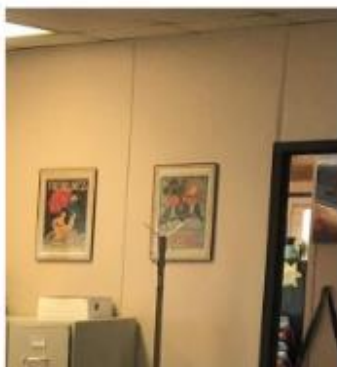
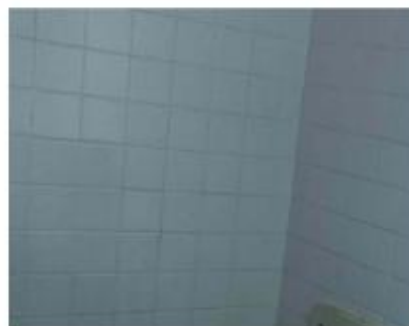
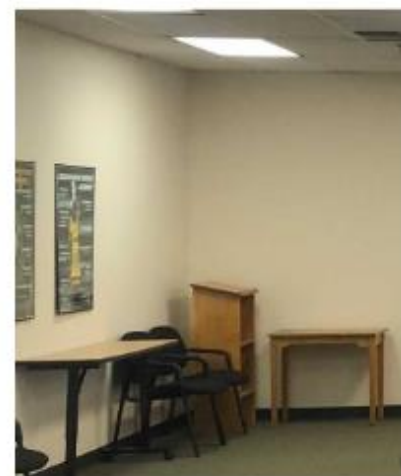
Wall Finishes - Fair to Good Condition

- Wall Finishes - Conditions range from fair to good while type of finishes range from (predominately) paint on various wall substrates, ceramic / porcelain tile (restroom walls) wood paneling / trim (either original or replicated in the 1970’s) and painted wall panels (demountable partitions).

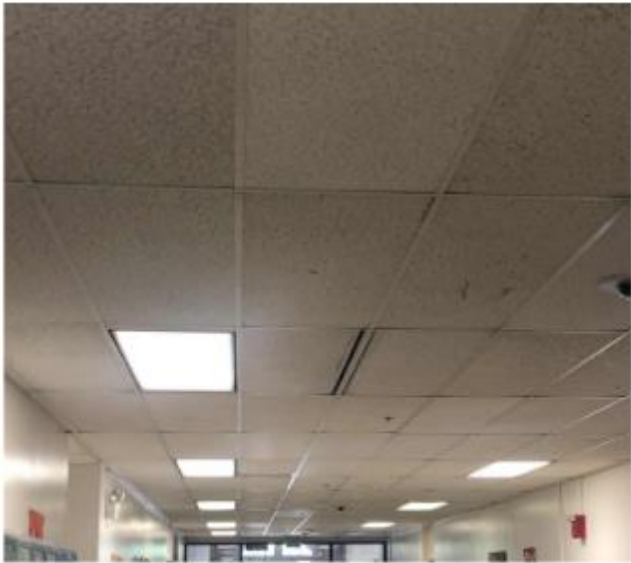
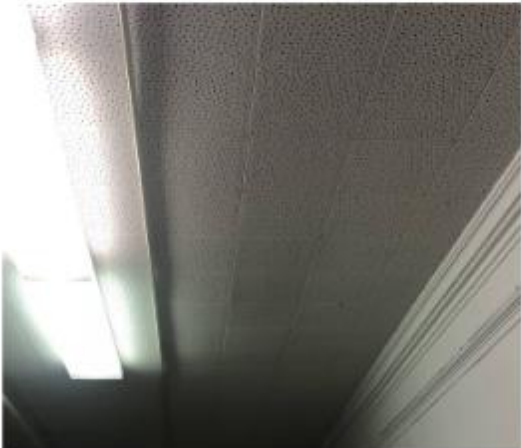
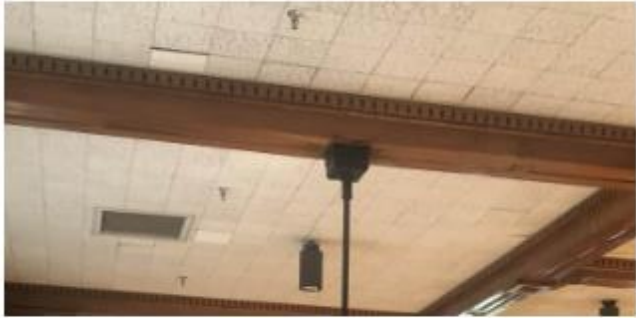
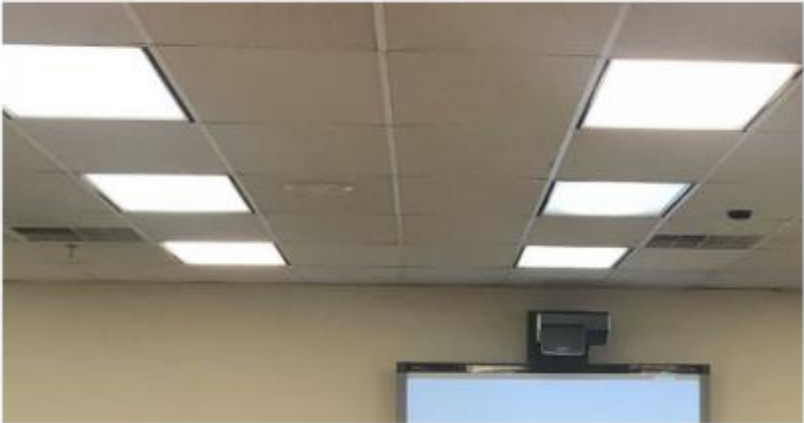
Ceilings - Poor to Good Condition

- Ceilings – Range from poor to good. Older ceiling systems consisting of concealed spline acoustical tile and older suspended ceiling systems. Tile sagging / staining from humidity / moisture and or other type leaks are evident. Size of the suspended acoustical tile is nonstandard and would be difficult to replace. Some areas of plaster or gypsum board ceilings exist in various conditions.

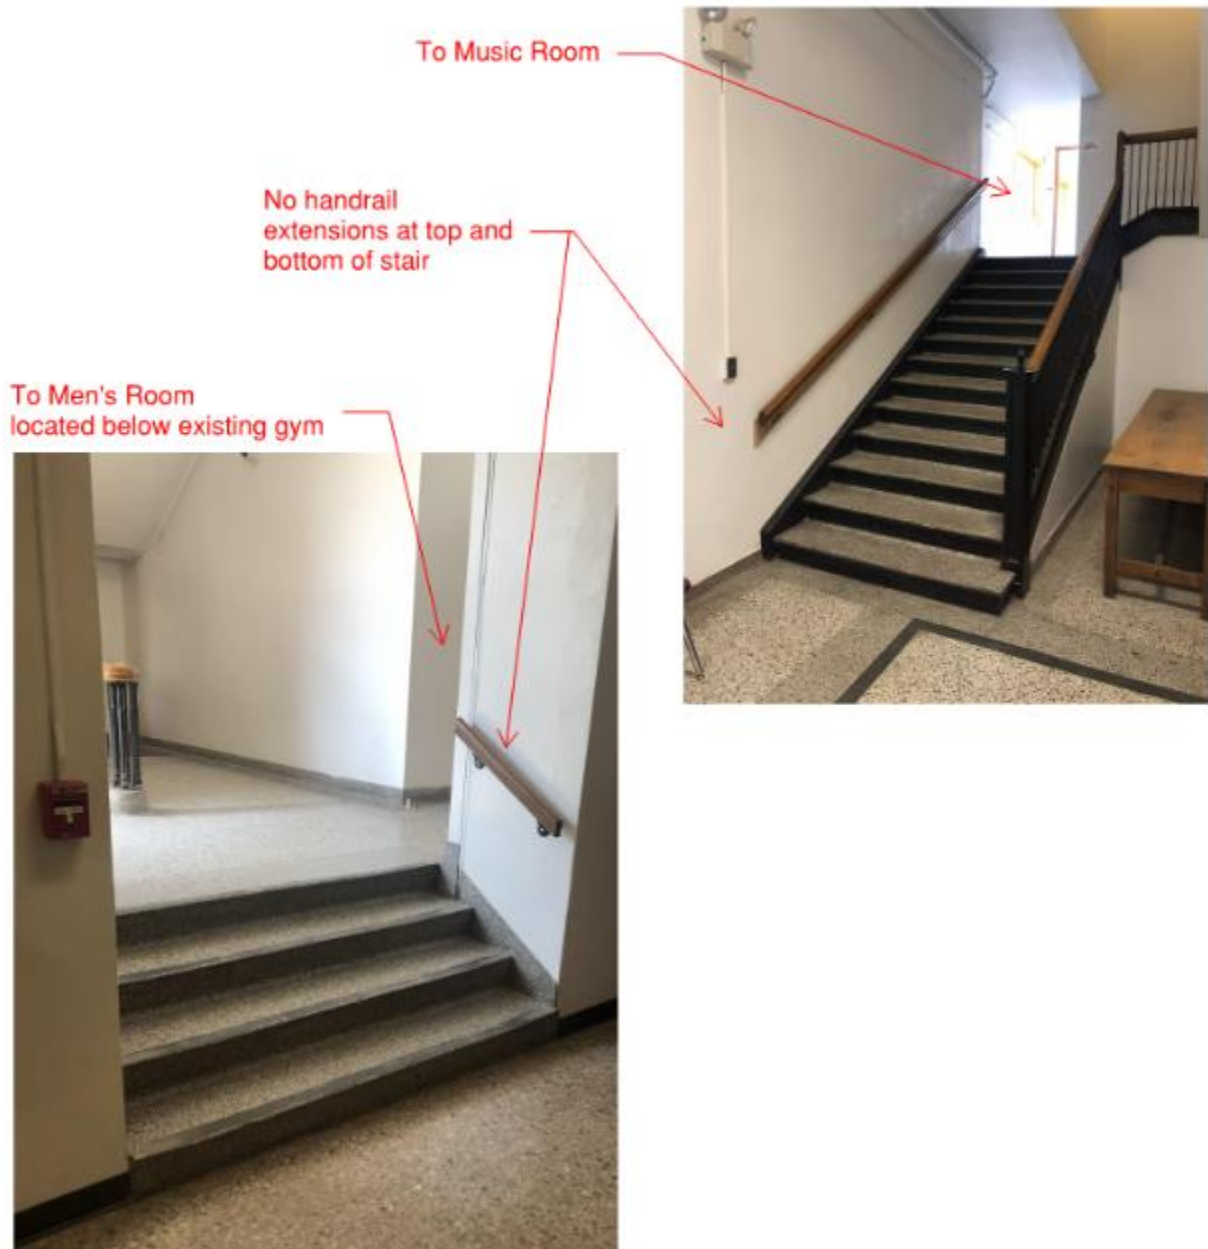
Stair handrails and guardrails – Lack of extensions at top and bottom of stair runs.

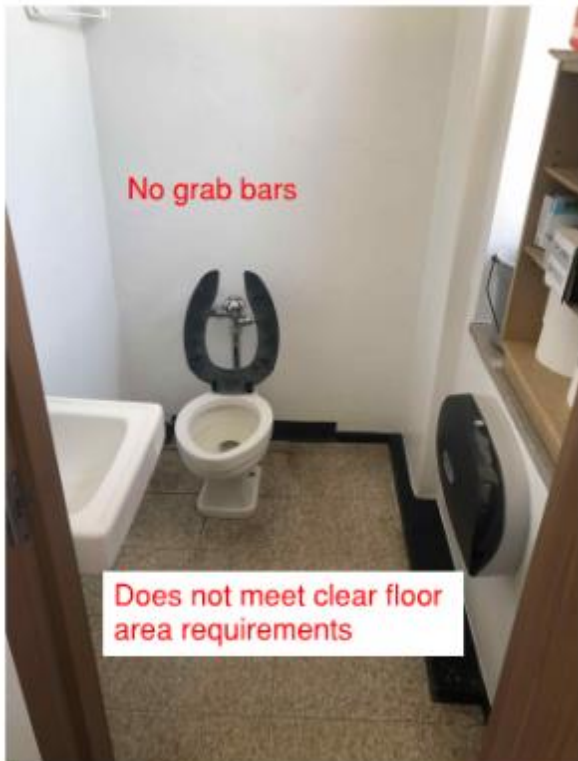
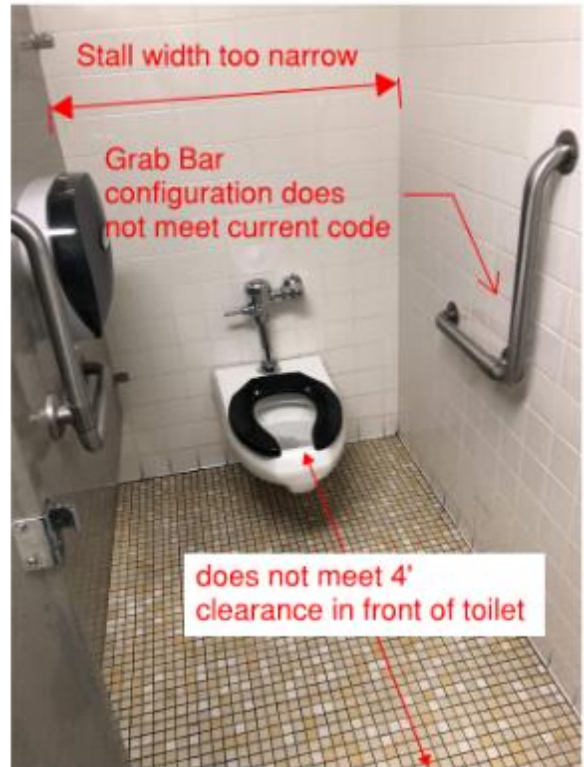
Restrooms- Non-compliant stalls and grab bar configurations and room clearances

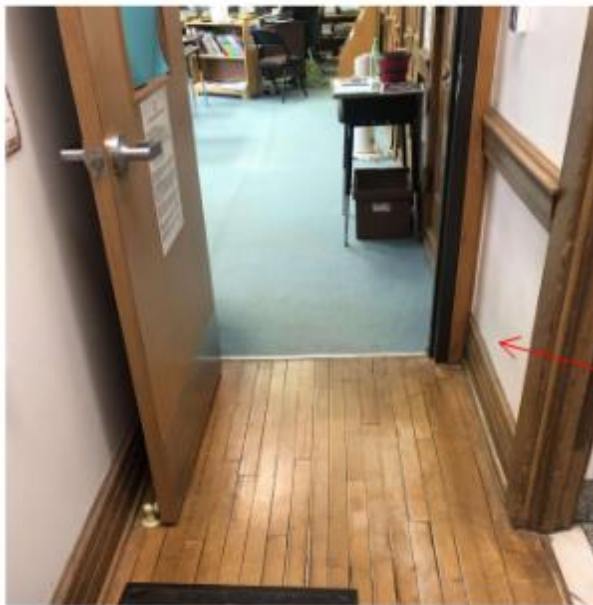
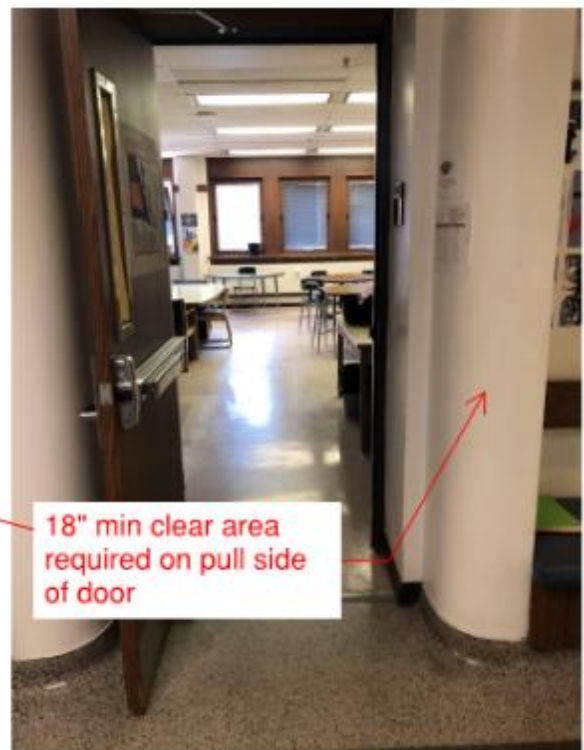
Door Entrances – Non-compliant clearances on push and pull side of doors.

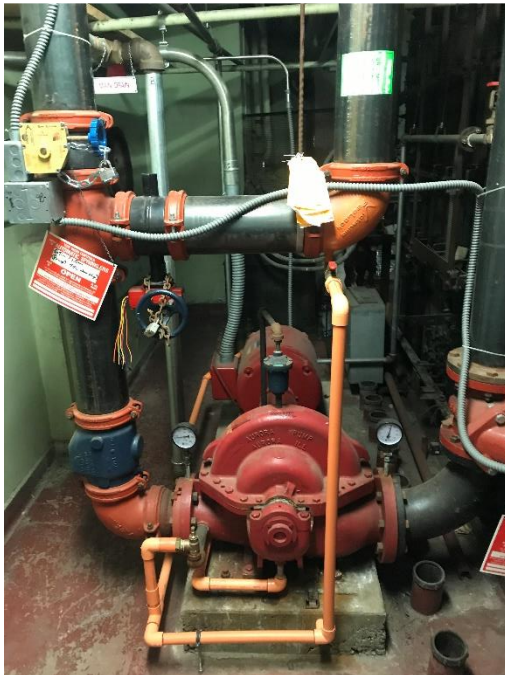
FIRE PUMP

The existing building is fully sprinkled (1973) and includes a 50 horsepower, electric pressure booster pump as well as various dry sprinkler zones serving the attic spaces. The system is fully functional as it stands however work by other trades will require removal and reinstallation of the majority of the ceilings relocation of most of the existing runout piping.

It would be advisable to consider placing the fire booster pump on standby power if it becomes available.

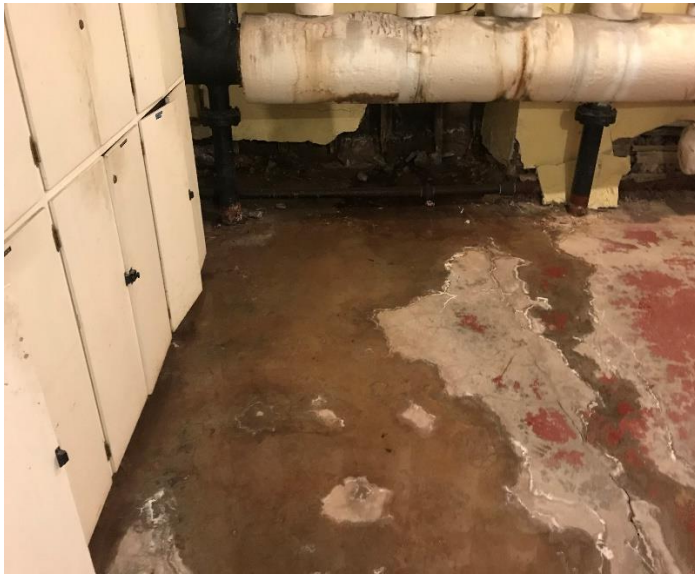
GROUND WATER

Perimeter foundation drainage and waterproofing on the northwest side of the building have failed. As a result, ground water is leaking into the basement and crawl spaces causing building and systems damage as well as creating a health hazard due to potential mold growth.

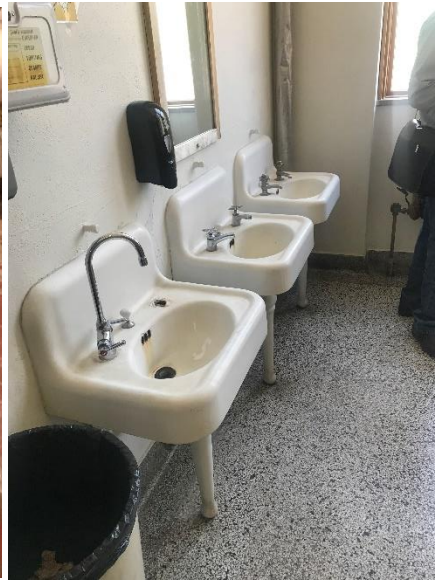
1920's PLUMBING FIXTURES

- Plumbing: Piping systems in much of the building are at or beyond their expected service life. If significant interior work is undertaken, it would be recommended that piping and plumbing fixtures are replaced at that time.

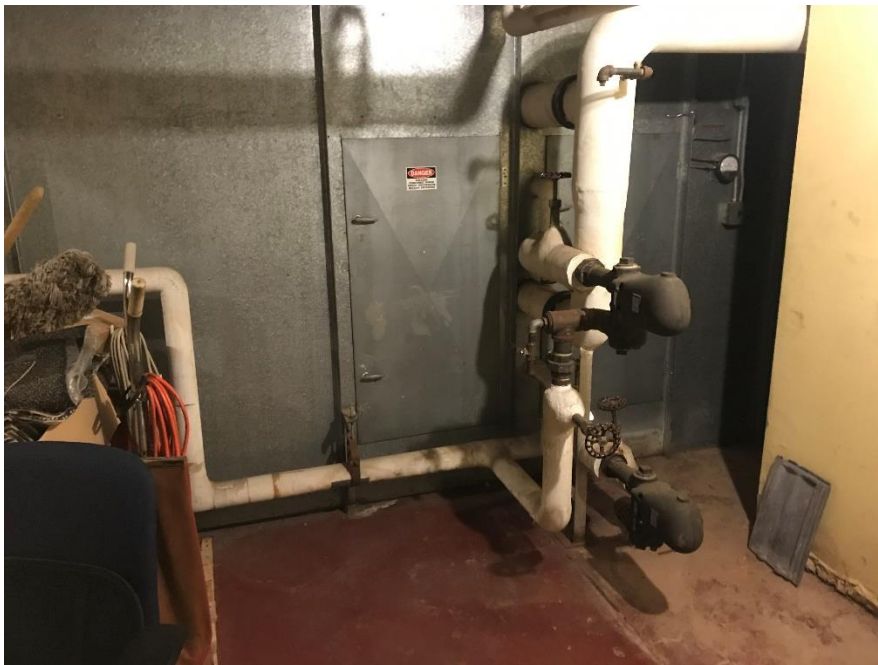
SUPPLY FAN SF-3 (1973) 1

Most of the ventilation equipment was installed when the building was converted from a high school to the central administration building in 1973. Modification were made under the 1993 administration area renovation, reusing existing equipment and ductwork. The 1926 addition (gym wing) still retains much of its original ventilation system. Cooling exists only on a local basis in some office areas but does not existing in central air handling equipment.

- HVAC: Ventilation and heating systems are 46 to 90 years old. They are inefficient, inadequate and difficult to control. It is recommended that the majority of them be fully replaced with new and cooling be added to appropriate spaces. New temperature controls would be installed as part of this scope.

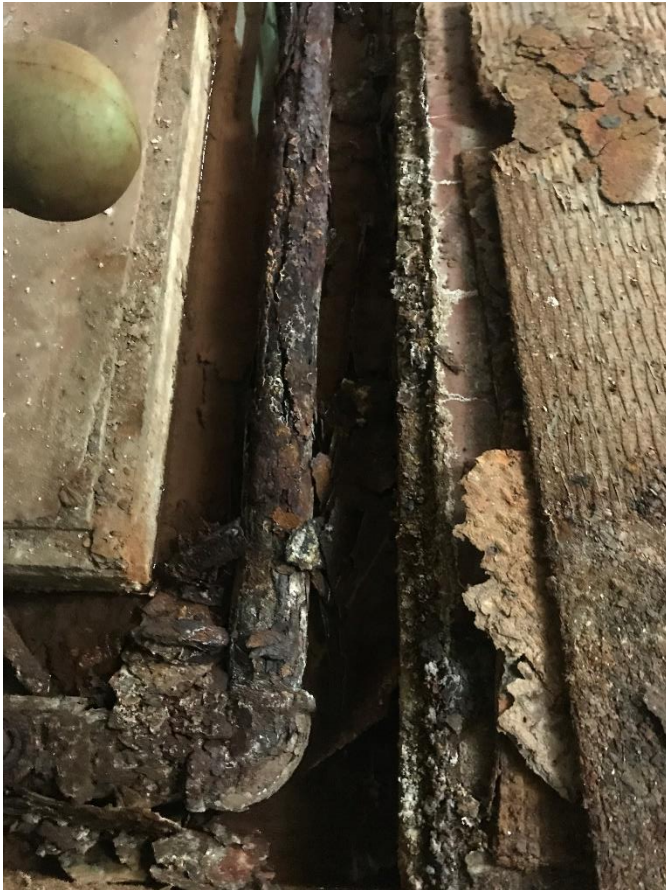
FAILED CONDENSATE LINE

During the 1973 remodel, much of the steam runout piping was replaced while portions of the heating system date back to the 1920. Steam and condensate are very corrosive due to the combination of elevated oxygen concentration and temperature. To compensate for this, piping used for condensate is thicker than standard. Despite this, pipe failure begins to appear at approximately 50 years. (see condensate piping photo below:

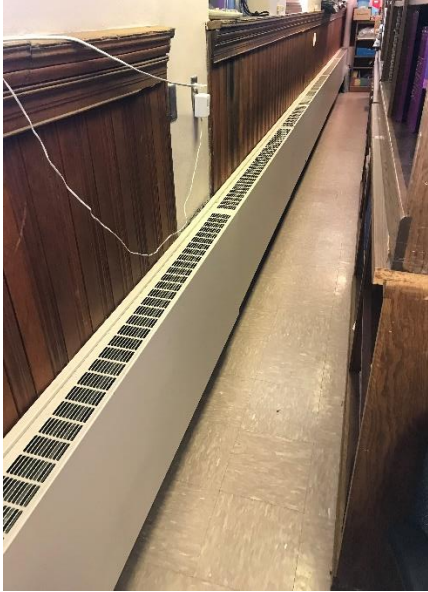
1970'S RADIATION

Terminal heating devices (radiation) were largely replaced during the 1973 remodel, with small areas having later updates. This radiation however is approaching 46 years old and at or beyond its expected life. Devices in the gym addition are largely original from the 1920's. This radiation is the traditional sectional cast iron. Multiple styles are shown below:

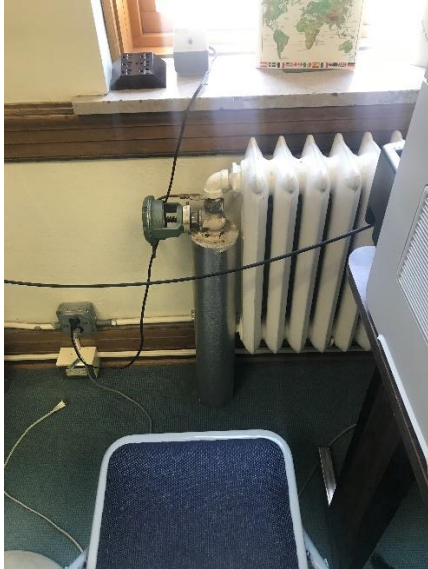
PNEUMATIC RADIATION VALVE

Much of the building's temperature controls still use pneumatic actuation to move dampers and valves. Pneumatic controls have virtually been eliminated in modern HVAC systems, have been replaced with electric/digital control systems. Service and parts for pneumatic controls are becoming quite scarce.

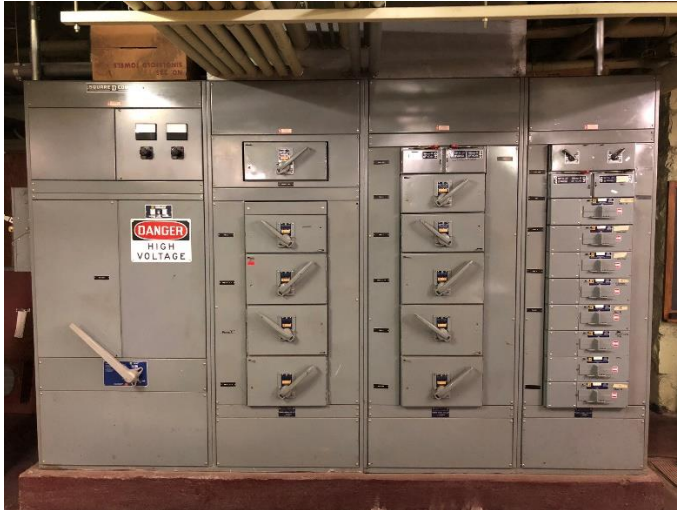
EXISTING 120/208V 3000A FUSED SWITCHGEAR

Power: Existing electrical service is 120/208 3PH, with a 3000A switchboard. If additional capacity is needed at this switchboard, another section would need to be added, as this appears to be fully utilized. This could be accomplished by adding another section to the right side, which would also require modifications to the floor drain and a new concrete pad for the new section.

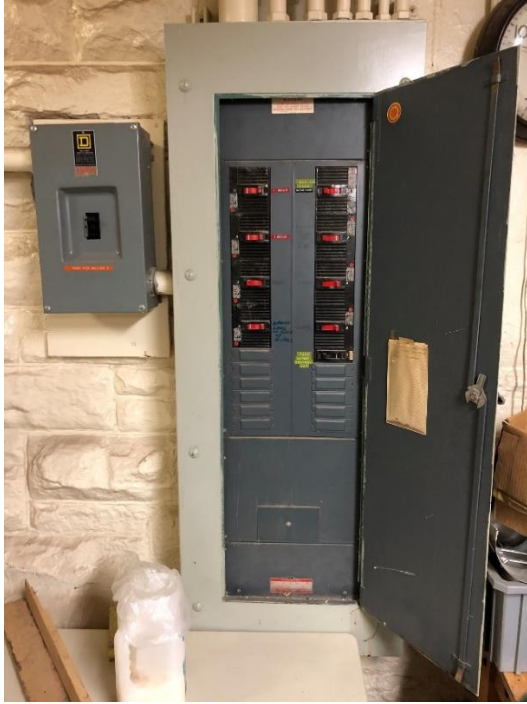
GENERAL ELECTRIC BOILER PANEL

This panel feeds the old boilers that are not in use. If this panel is needed for future modifications to HVAC systems, it should be replaced due to age and availability of replacement parts.

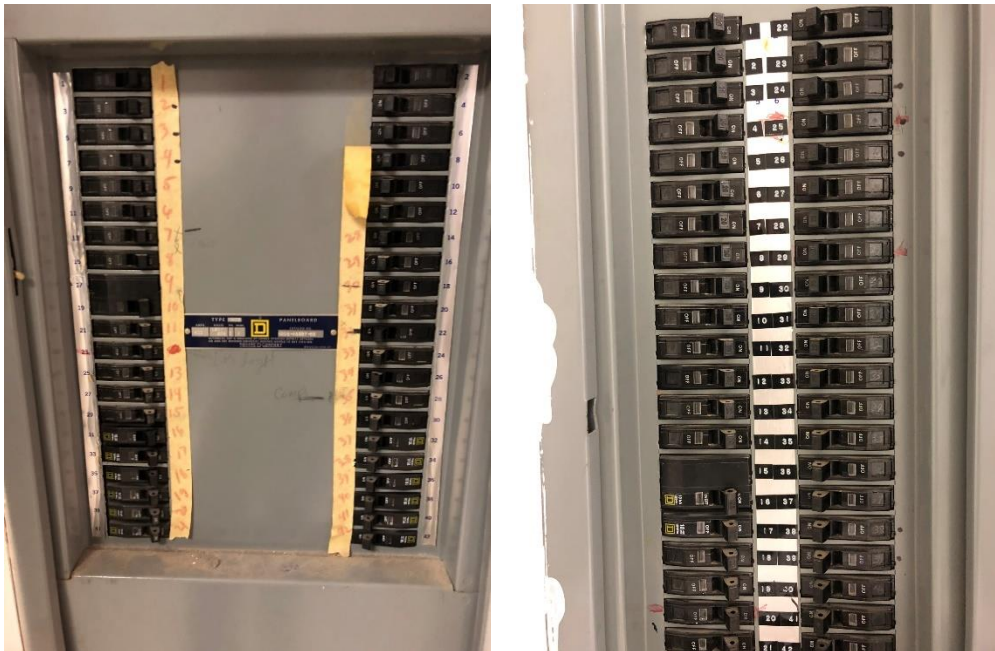
FULL PANELS

Some panels appear to be full and no spare breakers or circuits are available. Some of these 42 space panels could be replaced with a 54, which may fit in the same space as the 42. Some spares may become available during a remodel, especially with lighting being much less of a load, some circuits may be combined if designed in such a way. Panels that do have space can still be expanded with new circuit breakers that are still being manufactured.

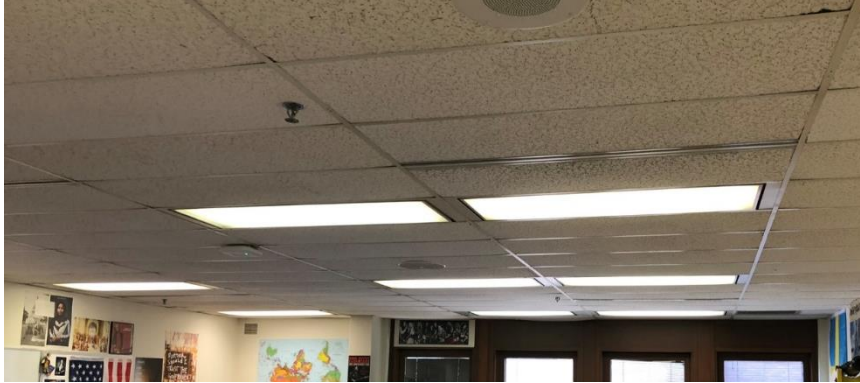
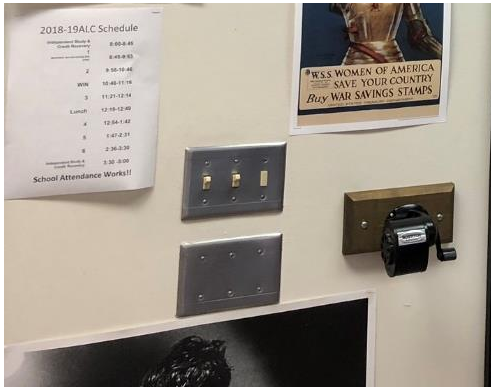
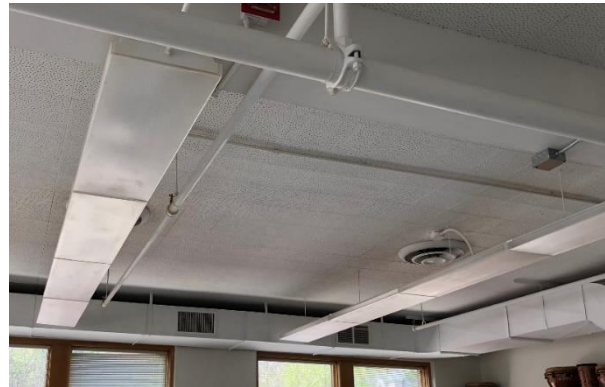
EXISTING FLUORESCENT FIXTURES AND CONTROLS.

Currently fluorescent fixtures are installed throughout the building. With other renovations recommended in these spaces to the ceilings and HVAC, it would be recommended to replace these fixtures with LED fixtures to take advantage of reduced maintenance and energy savings. Further energy savings are required by the MN Energy Code with lighting controls. Dimming, Occupancy Sensors and Daylight sensors would be necessary in most spaces as required by the MN Energy Code.

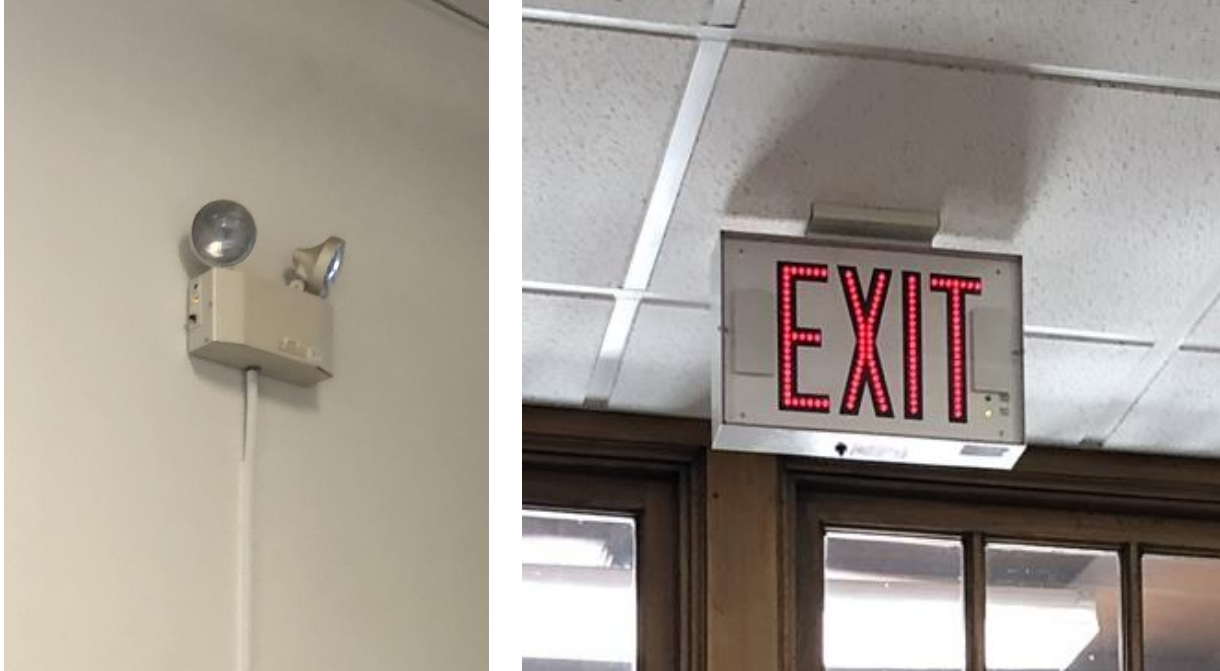
EXISTING EGRESS LIGHT FIXTURE AND EXIT SIGN.

Existing egress lights and exist signs are self-powered with internal batteries. Additional egress lighting may be required to provide the proper level of footcandles for egress. As part of a remodel, the new Egress and Exit lighting could be powered by the existing generator (assuming capacity exists) and a new emergency transfer switch. This would eliminate the need for batteries (and associated maintenance) in these fixtures. In lieu of wall mounted egress lighting, specific ceiling fixtures could be connected to an emergency circuit, providing the lighting needed in an emergency.
