# Turtle Lake School District

Facility Condition Assessment Performed by:

## Facility Condition Index (FCI)

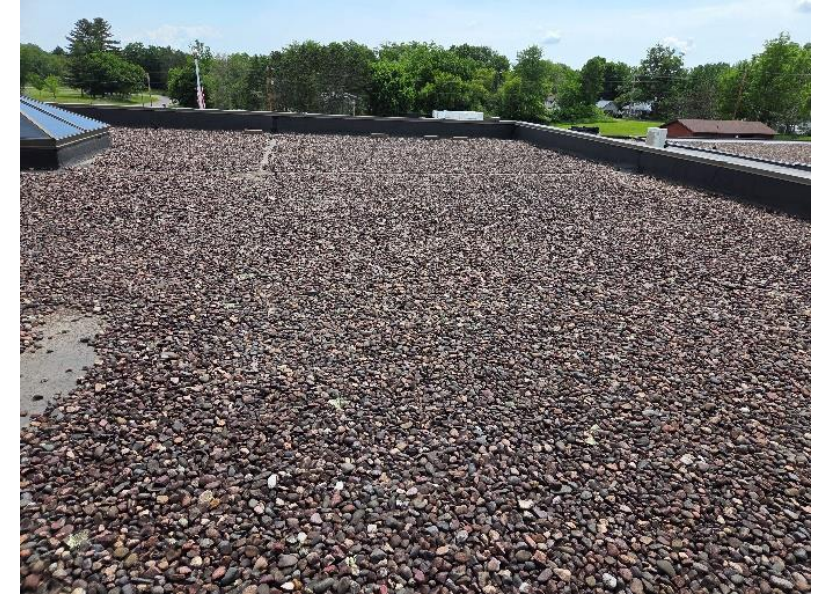
- School has newer fully adhered EPDM roofing (2015–2025) and older ballasted EPDM from 1995
- Newer sections are in good condition; older ballasted areas are worn and damaged

1995 ballasted roof.

- Consider replacing 1994 ballasted roof soon
- Add permanent ladders or safe access for maintenance

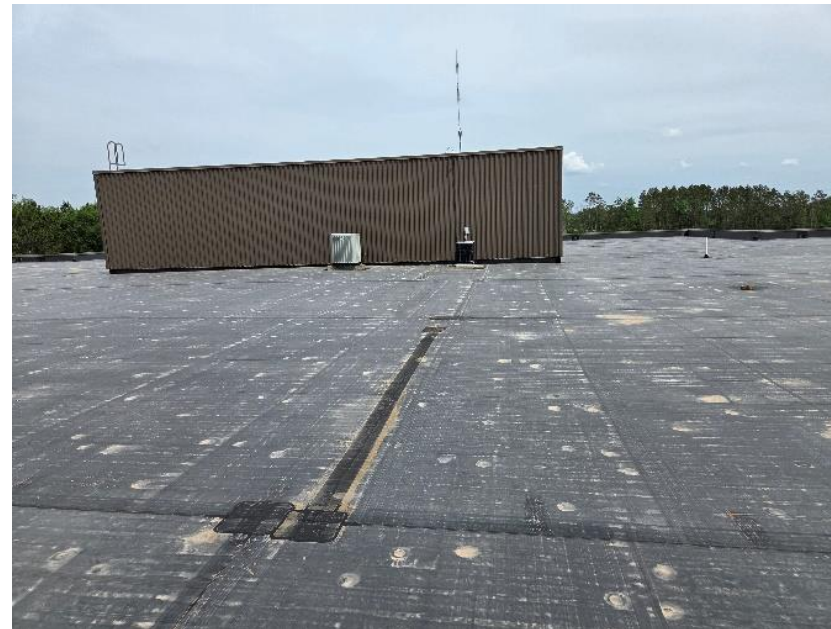
Fully adhered roofing.

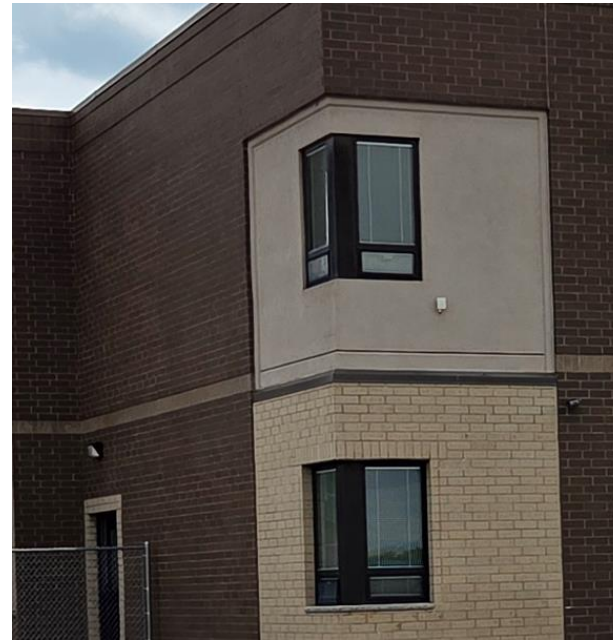
- Generally intact with no major damage
- Blinds sealed between panes that can't be repaired
- Failures often require full window replacement
- Poor seals can make rooms colder and reduce energy efficiency

Windows with curtains inside them  
on the north side of building

- Prioritize replacement of problem windows
- Remove built-in blinds for easier maintenance and better efficiency

| | | \$15,118,000 |
|---|---|---|
| <b>Window Replacement</b> - Replace blind windows area | Elementary School | \$555,000 |

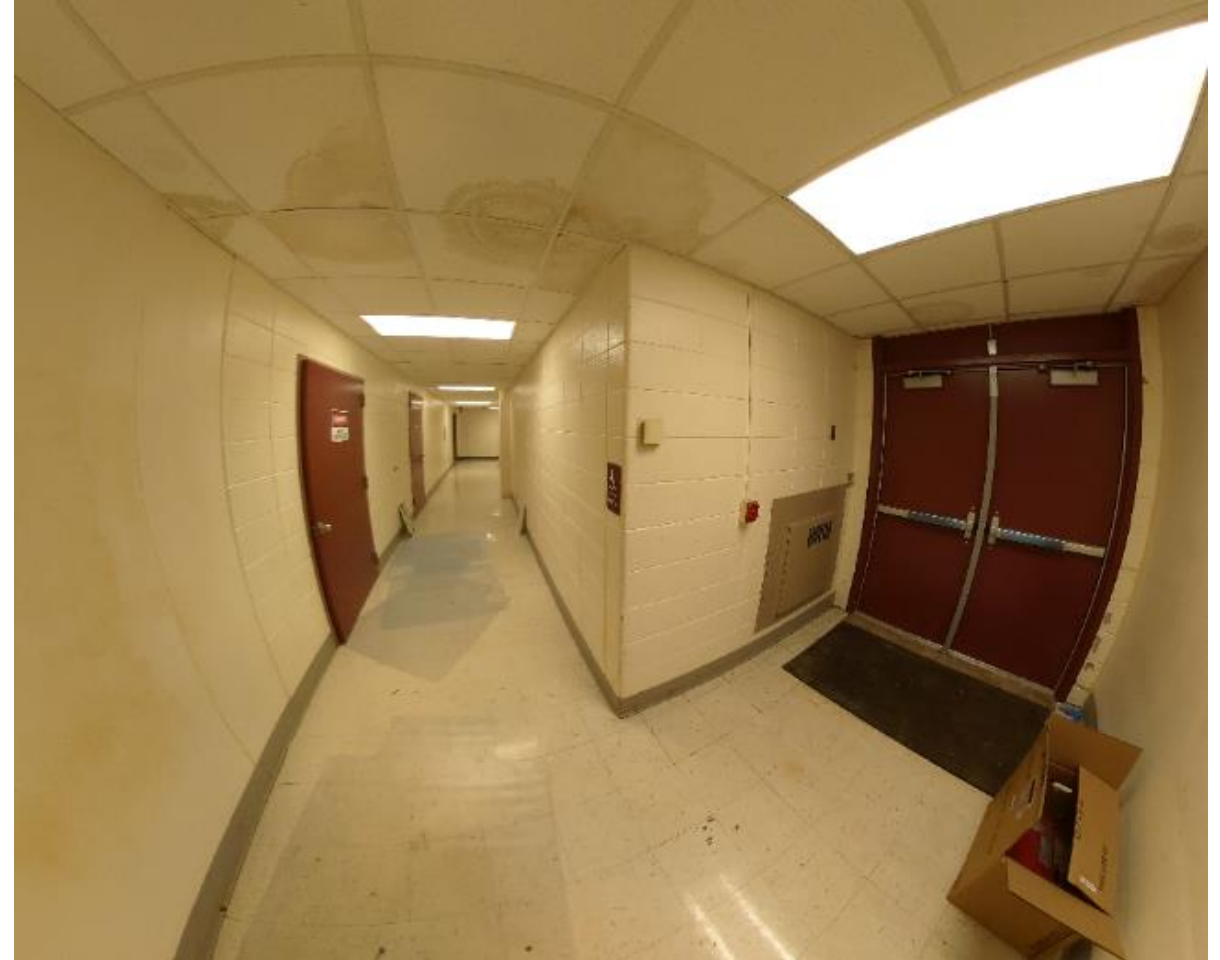
- Acoustic ceiling tile in 1962 and 1994 sections is aged
- Dark stains and wear visible across ceiling tiles
- Leaks sometimes appear in classrooms due to tile condition

Aged ceiling tile with dark staining found in the 1962 section of the school.

- Replace ceiling tile for cleaner appearance
- Reduce risk of mold and leak damage

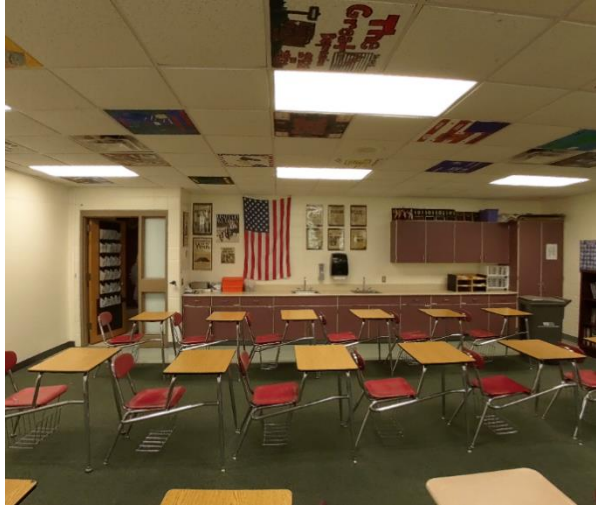
- Cabinetry in classrooms and support areas is dated in appearance
- Most cabinets are functional and structurally sound
- Minor wear seen in a few units, such as loose hardware or small damage
- Aged finishes and hardware may detract from the learning environment

Outdated cabinets in classrooms.

- Update or refinish cabinetry to modernize and improve aesthetics
- Resurface cabinet faces and replace hardware where needed
- Selectively upgrade high-visibility or frequently used areas
- Enhances atmosphere without full replacement

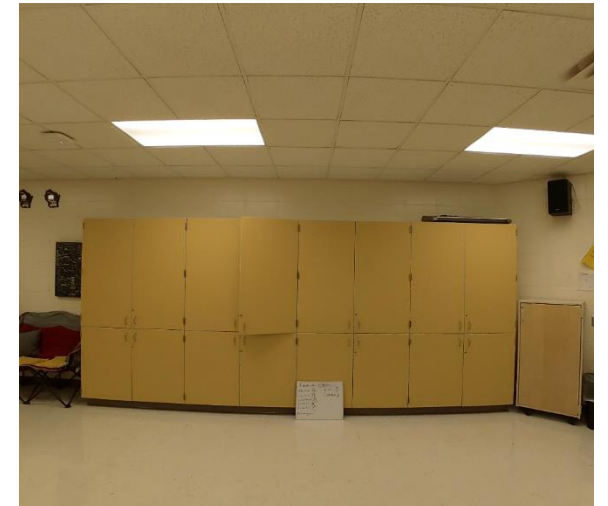
Outdated cabinets in choir room.

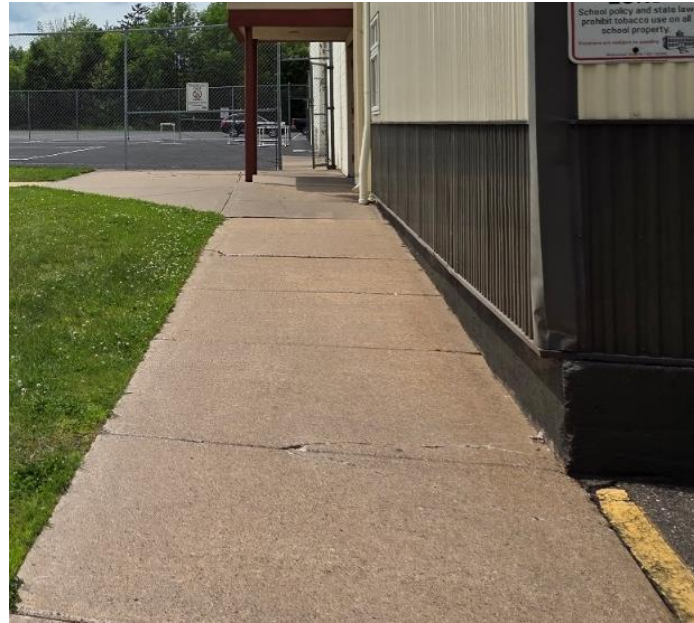
- Current sidewalks show signs of wear and cracking
- Cracks are spread throughout perimeter of the building
- Multiple areas have major cracking that could be repaired

Cracks/wear found in the sidewalk next to the south part of the building.

- Replace damaged concrete sidewalk sections
- Repair or resurface worn parking lot areas

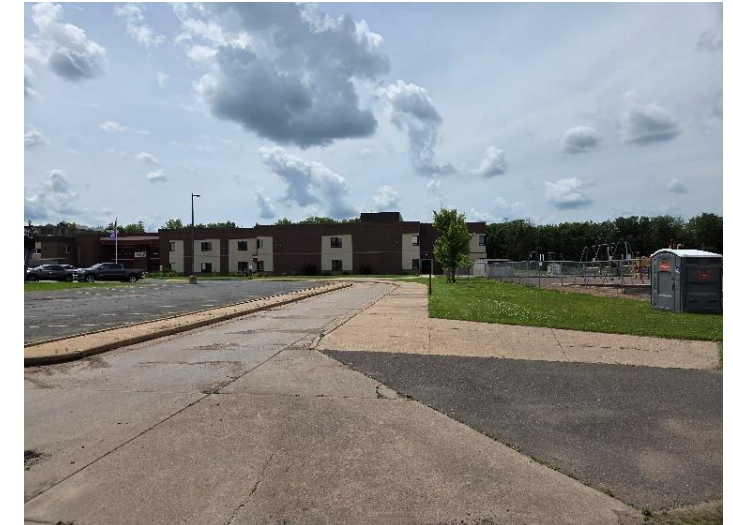
Cracks/wear found in the sidewalk and road by the east side of the building.

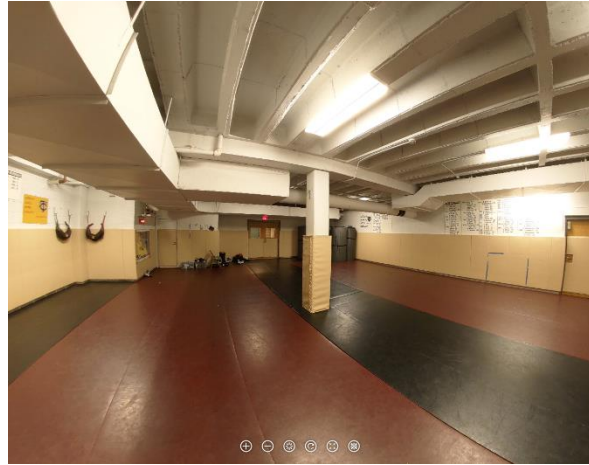
- Current space is unsuitable for athletic use
- Only one small ventilation vent, insufficient for wrestling needs
- Structural support post in center creates safety hazard and limits space

Post in the center of wrestling room.

- Alternative location within the building
- New space should have proper ventilation and clear, open layout
- Enough room needed for wrestling mats and athlete movement
- Relocation will create a safer, more functional environment

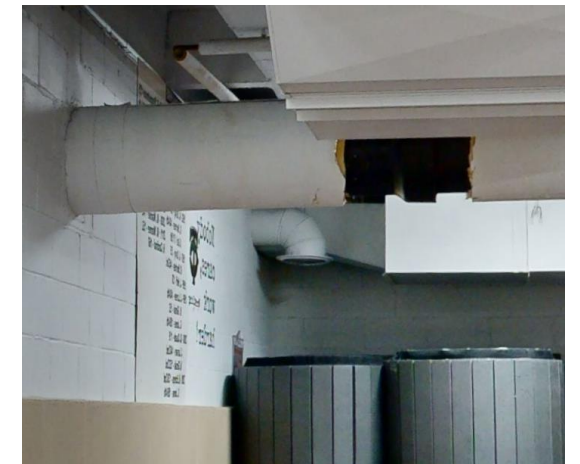
Small vent in the corner of the room.

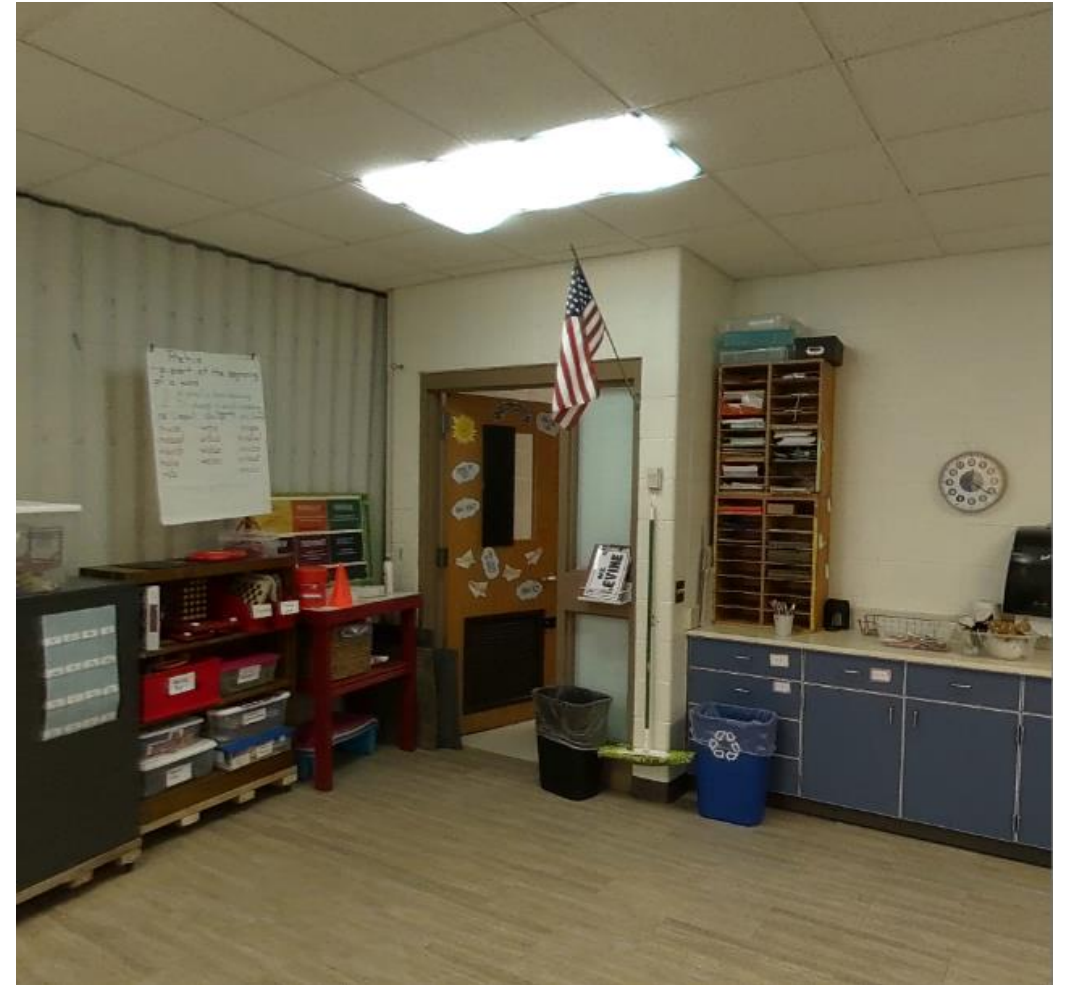
- Several interior doors have ventilation grilles or louvers for air circulation
- Areas with door vents currently lack sprinkler systems
- Door vents can accelerate spread of smoke and fire without suppression

Vent on door in classroom.

- Conduct fire safety audit to assess code compliance
- Retrofit sprinkler systems where required
- Modify door designs to limit fire and smoke spread
- Improve occupant safety and reduce emergency liability
