Edwards Early Childhood Campus Map

1605 Rand Rd, Kaufman, TX 75142

March 3rd, 2025

Kaufman Independent
School District

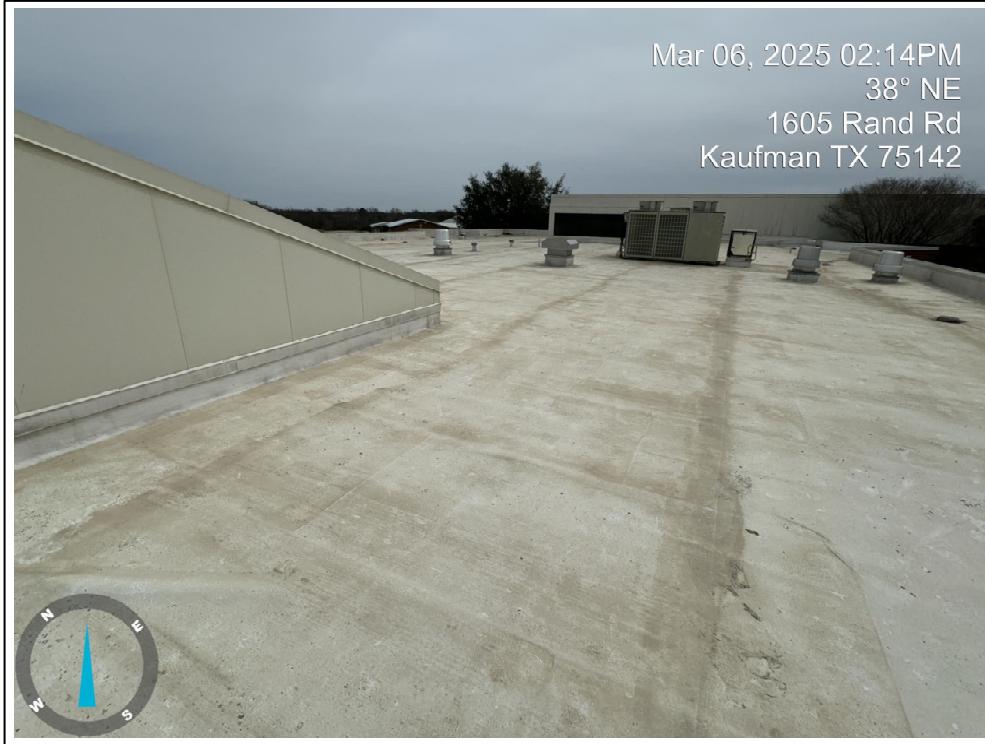
ROOF SECTION PHOTO(S)

Roof Section Name: North Extension Fingers
Square Footage: 40,500
Year Installed/Age: 20+
System Type: Single Ply
Slope: 1/4:12
Height: ~25
Drainage System: Internal Drains
Accessibility: Roof Hatch
Inspection Rating: Failed
Notes: N/A

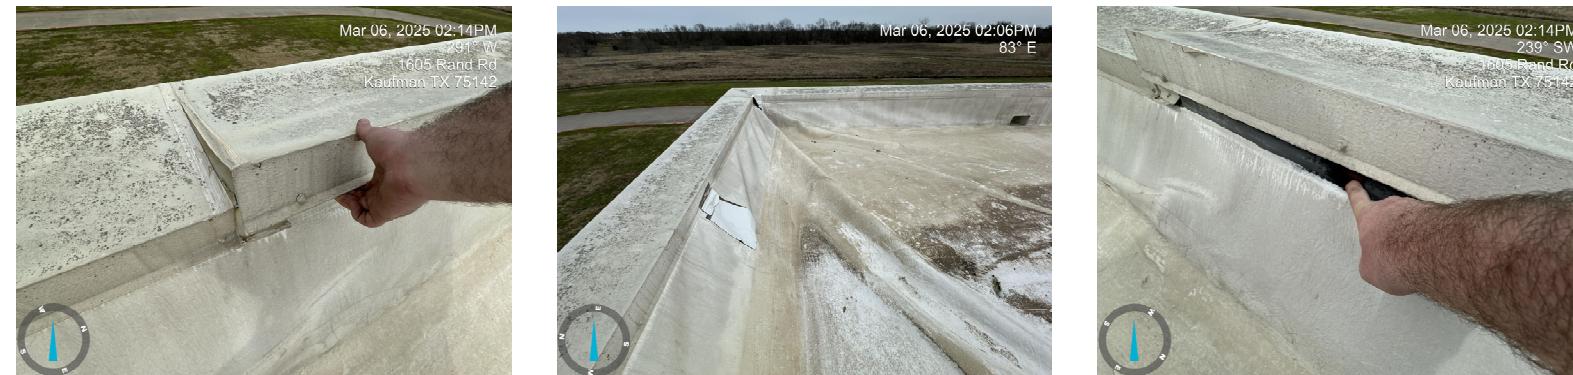
EXISTING ROOF SYSTEM PHOTOS

- Core Analysis: Coating, Single Ply, 2 Layer ISO
- Metal Deck
- Structurally Sloped

- The single-ply membrane exhibits **advanced aging and deterioration**.
- Numerous **fractured seams** were observed, compromising the waterproofing integrity.
- **Widespread surface wear** is evident, with sections of the membrane appearing brittle and discolored.
- Visible **cracking and splitting** along stress points, particularly near seams and transitions.

- Multiple **open and fractured seams** were noted throughout the roof.
- **Adhesion failure** was observed at seam overlaps, leading to water infiltration.
- In some sections, seam separation has resulted in **exposed insulation and substrate**, increasing the risk of structural damage.

- Flashings around penetrations and parapet walls are **failing or detached**, further contributing to water ingress.
- Edge terminations show **lifting and shrinkage**, indicating prolonged exposure to UV degradation.

Repair Water Tight
Estimate \$24,000
