Peak Innovation Center – Roof Drainage Systems Assessment for Fort Smith, Arkansas

Date: 05/11/2023

Building: Peak Innovation Center
5900 Painter Lane
Fort Smith, Arkansas

Reported by: M. Scott Archer, P.E.

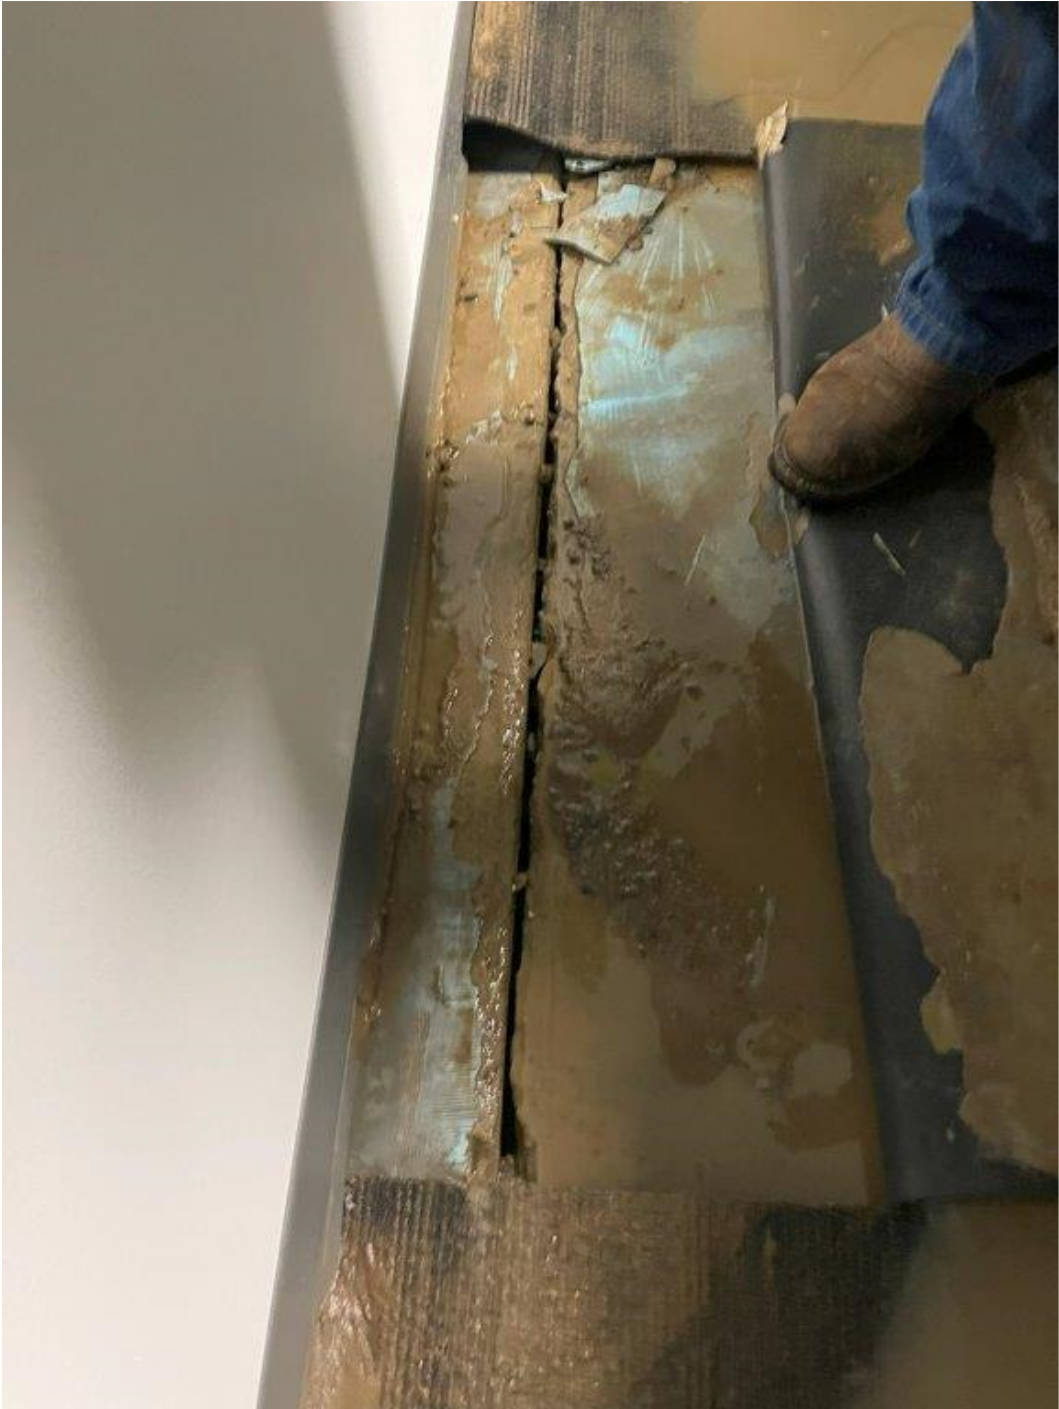
Based on initial visual inspection, on March 24, 2023, water intrusion event appeared to originate along the south wall of the office area between column lines 2 and 4. Most of the intrusion appeared to happen between column grids 2 and 3 at the interface of the slab and grade beam carrying columns along the "L" gridline. Evidence indicated a very substantial and sustained flow from this interface (See Photo 1). In addition to water, a significant amount of silt infiltrated the building as apparent in Photo 1. Based on this initial evidence, our suspicion was that a below slab roof drainpipe had failed allowing water to escape below slab. Based on this we decided that visual inspection of the below slab roof drain piping using a camera inspection system was warranted.

Photo 1: Infiltration Along Grade Beam and Slab

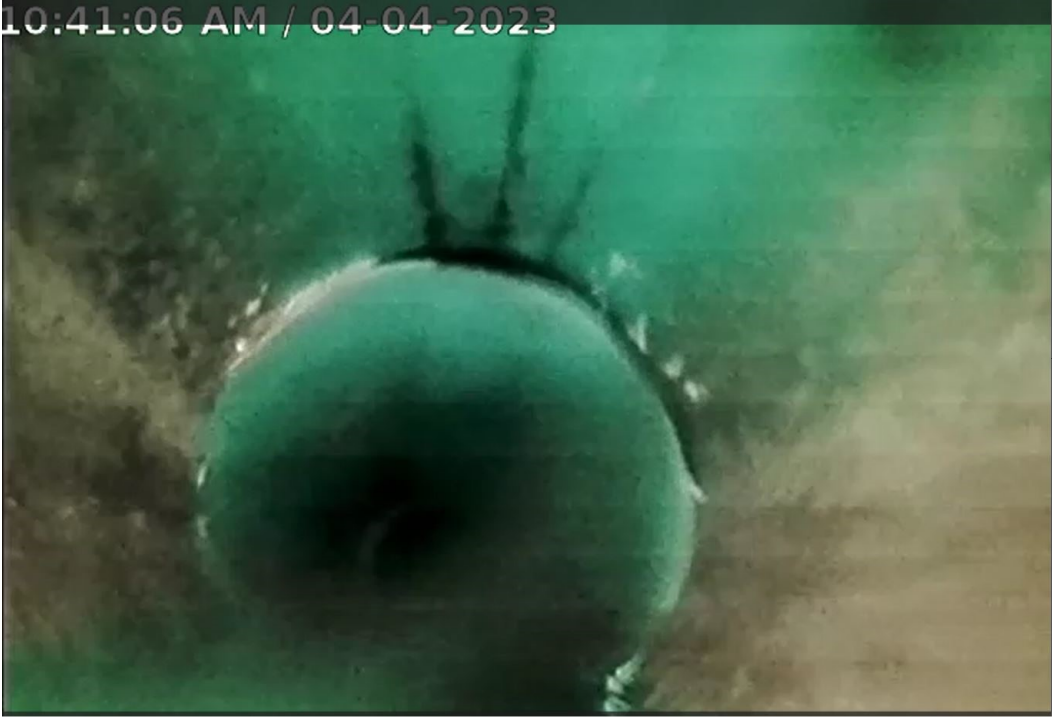
Photo 2: Drainage Repair Interface at Location 2

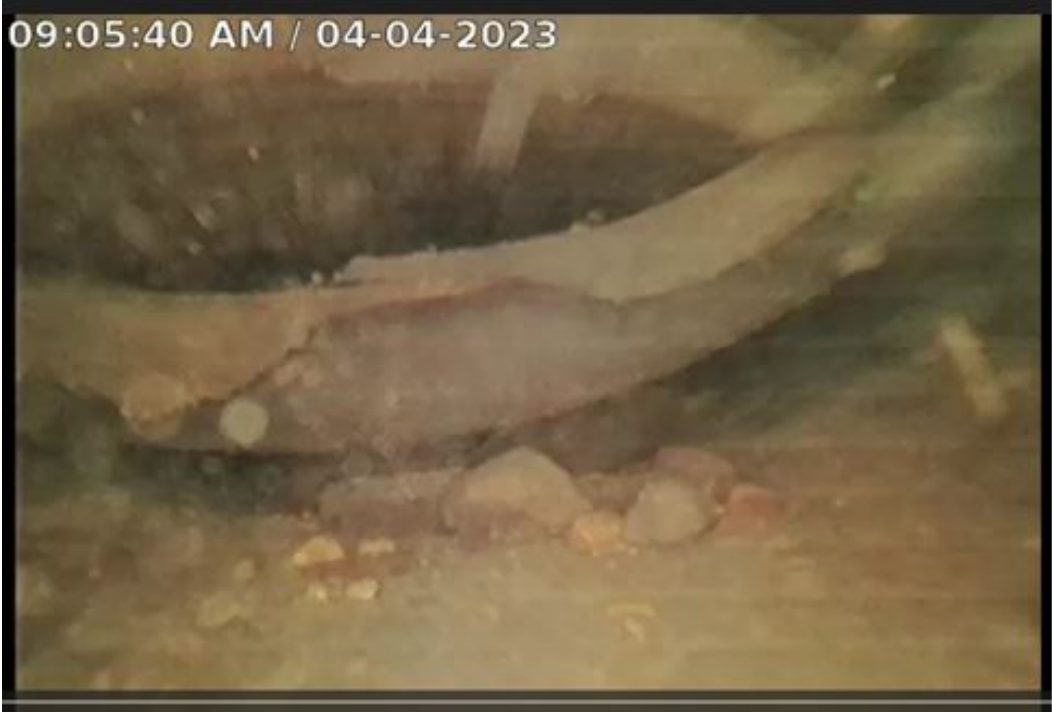
The yellow highlighted area on the site keying plan in Appendix “C” indicates the area we were most concerned with at the beginning of our assessment. Our original concern was that the piping in this area had failed somewhere in the intrusion area and was allowing water to escape below the slab. Our investigation eliminated this possibility, as this below slab piping appeared fully intact based on our inspection. However, it appears to be undersized based on our roof drainage sizing investigation as discussed above. This portion of the original existing piping continues out the south side of the east wing terminating in the drainage ditch to the south of the facility. There was a failure in this portion of the original drainage piping external to the building causing a sink hole to form in the green highlighted area of the site keying plan. We inspected that repair to ensure that was still intact. The repair interface can be seen in Photo 2. We inspected this same pipe from the terminus end at the drainage ditch and found a piping connection that had appeared to fail at approximately location 1 on the site keying plan. This can be seen in Photo 3. This break is far enough outside the building that it does not cause concern.

Photo 3: Piping Connection a Location 1.

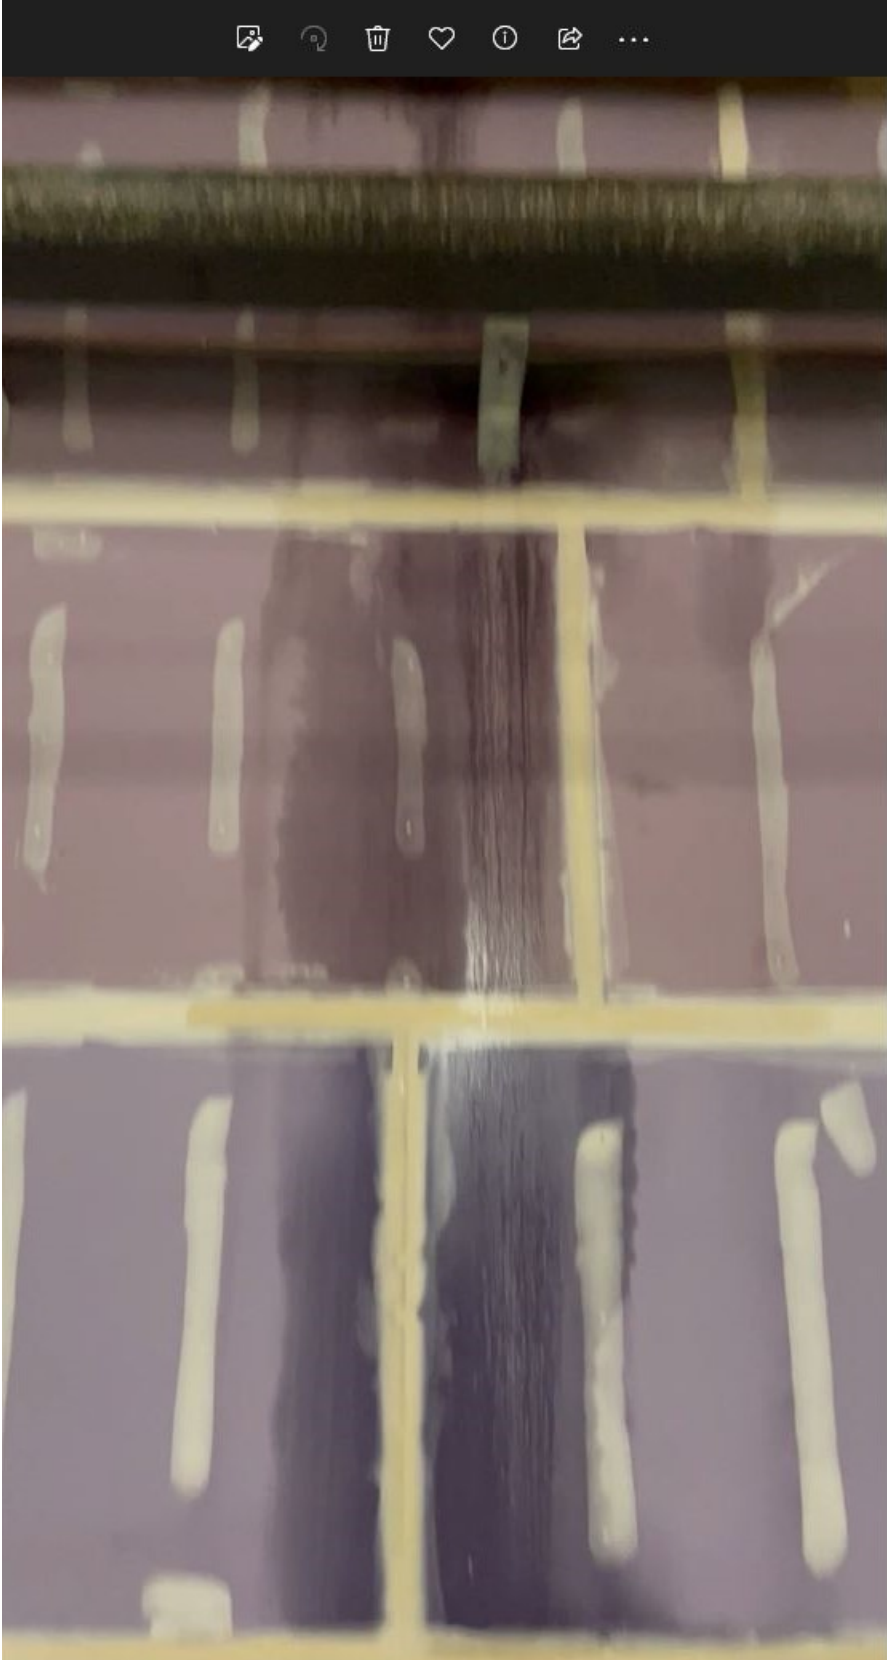
An internal gutter drain was employed in the original design of the east wing where the west wing of the building joins the east wing of the building. The gutter drain is a flat pan style drain that runs the length of the interface between the buildings (see Photo 5B for a section detail of this gutter) with roof drains that feed into the piping system described in the previous paragraph. Evidence indicates that this gutter drain is not draining sufficiently to alleviate the amount of water that was experienced during the March 24 event. Evidence of this can be seen in Photo 4 and Photo 5 as water was witnessed sheet flowing down the wall between the two buildings, as well as wetting the underside of the roof in several areas.

Photo 4: Sheet flow on wall between east and west wings of the building.

1. Abandon the existing below slab drainpipe and reroute the drains serving the internal gutter drain between the east and west wings of the building from the existing below slab drainpipe to the south end of the building and terminate them into the existing south drainage ditch. The size of this new drain could be minimized by routing a portion of the redesigned drainage system into the existing roof drain system at the southeast portion of the west wing. As part of this work, we recommend a full analysis be conducted to determine if the number of roof drains located in the internal gutter drain are adequate to drain the gutter drain during a minimum 4 inch per hour rain event to help ensure that the gutter does not overflow and allow water into the building as shown in photos 4 and 5.

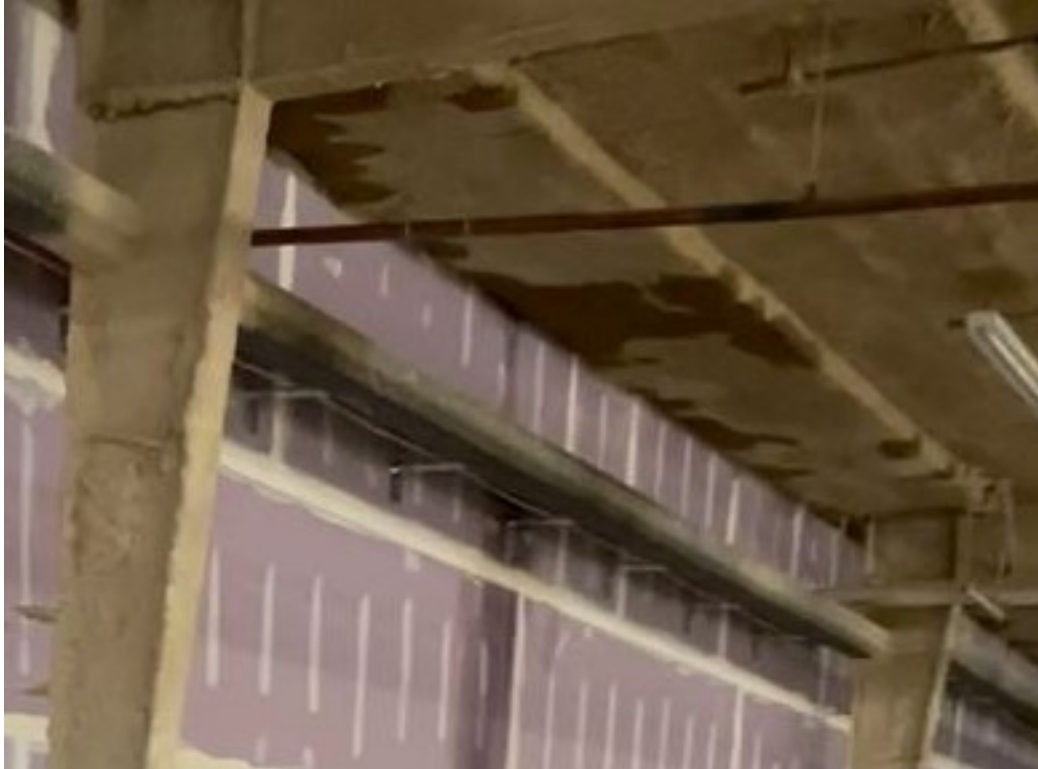
Photo 5: Water on west side of wall between the east and west wing, and indication of water on the underside of the roof in the west wing of the building.

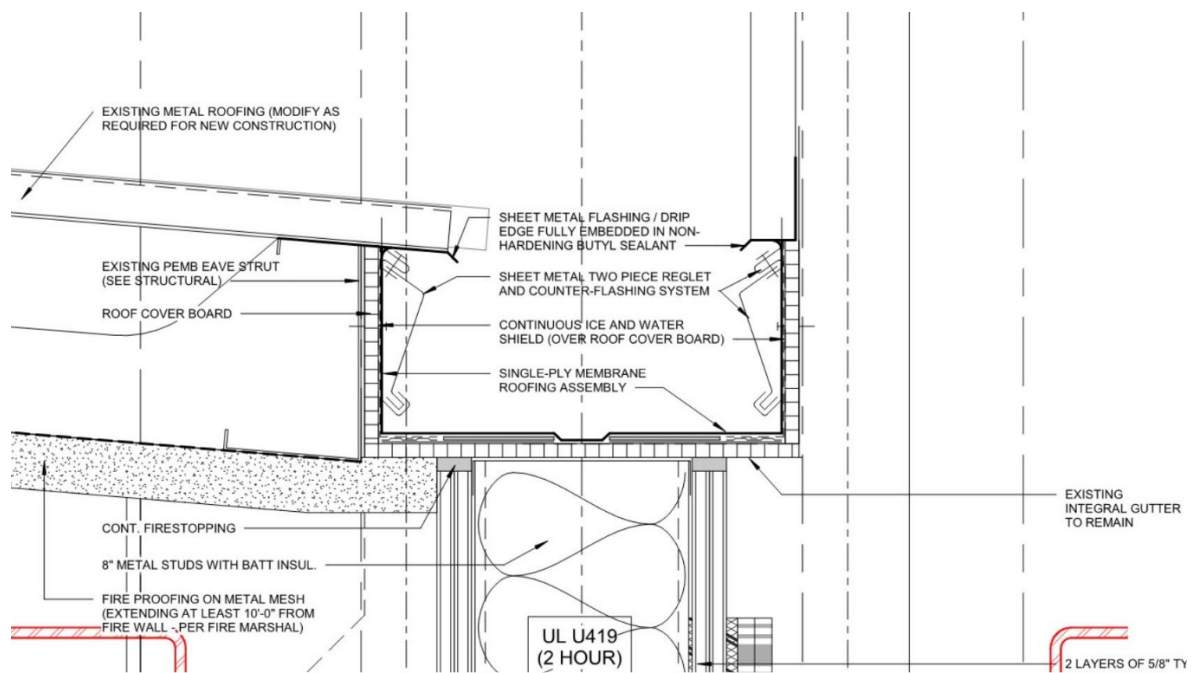
Photo 5B: Detail of Internal Gutter Drain at interface of east and west wing.
From Sheet A06-23

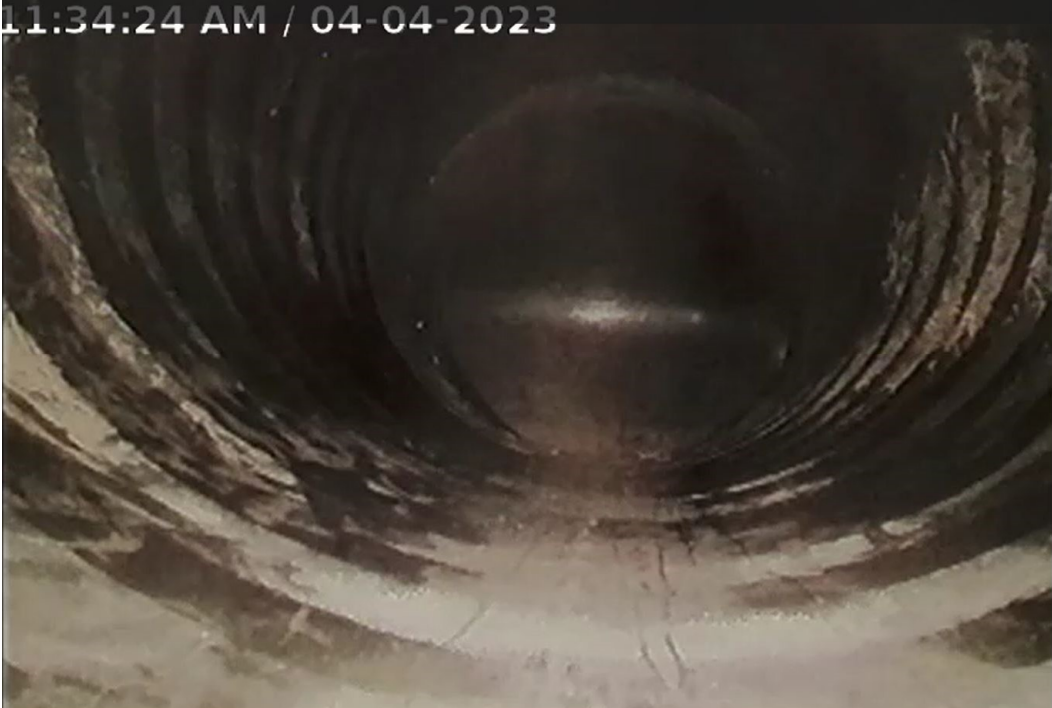
All connections made by fittings in this area of the piping system are made using bull head tees or pipes stubbed directly into another pipe without a fitting. No directional fittings were employed. Directional fittings help direct water flow in the desired direction of flow. This can be seen in Photo 6 at location 3, Photo 7 at location 7 and Photo 8 at location 10. At location 10 & location 11, these two 12in x 12in x 12in bullhead tees are delivering the drainage from approximately 43,000 SF of roof area into a single 12-inch corrugated drainpipe. This is a significant amount of drainage being delivered to this main drainpipe and would have benefited from directional fittings at this location. In addition, the 12-inch main drainpipe appears to be undersized based on the flow. In our opinion, this pipe should probably be at least a 15-inch drainpipe. Our review of the drawings indicates that this main drainpipe was appropriately sized at 12 inches prior to the addition of the roof drain piping added in ASI 04 EXT. It appears that the roof drain design changes contained in the referenced ASI were never communicated to or coordinated with the civil design team.

Photo 6: Bull Head Tee at Location 3

2. Rework the below grade roof drain piping on the south side of the east wing to allow adequate relief of the drainage from the south half of the east wing of the building. There are several options for accomplishing this while minimizing the required disturbance of the existing concrete in the area.

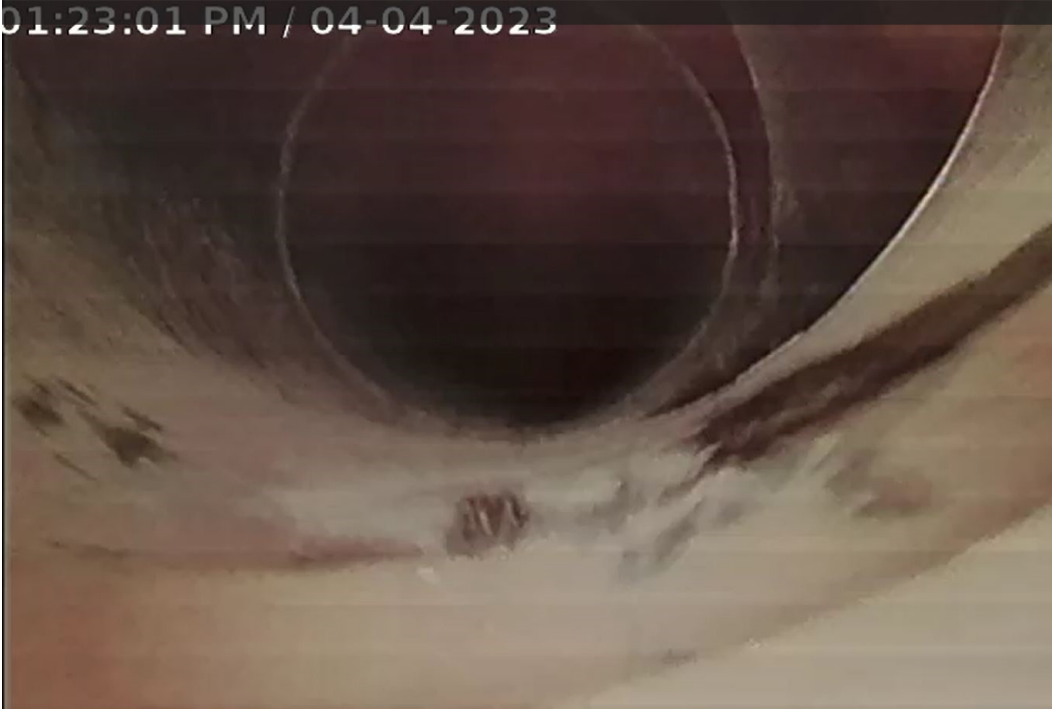
Photo 7: Bull Head Tee at Location 7

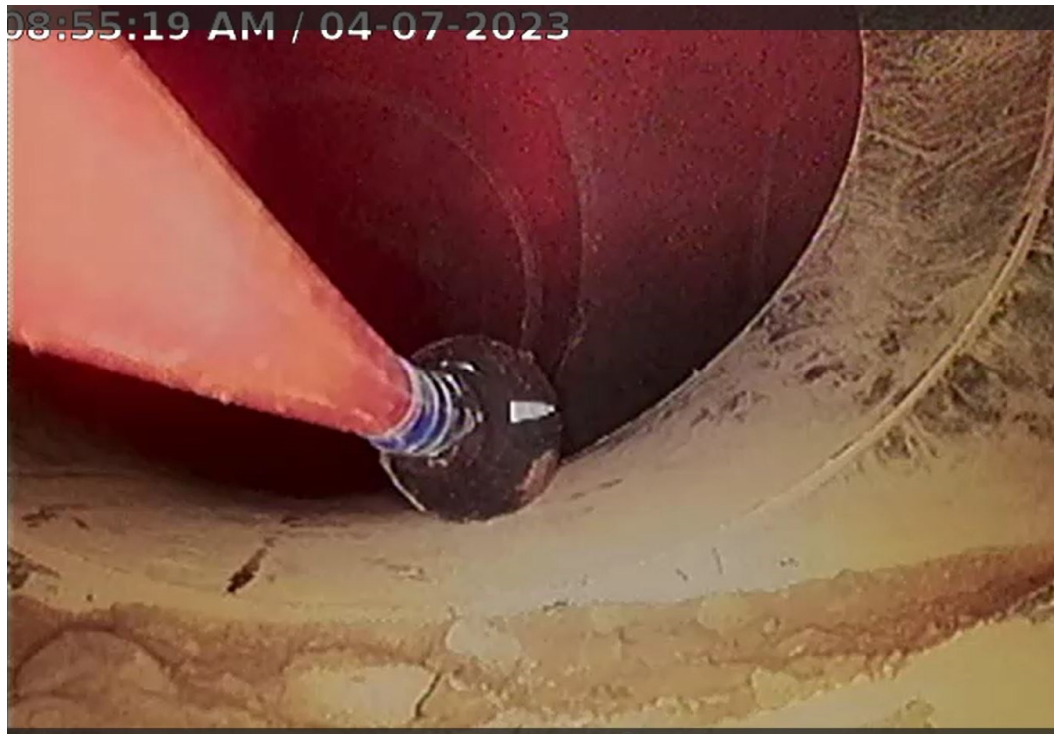
Photo 8: Bull Head Tee at Location 10

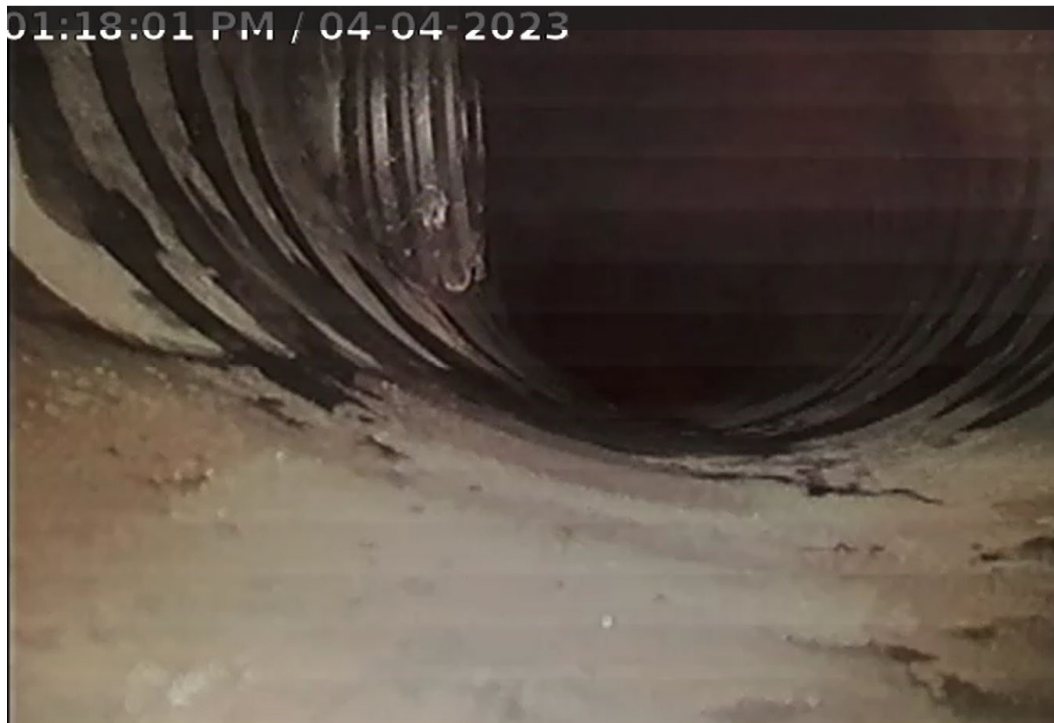
Where the 4-inch canopy roof drains tie into the 12-inch main corrugated below grade pipe, no fittings were used. The 4-inch corrugated pipe from the canopy roof drain is simply shoved through a hole cut into the side of the 12- inch corrugated pipe. This can be seen in Photo 9 taken at location 8. We were not able to inspect the connection from the outside of the pipe to determine if the connection had been sealed in some fashion.

Photo 9: 4-inch corrugated penetrating through the wall of the 12 Inch corrugated pipe at Location 8.

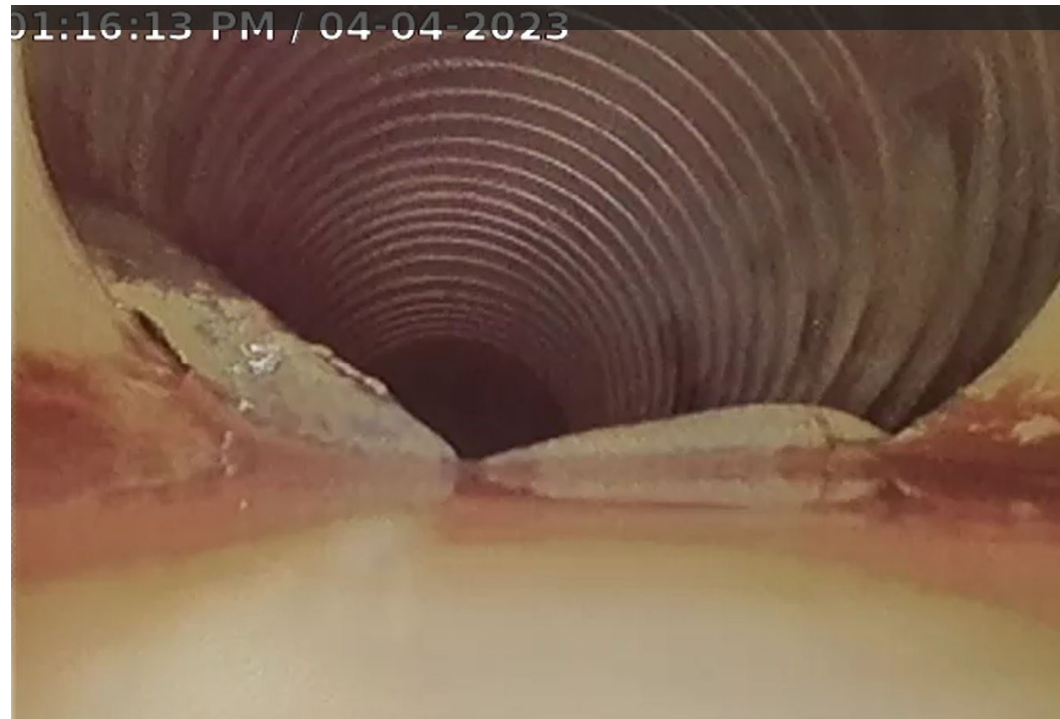
The 4-inch canopy drains are PVC pipe until they get below grade. At some point below grade, they connect to 4-inch corrugated piping. During our inspection we found a poor connection at one of these PVC/corrugated interfaces. Based on our inspection it appears that the 4-inch PVC has been inserted into the 4-inch corrugated and has not been sealed. You can see the poor connection that we found during our inspection in Photo 10 in the appendix.

Photo 10: Poor connection of canopy roof 4-inch PVC to 4-inch corrugated piping.
