Re: Approval for Bid process to retrofit LV Roofing sections 1, 2 & 3

CCSD66 LAKEVIEW JUNIOR HIGH

Inspection Report

FACILITY: Lakeview Junior High	ROOF SECTION: 1	DATE: 03/15/2023
---------------------------------------	------------------------	-------------------------

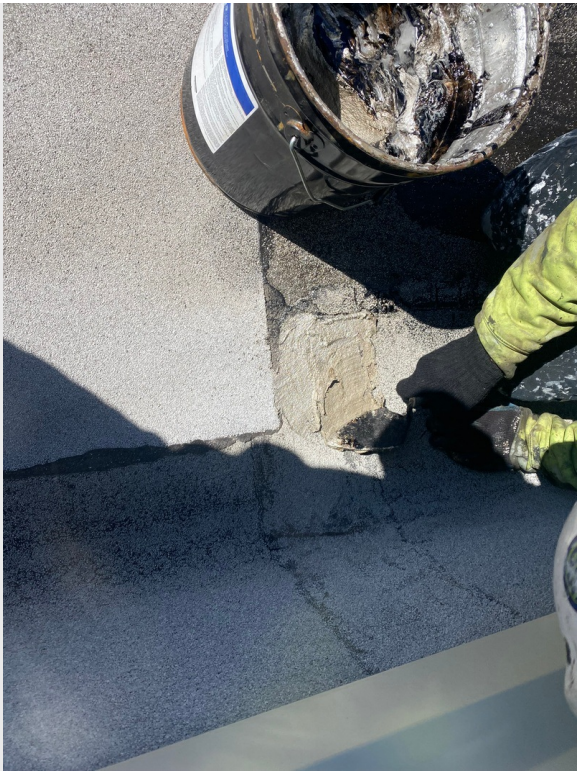
1

Mastic is applied to vertical seams which are aging and open due to exposure.

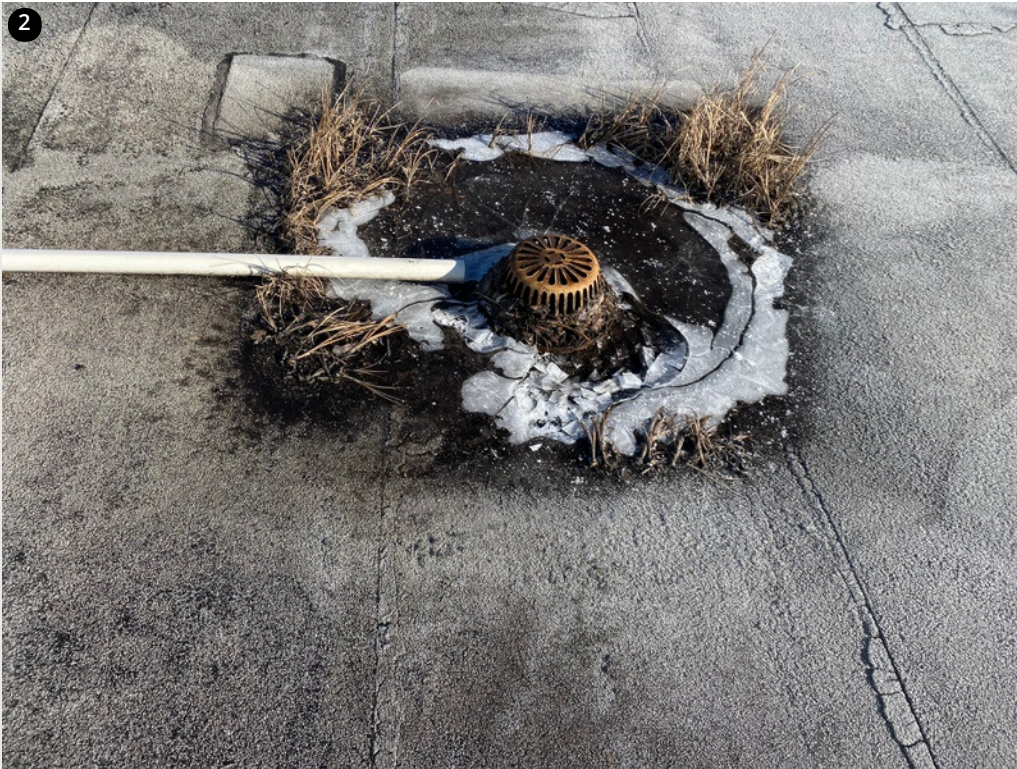
2

Debris is removed from drain sumps to prevent vegetation from penetrating the waterproofing membrane.

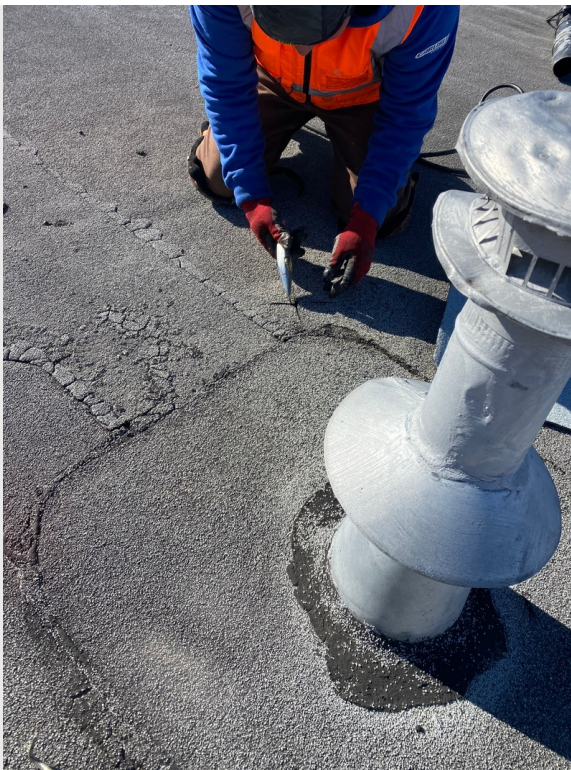
3

Seams around this vent stack are aged and repaired to prevent leaks.

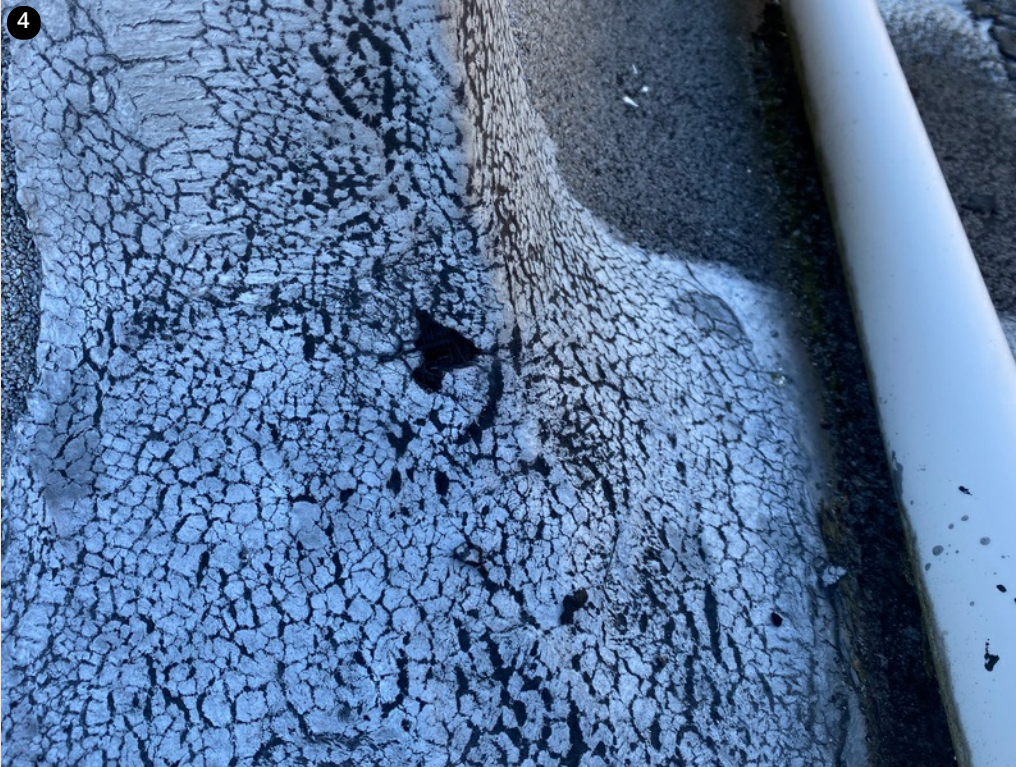
4

This corner seam has a small hole requiring repair.

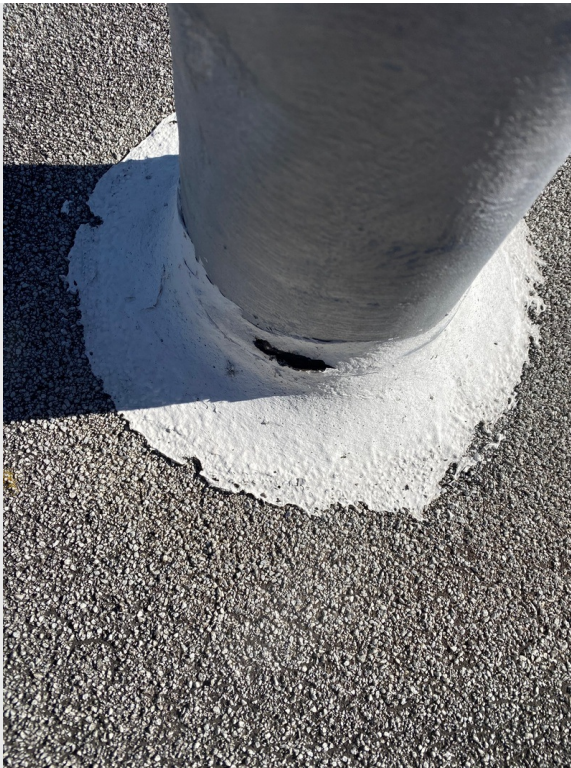
5

The sealant around this soil stack has failed and needs additional repair.

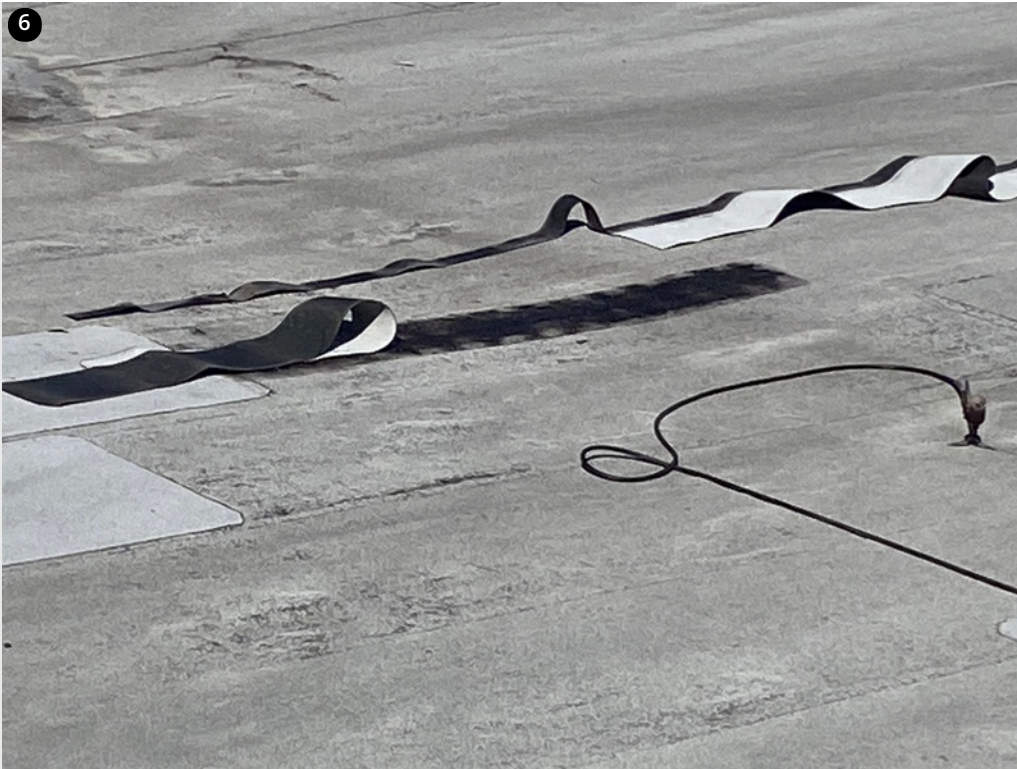
6

Seam repair strips are placed next to areas which have questionable adhesion.

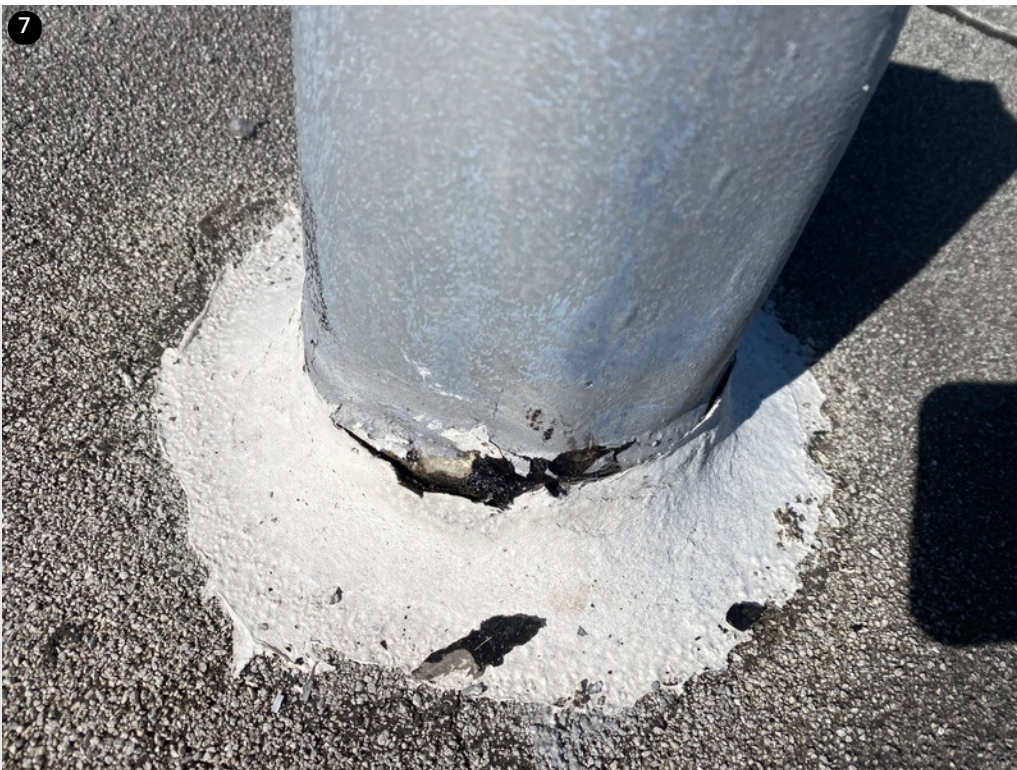
7

This is another soil stack with failed sealant.

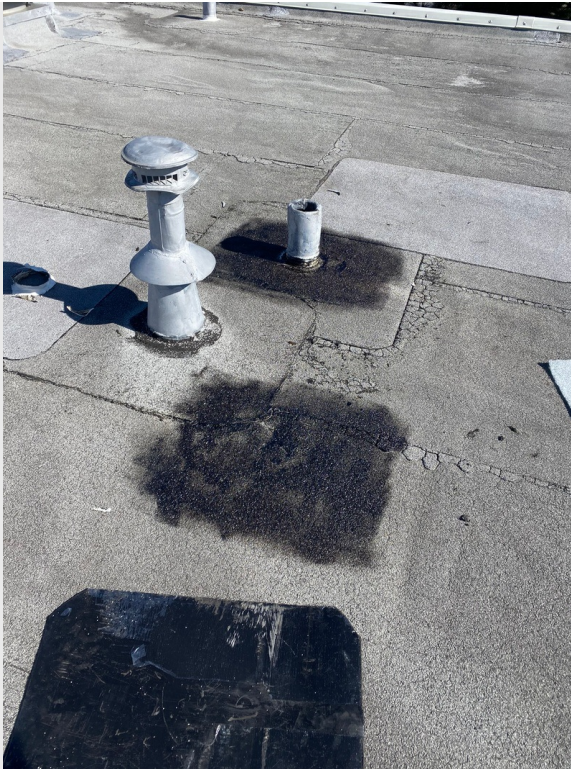
8

Repair areas are primed prior to installation of the target patch.

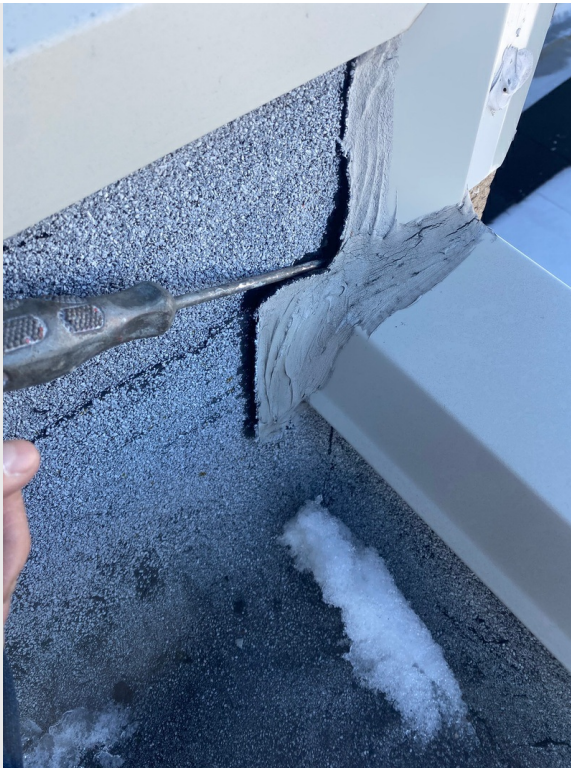
9

This corner flashing has a small opening which will be repaired.

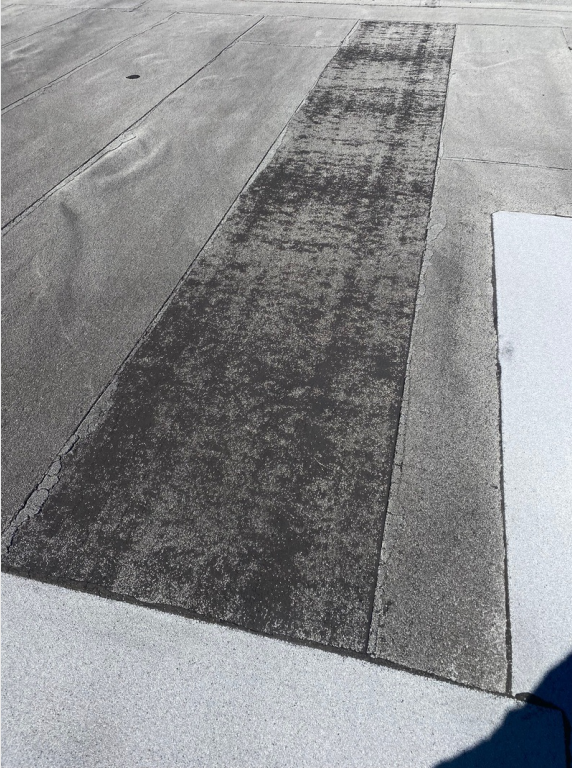
10

Small blisters and mineral granule loss are evident in this photo.

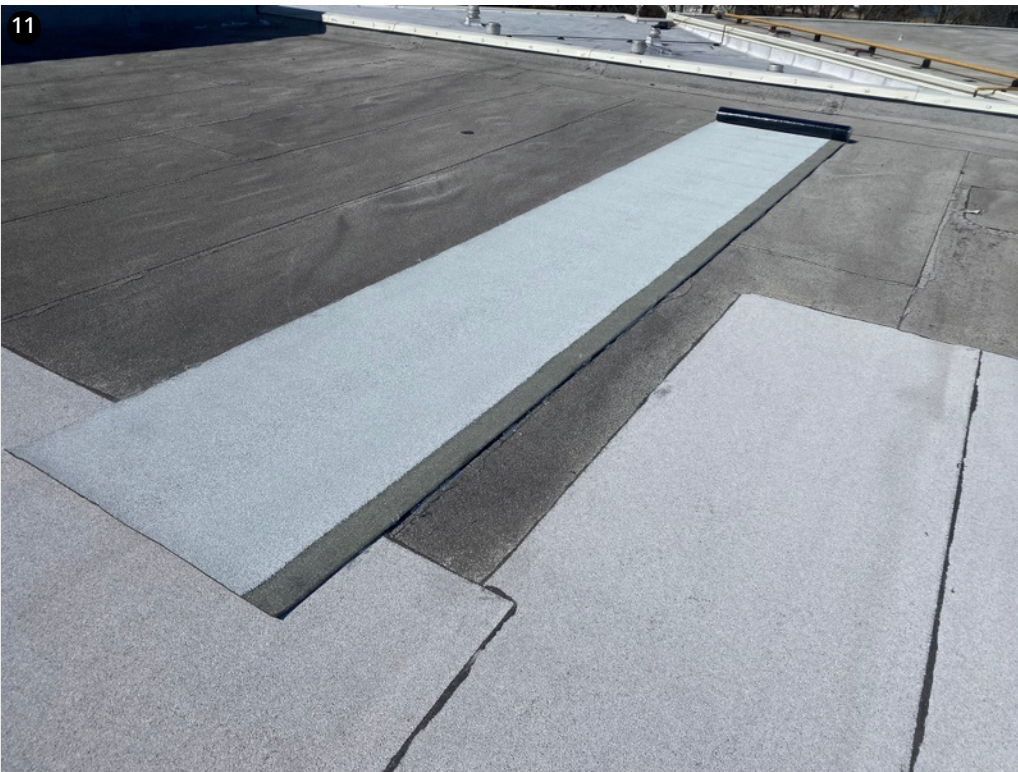
11

Repair material is relaxed prior to installation on the roof section.
