Summary: Lincoln Park Middle School is a three-story masonry building constructed in 2012 (189,137 sf).

Lincoln Park Middle School
3215 West 3rd Street, Duluth

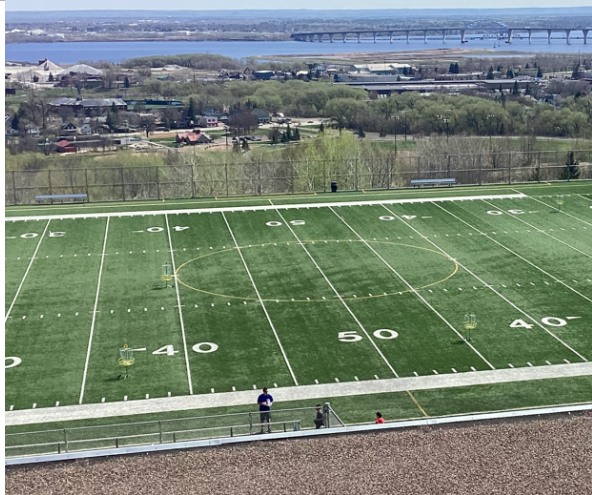
Site Projects: Parking lots need seal coating, patching, crack filling, and re-striping. Artificial turf is worn and should be considered for replacement within three years. A few sections of walk have settled creating trip hazards at entrances. Grinding should be done.

Worn artificial turf

| • Artificial Turf Replacement (2024 & 2032) | \$701,000 |

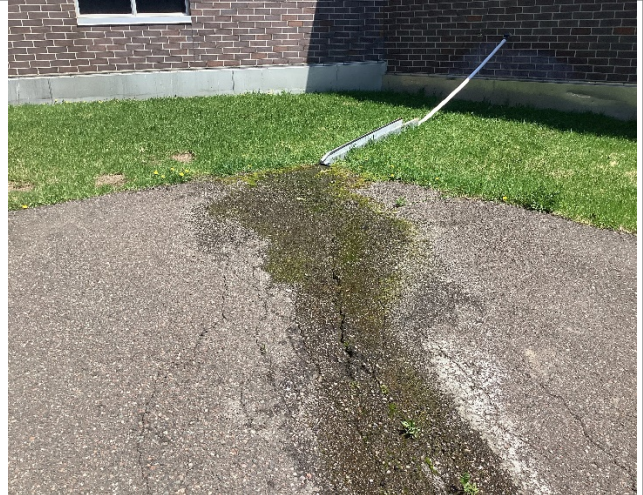
Drainage issue

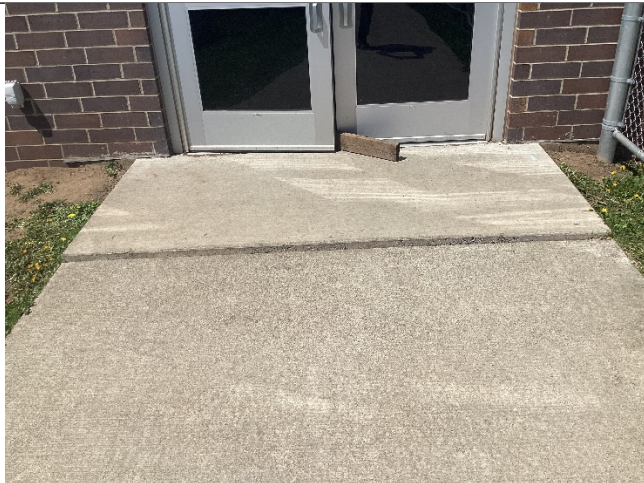
Settled concrete

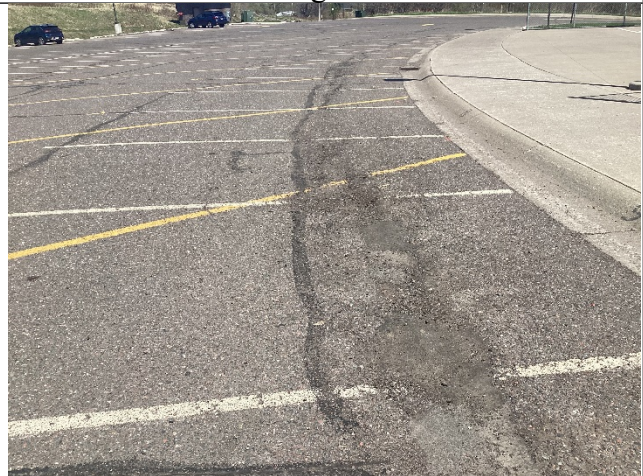
Needed pavement repairs

| • Asphalt Maintenance and Repairs (2025-2031) | \$866,226 |

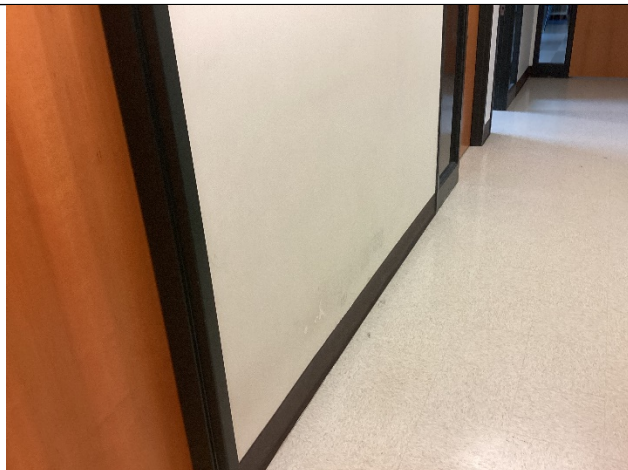
Scuffs on painted surfaces

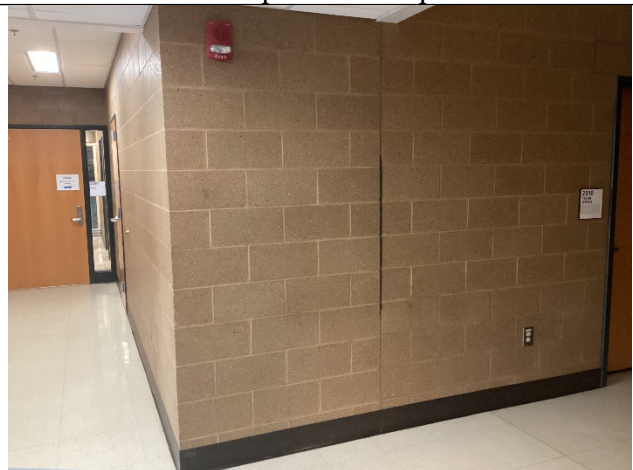
Interior Surfaces: Most items are in very good condition except a few minor items like damaged walls, missing sealant at expansion joints in burnished block walls.

Missing sealant

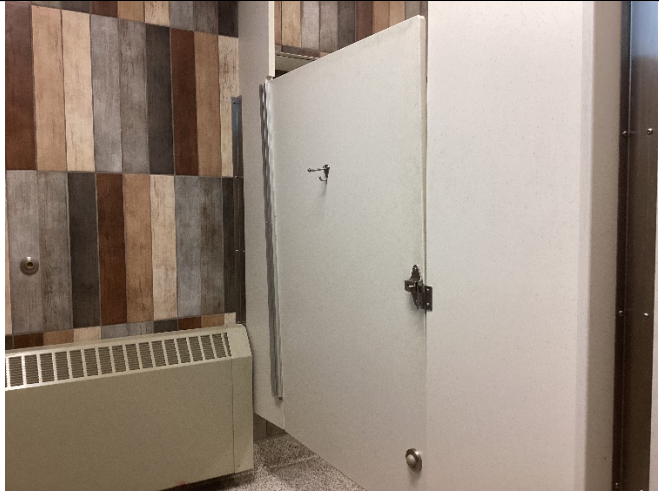
Damaged restroom partition	Leaking main pool pump

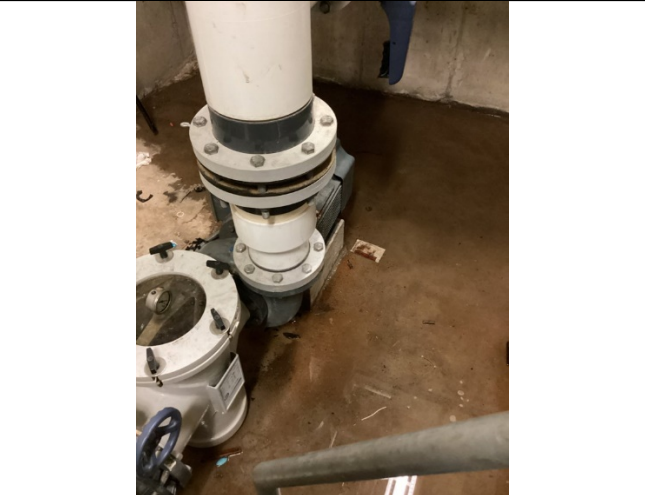
Building Hardware & Equipment: The pool's main pump is leaking, which has caused a half inch of water to pool in the pit. The main pump and seals need to be replaced to fix this issue. The chemical system and UV sanitizer are nearing the end of their useful service life and will need replacement. There are some damaged toilet partitions and restroom accessories.
