**MADDOX ROOFING & CONSTRUCTION, INC.**

To: Browning School District  
RE: Fall Facility Roof Inspections

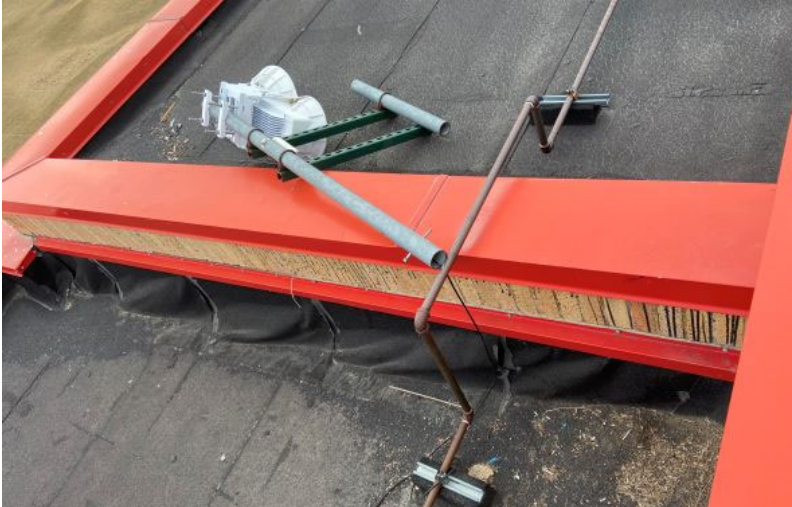
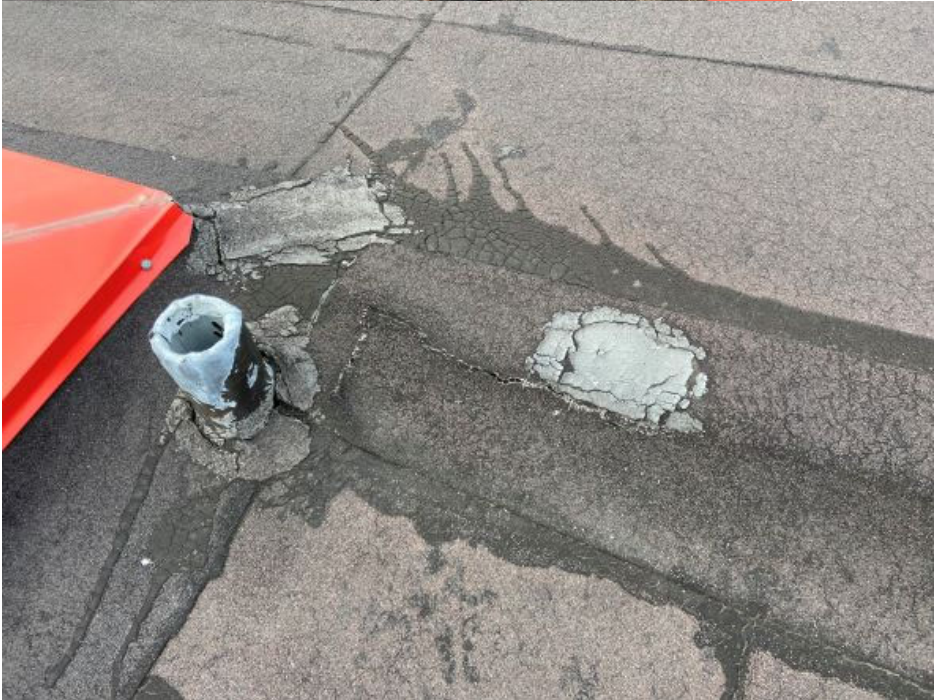
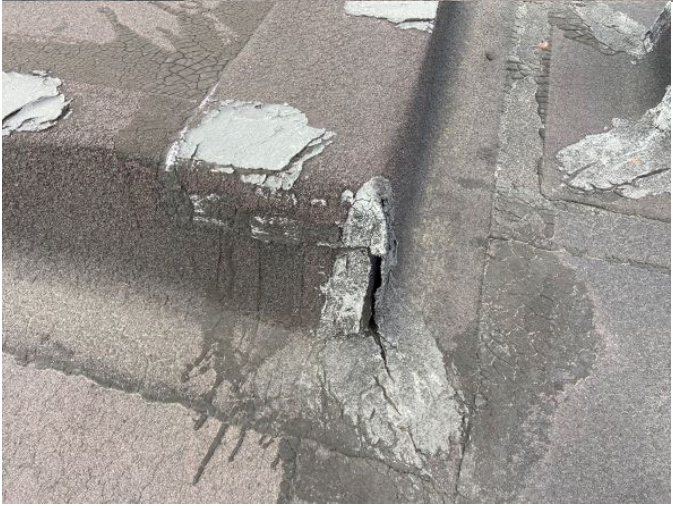
#### NAPI ELEMENTARY SCHOOL

The general condition of this roof assembly is “poor”. The membrane itself is in decent condition, but there are an exceptionally large percentage of the flashings which are in very poor condition.

Observed deficiencies are: cracking at flashings/penetrations, moderate granule loss, deteriorated flashings, missing drain strainers, splitting of the plies due to movement of the building, penetrations that have not been flashed and migration of some wall flashings.

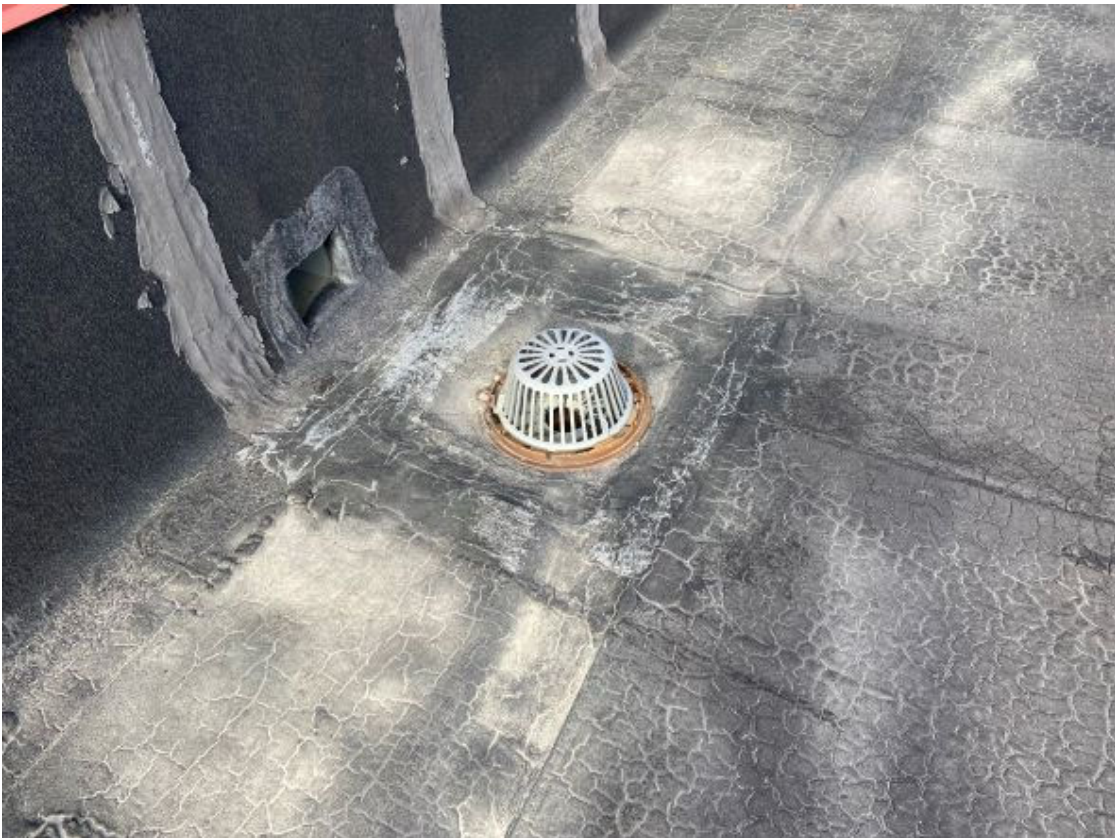
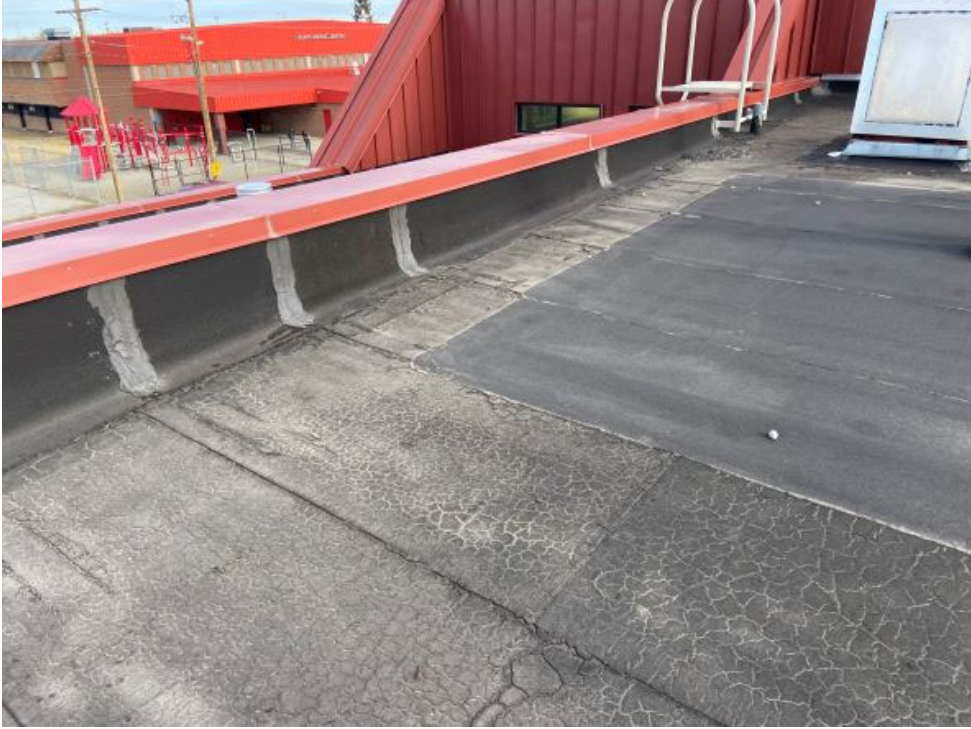
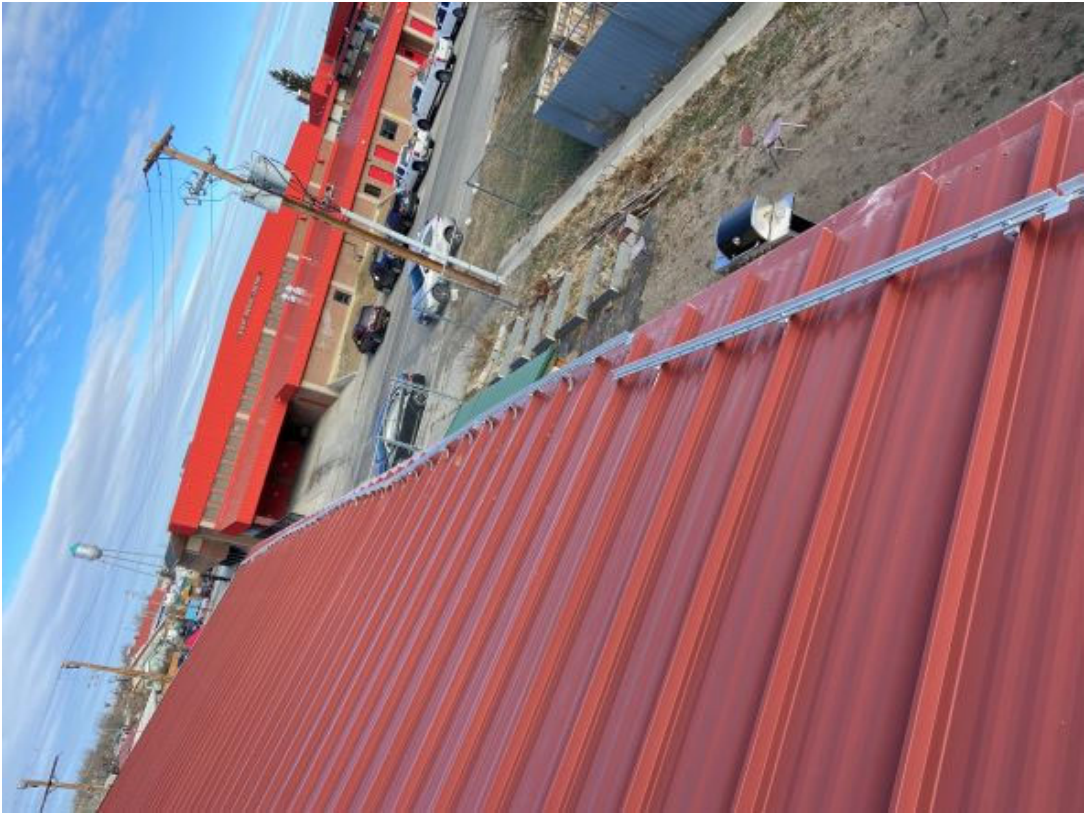
## WILLIAM BUFFALO SCHOOL

The general condition of this roof assembly is “poor”. The membrane and flashings are still in an overall watertight manner. However, the overall condition at both the membrane and flashings are showing significant wear with little to no granule retention. Observed deficiencies are: extreme granule loss, loose flashings, loose seams, damaged/missing snow retention system.

While this system looks bad on the outside, there are few leaks inside the building. This is due to the majority of the transitions or flashings still be sealed. The thermal shock from cold to hot will be an issue with this system very soon due to its age.

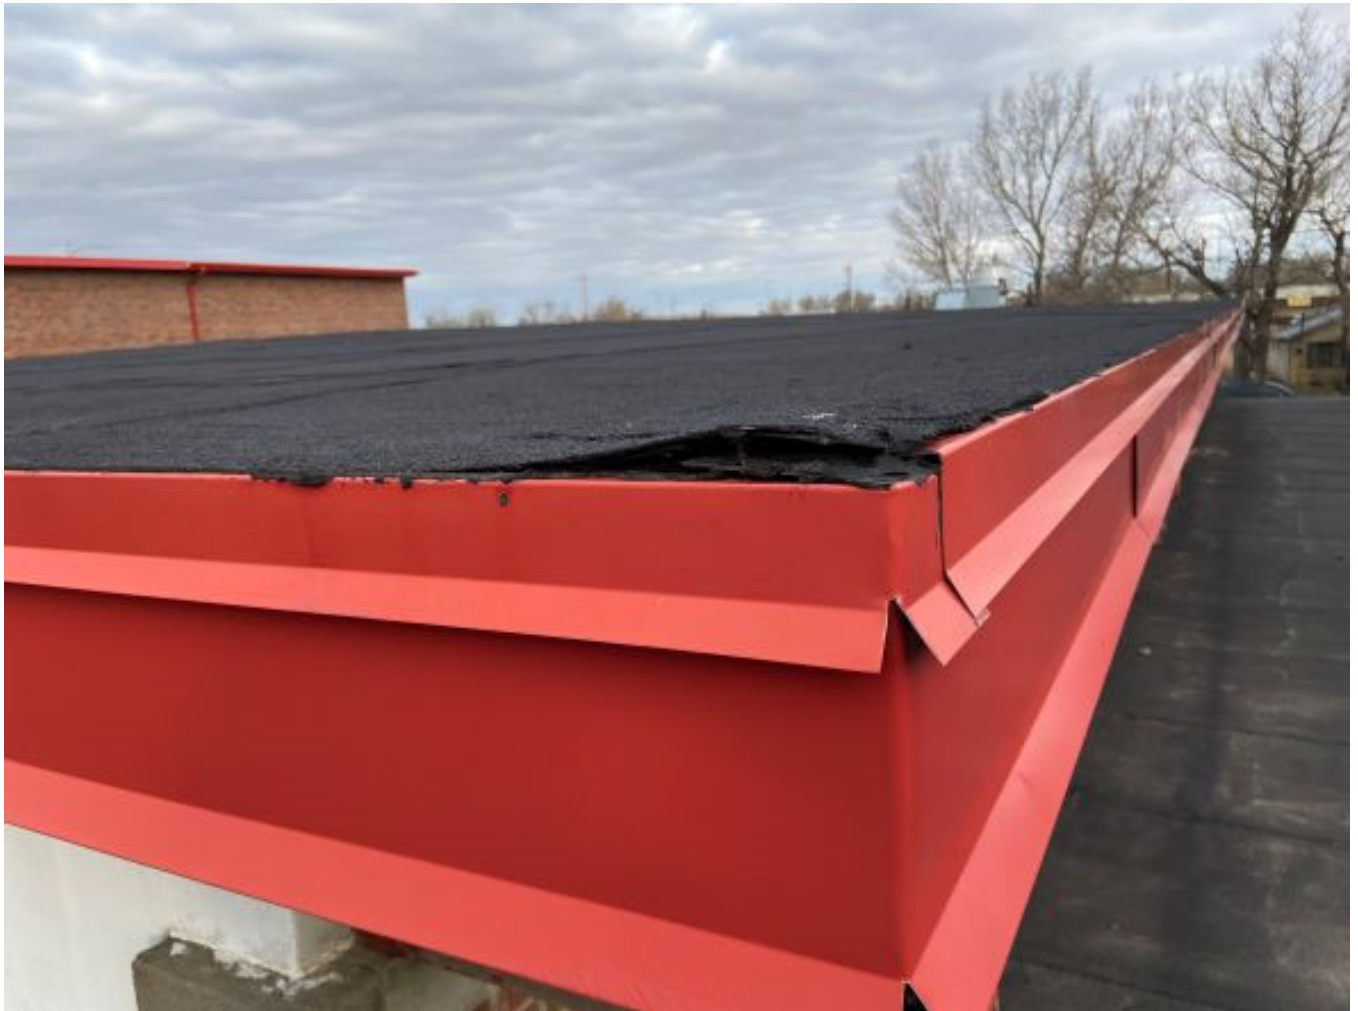
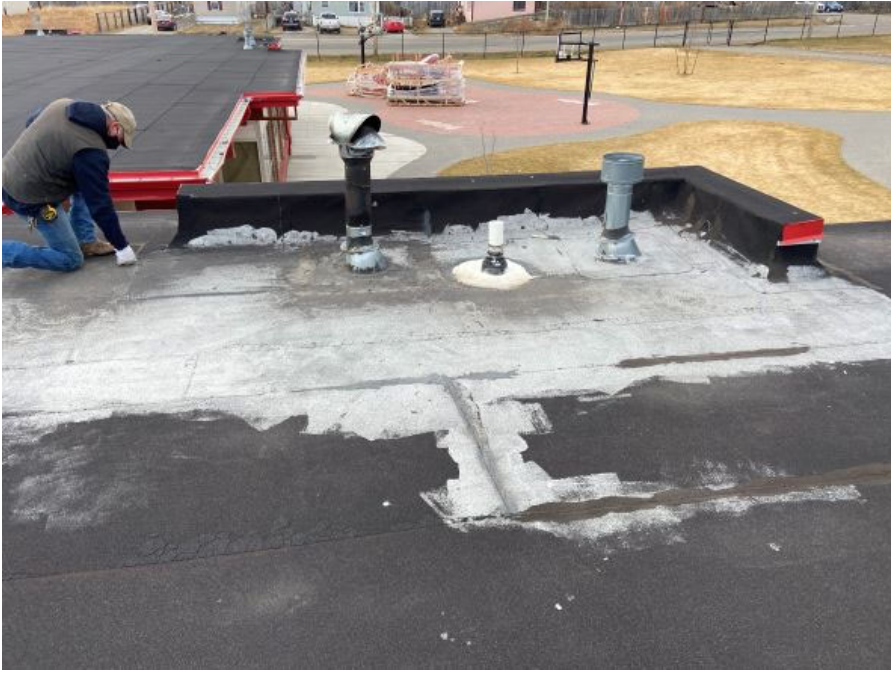
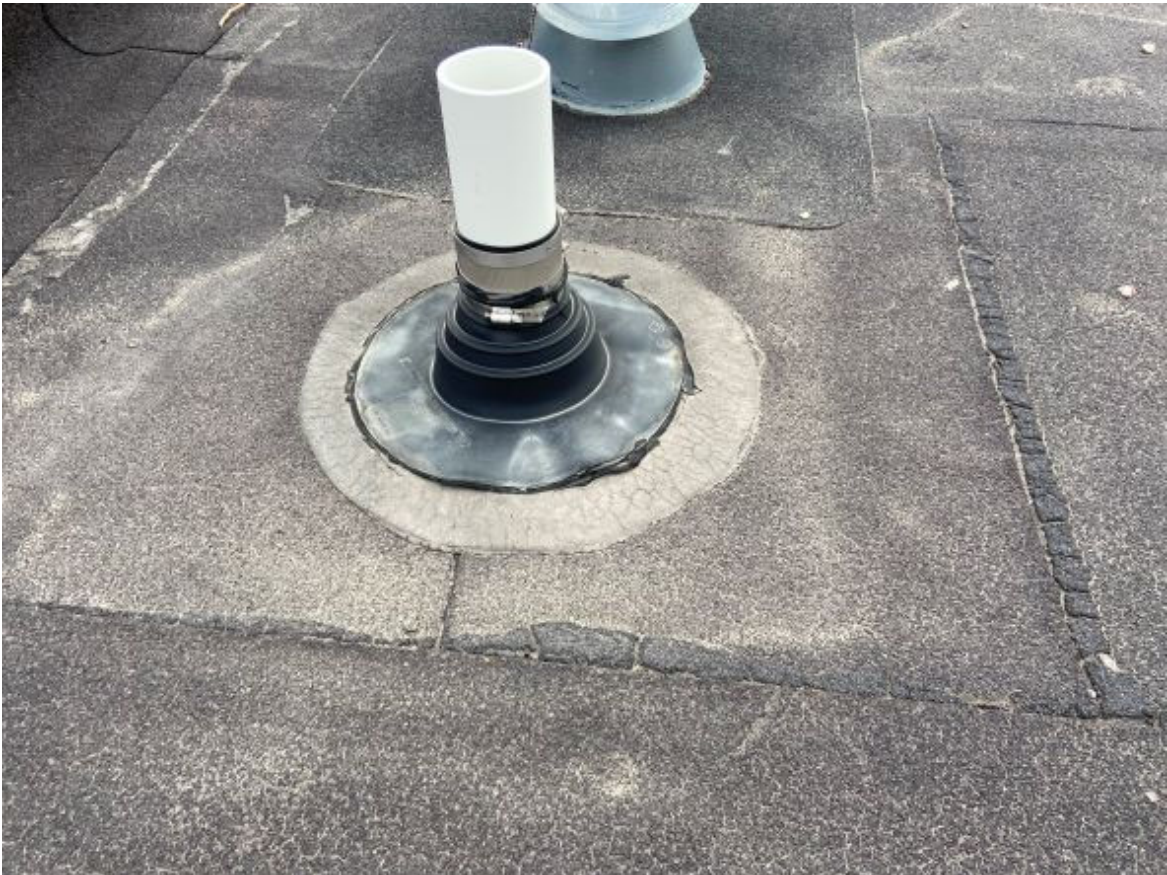
## KW BERGAN

The general condition of this roof is still borderline fair. The membrane/ cap sheet is still in fair condition with good granule retention. Some of the flashings at the penetrations, especially the pipes, are in need of some maintenance, but the system overall is still watertight with the exception of one area.

Deficiencies observed are; pipe flashings, loose stripping/flushing, loose wall flashings and a deteriorated sheet in one area.

There was one leak noted during the walkover at a corner on the SW side. This area is waterlogged and should be removed and replaced. The short parapet wall is holding the water here. It would need to be crickets and the membrane replaced.

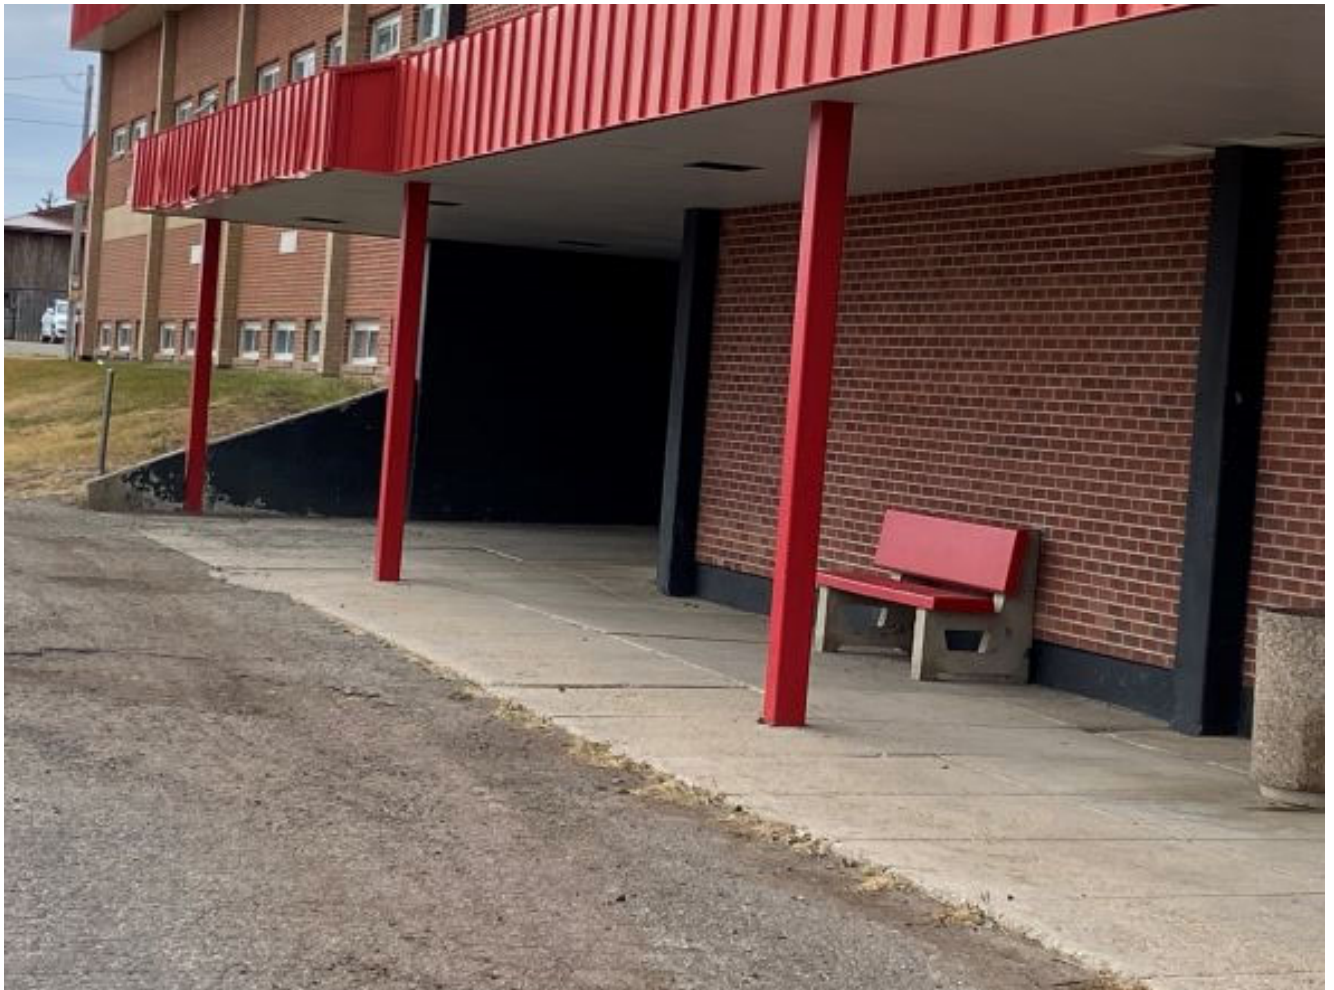
Vina Chattin

The only deficiencies noted on this building are at the flat roof at the entry way and fascia damage on the east entry way.

The flashings from the flat roof to the metal wall panel assembly are in poor condition.

The roof itself is also in poor condition and should be considered for replacement. The damage to the metal fascia is not weather related, possibly damage by a delivery vehicle. It looks to be secure and the damage is just cosmetic.

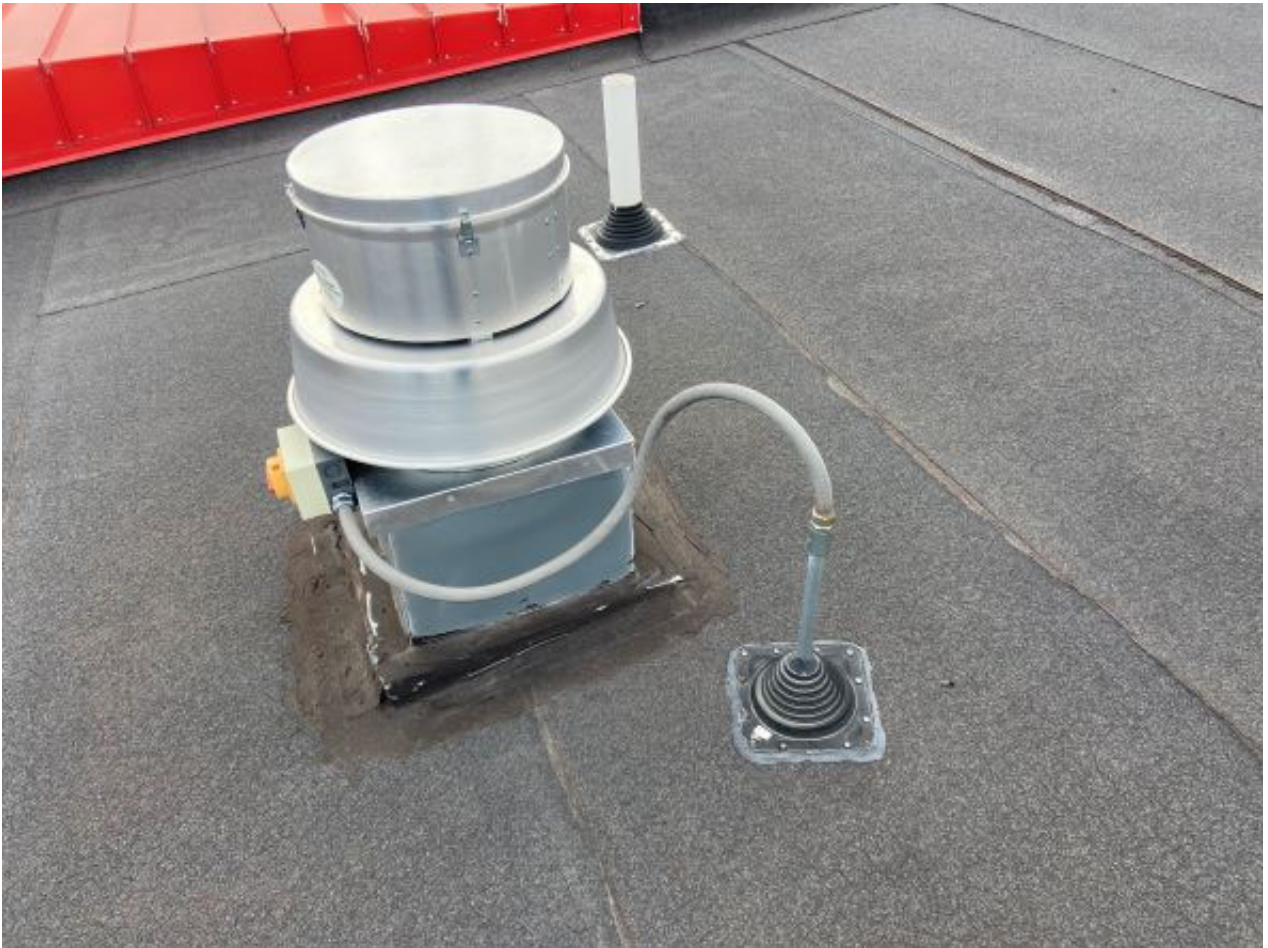
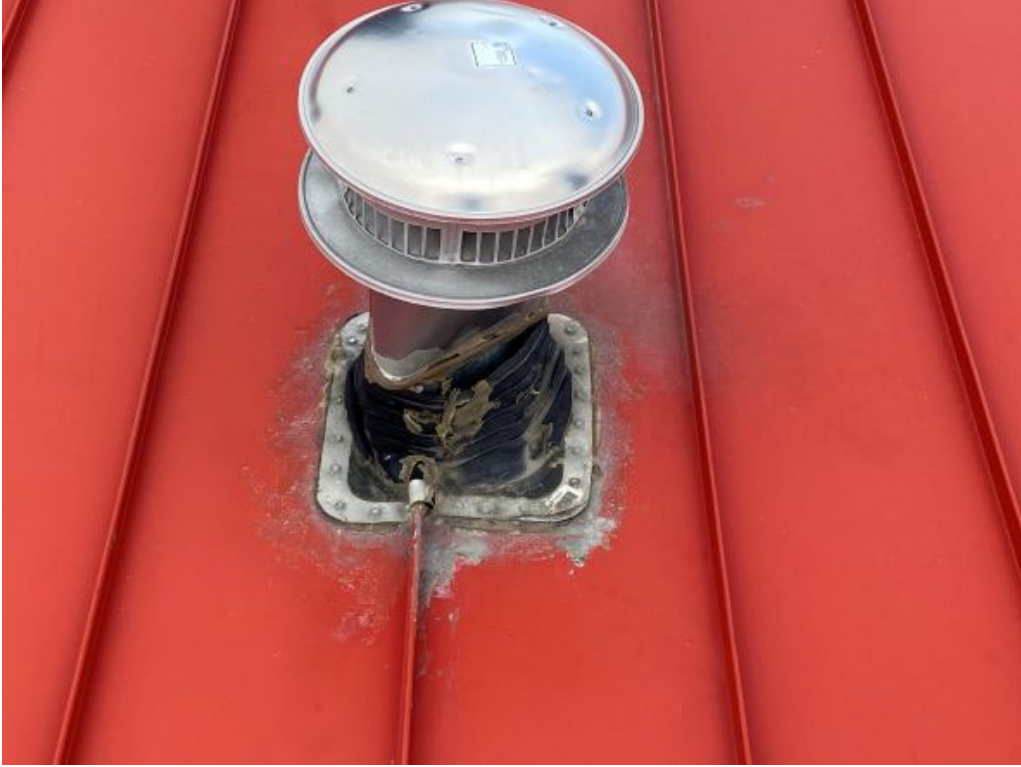
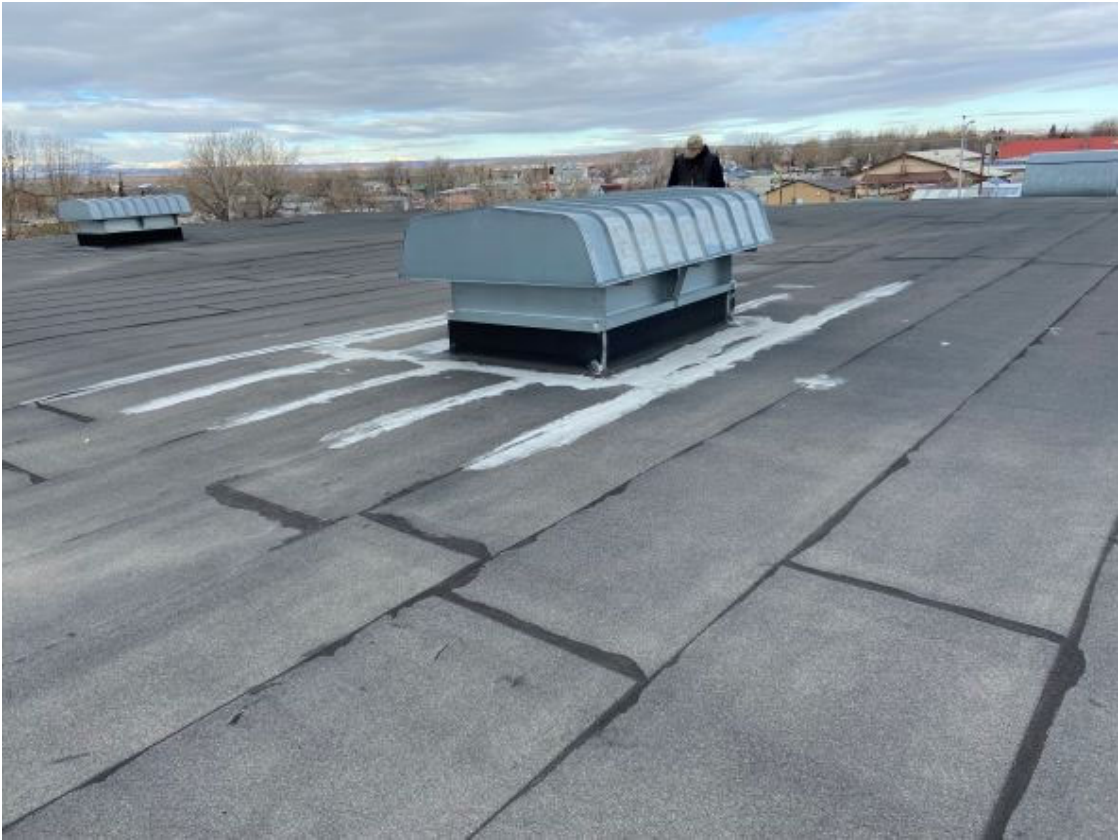
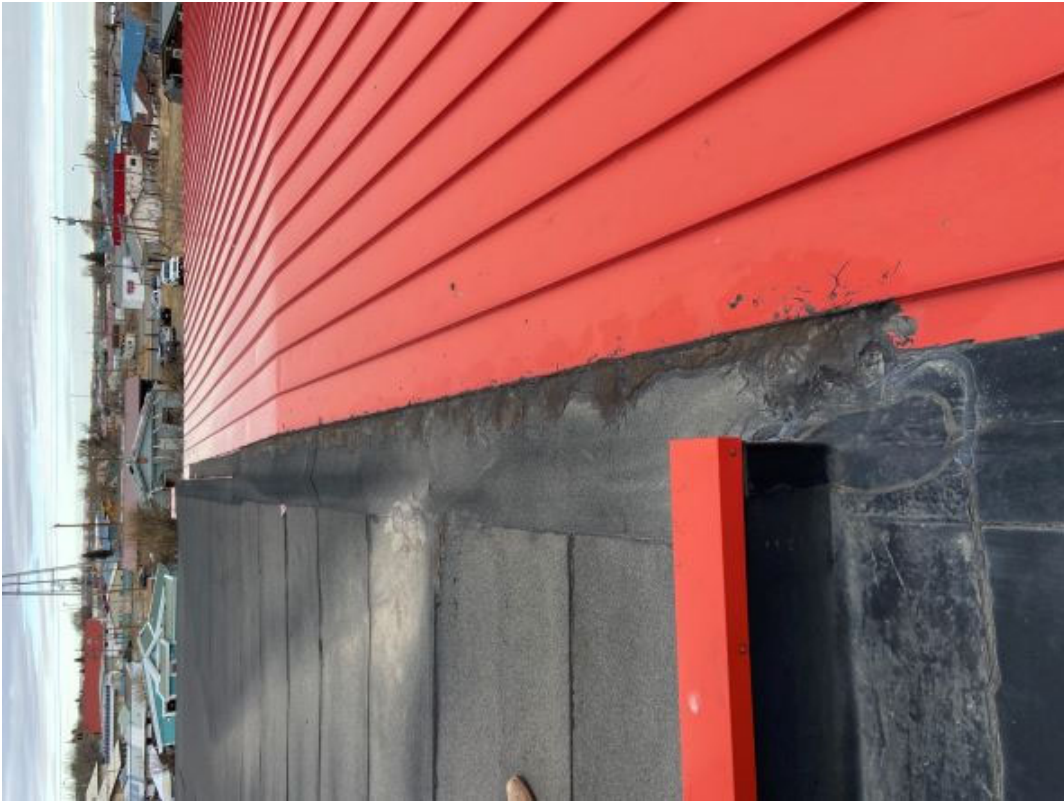
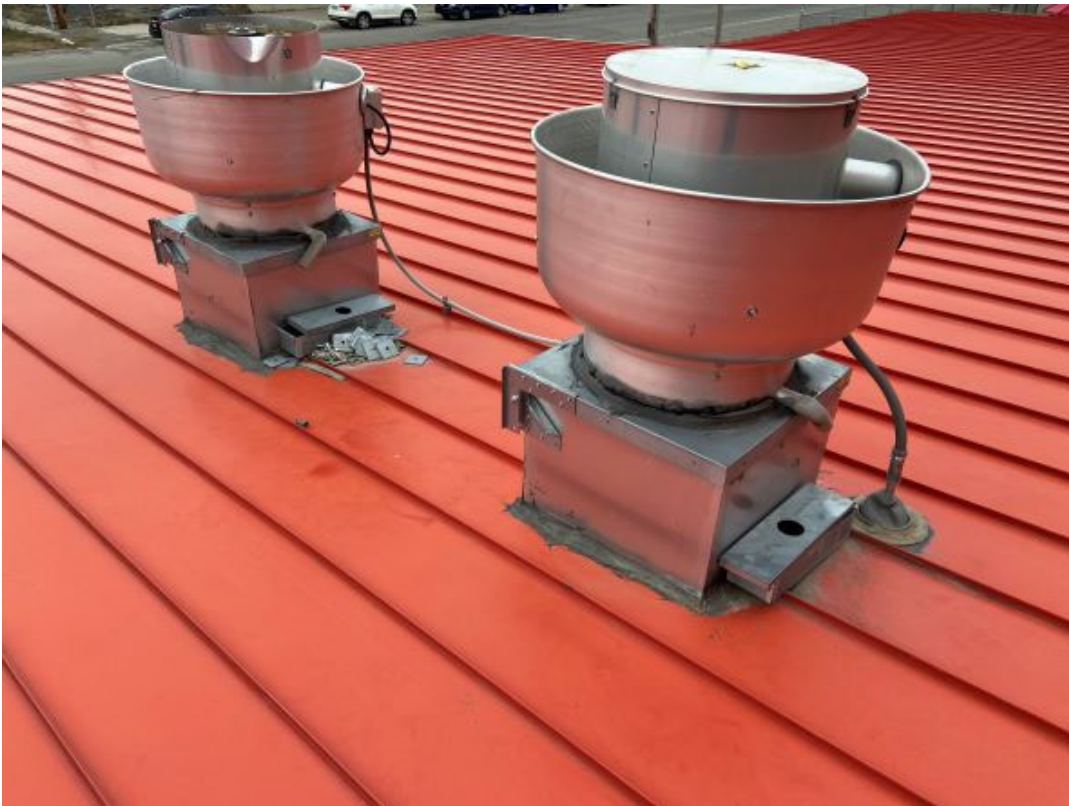
## Old Browning High School

BUR: Modified flashing loose at perimeter metal, some minor splitting of cap sheet, tie-in transition to metal roofing, penetrations with no flashing, loose/delaminated seams, loose flashings at some units.

Standing Seam: Improperly flashed or missing flashings at penetrations (units, pipes), tie-in at BUR transition.

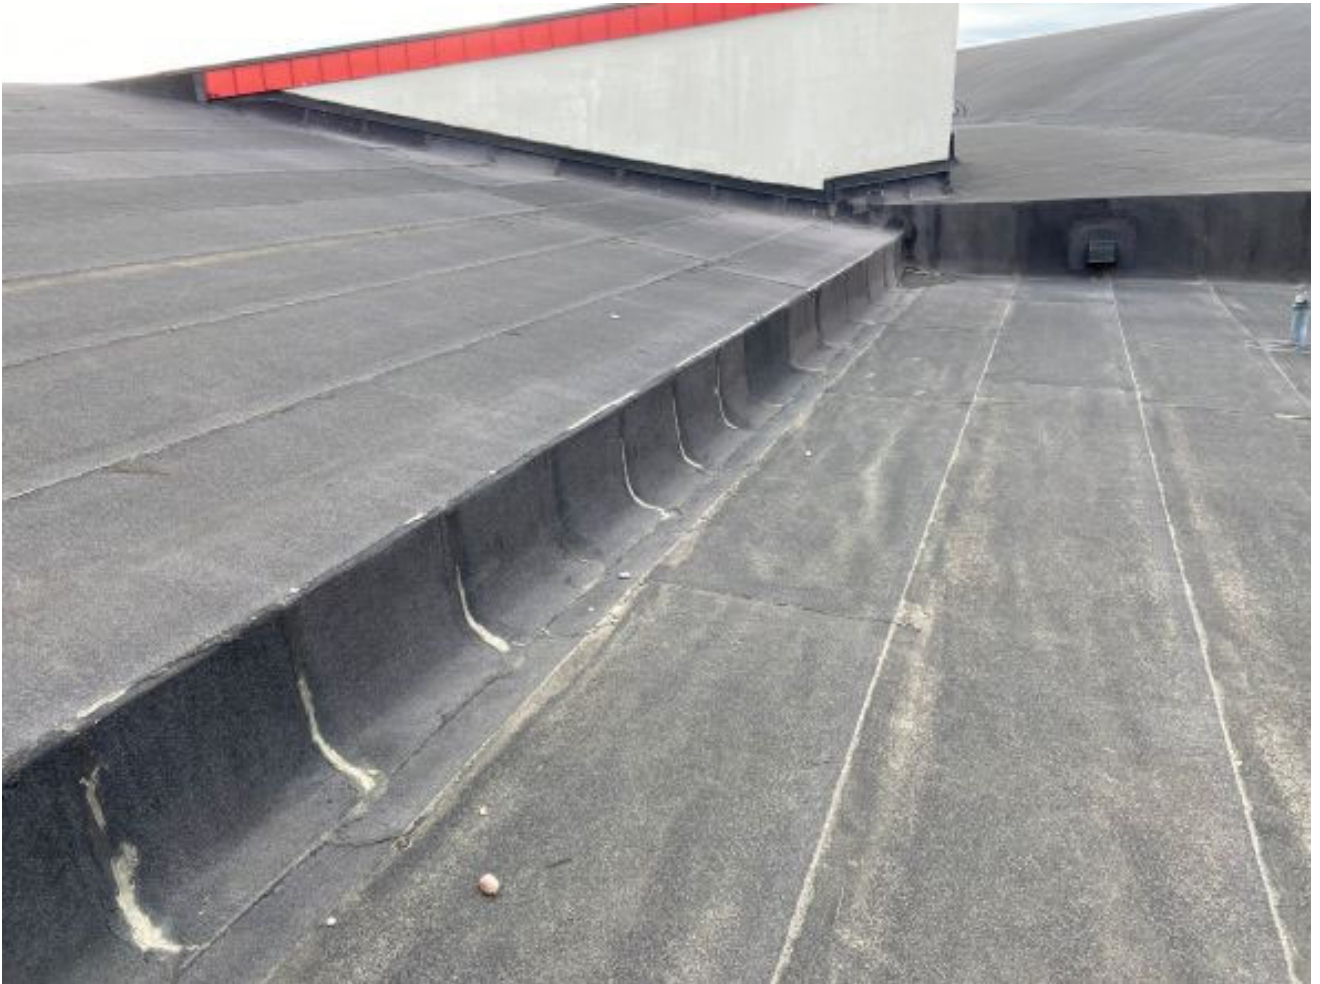
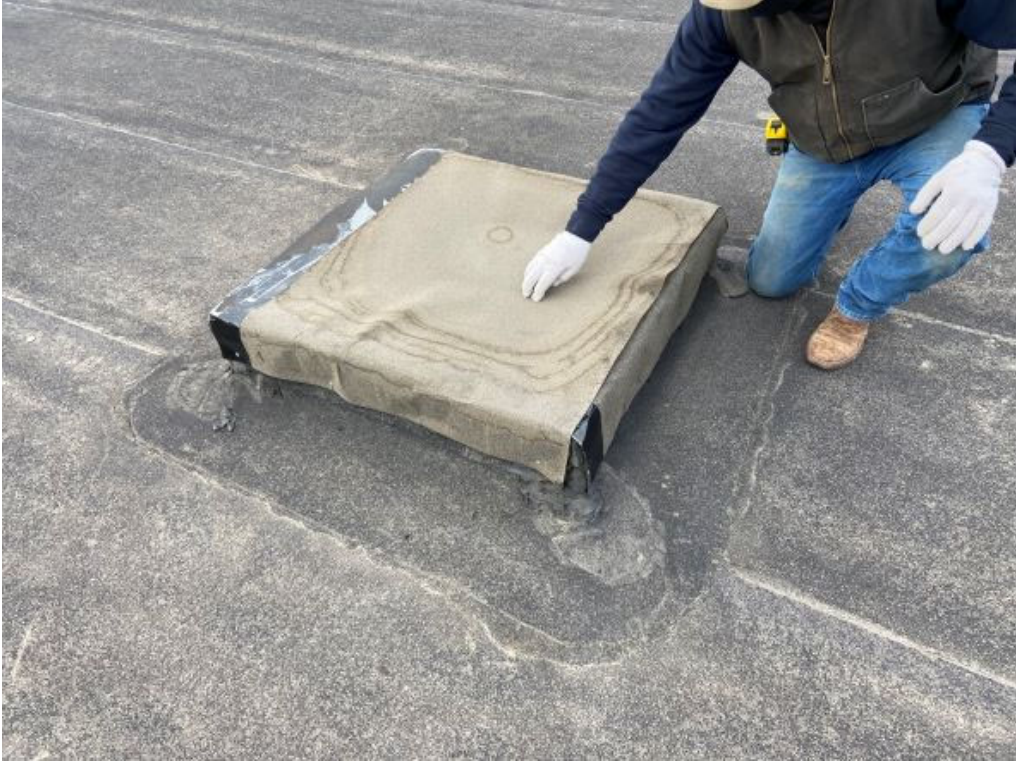
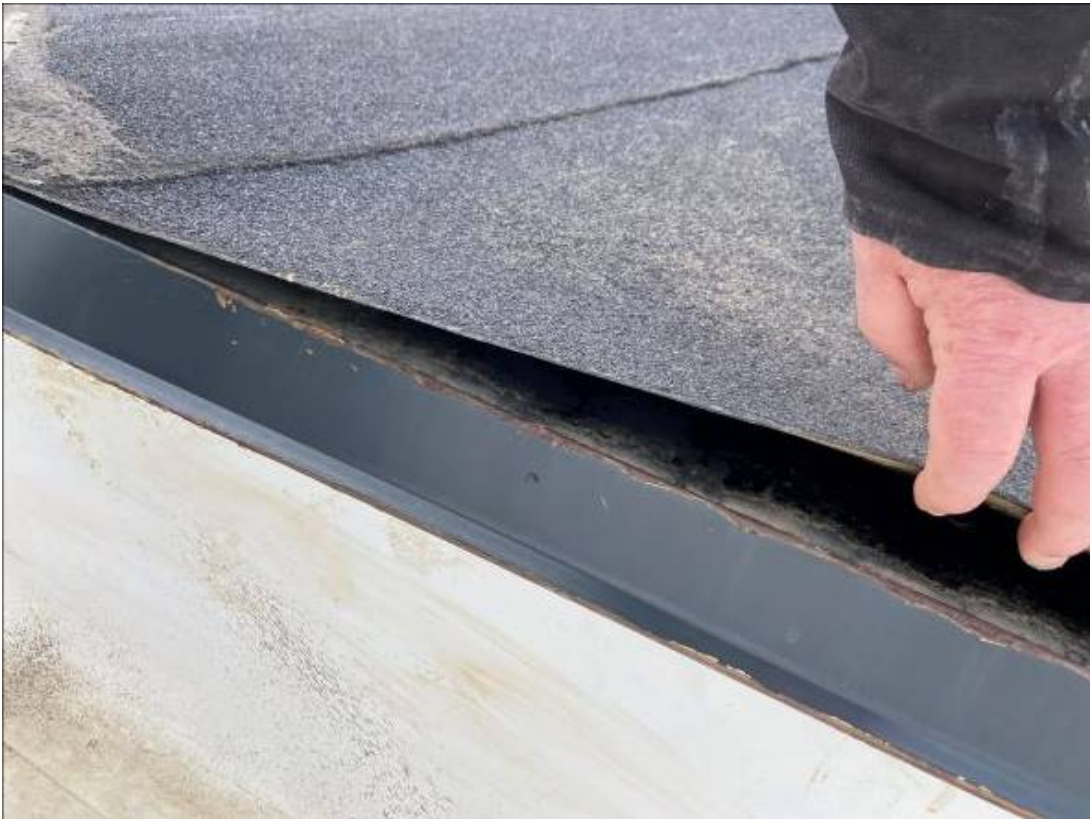
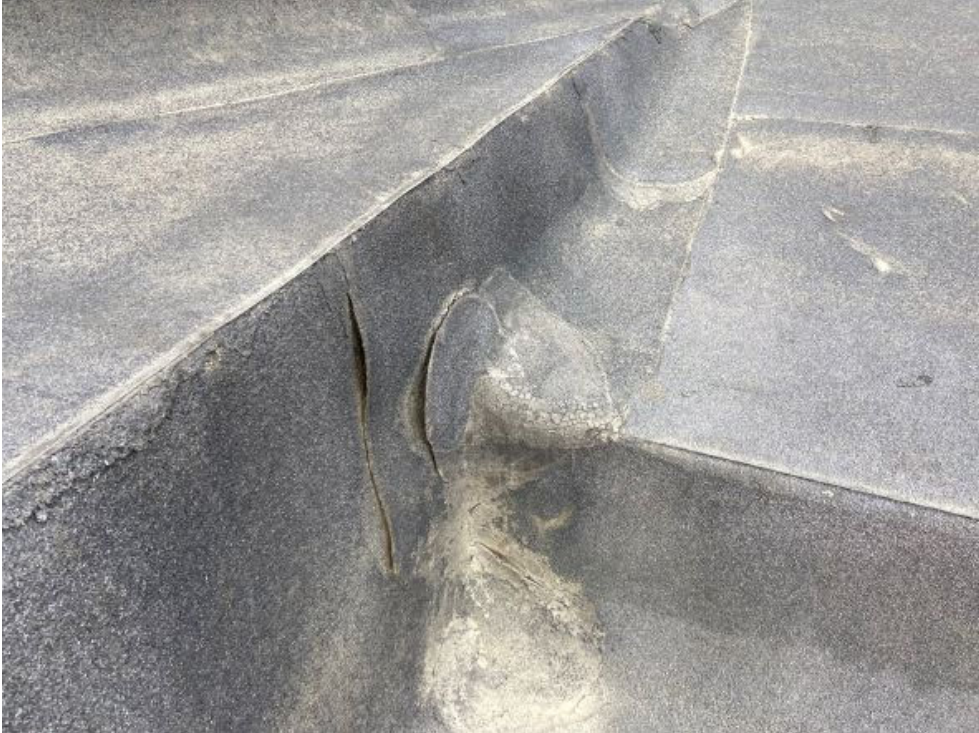
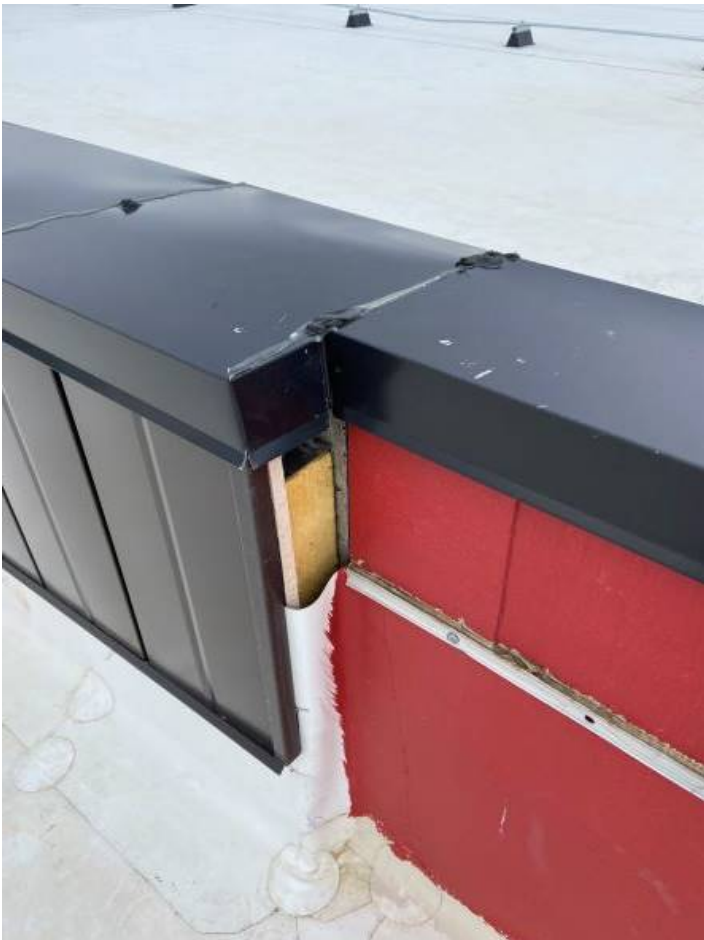
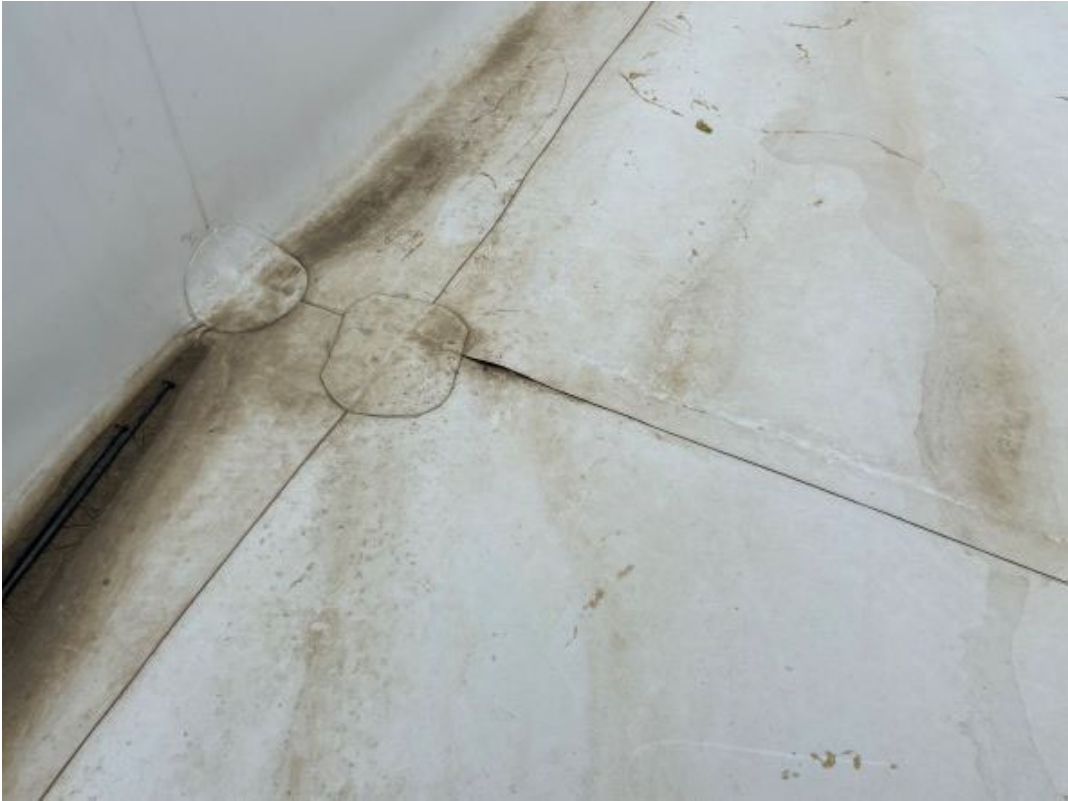
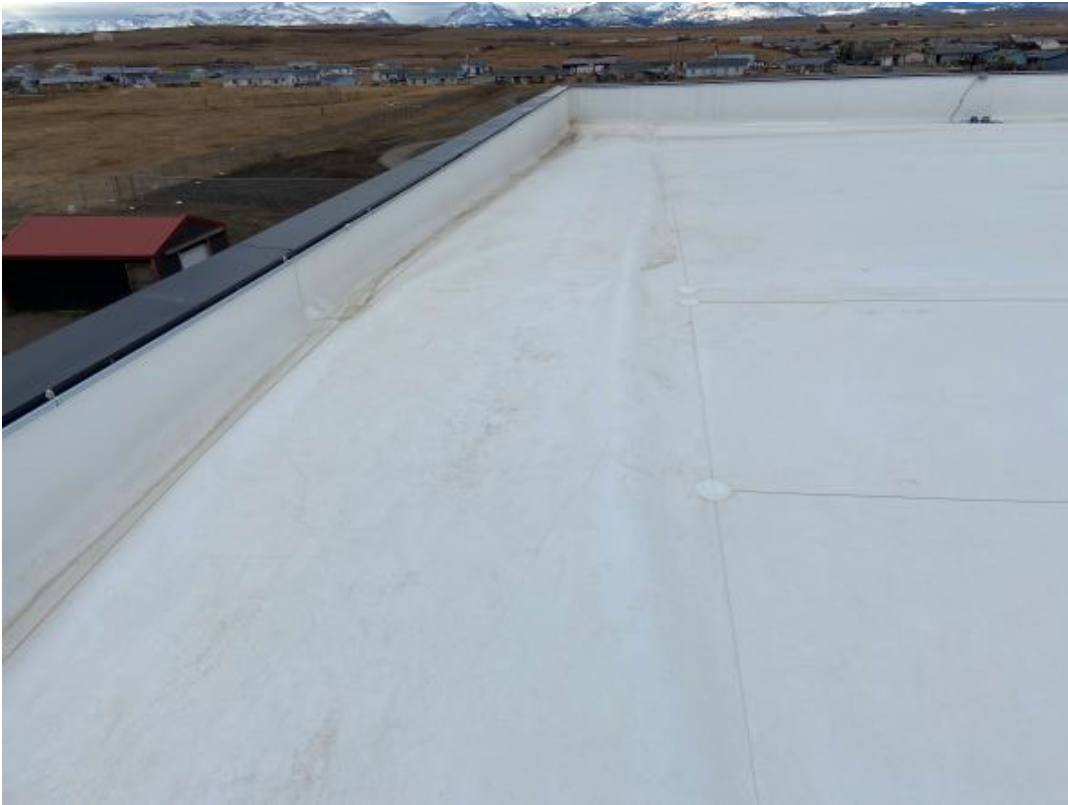
## Browning Middle School

BUR: loose flashing at corners, steep to lower slope transition seals, curbs that need to be covered, cap sheet flashing at perimeter metal needs re-sealed, some curbs need to be properly flashed, some loose seams, plugged downspouts at north entry way causing overflow of the gutter and icing problems on walkway.

TPO: very minimal seam deficiencies, a few blow patches to re-seal, some loose wall flashing at the top/gym roof.
