**MADDOX ROOFING & CONSTRUCTION, INC.**

To: Browning School District  
RE: Fall Facility Roof Inspections

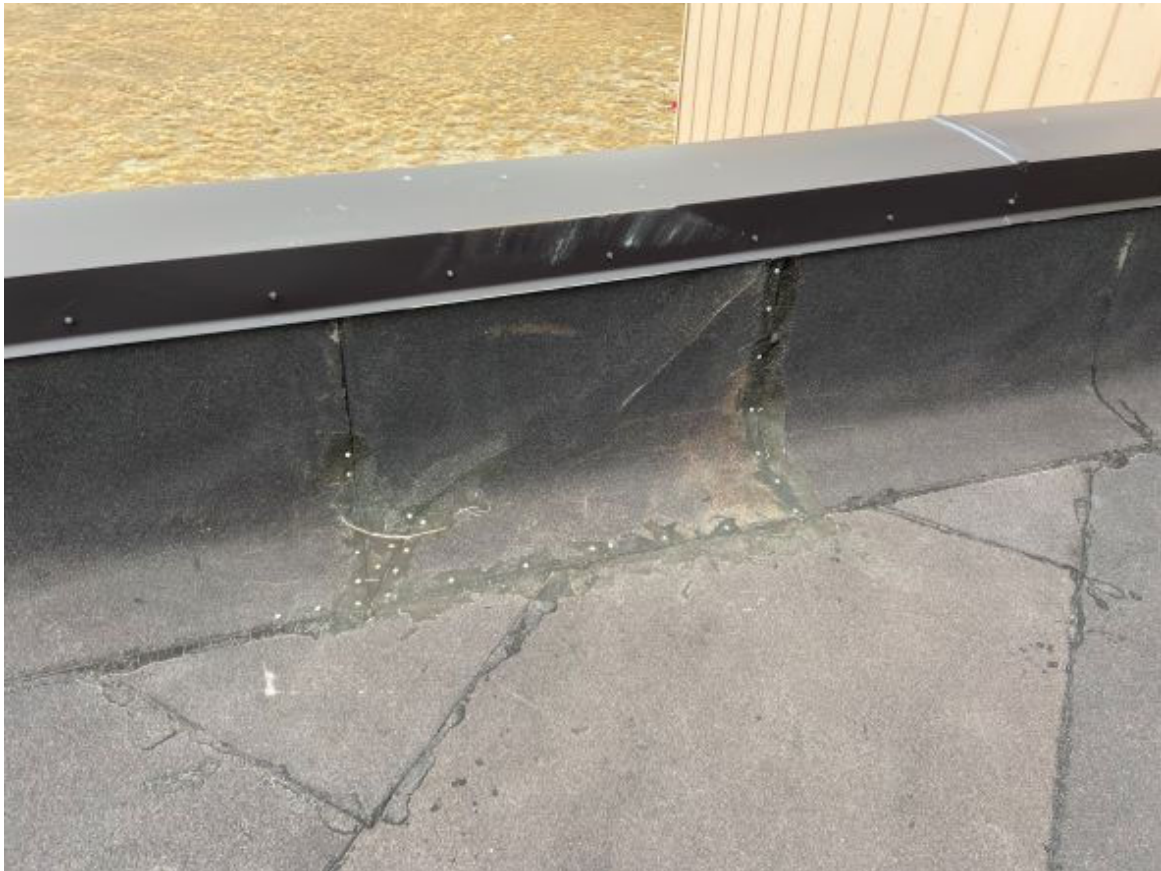
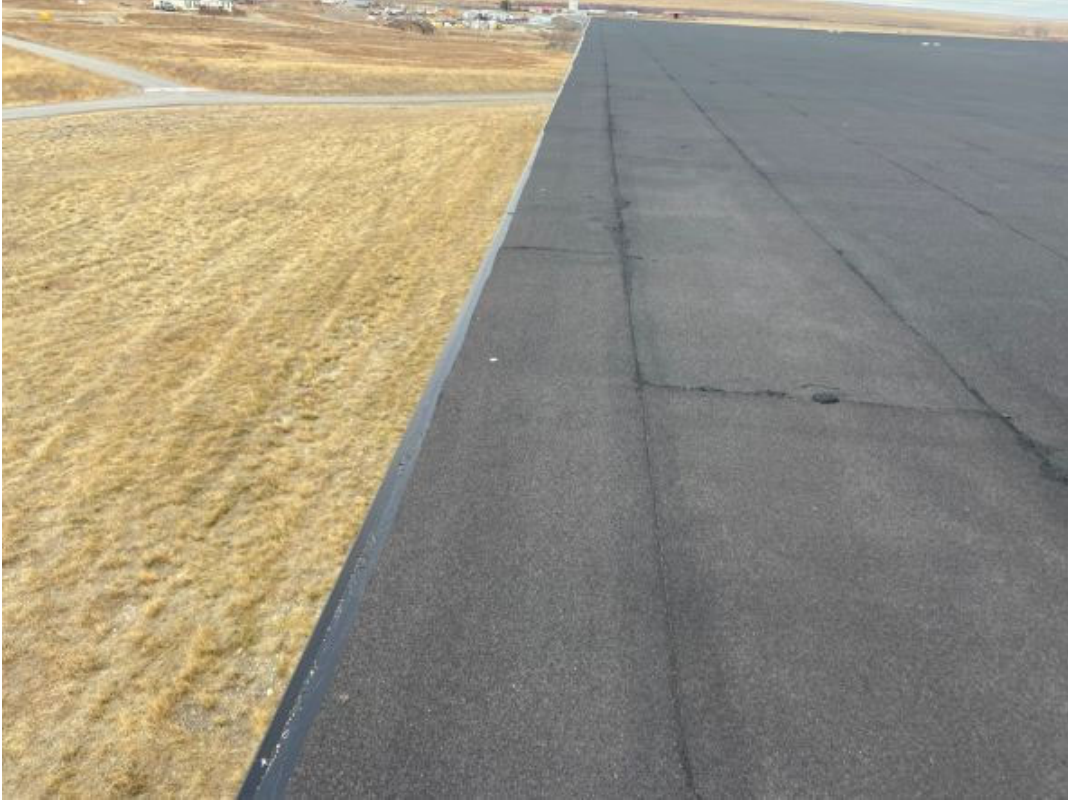
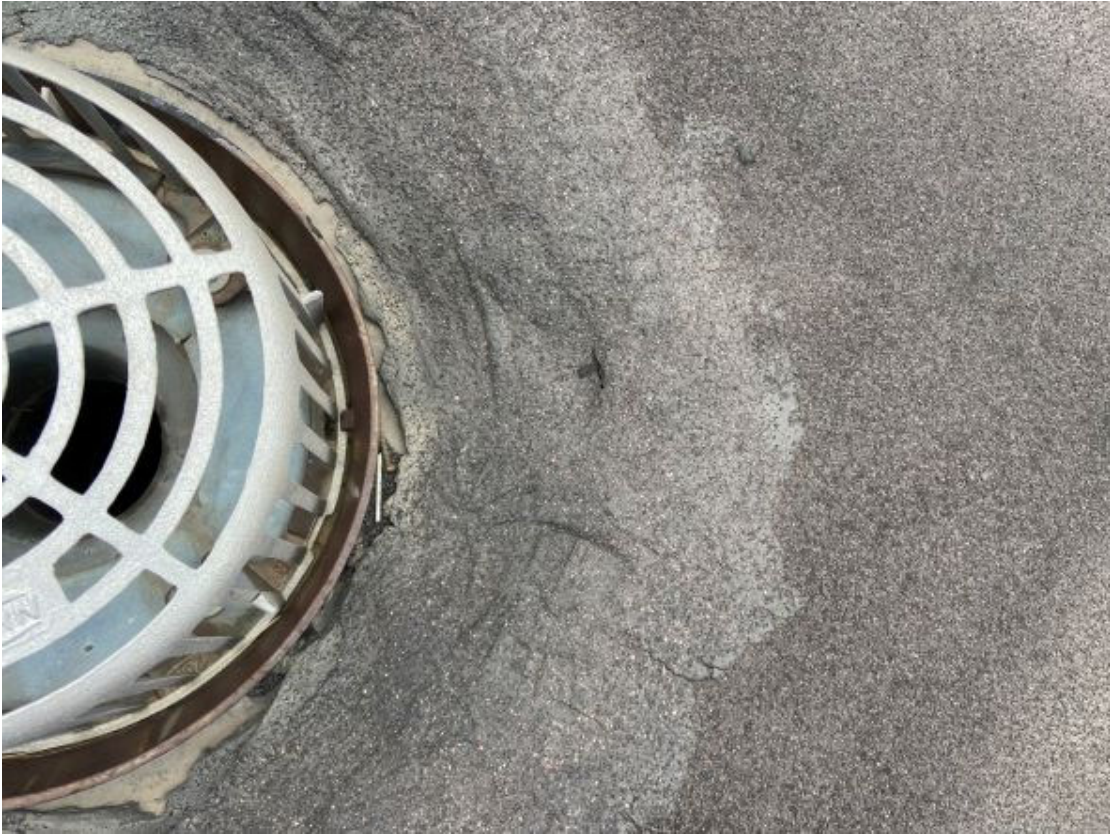
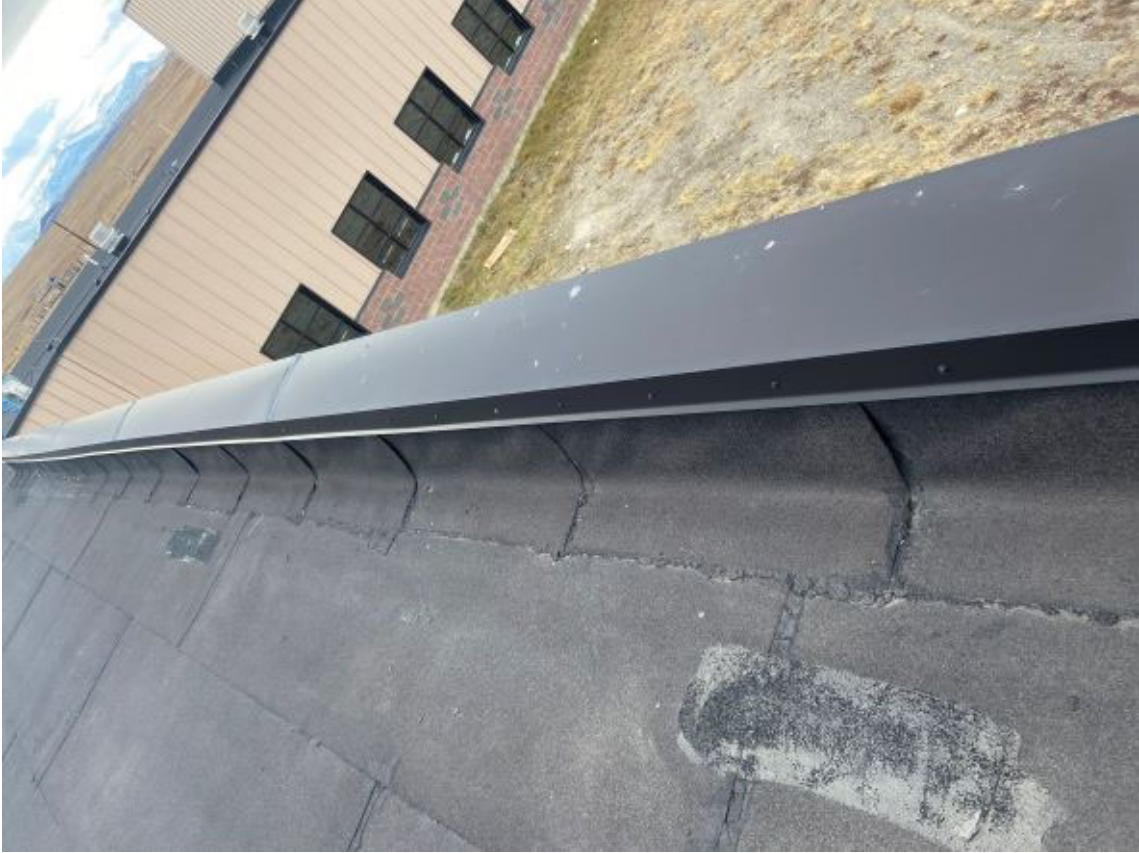
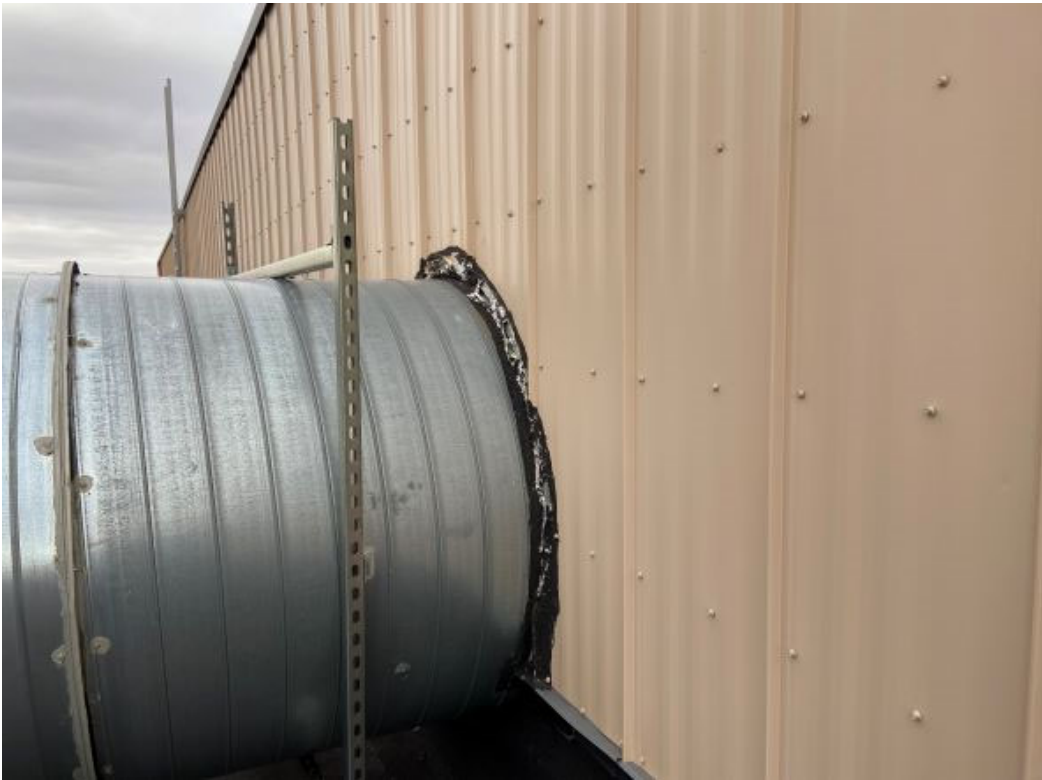
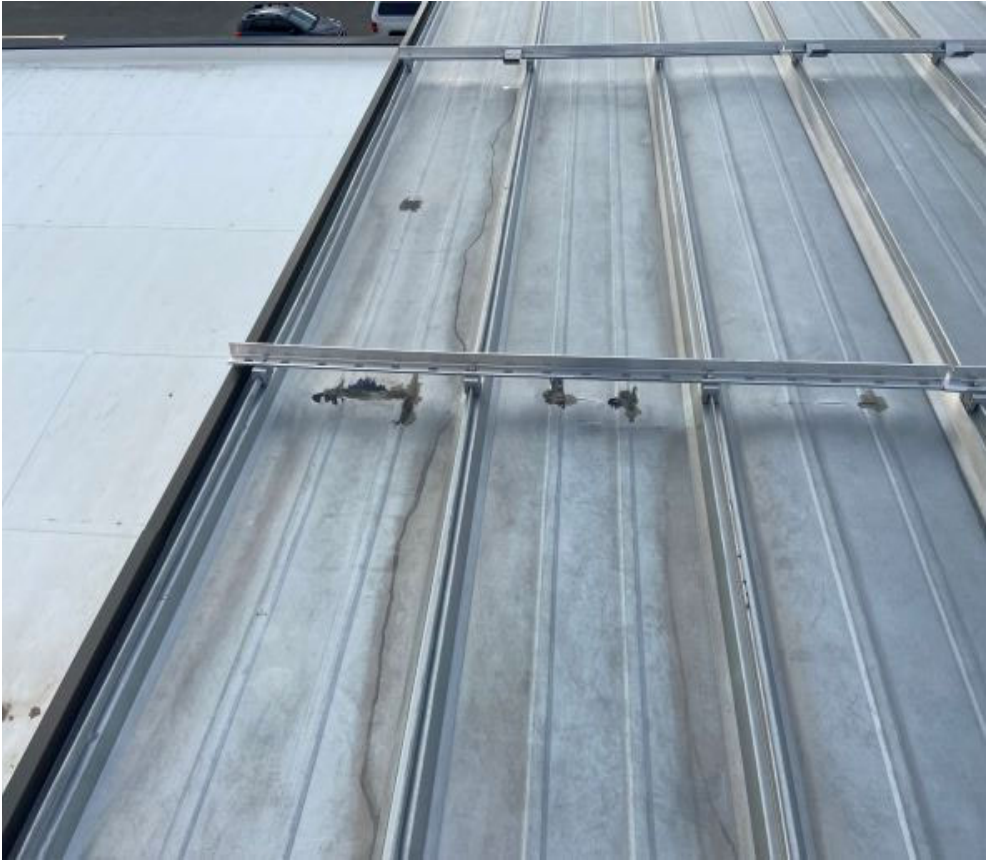
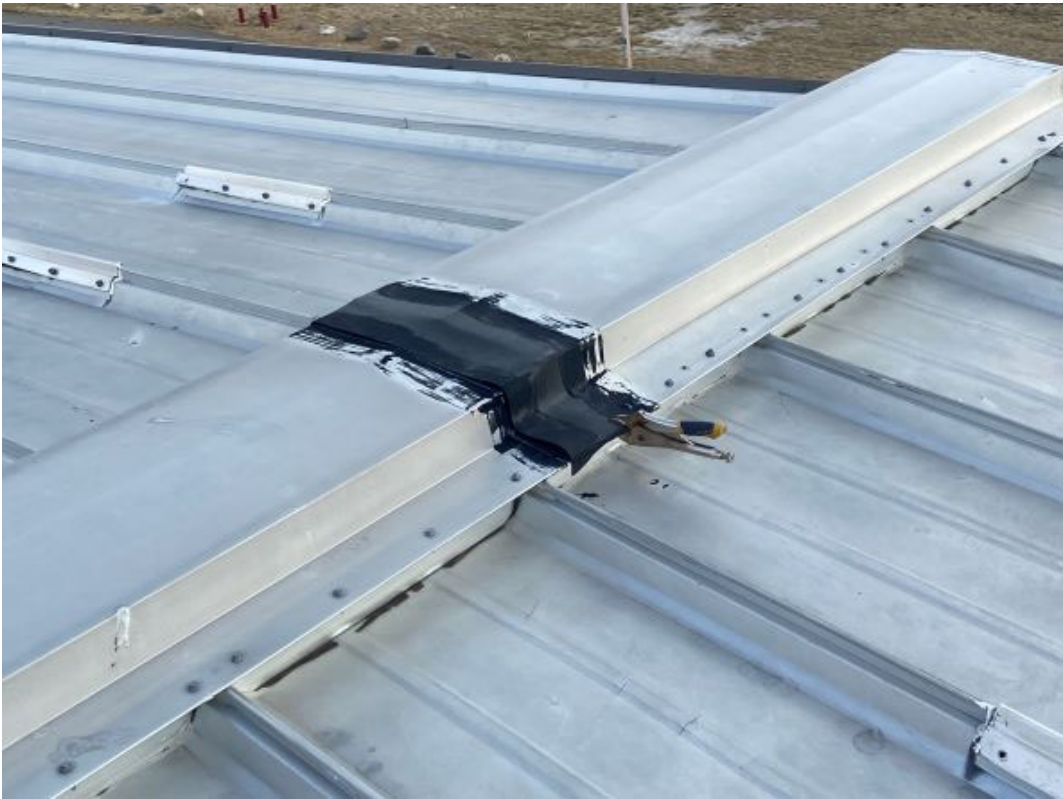
## Browning High School

BUR: loose laps at vertical joints, flashings at pipes cracked or loose, loose/missing or cracked out corners on units, pipes not flashed, holes in the drain sumps, modified flashings at perimeter metal is loose or not attached, metal flashing at perimeter needs to be re-attached/hooked to cleat

TPO: minor peeling at some t-joints

Metal Panel Assembly: some snow guards are ripped off/missing, dented metal panels due to movement from the wind, holes or breaks in the panel due to the wind, sealant at units had deteriorated and they need to be flashed with uncured membrane, loose damaged panels that need to be replaced on the south side of the gym.

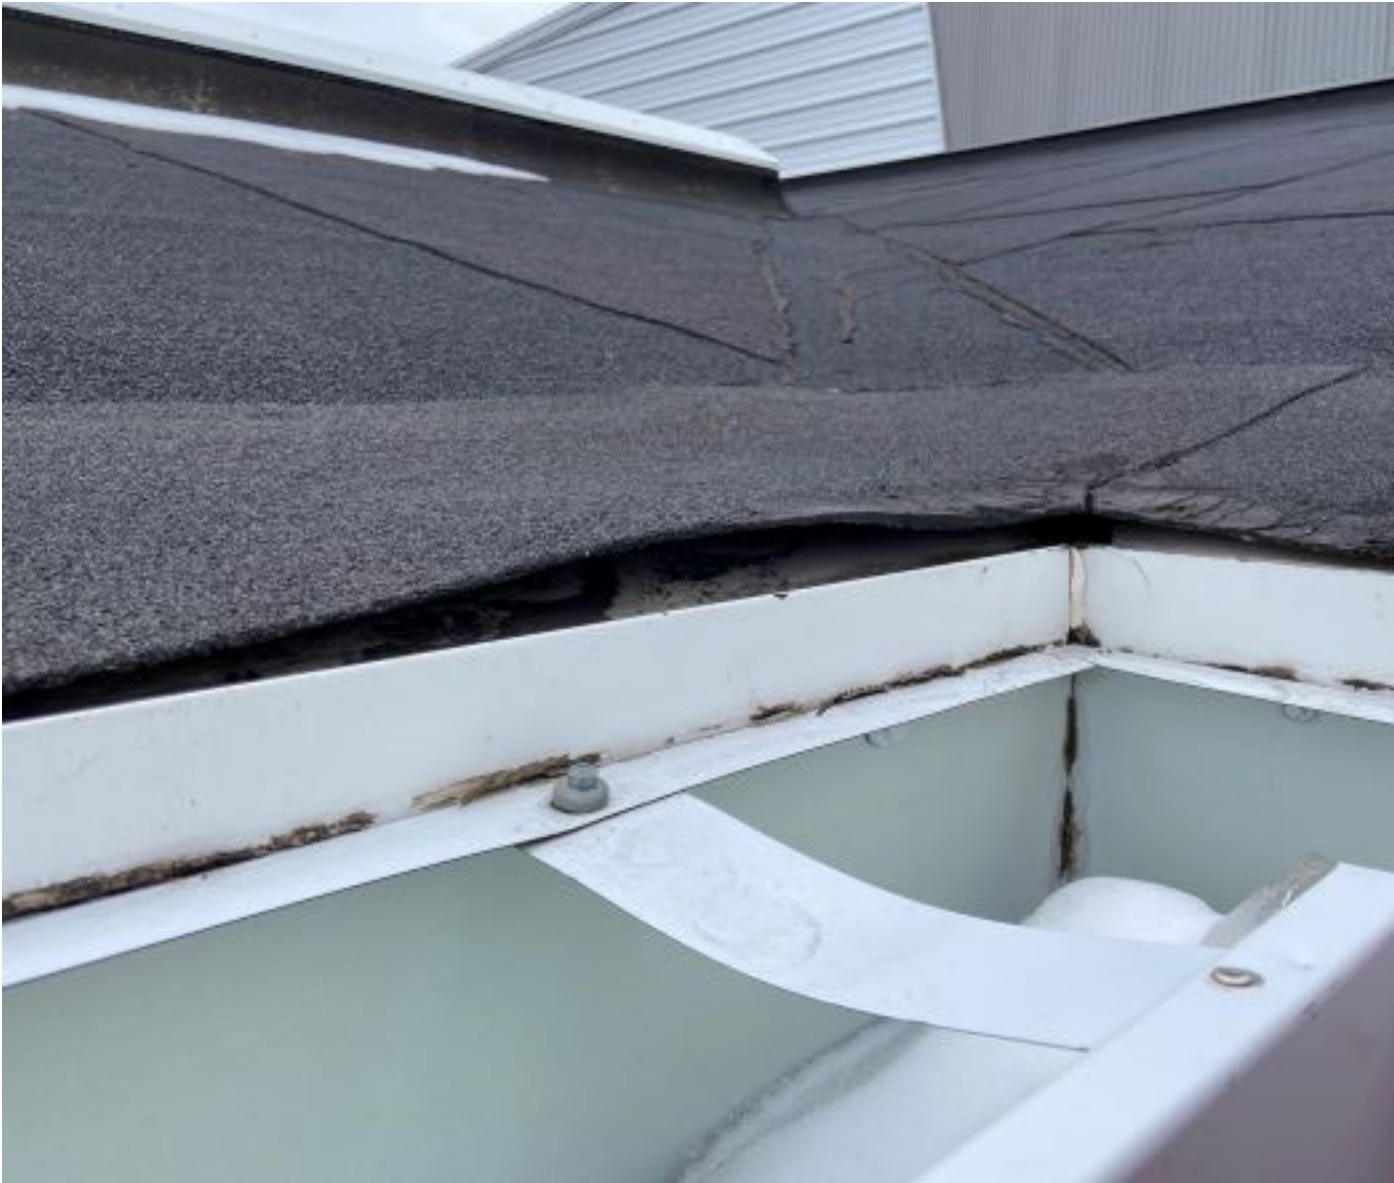
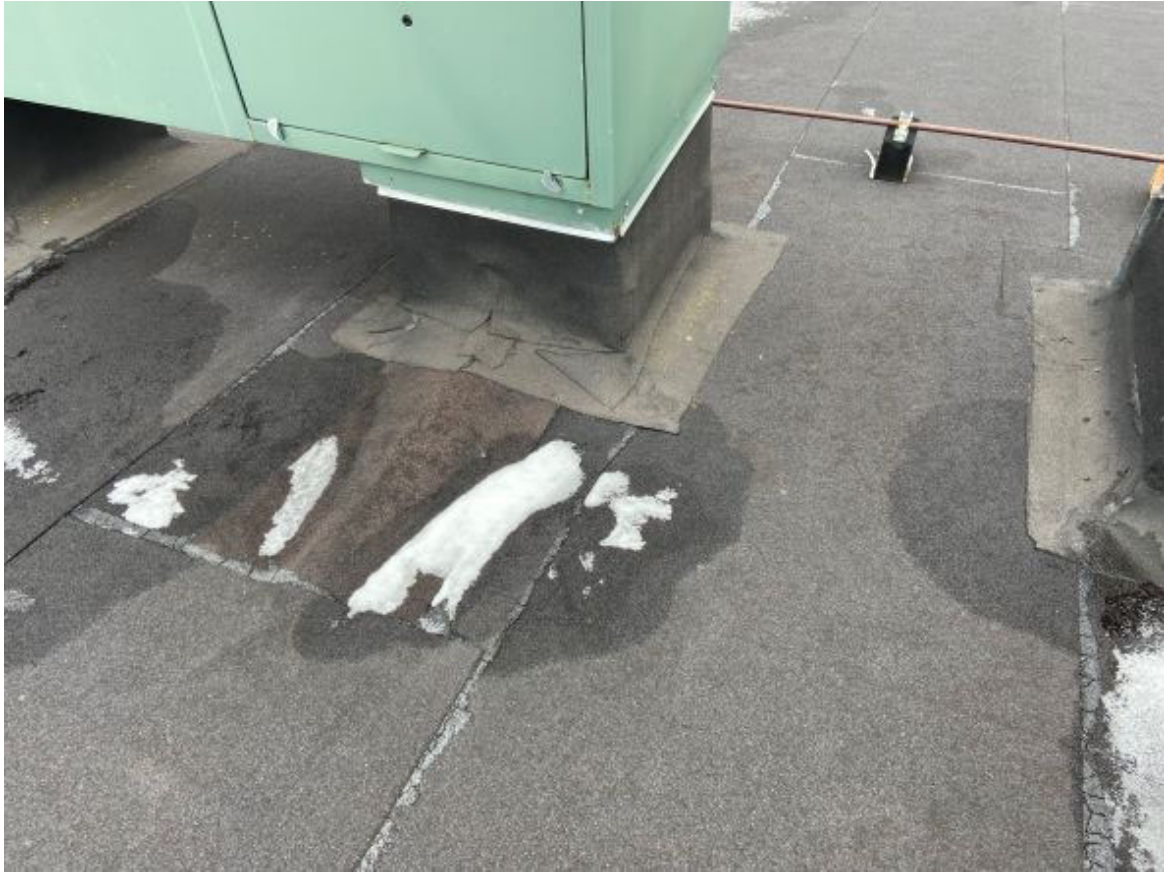
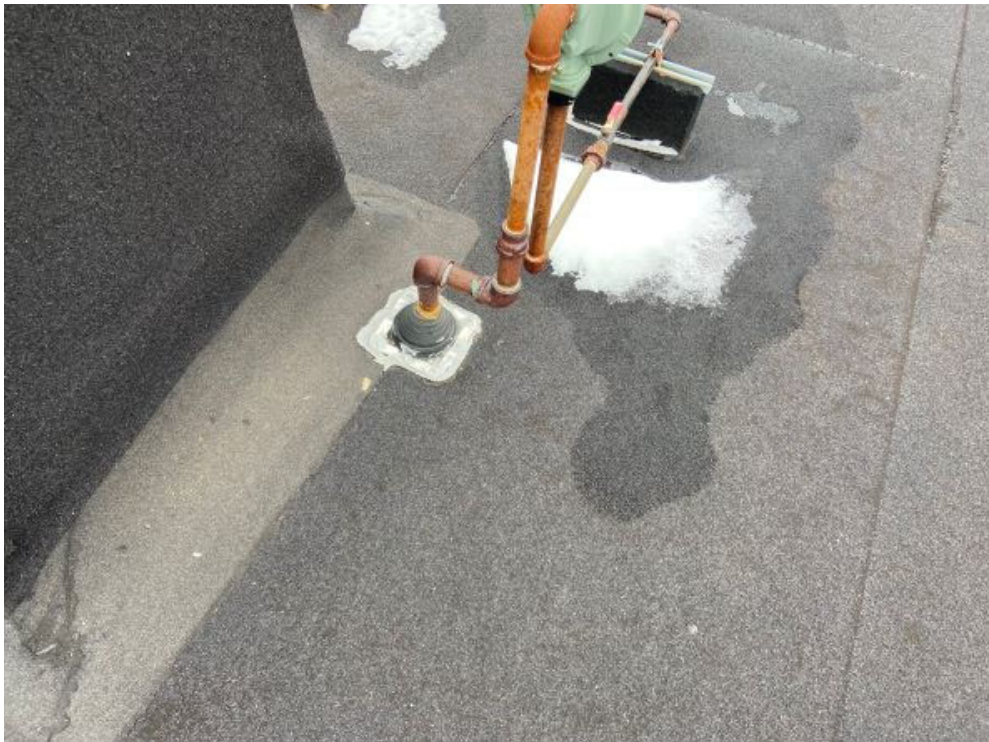
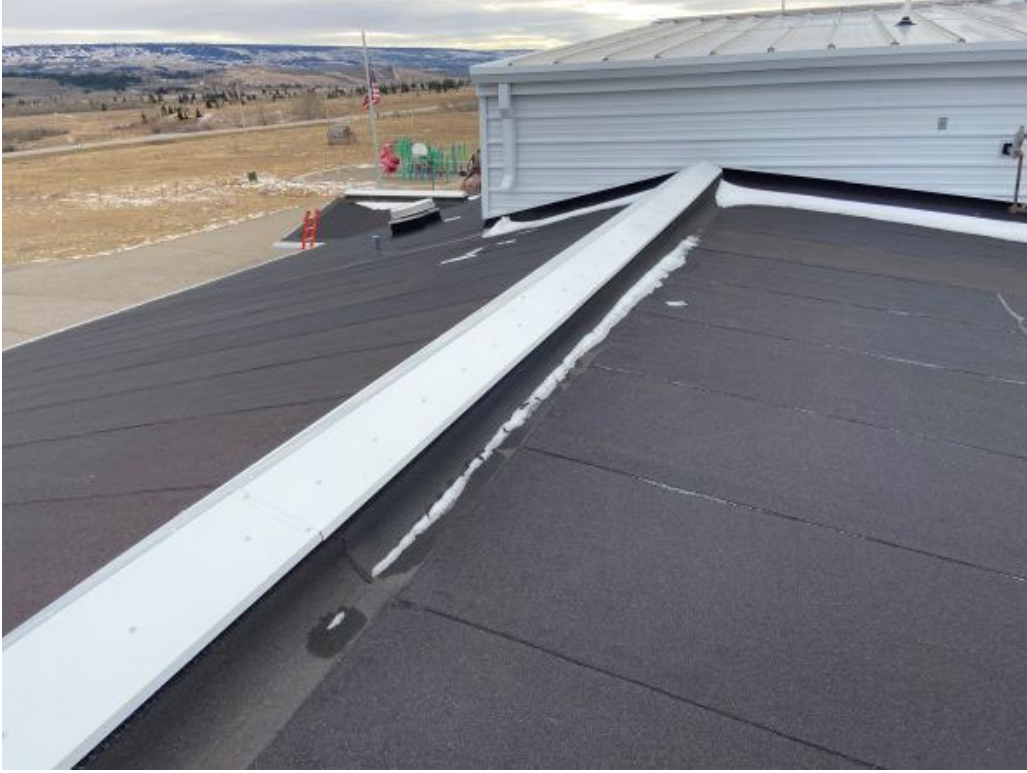
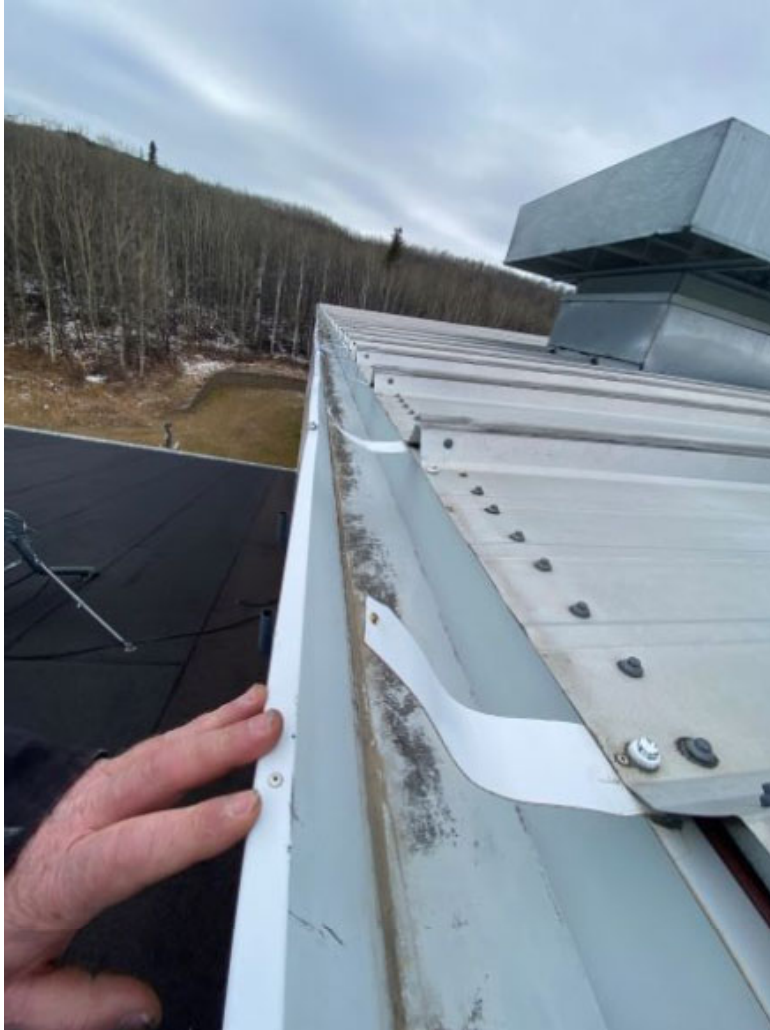
## Babb School

BUR: Modified BUR flashings are loose/peeling at the metal edging, corners are loose or missing at some units, pipe improperly flashed, snow entering thru the metal ridge cap

Metal Roof: extreme snow weight has broken the gutter straps, frozen downspouts have been blown out
