Roof Asset Management Program

Pana High School Roof Report

Prepared By
Ryan Benson

February 07, 2022

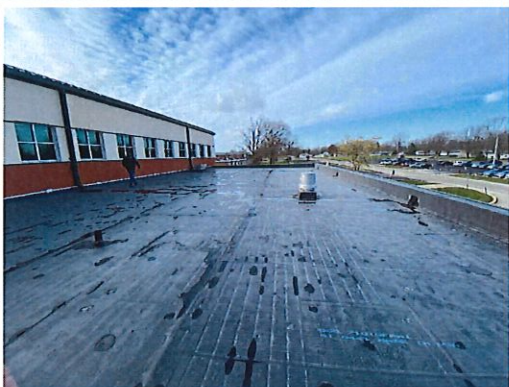
Photo 1

Overall of roof, roof is in excellent shape, appears to only be a year to two old.

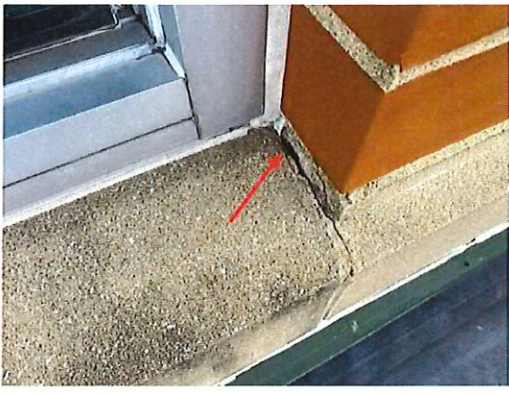
Photo 2

Grout missing in the joint and needs to be addressed.

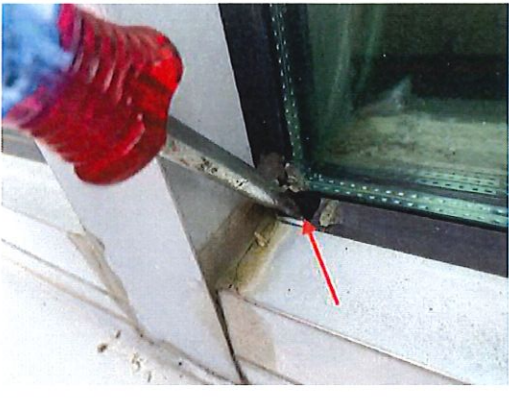
Photo 3

I would check with window specialist to ensure that this gap is to spec.

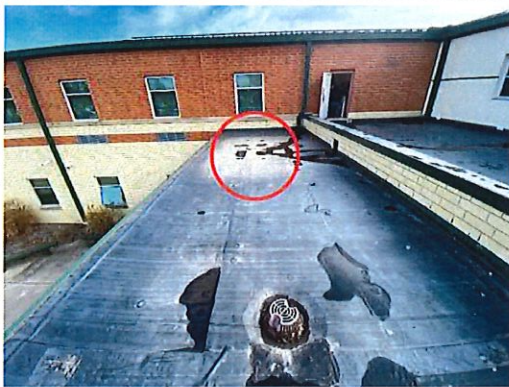
Photo 1

Red circle is showing where water was ponding on the roof. Drains were clogged with debris.

Overall roof was in good shape.

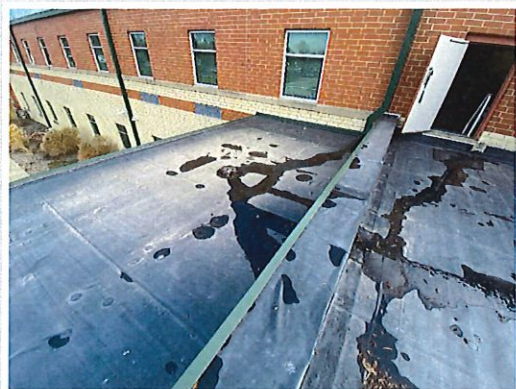
Photo 2

Alternate view of the ponding water.

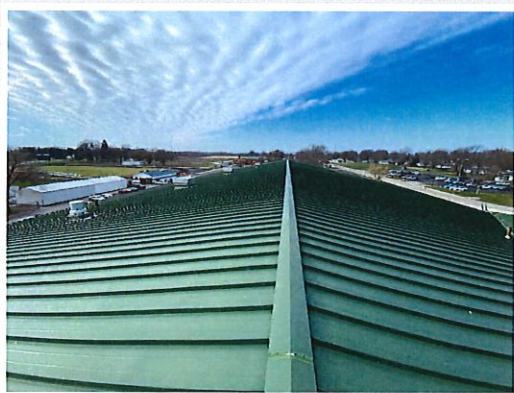
Photo 1

Overall of the roof looking to the West.

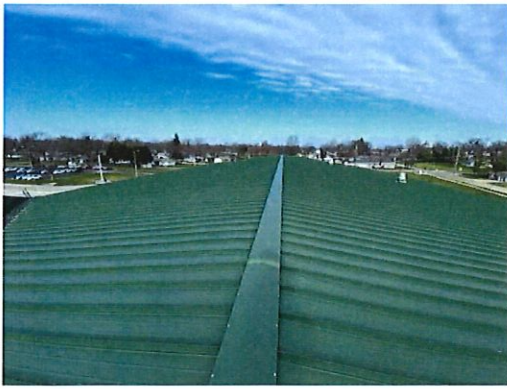
Photo 2

Overall looking to the North.

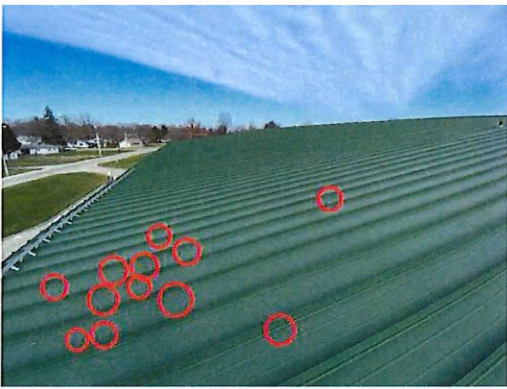
Photo 3

Overall looking North, red circles are just highlighting some of the rust areas on the roof.

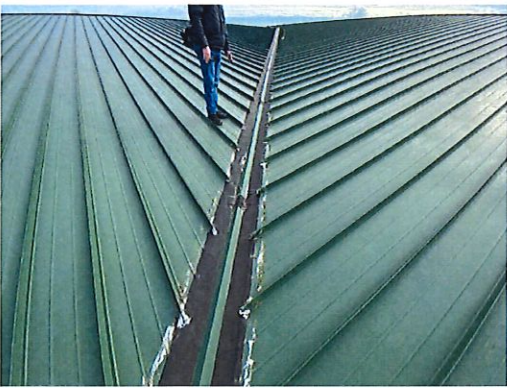
Photo 4

Overall	
Rating	Poor
Condition	<p>Based on visual inspection the roof was in poor shape. There has been an ongoing leak located in the valley. This was due to the EPDM (black membrane) being installed in the valley. Once the EPDM started to peel it allow water to be trapped and start rusting the panels.</p> <p>Deficiencies Found:</p> <ul style="list-style-type: none"> • Rusting Panels (Numerous areas through out the roof). • Failed Valley repair. • Deteriorated Pipe Boots. • Deteriorated repairs around penetrations causing water intrusion. <p>Roof is recommend for a fluid applied restoration that will come with a 10 yr warranty and can be extended 10-20 years. This will be the most cost effective solution for the district as the roof is currently a candidate for the application. If left untreated then the issues on the roof will continue to get worse and cost the district more money to fix and fight leaks.</p>

Valley Area has been a leak location for sometime.

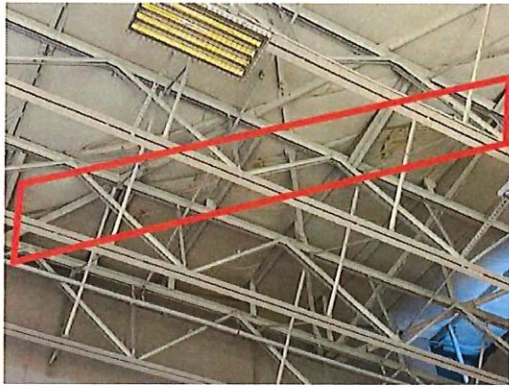
Photo 6

The area with the red rectangle is where the valley is located on the roof above. The batten insulation has water staining all over which corresponded to the damage found on the exterior of the roof during the leak investigation.

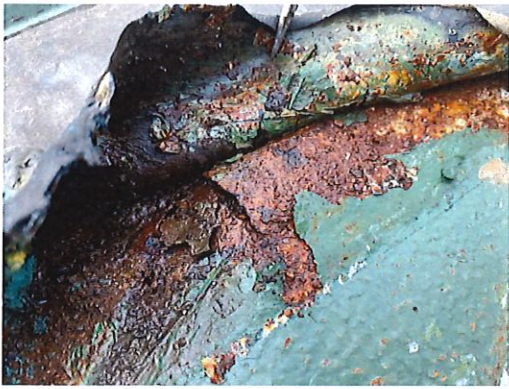
Photo 9

Upon inspection, the EPDM was removed and water has been getting trapped under the patch area.

This has resulted in the panel starting to rust. A repair was made with a fluid applied roof system.

The EPDM was removed
All rust was wire brushed
The entire area was primed
Base and Top Coat were applied to the valley area.

No active leaks have been reported since the repair was made in April of 2021 , and this area has seen a tremendous amount of rain fall in the 2021 summer and fall.

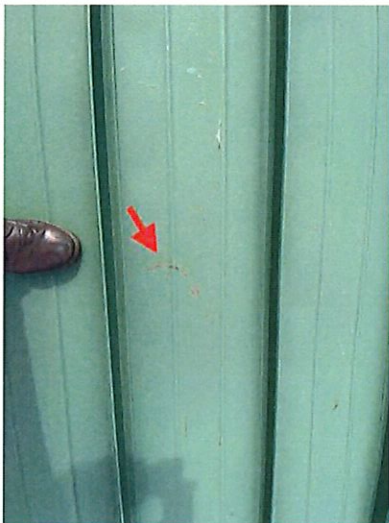
Photo 11

The roof panels throughout the roof are starting to have surface rust form. The Kynar finish on the panels is fading away and the bare metal is becoming exposed. This is leading to surface rust forming across the entire roof.

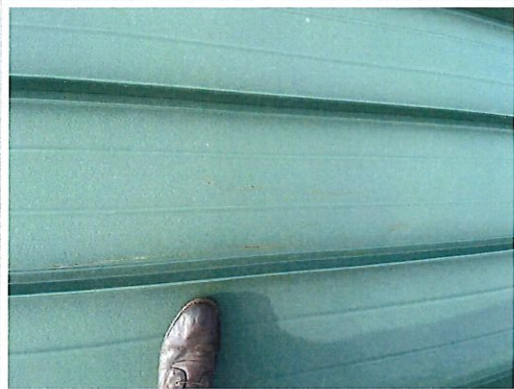
Photo 12

Rust on Panel.

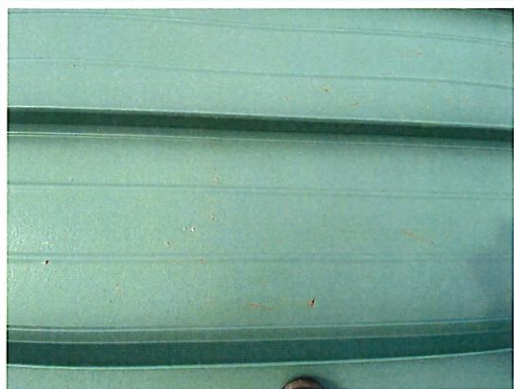
Photo 13

Rust on Panel.

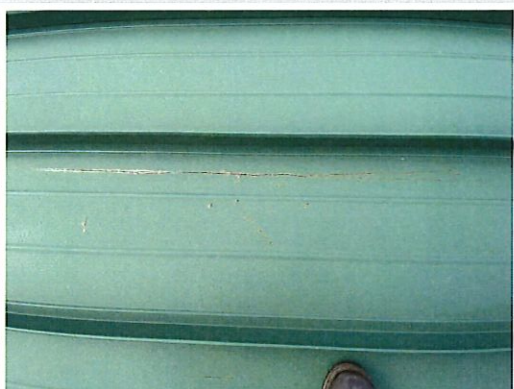
Photo 14

Rust on Panel.

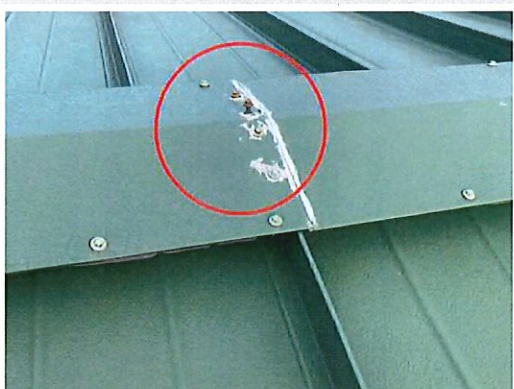
Photo 15

Fasteners are backing out of the ridge cap detail, pm needed.

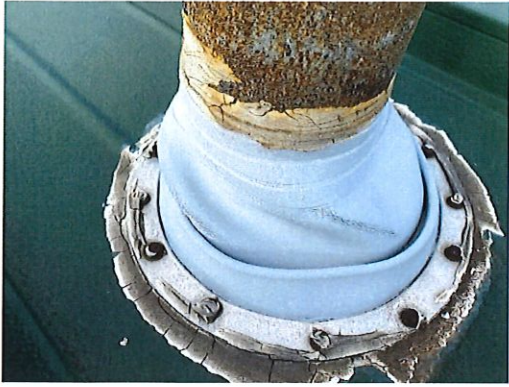
Photo 16

Pipe boots are starting to dry rot and need pm.

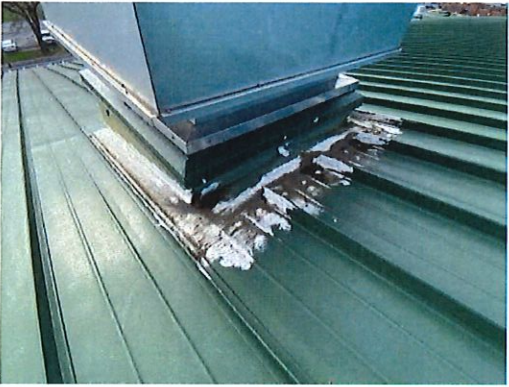
Photo 17

Previous repair made to penetrations that had leaked on and off.

Areas were maintained in April of 2021 with the same solution as the valley.
