LAKE BLUFF SCHOOL DISTRICT 65

RE: Facility Assessment

Lake Bluff School District 65

Updated Facility Assessment Report

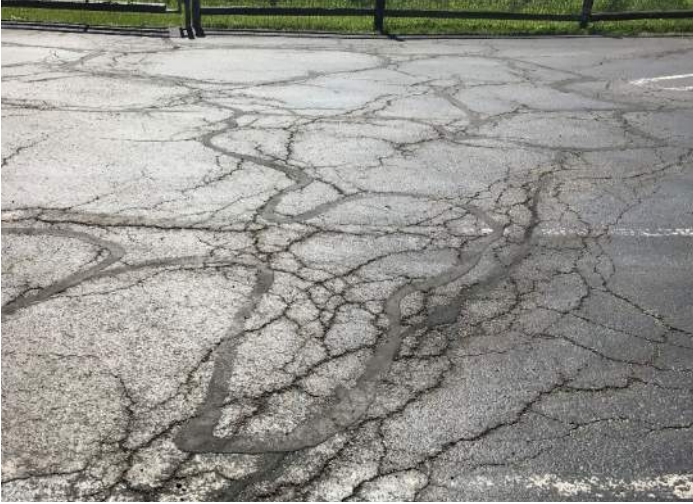
PARKING LOTS

Both the Main parking lot and drive and the Northeast parking lot and bus lane are in fair to poor condition. There is significant cracking throughout the asphalt pavement as well as rutting at parking spaces. The asphalt may continue to be maintained with annual crack repair and sealcoating to extend its life, but it is recommended to budget for full depth replacement of the pavement in three to five years.

Replacement of these asphalt lots is recommended in about four to six years. In the meantime, we recommend that the District continue with yearly crack sealing and sealcoating and restriping every two to three years as needed.

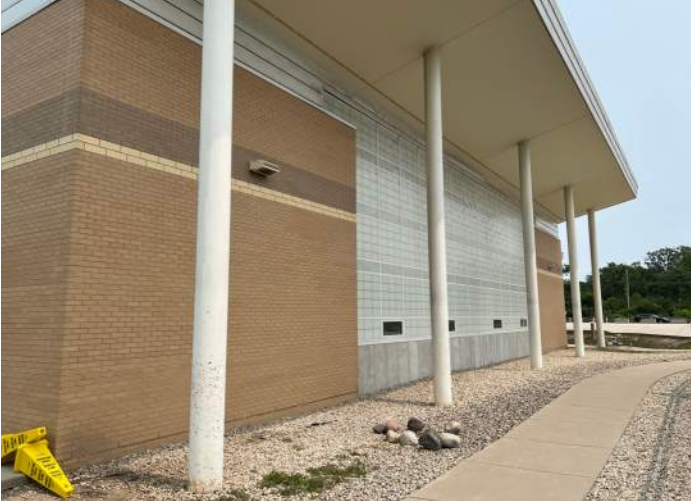
EXTERIOR WALLS

The brick facade on the building is in good condition and no work is recommended.

The building also includes metal siding at various locations, which is generally in good condition with the exception of the bottom portions metal siding that are adjacent to walking surfaces and especially entrances. At these locations there is corrosion resulting from the salt usage required. The most significant area of corrosion observed was at the north door to the playground area. Any replacement of these areas will likely require replacement of the siding up to the window sill, where there is a transitional condition, and it is recommended that any such replacement include a more salt-tolerant material at the base of the wall.

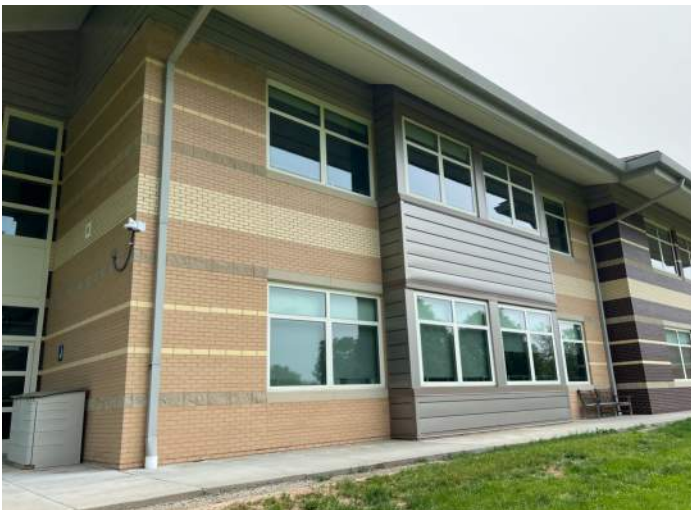
CANOPIES, ENTRANCES, AND EXIT DOORS

The exterior aluminum canopies, entrance systems, and exit doors all appear to be in good condition and require only ongoing maintenance and annual cleaning.

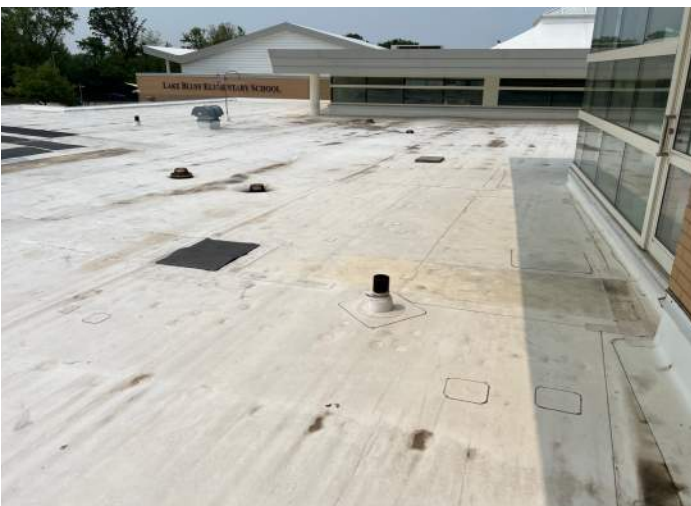
ROOF

The existing flat roofs have the original white single-ply roofs installed in 2009. The roofing membranes are still under the manufacturer's original 20-year warranty, appear to be in good condition, and no work is anticipated within the next 5 years. It is recommended that these roofs be reevaluated in 3-5 years to determine a replacement schedule for the roofs.

The remainder of the roofs are asphalt shingles, also part of the original building construction completed in 2009. Visual assessment of these roofs was limited, as only areas that could be seen from nearby flat roofs were viewed. The shingles appear to be in good condition and should be expected to last another ten to fifteen years.

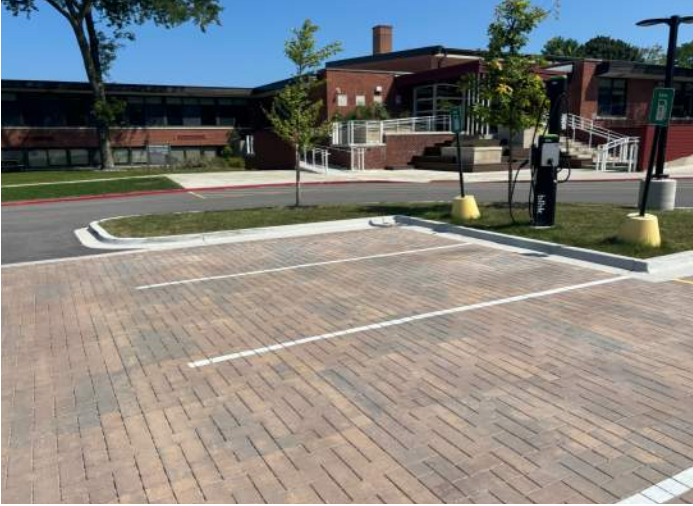
PARKING LOTS

The west parking lot was replaced in 2023 and is in very good condition. It is made up of a permeable paver parking area with an asphalt pavement perimeter drive aisle.

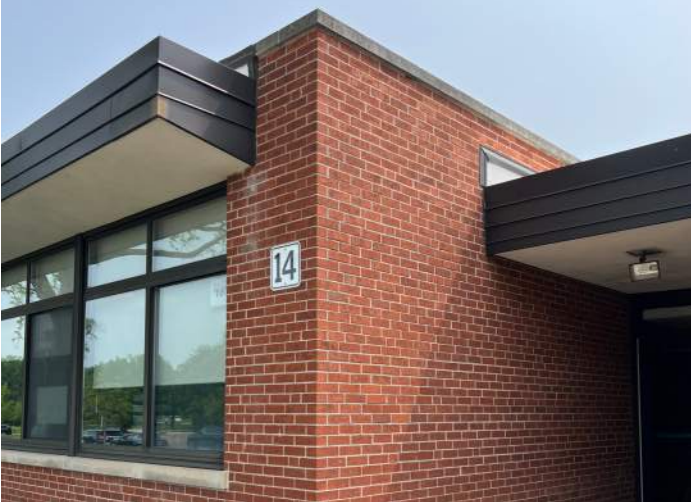
EXTERIOR WALLS

The brick facades at the 1954 original building and 1959 south classroom wing addition are generally in good condition with a few exceptions. The portions of the walls located immediately below the stone copings have deteriorated and it is recommended that the brick in these areas be tuckpointed, and that the head joints in the stone copings receive new sealant. There are several areas where a roof overhang condition transitions to a stone coping condition, and there is minor damage (e.g. cracking and/or spalling) at these transitions where repair is recommended. Additionally, the north wall of the library (located above a lower roof level) has deteriorated more than the other elevations and more extensive tuckpointing is recommended at this particular elevation.

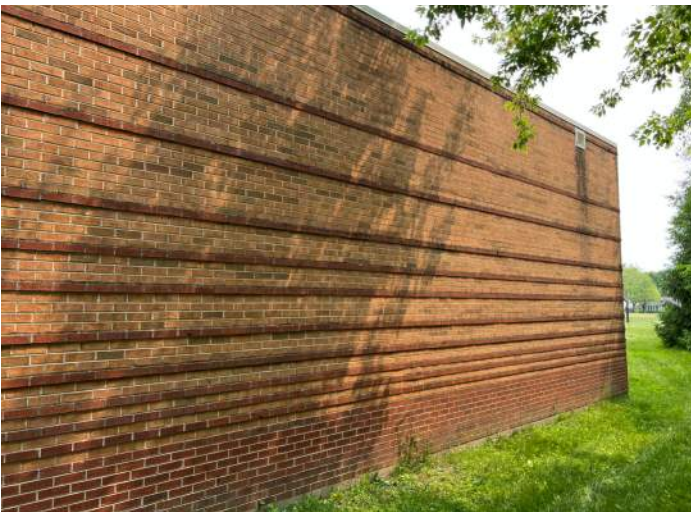
The brick facade at the 1986 gymnasium addition is generally in good condition with the exception of the north wall of the gymnasium (located above a lower roof level). This wall has deteriorated more than the other elevations and more extensive tuckpointing is recommended at this particular elevation. Additionally, the parapet wall at the gymnasium roof has significant deterioration on the roof side of the parapet and tuckpointing is required at several locations, with general tuckpointing recommended for all sides.

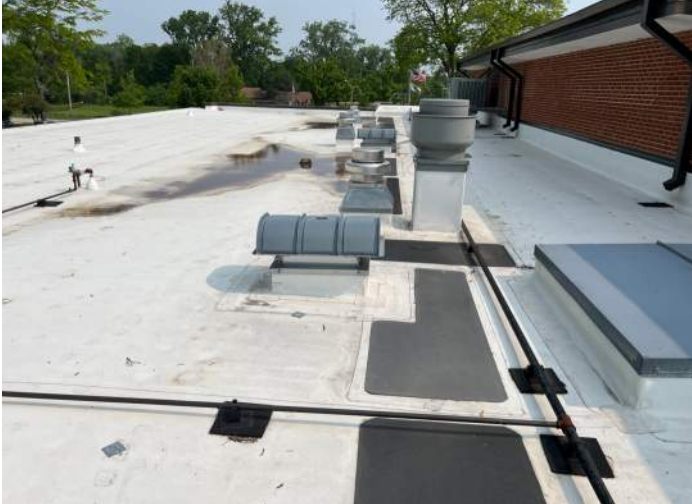
ROOFS

The 1986 gymnasium addition has a new white fluid-applied roof membrane that has been installed over the existing built-up roofing membrane. The aggregate on the original built-up roof system was removed prior to the installation of the new fluid-applied roof membrane. This roof is in good condition and no work is required at this time.
