On May 26, 2015 ATS&R visited the site, observed existing roof 1 conditions, reviewed current leak locations, met with and discussed past leaks and observations with the district's current roofing maintenance contractor, Knickerbocker Roofing and Paving and note the following conditions:

EXISTING ROOF 1 MATERIALS:

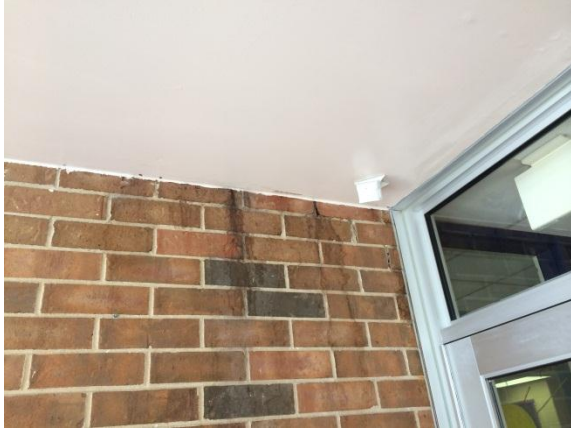
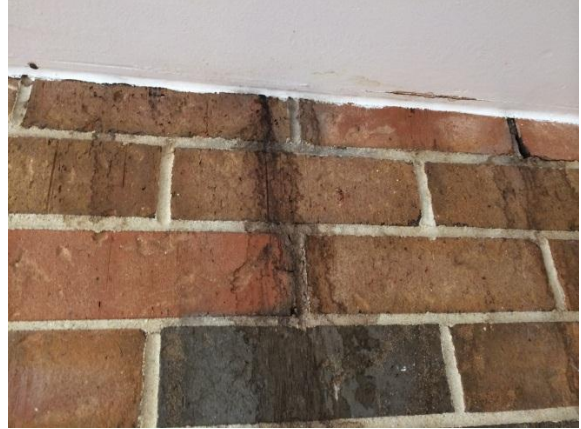
There is stained drywall ceiling and water stains on the west wall of the entry vestibule. There is a related stain directly opposite the vestibule water stain on the reception/secretary side of the wall at the ceiling and a water stain down the wall from the ceiling. (Photos 1, 2)

Photo 1: Vestibule Ceiling / Wall

Photo 2: Vestibule Ceiling / Wall

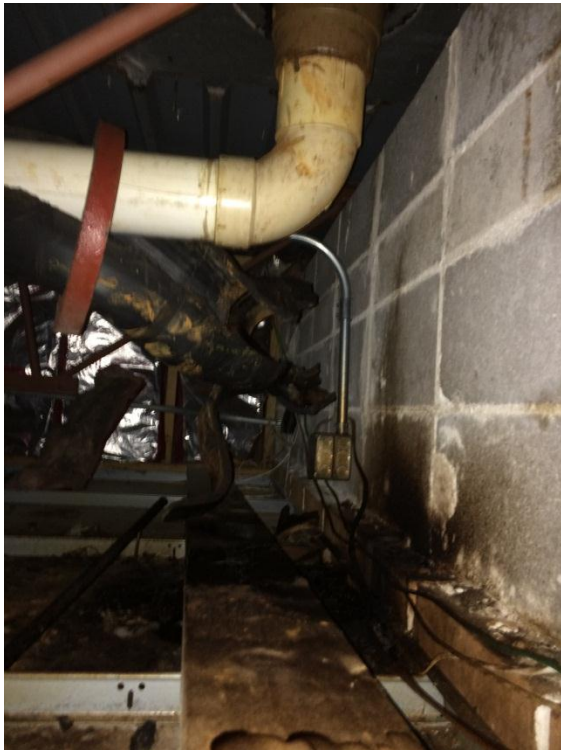
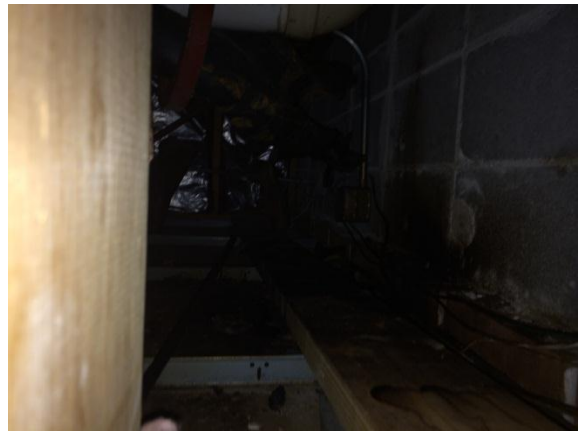
Observation was made above the corridor ceiling at the vestibule door. There is a roof drain just south of the interior vestibule doors that exhibits water stains on the pipe and on the pipe insulation. There is significant evidence of water leaking on the wall, vestibule wall insulation and on the roof drain pipe insulation which is falling off the pipe. (Photos 3, 4). Repairs have been made by the maintenance roofer including the re-setting of the roof drain into new roofing at the area drain at the roof drain. It is

believed that a plumber has not been contacted to check the roof drain and rainwater leader piping connections.

Photo 3: Above Vestibule

Photo 4: Above Vestibule

- Request plumber to examine the vestibule roof drain bell and pipe to confirm it is not leaking. If it is leaking then replace the drywall vestibule ceiling with lay-in vinyl faced drywall tile ceiling and replace roof drain / reinsulate piping, replace roof drain pan and replace roofing to the vapor barrier on the deck to a minimum distance of 4' around the roof drain and create a new roof drain sump from tapered insulation. If water is found in the existing roofing system, then extend roofing replacement out to the extent where moisture is no longer discovered in the system.

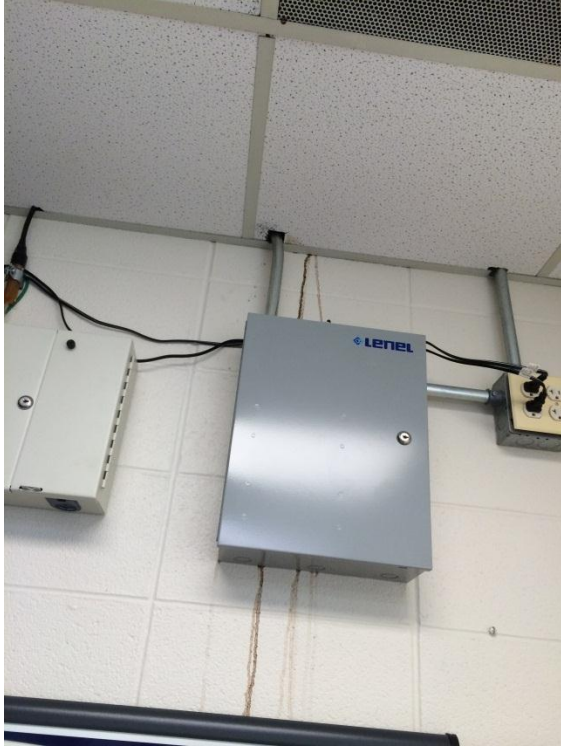
A related water stain is on the secretary side of the wall to the vestibule and south of the wall mounted technology rack. Above ceiling observation shows water from around the roof drain pan / from the roofing felts has dropped onto the top of the wall between vestibule and secretary and staining both sides of the wall. (Photos 5, 6).

Photo 5: Wall – Secretary to Vestibule

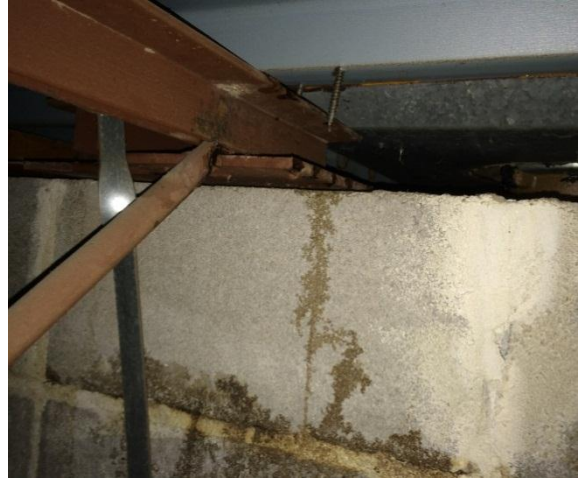
Photo 6: Above Secretary to Vestibule

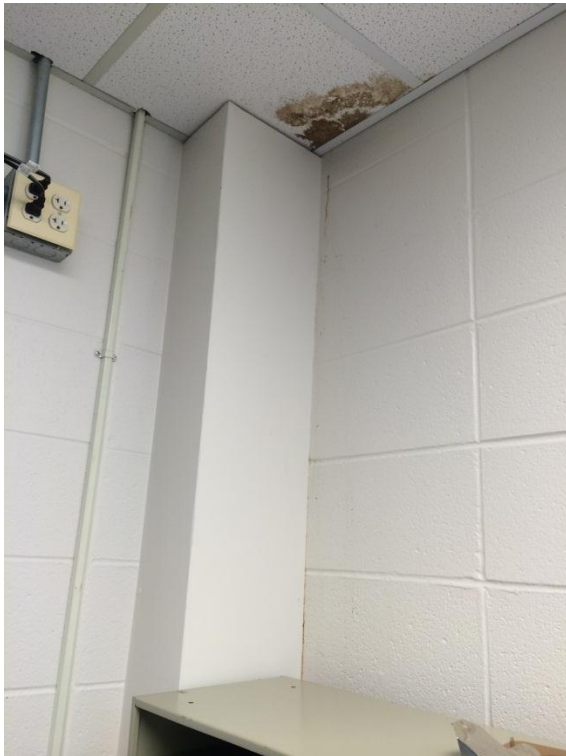
There is a water stain at the southeast corner of the reception/secretary room. (Photo 7) The stained acoustic ceiling tile could not be removed to observe this stain. Repairs of the corner of the parapet above this area have been reported to have been made. This location is adjacent to the vestibule roof drain but is a bit southwest and outside of the location of the roof drain sump pan. The above ceiling observation reveals significant stain of the wall directly above the ceiling at this location. (Photo 8) The stain appears to be coming out of the deck flute at the exterior wall intersection of the east-west exterior wall of the office and the north-south exterior wall of the vestibule. The exterior wall at this corner was observed and the parapet walls above were also examined. Another observation may be in order. Several layers of caulking attempts on the wall and the parapet are visible. However, there are not self-evident leaks at these locations.

Photo 7: SE Corner Secretary

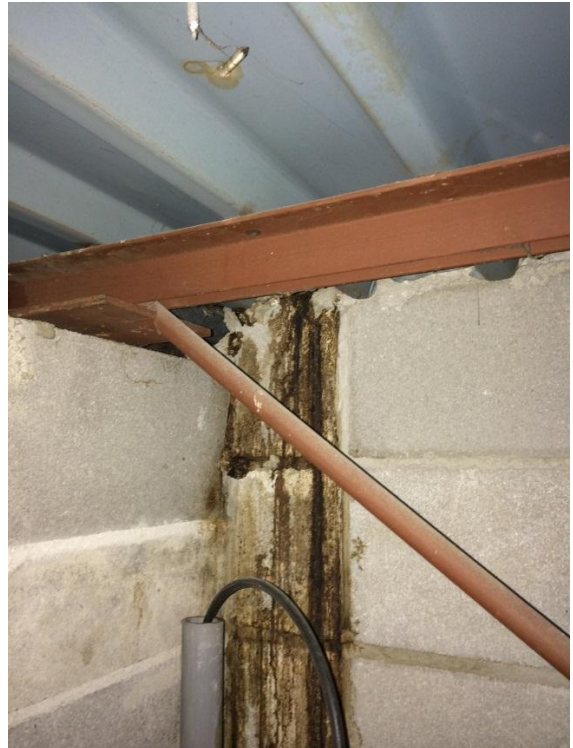
Photo 8: SE Secretary Above Ceiling

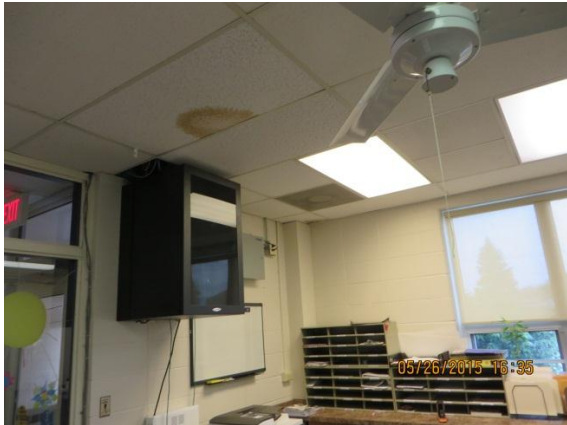
There is stained ceiling tile adjacent to the wall mounted technology rack in the reception/secretary room. (Photo 9) This rack is mounted to the vestibule wall but is north of the interior vestibule doors and is not directly adjacent to the observed stain in the vestibule. There is an unused conduit above this area with a weatherhead on the end of the conduit above the roof. The conduit weatherhead appears to be dry and the leak appears to be from water in the roofing system coming out around the conduit penetration or hole(s) in the metal deck and / or roofing above. (Photo 10)

Photo 9: Stain by Technology Rack

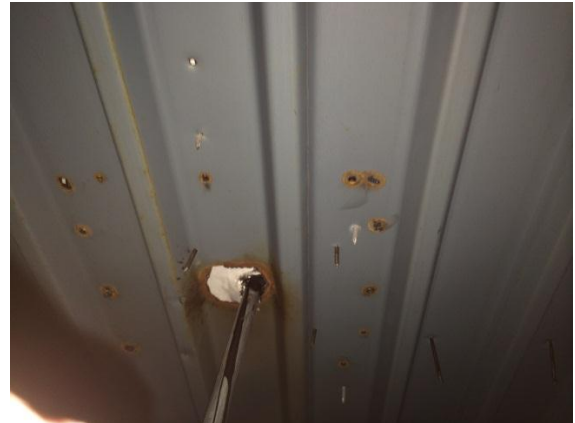
Photo 10: Conduit Above The Ceiling Stain

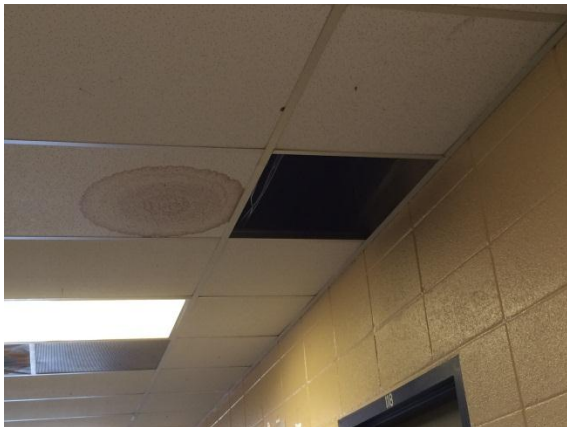
Water stains are evident on the corridor side and the classroom side of the wall of Room 118. (Photo 11 corridor), (Photo 12 classroom)

At the corridor side of room 118 there are water stains are visible at two locations adjacent to the corridor door to 118. One is due to water dripping from the roof deck and one where water is dripping from the roof joist which slopes down to the corridor wall from the gym wall to the east. The relief vent drip pan in the corridor was examined and there is no current evidence of water standing in the pan or leaking from the pan. This relief vent hood has been caulked at the exterior above the roof and the base flashing repaired in the past.

Photo 11: Corridor by Room 118

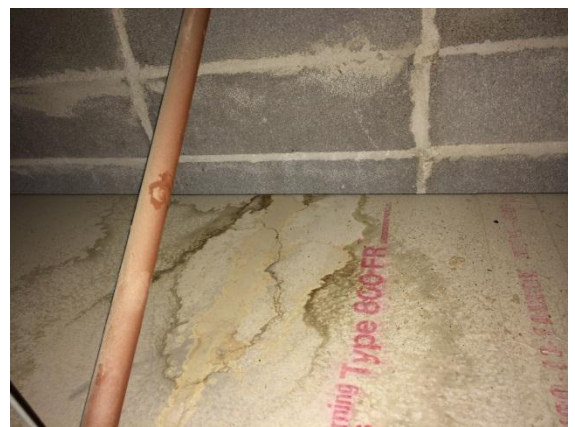
At the classroom side of the building, the west wall roof coping from the southwest corner of the building to about the location of the gas pipe on the roof has open joints. Moisture could be entering the roof edge and following the sloped joist down to the flutes of the deck or on top of the vapor barrier to an open deck lap or hole in the vapor barrier to the classroom side of the wall.

Photo 12: Room 118 Corridor Wall

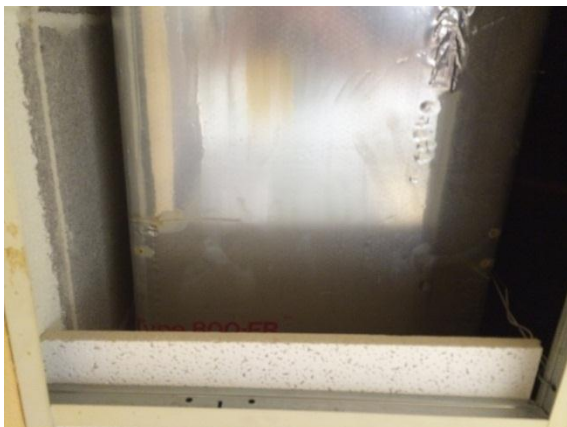
There are water stains on the ceiling grid and the above ceiling ductwork insulation above the door from the corridor. (Photo 13)

Photo 13: Room 118 Duct Insulation Stain

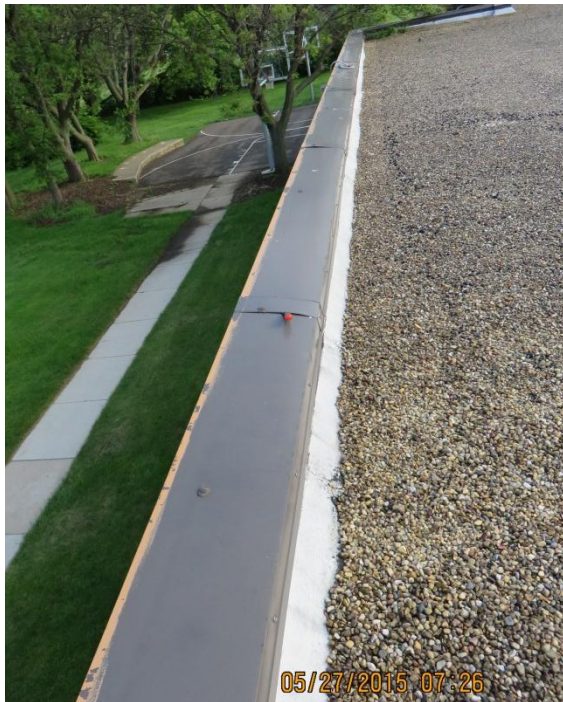
- West wall roof coping with apparent open seams. (Photo 14)
- Roof drain sump above the front entry vestibule and at the surrounding area including the area of the conduit penetration.
- Roof cap / wall construction at the intersection of the vestibule and office wall to be water pressure tested for leaking through the wall. Southwest roof coping intersection to be caulked weathertight. (Photo 15)
- Blister which may have water or air in it at the south wall adjacent to the roof drain / conduit penetrations. (Photo 16)
- Potential opening of seams at the perimeter of the roofing replacement around the roof drain, relief vent at the corridor and at room B118. (Photo 17)
- Soft area by exhaust fan serving office changing room / toilet. (Photo 18)

Photo 14: West Wall Roof Coping

- Cover and caulk the pre-finished cap joints on the south parapet walls and the west wall of the canopy including the vertical joints
- Cover and caulk the pre-finished cap joints on the west walls including the vertical joints

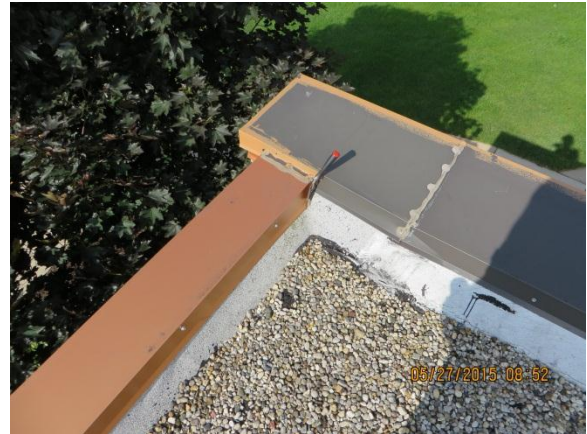
Photo 15: SE Roof Coping Intersection

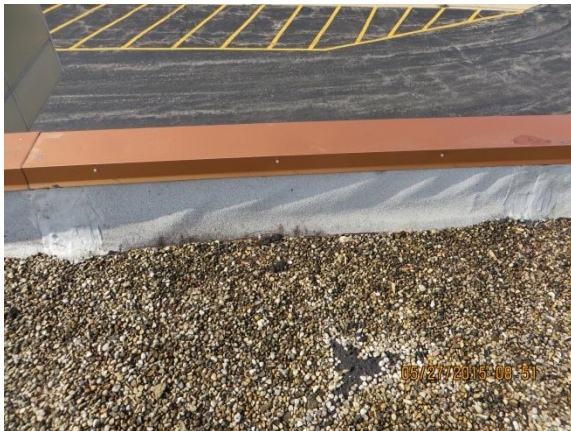
Photo 16: S Wall Blister By Vestibule Roof Drain

- Repair blister /soft area at the south wall southwest of the vestibule roof drain
- Repair soft areas by exhaust fan serving office changing room / toilet

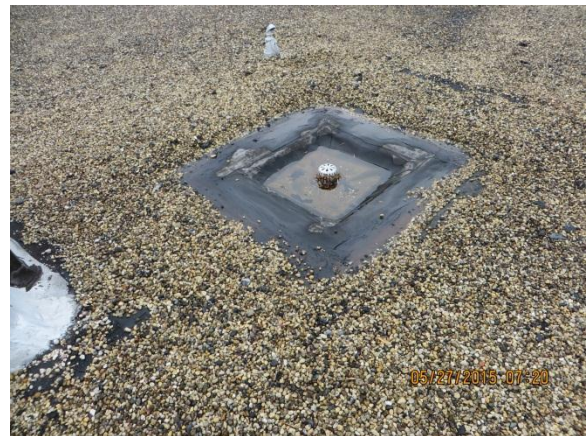
Photo 17: Vestibule Drain / Conduit Area

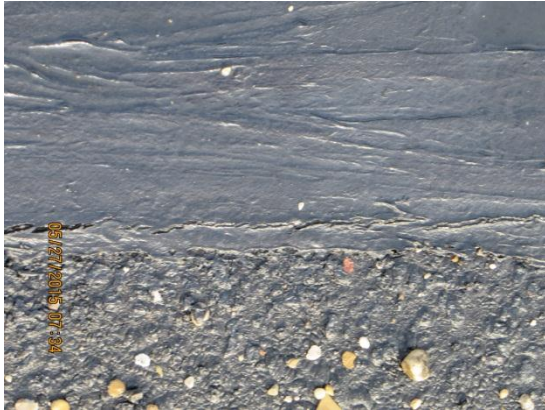
Photo 18: Roof Replacement Seam

- Patch seams of roof replacement above corridor to existing roofing by stripping new roofing felts into the existing felts instead of the reinforced cotton fabric and roofing cement previously employed.

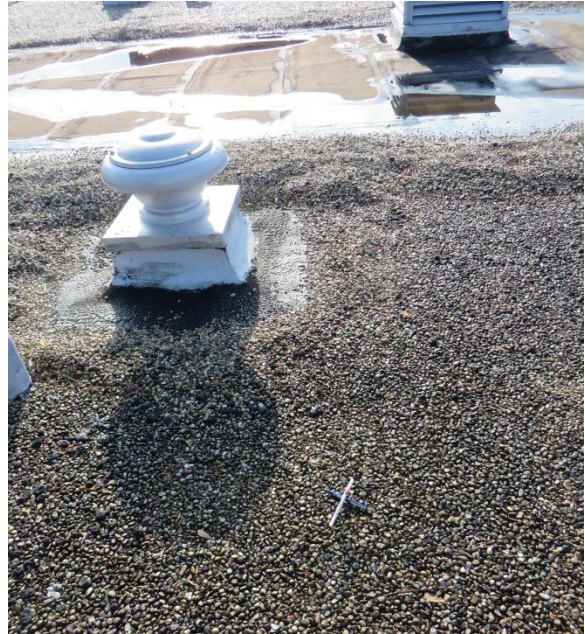
Photo 19: Soft Area By Office Exhaust Fan

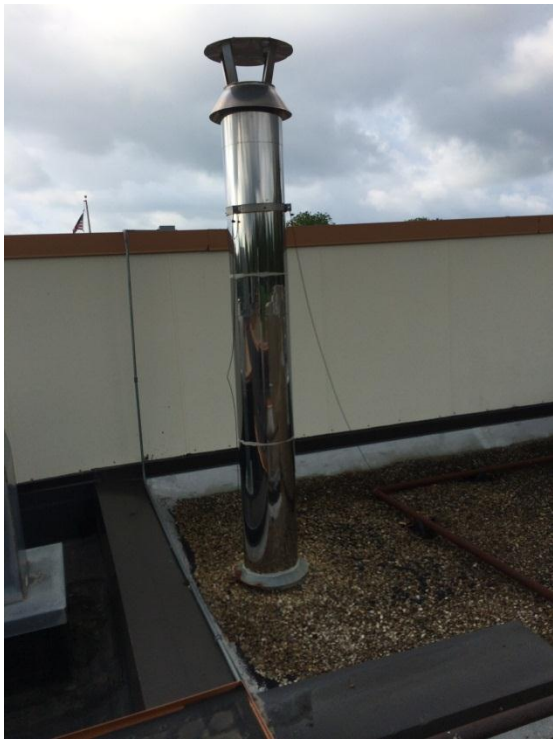
The newer boiler stack above the mechanical room is not guy wired to the roofing or walls to support it and to maintain it in a vertical position in a strong wind. The guy wires are present but are no longer fastened to the building or roofing. The boiler installer should be contacted to correct this installation by the district. (Photo 20)

Photo 20: Unsupported Boiler Stack
