# ENGINEERING MEMORANDUM

<b>TO</b>	Brandi Sweeney, Morrow County School District				
<b>FROM</b>	Jeff Schott, P.E.				
<b>PROJECT</b>	Irrigon Jr/Sr. High School				
<b>SUBJECT</b>	Structural Observations				
<b>DATE</b>	12/23/2025	<b>PROJECT #</b>	2025-053	<b>MEMO #</b>	EM-01

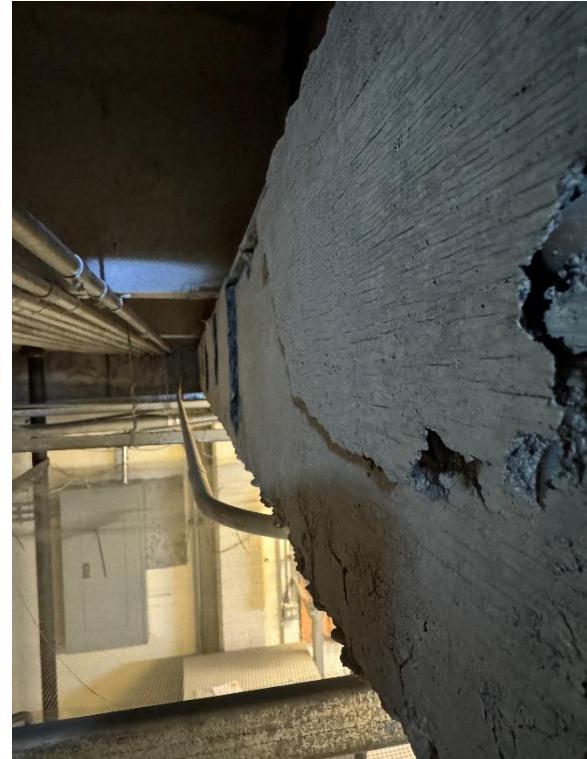
Our opinion established in 2023 is that the damage observed at P6, B10 and B11 is primarily due to the double-tee roof panels being welded and rigidly connected at both ends of the panels. This restrains expansion and contraction along the length of the roof panel that may occur due to changes in temperature, changes in roof loads (rain/snow), changes in moisture content and/or creep. The force required to restrain the change in length is substantial, and it is greater than the connections can resist. The result is that "something must give" and in this case it's a rupture of the connections at P6, B10 and B11.

Based on our observations, the connections have ruptured, but in doing so it relieved the stress on the panels and connections. This new state of equilibrium appears to be relatively stable with respect to panel end position.

*Picture 1: B11 South Face*

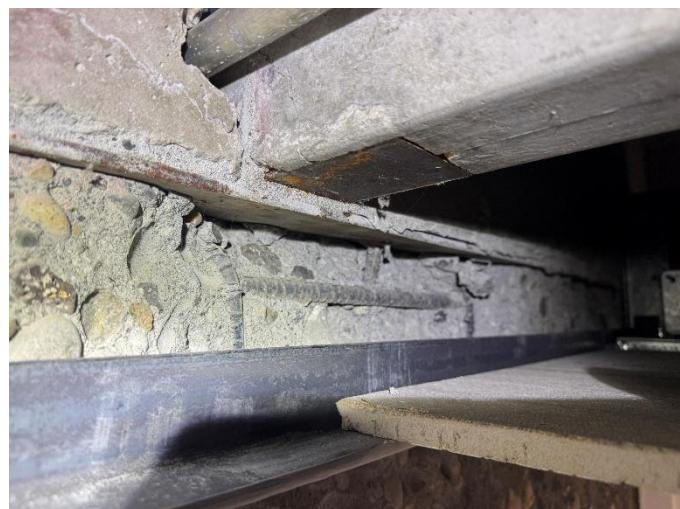
I met Quentin Wares, the head custodian, and we did a brief walk-through of the facility and the areas that had previously been inspected and/or shored. The most severe and obvious damage is near the main building entrance at panel P6, and beams B10 and B11. There is concern that the damage observed in 2023 may be getting worse and that there is further displacement between building elements.

*Picture 2 South Face Panel P6*

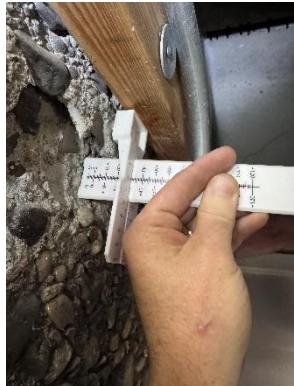
Picture 3 P6- Rule type

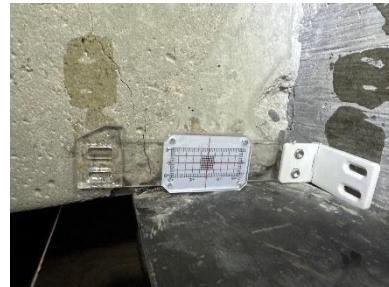
Picture 5 B10 North side, corner type.

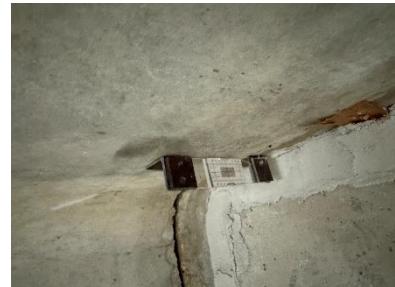
There is also cracking near the bearing plates of some of the double-tee roof panels over the maintenance storage mezzanine. These are cracks and not full ruptures but may be indicative of unintended axial stresses in the panel.

Picture 8 Mezzanine t/panel

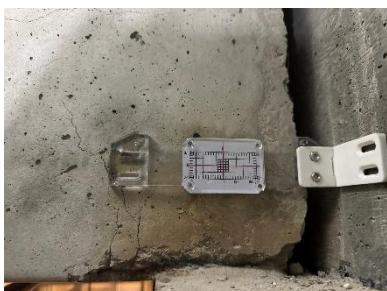
Picture 4 B11 Corner type

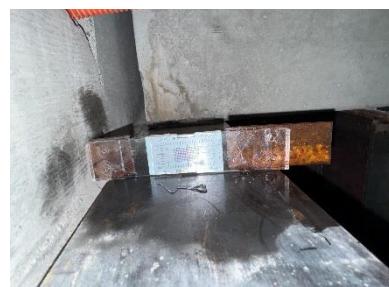
Picture 6 B10, North side

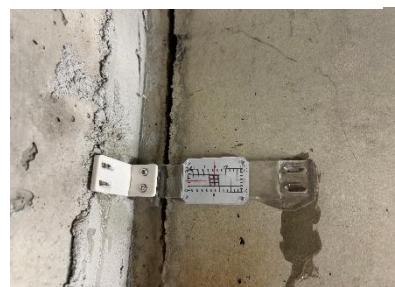
Picture 9 Mezzanine, m/panel

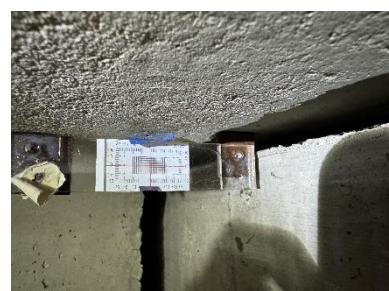
Picture 7 B10, South side

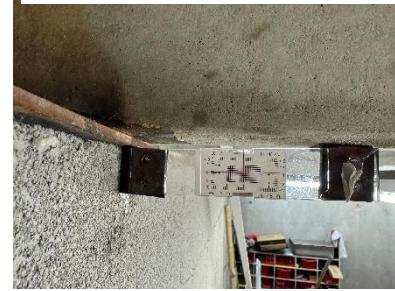
Picture 10 Mezzanine, b/panel

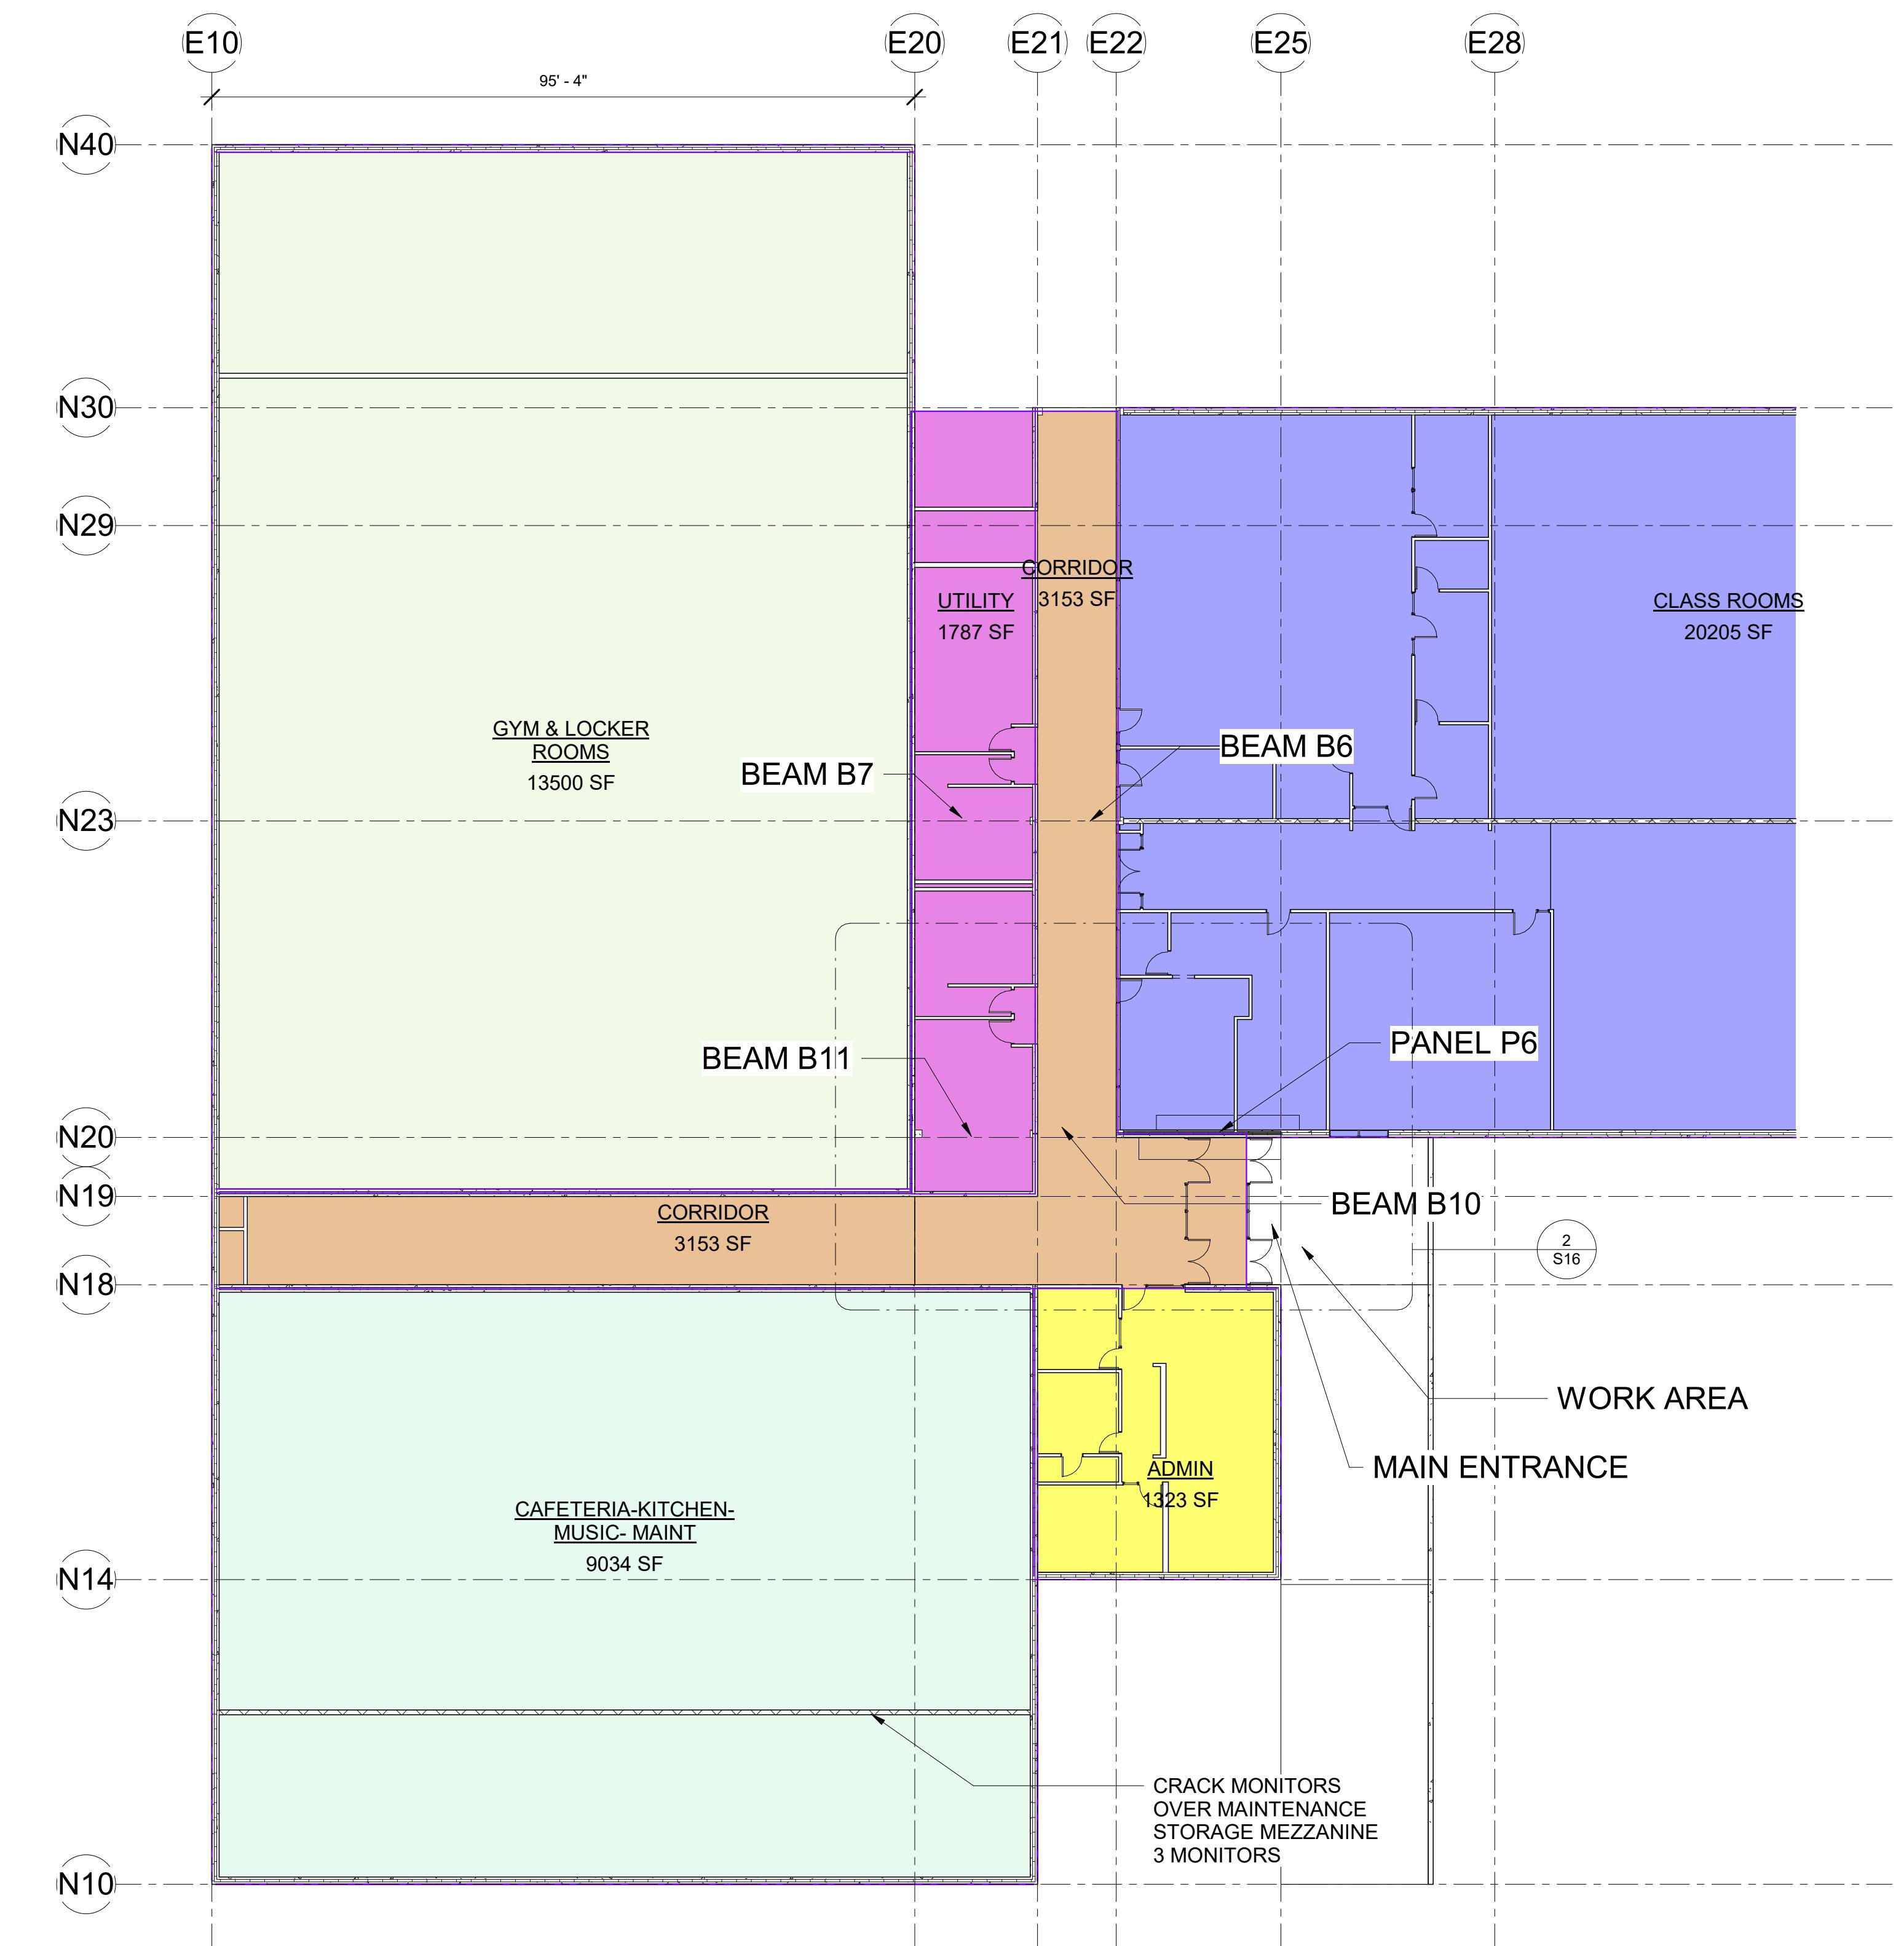
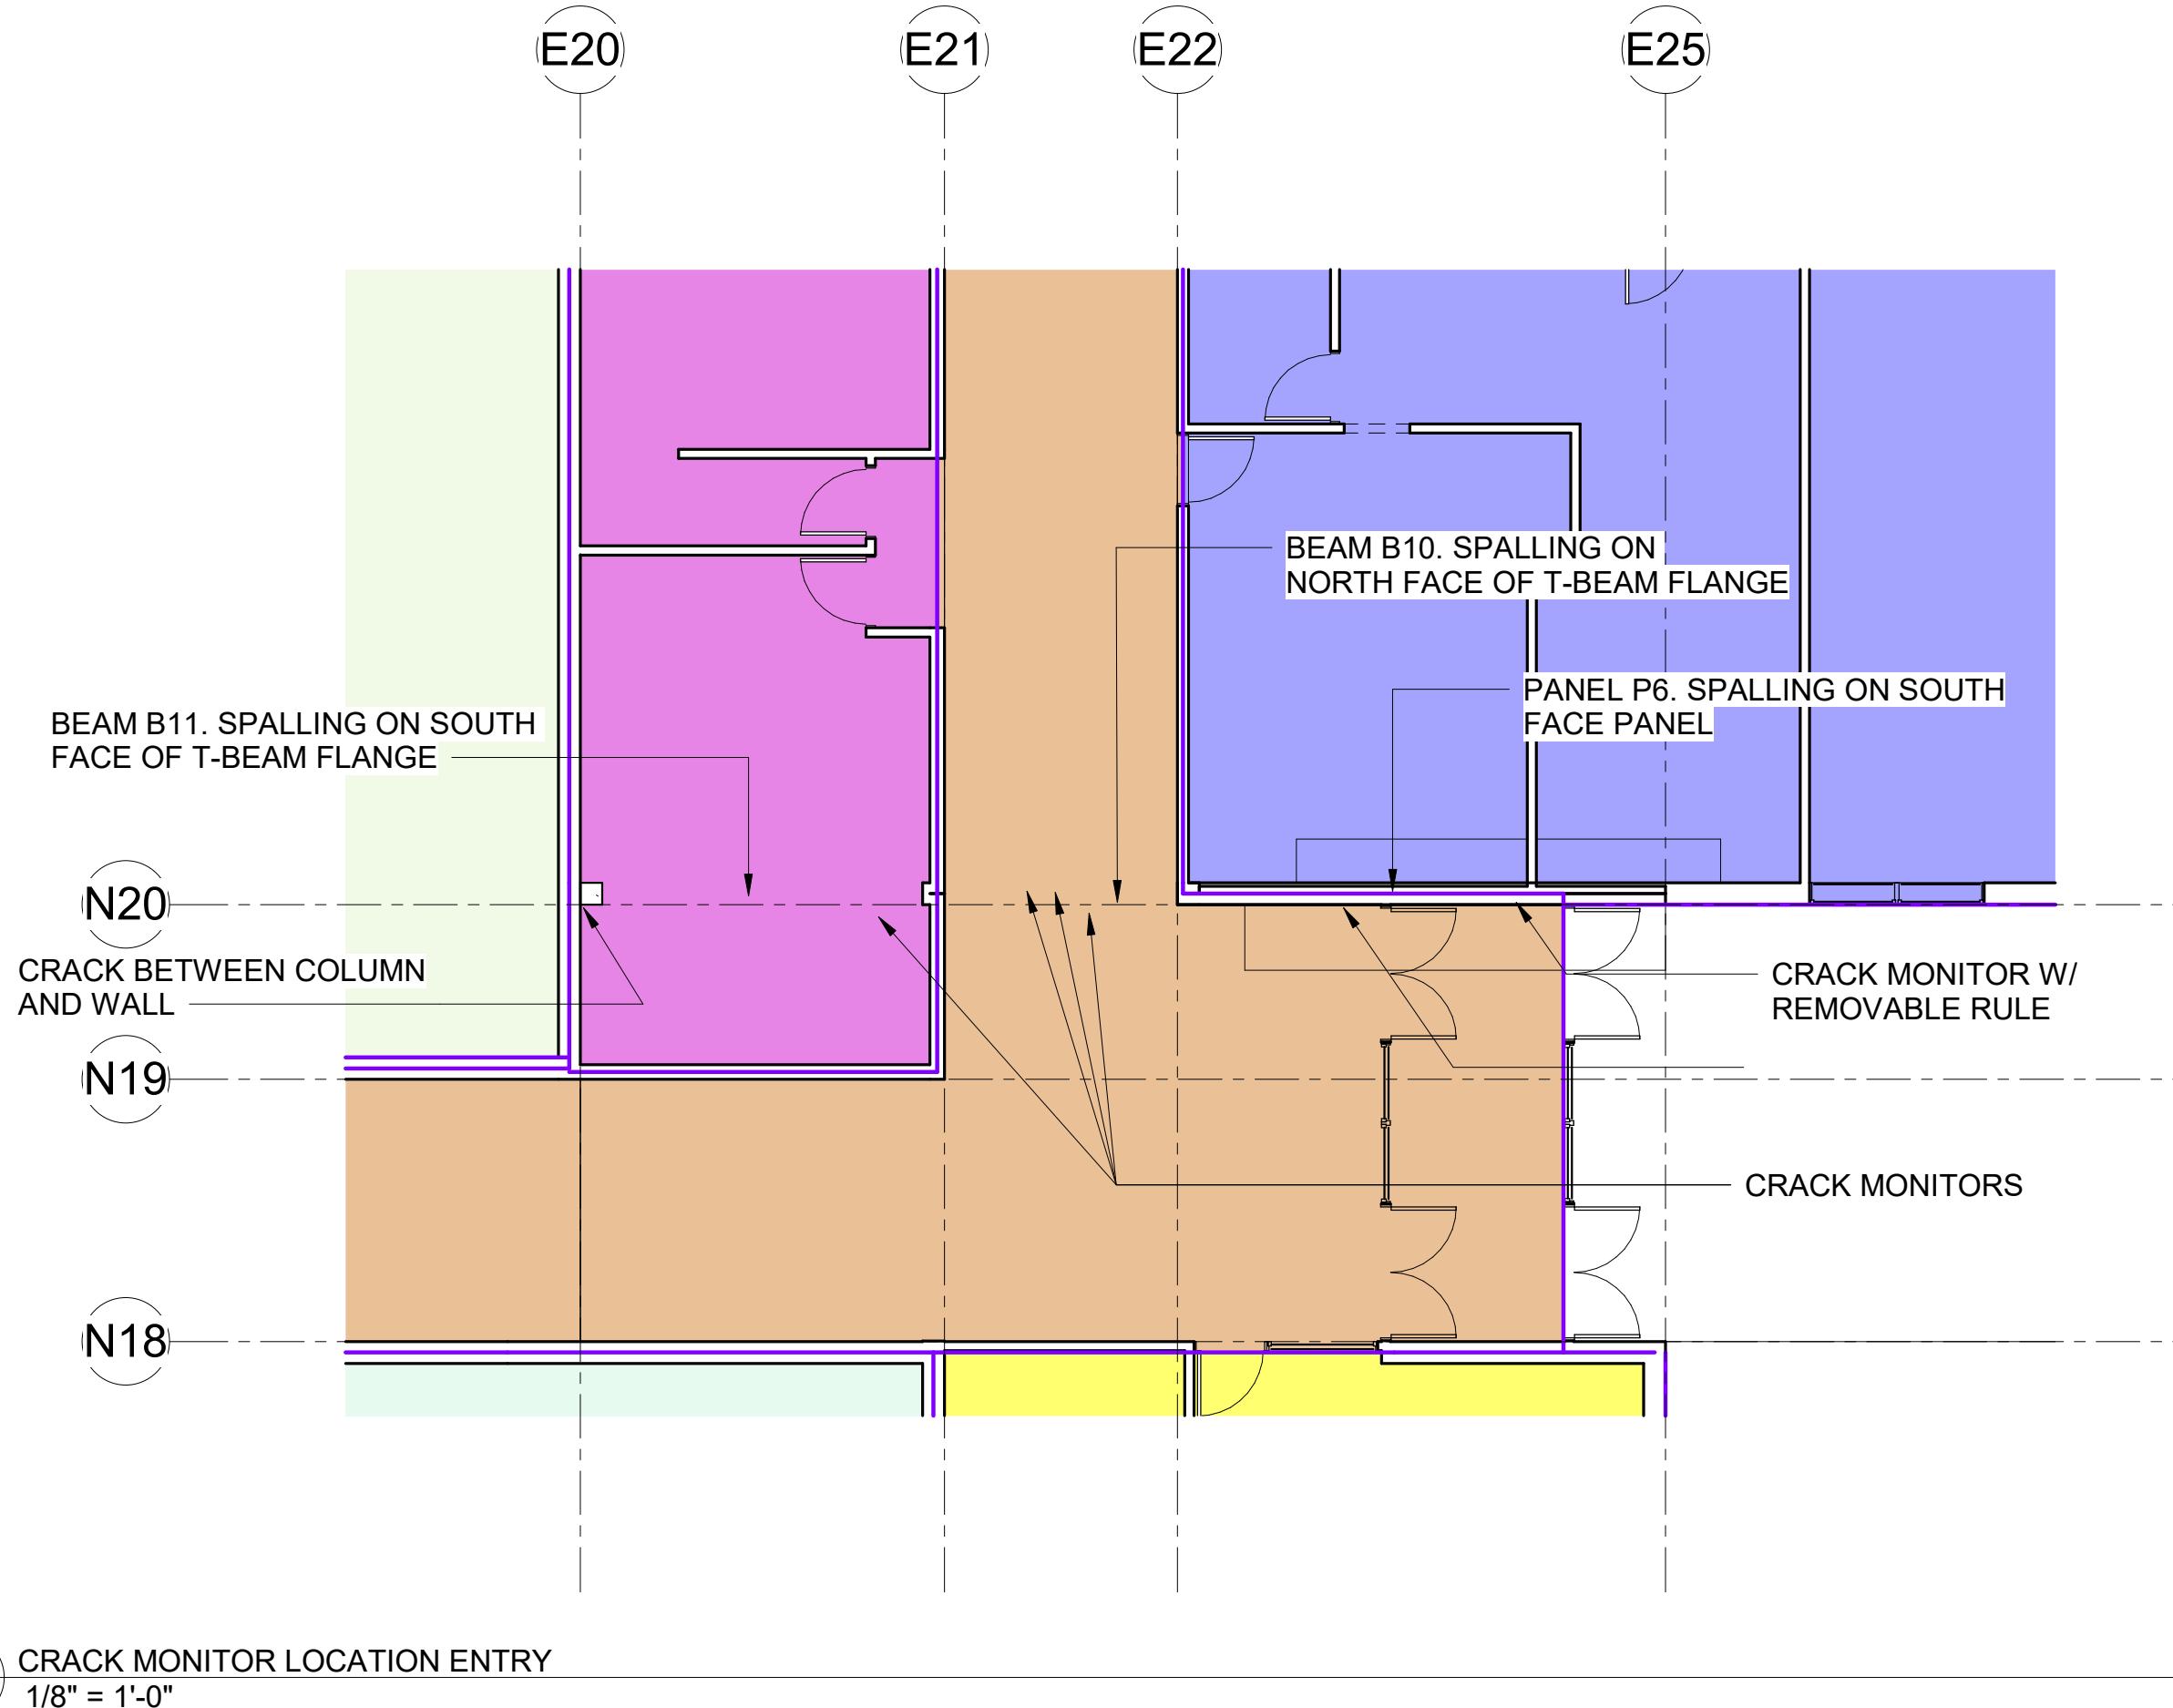
**S16**

To better monitor future displacement, we placed 8 crack monitoring gauges near the location of the damage to monitor movement of the roof panels relative to the supports at P6, B10 and B11 and over the maintenance mezzanine. The pictures below indicate the location, and the status of the crack gauges. Attached drawing S16 shows the location of the gauges.
