FACILITY ASSESSMENT

FACILITY REPORT EXCERPT

Strickland Middle School

Huckabee | Facility Assessment Report, Denton Independent School District

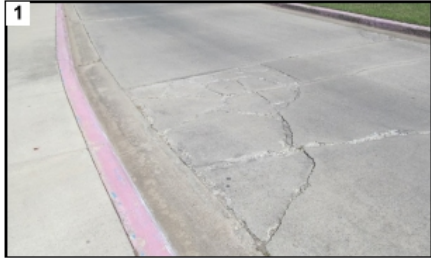
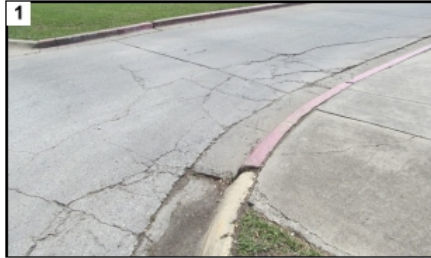
Failed Concrete Pavement - Removed and Replace Subgrade and Concrete

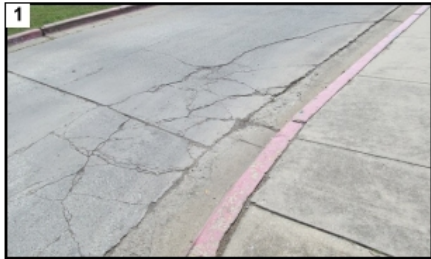
Failed Concrete Pavement - Removed and Replace Subgrade and Concrete

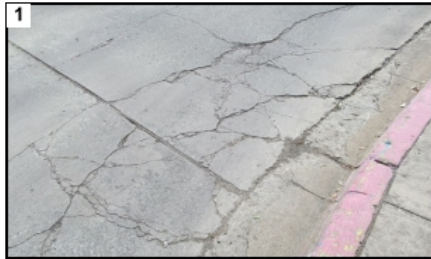
Failed Concrete Pavement - Removed and Replace Subgrade and Concrete

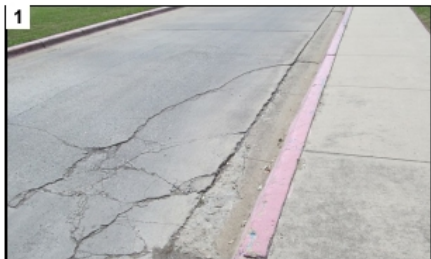
Failed Concrete Pavement - Removed and Replace Subgrade and Concrete

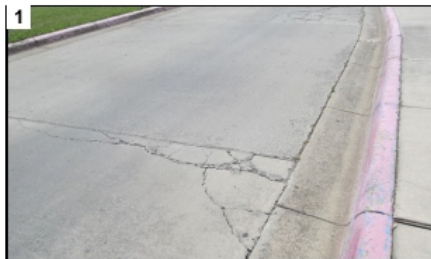
Failed Concrete Pavement - Removed and Replace Subgrade and Concrete

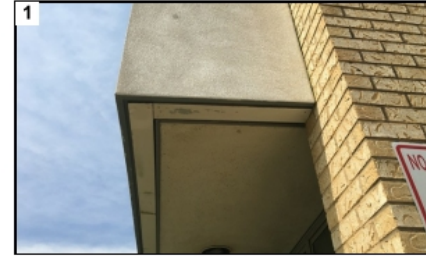
Replace metal soffit trim and wood blocking, typical.

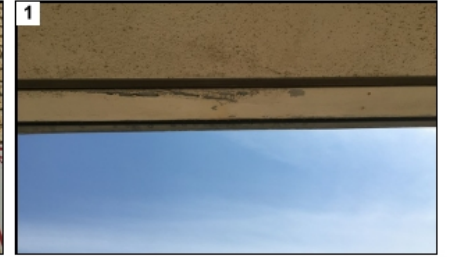
Replace metal soffit trim and wood blocking, typical.

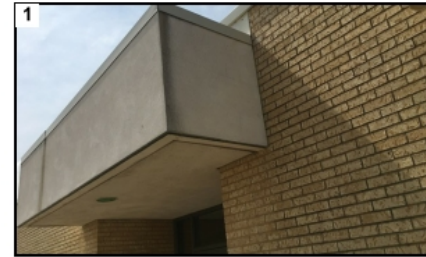
Replace metal soffit trim and wood blocking, typical. Acid wash plaster and masonry veneer.

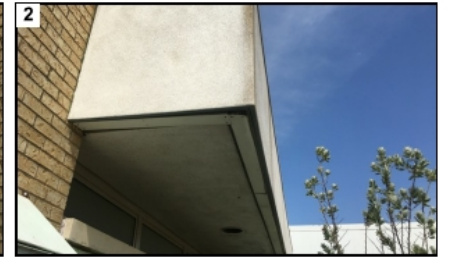
Replace metal soffit trim and wood blocking, typical. Repair cracks in plaster veneer.

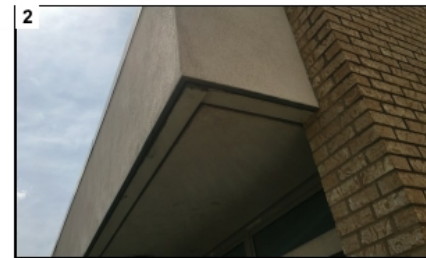
Replace metal soffit trim and wood blocking, typical. Repair cracks in plaster veneer.

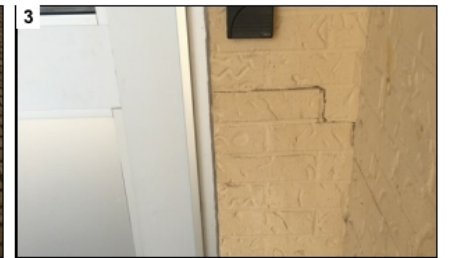
Masonry pointing.

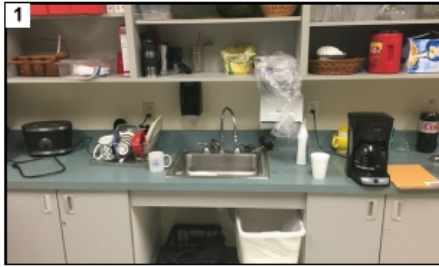
1 Admin - Replace aged casework in lounge.

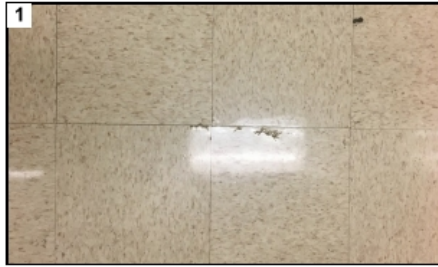
1 Admin - Replace aged VCT.

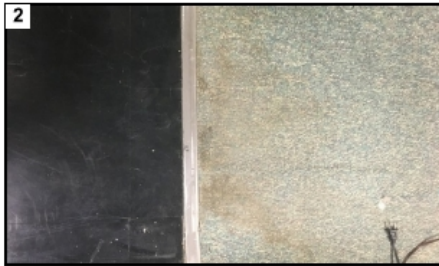
2 Fine Arts - Replace aged carpet in Black Box office and Orchestra office .

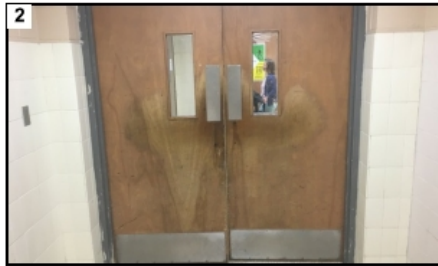
2 Fine Arts - Replace aged doors and frame.

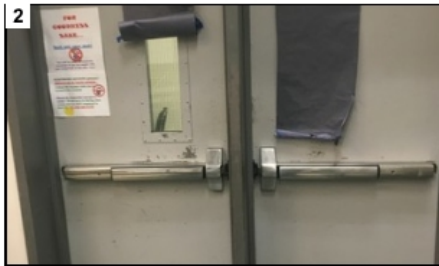
2 Fine Arts - Replace aged doors and frame.

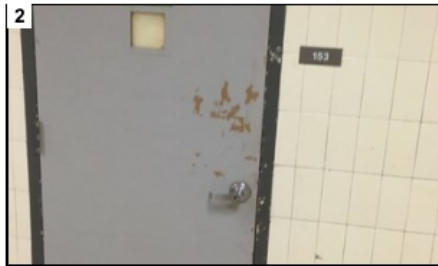
2 Fine Arts - Replace aged doors and frame.

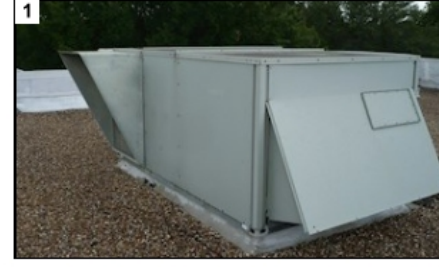
1 Trane rooftop a/c unit

MEP – Mechanical: All the rooftop A/C units that were manufactured before 2003 are past their estimated useful service life.

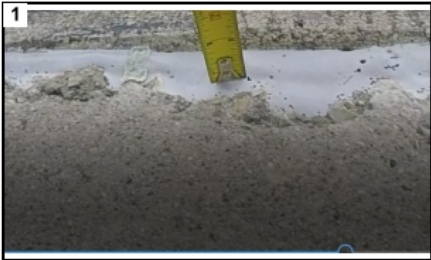
Greater than 1/2" vertical level change on path of travel.

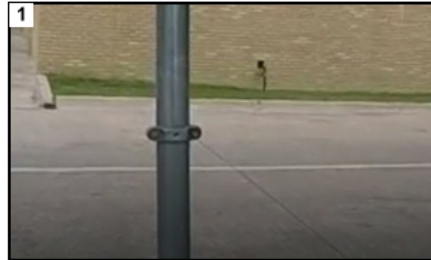
Signage missing

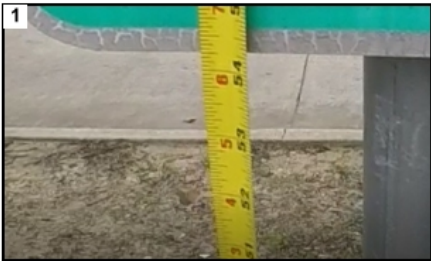
Signage not located at 60" (54")

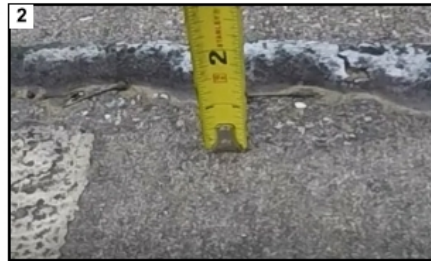
Greater than 1/2" vertical level change on path of travel. (3/4")

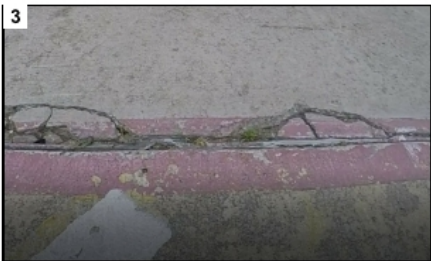
Broken pavement creates multiple level change violations along path of travel.

Accessibility - Extensive concrete replacement is required throughout the campus to bring accessible routes in to compliance with TAS/ADA. Interior of the facility requires a significant number of miscellaneous corrections to meet TAS/ADA standards. The largest remediation will be modification of the bleachers in the Viking Gym to provide wheelchair spaces.

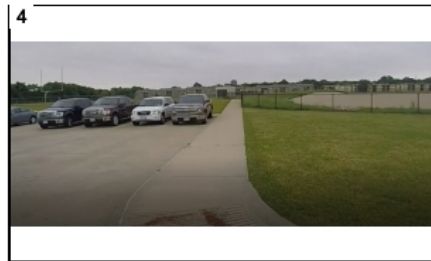
No accessible route to football field or track.
