Morrow County School District Facilities Assessment

May 9, 2024

Morrow County School District Facilities Assessment Report

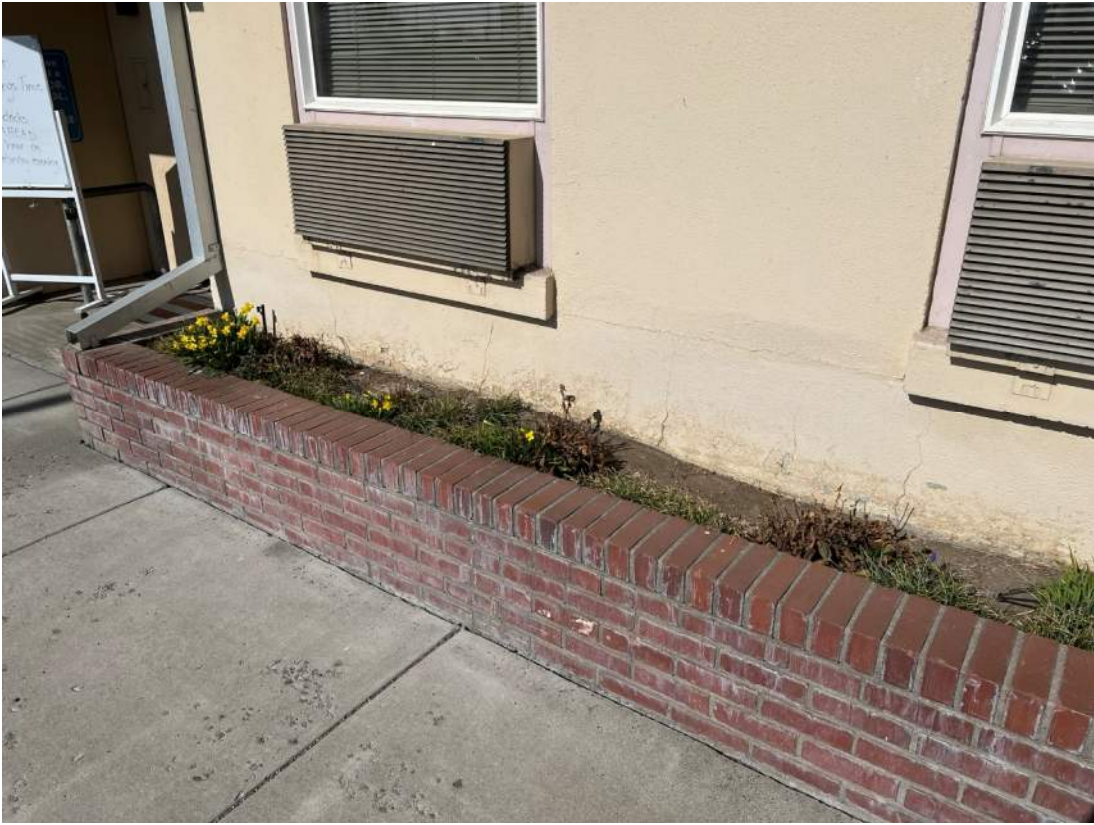
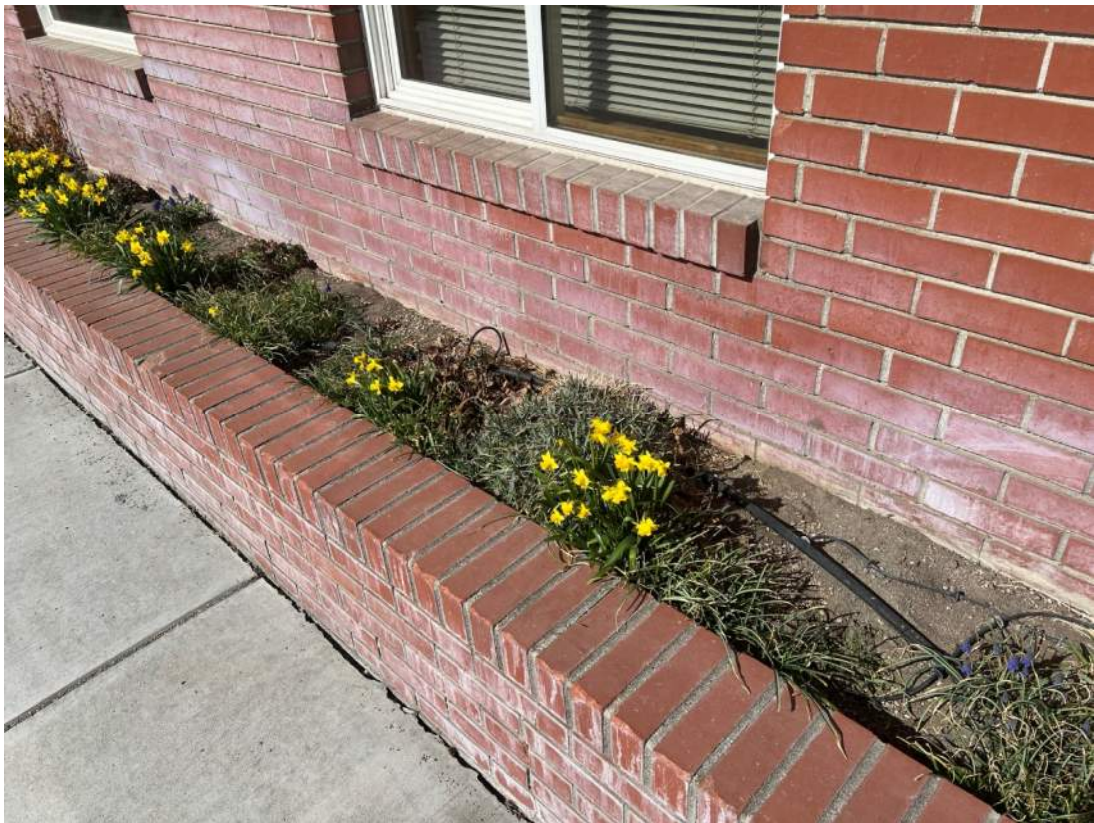
(Above/Below: Planter bed next to building)

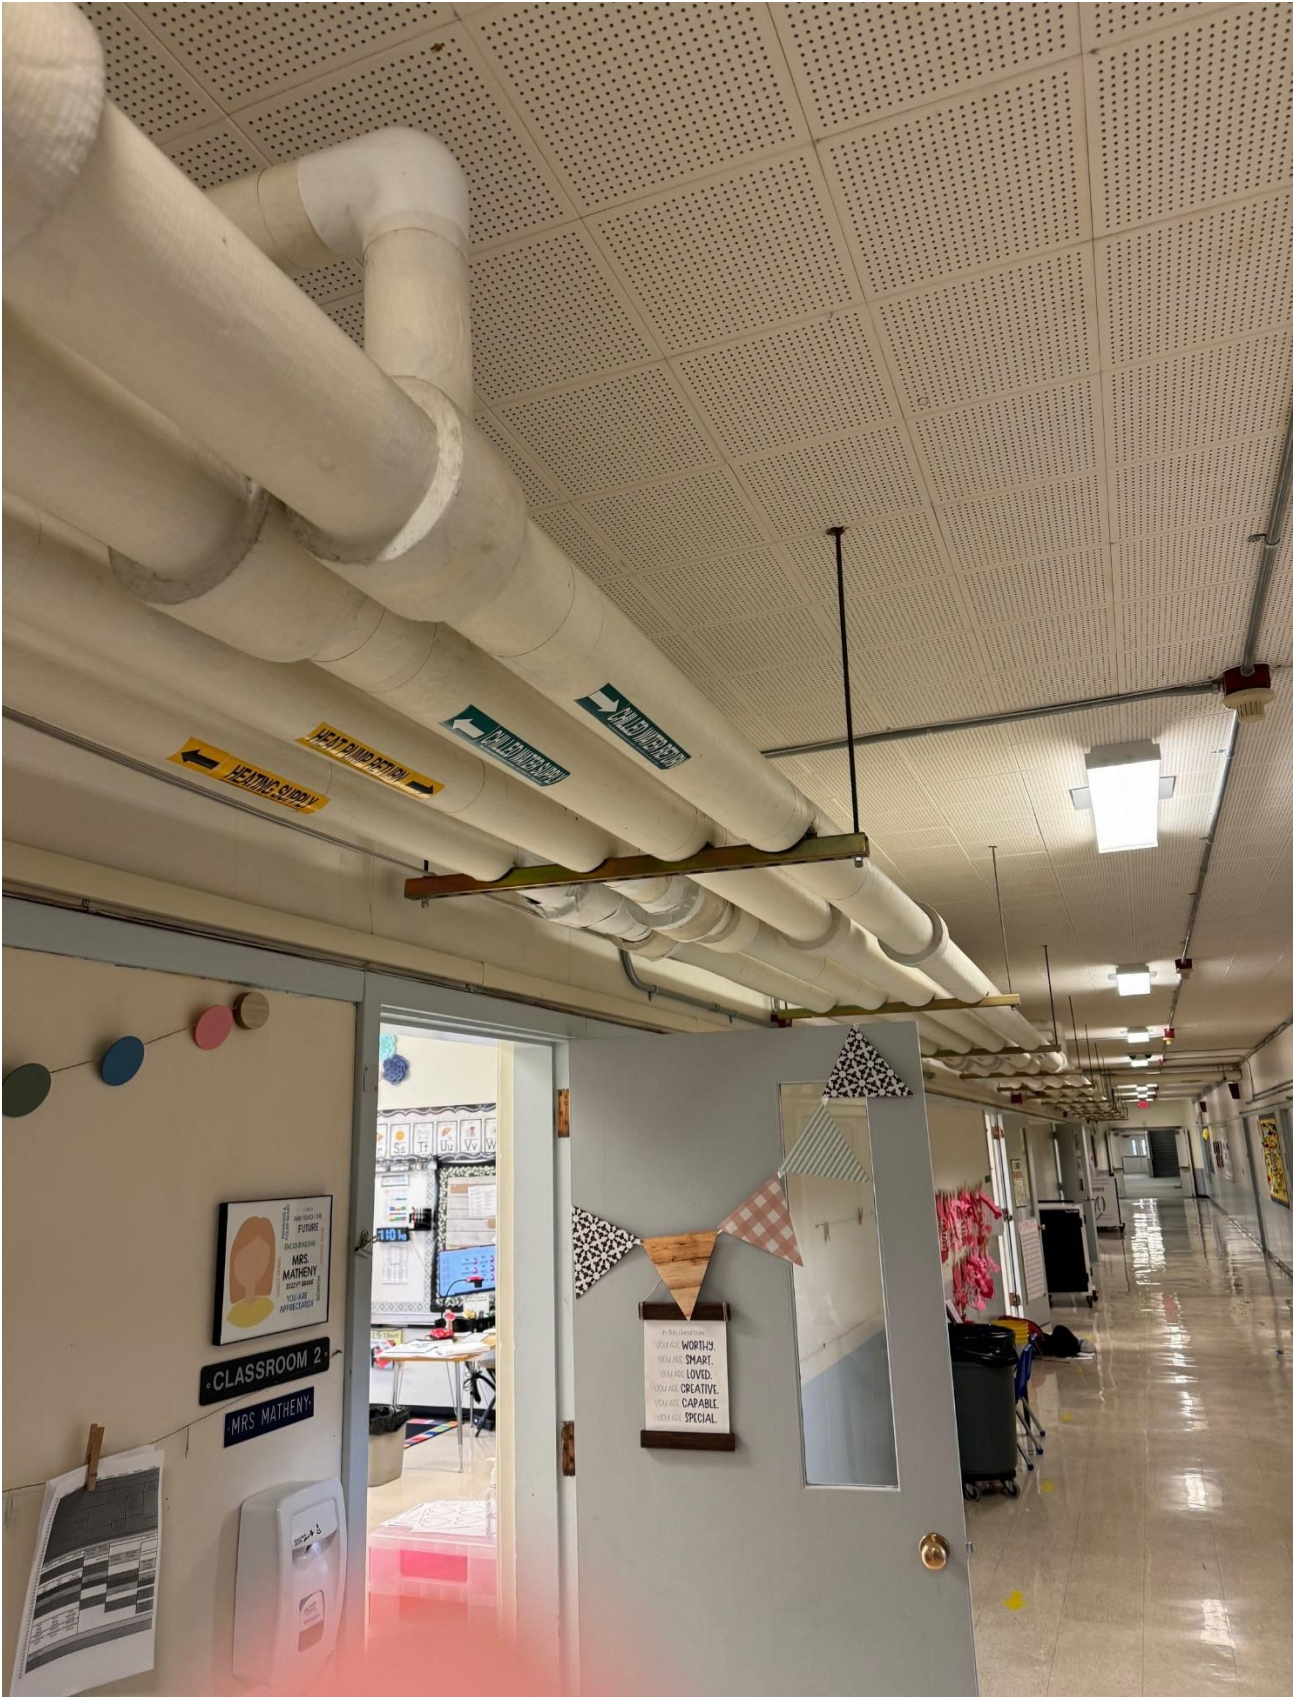
- In general, the overall condition of the school is good. No major structural concerns were observed.
- Multiple large pipes extend down the hallway with no diagonal seismic bracing.

(Above: no lateral bracing of pipe trapeze's in hallway)

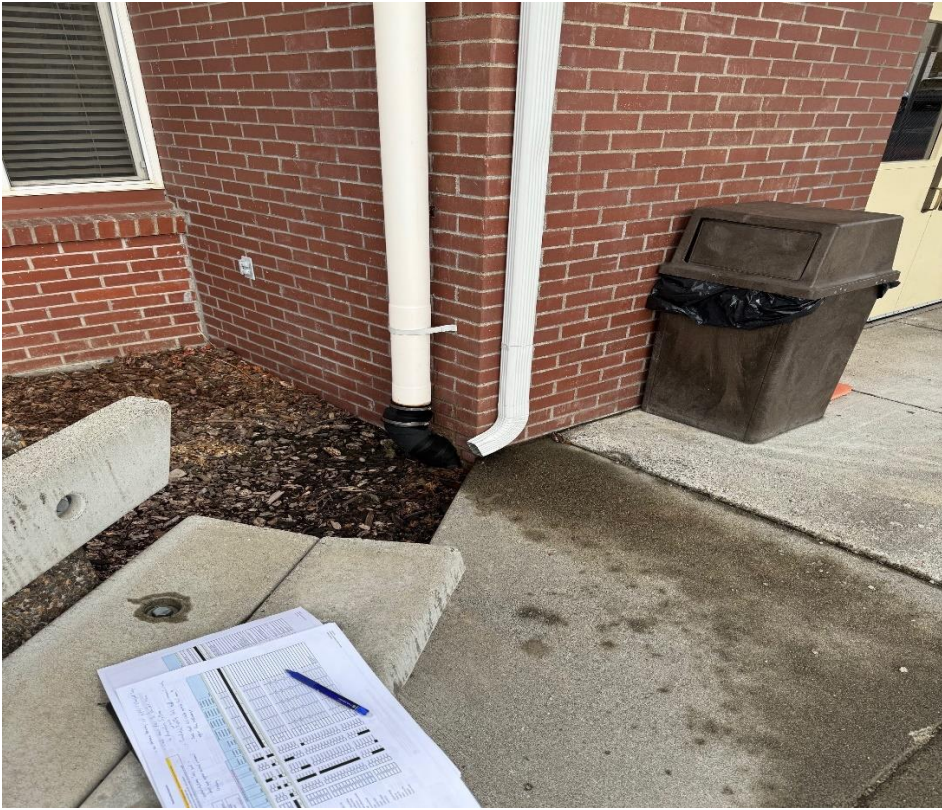
- A downspout adjacent to the main entry on the Southwest side of the structure discharges into the planter area and is not properly piped away from the structure with storm drainage. Prolonged infiltration of water next to building foundations can eventually result in settlement issues.

(Above: improper roof drainage at entrance

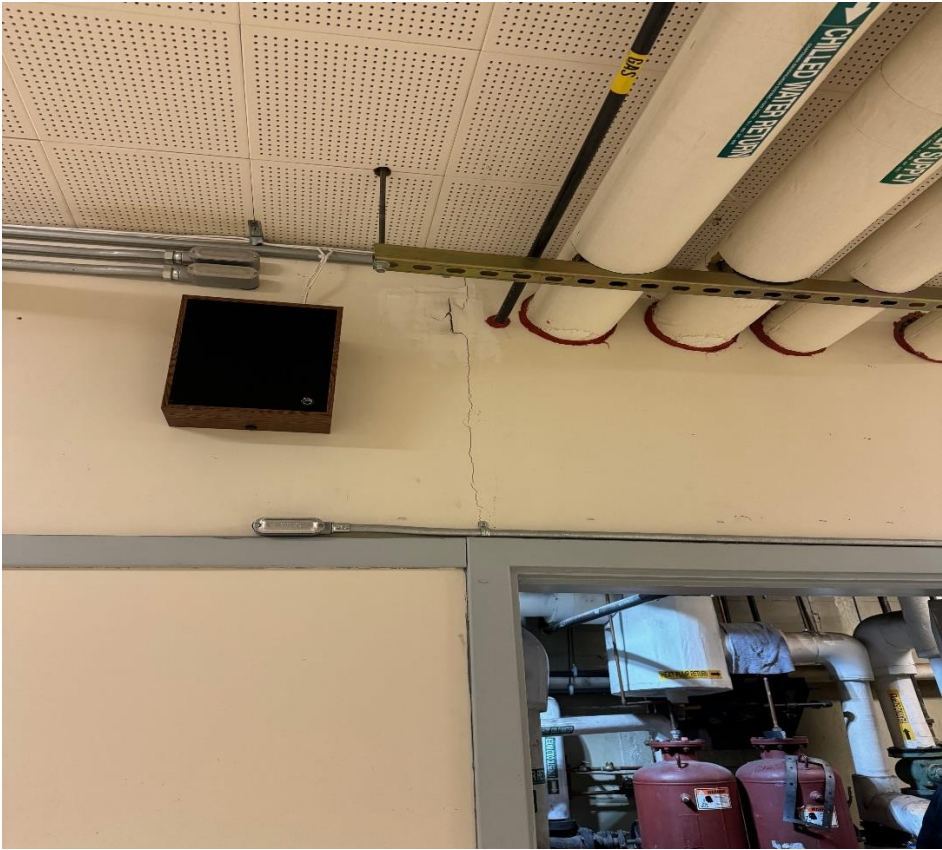
- A larger crack exists above the door to the Boiler Room in the downstairs hallway.
- Mortar has deteriorated in the brick on the West

Below: Boiler Room wall crack)

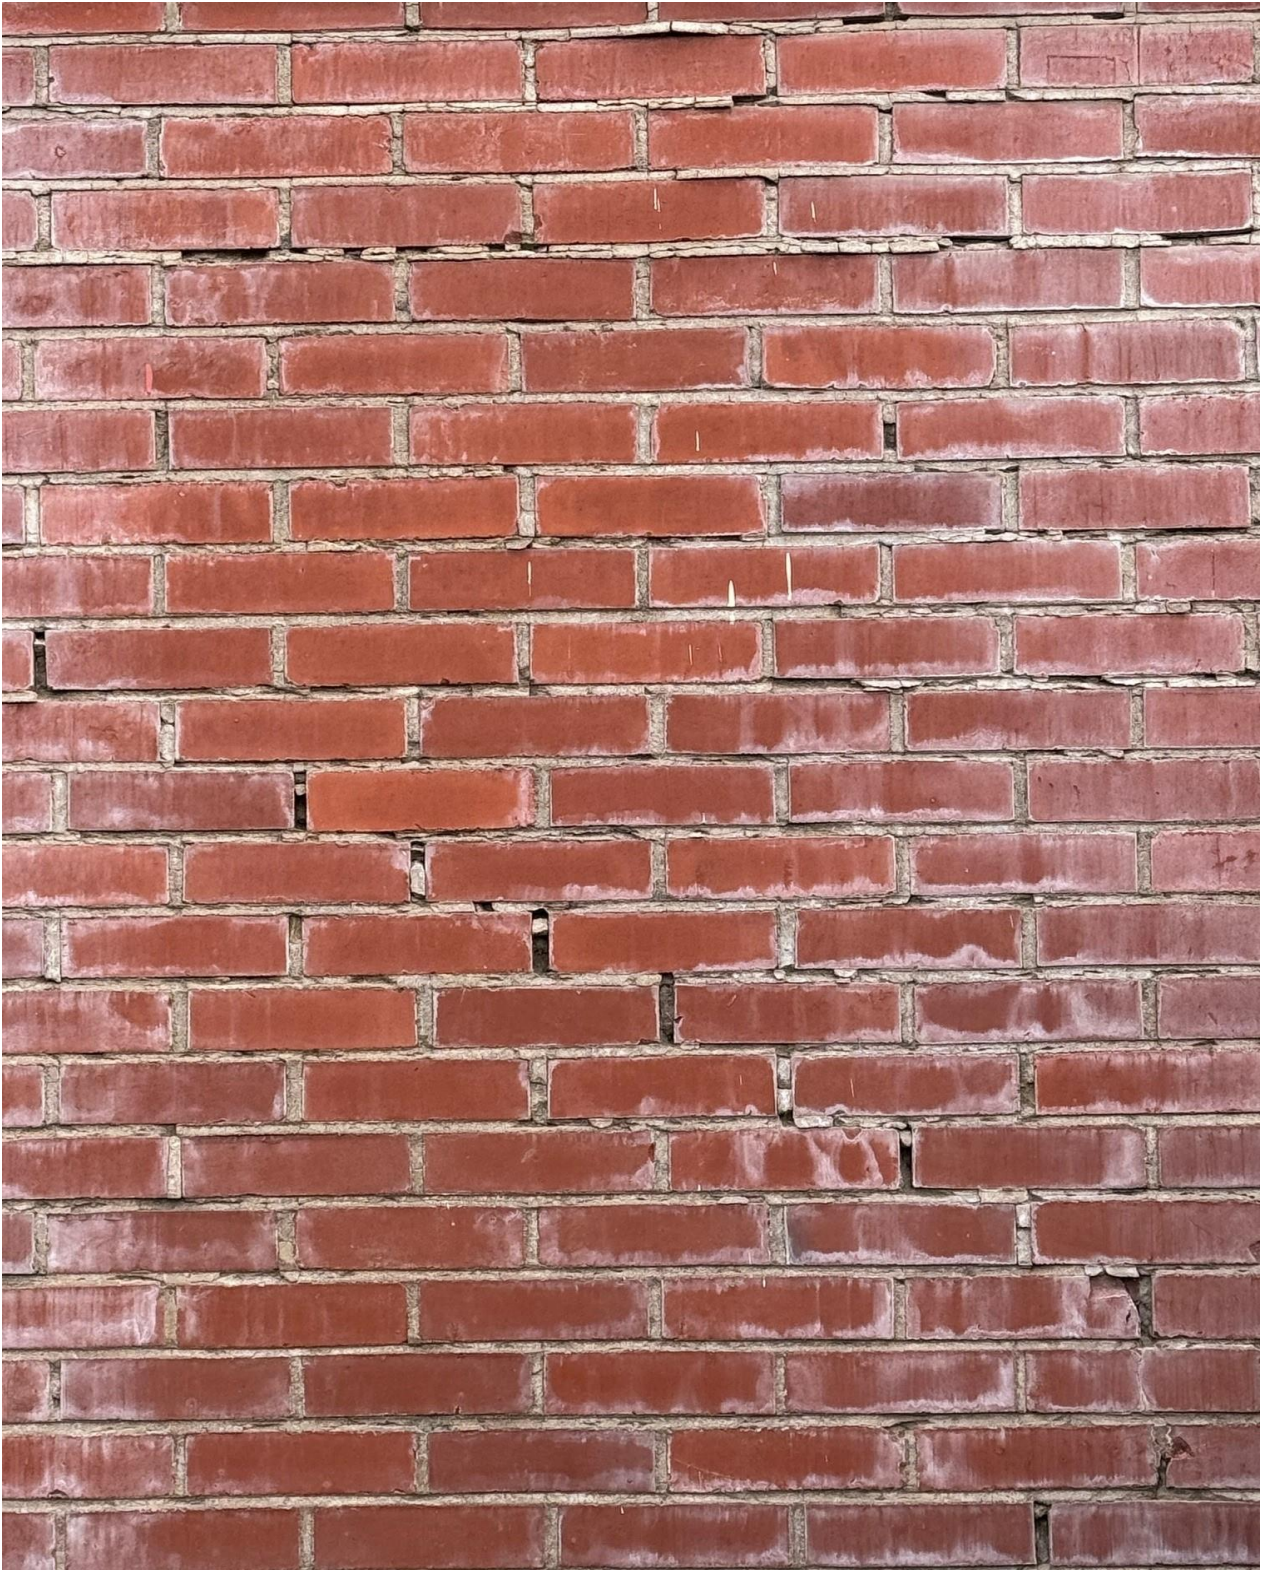
face of the building below the large glass block area.

(Above: mortar damage at existing brick wall on West side)

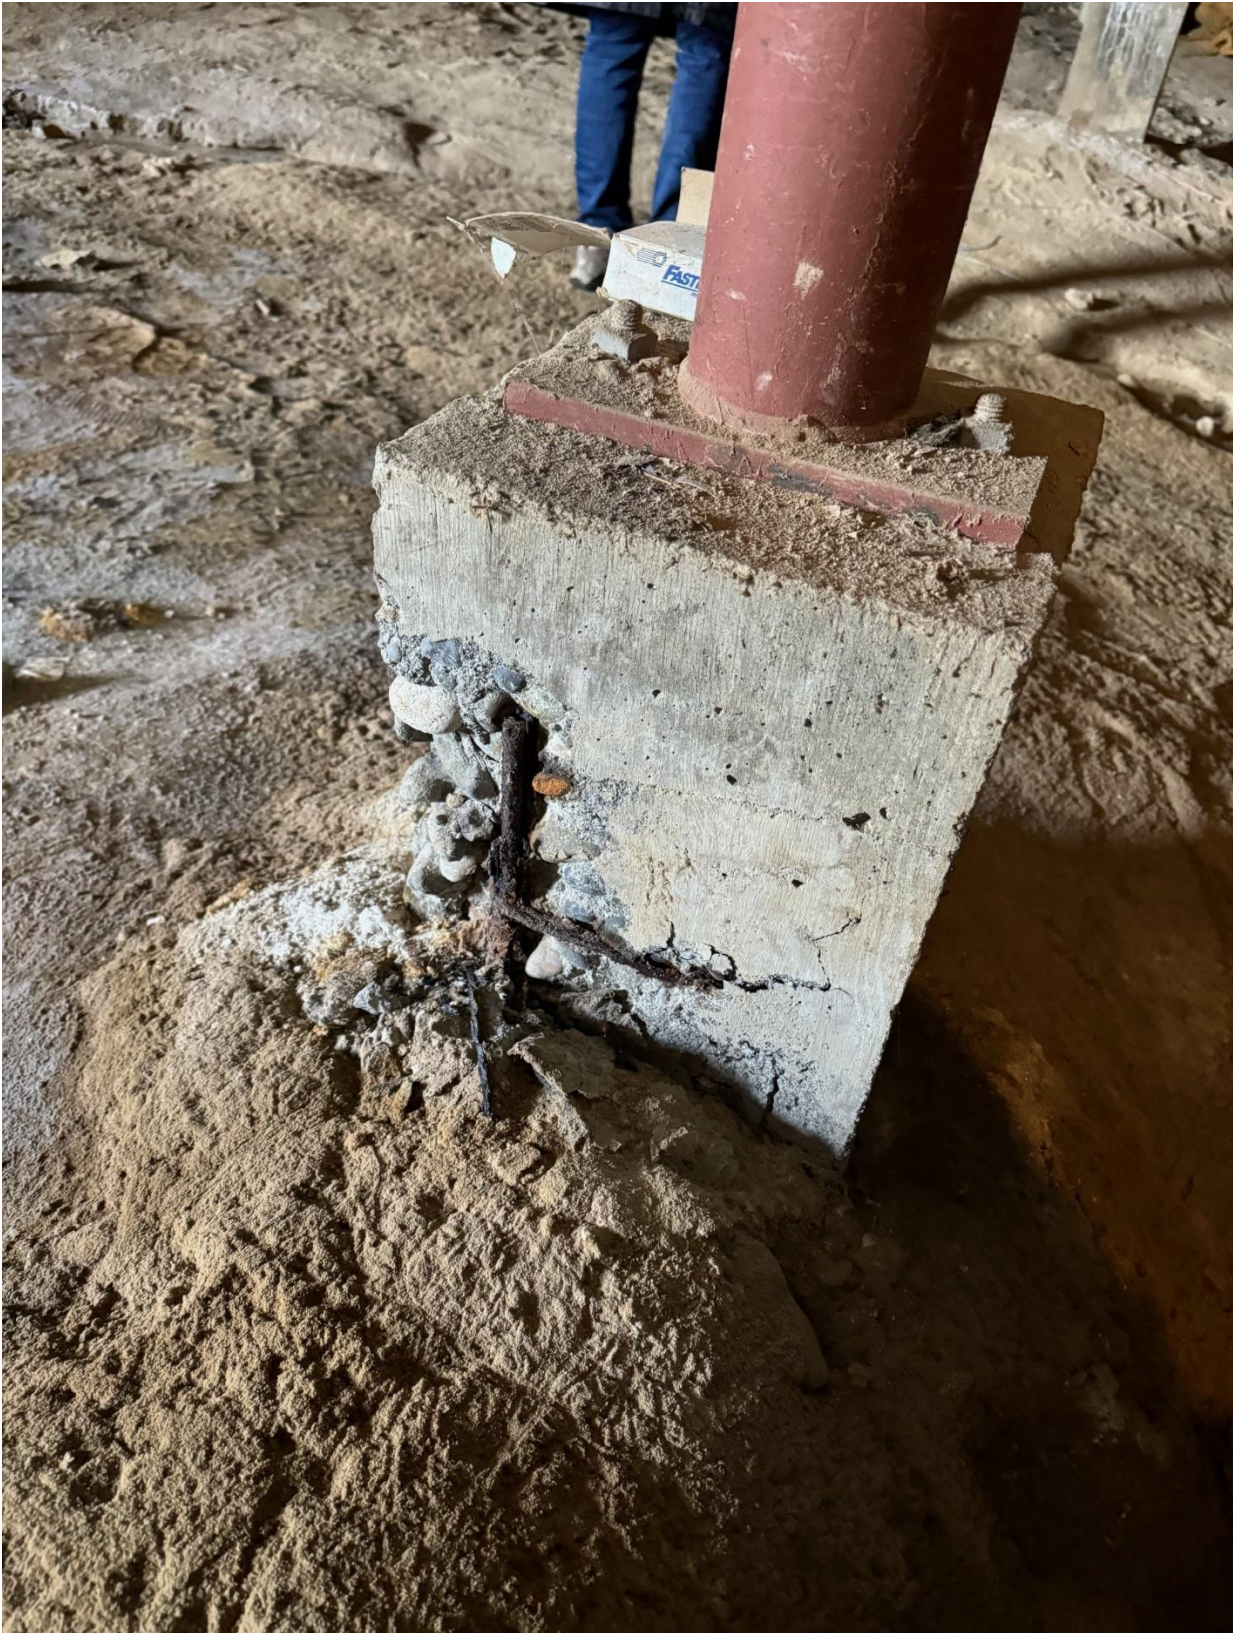
- Several concrete pilasters in large crawl space have damage at the corners and rusted reinforcing. Additionally, storm drainage is currently flowing through this crawl space and adjacent to these pilasters and footings below.
- Glulam floor beams for classrooms above were installed upside down with "Top" being visible from the bottom of the beam.
- Significant damage has occurred where the guard rail at the exterior ramp attached to the concrete wall on the South end of the Gymnasium.
- There are signs of roof leaks due to visible stained ceiling tiles in the small wrestling room & band room.
- Upstairs classrooms and hallways look good with minimal cracks in sheet rock and proper gapping at doors.
- Shop building structure appears in good condition

(Above: damaged pilaster in crawl space)

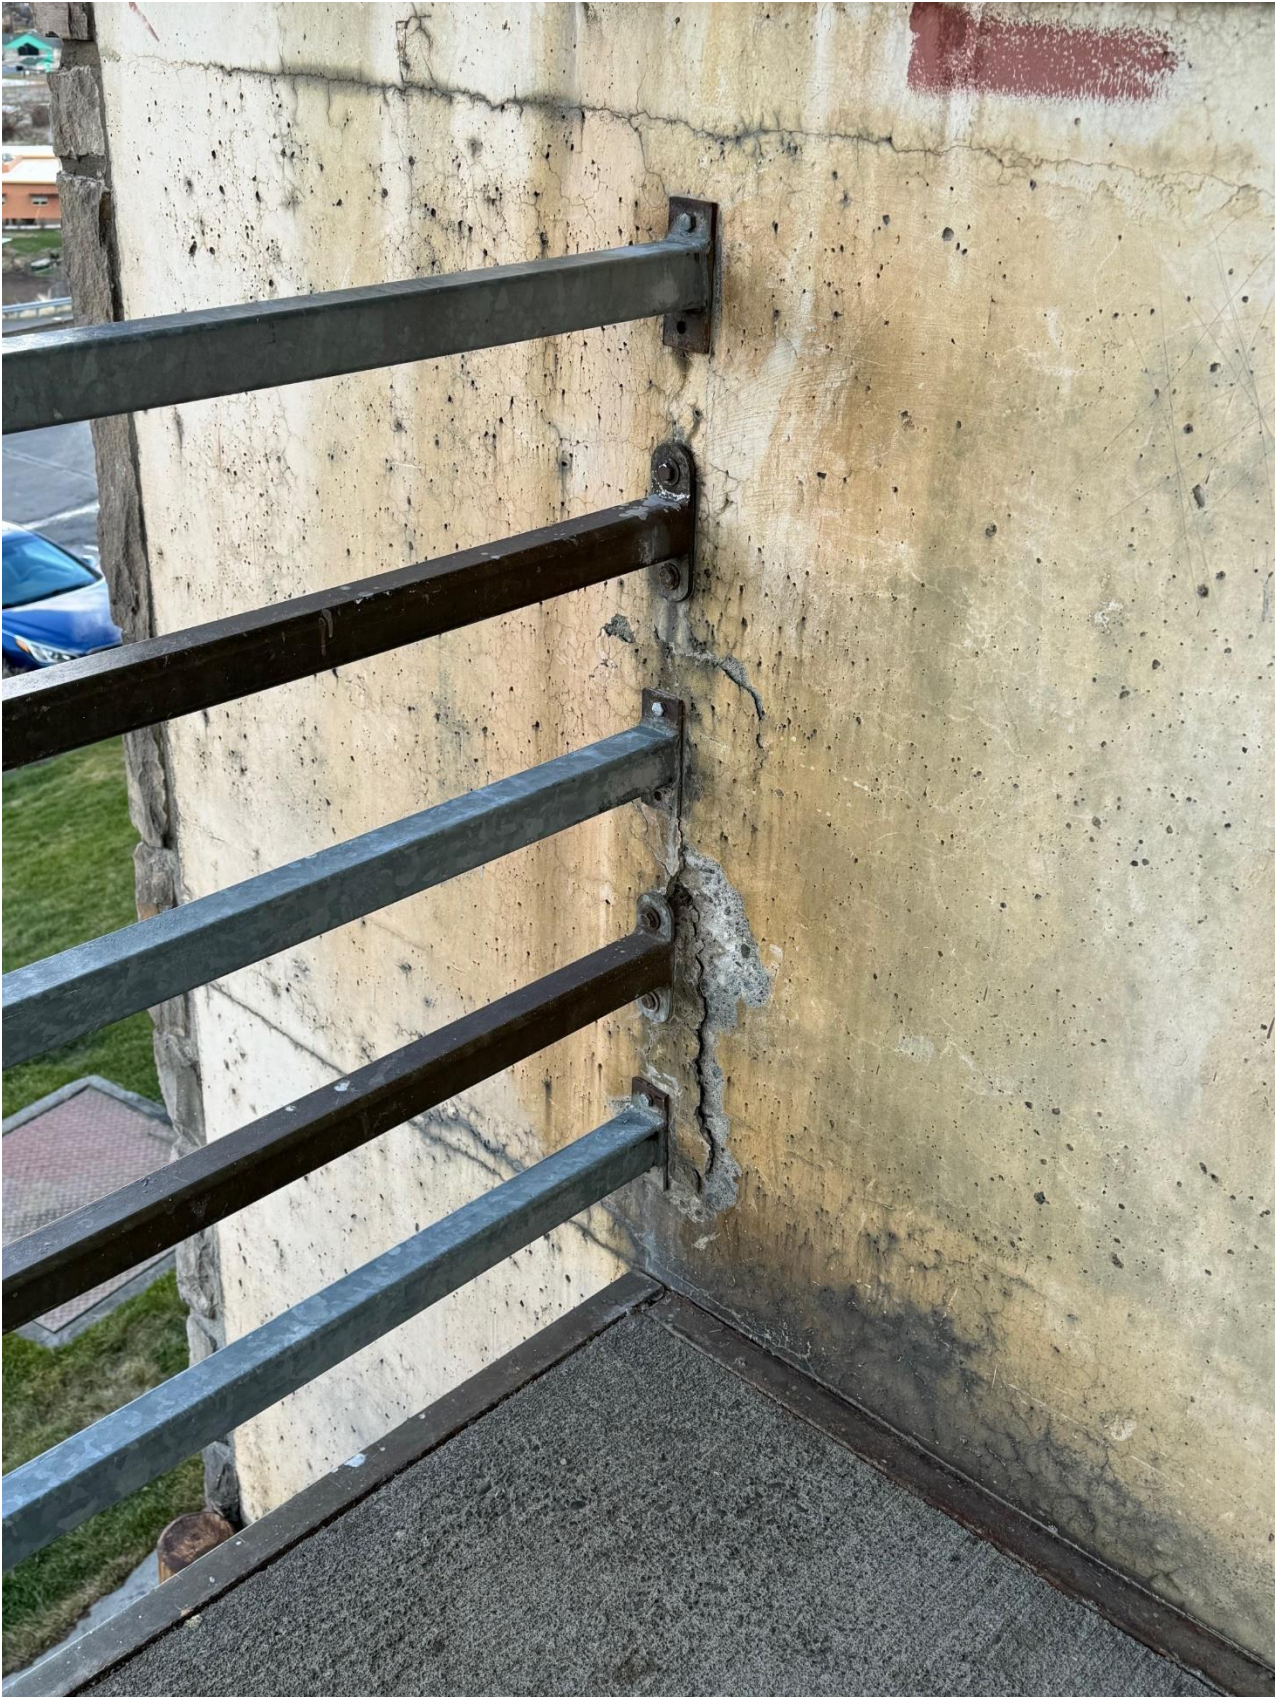
(Above: damaged guard rail connection)

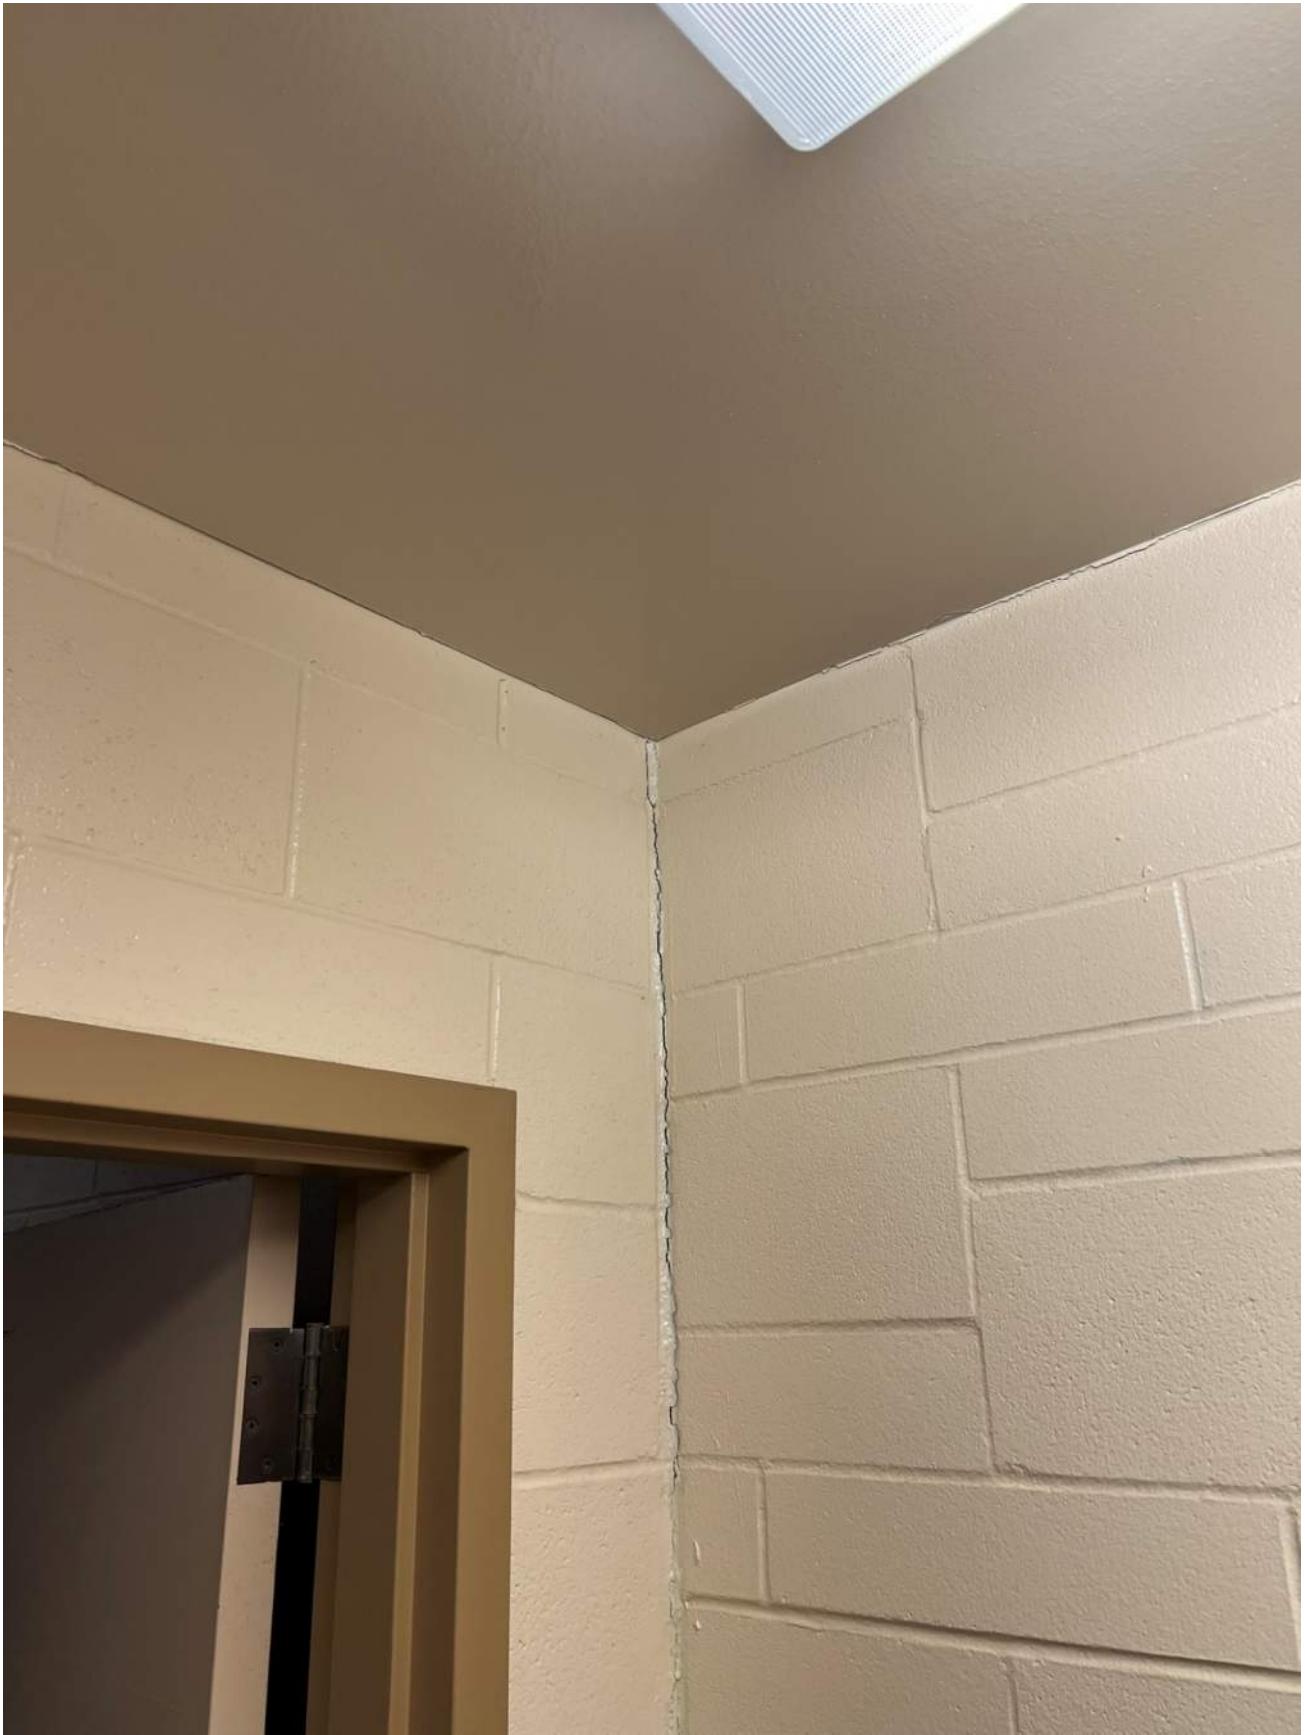
(Above: Cracks in wall of restrooms)

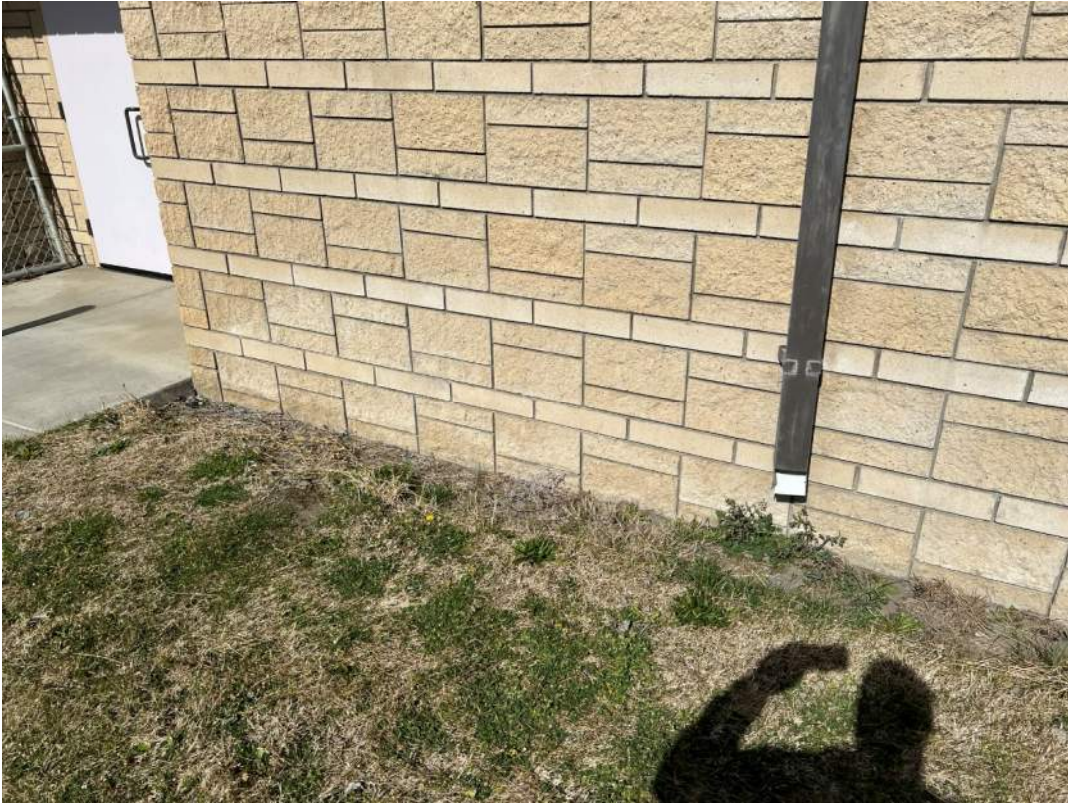
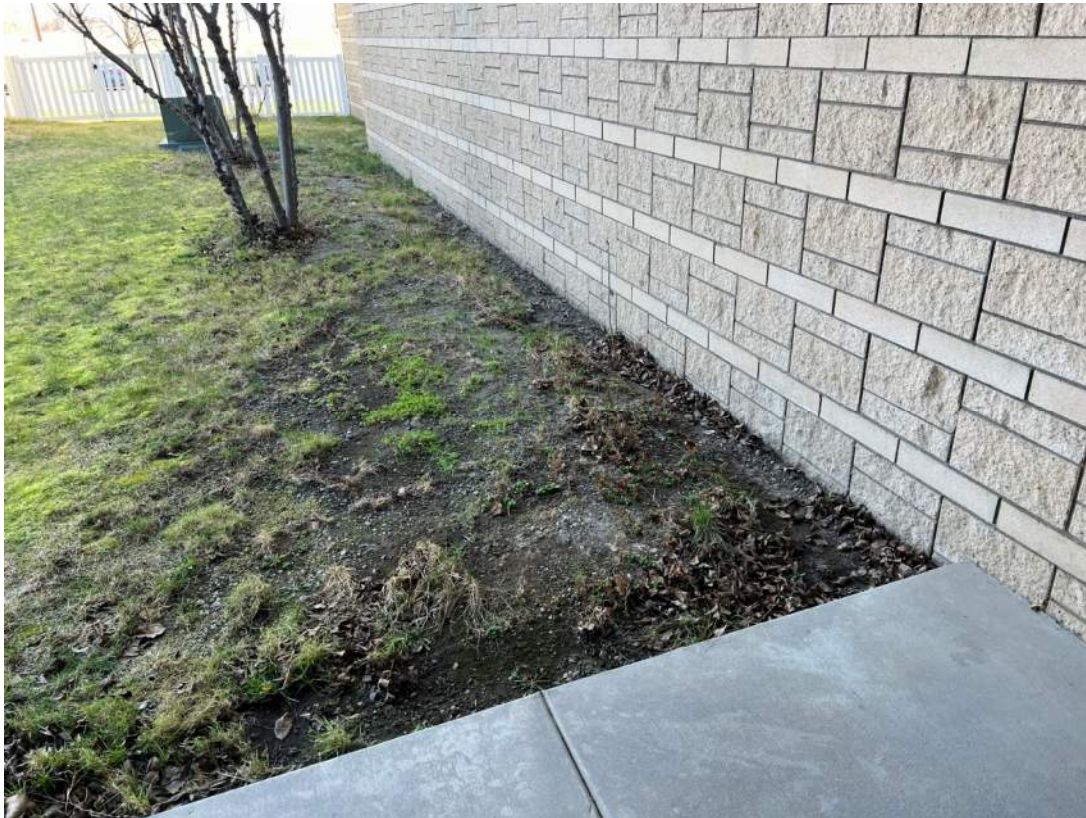
(Above: Downspout draining next to wall Below: Grade sloping toward building)

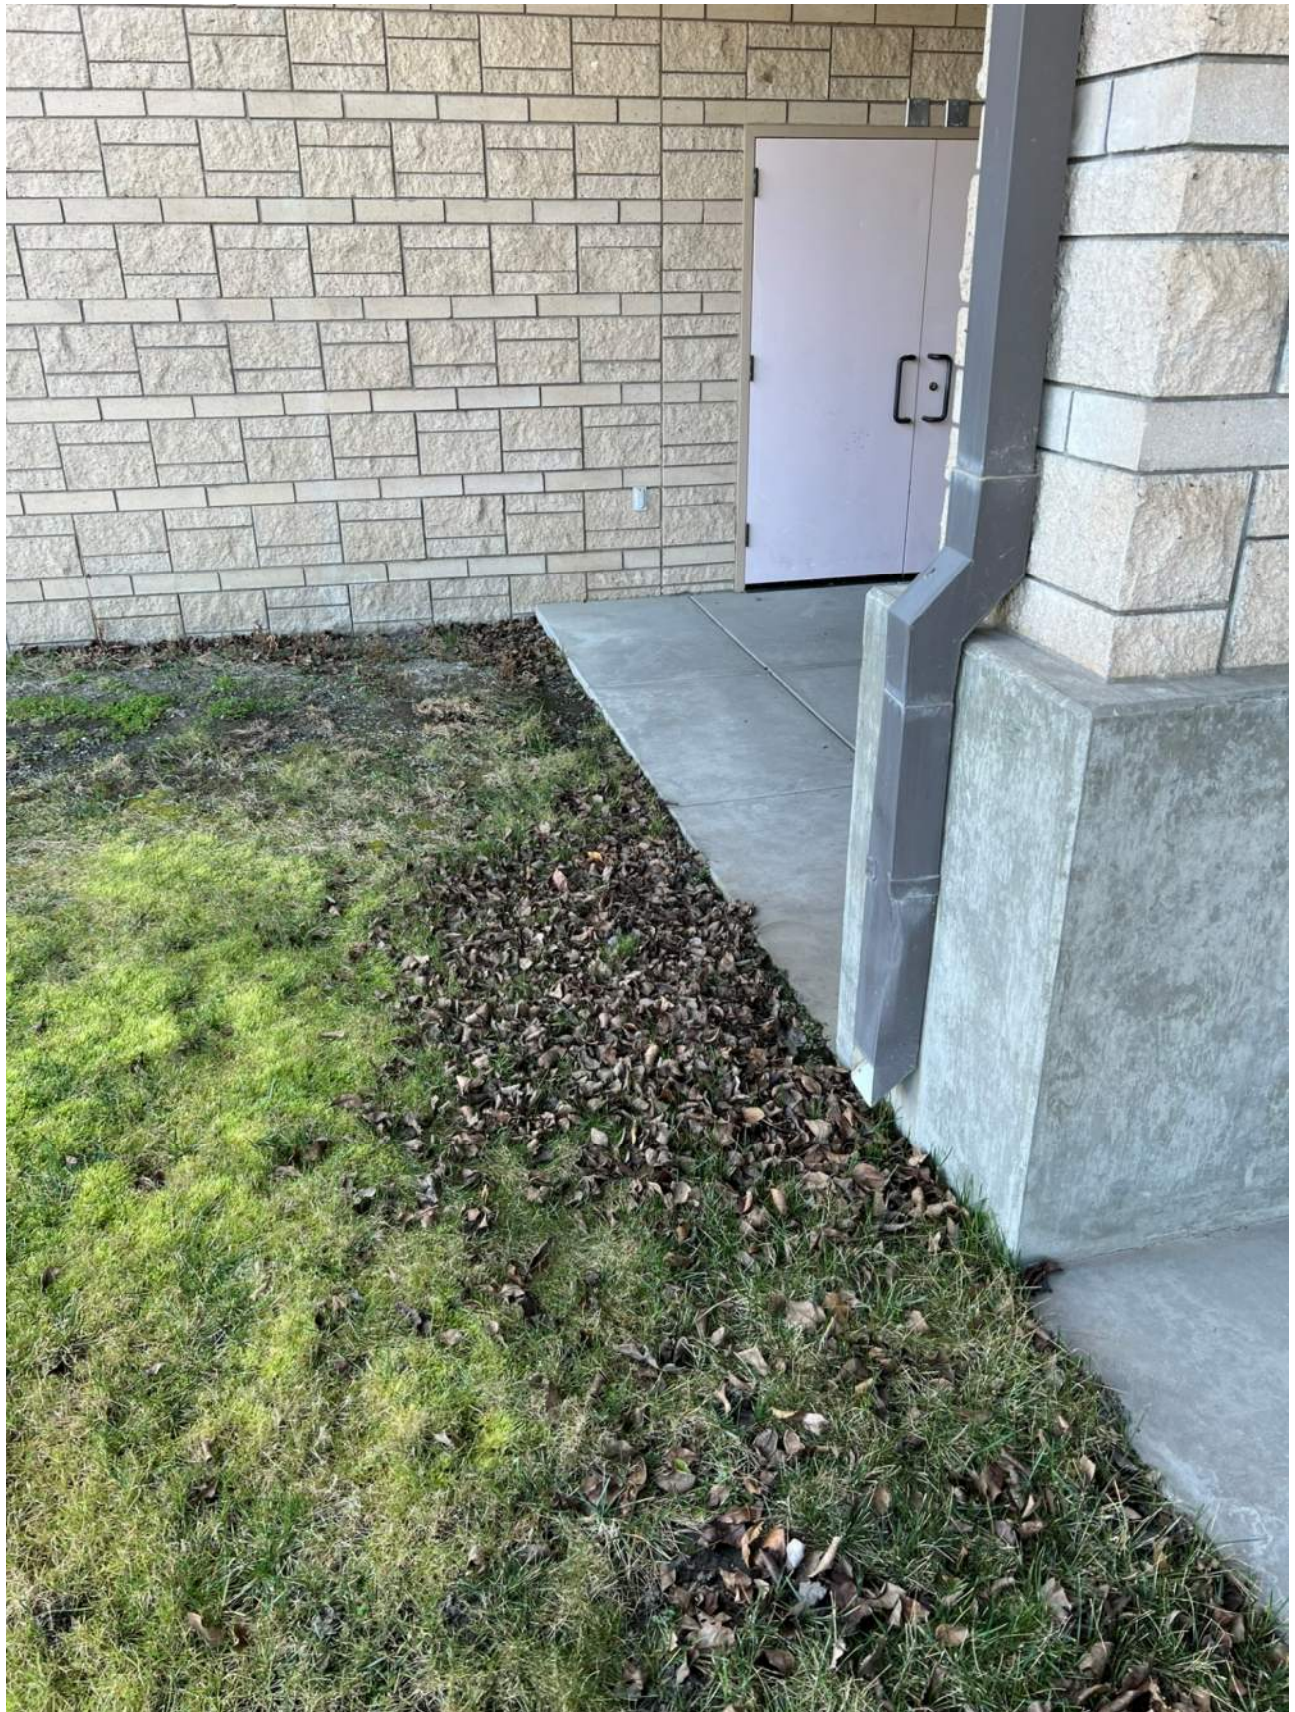
(Above: Downspout draining next to foundation and grade sloping toward building)

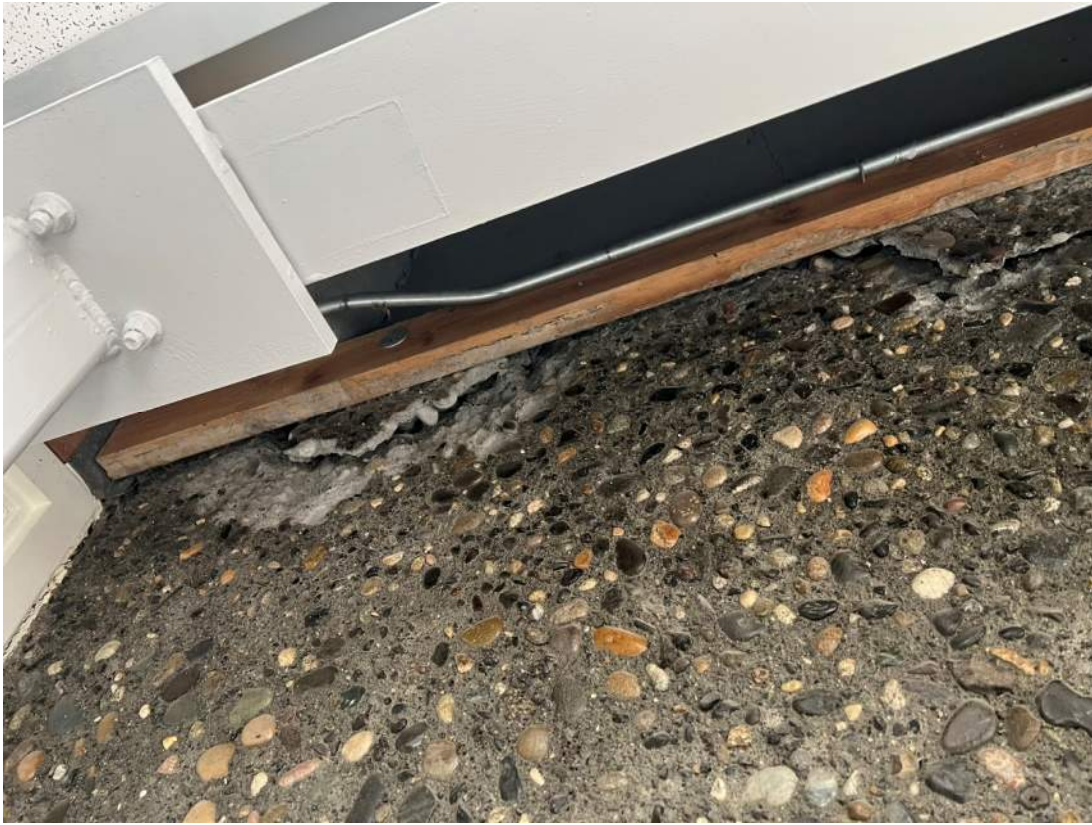
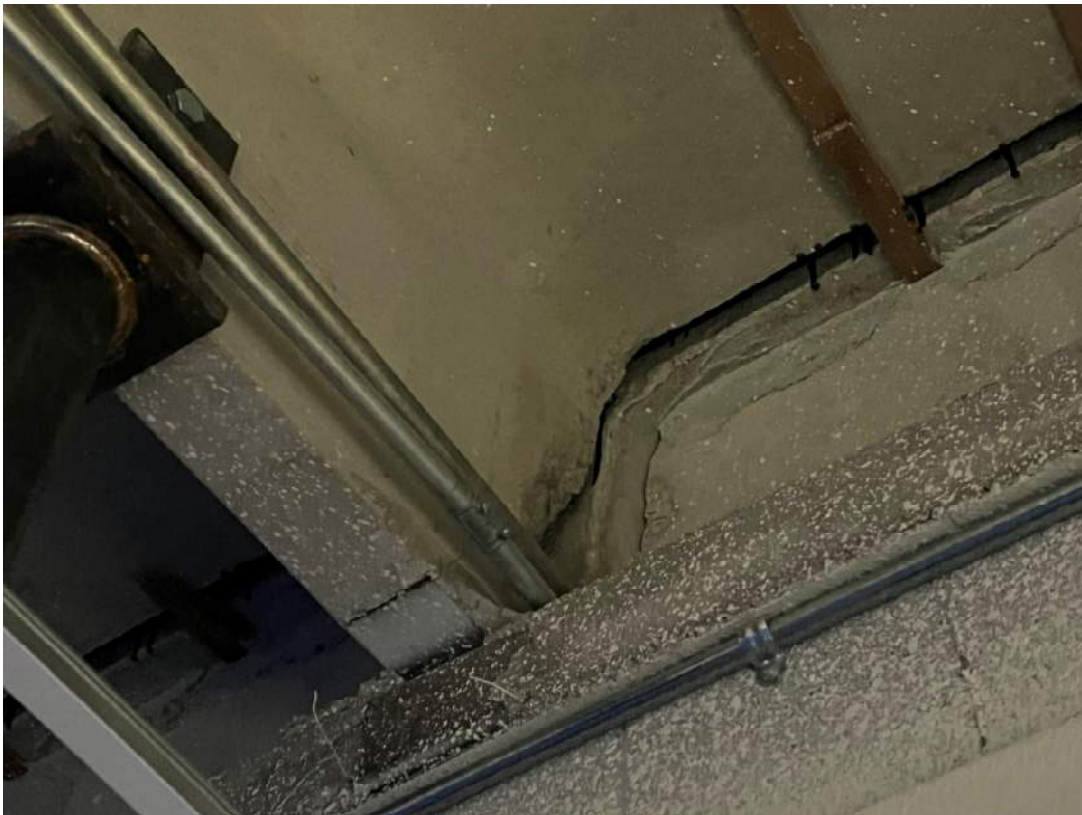
(Above: Wall Spalling Below: Cracking @ Double Tee Bearing End)

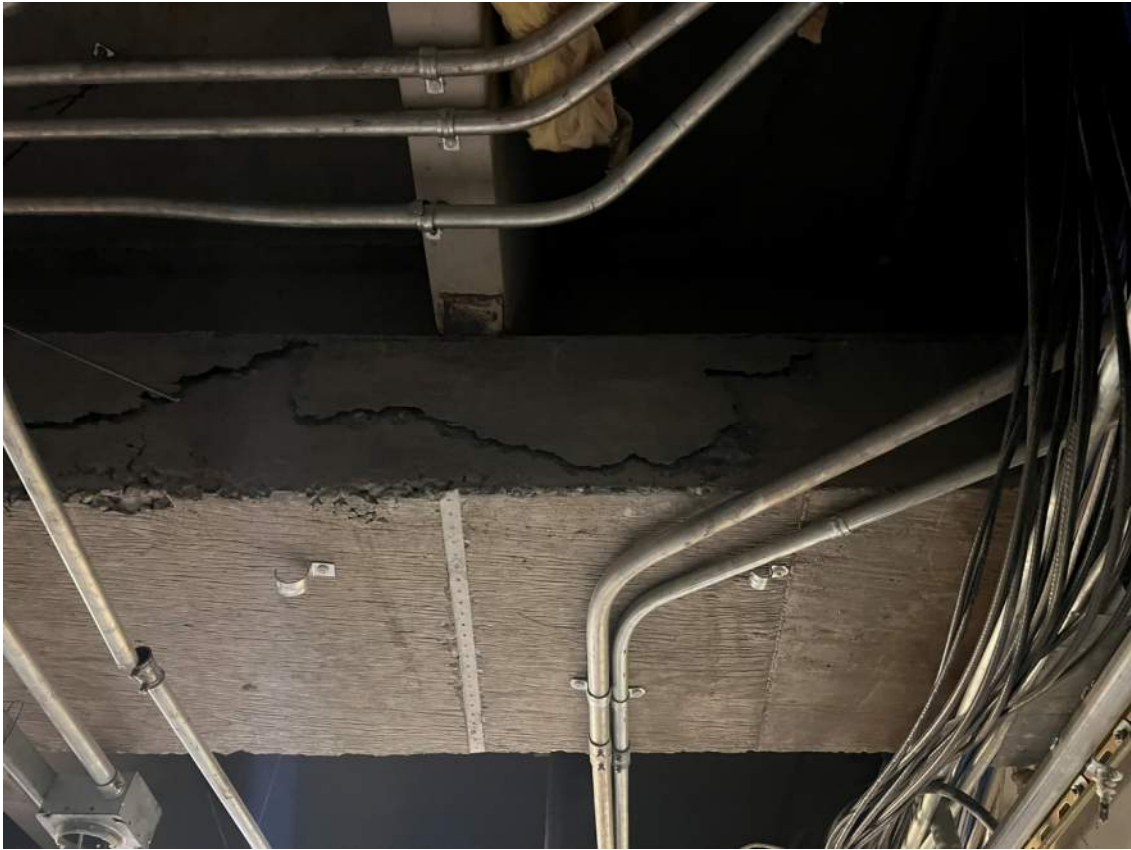
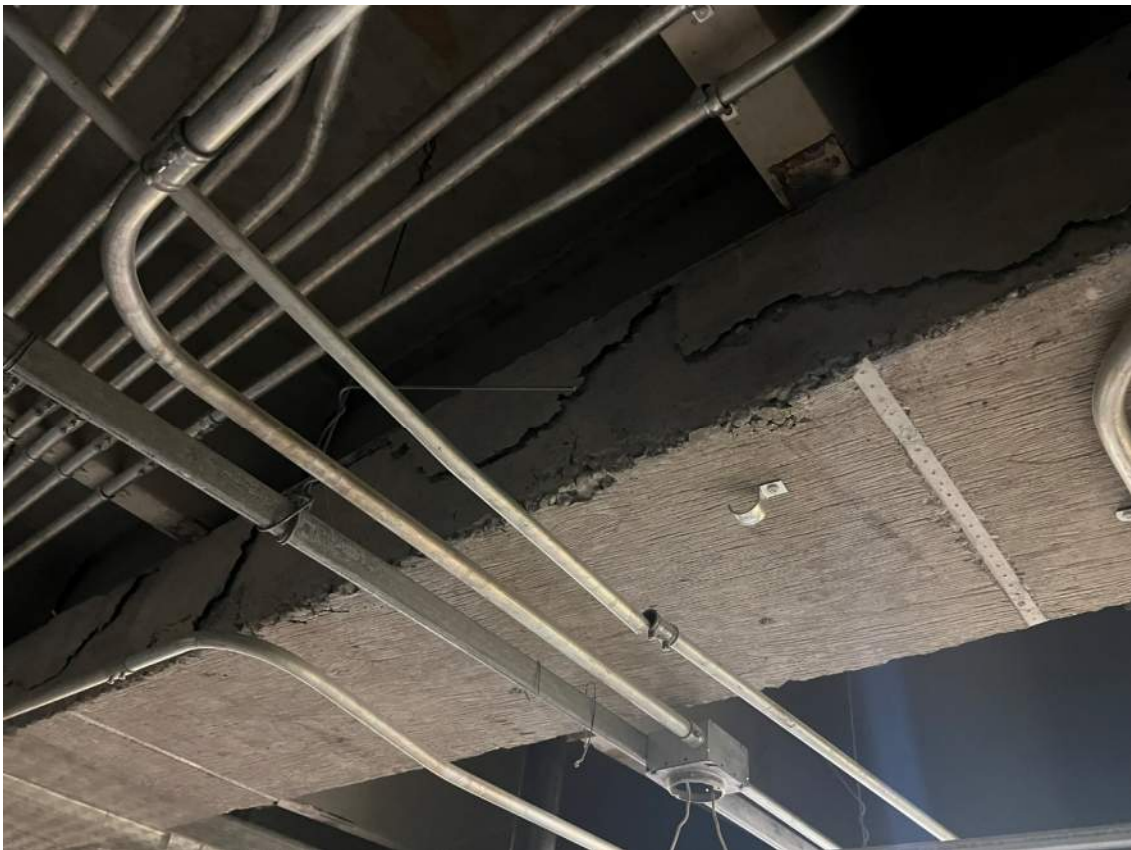
(Above/Below: Cracks in roof support beam)
