Morrow County School District Facilities Assessment

May 9, 2024

Morrow County School District Facilities Assessment Report

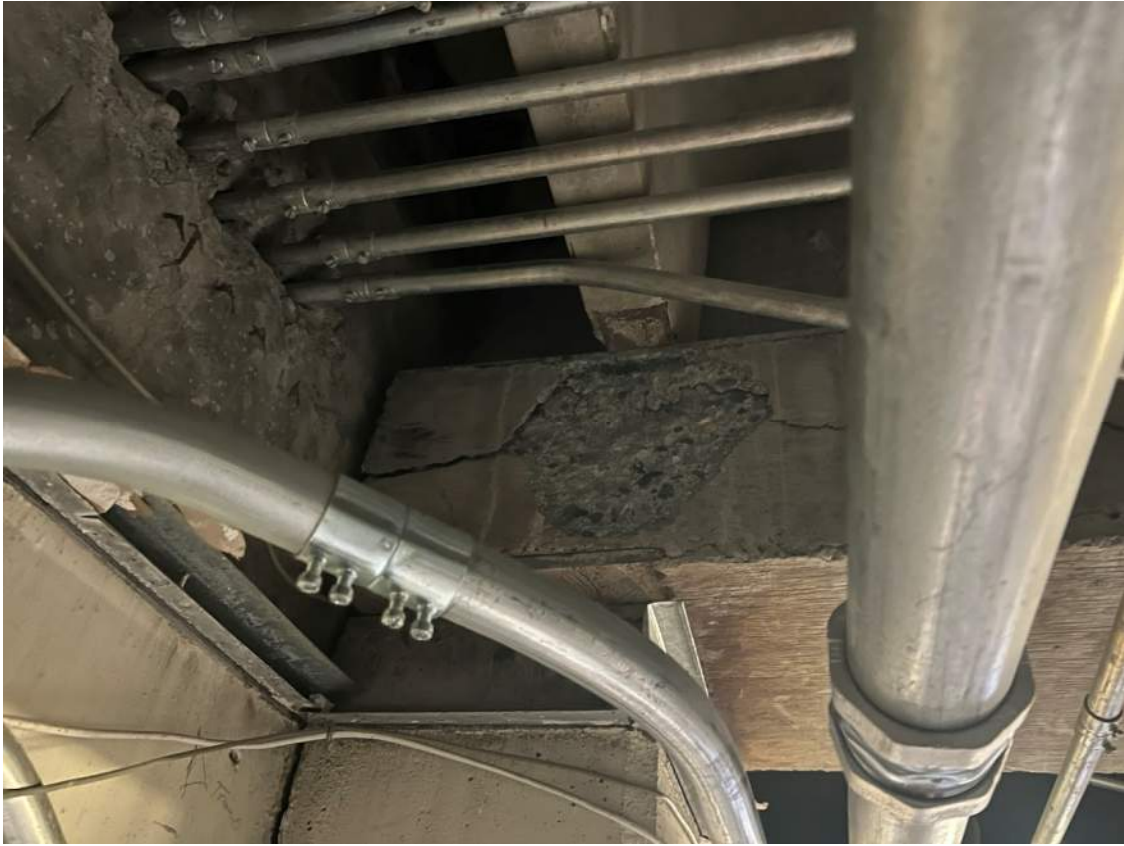
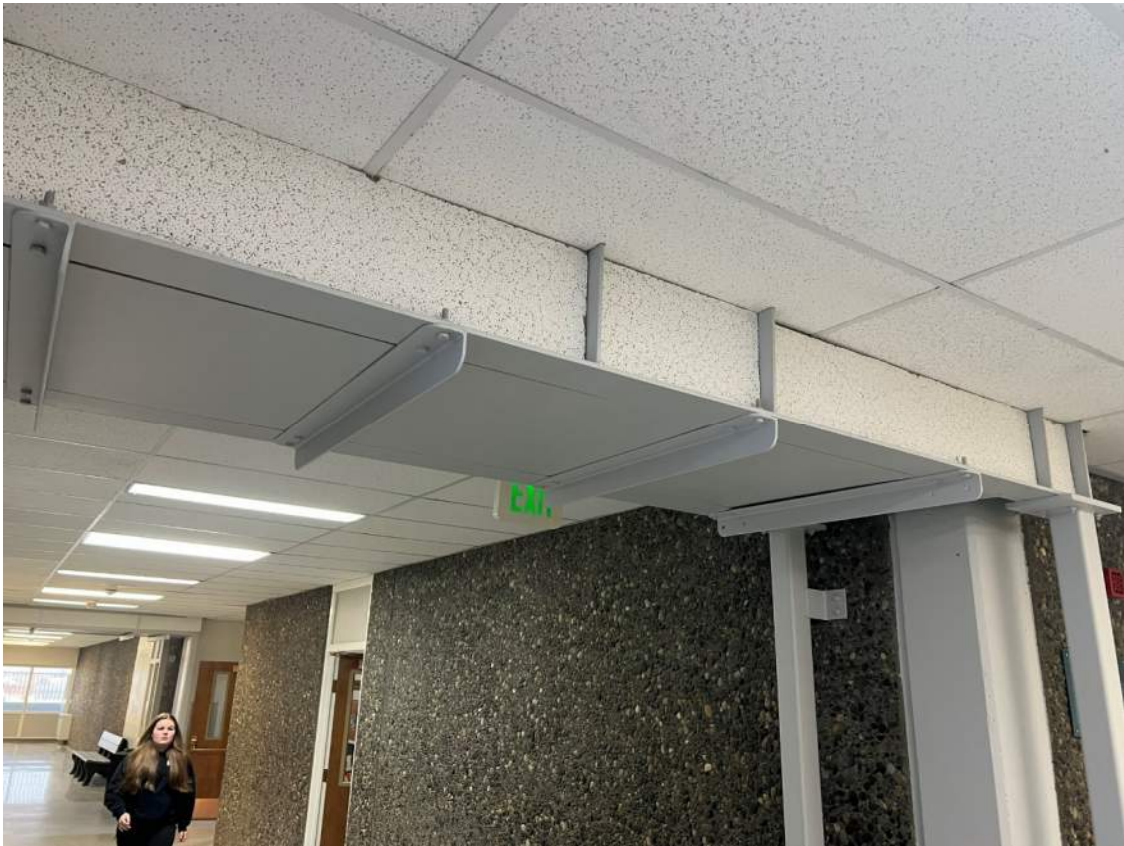
(Above: Crack/Spalling at roof support beam Below: Temporary Shoring in place)

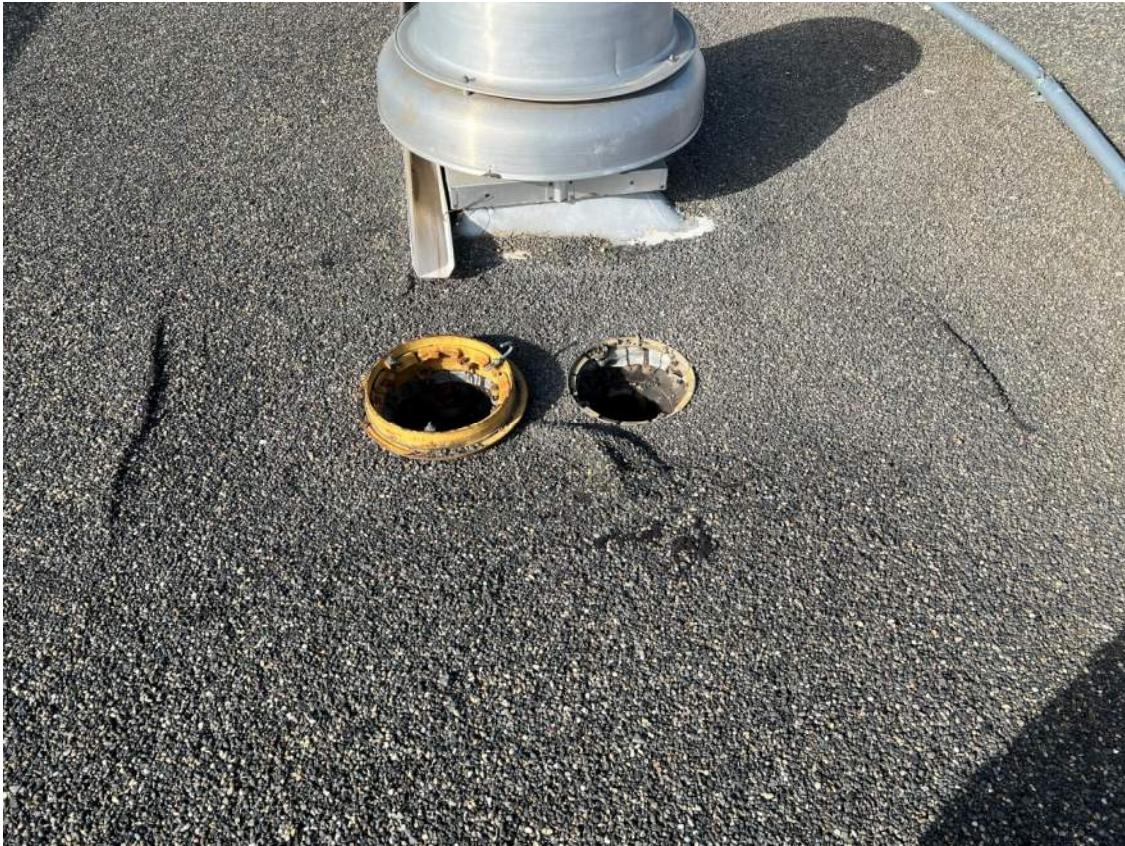
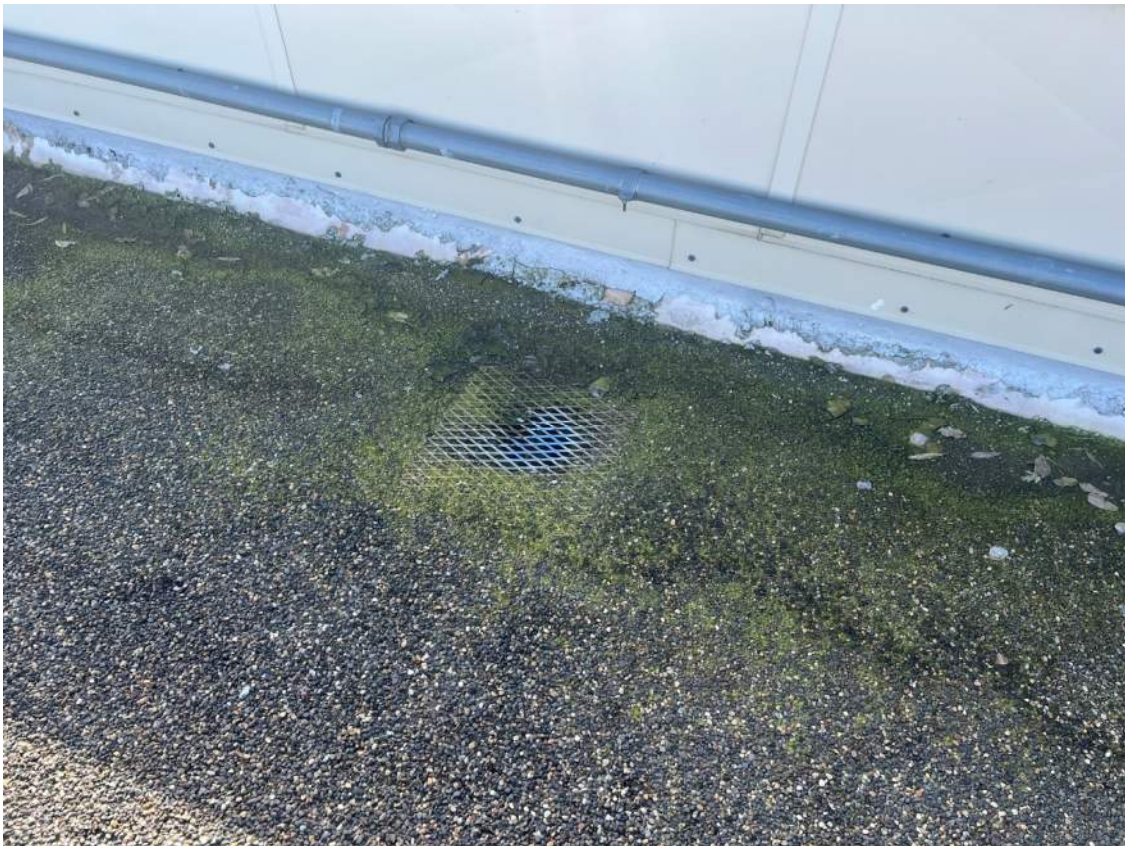
(Above: Roof drain not covered Below: Mesh roof drain cover)

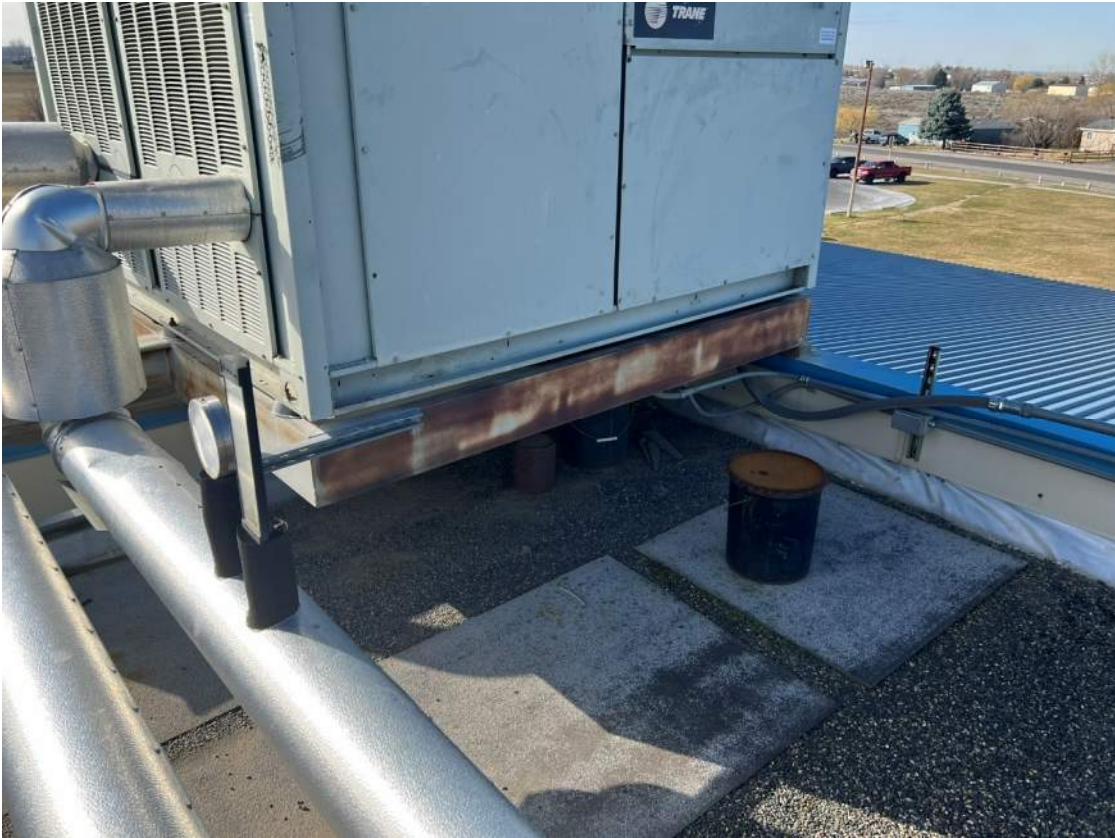
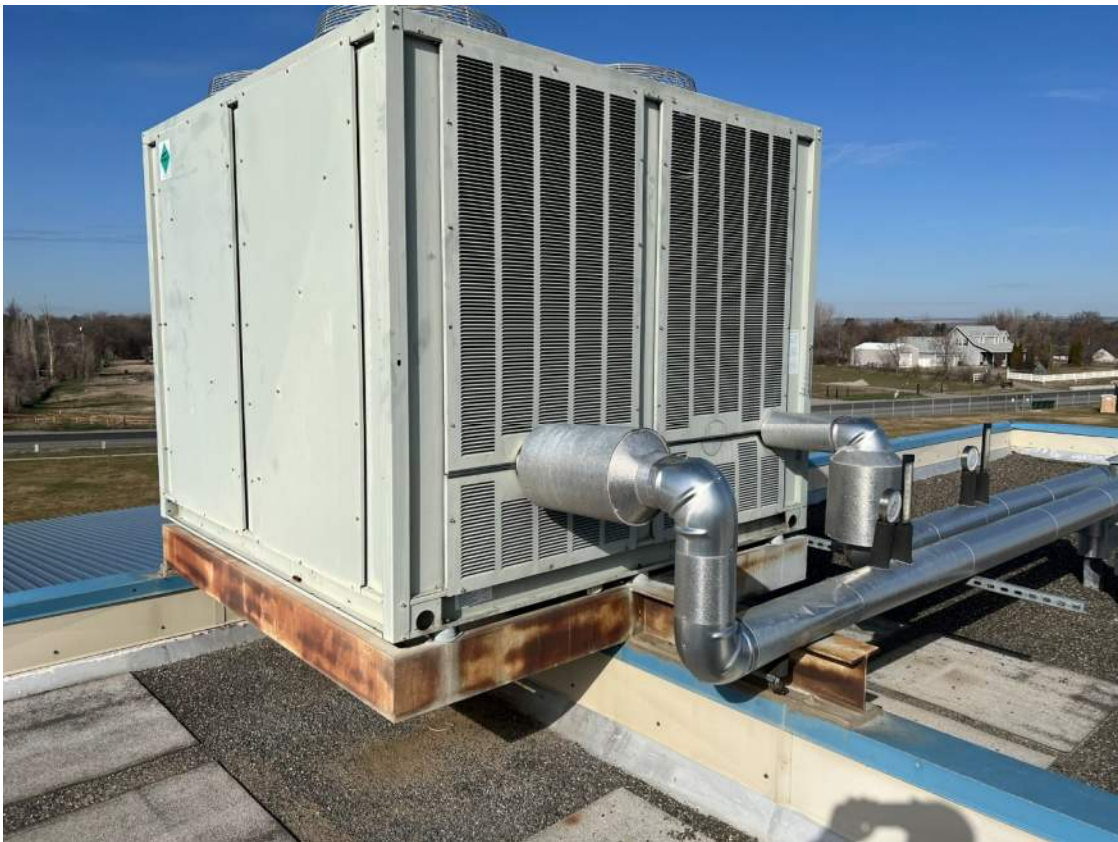
- There is a roof top mechanical unit above the gymnasium/mechanical mezzanine that sits on a steel frame supported atop the parapet. This does not appear to be adequately supported and

it is generally advised not to support equipment on parapets. In a seismic event, the parapet may not be adequate to support the unit causing it to collapse on the upper or lower sloped roof.

(Above/Below: Rooftop mechanical unit supported by parapet)

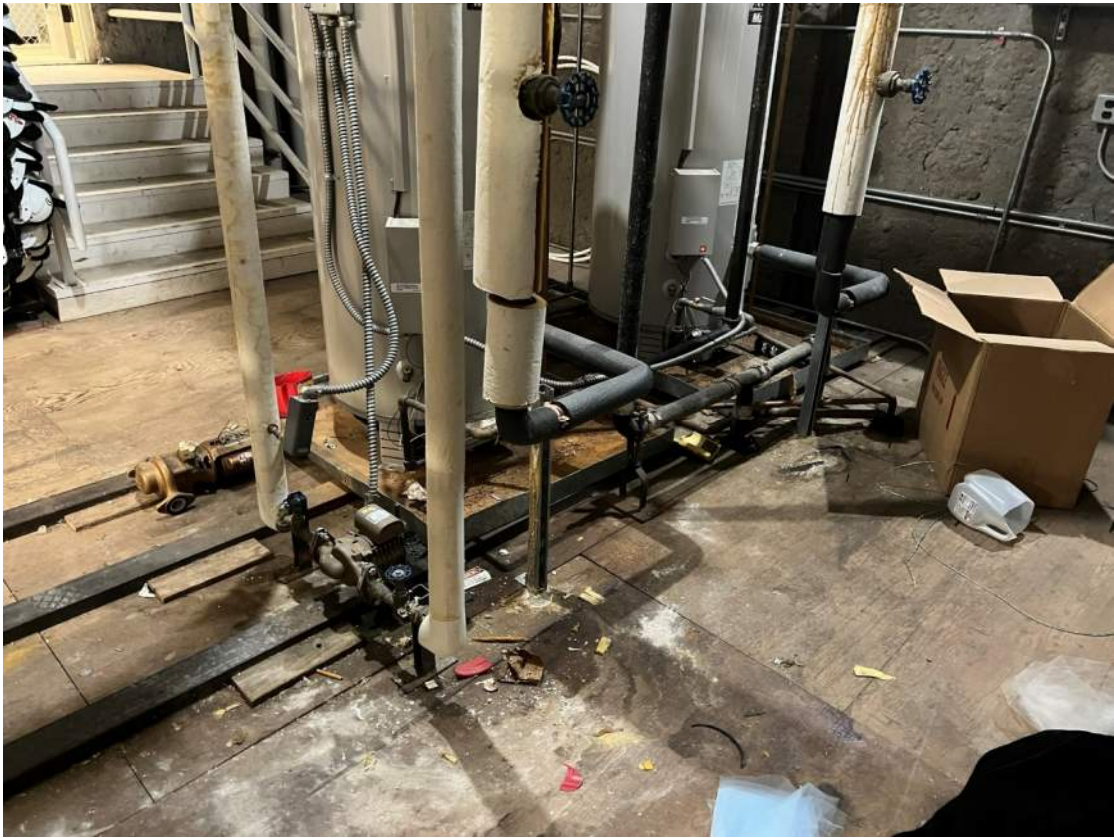
(Above: Flooring below water heaters @ mechanical mezzanine)

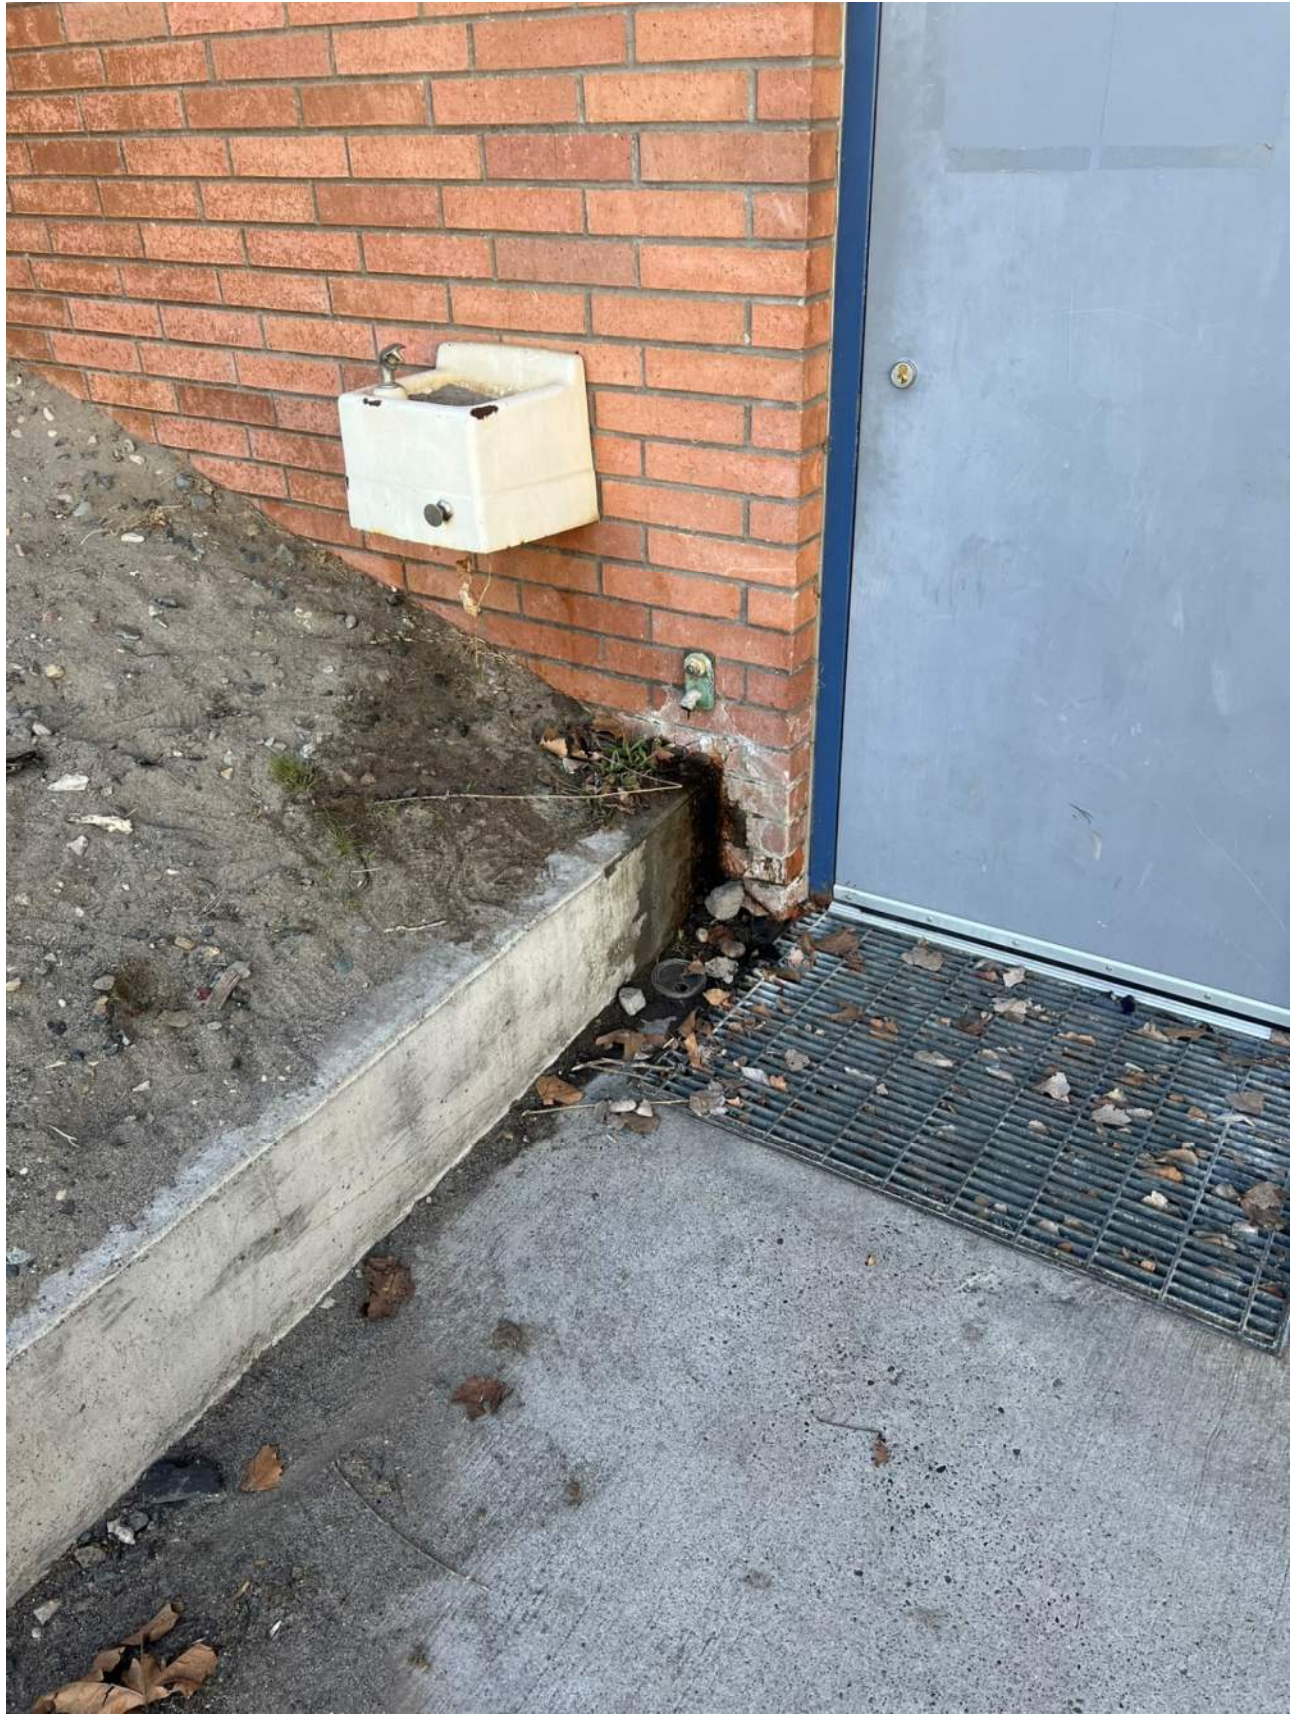
(Above: Water dripping from spicket outside North side of gymnasium door)

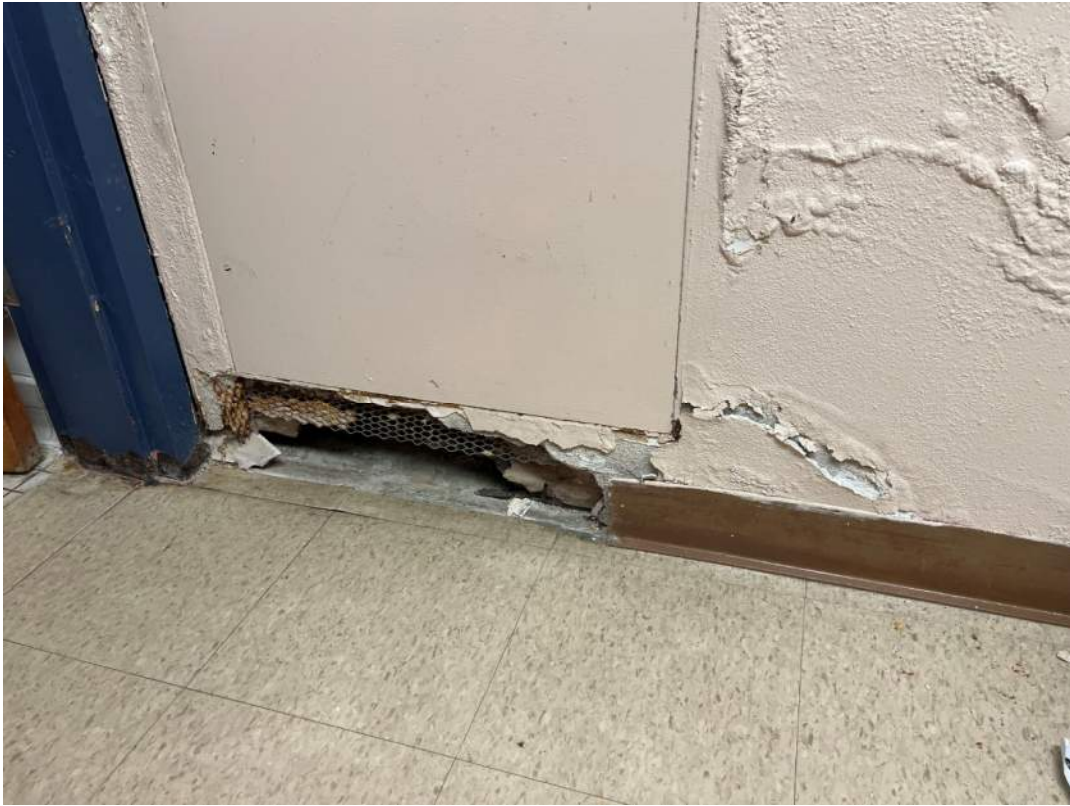
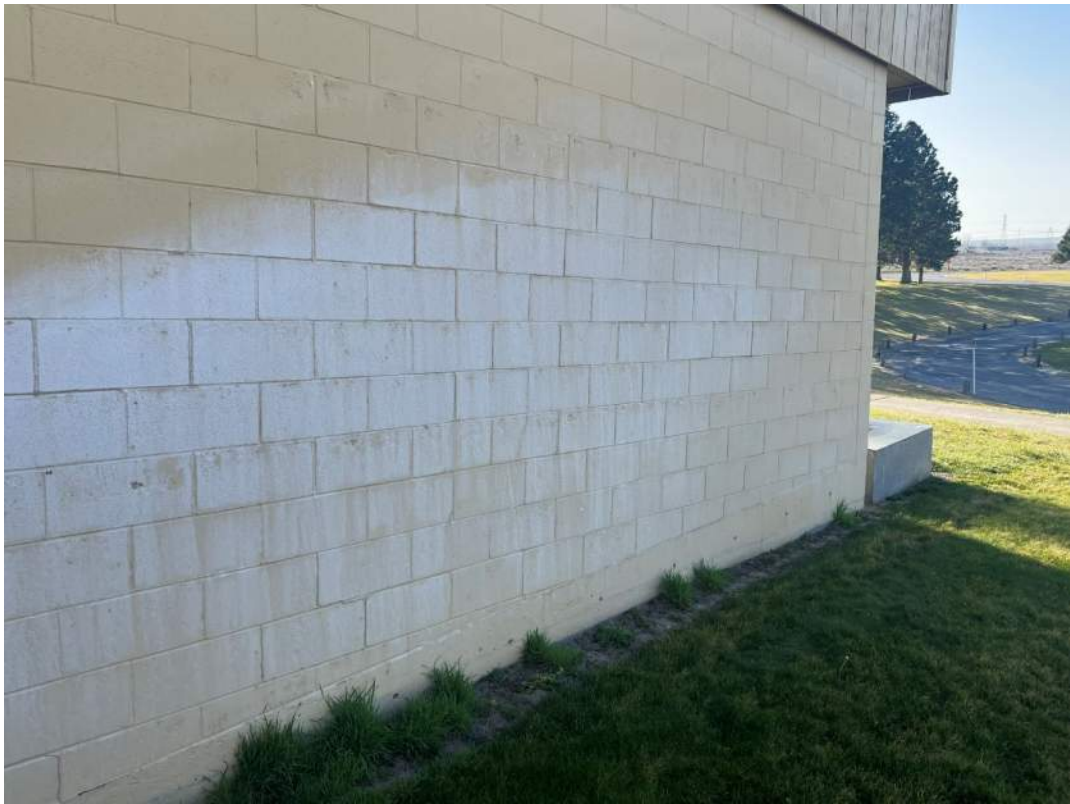
(Above: Deteriorating walls at locker rooms Below: Irrigation spraying walls)

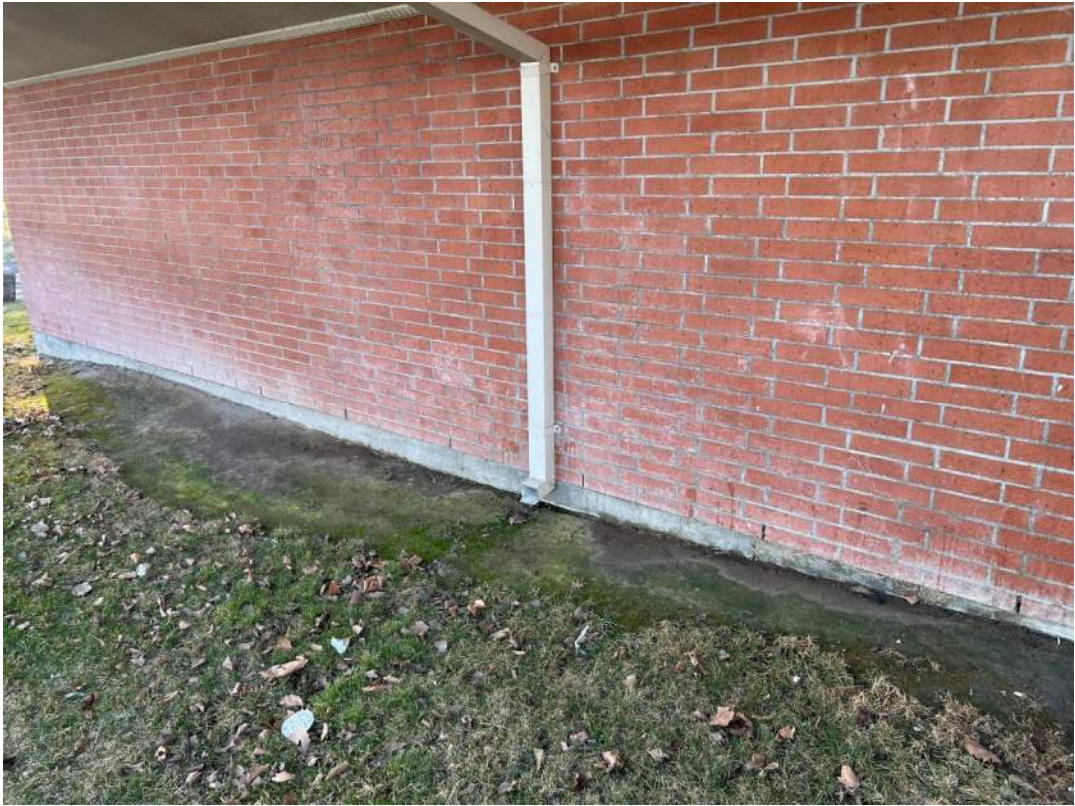
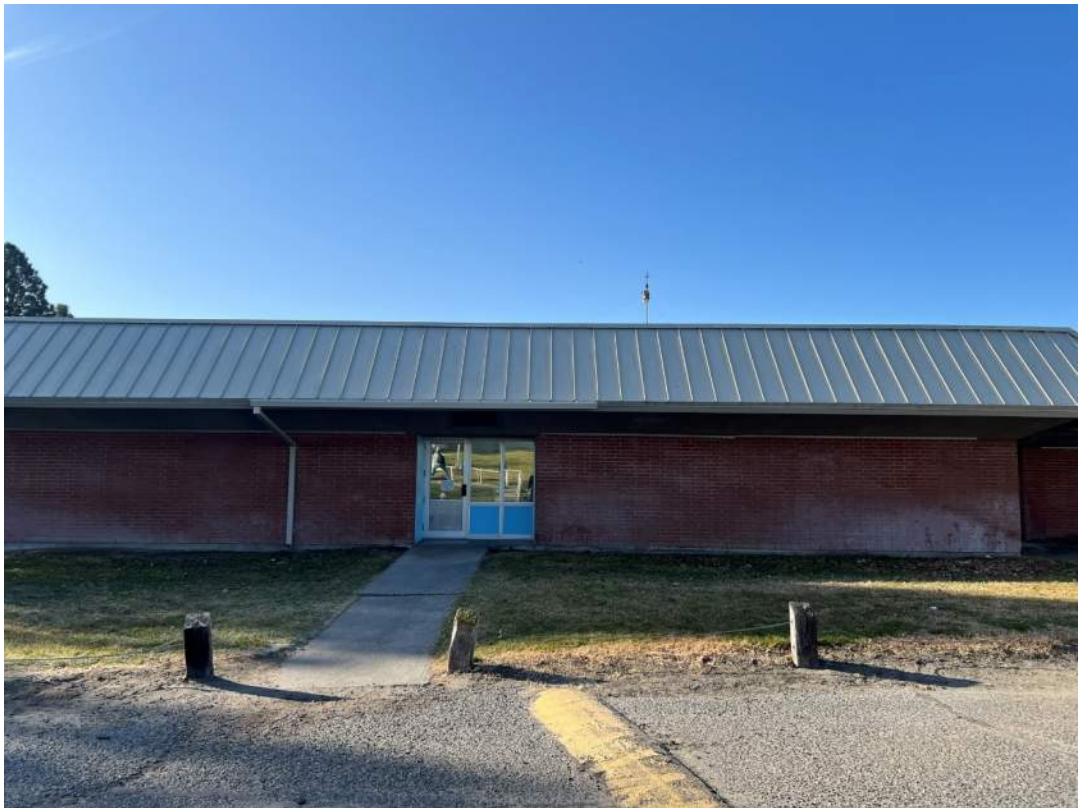
(Above: Downspout draining next to building Below: Irrigation spraying walls)

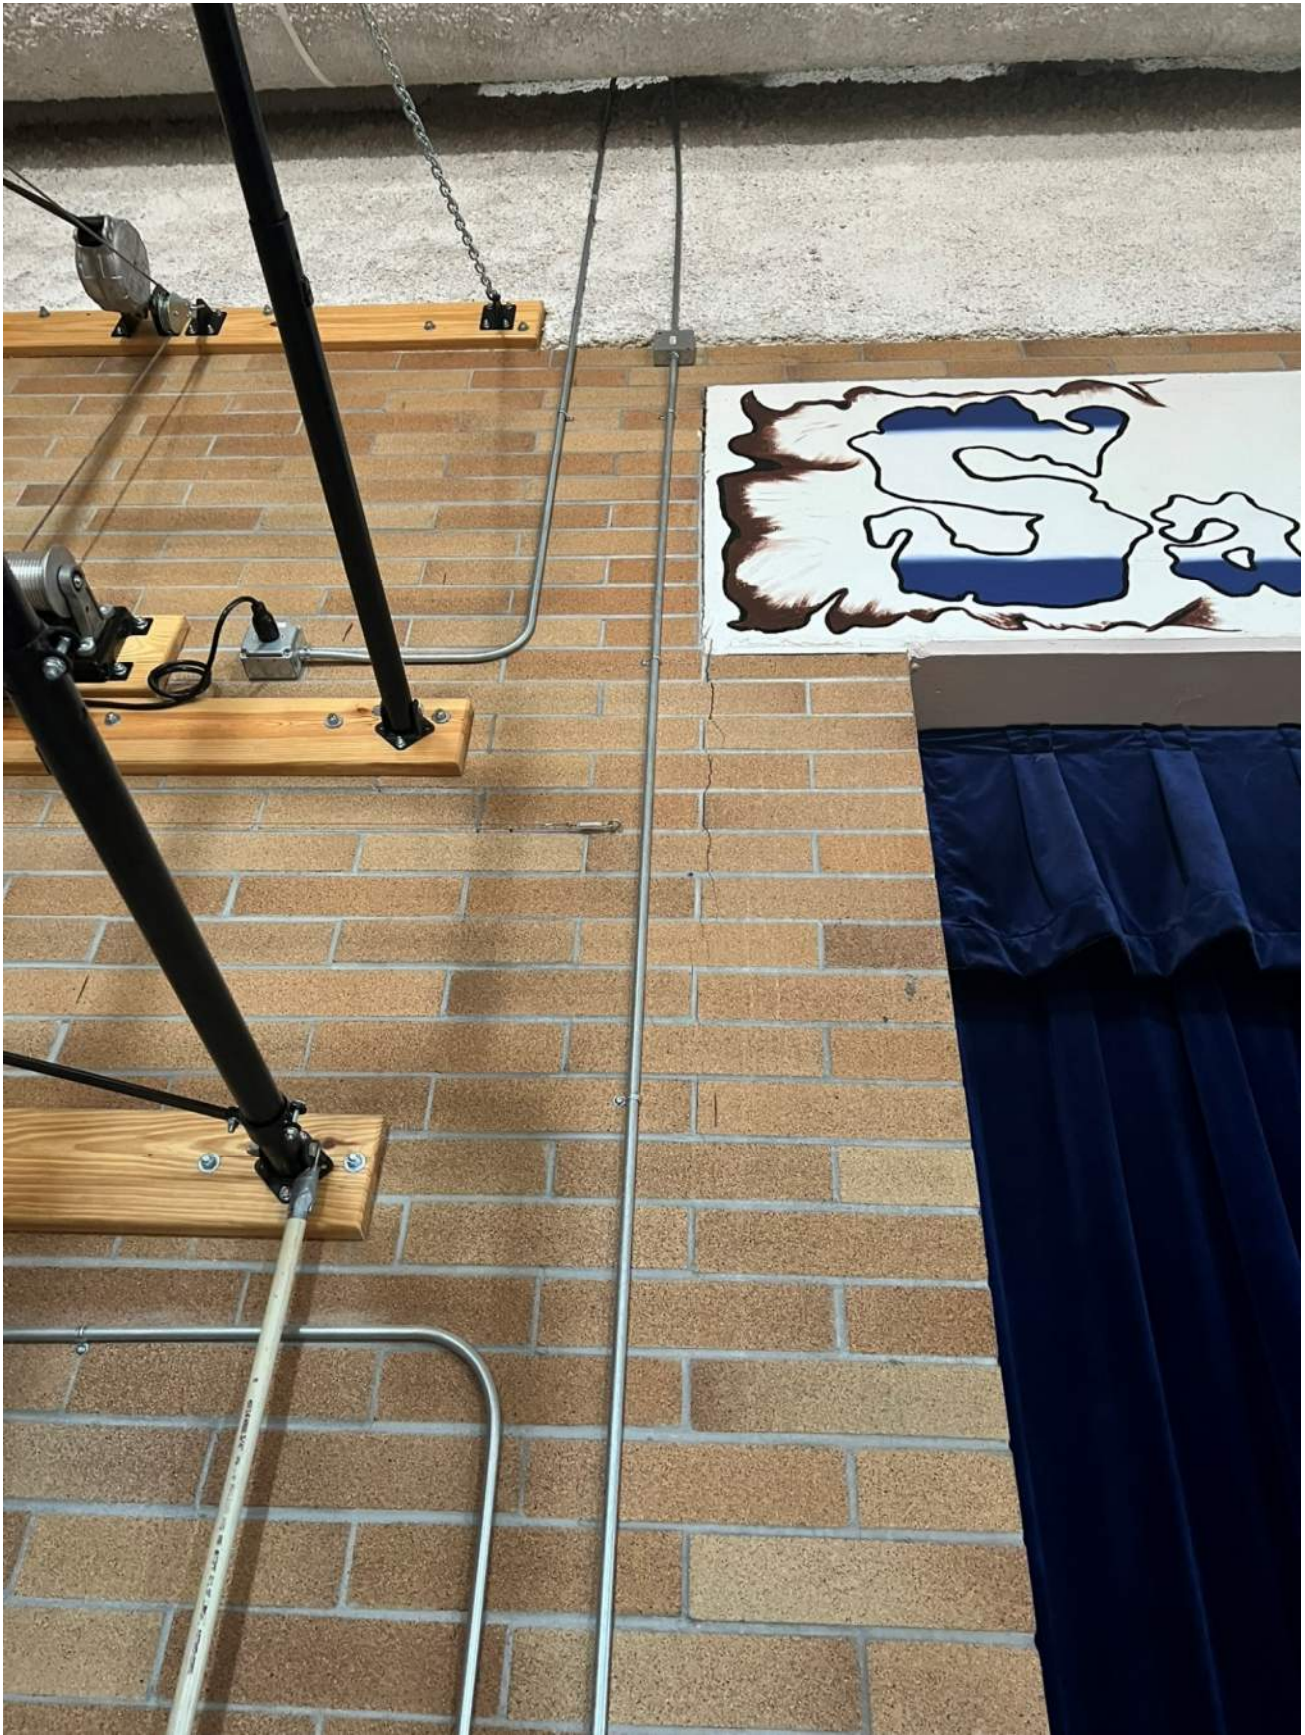
(Above: Minor cracks in pilaster adjacent to stage opening)

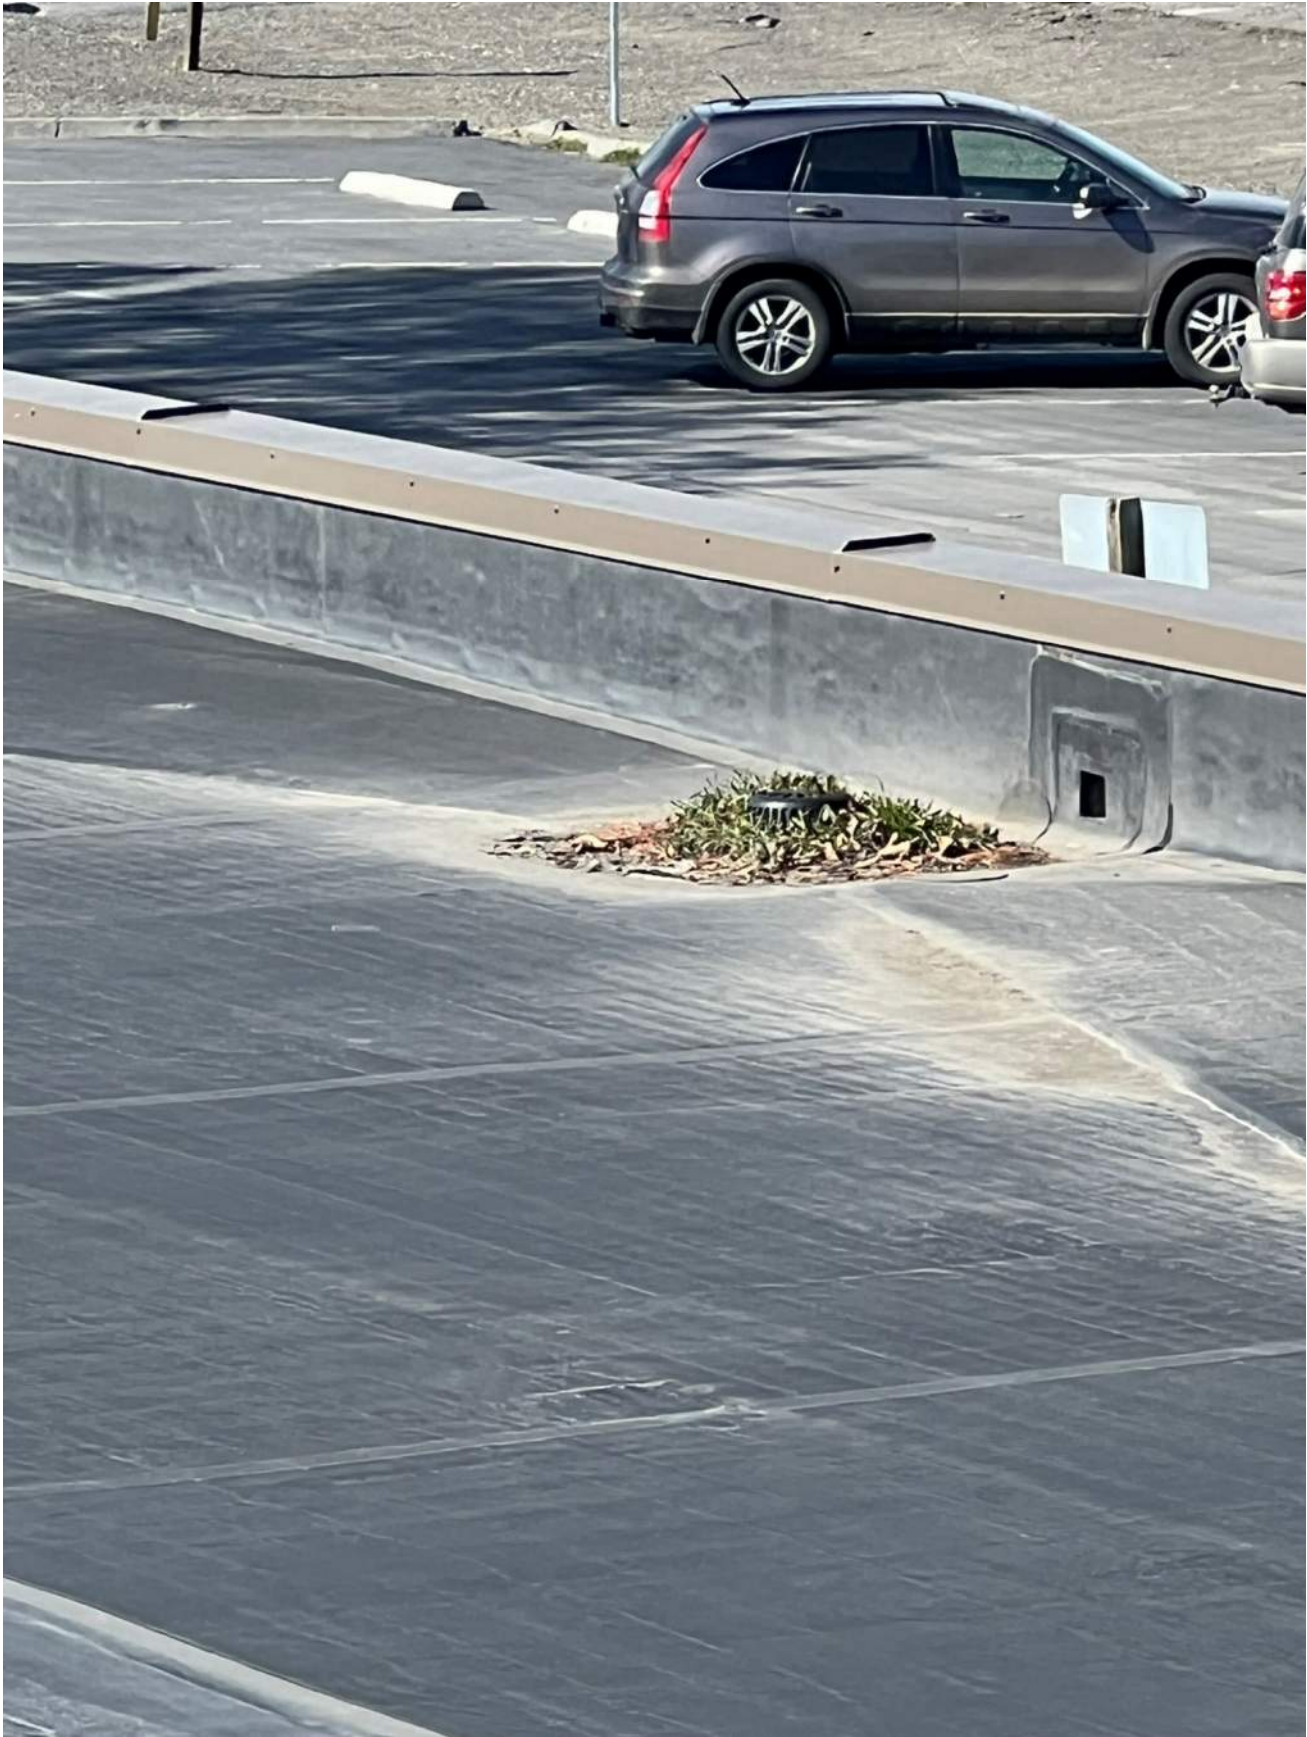
(Above: Roof debris and grass clogging drain)

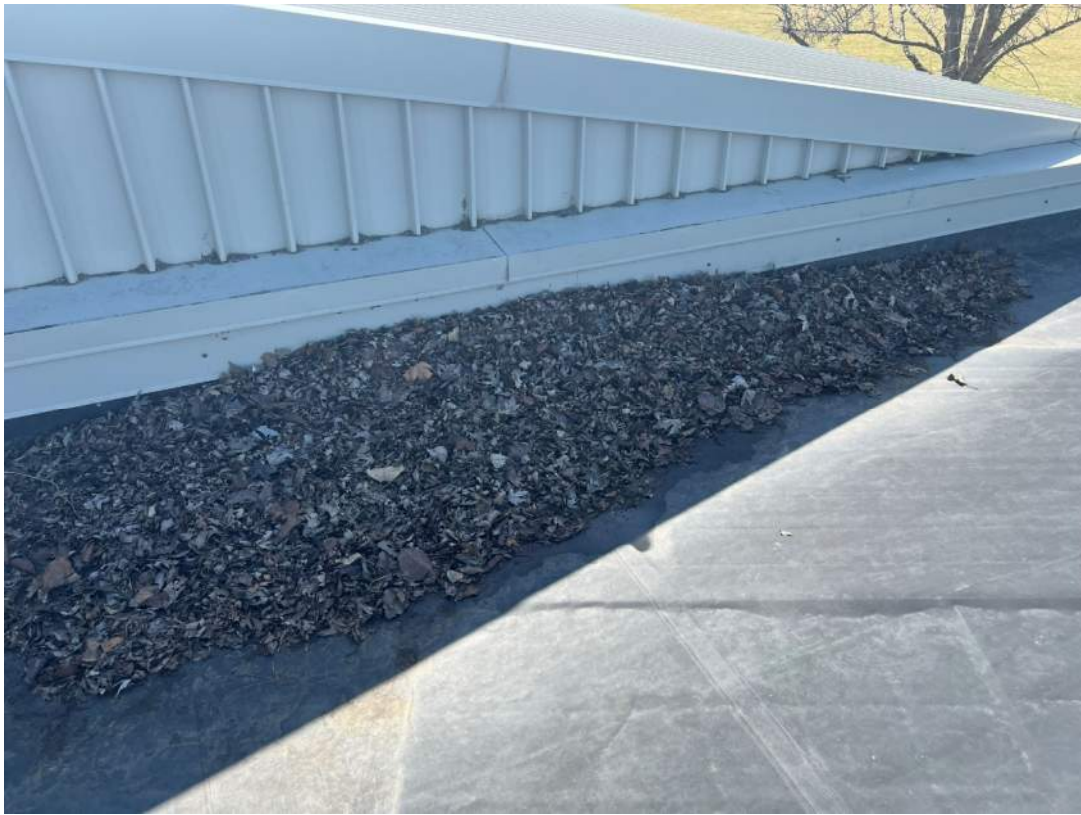
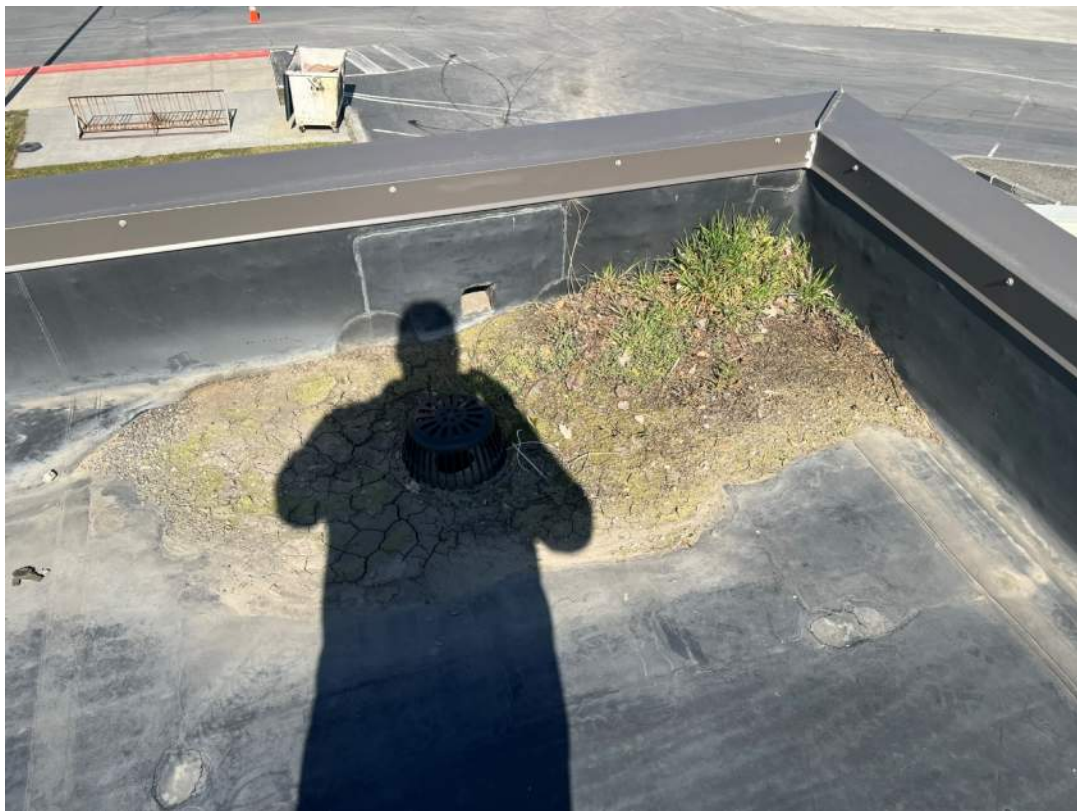
(Above: Roof debris Below: Roof debris and grass clogging drain)

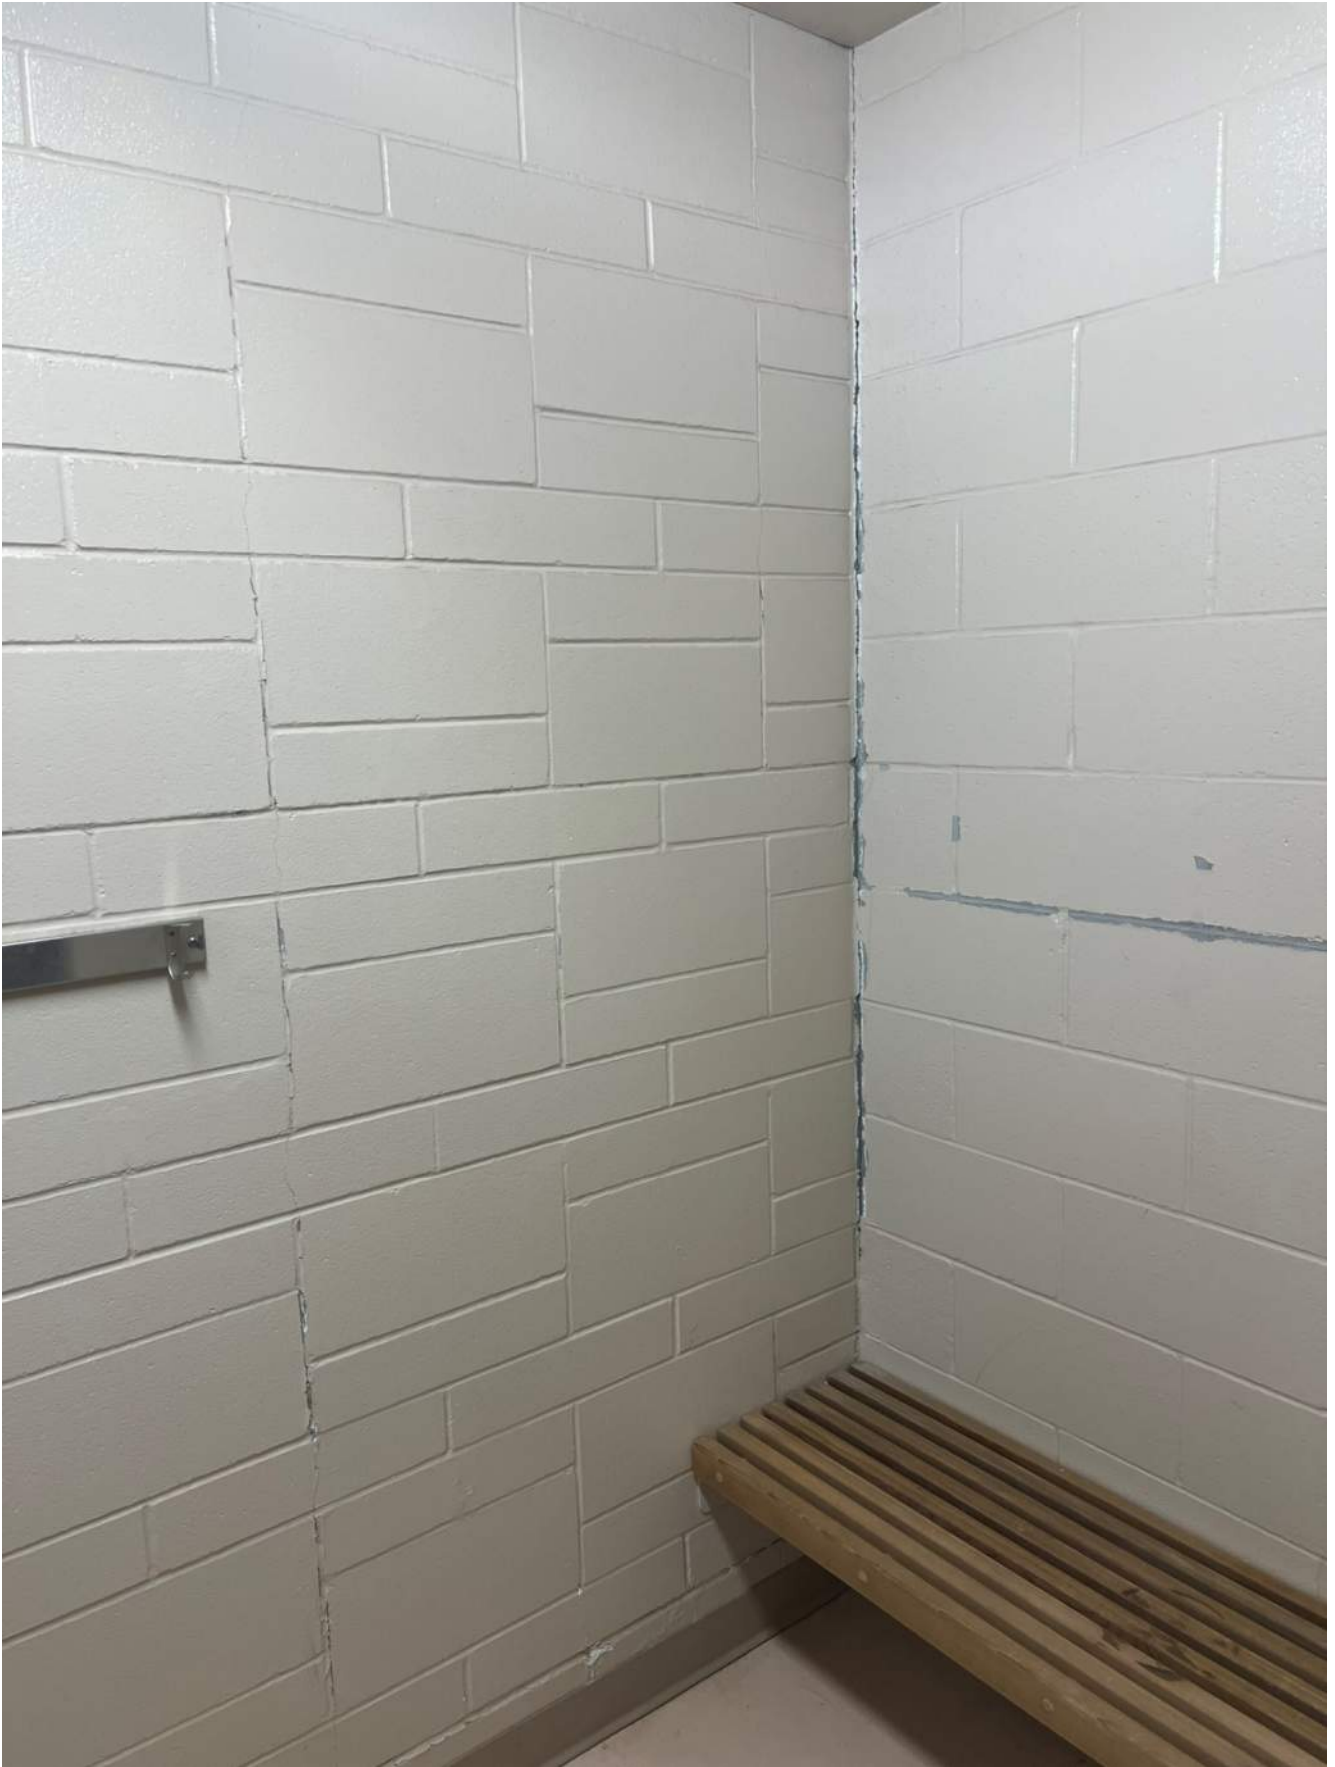
- No major structural concerns were observed.
- On the South side of the gymnasium at the restroom walls, there was some cracking occurring in the CMU walls that appears to be due to settlement. It was noticed at the exterior of the building that roof downspouts discharge at the base of the walls and does not pipe away from the building. In addition, the grading of the landscape generally slopes toward the building. Prolonged infiltration of water next to building foundations can eventually result in settlement issues.

(Above: Cracks in wall of restrooms)
