Morrow County School District Facilities Assessment

May 9, 2024

Morrow County School District Facilities Assessment Report

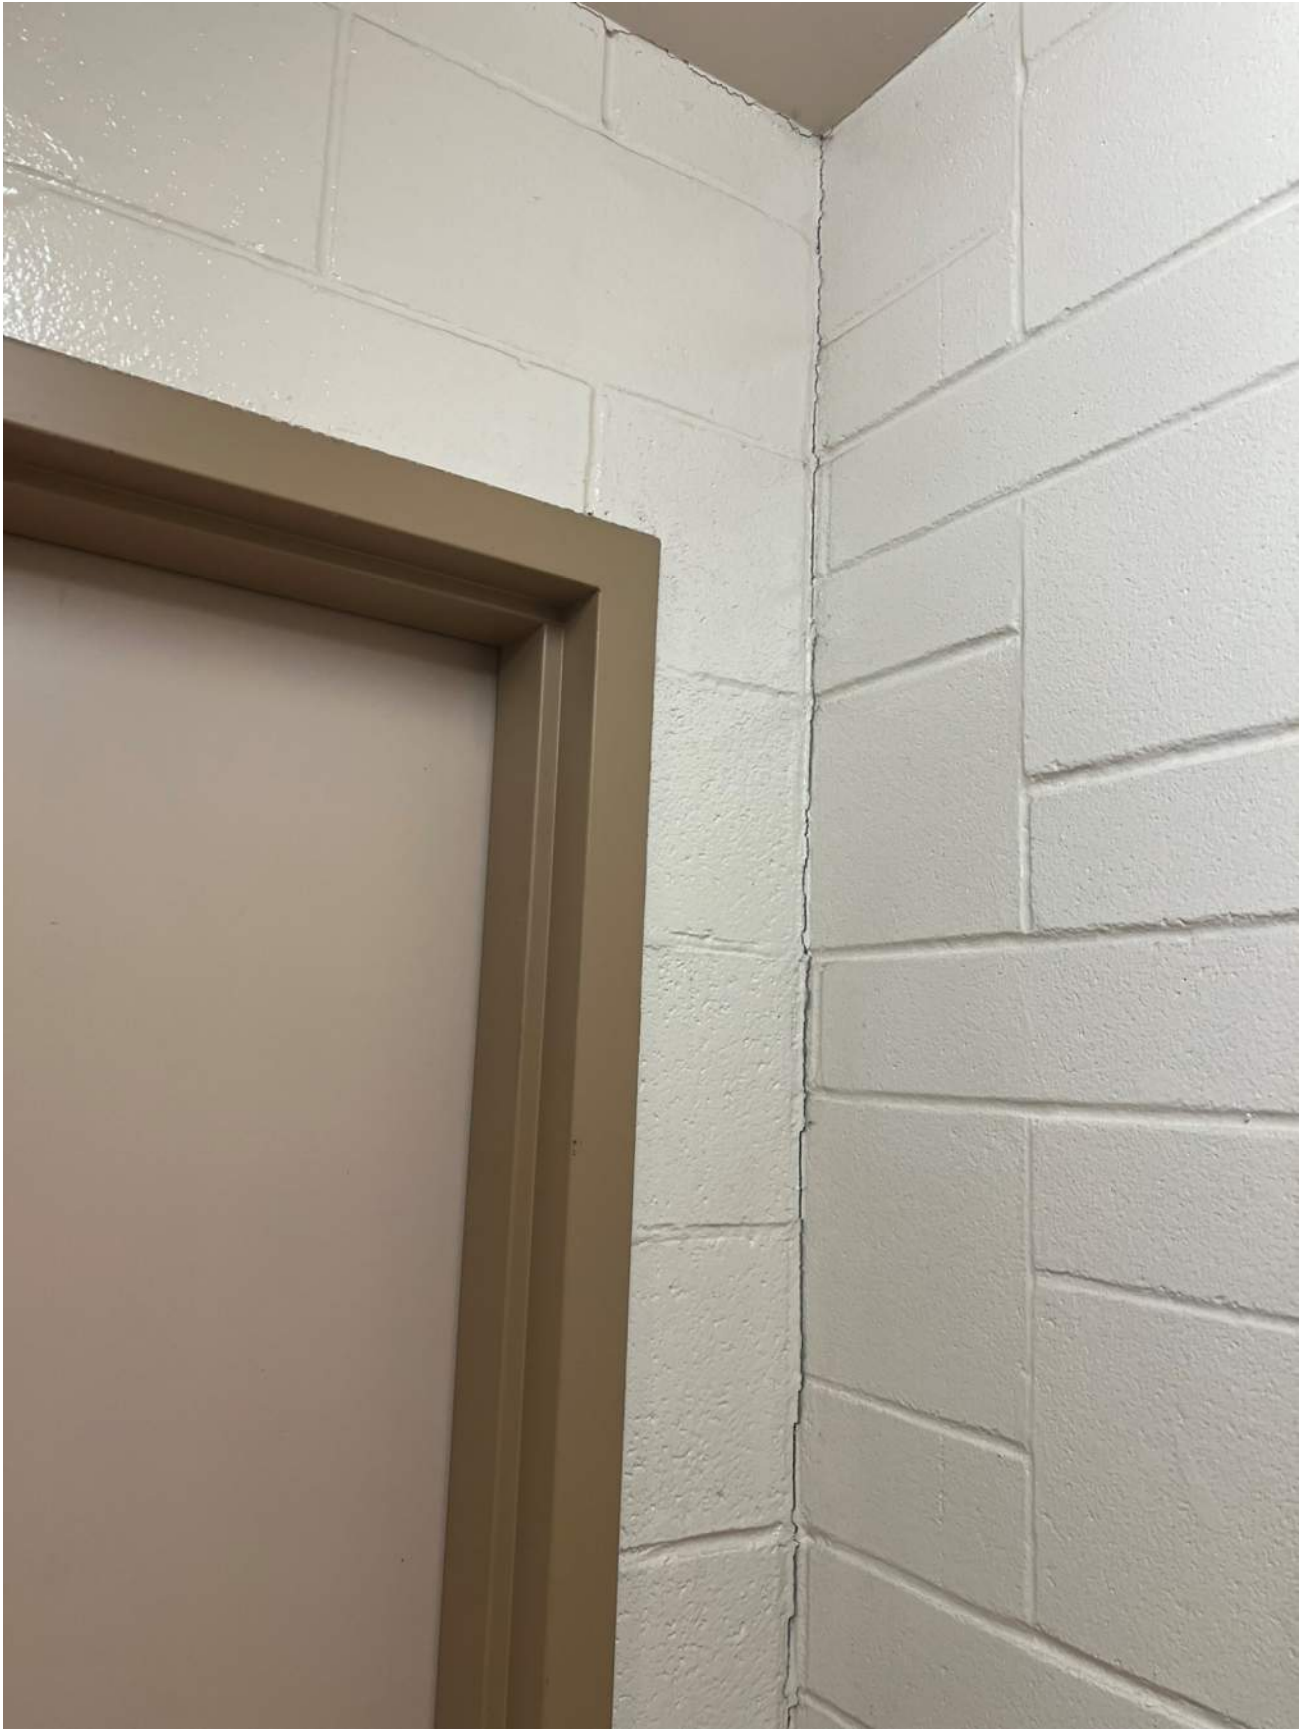
- No major structural concerns were observed.
- On the South side of the gymnasium at the restroom walls, there was some cracking occurring in the CMU walls that appears to be due to settlement. It was noticed at the exterior of the building that roof downspouts discharge at the base of the walls and does not pipe away from the building. In addition, the grading of the landscape generally slopes toward the building. Prolonged infiltration of water next to building foundations can eventually result in settlement issues.

(Above: Cracks in wall of restrooms)

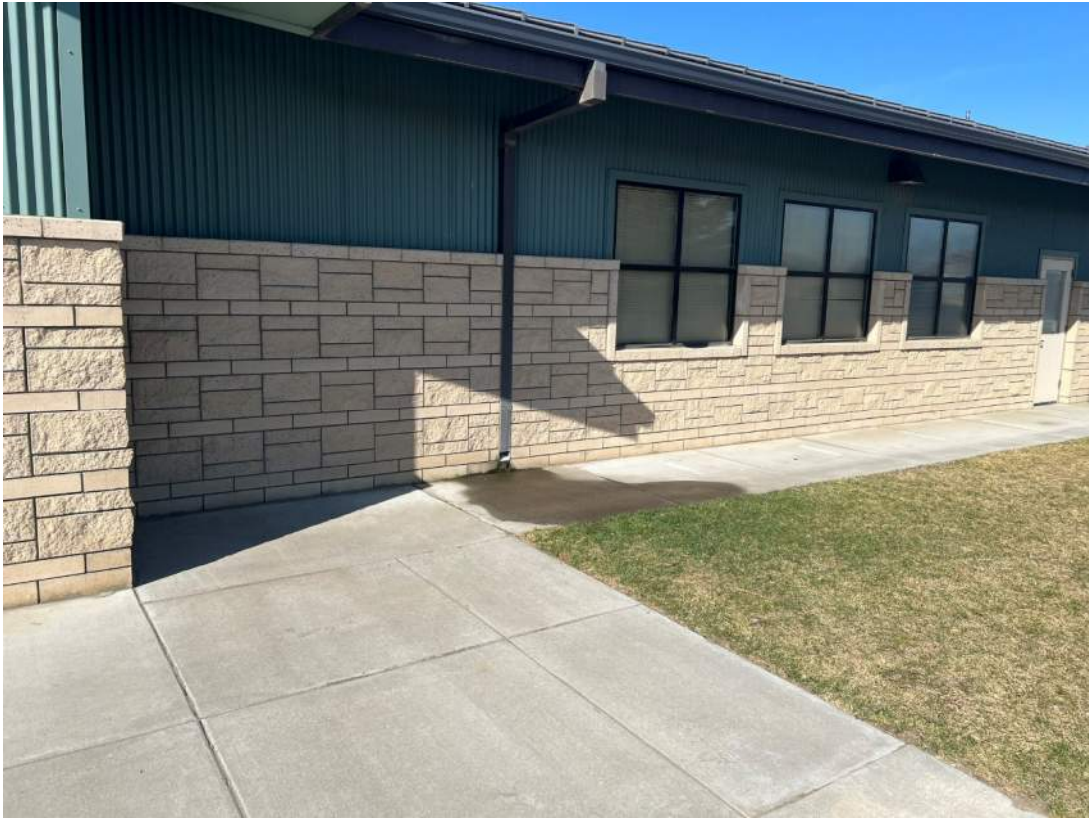
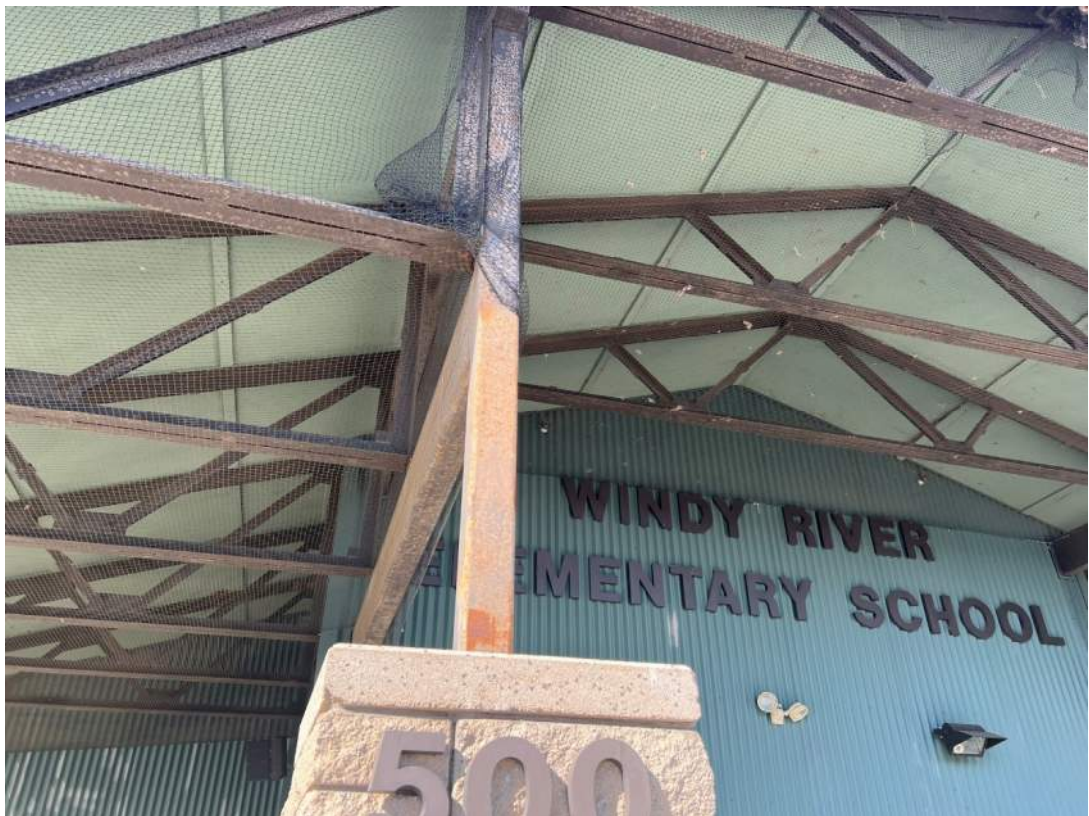
- At the main East entry and South entry into the gymnasium, the steel beams and joists are showing signs of rust and weathering. If not maintained, over time the rust will continue to

degrade and may start to drip down onto the CMU block and be unsightly. Over long periods of time the rust may degrade the steel and become a structural concern.

(Above: Downspout draining next to wall Below: Weathered steel @ entries)
